**ERA19FA049**

**Lancair Legacy RG – N8448J**

**NTSB COMPONENT EXAMINATION REPORT**

**Control Sticks, Trim Switches, Elevator Trim Tab Servo**

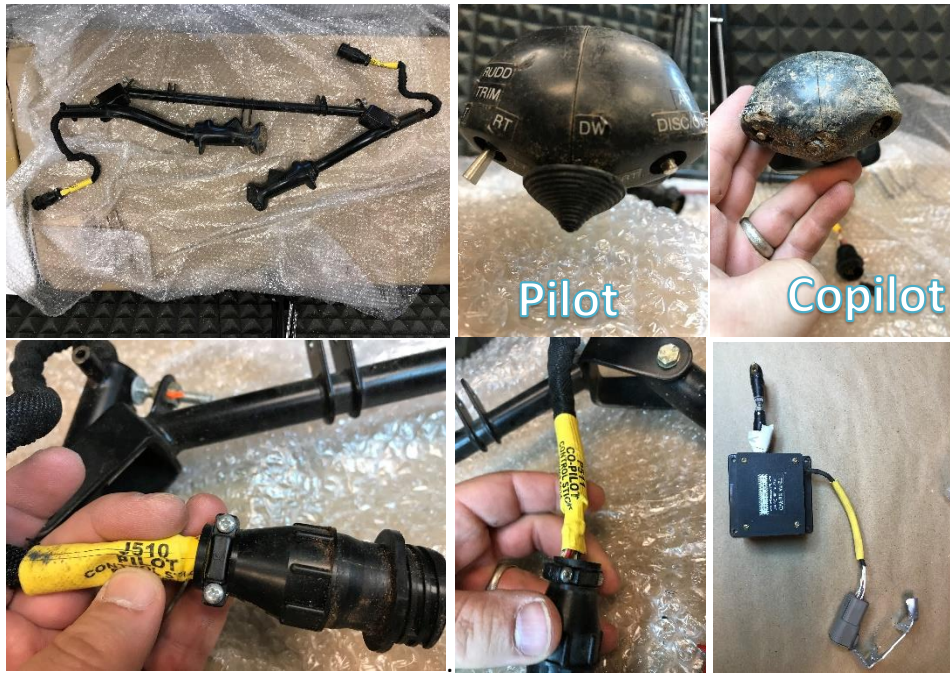
The pilot (left) side 4-way trim switch was undamaged. The copilot (right) side trim switch “china hat” had broken from the switch shaft and was not attached. The hole in the grip surrounding the broken shaft was filled with dirt. The switch shaft was found slightly left of the center of the hole (toward the left roll trim position). The wiring connectors for both control sticks were intact and undamaged.

The elevator trim tab servo was in good condition with its wiring and connector attached. The turnbuckle “push-pull” rod was slightly bent, and was attached to the servo actuator arm.

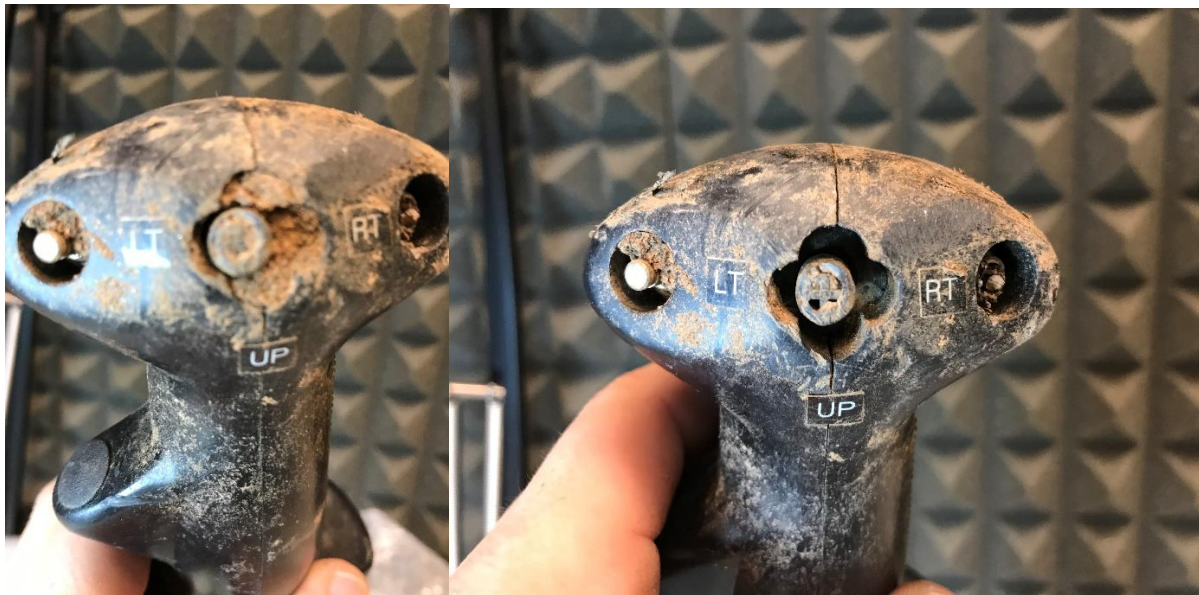
Copilot (right) control stick grip

The dirt surrounding the trim switch shaft on the copilot (right) side control stick was removed to allow the switch to move.

For the copilot (right) trim switch, when moving the broken switch shaft to the left (roll trim left) position, more force was required to detect continuity in the wires than was needed when moving switch to the right, up or down positions.

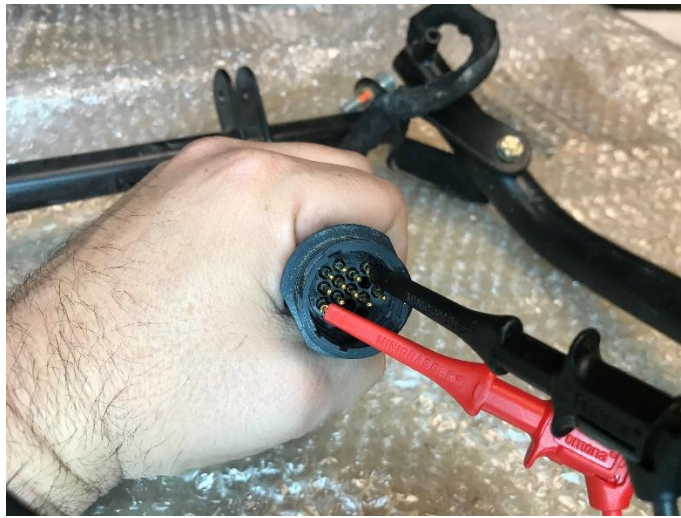
Continuity was tested at the connector pins in all cases, as shown by example in the figure below.

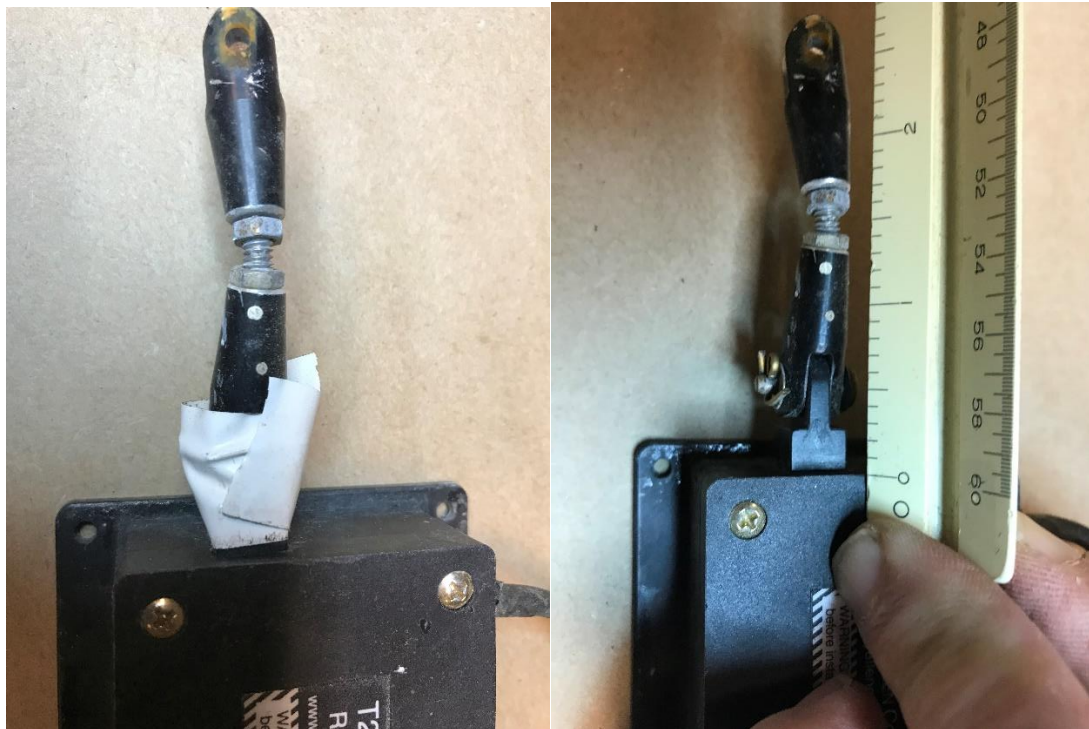
The servo motor actuator arm was marked with white tape before it was removed from the airplane, to note its position as found. When removed, the elevator trim tab was found deflected about 30-35° trailing edge up, relative to the elevator (this direction is airplane nose downward trim). The tape was removed, and the arm was scribed on all sides where it met the servo body, to maintain the reference for the as found position of the arm.

The arm extension, as measured from the servo body to the edge of the shoulder of the connecting tab, was 0.25 inch.

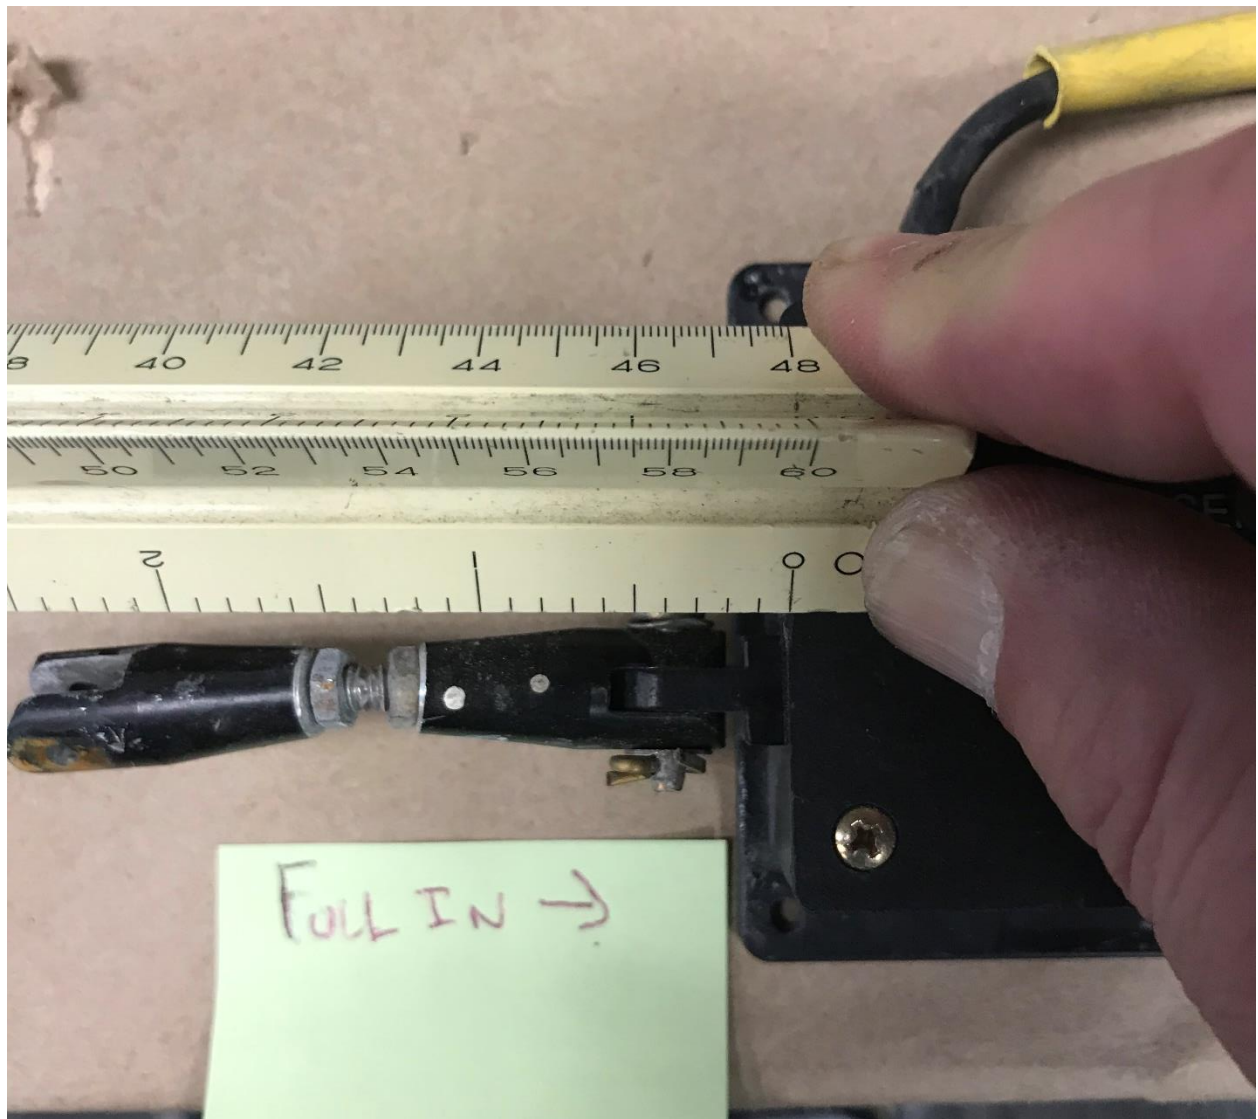
After applying 12VDC to the motor wires at the connector, the arm retracted into the body until it stopped. The arm extension at the “full in” position was measured as 0.15 inch

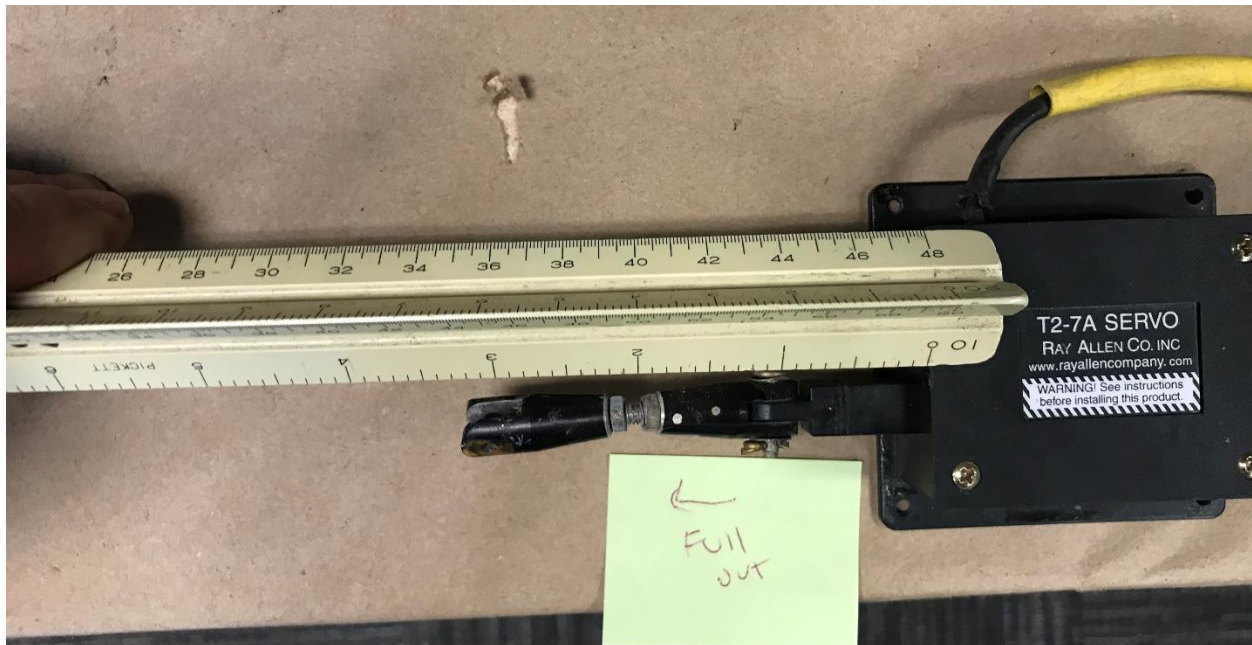
The voltage polarity was reversed, and the arm extended outward from the body until it stopped. The arm extension at the “full out” position was measured as 0.80 inch.
