## **NATIONAL TRANSPORTATION SAFETY BOARD**

# **EXAMINATION SUMMARY**

**ERA19FA059**

Location: Apalachicola, Florida  
Date: November 30, 2018  
Time: 1805 EST  
Airplane: Cessna 210D, N3995Y

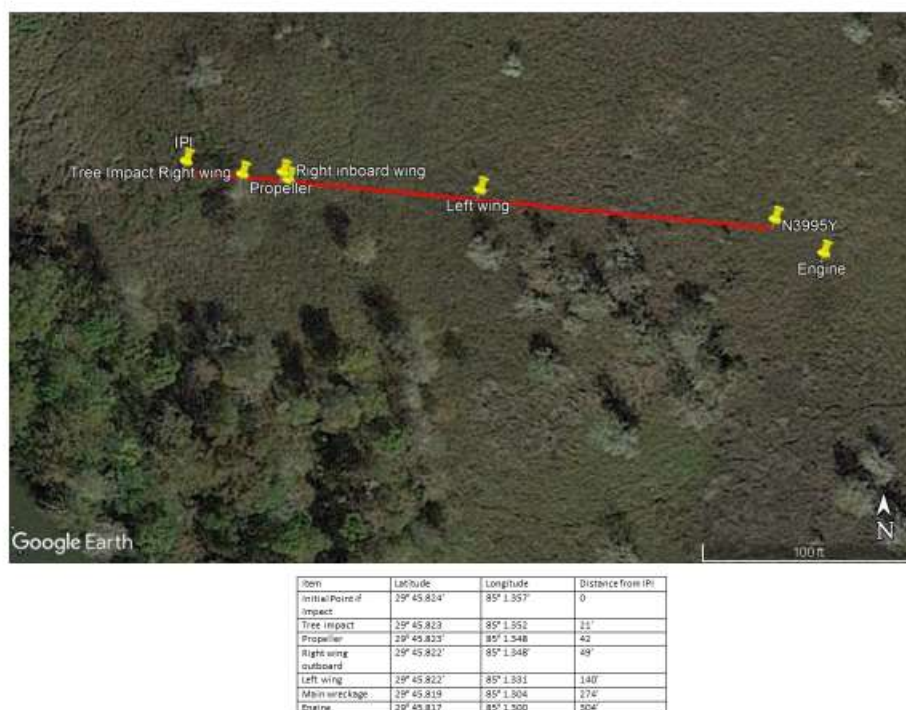
**Figure 1 – Wreckage Diagram**

The accident site examination was conducted on December 2, 2018. The airplane impacted a marsh, adjacent to the Apalachicola River, about 2 miles north of AAF. The coordinates of the main wreckage were 29° 45.819N, 085° 1.304W. The right wing impacted the base of a cypress tree near the point of initial impact. Components of the airplane located near the point of initial impact included right wing components, a main landing gear strut, and the propeller. The wreckage path was oriented on a heading of 100° and was about 304 feet in length. The main wreckage, located about 274 ft from the point of initial impact, included the fuselage, cockpit, left wing, and empennage. Postaccident fire signatures were observed on the main wreckage. The engine was separated from the airframe and was found about 304 ft from the point of initial impact.
