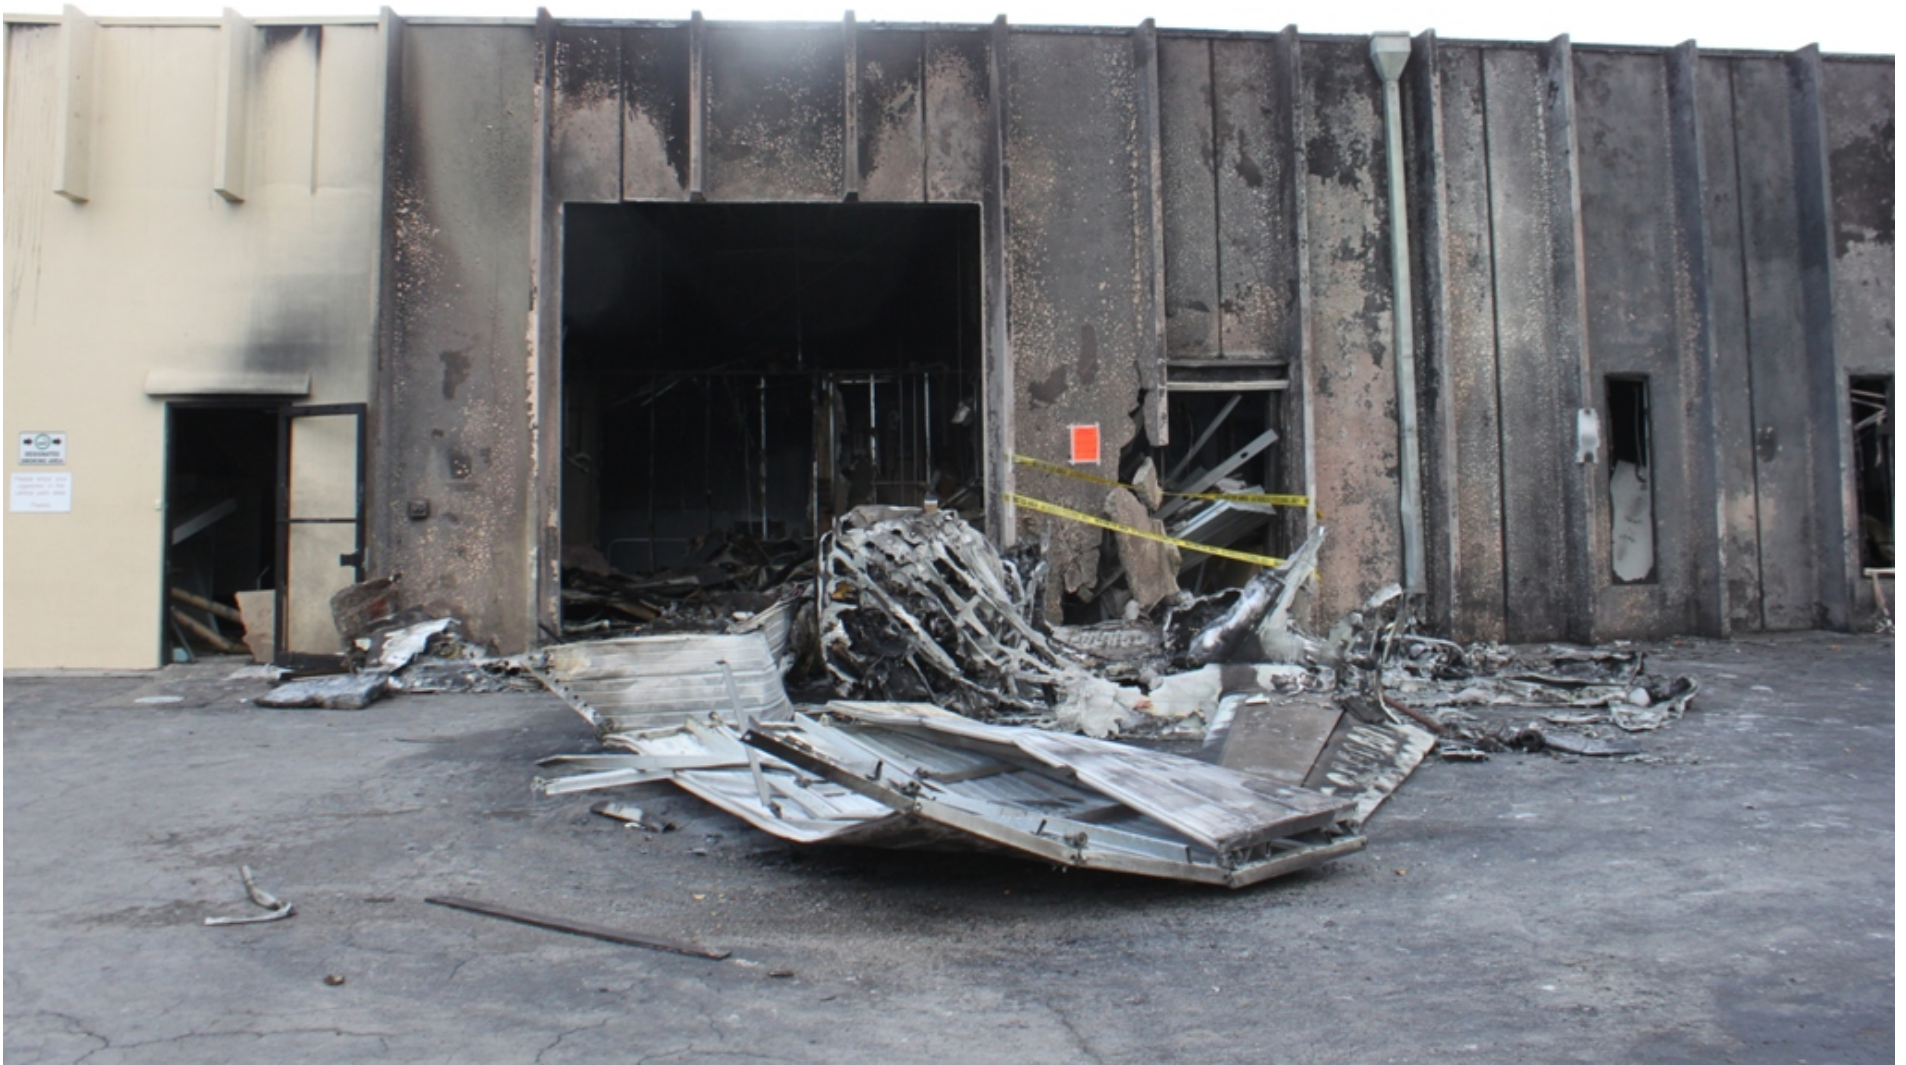
**Photo 1 – NTSB Digital Photograph. View Looking South Showing Wreckage in Relation to Impacted Building.**

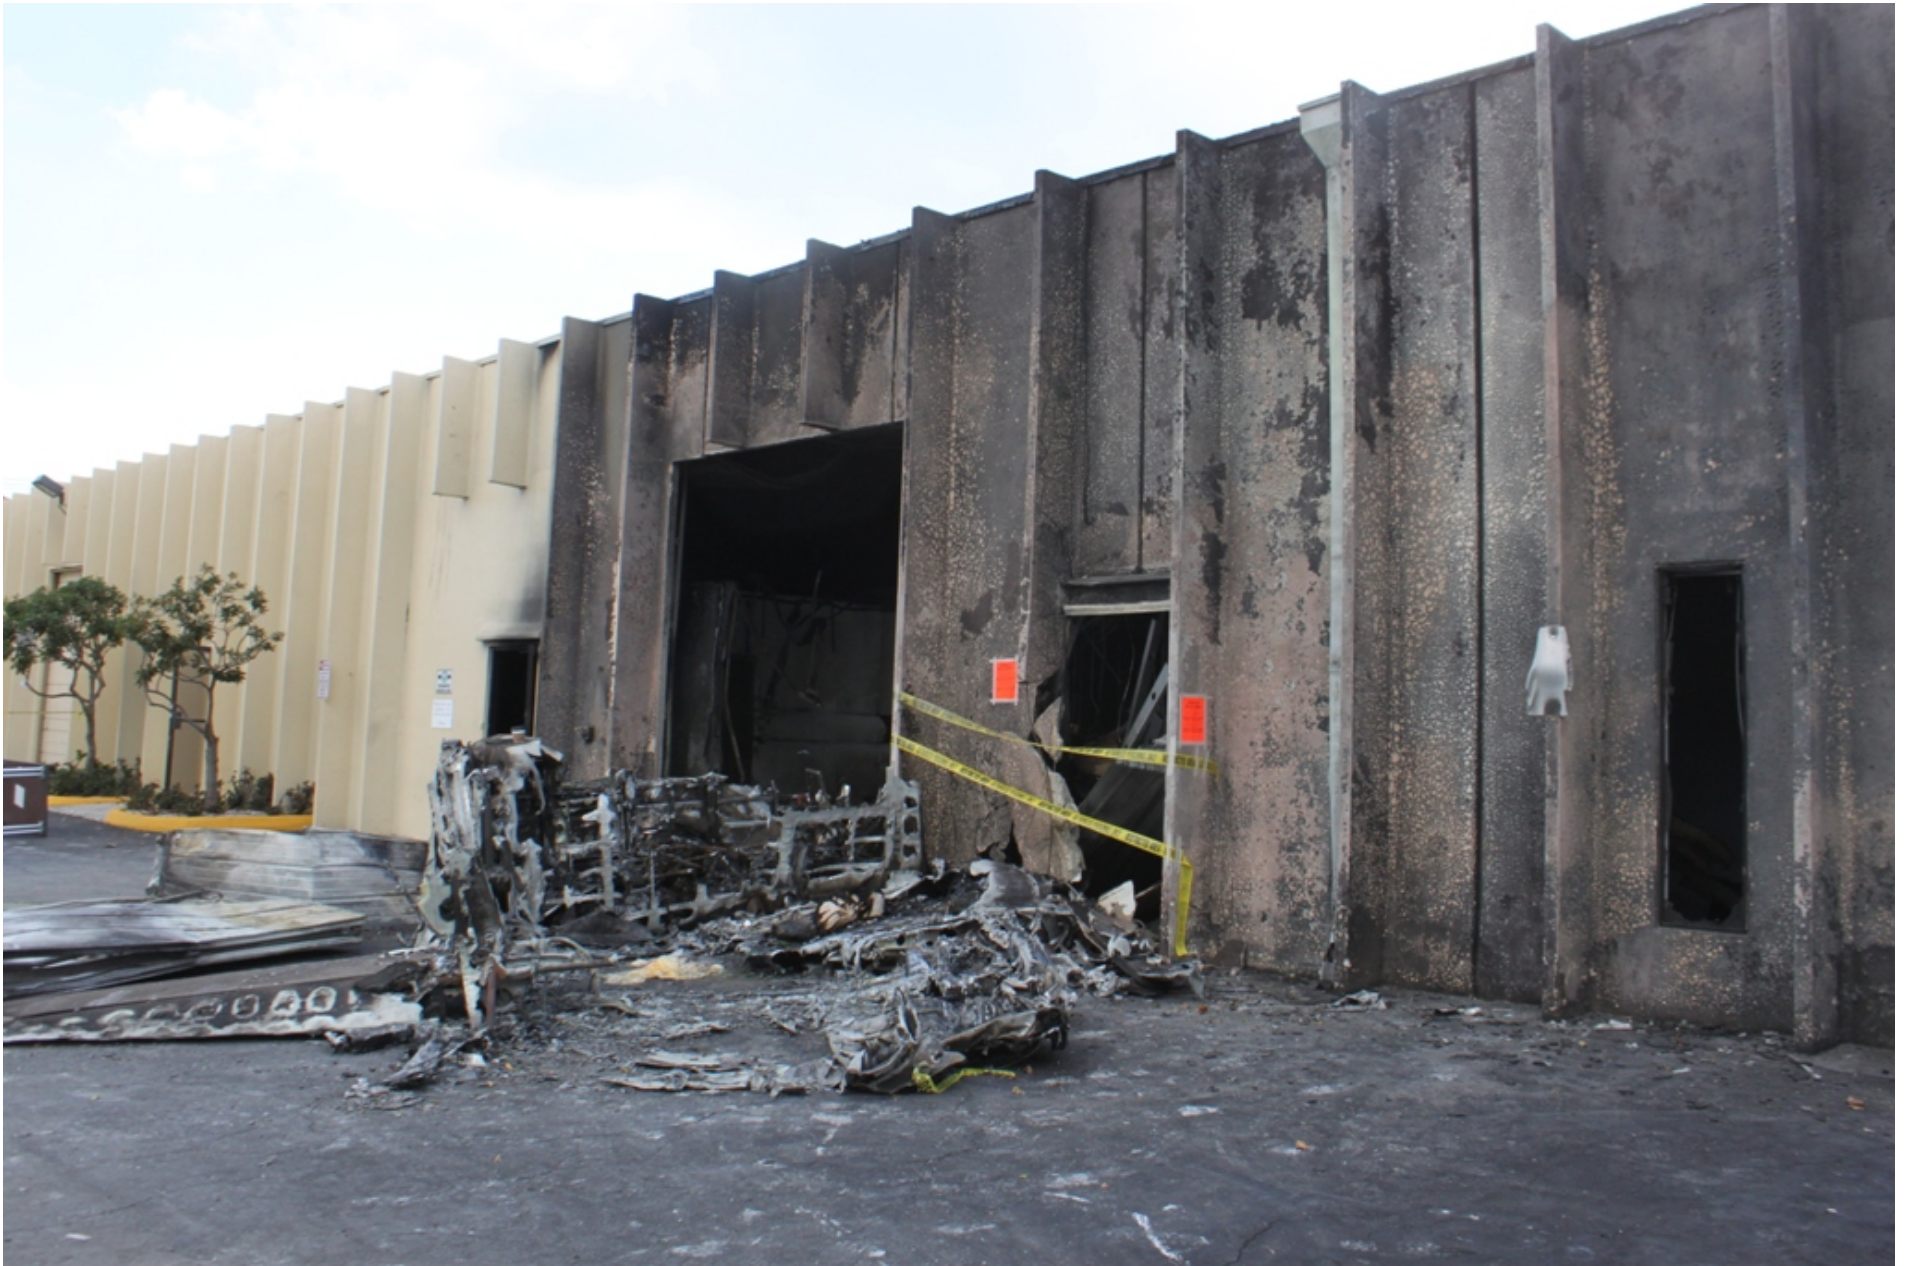
**Photo 2 - NTSB Digital Photograph. Right Rear Quartering View Depicting Wreckage in Relation to Impacted Building.**

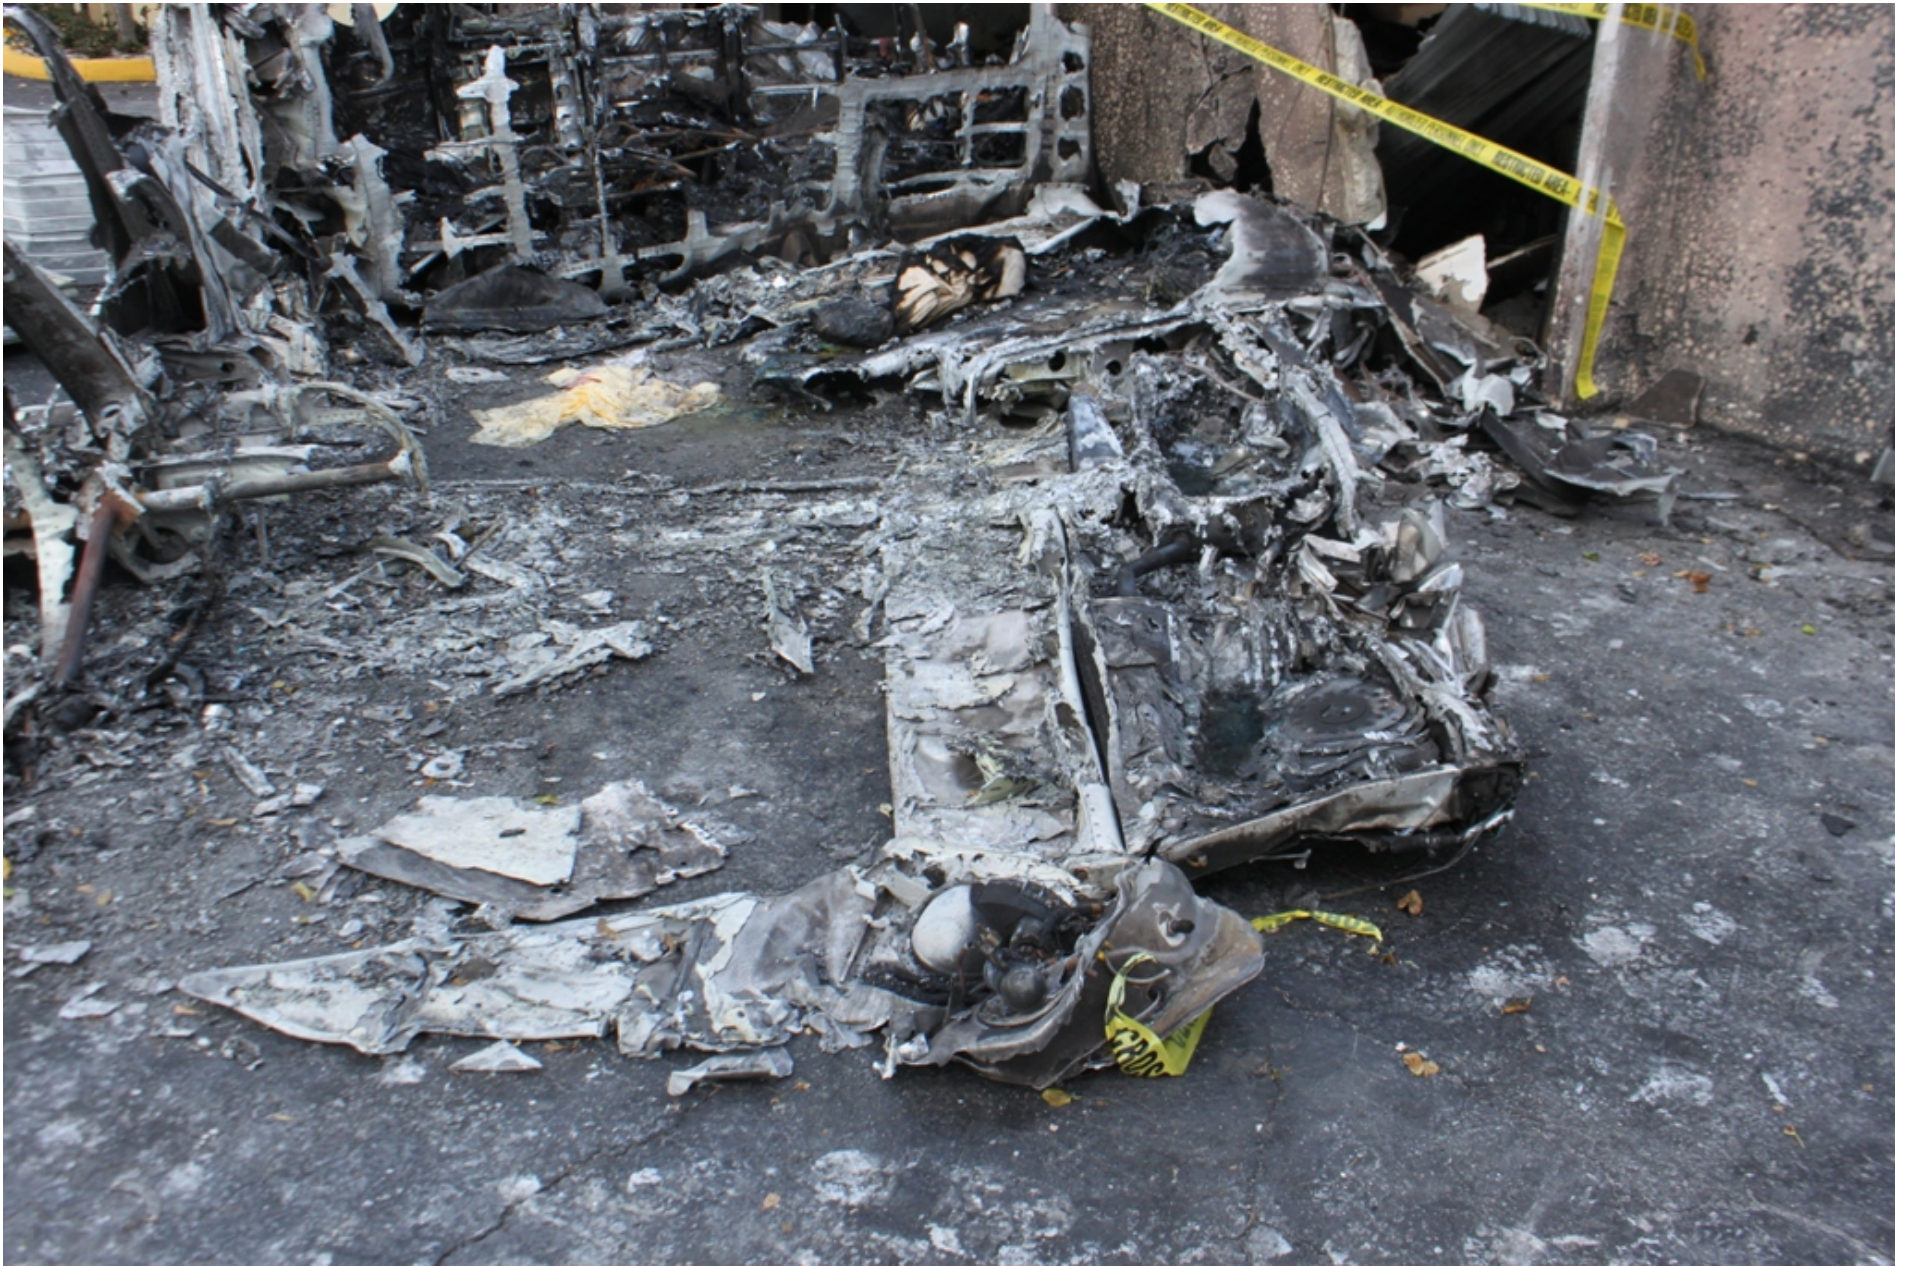
**Photo 3 - NTSB Digital Photograph. Right Side View of the Right Wing, and Portion of the Fuselage.**

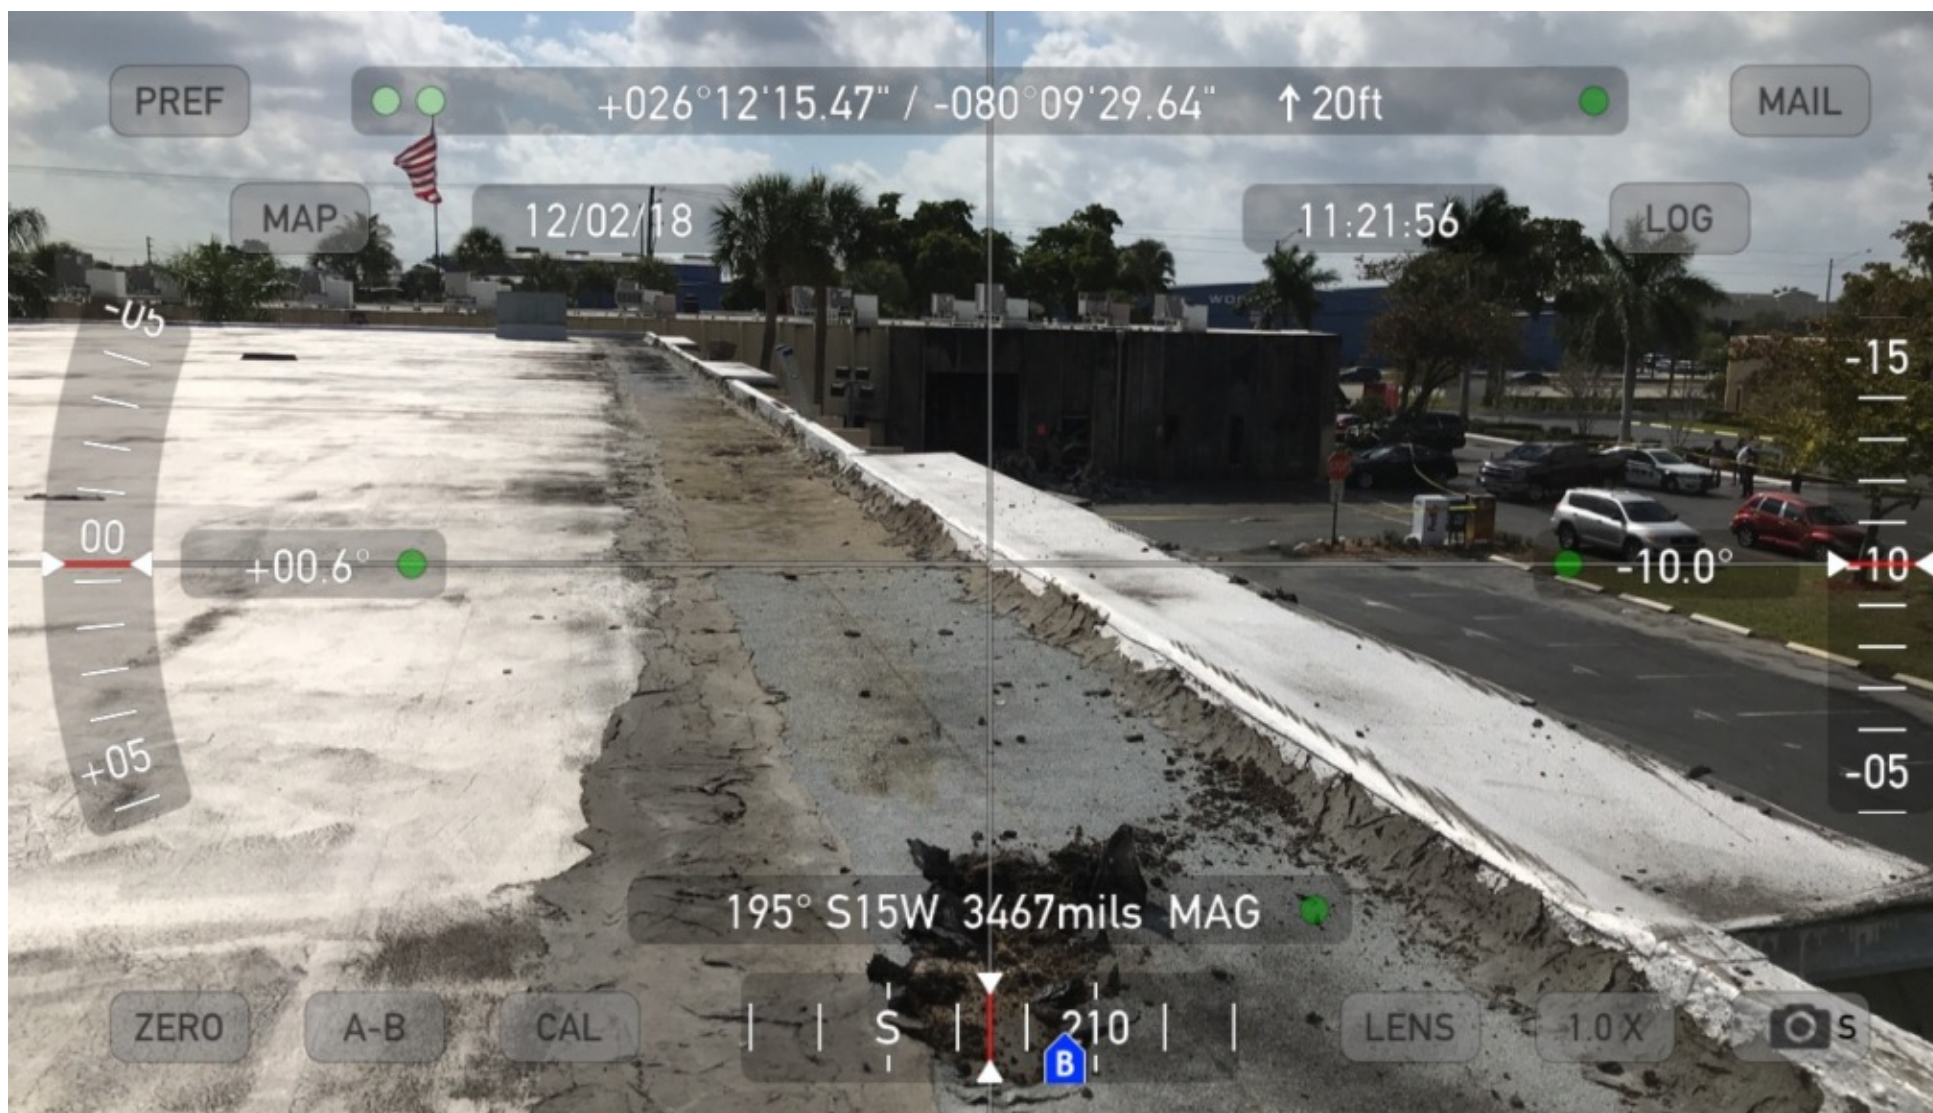
**Photo 4 - NTSB Digital Photograph. View Depicting the Initial Impacted Building with the Wreckage in the Background.**

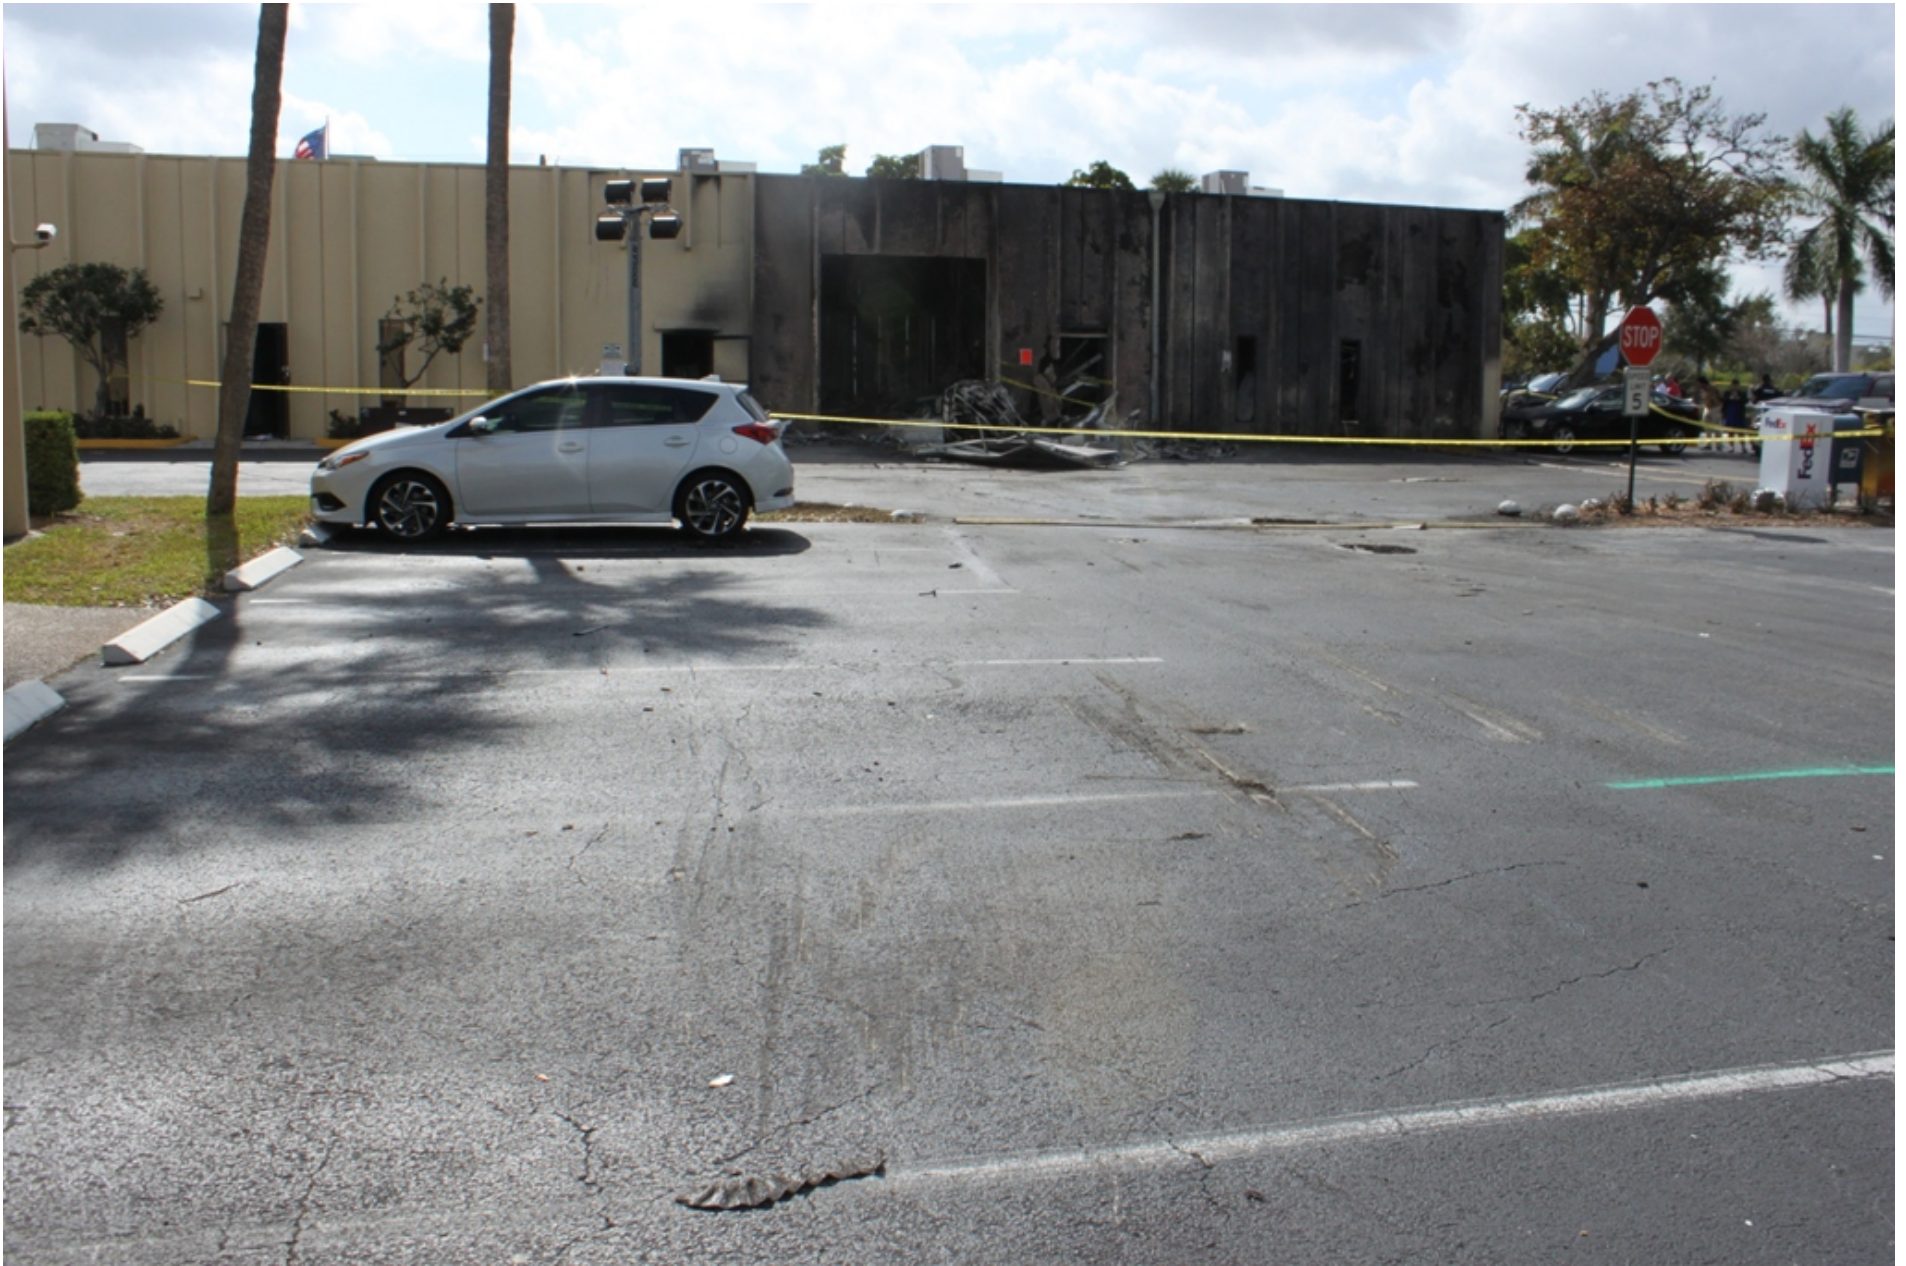
**Photo 5 - NTSB Digital Photograph. View of the Ground Scars With Wreckage in Background.**

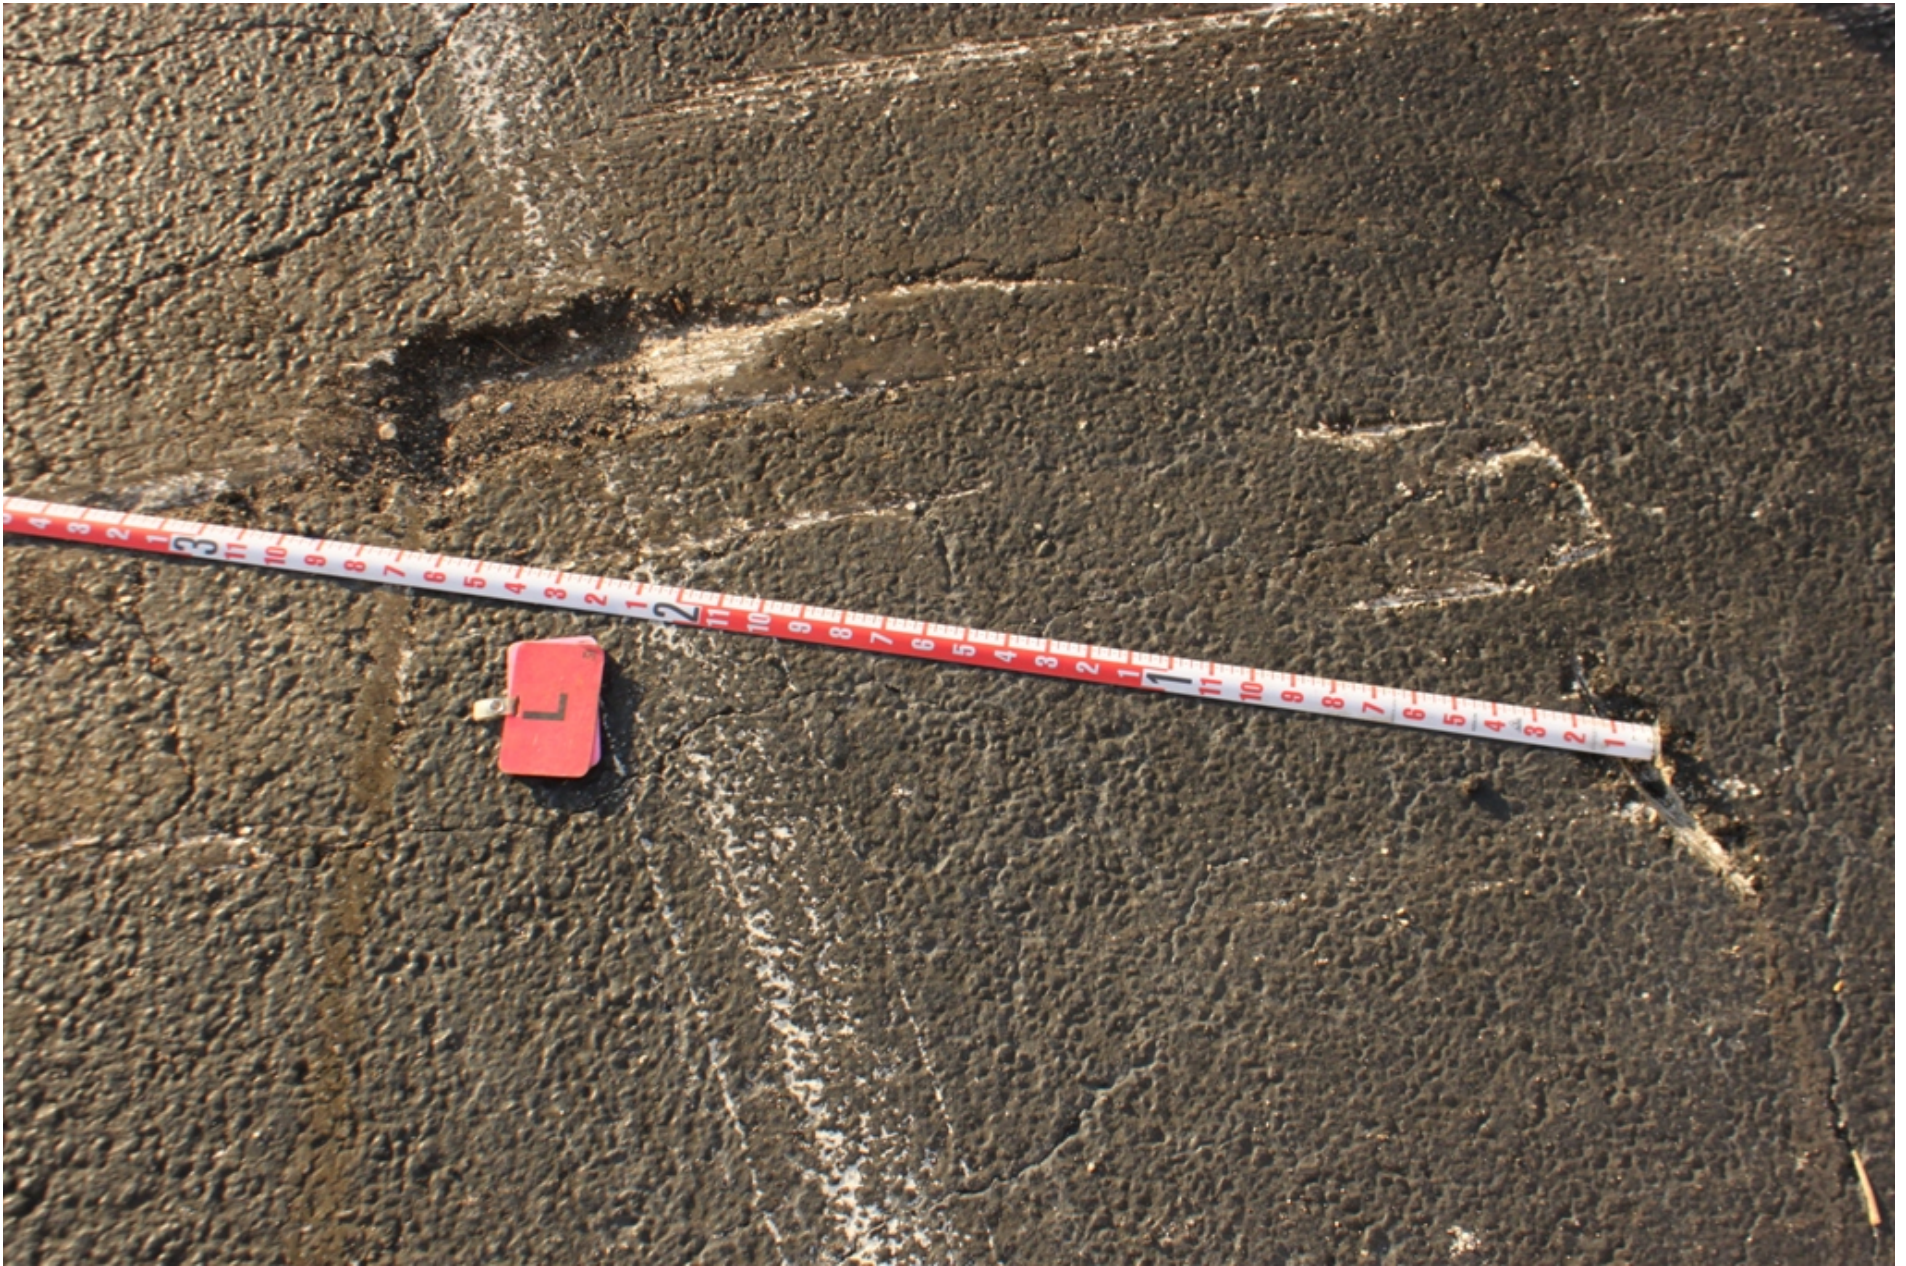
**Photo 6 - NTSB Digital Photograph. View of the First Two Ground Scars From Left Propeller. Note the Distance of About 30.5 inches.**

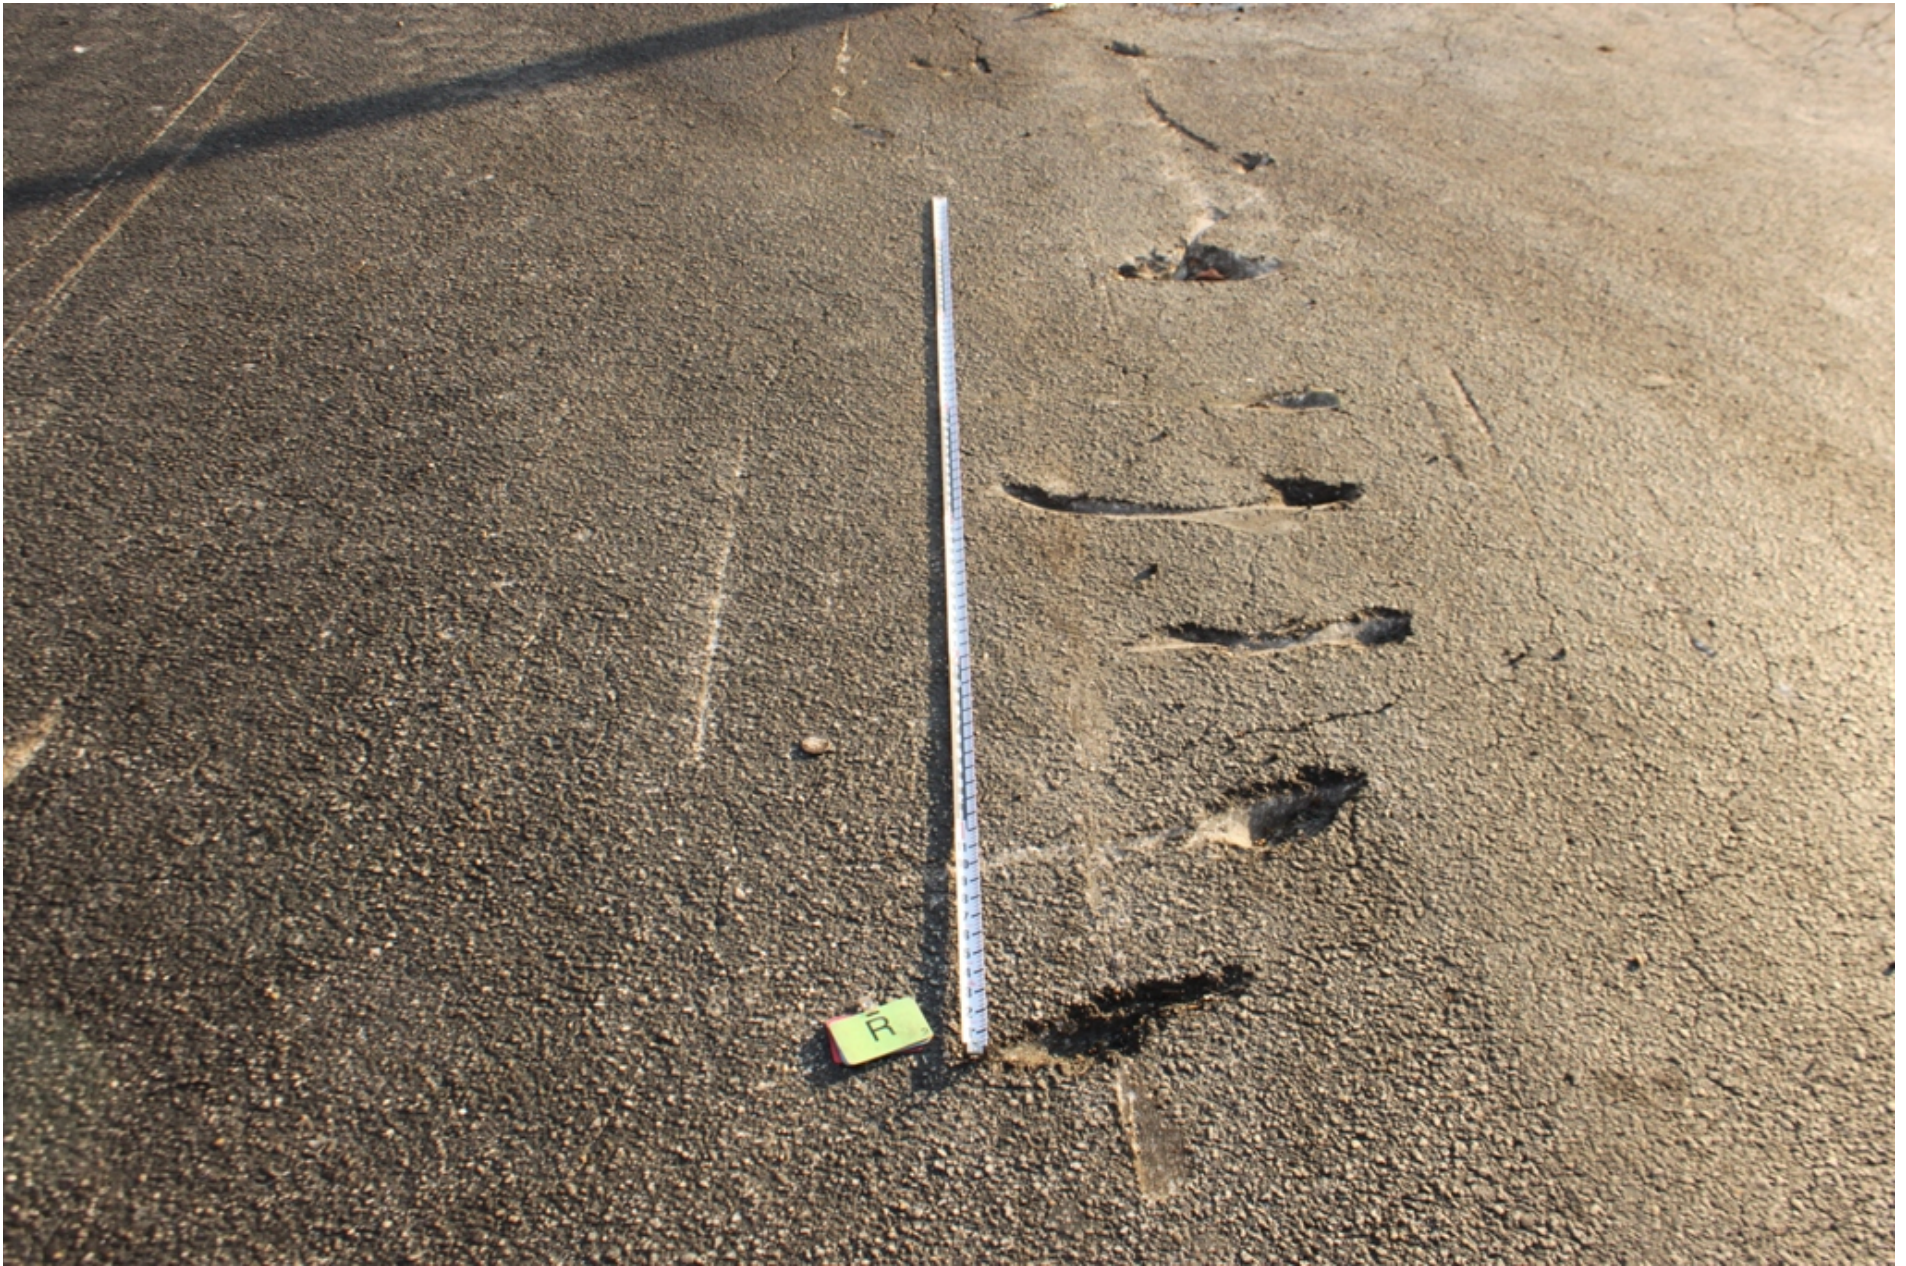
**Photo 7 - NTSB Digital Photograph. View of the Ground Scars From Right Propeller. Note the Close Spacing Between the First and Second Which Measured About 10 Inches.**

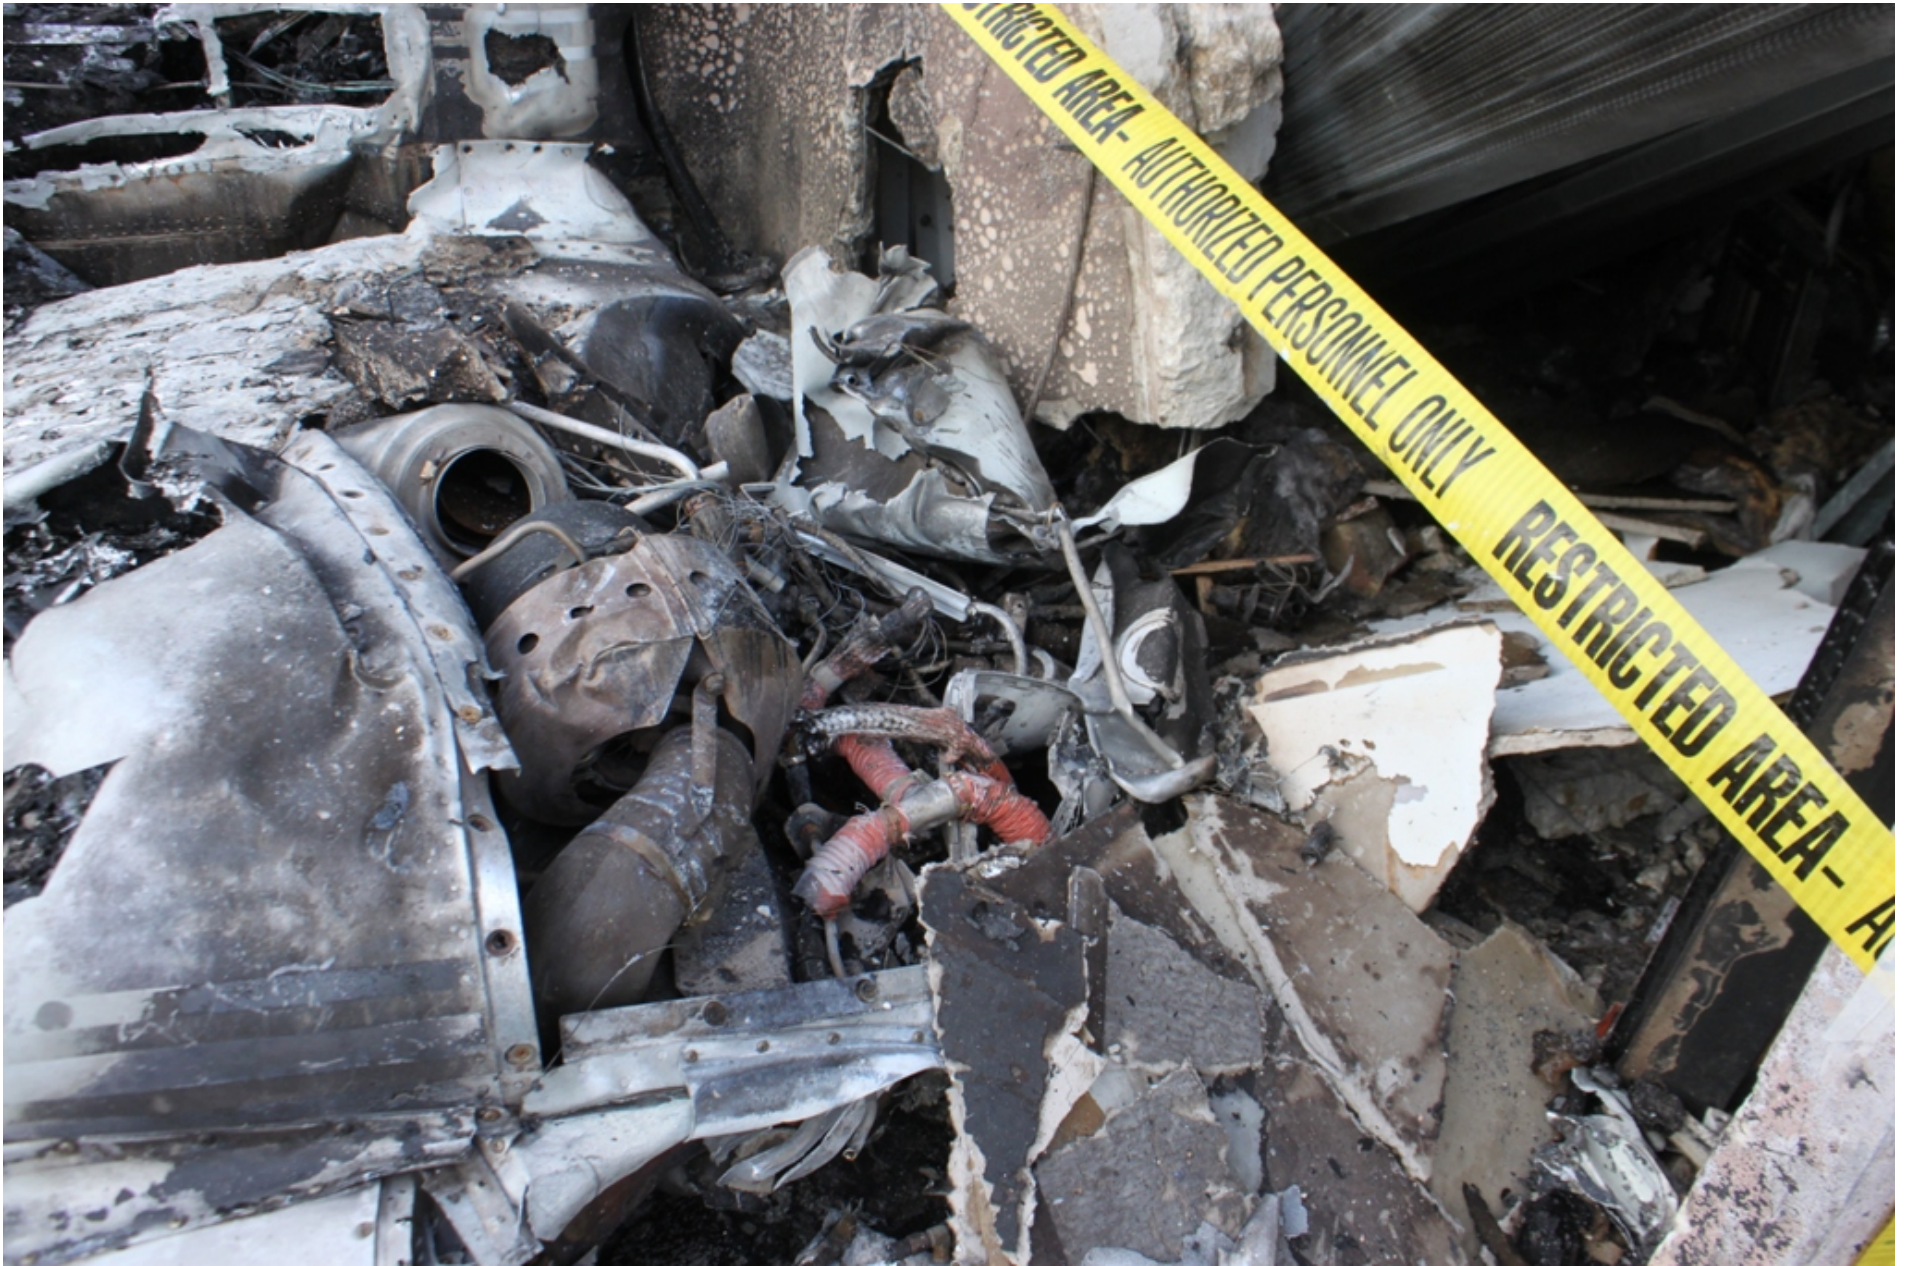
**Photo 8 - NTSB Digital Photograph. View of a Portion of the Left Engine Components.**

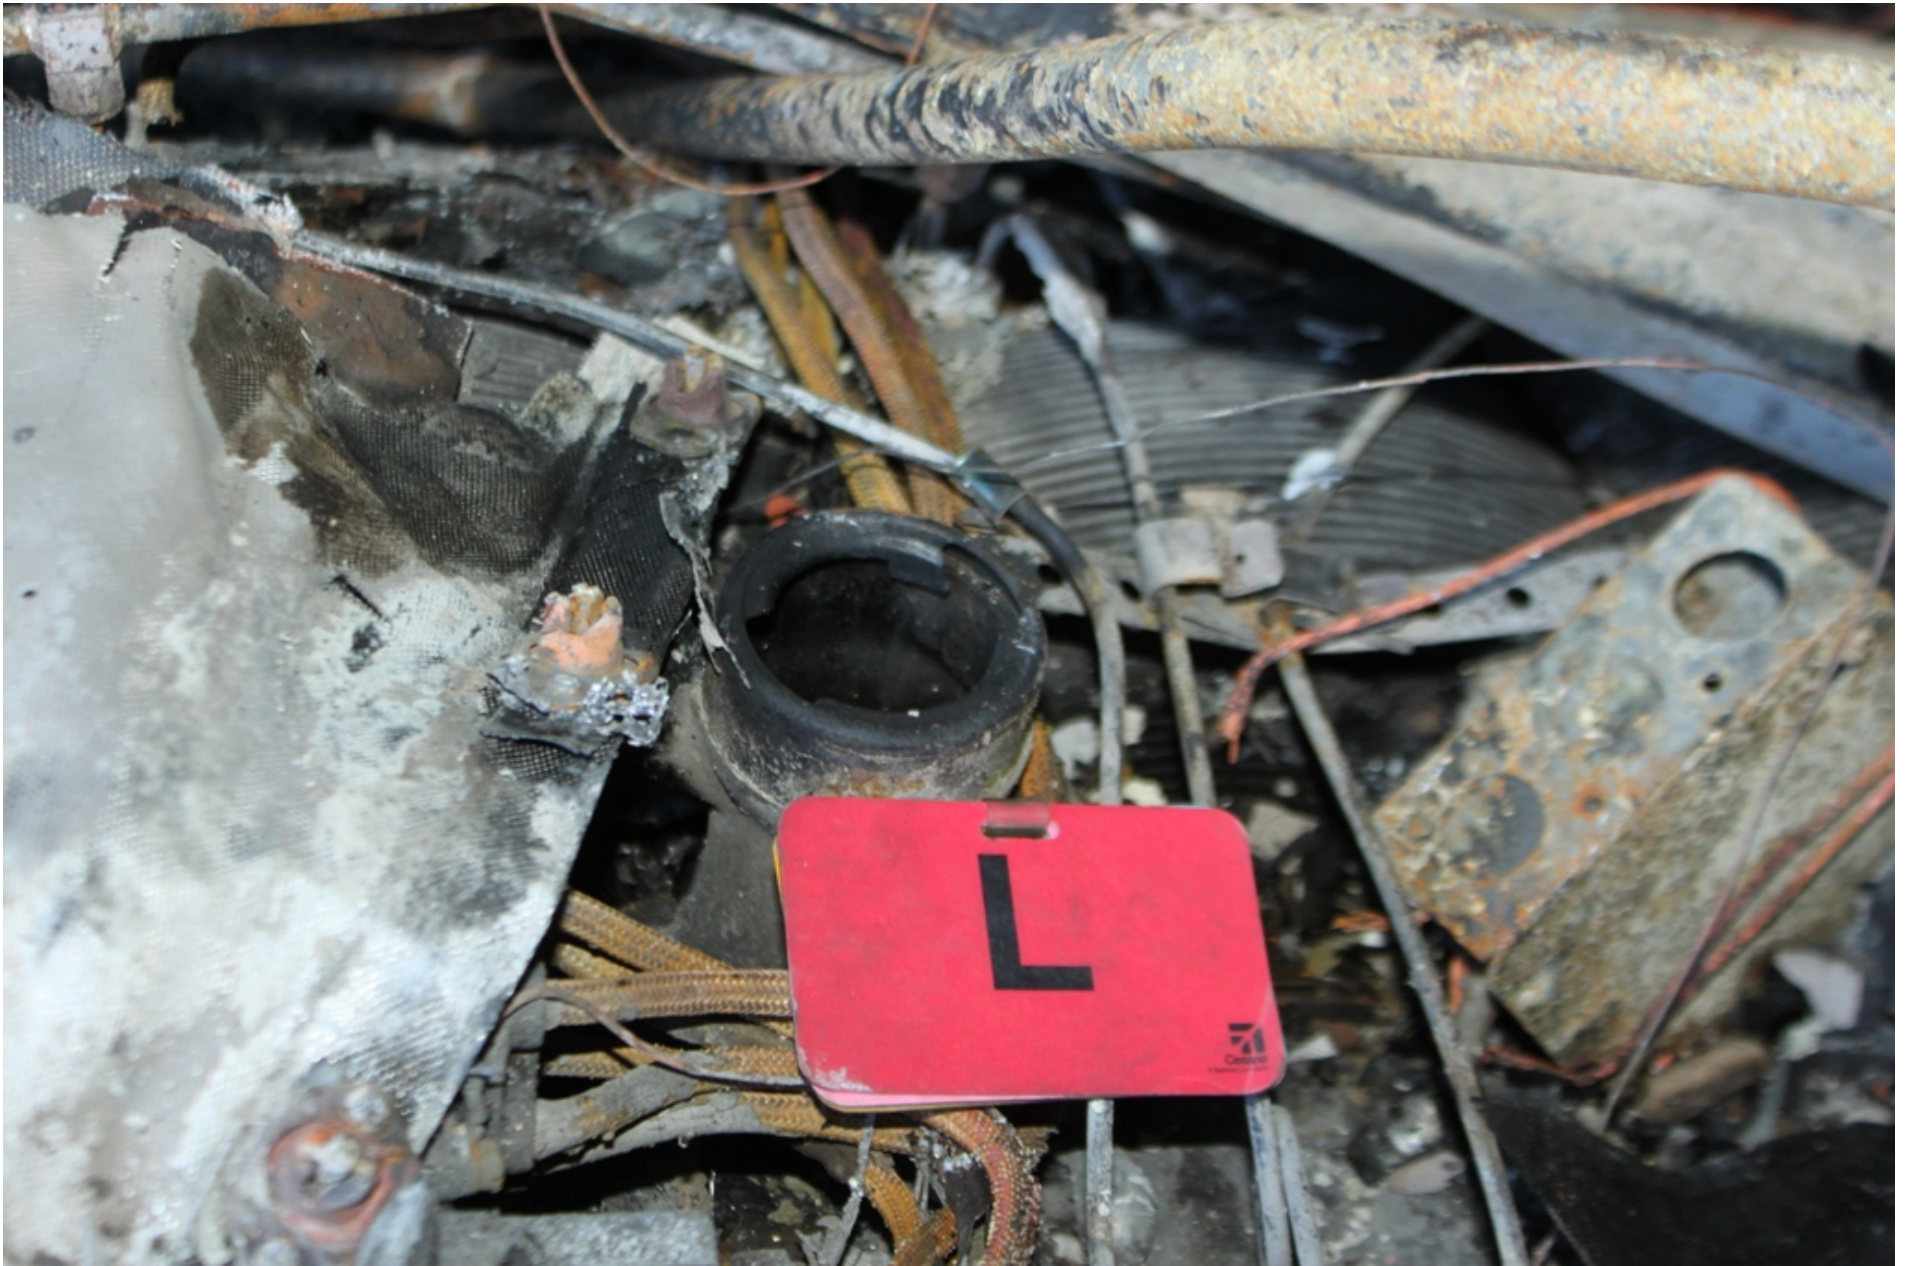
**Photo 9 - NTSB Digital Photograph. View of the Left Engine Breather Assembly. Note the Missing Rod-Oil Gauge and Cap Assembly.**
