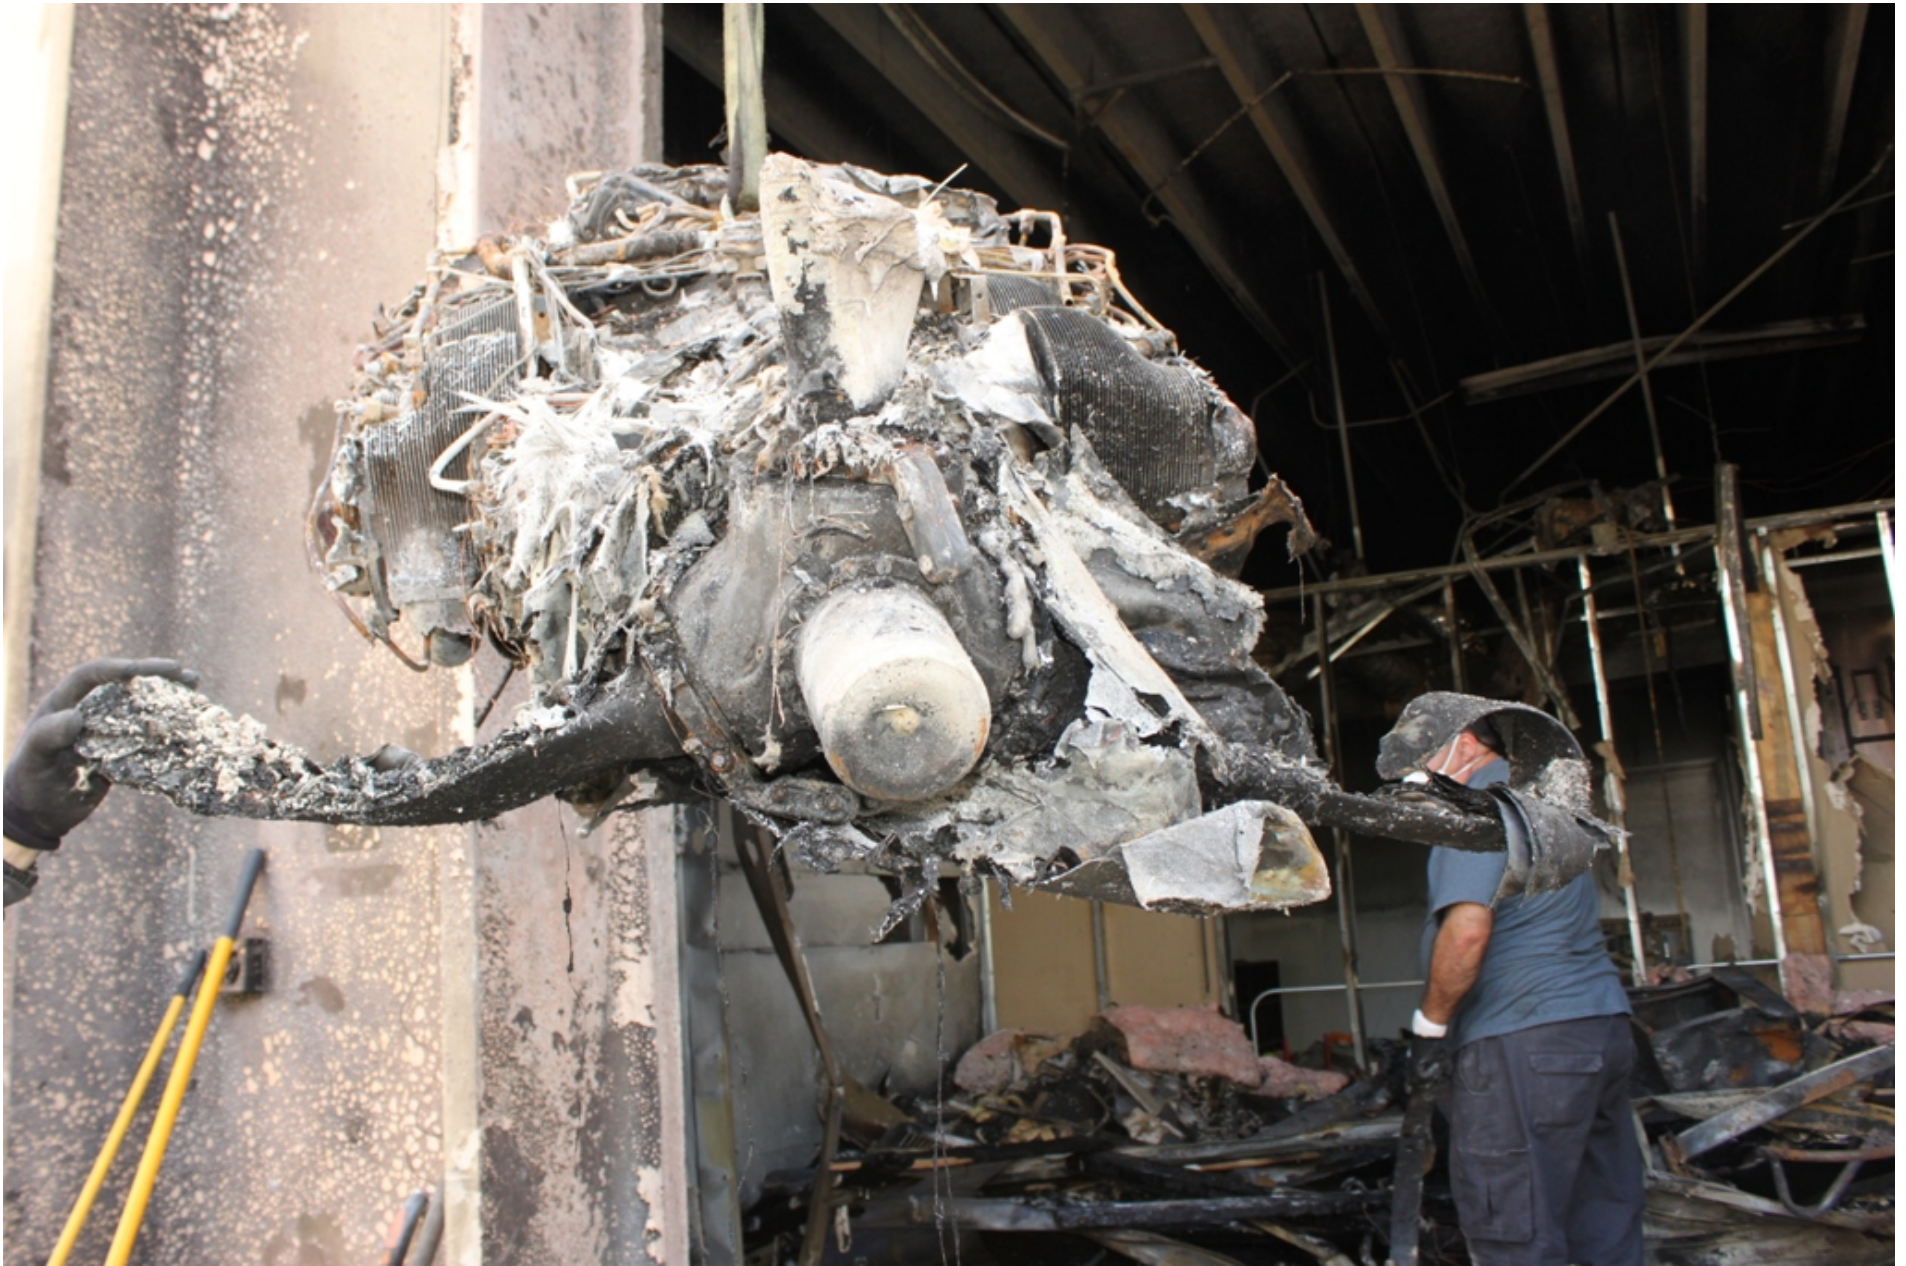
**Photo 10 - NTSB Digital Photograph. View of the Left Engine Assembly With Attached Propeller During Recovery From Building. Note the Extensive Fire Damage.**

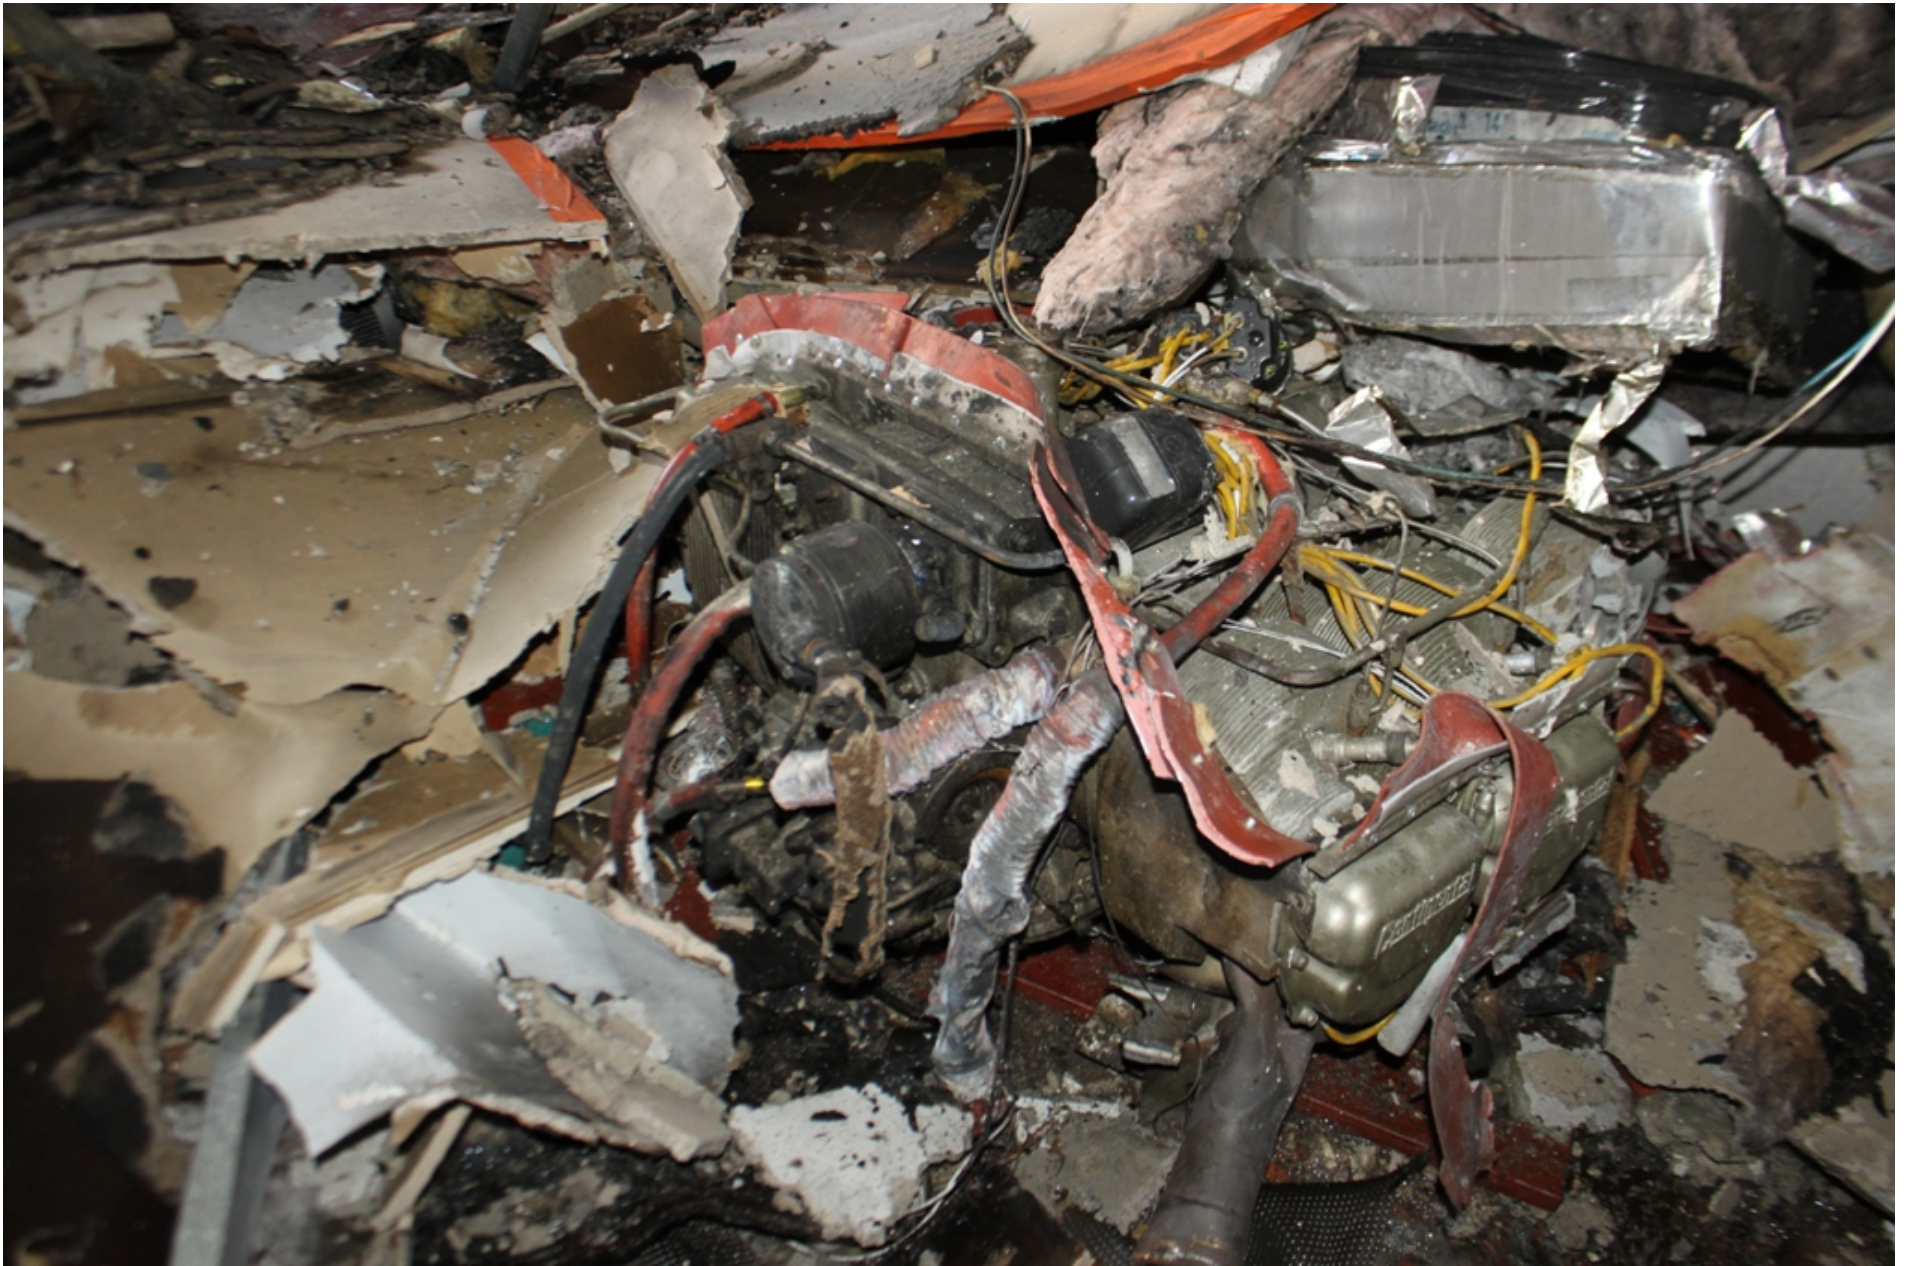
**Photo 11 - NTSB Digital Photograph. View of the Rear Portion of the Right Engine Assembly Before Recovery From the Impacted Building.**

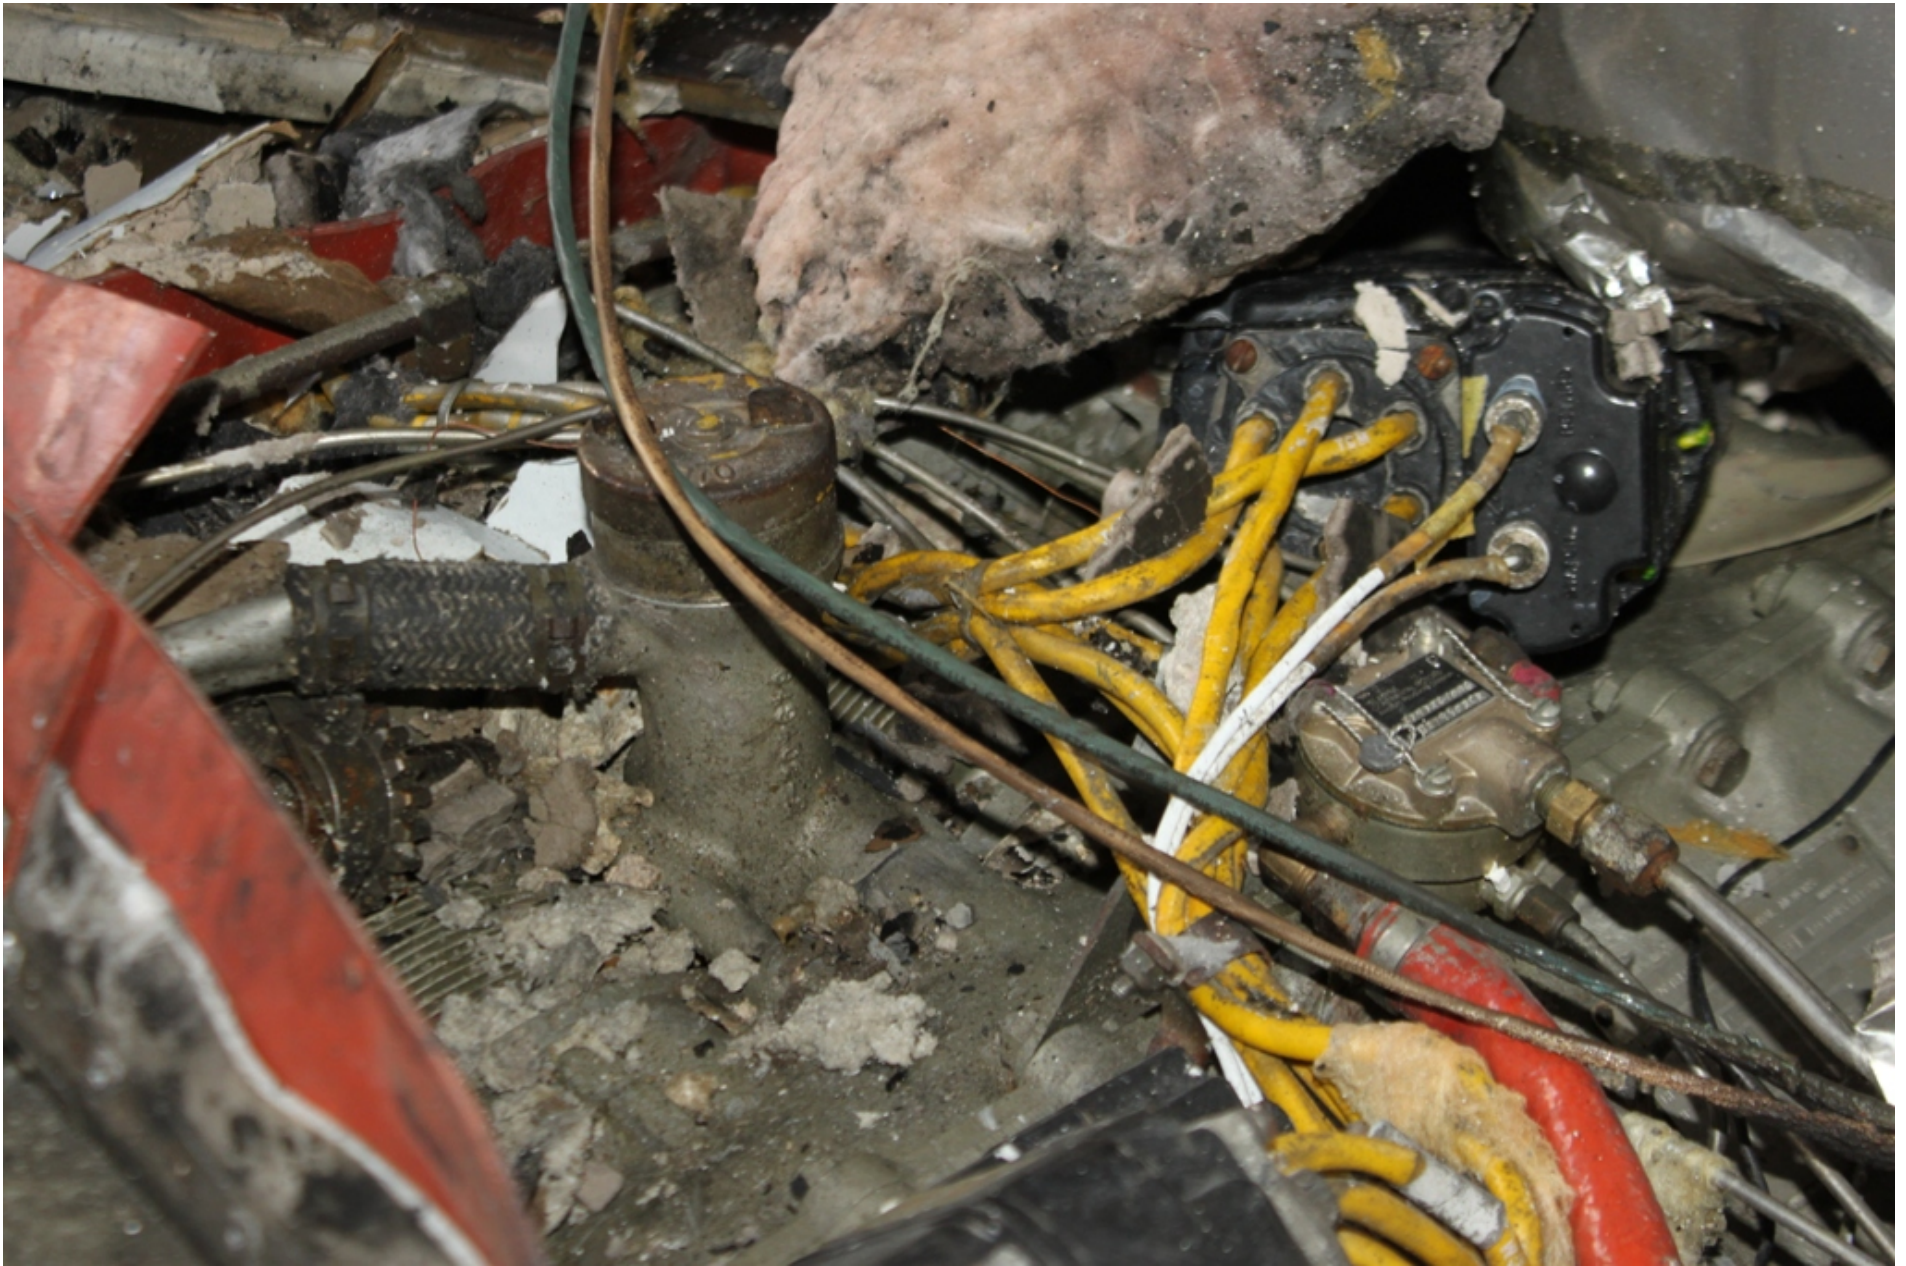
**Photo 12 - NTSB Digital Photograph. View of the Right Engine Breather Assembly and Attached Rod-Oil Gauge and Cap Assembly.**

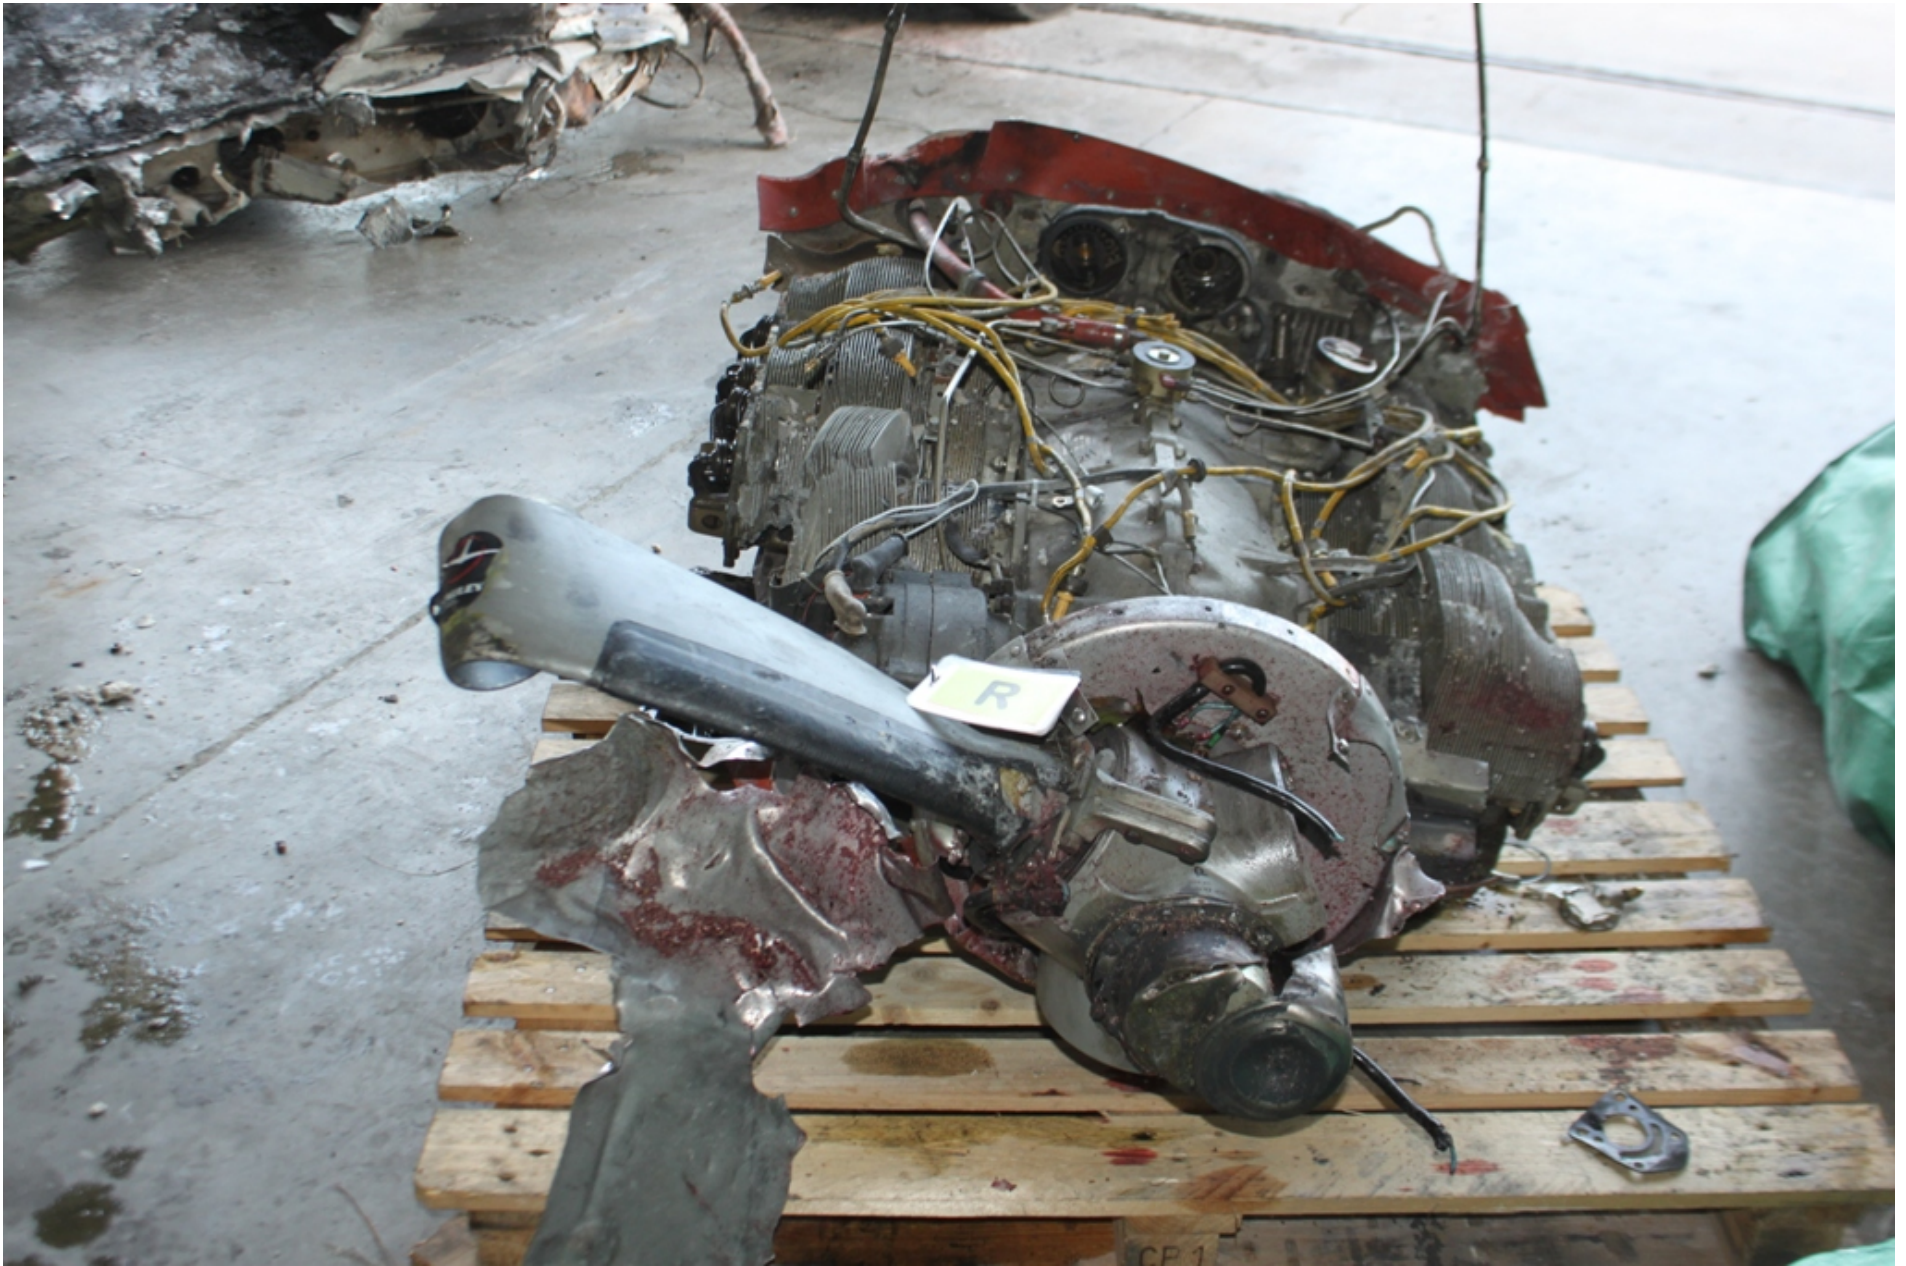
**Photo 13 - NTSB Digital Photograph. View of the Right Engine with Attached Propeller Following Recovery from the Impacted Building. Note the Separated Propeller Blades.**

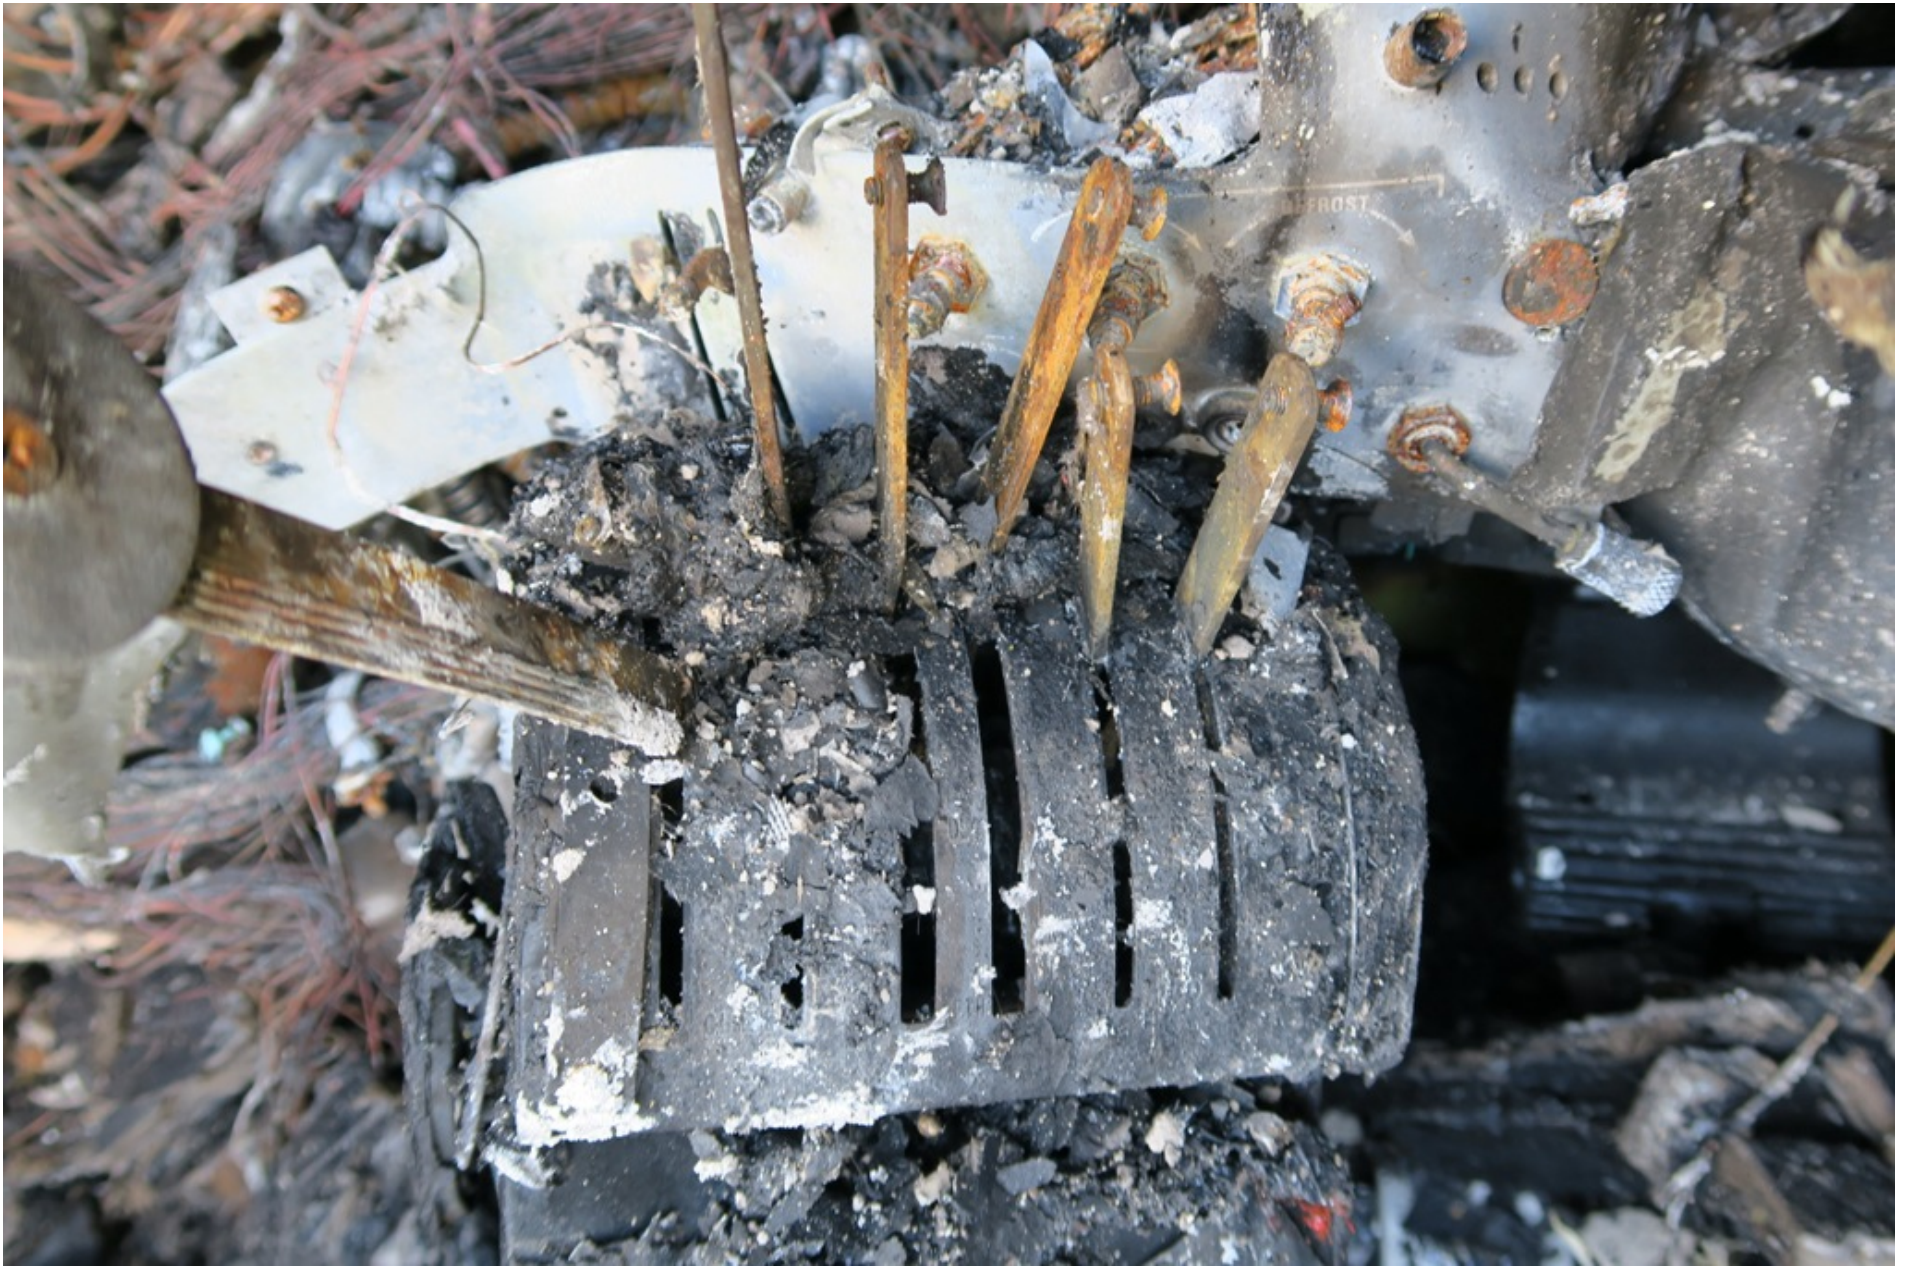
**Photo 14 – Textron Aviation Digital Photograph. View of the Throttle Quadrant.**

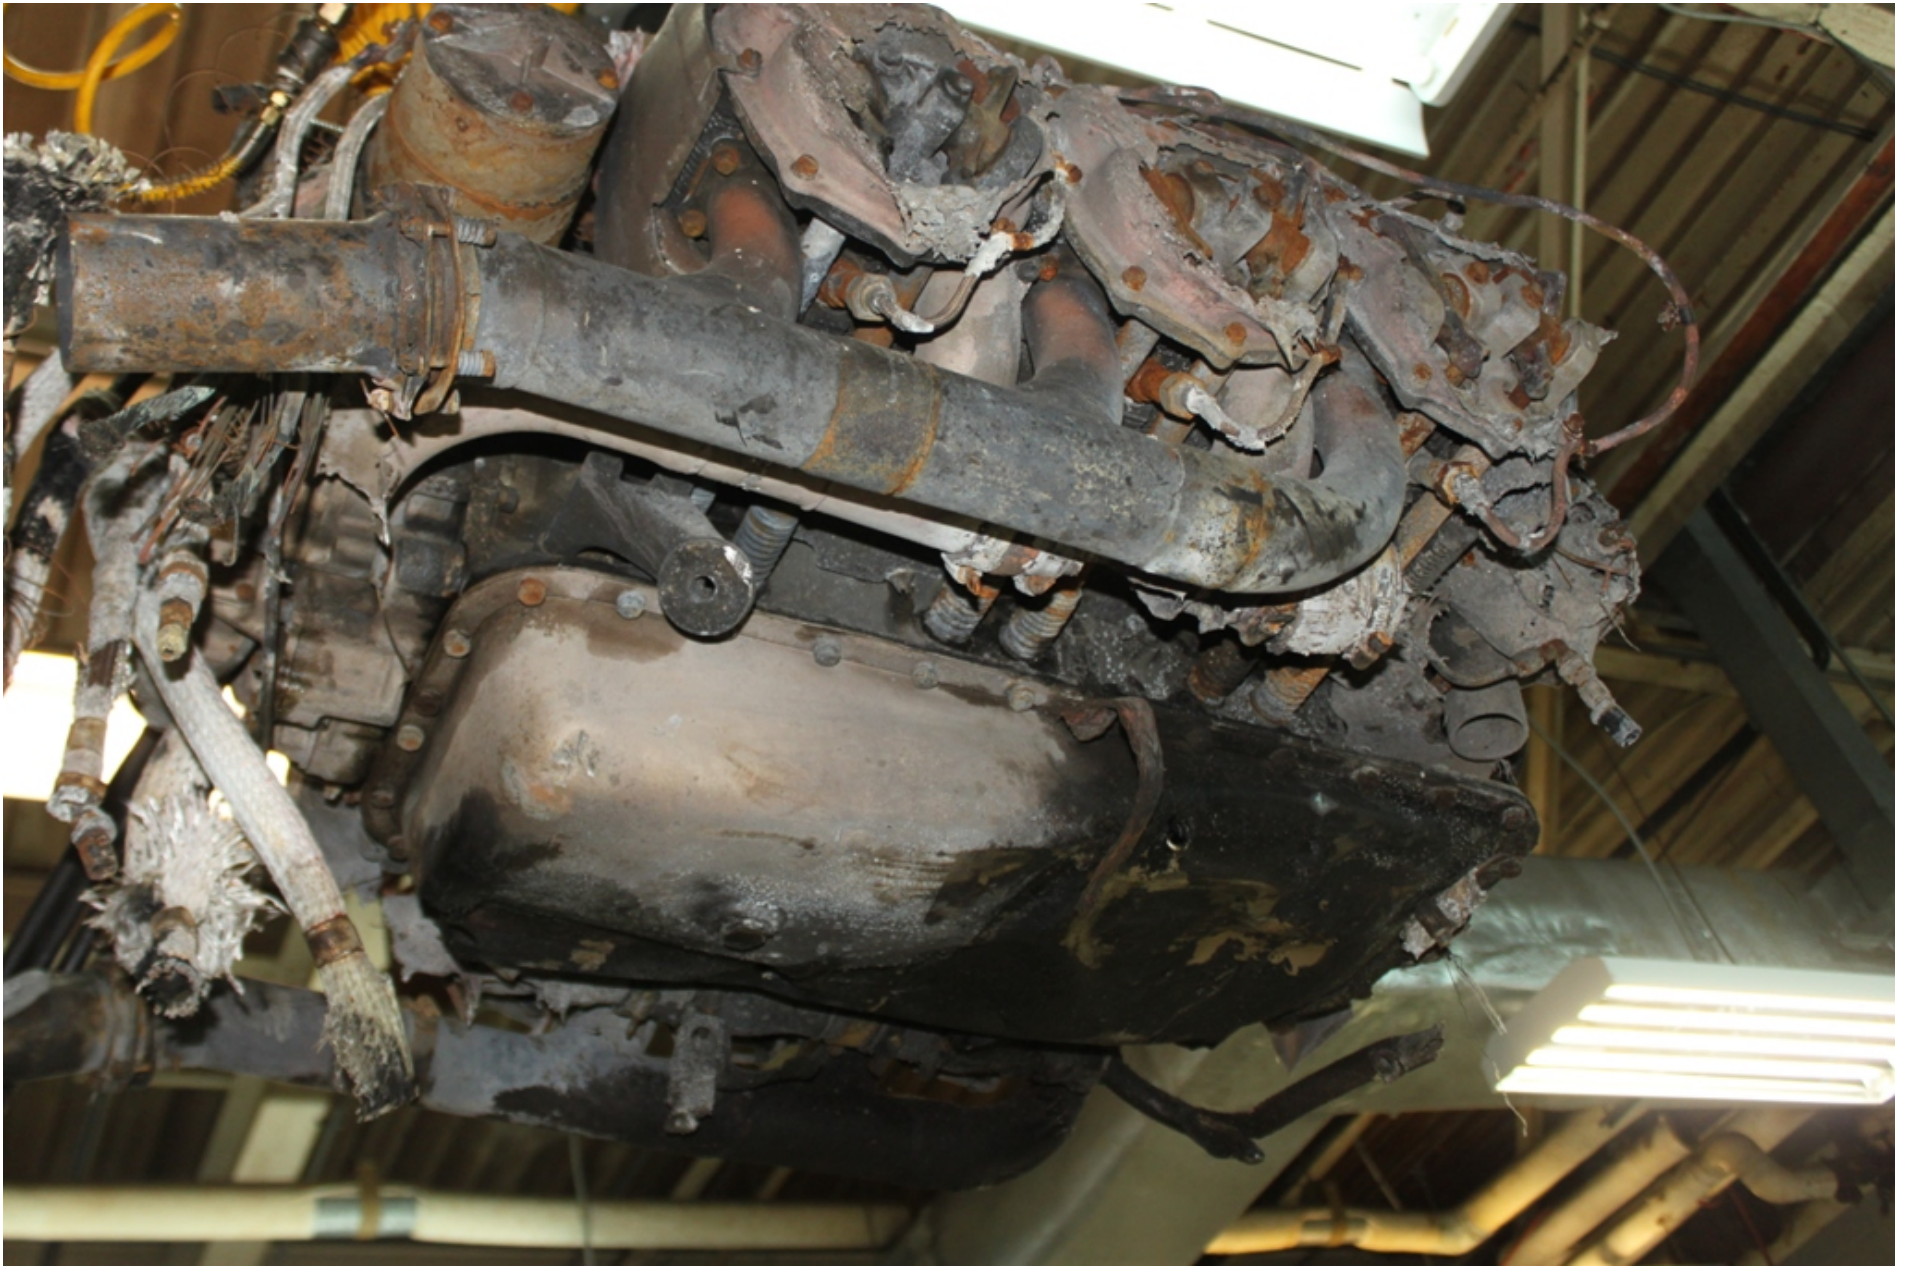
**Photo 15 - NTSB Digital Photograph. View of the Bottom of the Left Engine Assembly. Note the Discoloration of a Portion of the Exhaust for the Nos. 2, 4, and 6 Cylinders in the Background Compared to the Exhaust for the Nos. 1, 3, and 5 Cylinders in the Foreground.**

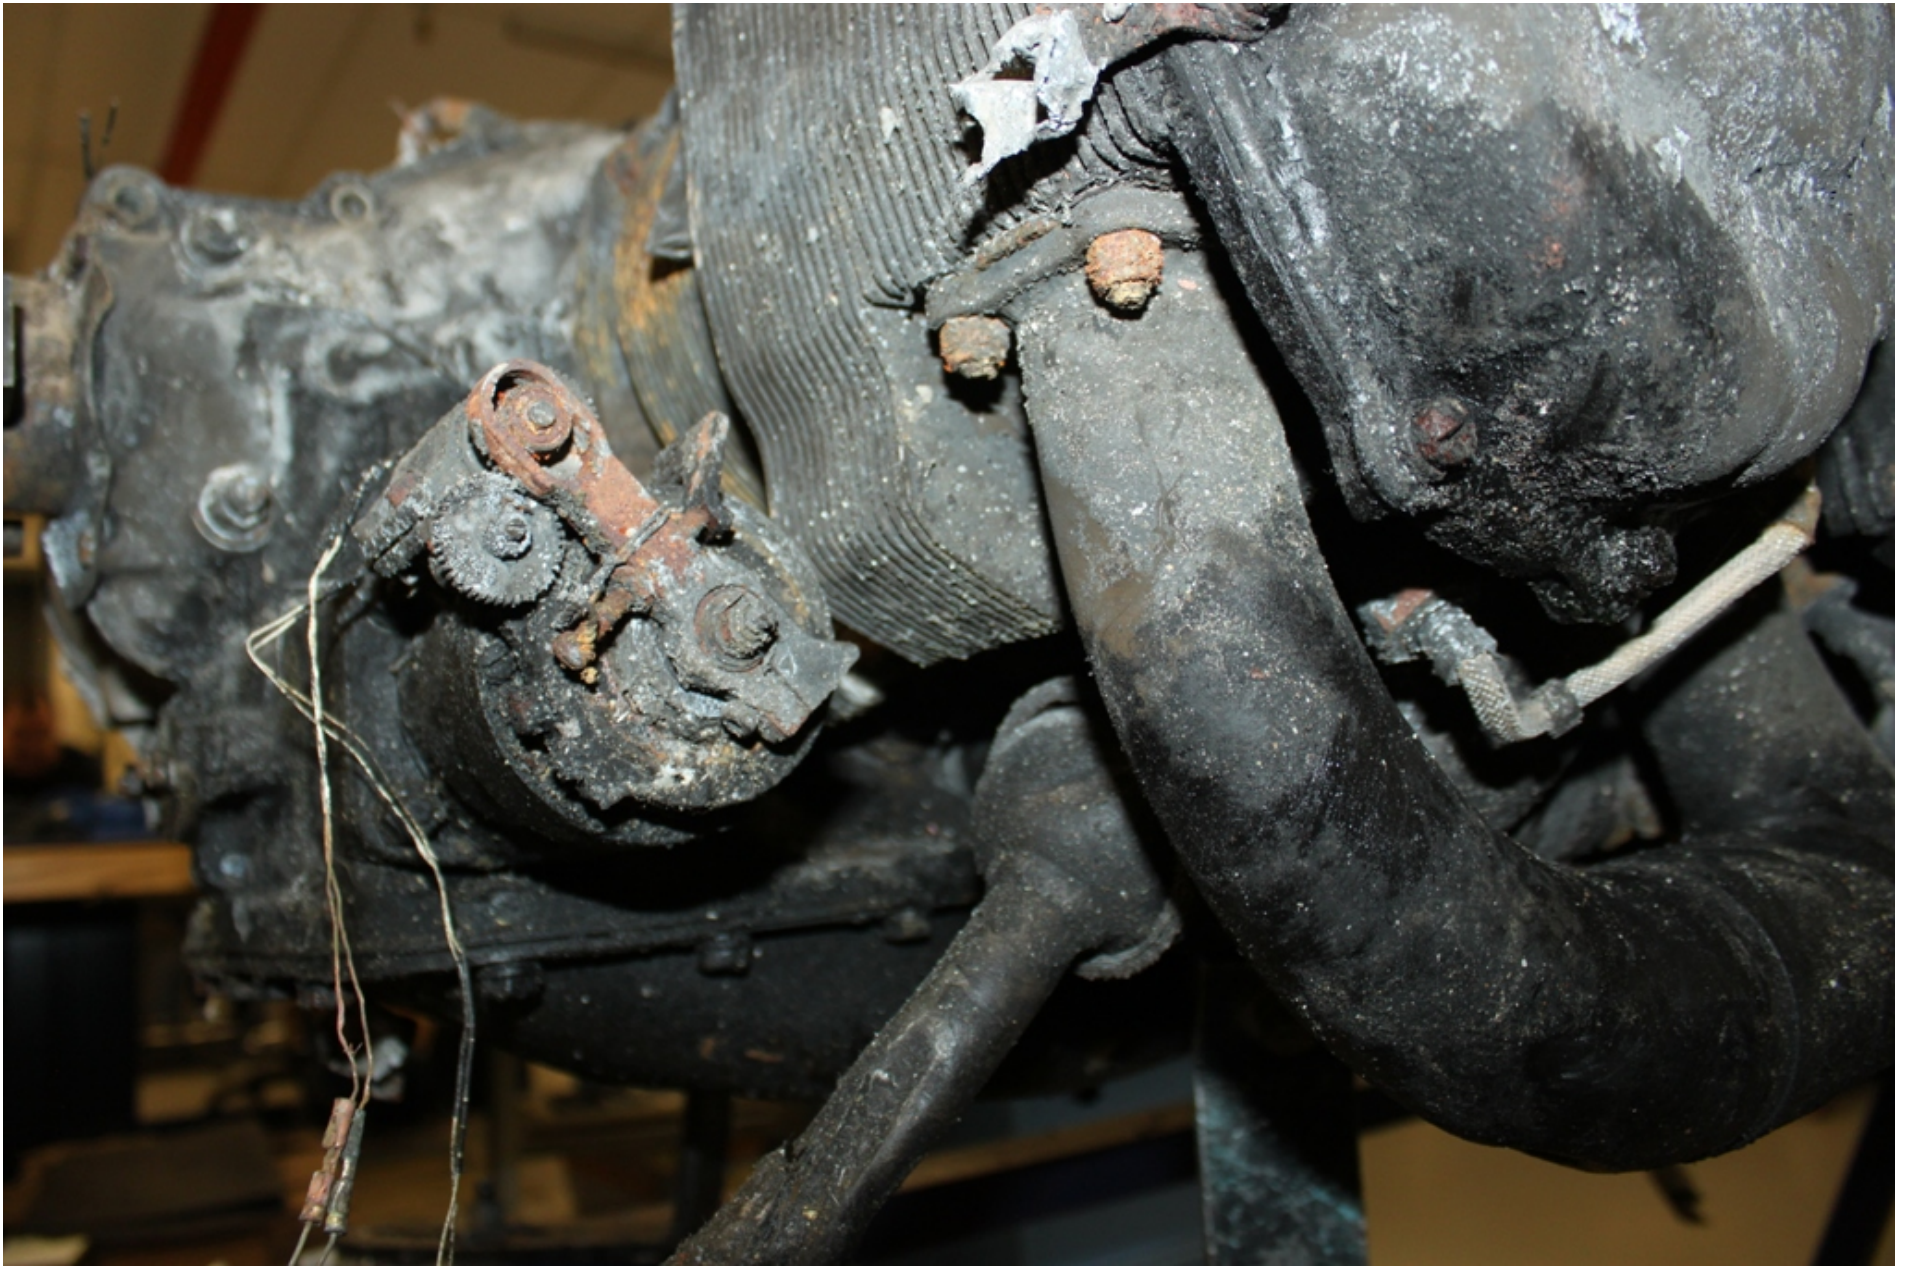
**Photo 16 - NTSB Digital Photograph. View of the Heat Damaged Left Propeller Governor. Note the Staining on the Adjacent Section of Exhaust.**

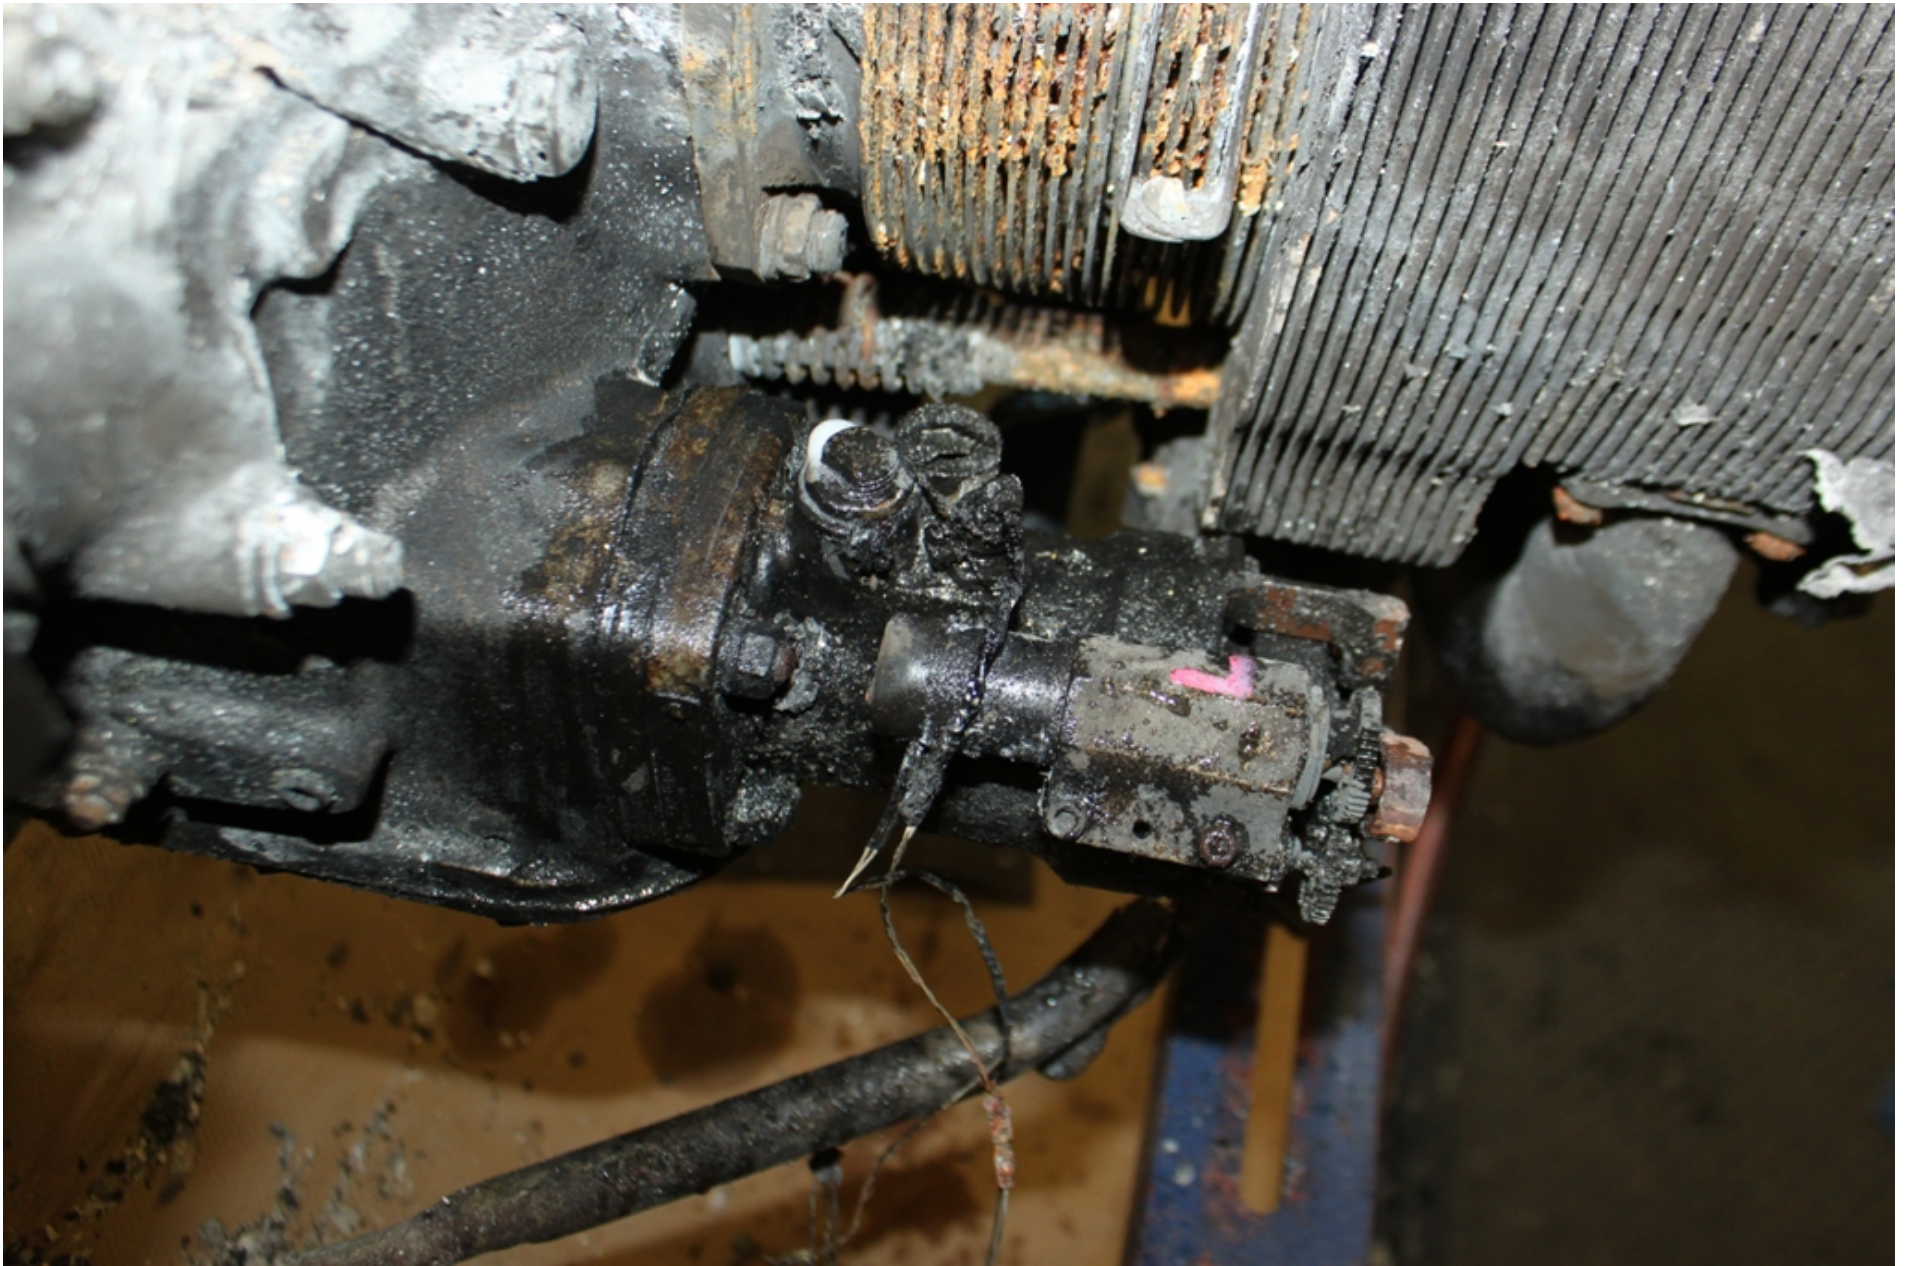
**Photo 17 - NTSB Digital Photograph. View of the Pressure Testing of the Left Engine Lubrication System. Note the Leakage at the Pressure Relief Valve of the Left Propeller Governor.**

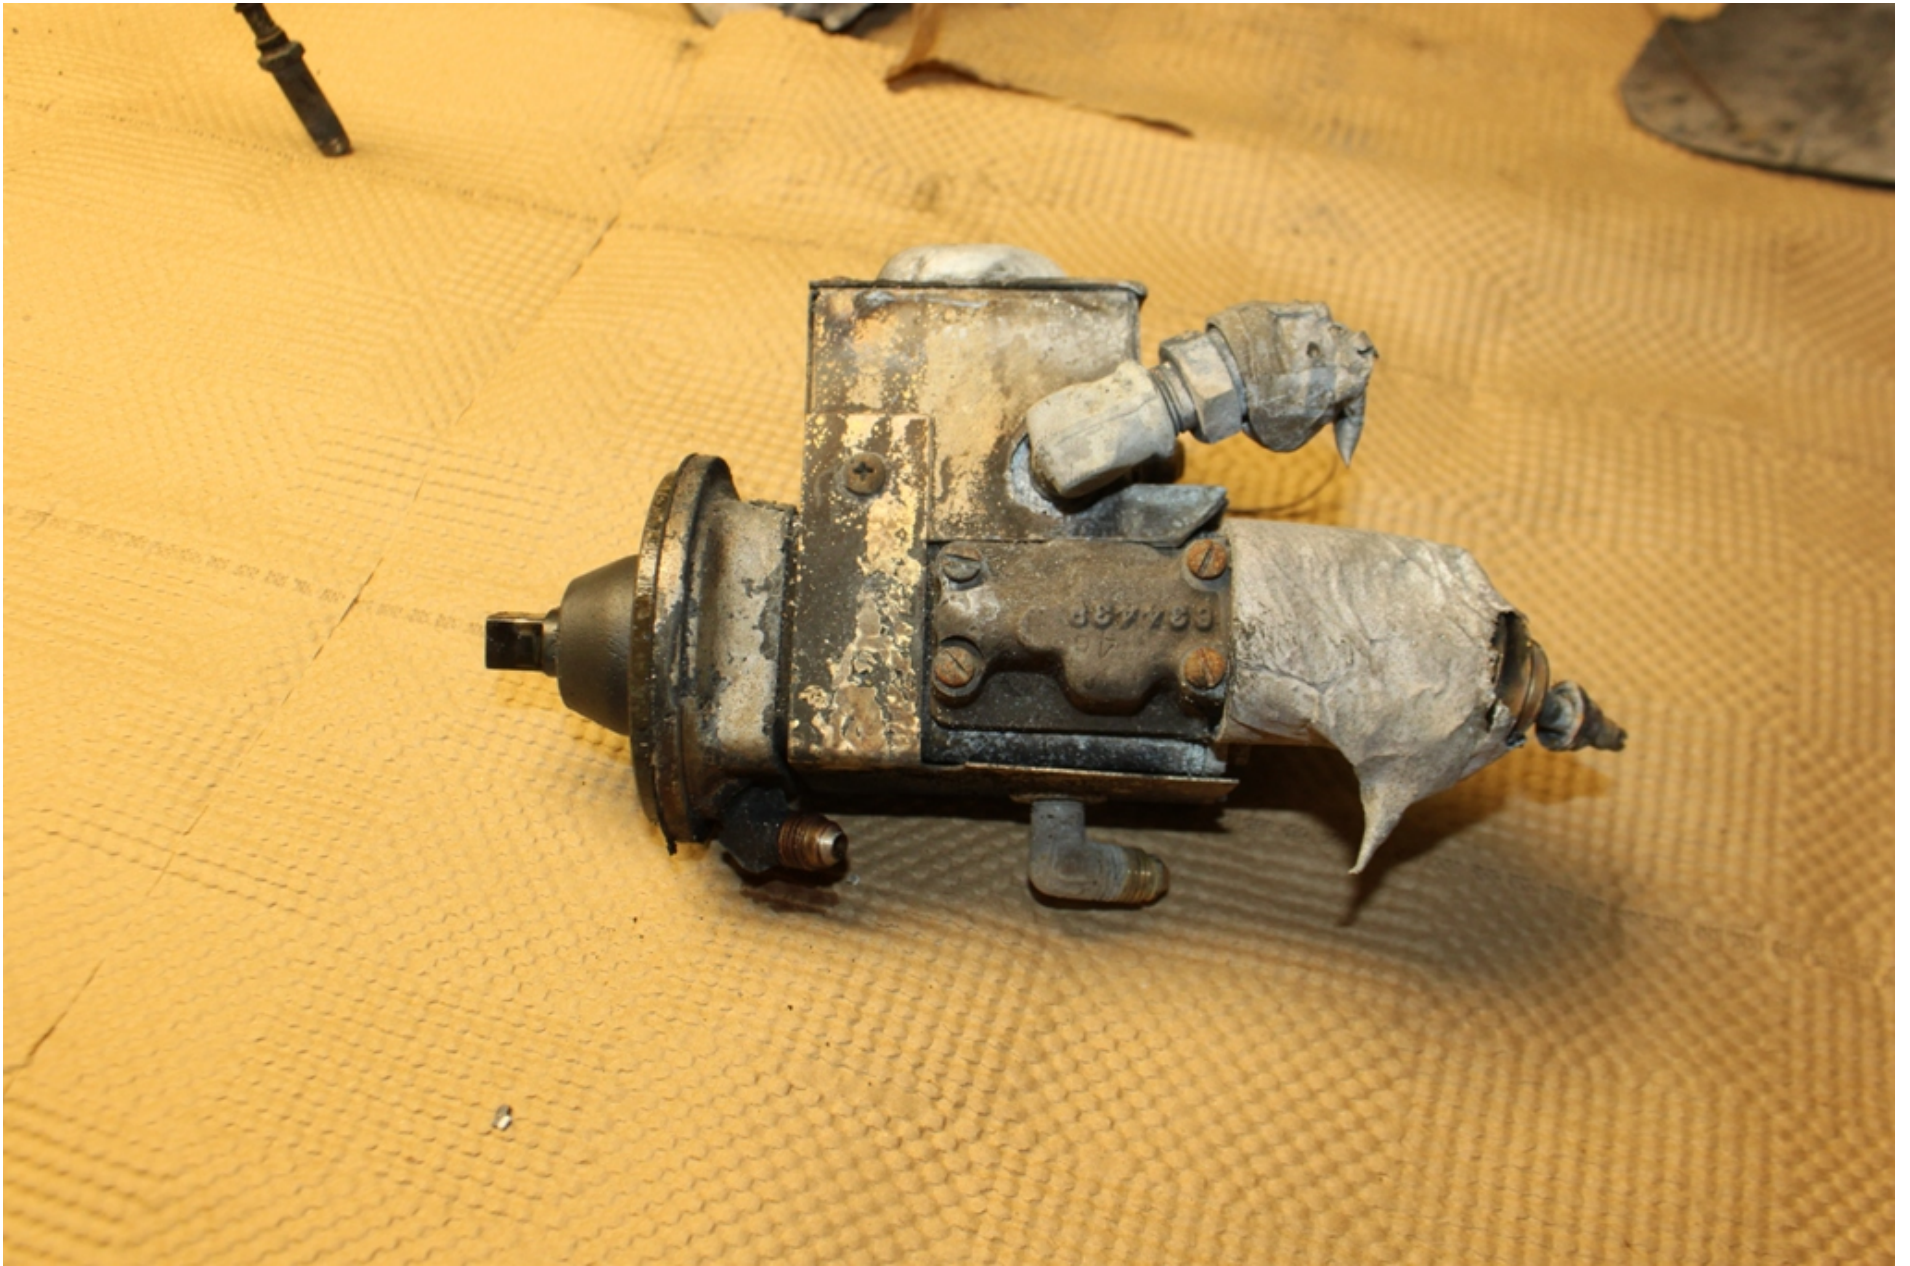
**Photo 18 - NTSB Digital Photograph. View of the Left Engine-Driven Fuel Pump. Note the Extensive Heat Damage.**
