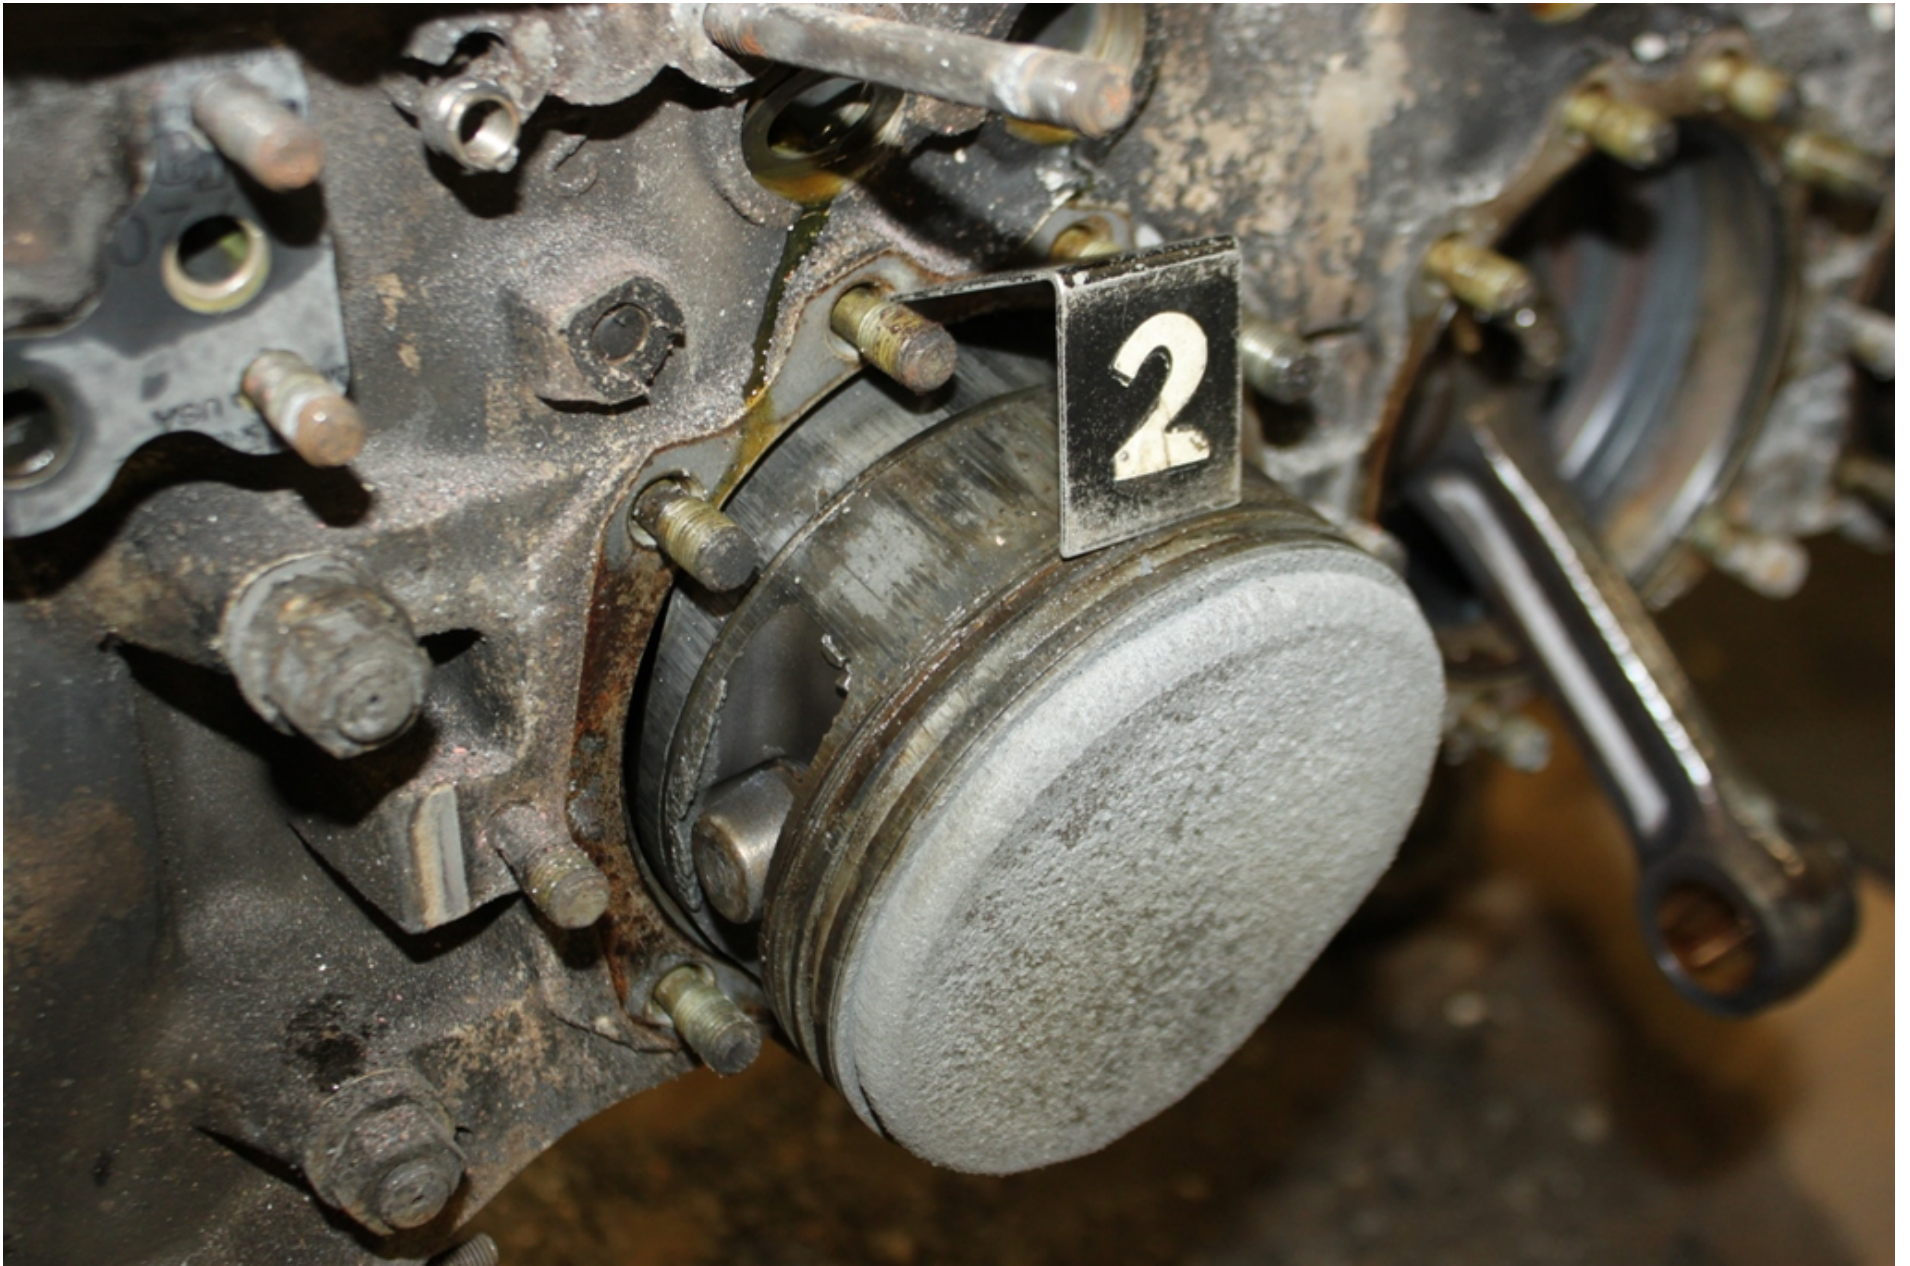
**Photo 19 - NTSB Digital Photograph. View of the No. 2 Piston. Note the Damage to the Crown.**

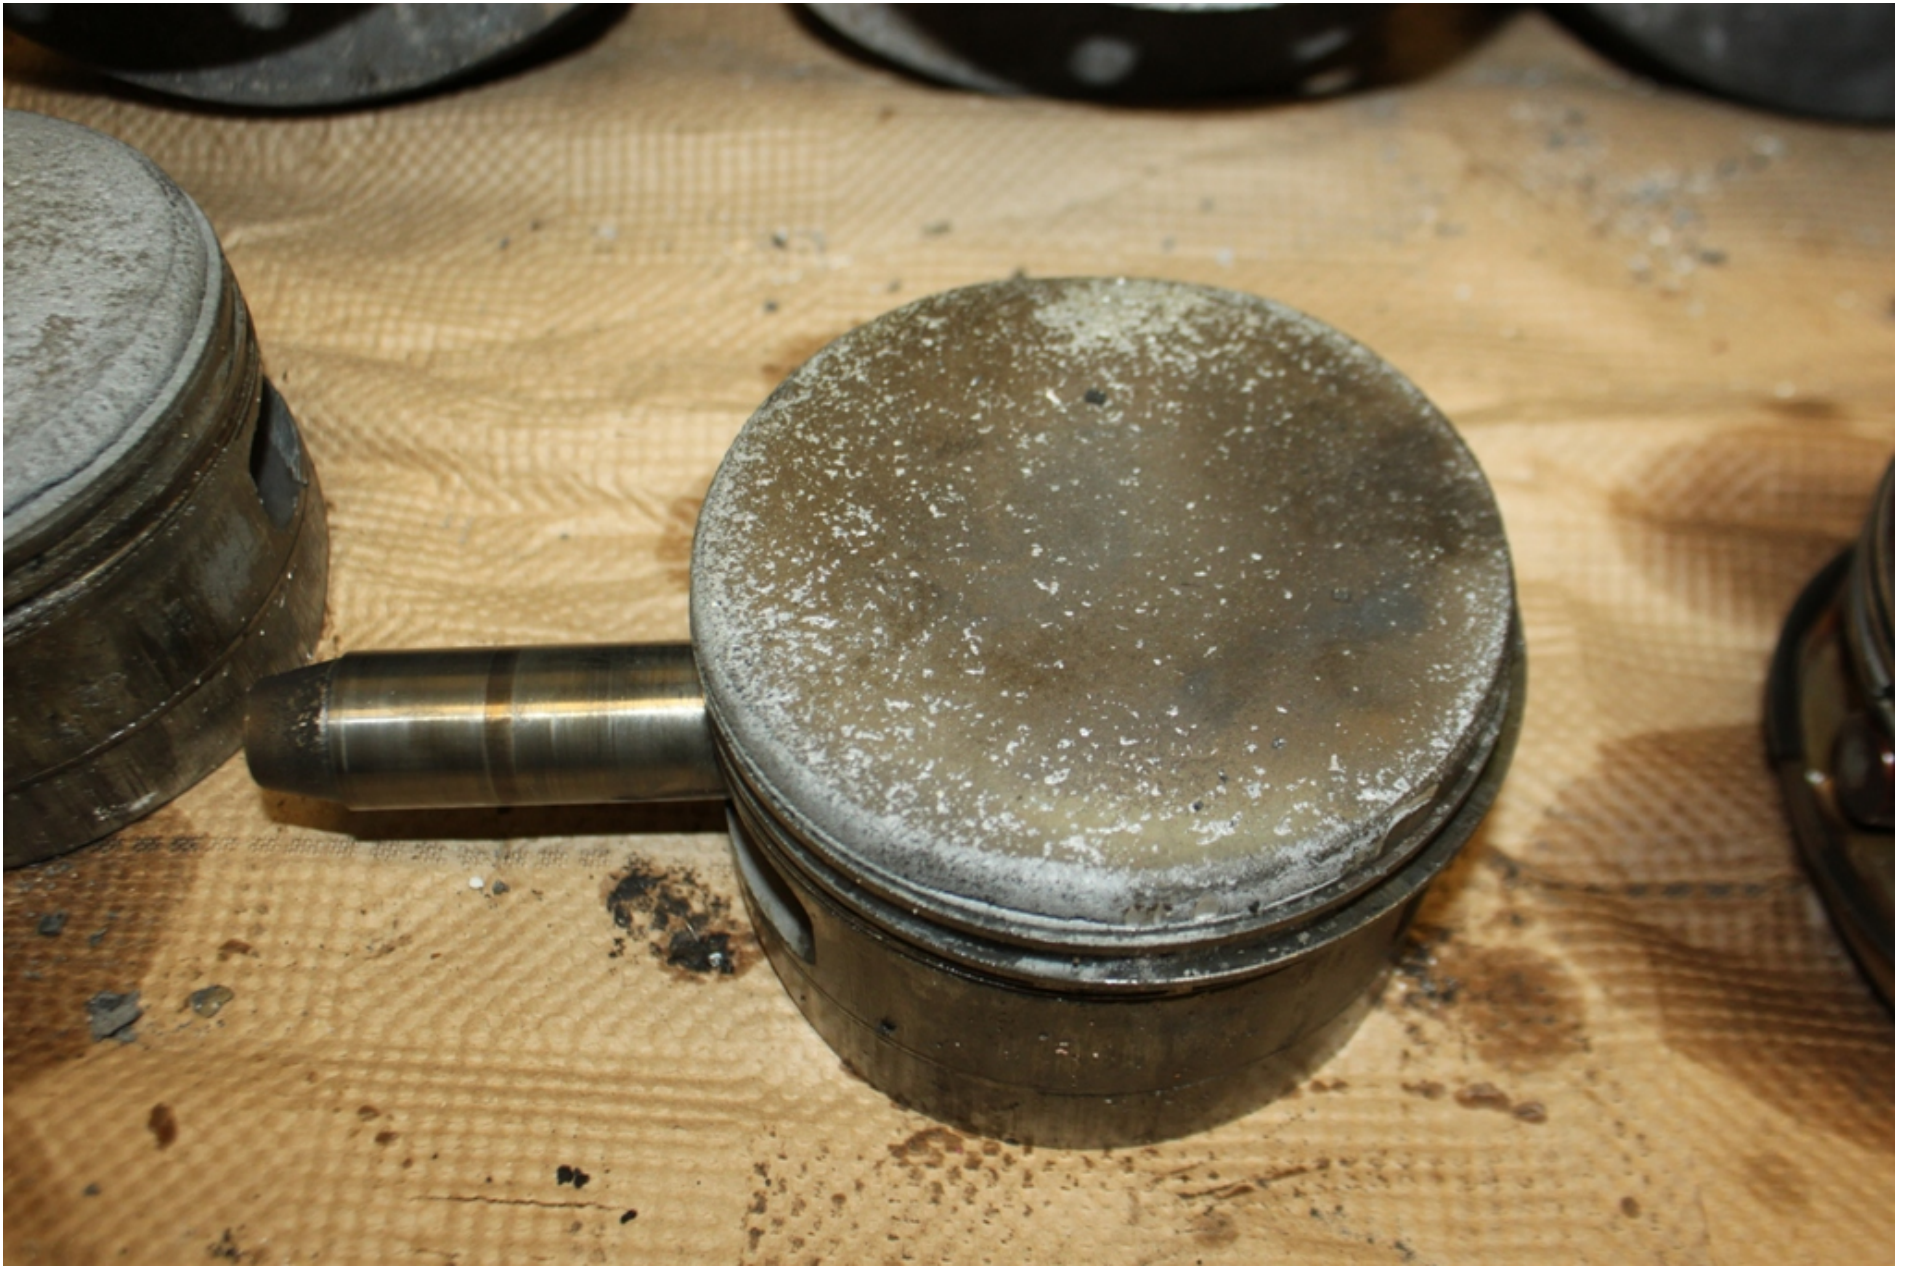
**Photo 20 - NTSB Digital Photograph. View of the No. 3 Piston. Note the Damage to the Crown.**
