## 2. FINDINGS OF TURBOCHARGER MODEL TE0659, PART NUMBER 406610-9025, SERIAL NUMBER BK0170 – LEFT SIDE

### 3. FINDINGS OF TURBOCHARGER MODEL TE0659, PART NUMBER 406610-9025, SERIAL NUMBER XKO14123 – RIGHT SIDE

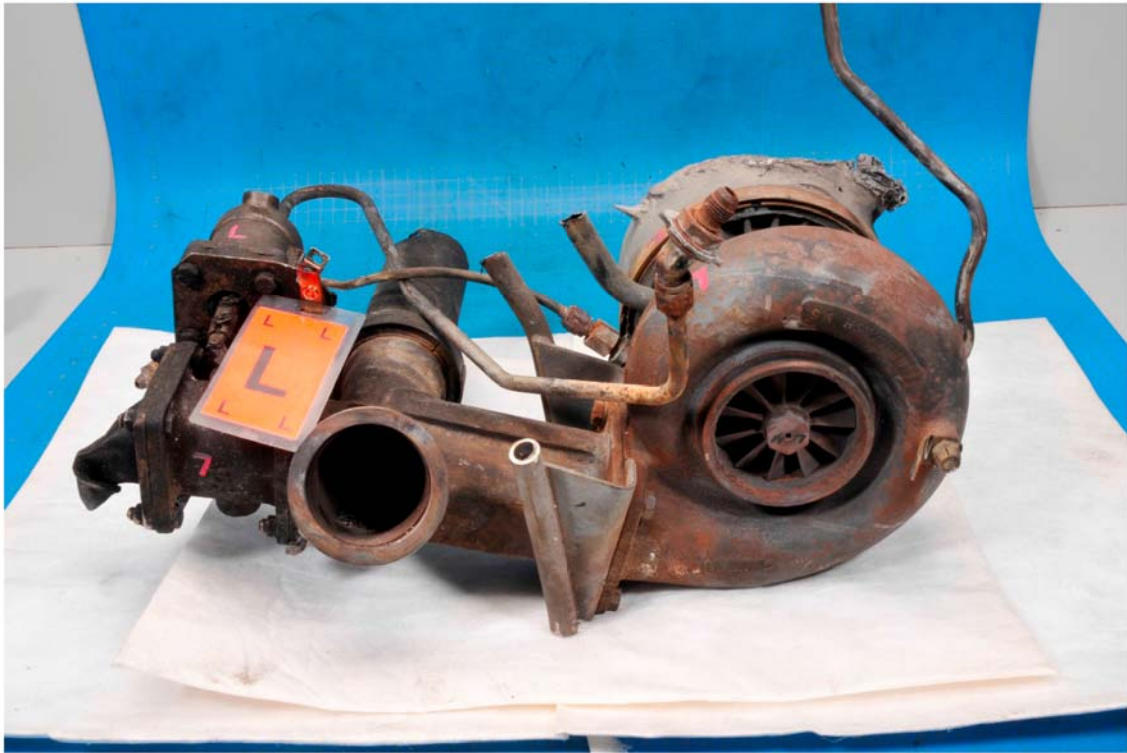
**Figure 2. Turbocharger, as Received.**

- (a) The turbocharger had been removed from the engine prior to the examination (Figure 2).
- (b) The turbocharger rotating assembly was not free to rotate. White debris was observed on the compressor blades (Figure 3). No apparent damage was observed on the turbine (Figure 4) blades. Both the compressor and turbine appeared to have non-uniform circumferential clearances between the wheels and their respective adjacent static structures.

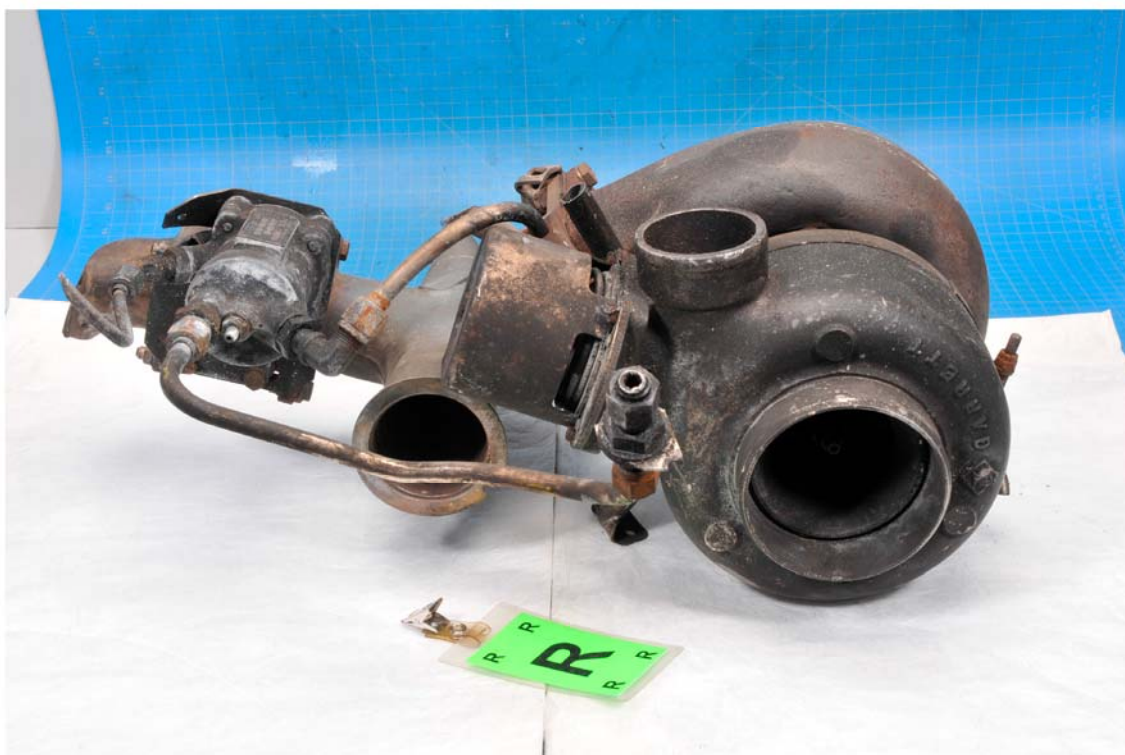
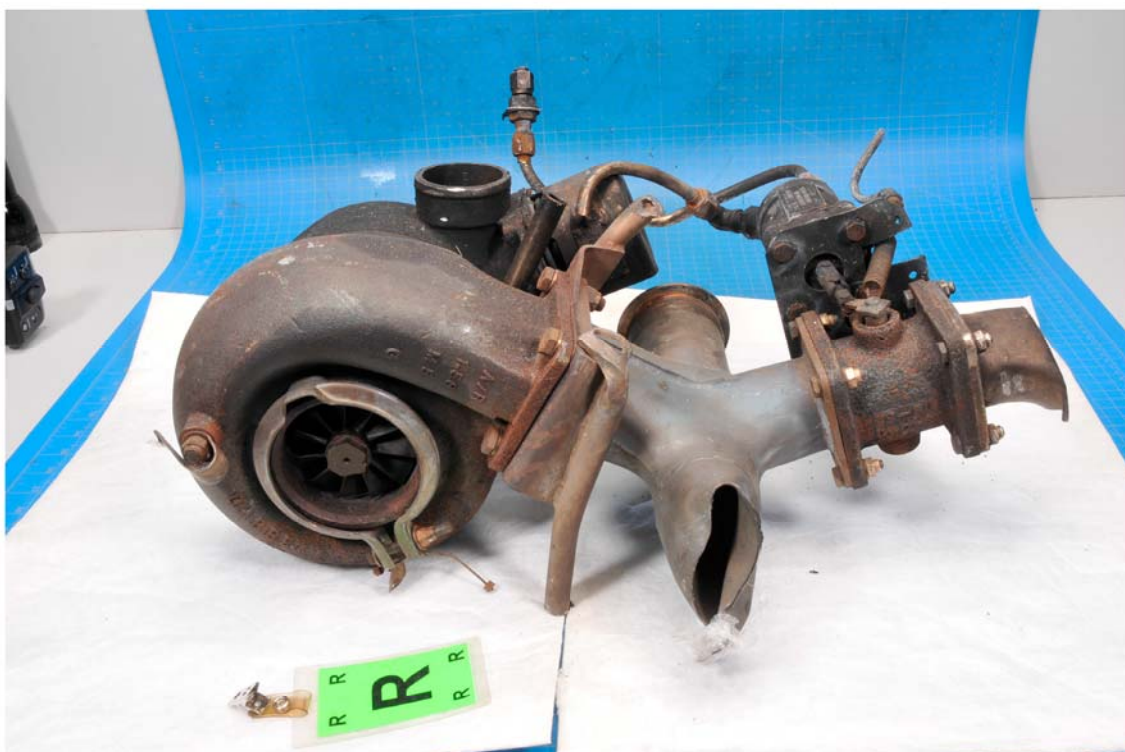
**Figure 58. Right Turbocharger System.**

- (a) The turbocharger had been removed from the engine prior to the examination (Figure 58 and Figure 59).
- (b) The turbocharger was connected to various exhaust ducting.

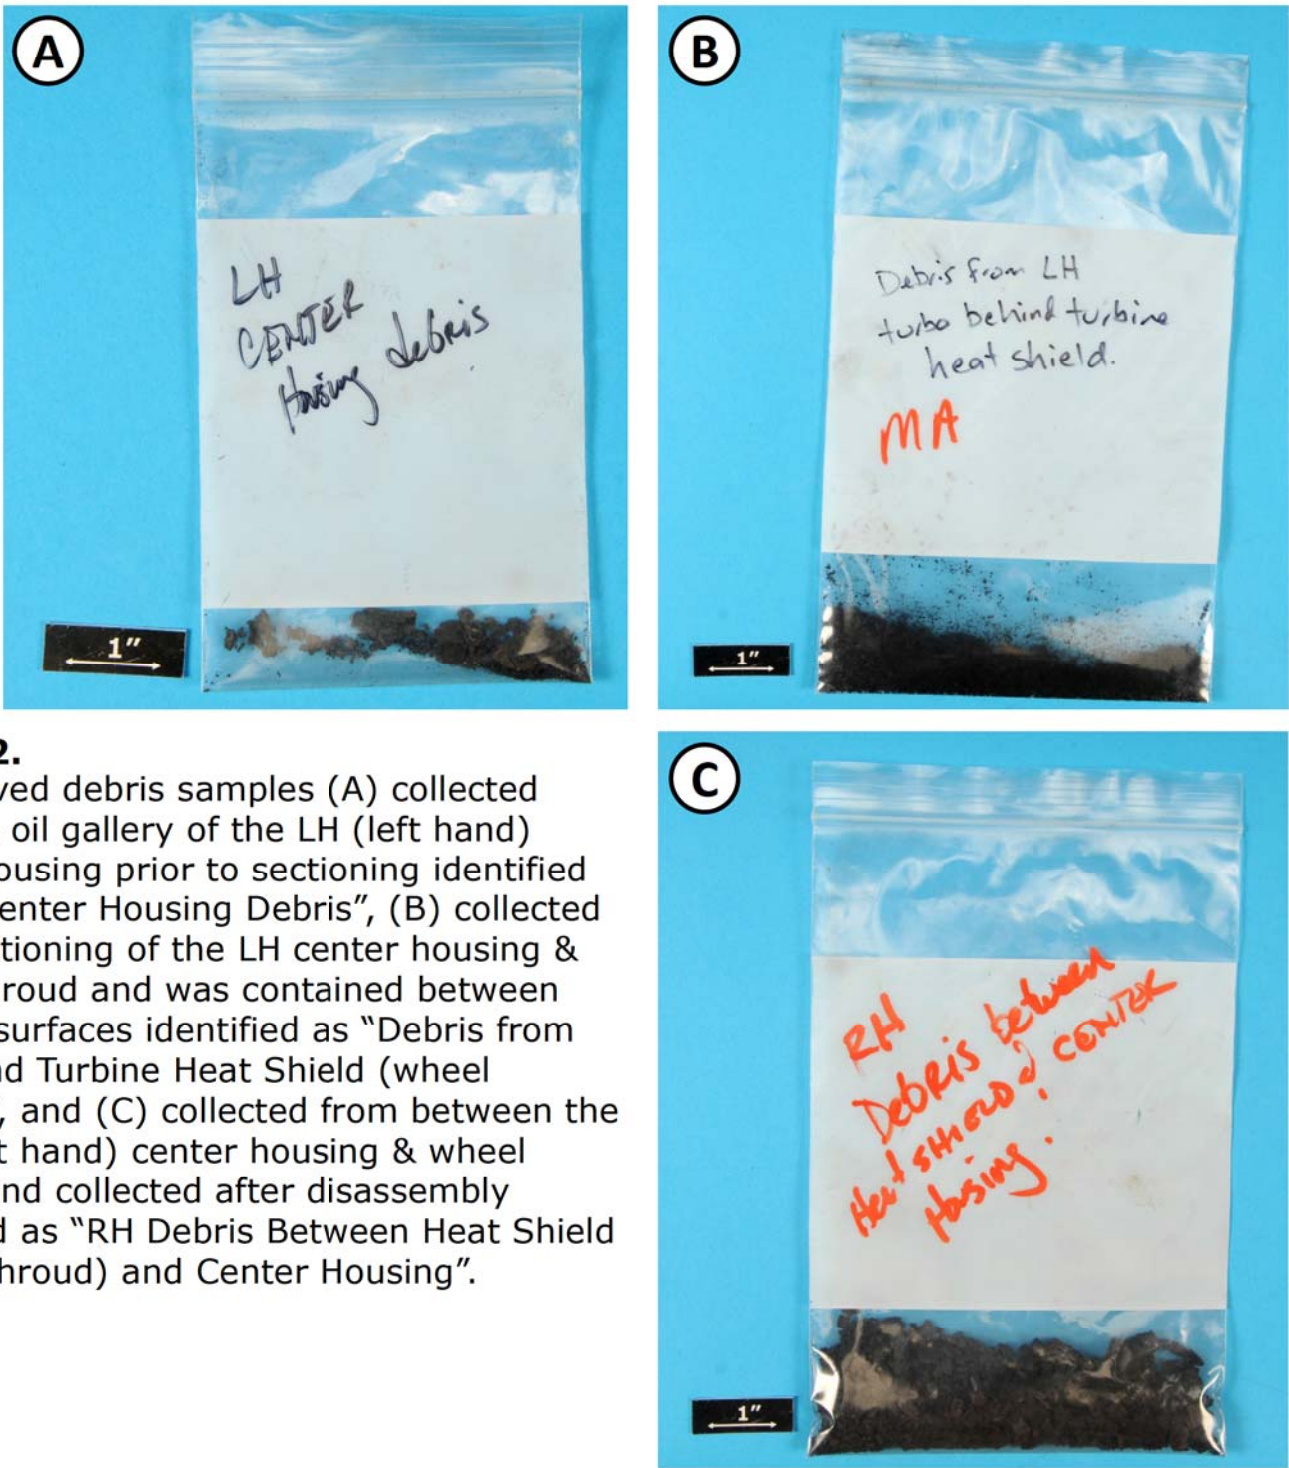
- (a) As denoted within the factual sections of this report, three different material samples were collected from areas of the turbochargers and submitted for material analysis with the following findings:
  1. LH center housing debris, Section 2.3(i):

**Figure 2.**  
As-received debris samples (A) collected from the oil gallery of the LH (left hand) center housing prior to sectioning identified as "LH Center Housing Debris", (B) collected after sectioning of the LH center housing & wheel shroud and was contained between the two surfaces identified as "Debris from LH Behind Turbine Heat Shield (wheel shroud)", and (C) collected from between the RH (right hand) center housing & wheel shroud and collected after disassembly identified as "RH Debris Between Heat Shield (wheel shroud) and Center Housing".

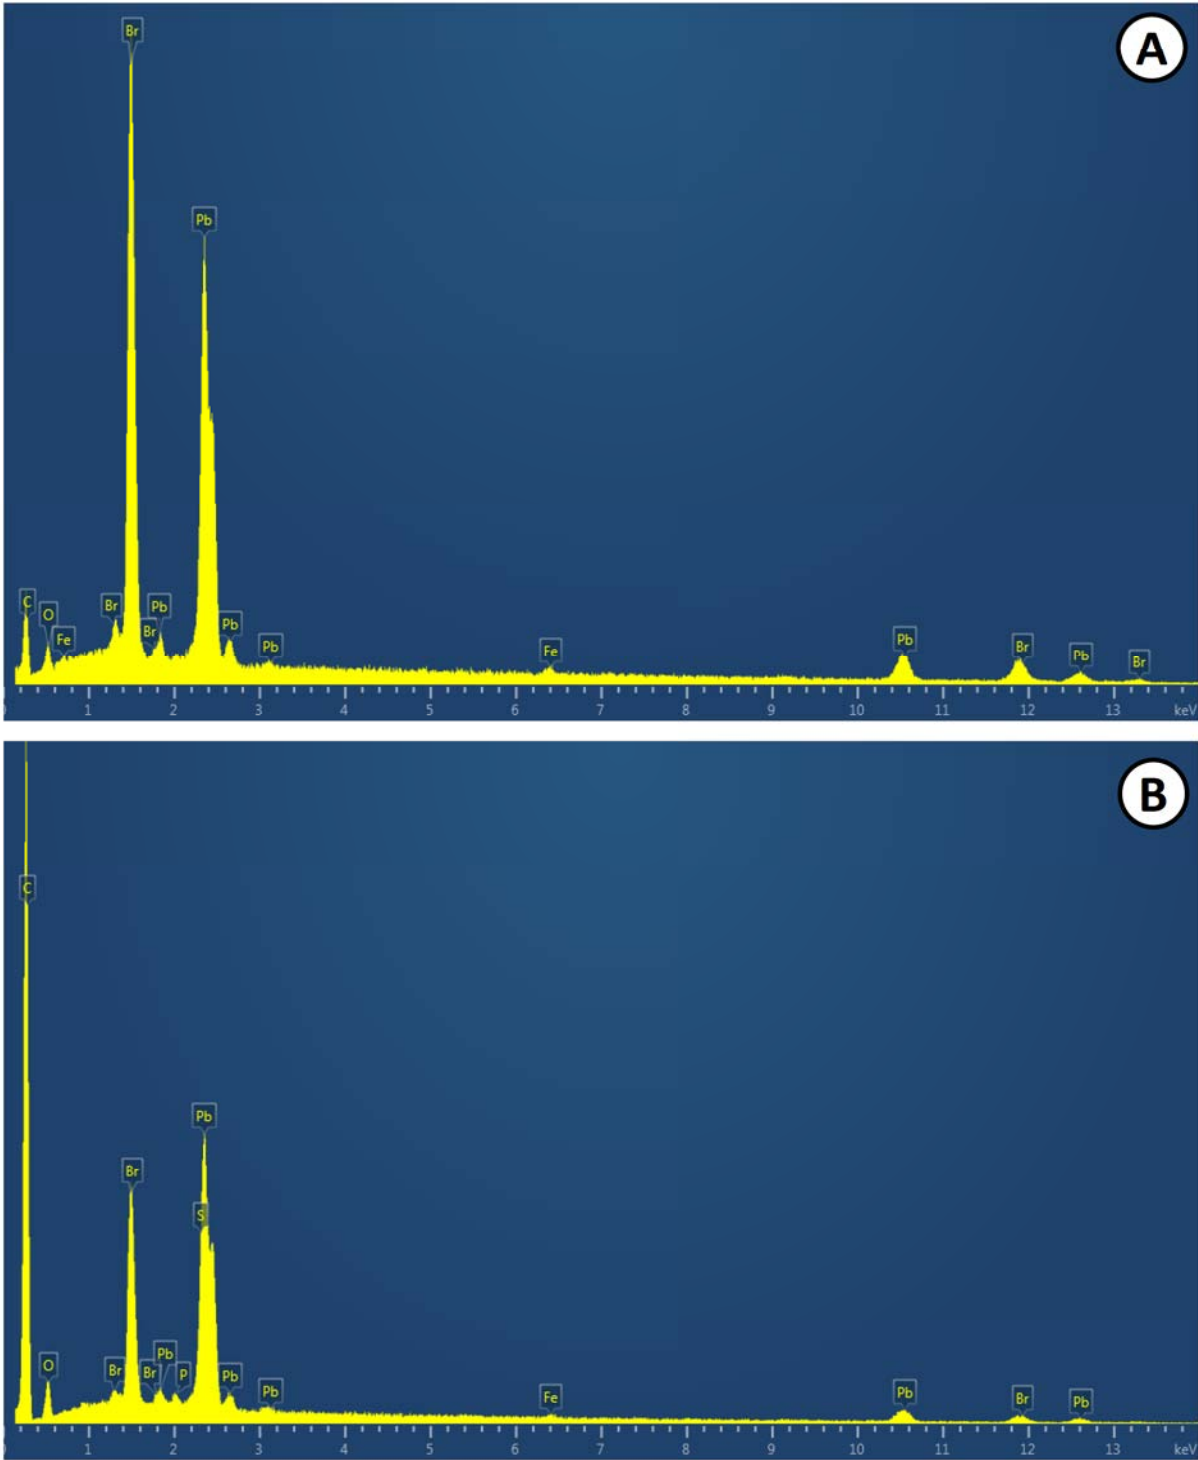
**Figure 5.**

“Energy dispersive X-ray (EDX) spectra produced from the analysis of the debris collected from the oil gallery of the center housing on the LH turbocharger showed high carbon, lead, and bromine concentrations. It is reported that AVGAS 100LL fuel can contain lead and bromine.”
  2. Debris from LH Behind Turbine Heat Shield, Section 2.3(j)

(A, B) EDX spectra produced from the analysis of the areas identified on the LH Center Housing Debris in Figures 4B and 4C, respectively, showing high lead and bromine concentrations. The source of the bromine and lead was likely the AVGAS 100LL fuel which contains lead and bromine.

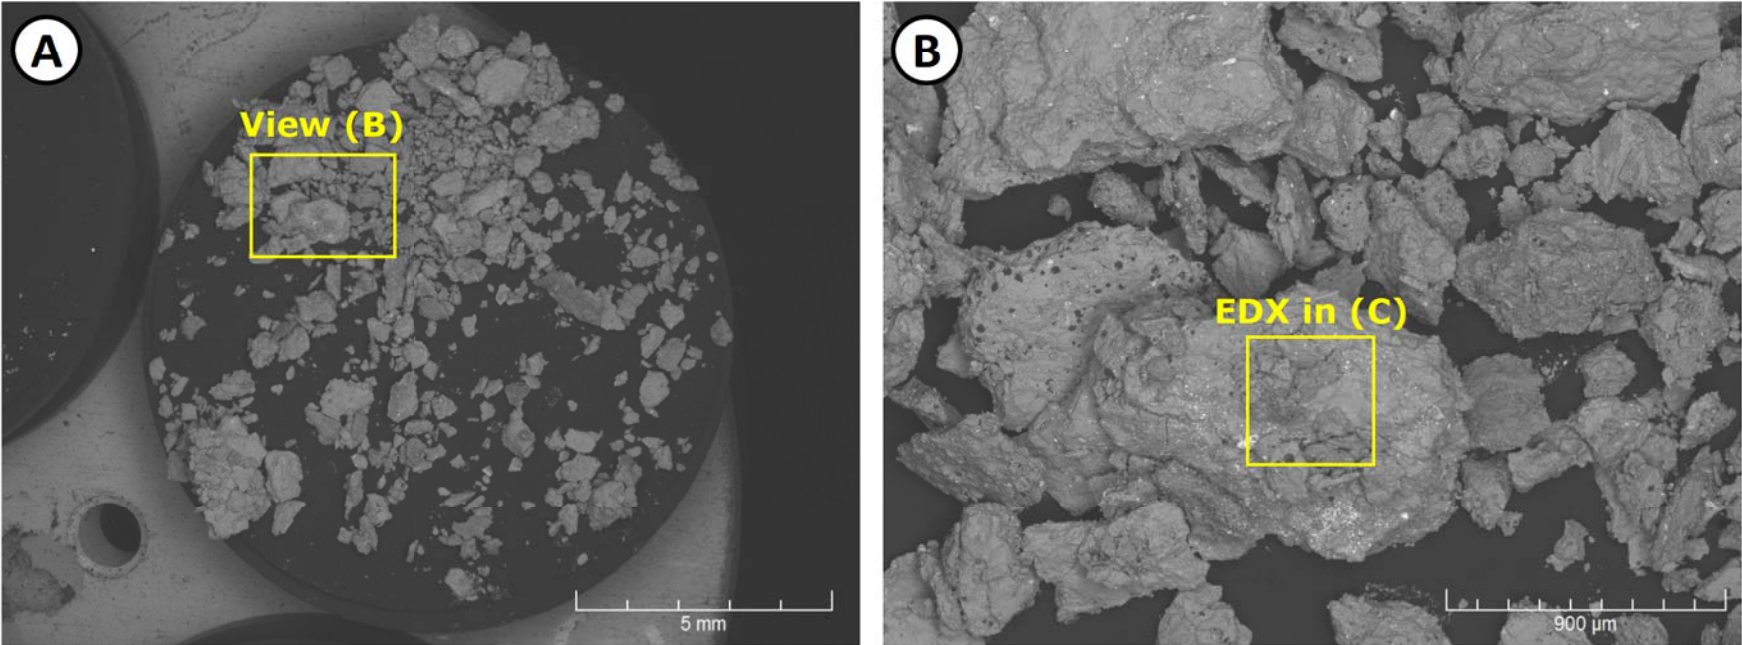
“EDX analysis spectra produced from the LH turbocharger debris located behind turbine heat shield (wheel shroud) exhibited high concentrations of

oxygen, carbon, and iron with lead and silicon and traces of bromine, manganese, and nickel. The iron-rich material containing manganese and nickel was characteristic of a low alloy steel. The alloy could not be definitively determined.”

**Figure 6.**  
(A, B) BSE SEM images of the LH Behind Turbine Heat Shield (wheel shroud) Debris, reference Figure 3B. (C) EDX spectrum produced from the analysis of the area in (B) showing a high concentration of oxygen, carbon, and iron with lead and silicon and traces of bromine, manganese, and nickel. The iron rich material containing manganese and nickel was characteristic of a low alloy steel. The weight % composition shown has the carbon, oxygen, lead and bromine removed from the analysis to aid in identification of the alloy. The alloy could not be determined. The lead and bromine were likely contributed by the AVGAS 100LL.

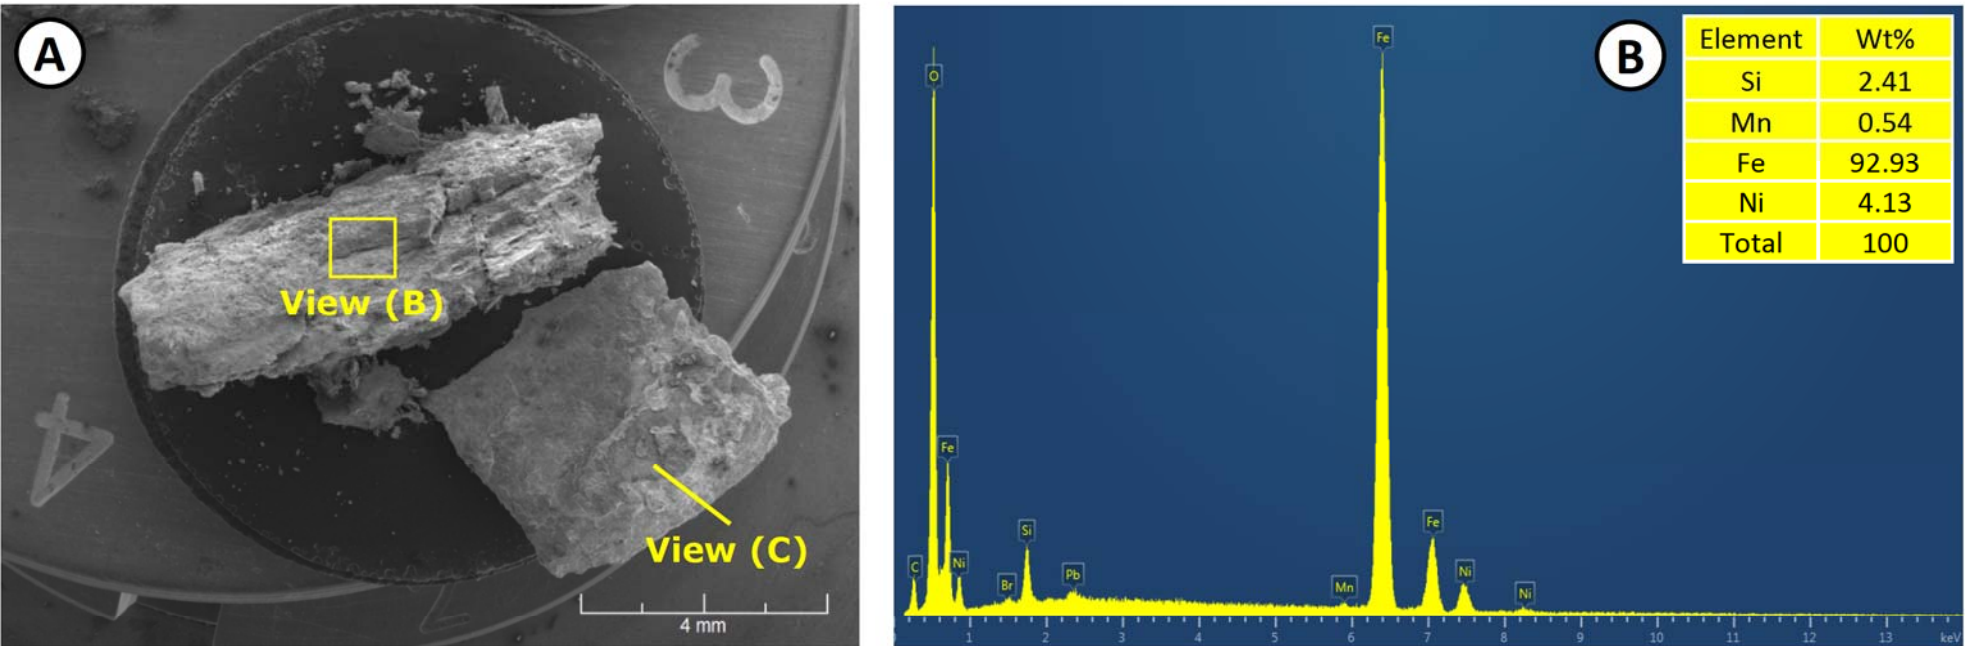
“EDX analysis produced from the RH turbocharger debris between the heat shield (wheel shroud) and center housing exhibited spectra similar to that of the LH turbocharger debris from the same location, but it contained higher nickel concentrations.”

**Figure 7.**  
(A) BSE SEM image of the RH Debris Between Heat Shield (wheel shroud) and Center Housing Debris, reference Figure 3C. (B, C) EDX spectra produced from the analysis of the areas in (A) showing high concentrations of oxygen and iron with carbon, silicon, and nickel, and traces of bromine, manganese, and lead. The iron rich material containing manganese and nickel was characteristic of a low alloy steel with elevated nickel concentrations. The weight % composition in the upper right corners have the carbon, oxygen, lead, and bromine removed from the analysis to aid in identification of the alloys. The alloys could not be determined. The lead and bromine were likely contributed by the AVGAS 100LL.
