# NATIONAL TRANSPORTATION SAFETY BOARD

MATERIALS LABORATORY FACTUAL REPORT

Report No. 19-076

Place : Fort Lauderdale, Florida  
Date : December 1, 2018  
Vehicle : Cessna 335, N79HP  
NTSB No. : ERA19FA060  
Investigator : Timothy W. Monville, AS-ERA

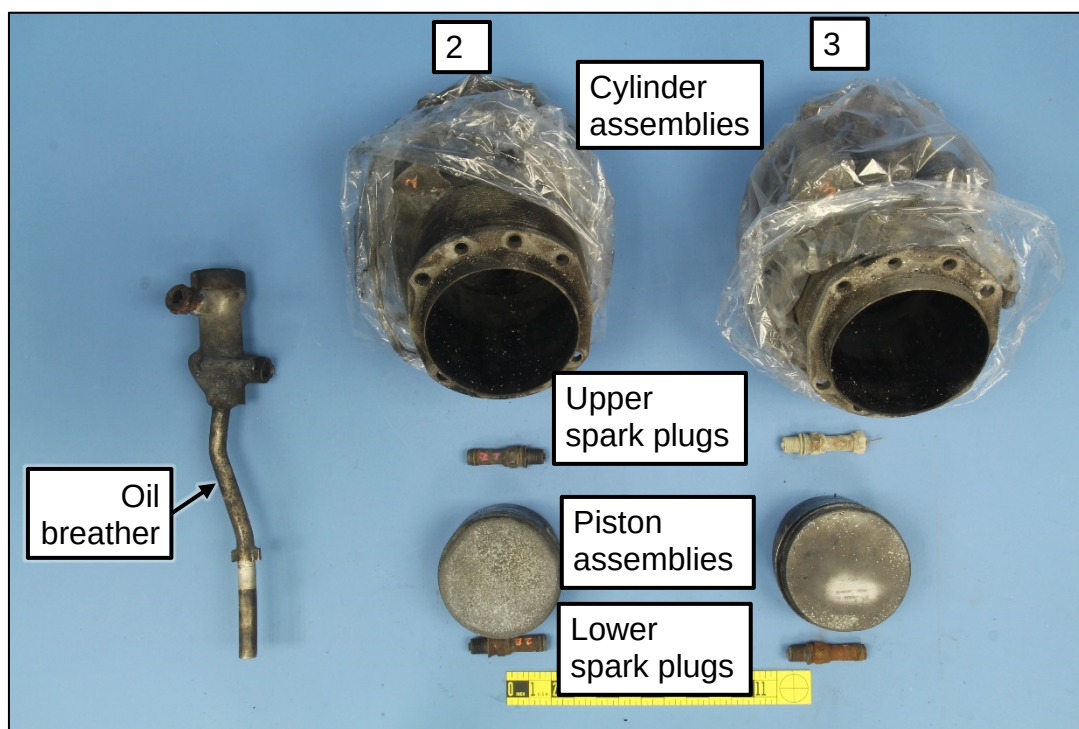
Figure 1. Overall view of the submitted components.

An overall view of the submitted components from the left engine is shown in figure 1. During the accident flight shortly after takeoff, an occupant in the airplane reported a left engine fire. The airplane also experienced a post-crash fire on the ground. The submitted components were received disassembled from the engine intact as shown in figure 1.

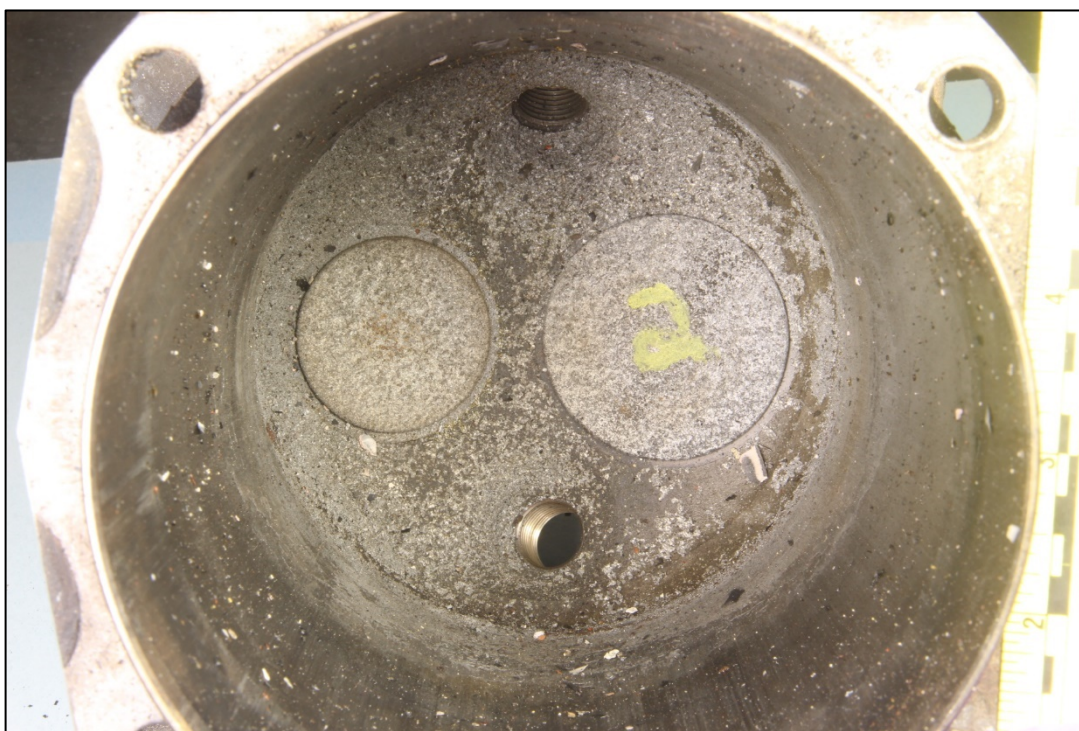
Figure 2. Cylinder 2 interior.

The cylinder head and valve surface on the interior surfaces of the cylinder assemblies had gray deposits with a rough gritty appearance that was particularly prominent in cylinder 2 shown in figure 2. Gritty deposits were also observed on the spark plug electrodes. The deposits were more extensive on the lower spark plugs compared to the upper spark plug as shown in figure 3. The upper spark plug from the number 3 cylinder was covered in a powdery tan substance, including the intact thread surfaces. The barrel surfaces of both cylinder assemblies had smooth gray deposits on the interior surfaces near the head. Longitudinal scoring was observed on the barrel sidewalls on both cylinder assemblies.

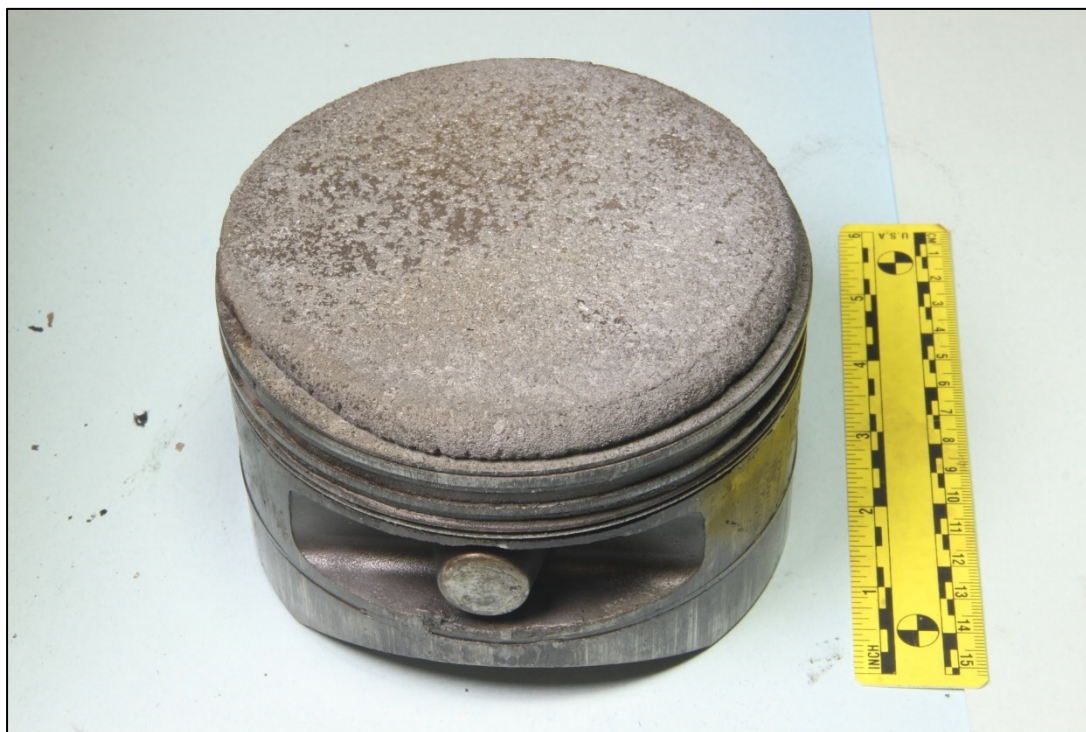
Figure 4. Number 2 piston assembly.

The number 2 and 3 piston assemblies are shown in figures 3 and 4, respectively. The edges of the piston crowns were eroded away and had a rough gritty appearance. The center of the piston crown for the 2 piston was also rough with most of the combustion deposits missing from the surface. Brown and tan combustion deposits were mostly present on the number 3 cylinder, but an area had been cleaned to reveal identification markings on the piston crown. The overall damage patterns on the piston assemblies was consistent with detonation.

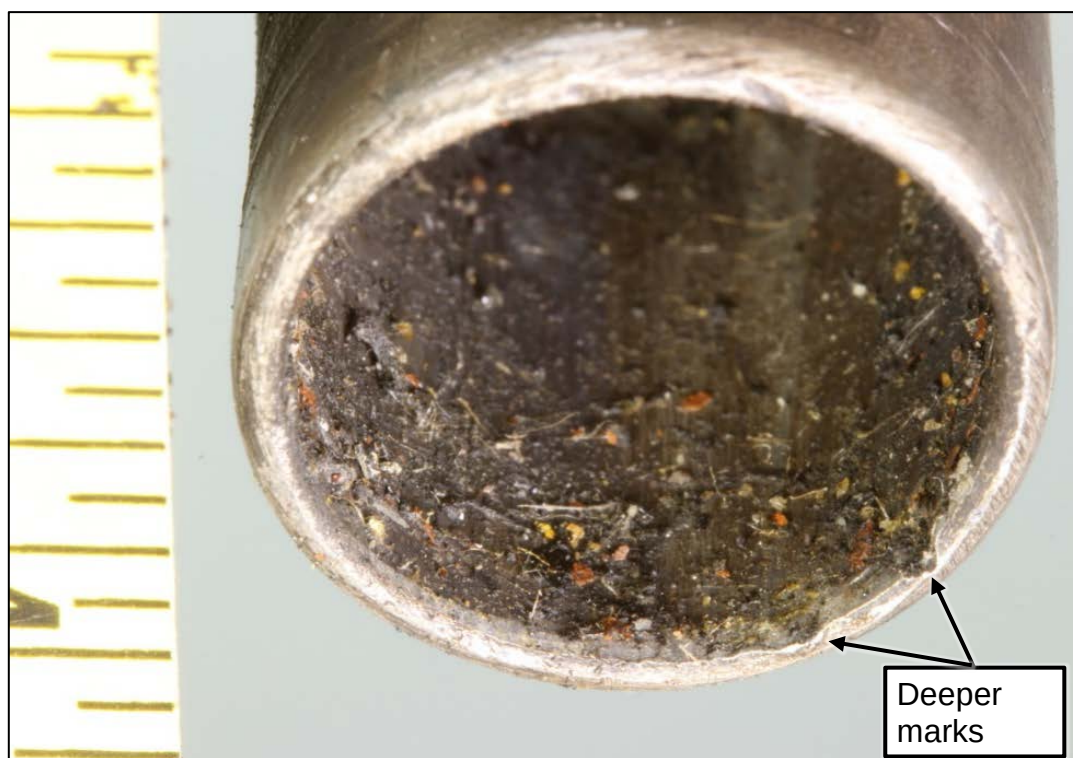
Figure 6. Lower end of the oil breather tube.

The oil breather was received without the cap and dipstick assembly, which was not recovered. Contact marks were observed on the lower end of the oil breather as shown in figure 6 before cleaning. Wear marks consistent with contact with the dipstick were observed on approximately  $\frac{1}{2}$  the circumference around the lower end of the breather tube adjacent to the end face. Deeper marks were observed at two locations on the chamfered edge at locations shown in figure 6 likely associated with the insertion position of the dipstick and the edge of the dipstick after twisting the cap clockwise to the closed position.

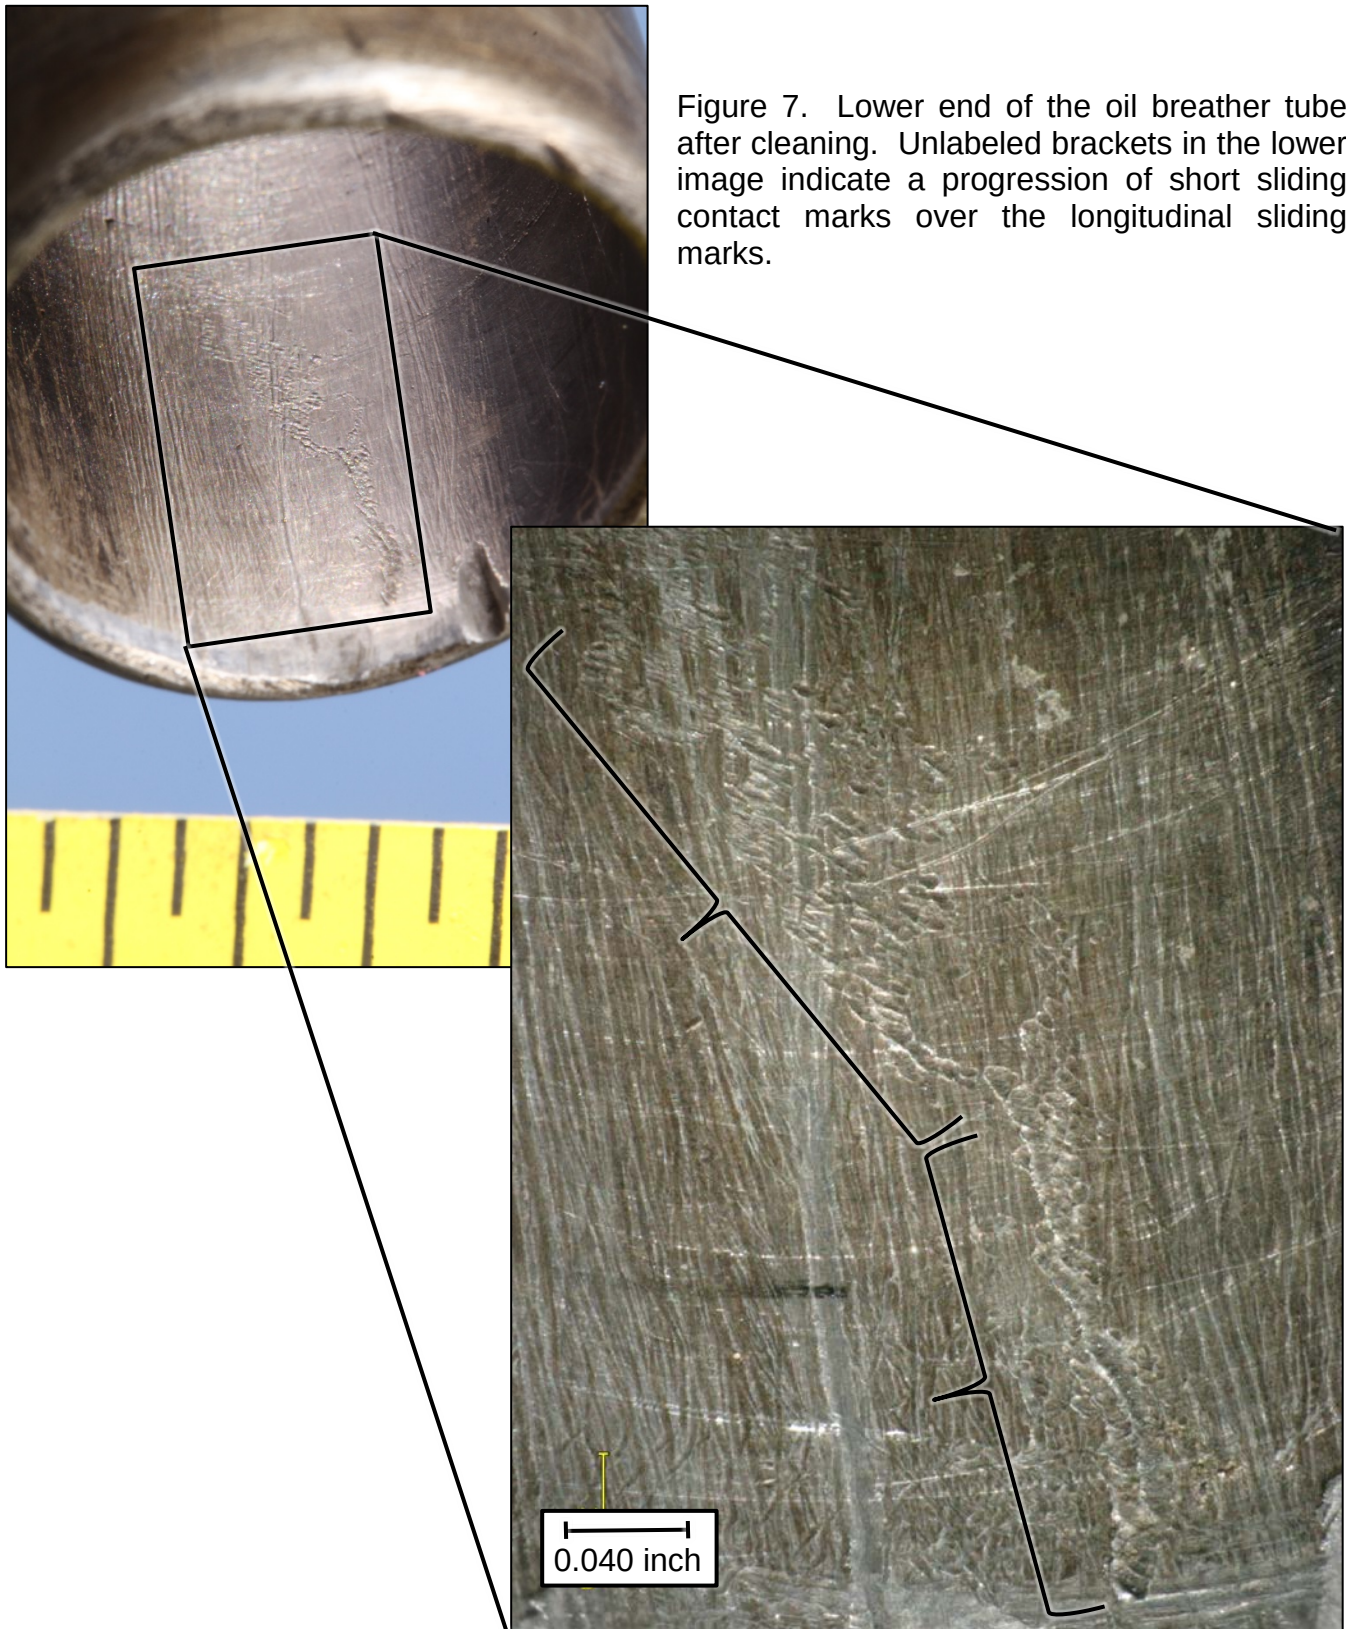
Oily deposits on the lower end of the breather tube were wiped from the surface using a cotton-tipped swab followed by cleaning using a soft-bristled brush dipped in a solution of Alconox detergent and water. The surface was then wiped dry with a paper towel. Optical images of the cleaned surface are shown in figure 7. A series of short sliding contact marks were observed on the interior surface of the breather tube as indicated with brackets in the lower image in figure 7 (a magnified view of the area within the rectangle in the upper image in figure 7). The short sliding contact marks were somewhat circular near the lower end and became more elongated in the circumferential direction at the upper end of the series. The marks overlaid longitudinal contact marks along the entire length within the image shown in figure 7.
