# NATIONAL TRANSPORTATION SAFETY BOARD

## MATERIALS LABORATORY FIRE FACTUAL REPORT

Place : Fort Lauderdale, Florida  
Date : December 1, 2018  
Vehicle : Cessna 335  
NTSB No. : ERA19FA060  
Investigator : Timothy Monville  
AS-ERA

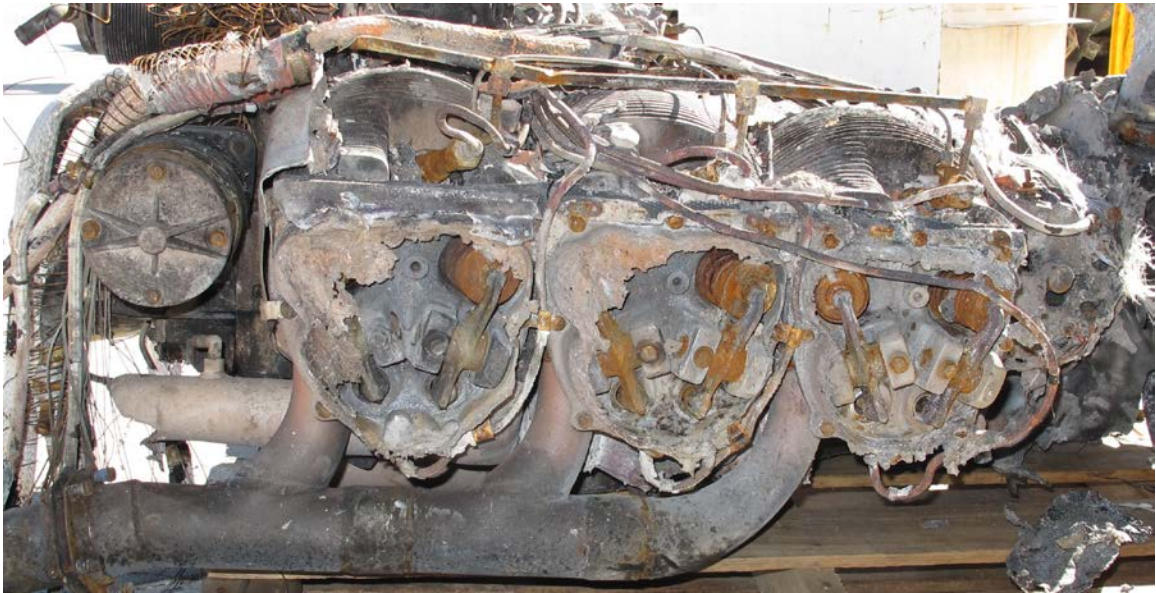
The left engine exhibited significant fire-related/thermal damage. One propeller blade was melted. The cylinder covers for Cylinders #1, #3 and #5 were melted with large area of material missing as shown in Figure 1. The cylinder covers for Cylinders #2, #4, and #6 were melted in areas and the remaining material was thinned, brittle and heavily sooted as shown in Figure 2. There was oil staining on the exhaust manifold on the left side for cylinders #2, #4, and #6 as shown in Figure 3. There was also some thermal discoloration on the exhaust tube.

Figure 1. Left Engine-Cylinders #1, #3 and #5.

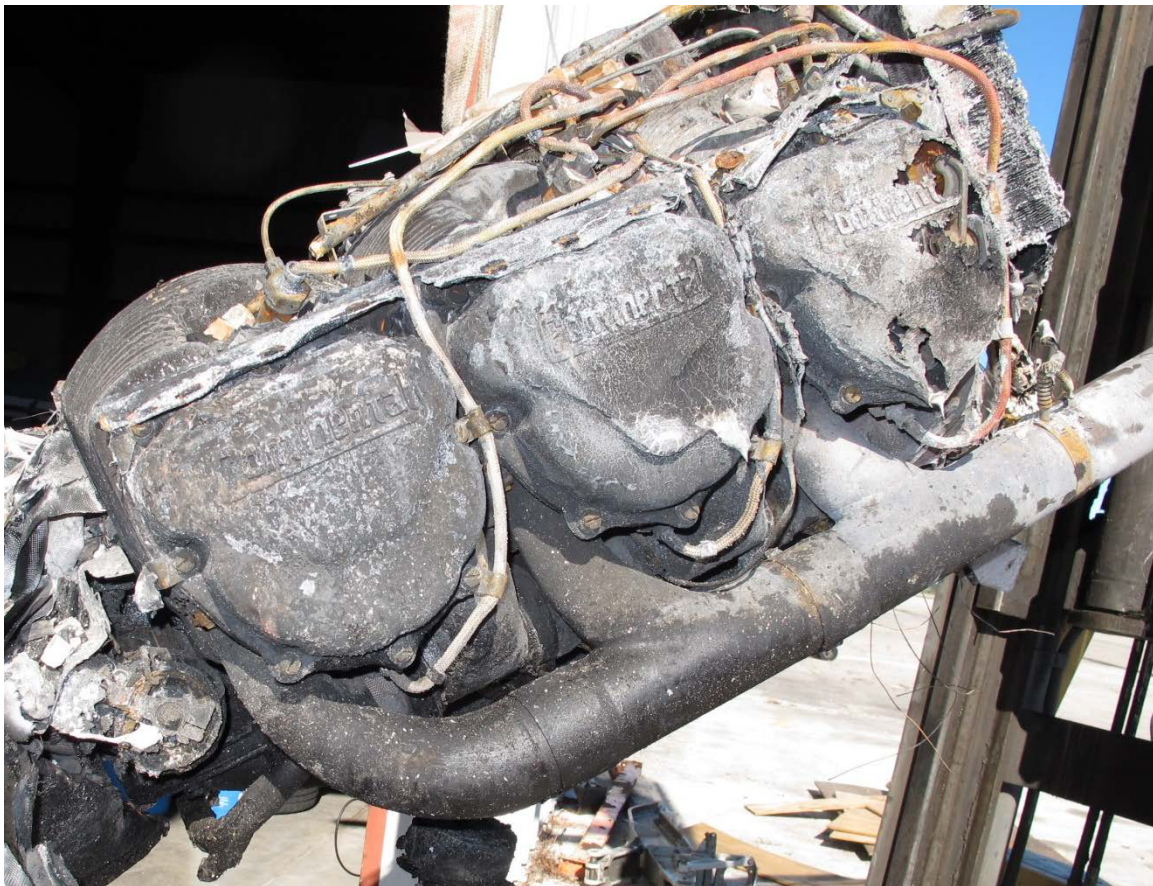
Figure 2. Left Engine-Cylinders #2, #4 and #6.

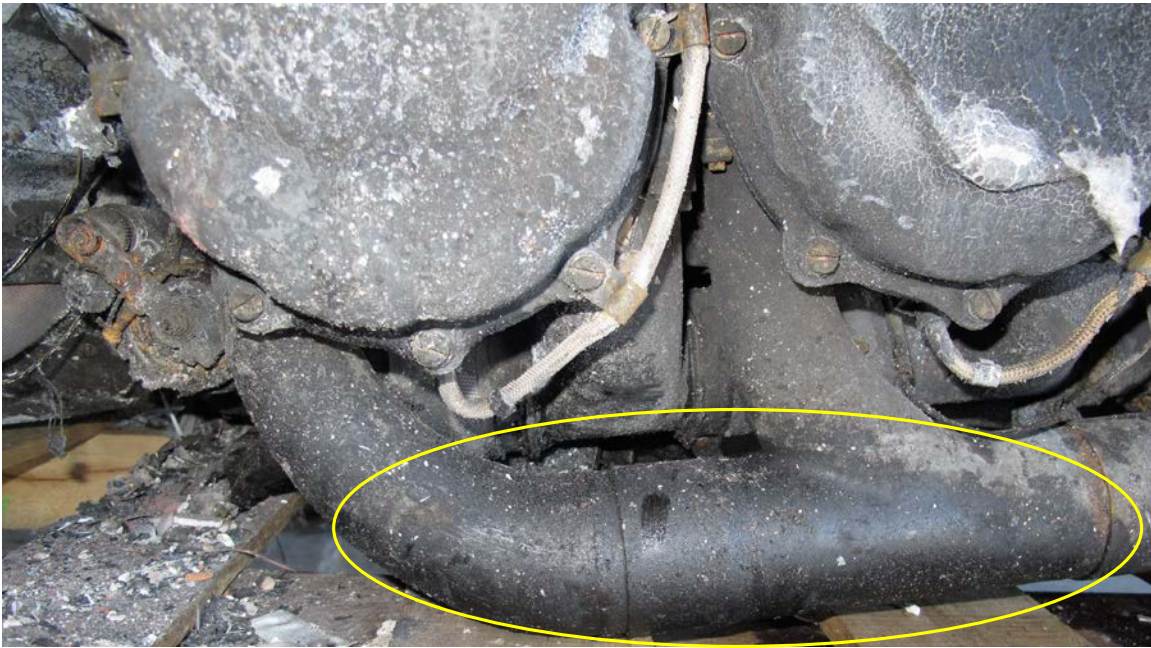
Figure 3. Close-up of oil staining (highlighted by yellow circle) left engine exhaust duct (#2, #4 and #6 cylinders' side).

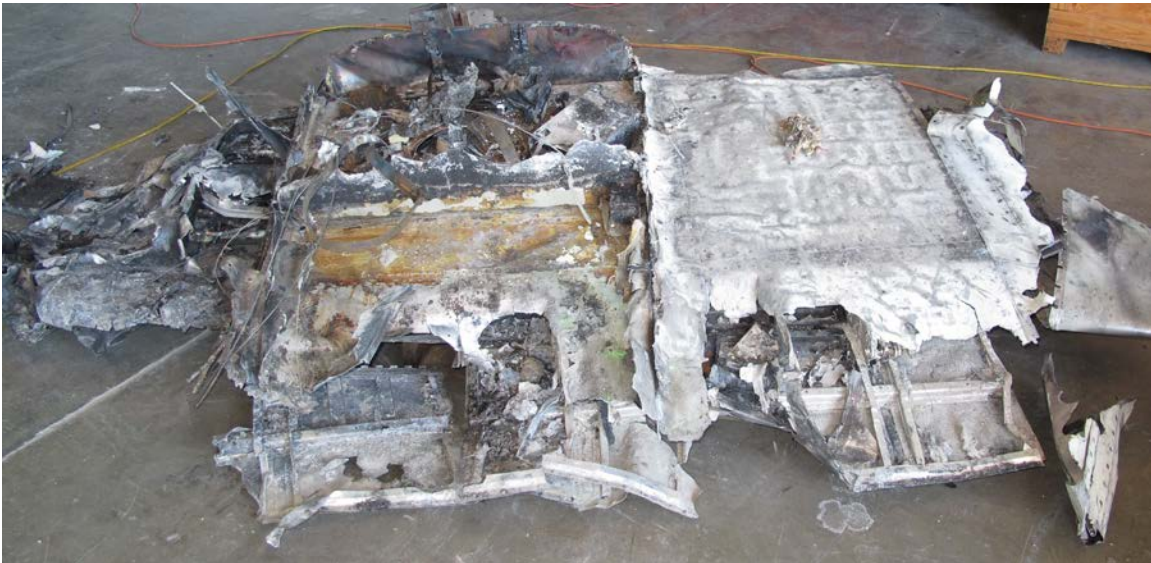
Figure 4. Left engine nacelle.

The left engine nacelle sustained thermal and mechanical damage as shown in Figures 4 and 5. The remaining paint aft of the firewall was thermally discolored. The upper nacelle skin aft of the firewall was dimpled and buckled by heat exposure. The firewall had thermal discoloration on the top half of both sides. The lower half of both sides was heavily sooted. The firewall was also buckled by impact. The cold side of the turbocharger was melted with large sections of material missing as shown in Figure 6. The turbocharge intake was not attached and presumed destroyed by fire. Most of the

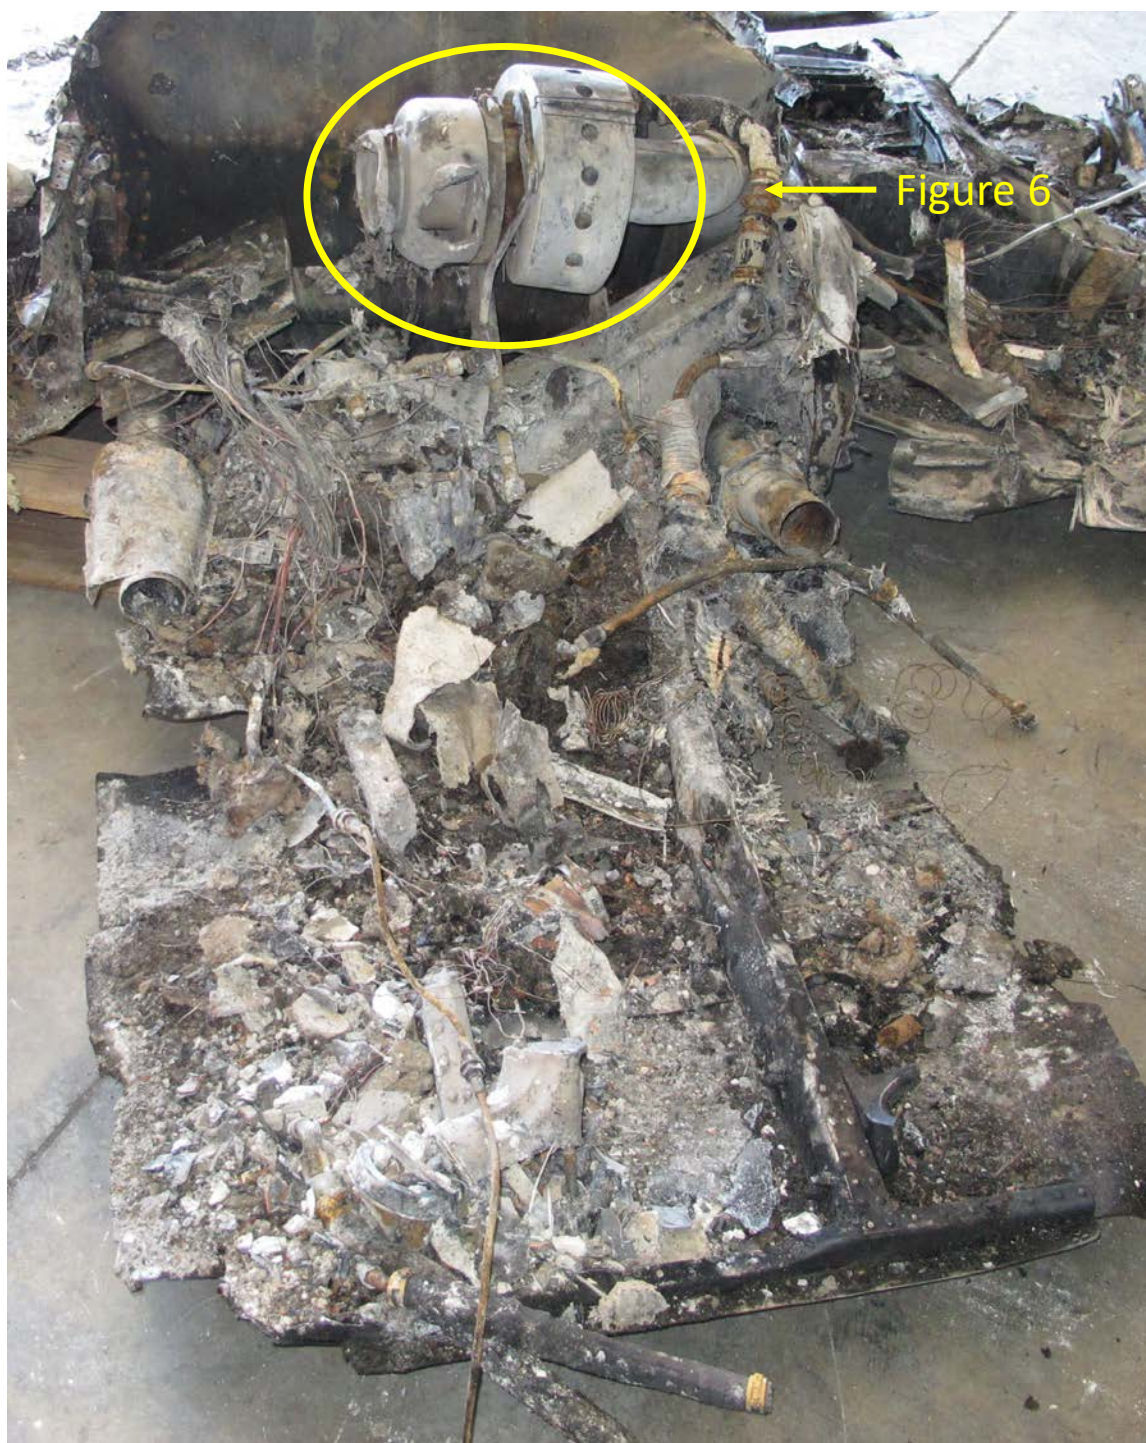
fuel and oil lines were missing. The remaining aluminum lines were melted. There was oil staining on the left side of the lower cowling, while the right side of the lower cowling was dry.

Figure 5. Left engine lower nacelle and cowling.

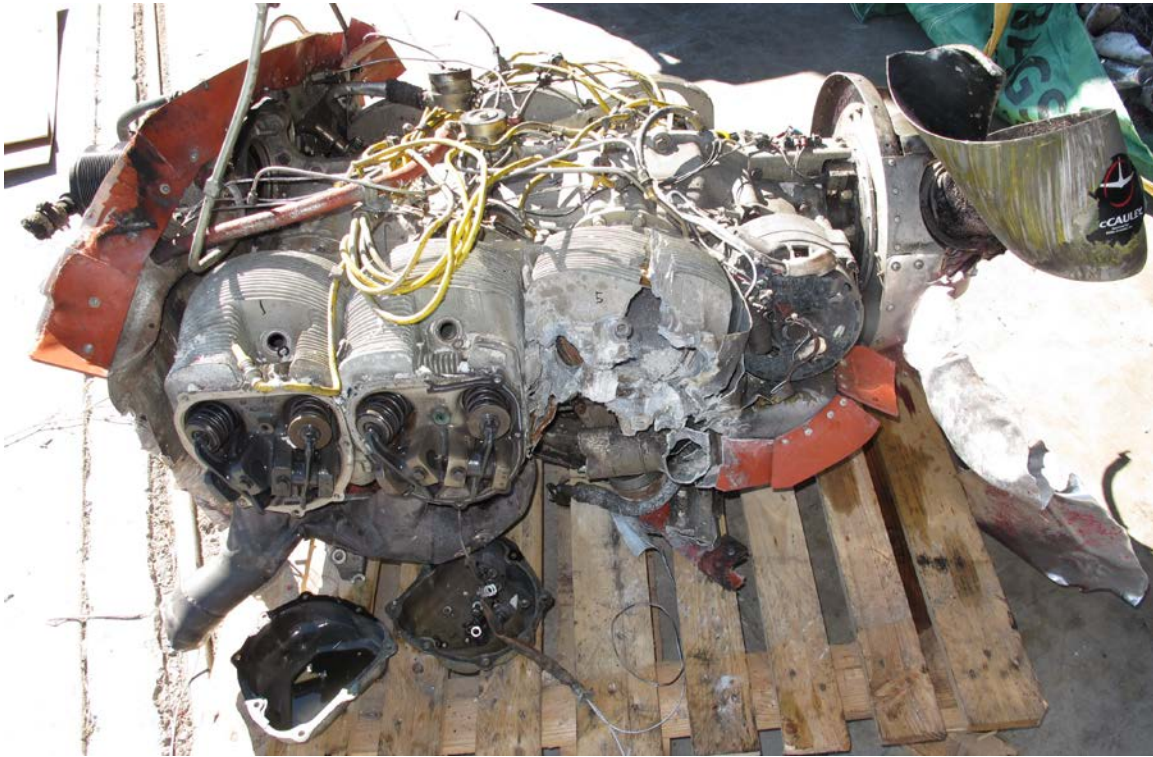
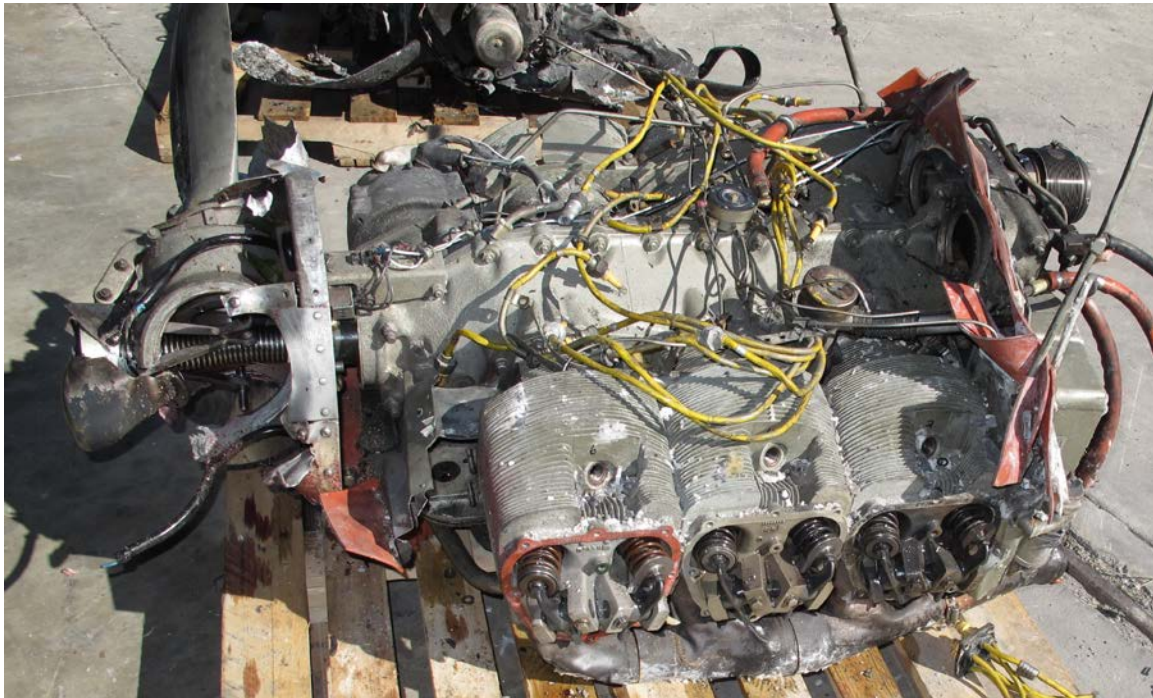
The right engine had little thermal related damage except for some light sooting on the cylinder covers and other engine hardware as shown in Figures 7 and 8. The aft end was mostly intact and exhibited only mechanical impact-related damage. The rubber skirt was intact and exhibited no thermal related damage.

Figure 7. Right engine cylinders #1, #3 and #5.

Figure 8. Right engine cylinders #2, #4 and #6.

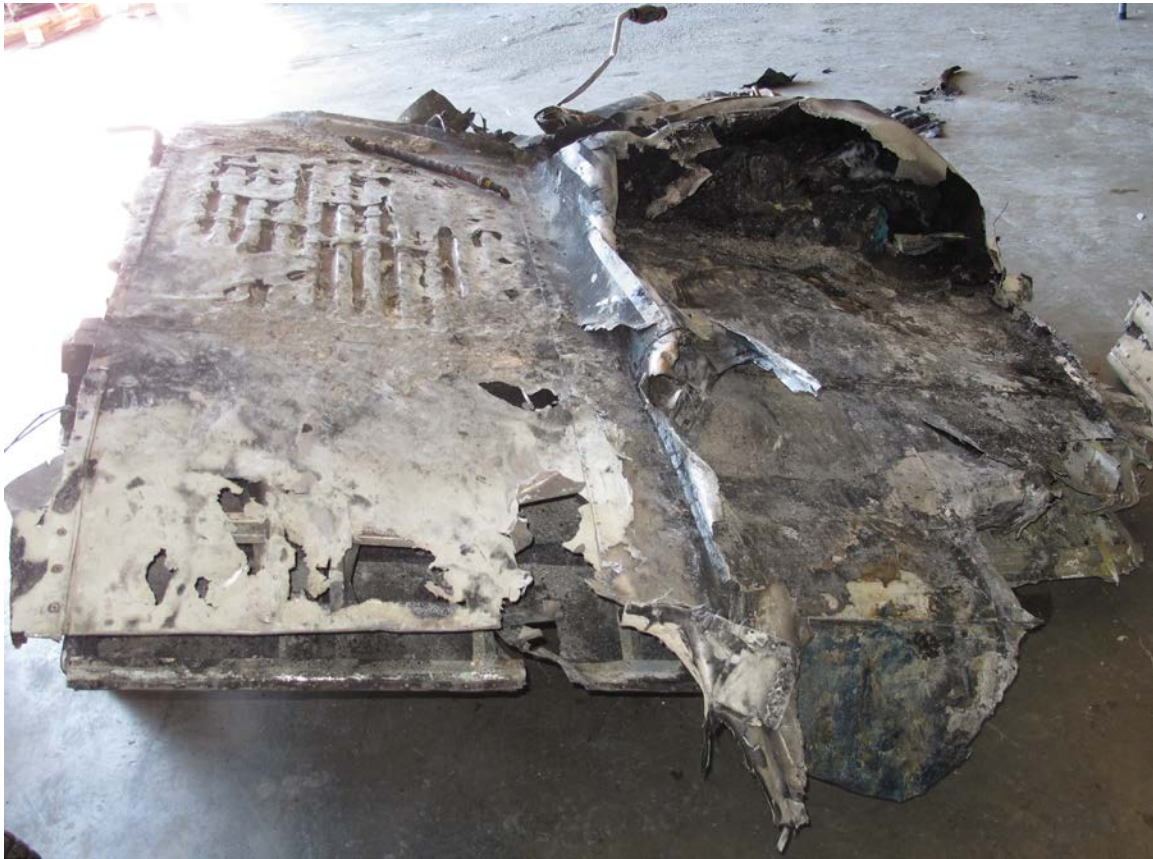
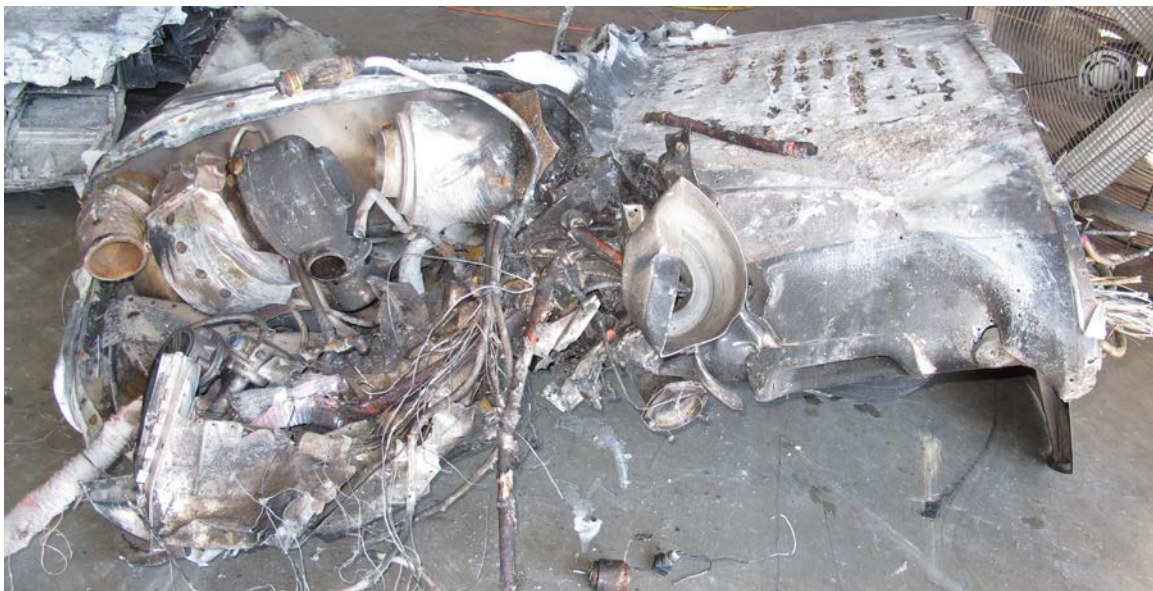
The right nacelle sustained thermal and mechanical damage as shown in Figures 9 and 10. The skin of the upper surface aft of the firewall was melted with the majority missing. There was no paint remaining. The cowlings were not attached to the nacelle. The firewall had thermal discoloration on the top half of both sides. The lower half of both sides was heavily sooted. The firewall was also buckled by impact. The oil and fuel lines were present and exhibited some mechanical damage.

Figure 9. Upper surface of right engine nacelle.

Figure 10. Right nacelle, firewall and turbocharger.

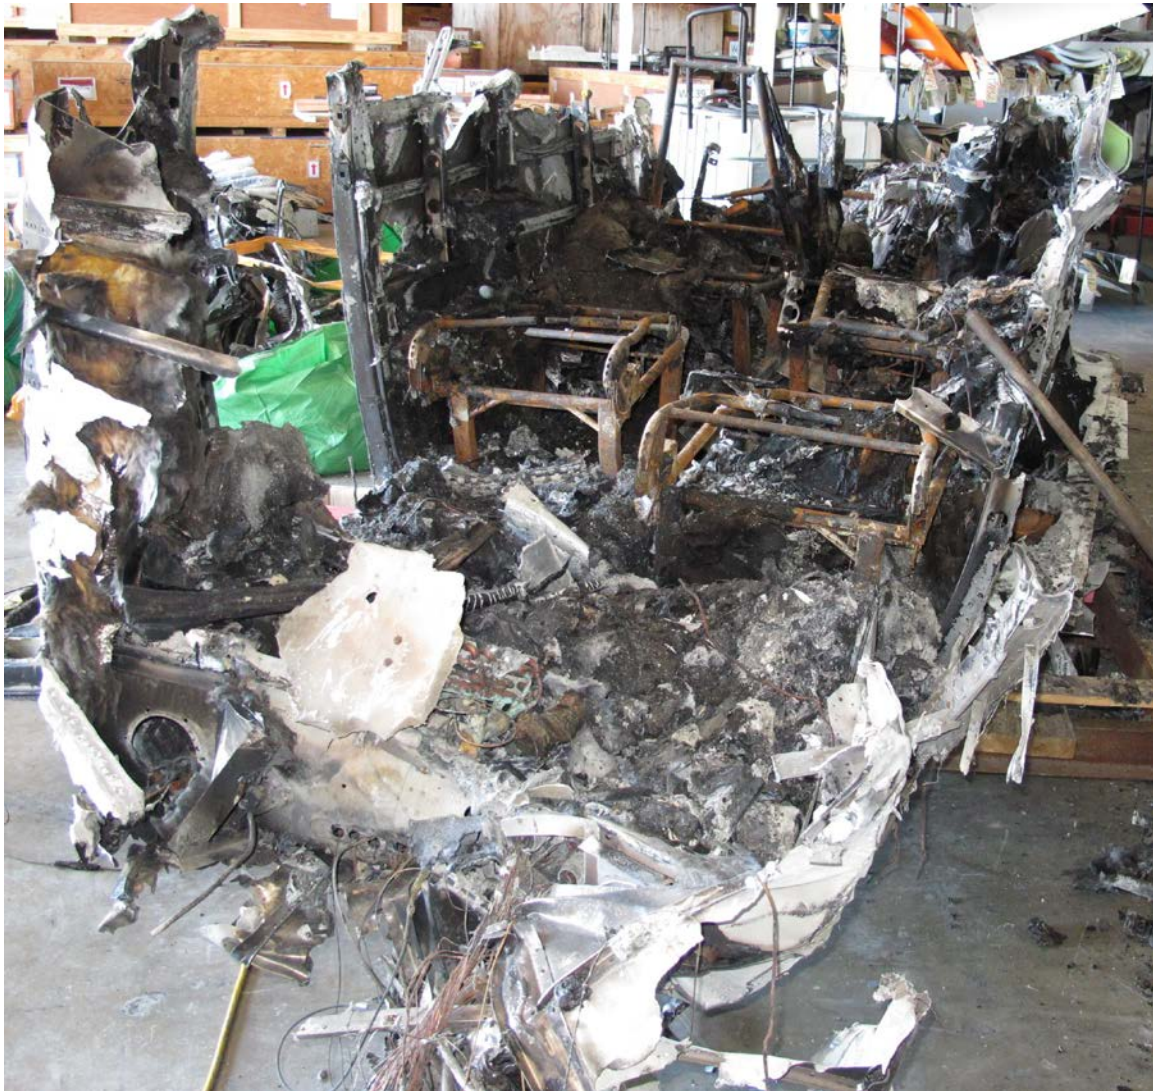
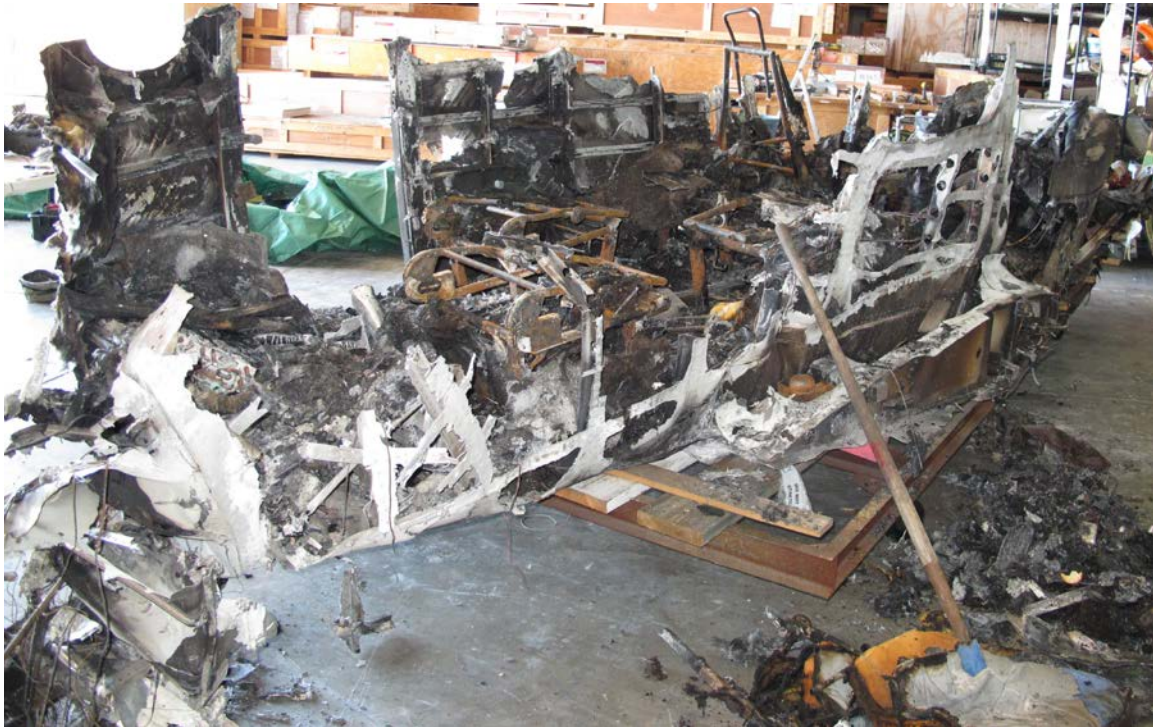
The fuselage sustained heavy thermal damage as shown in Figures 11 and 12. Only a small portion of the skin remained on the left side aft of the cockpit. Some of the stringers and other support structure remained on the lower half of the cockpit and cabin area.

Figure 11. Cockpit and cabin structure (facing forward).

Figure 12. Cockpit and cabin (right side).
