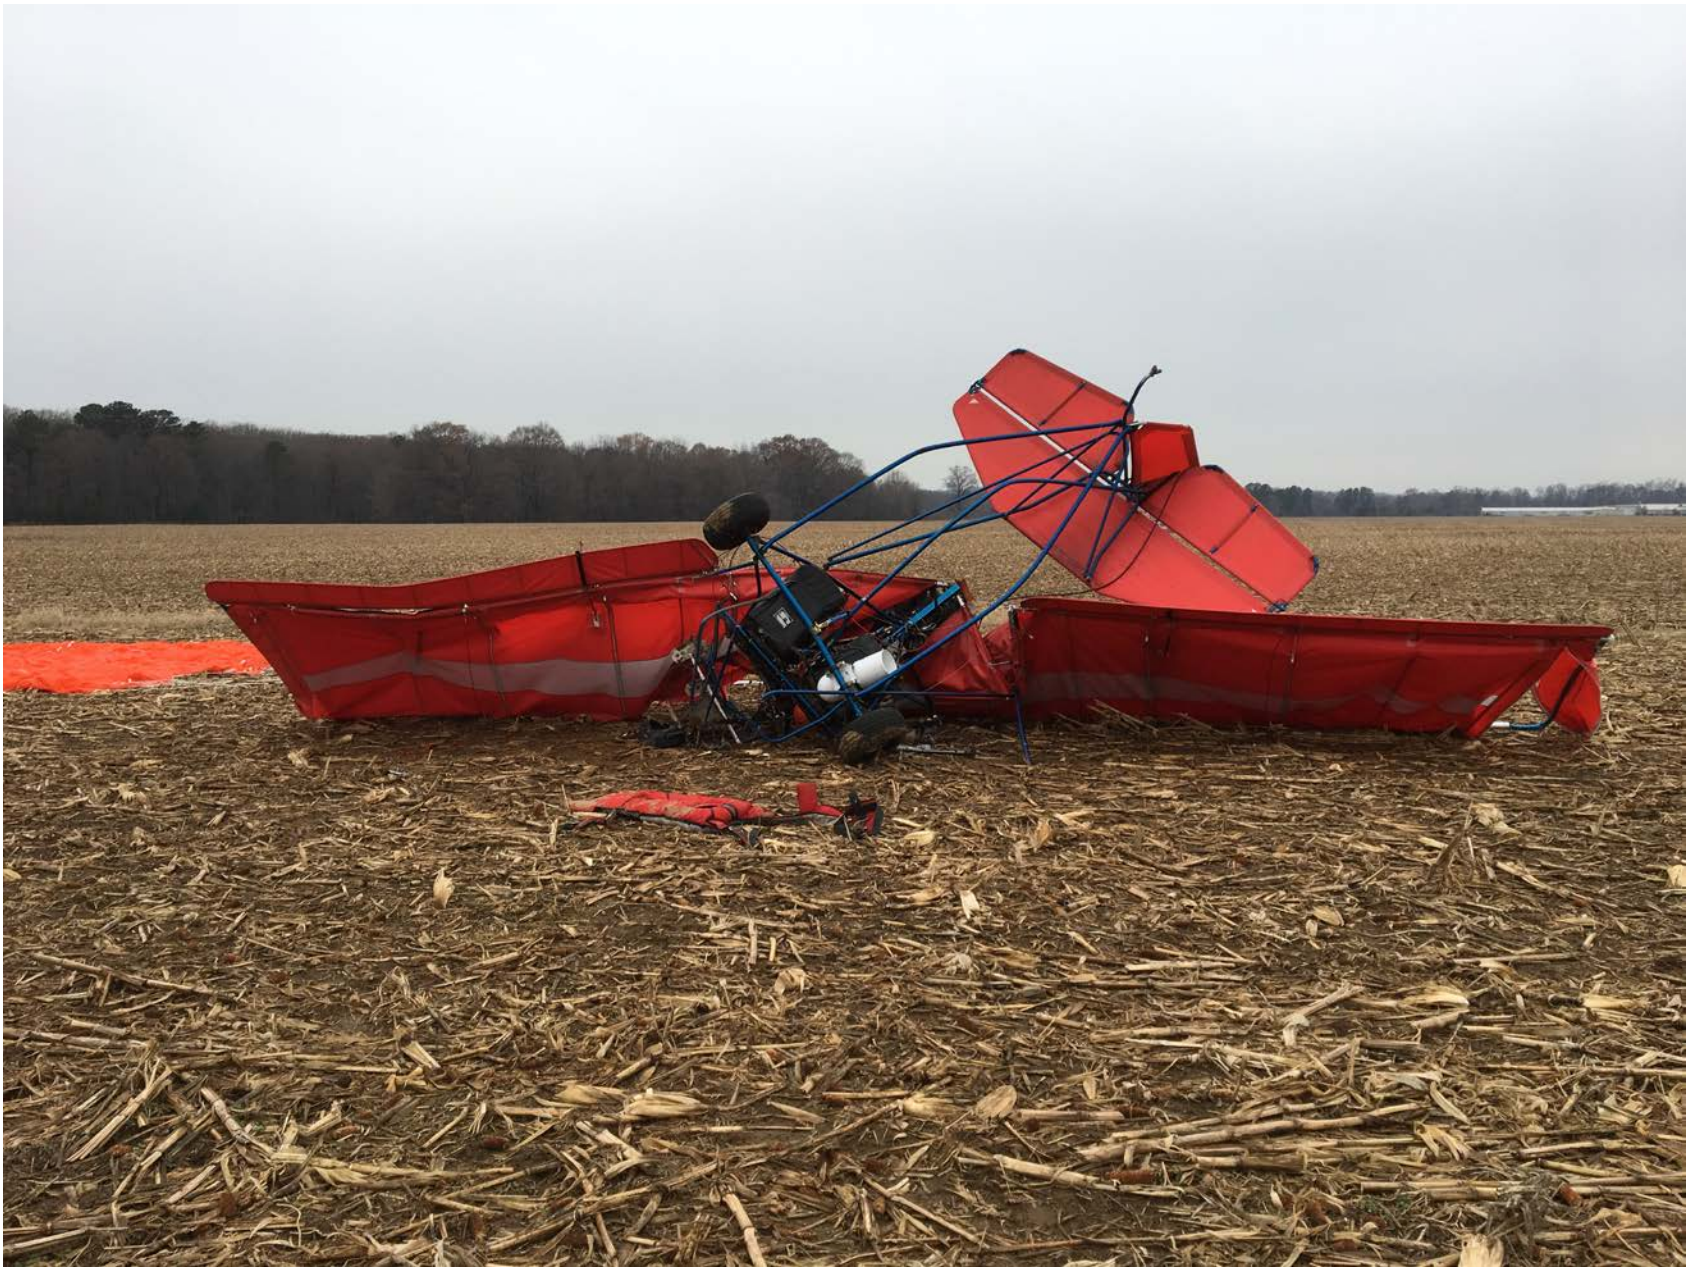
**Photo 1 – View of Main Wreckage as Found**

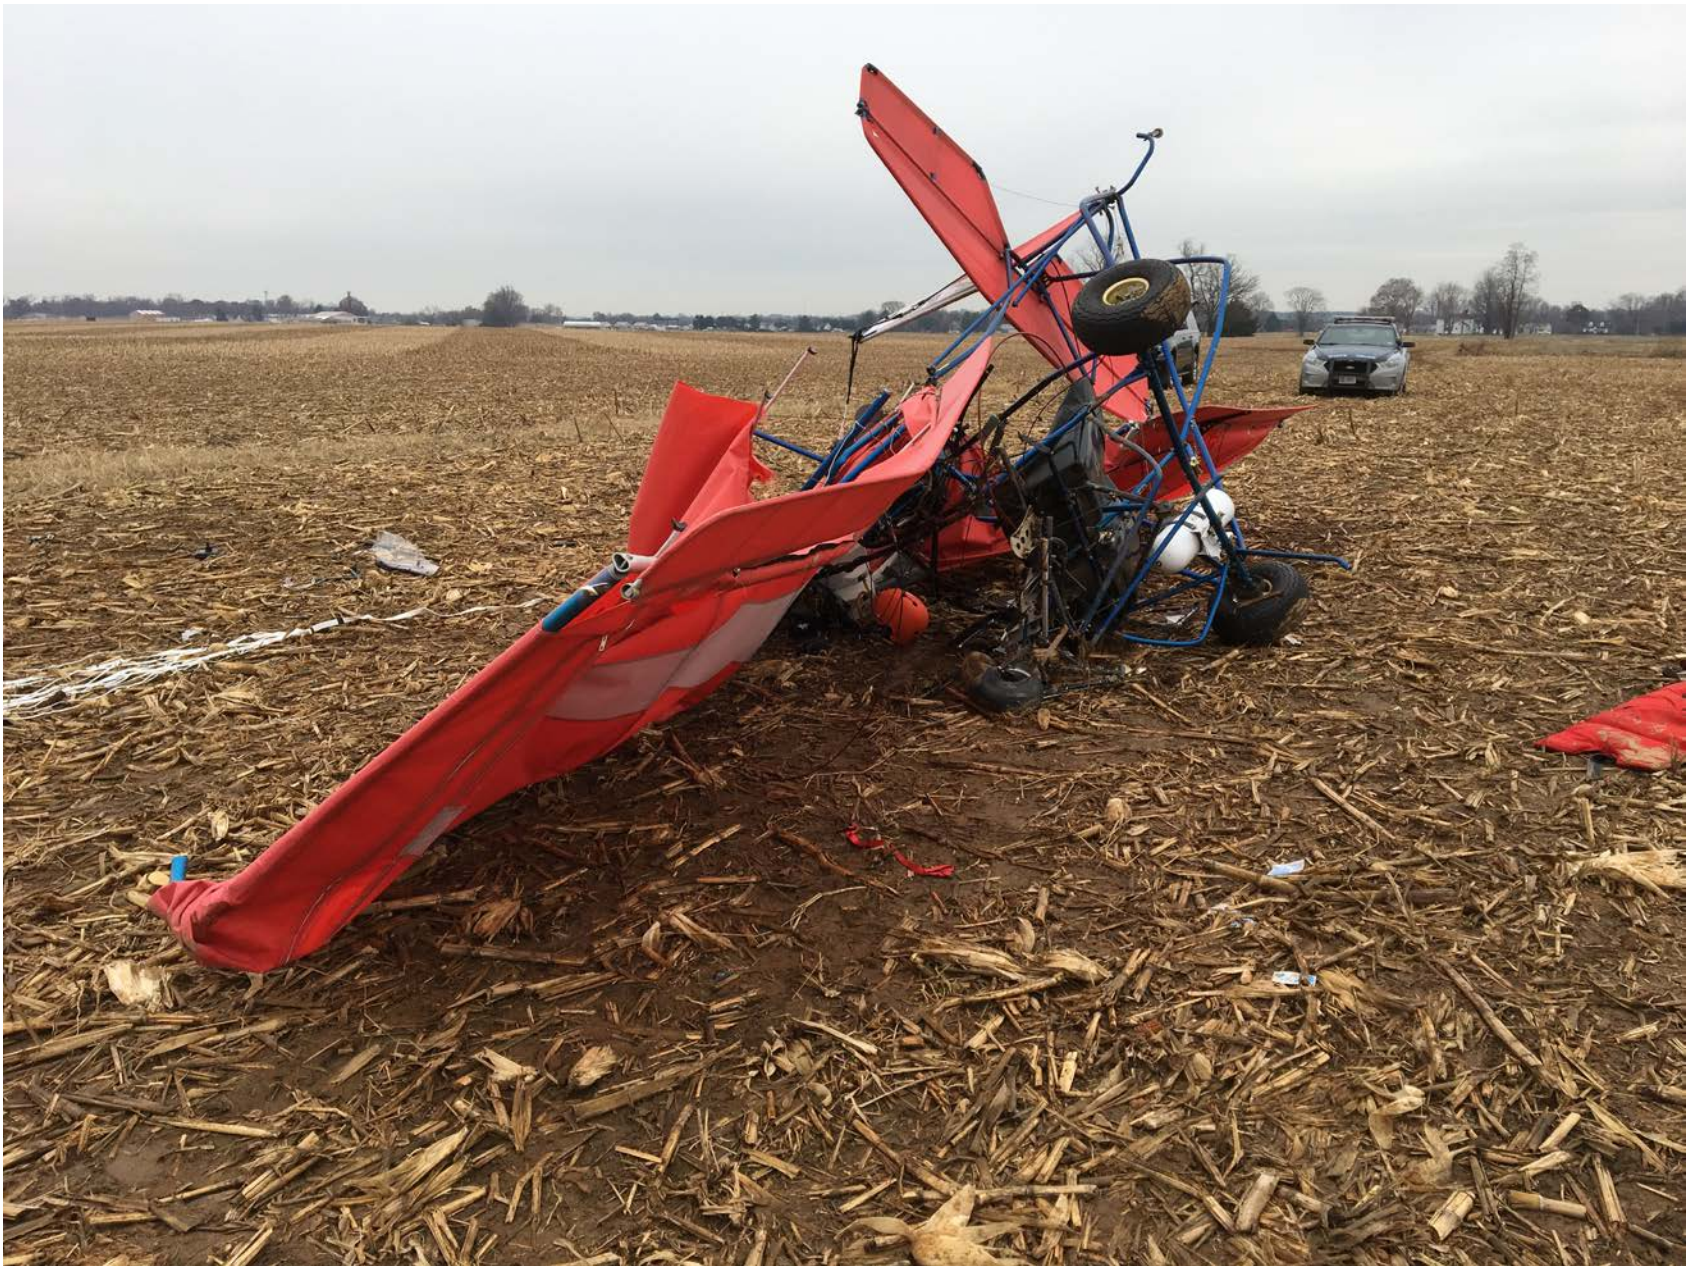
**Photo 2 – View of Main Wreckage as Found Facing Direction of Downwind Leg of Traffic Pattern.**

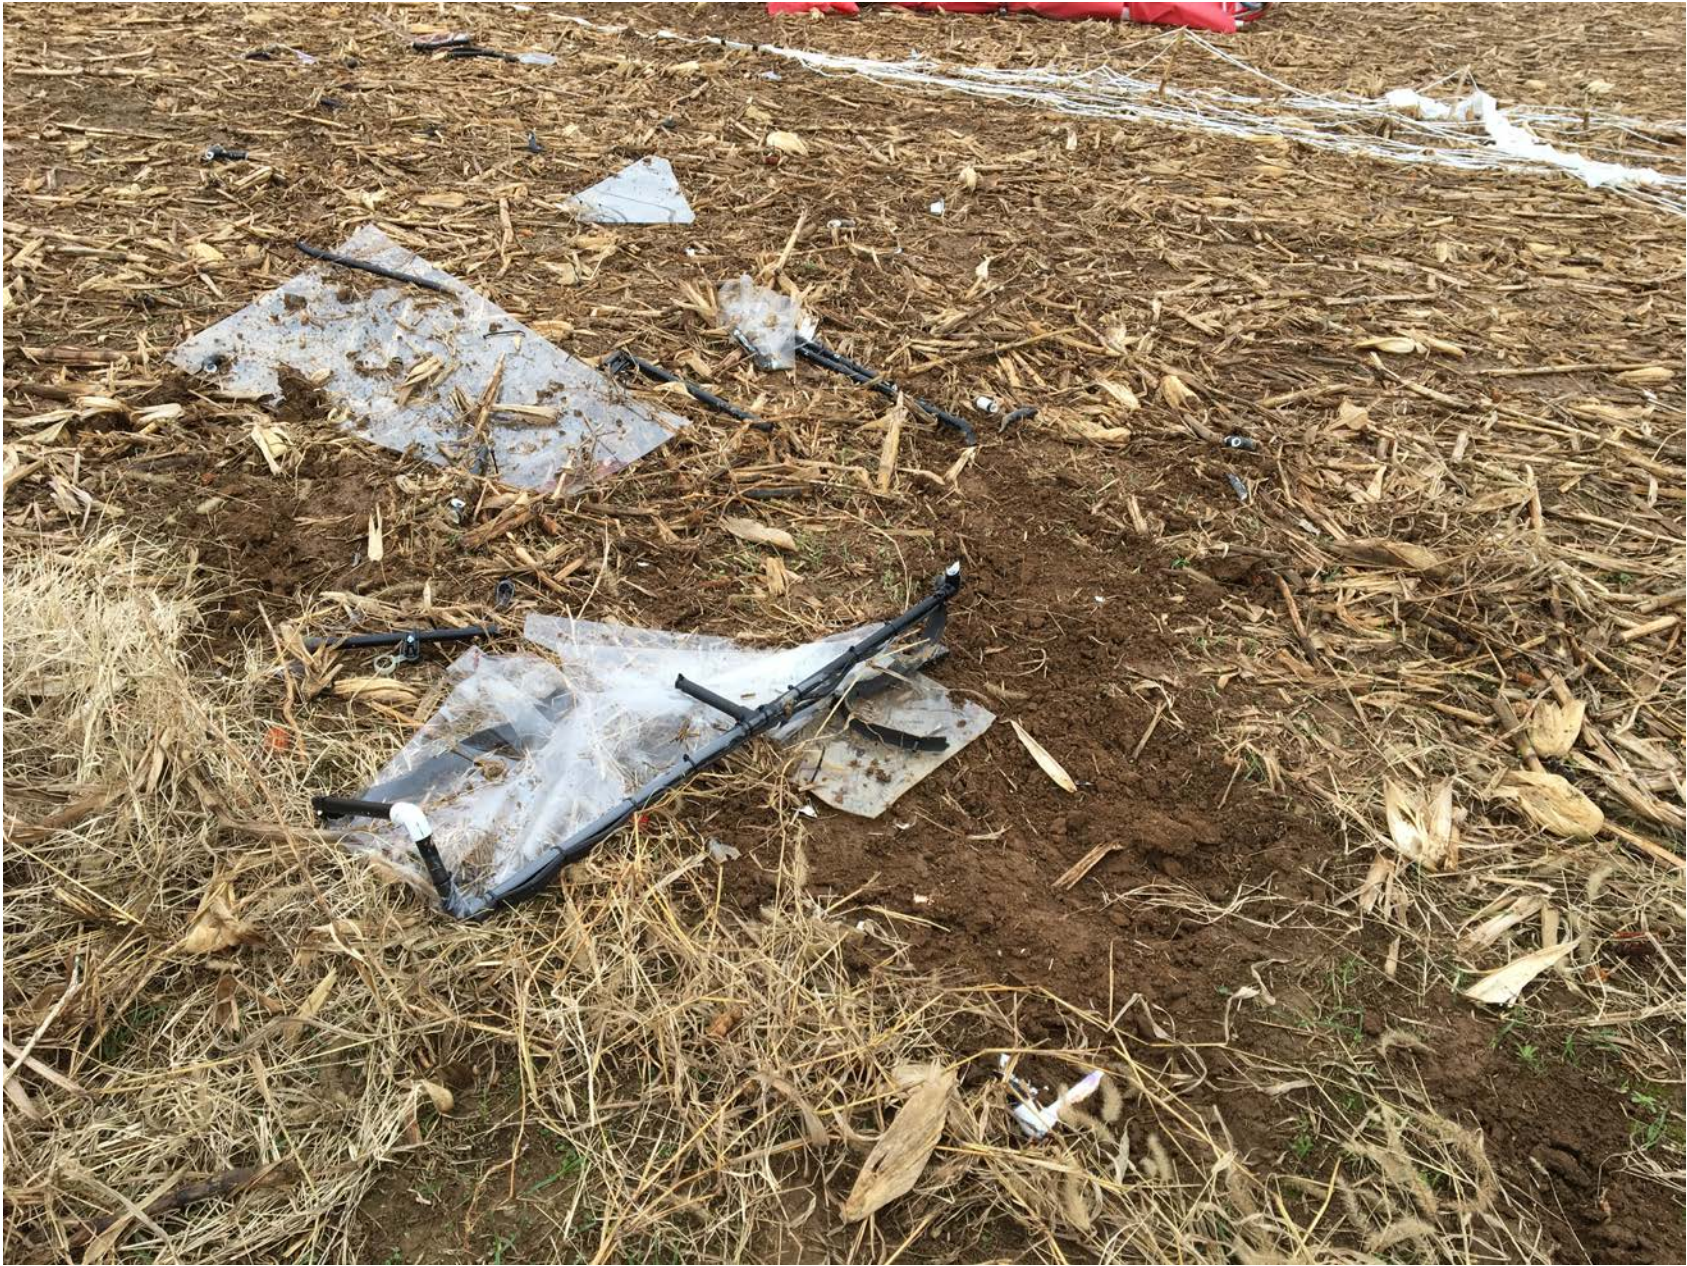
**Photo 3 – View of Lexan, PVC, and Zip-Tie Cockpit Enclosure Fragments**

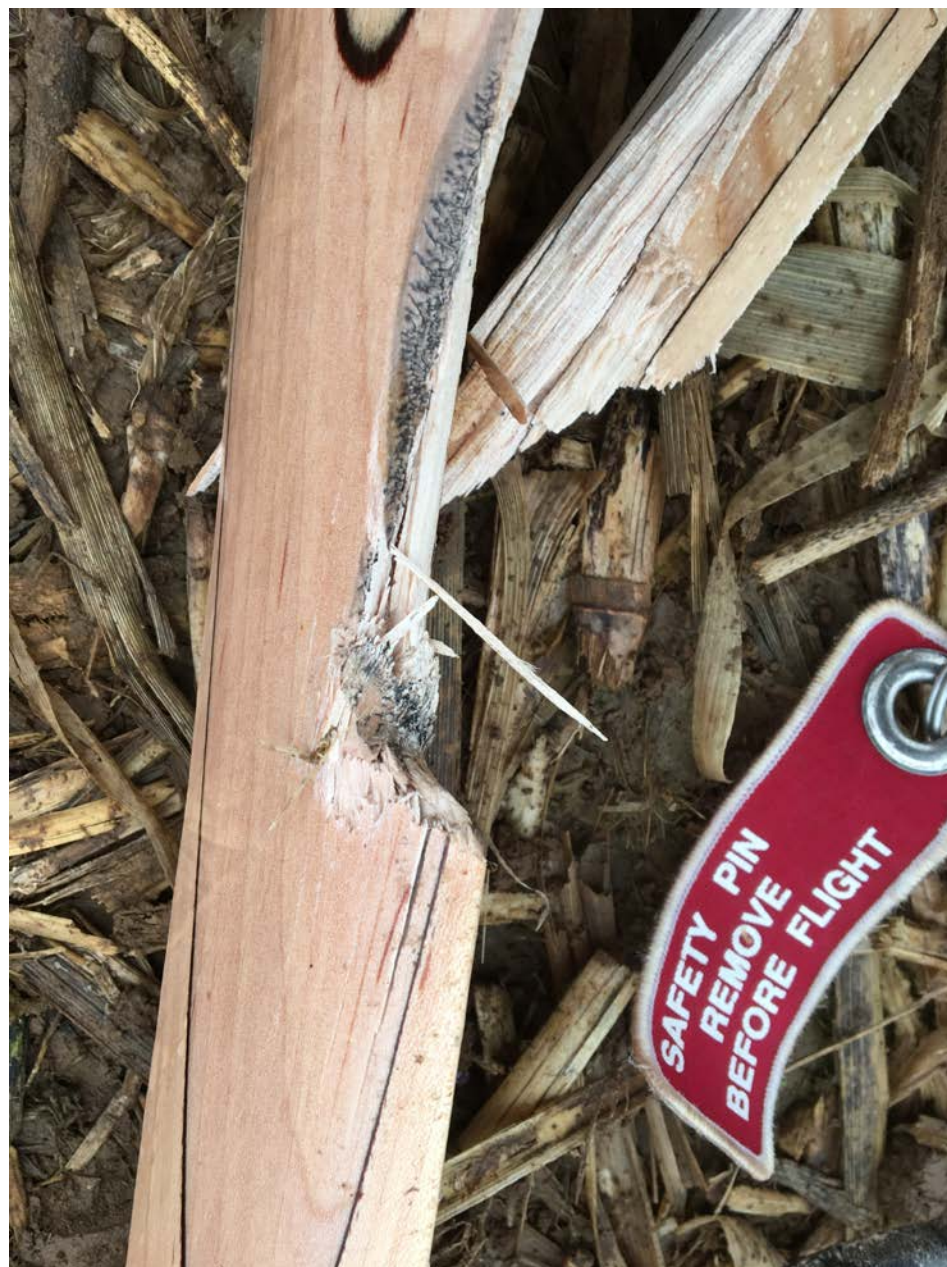
**Photo 4 – View of Propeller Blade**

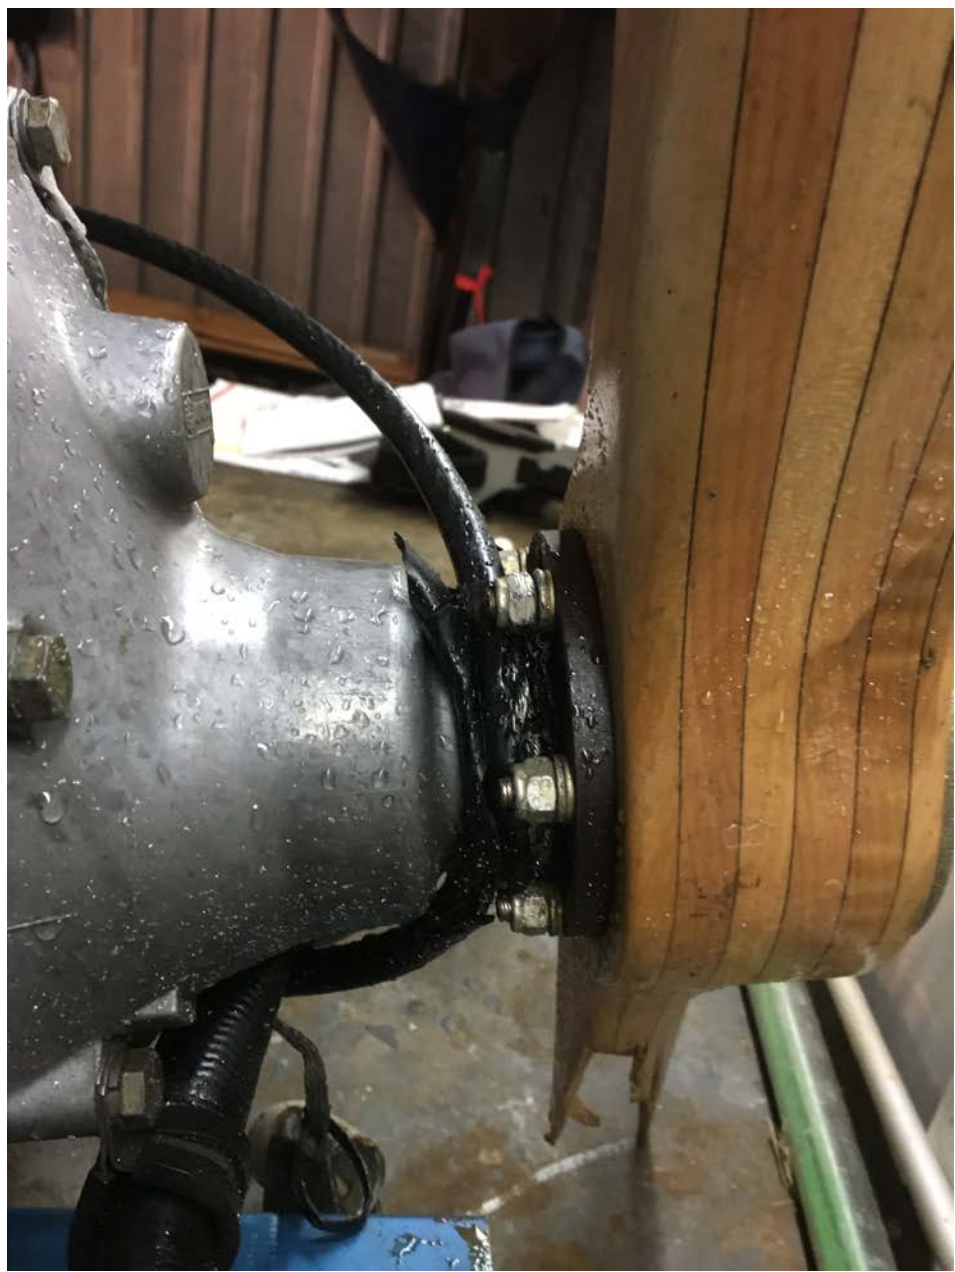
**Photo 5 – View of BRS Cable Wrapped around Propeller Hub**

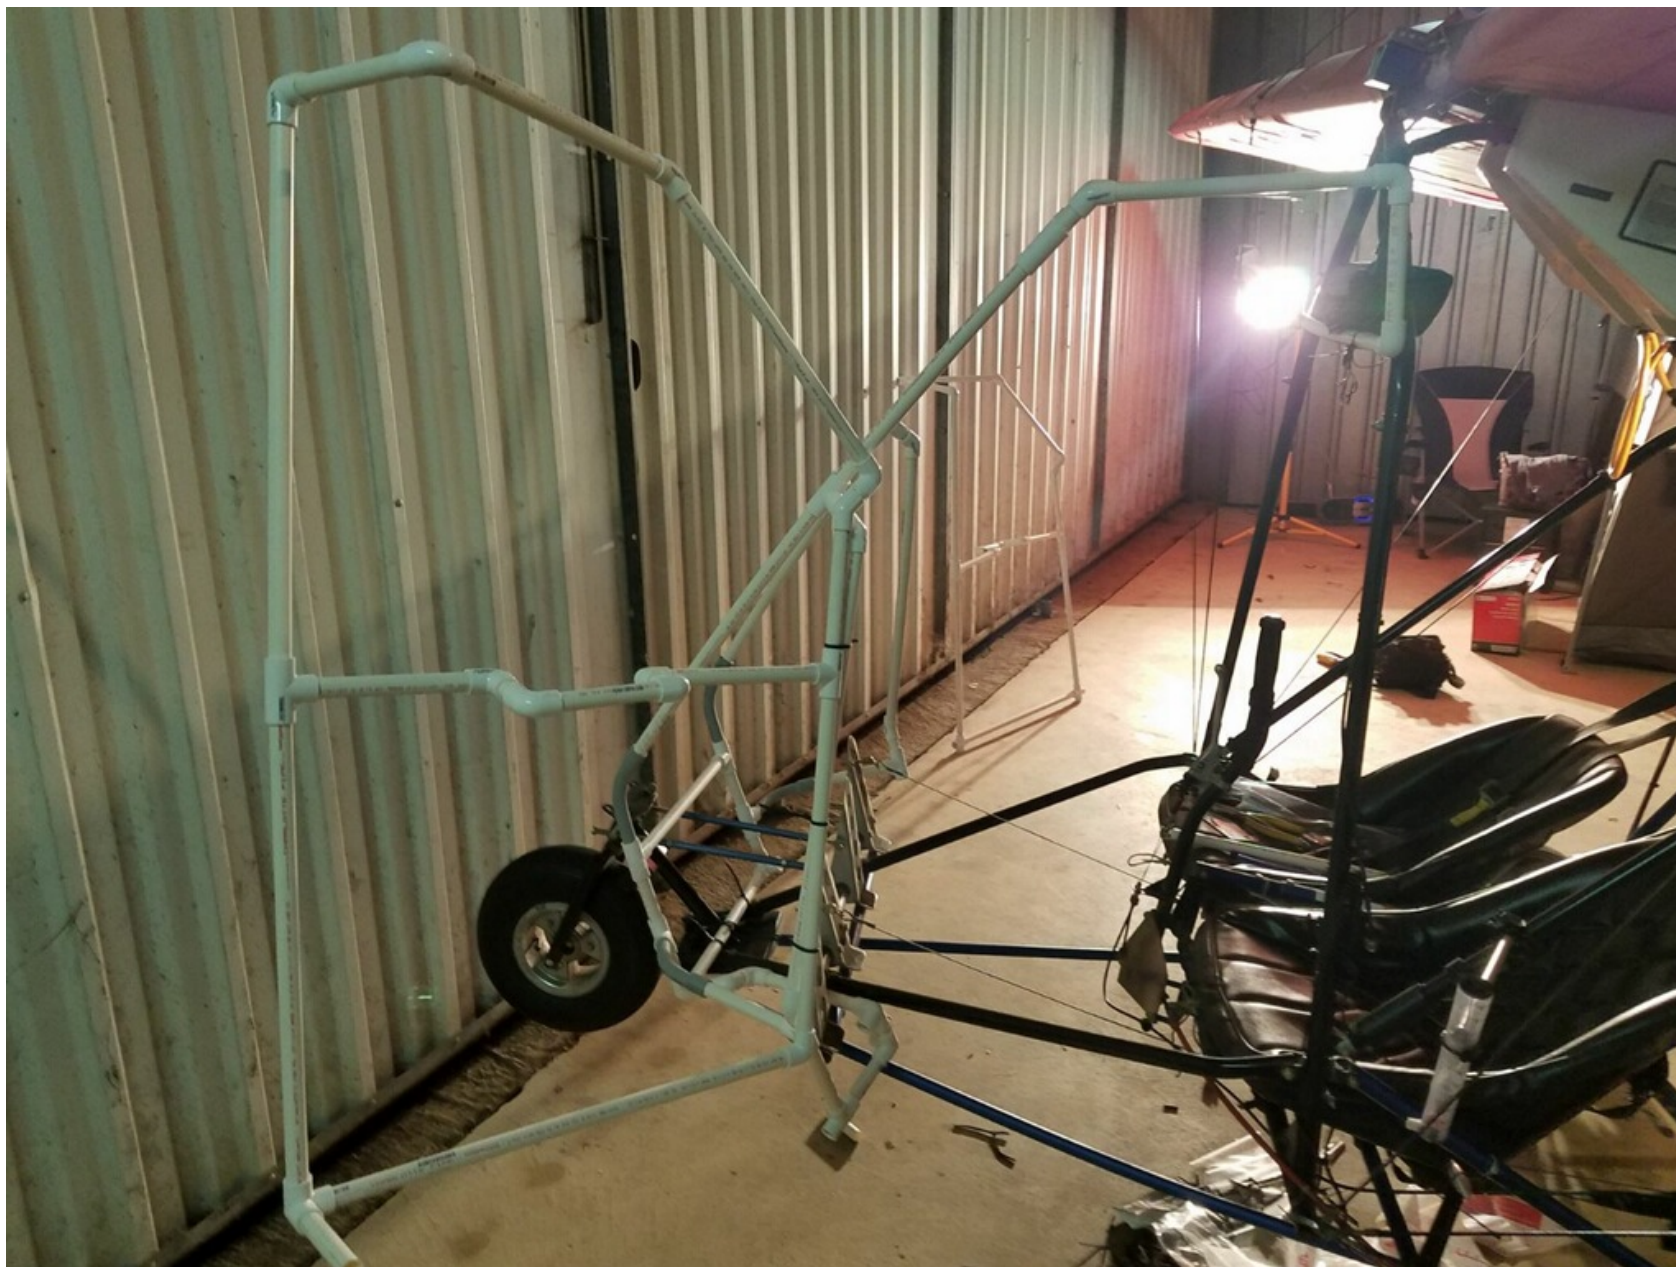
**Photo 6 – View of PVC-Tubing Frame for Cockpit Enclosure Secured with Zip-Ties**

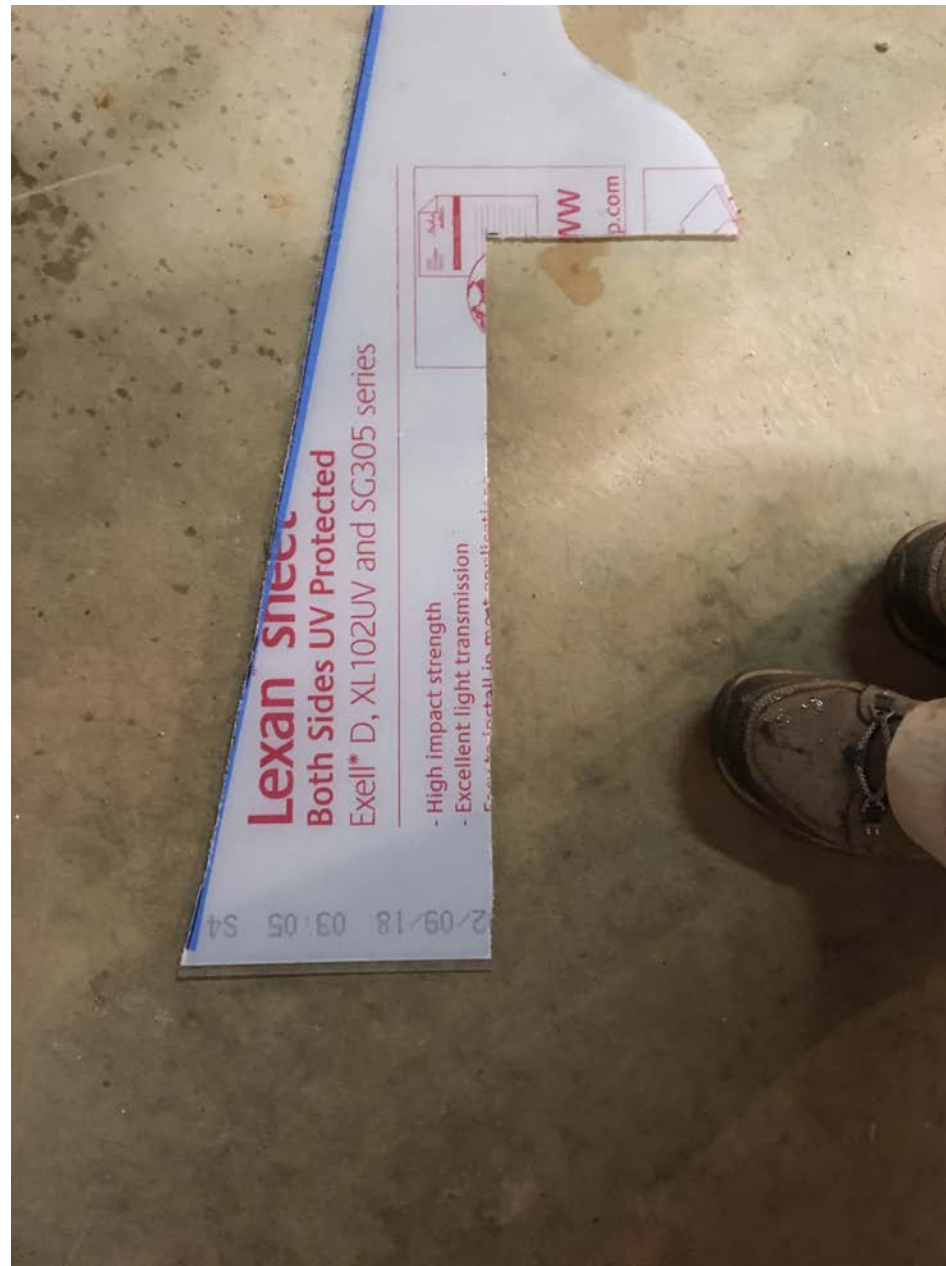
**Photo 7 – View of Lexan Scrap on Pilot/Owner’s Hangar Floor**

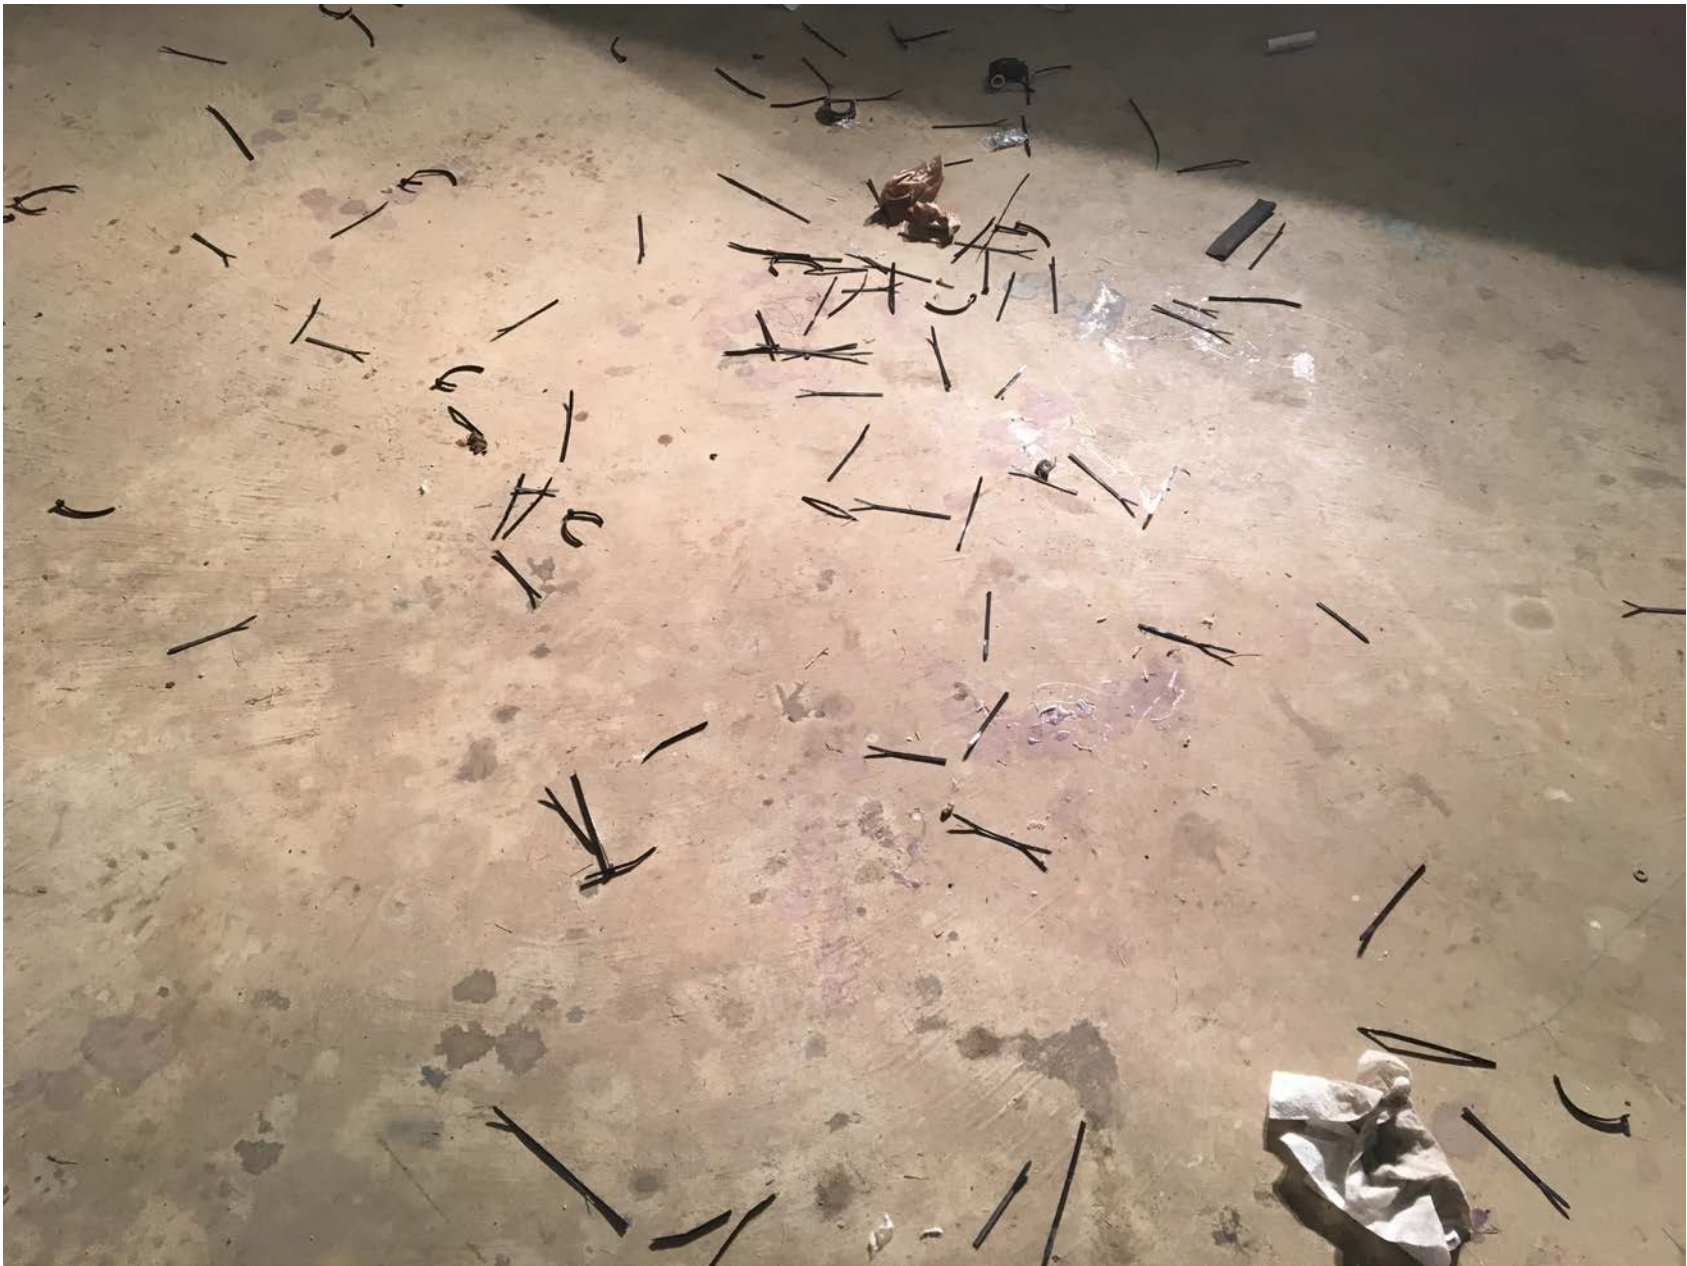
**Photo 8 - View of Zip-Tie Scrap on Pilot/Owner's Hangar Floor**
