## **NATIONAL TRANSPORTATION SAFETY BOARD**

# **STRUCTURES**

## **Group Chairman's Factual Report**

**ERA19FA068**

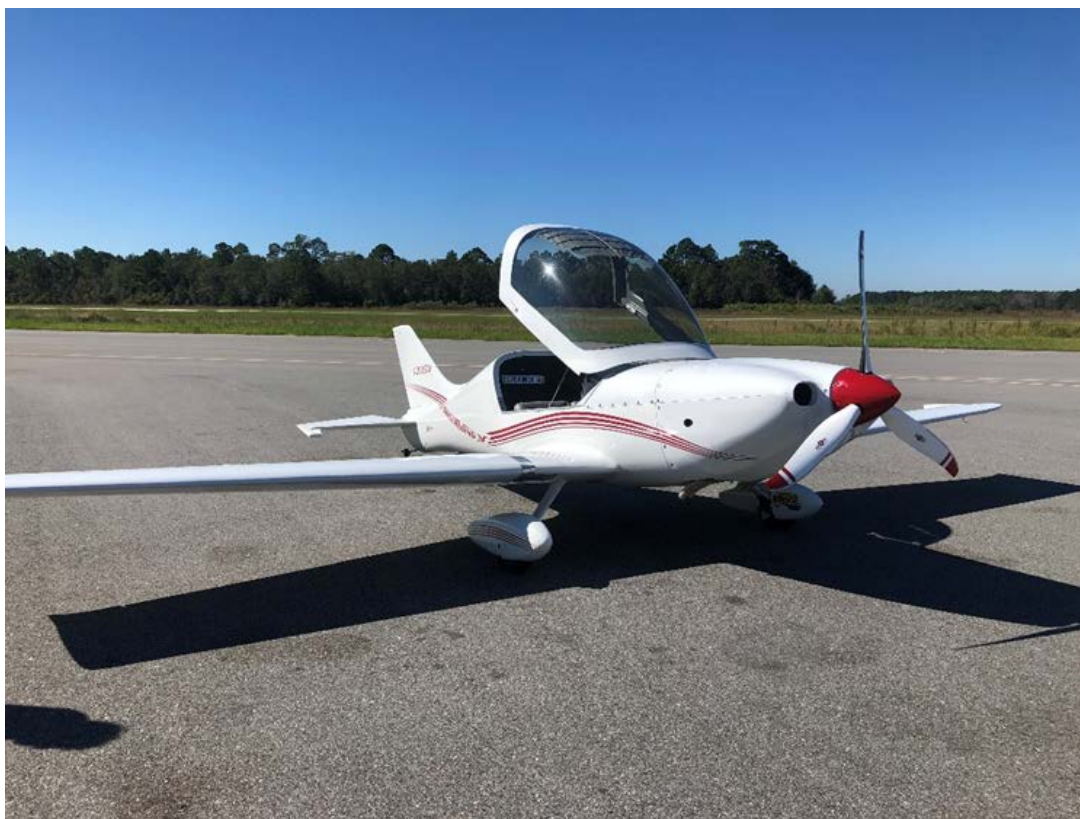
**Figure 2 – Azalea Saberwing accident airplane, N203SW**

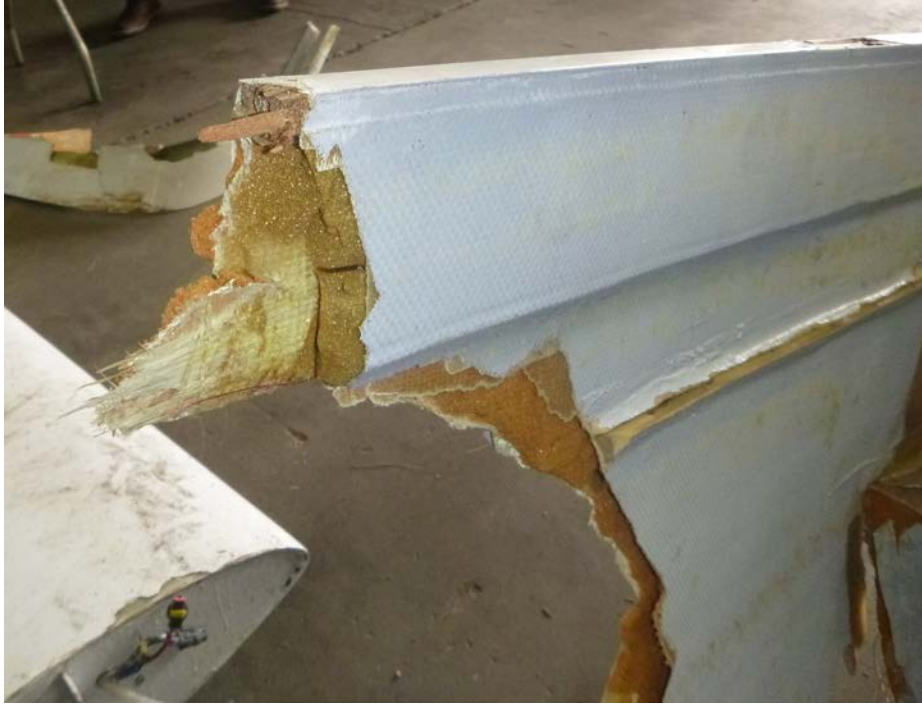
**Figure 3 – Left longeron fracture, forward fuselage section**

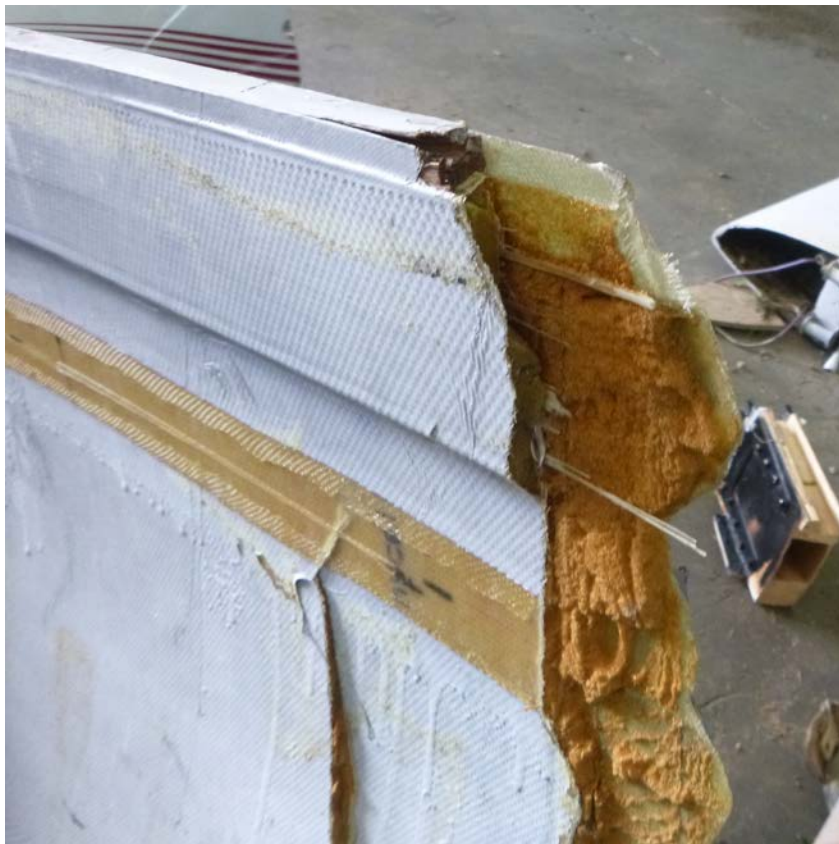
**Figure 4 – Right longeron fracture, forward fuselage section**

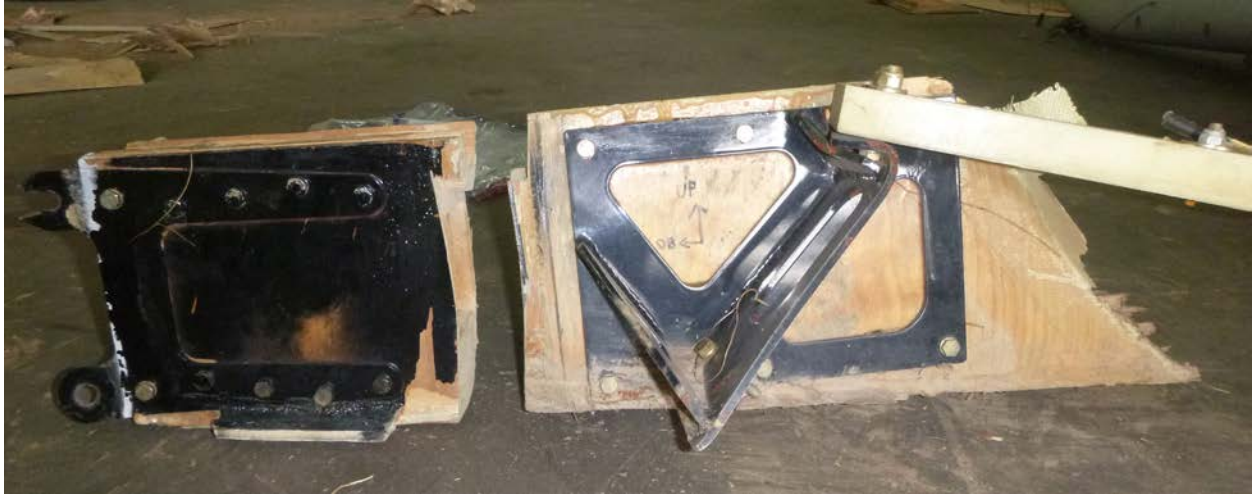
**Figure 5 – Right center wing forward spar, looking aft**

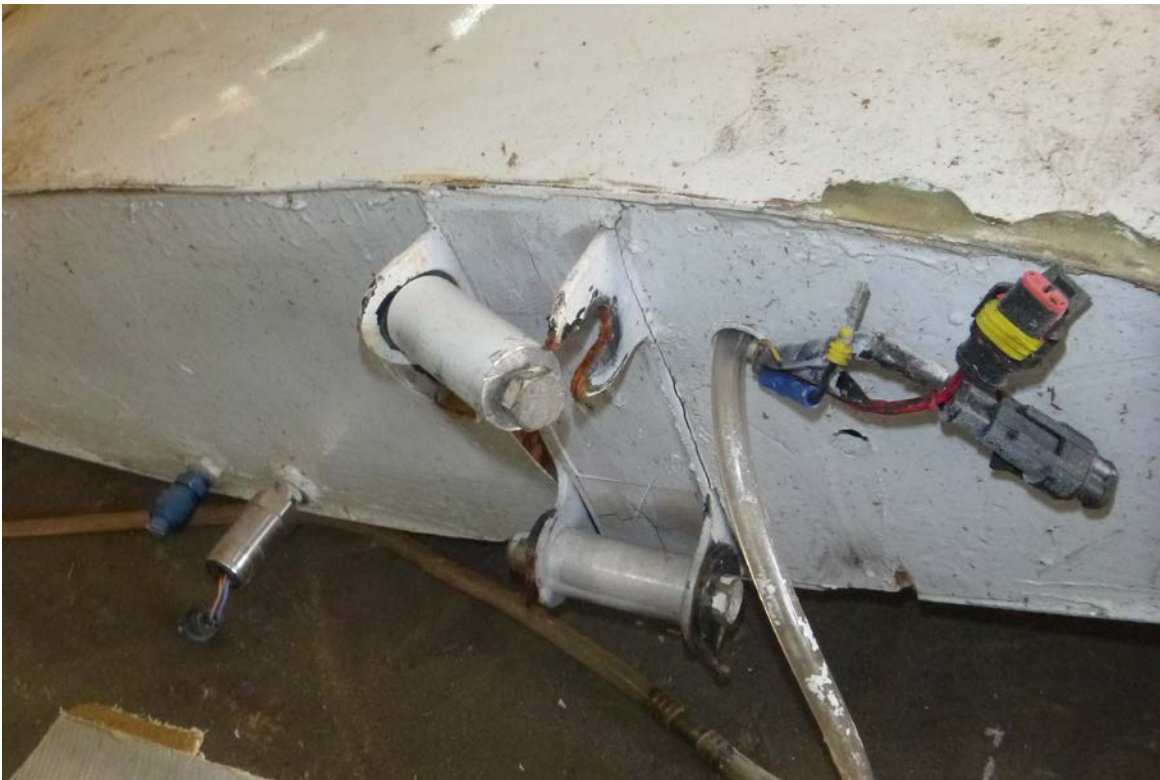
**Figure 6 – Left outboard wing forward spar attachment**
