**Photo 1 –Overview of Accident Site**

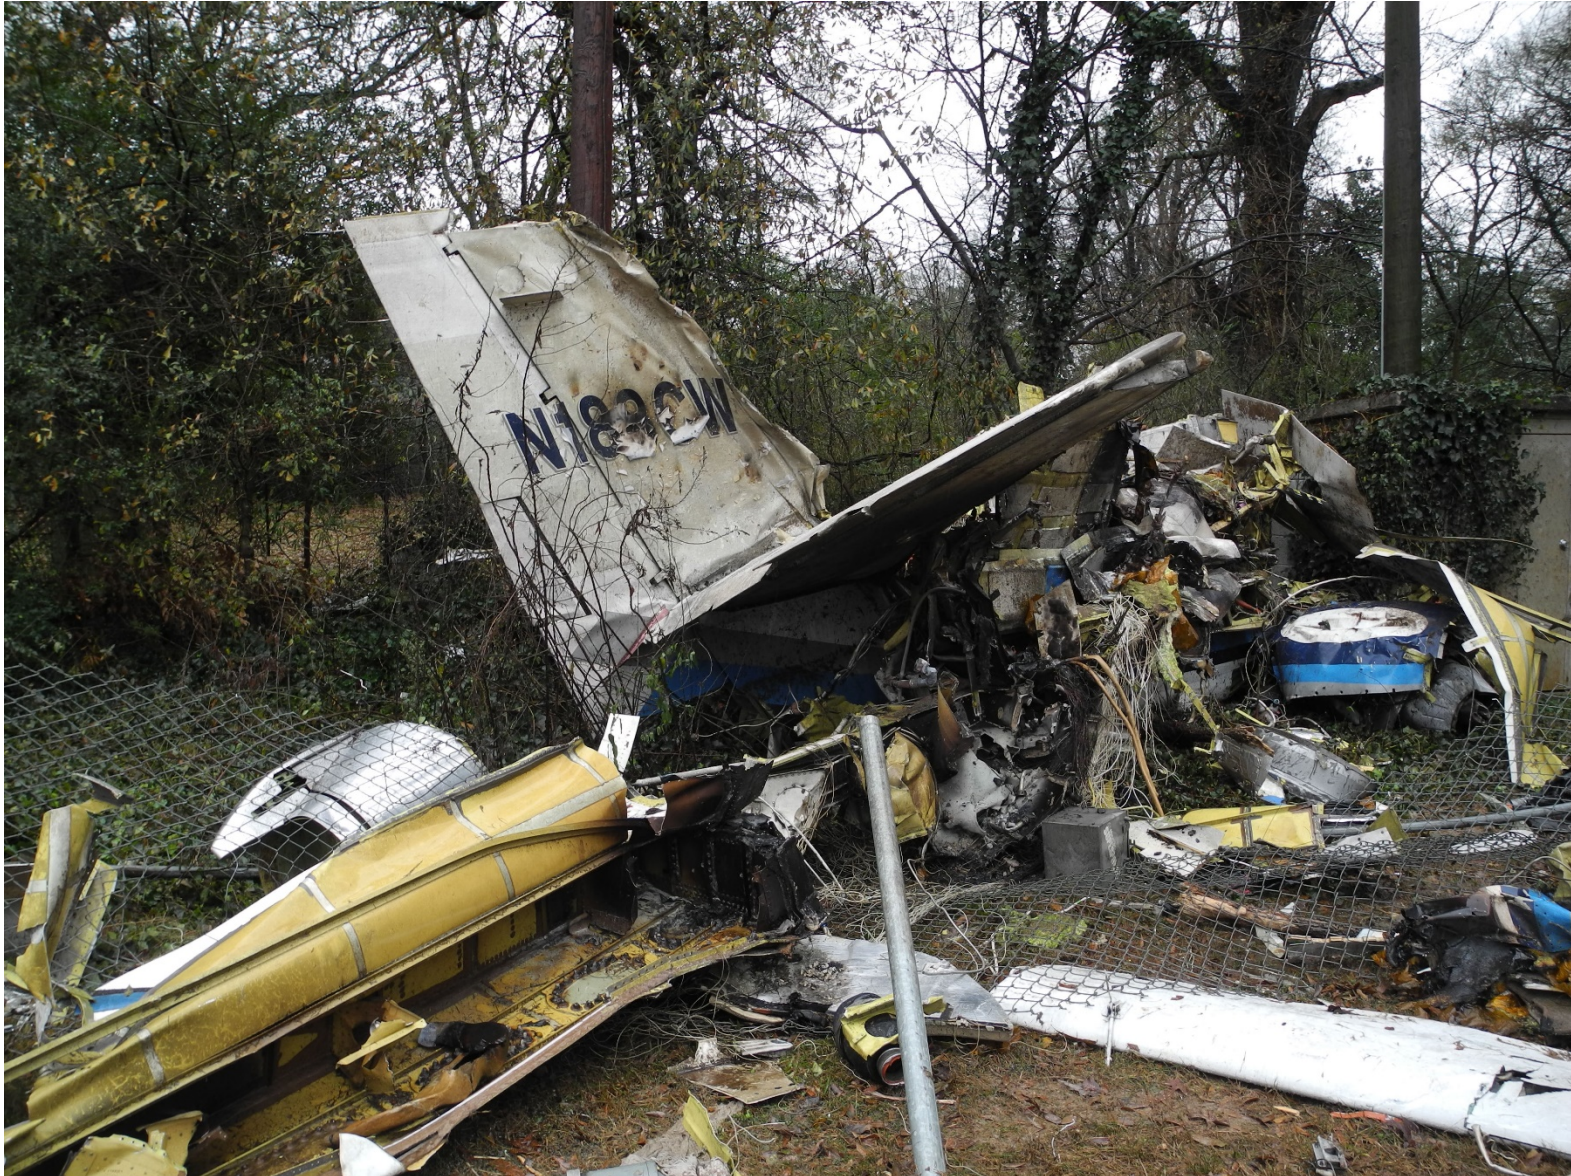
**Photo 2 – View of Empennage at Accident Site**

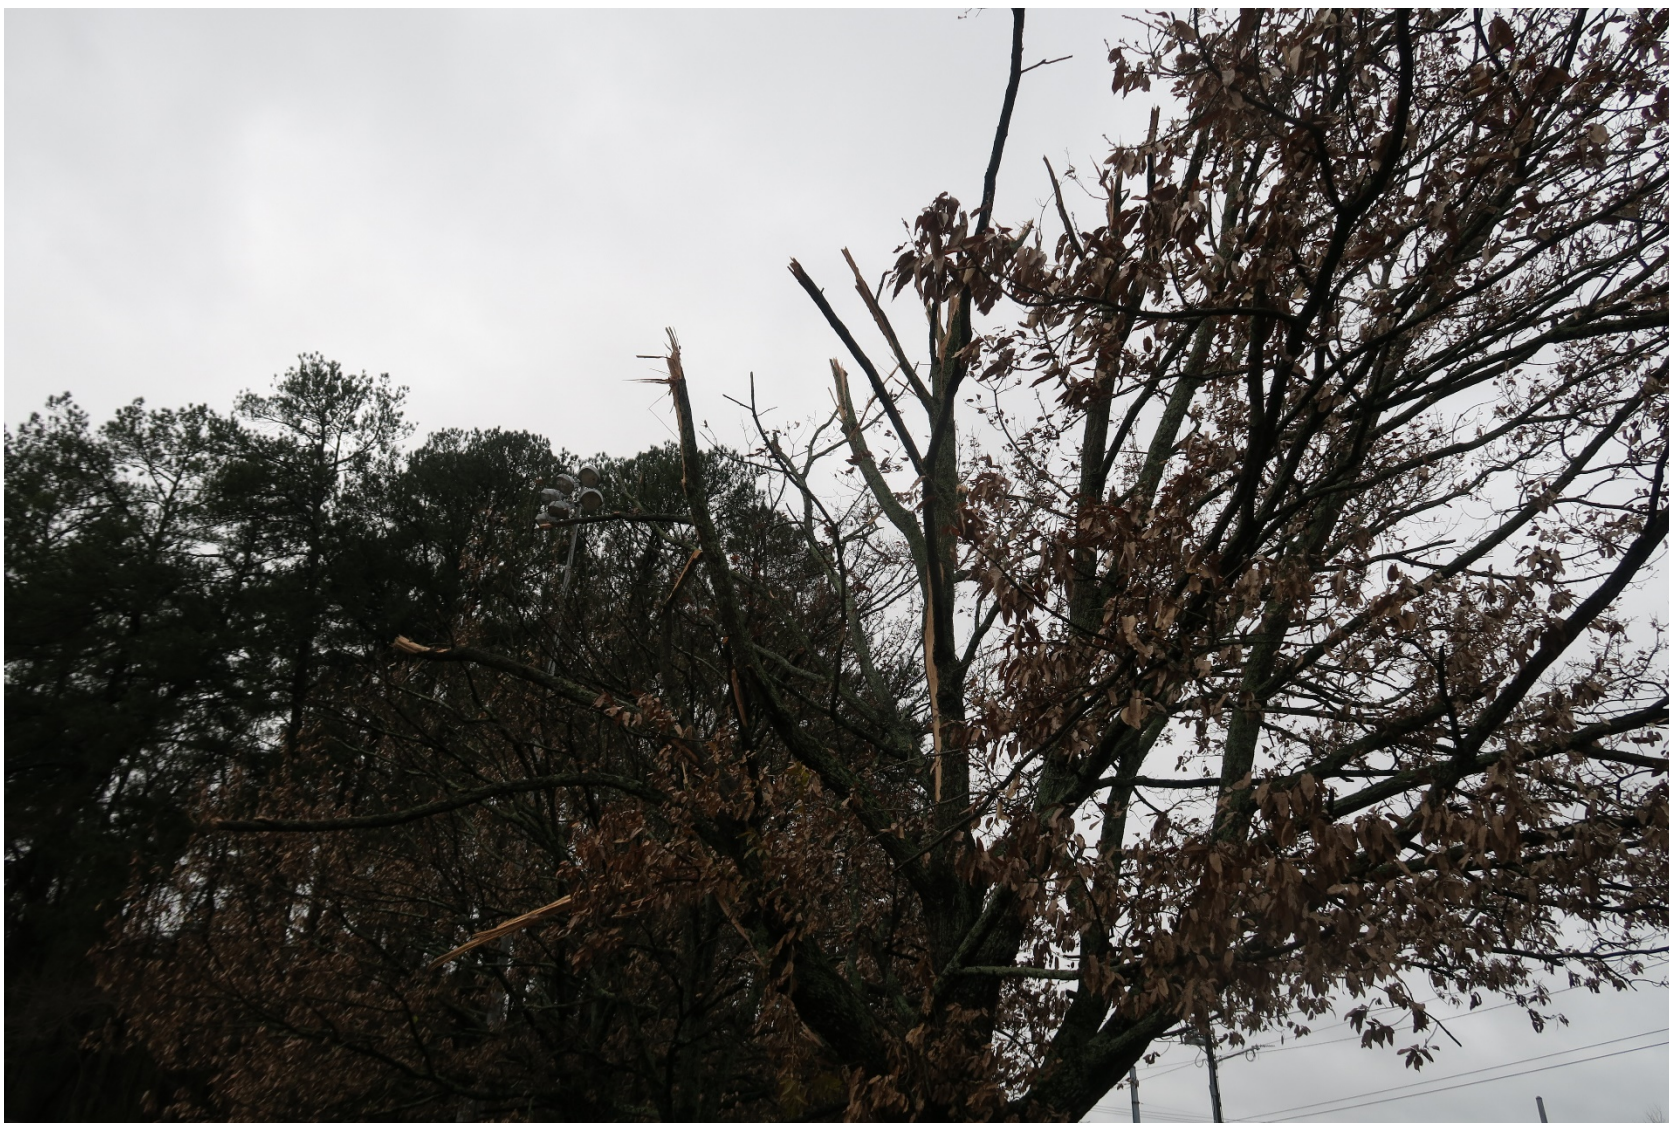
**Photo 3 – View of initial tree strike (Courtesy of Textron Aviation)**

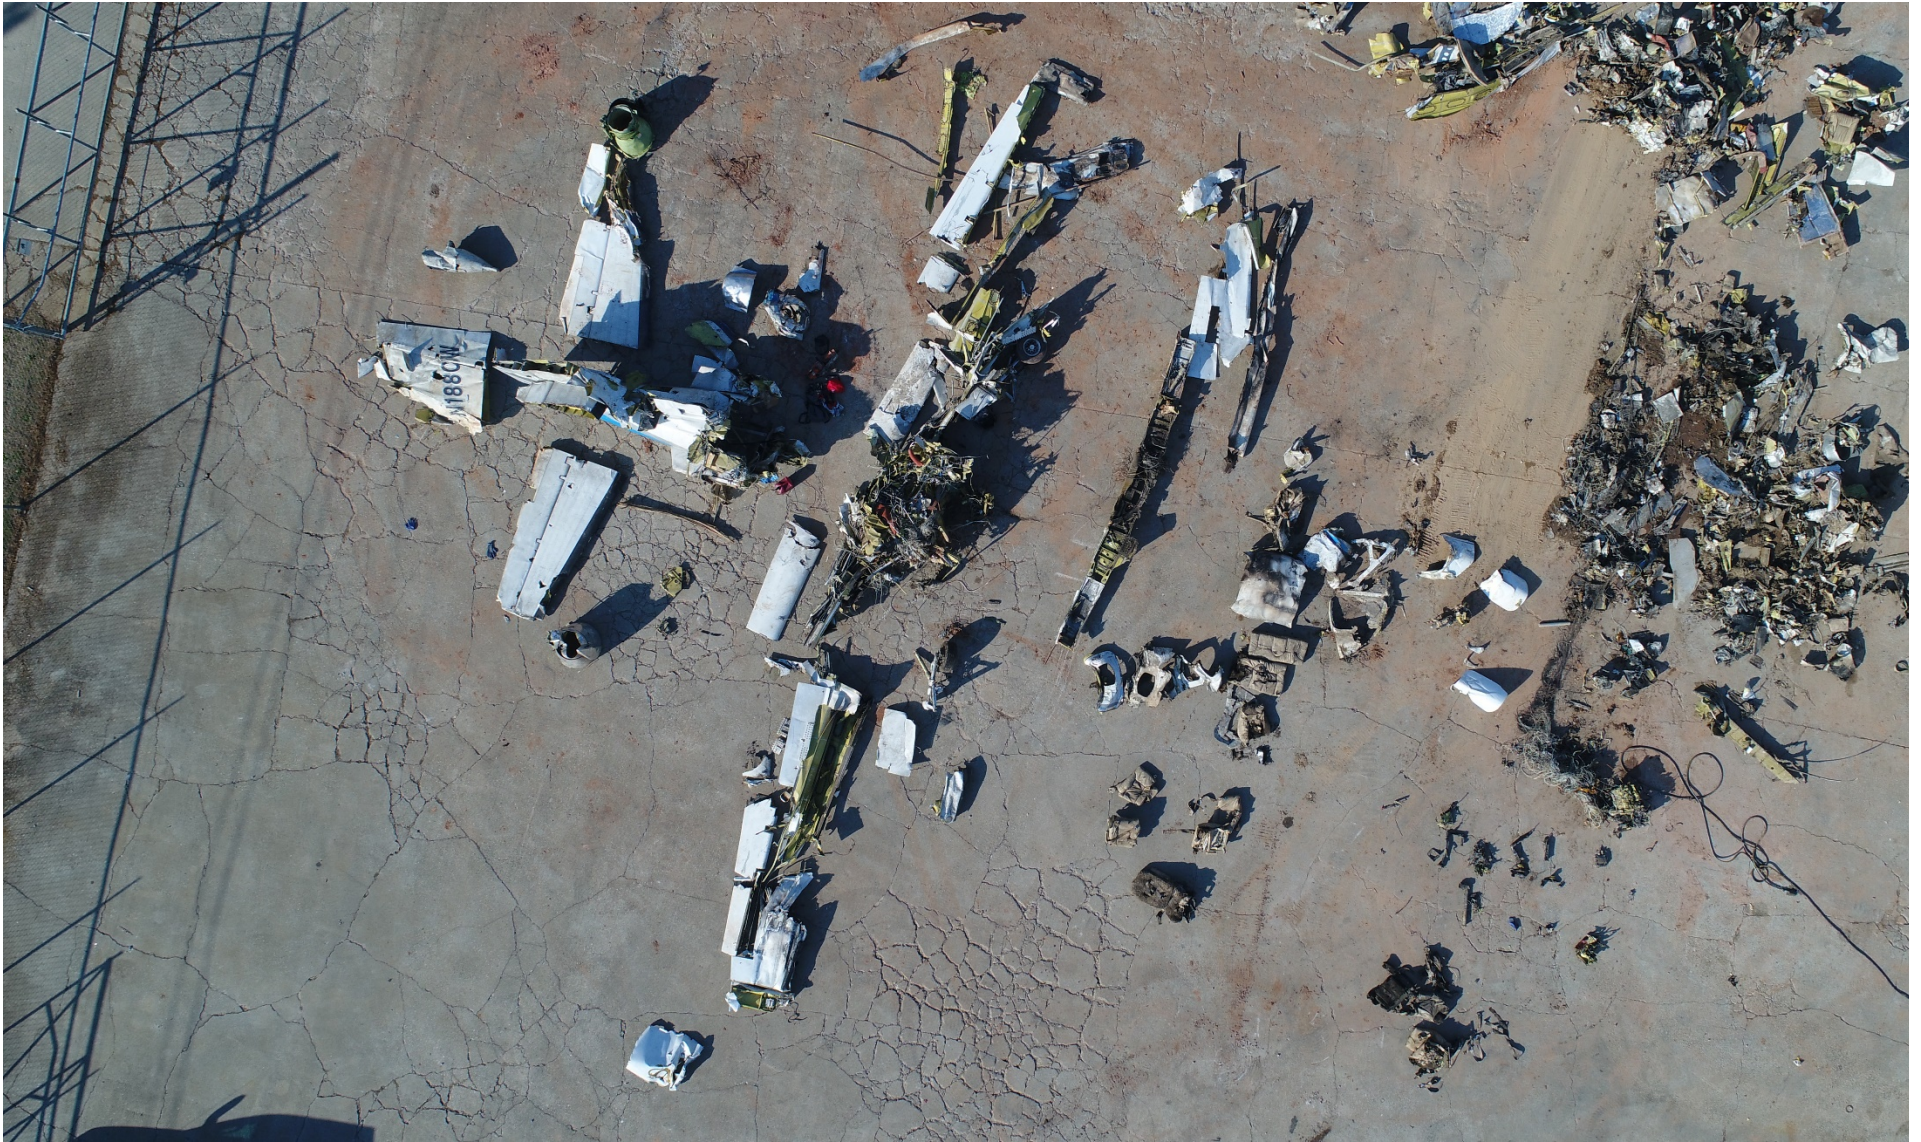
**Photo 4 – Overview of wreckage (Courtesy of Salvage Company)**

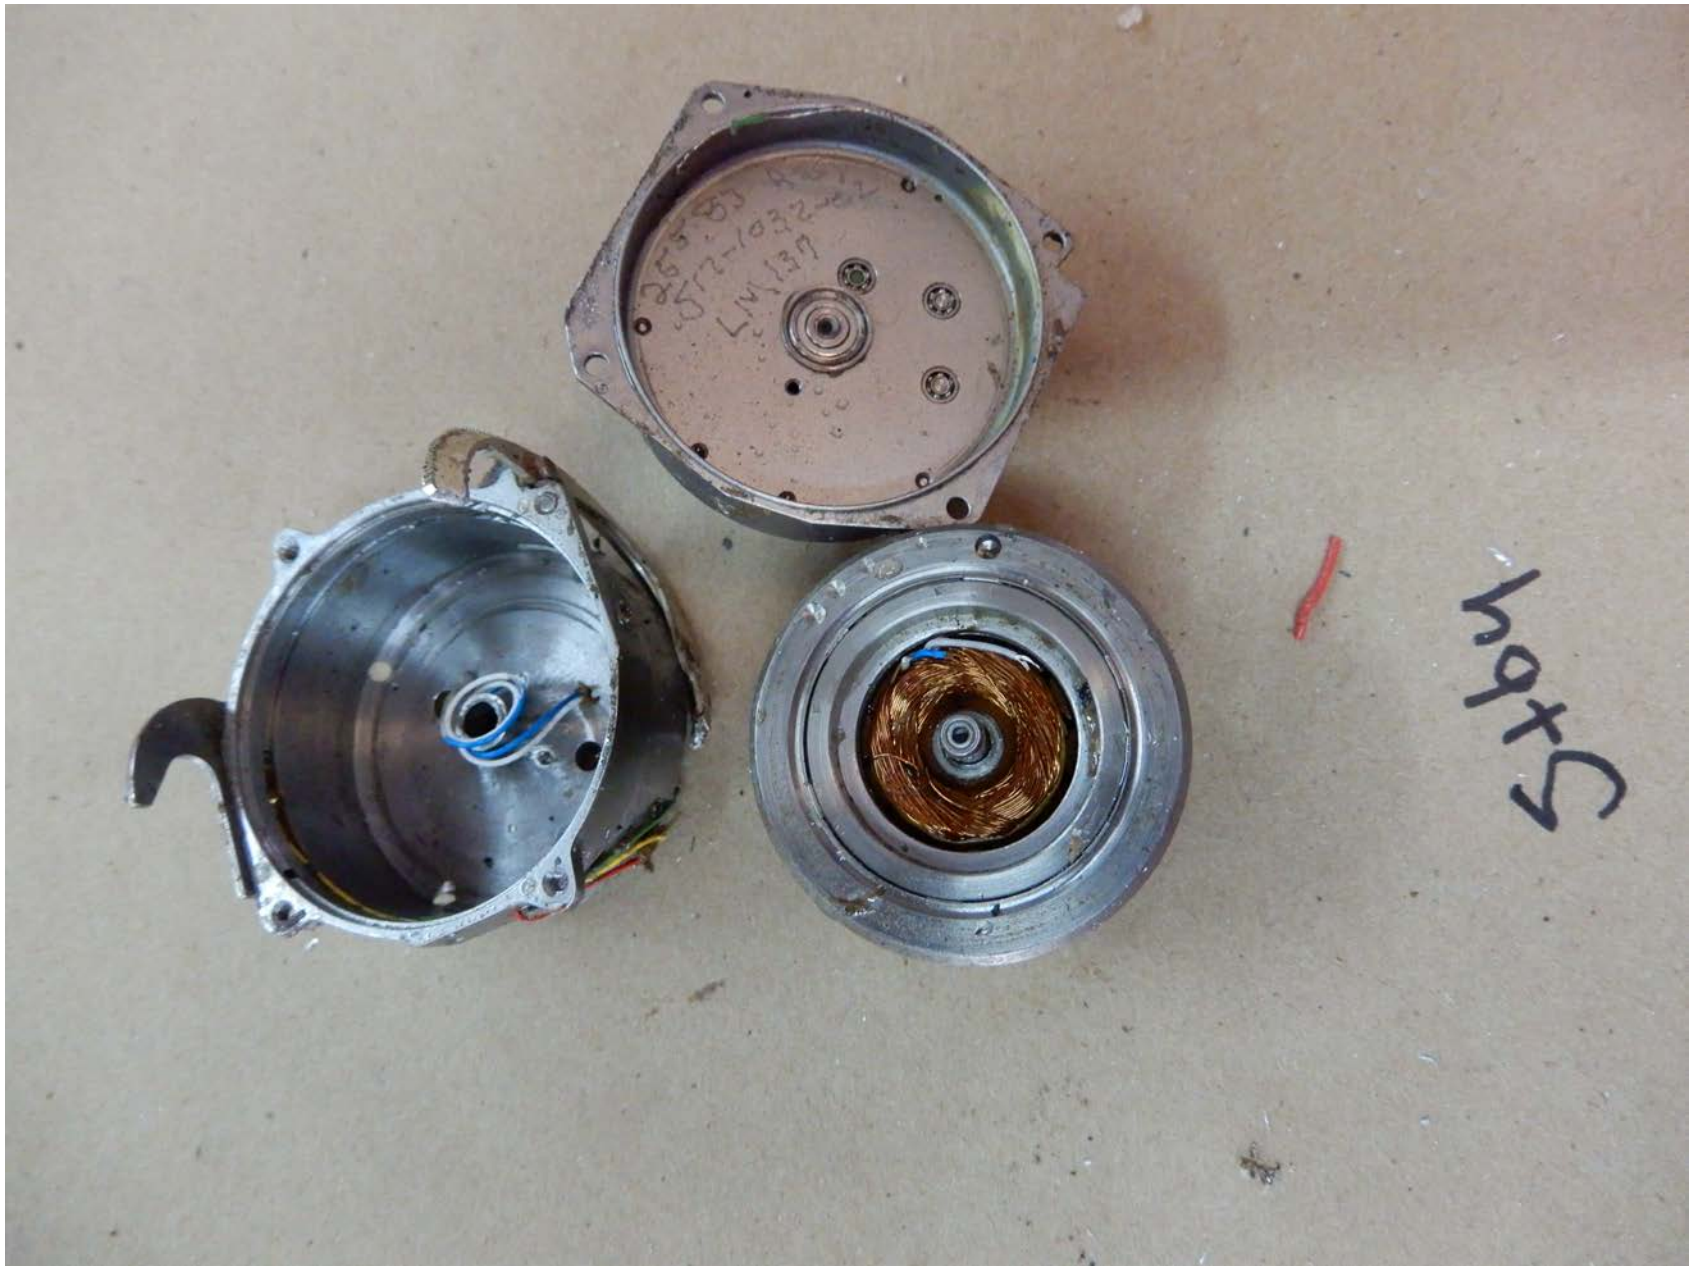
**Photo 5 – View of Gyroscopic Scoring from Standby Attitude Indicator**

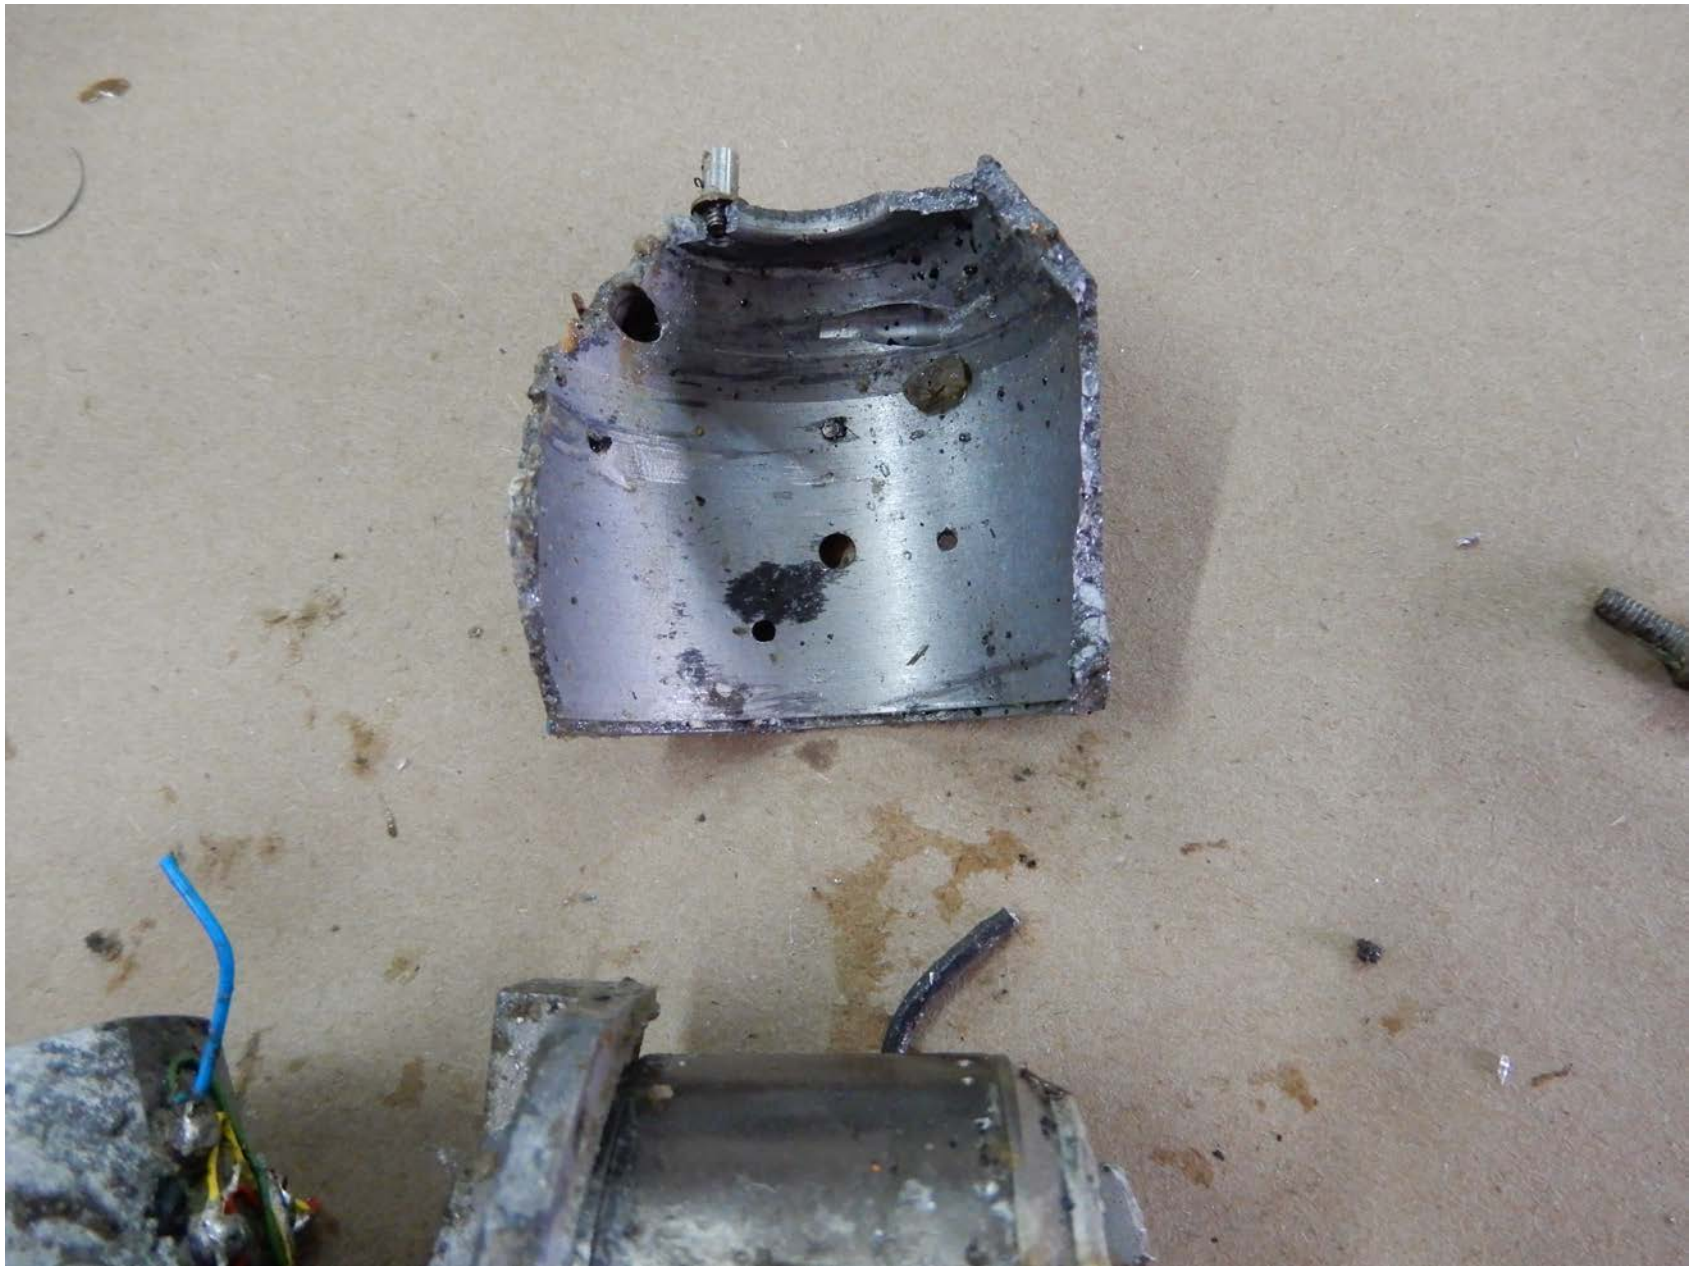
**Photo 6 – View of gyroscopic scoring from primary attitude indicator housing**
