**ERA19FA071**

**Citation 560 – N188CW**

**NTSB ENGINE EXAMINATIONS REPORT**

**April 1, 2019**

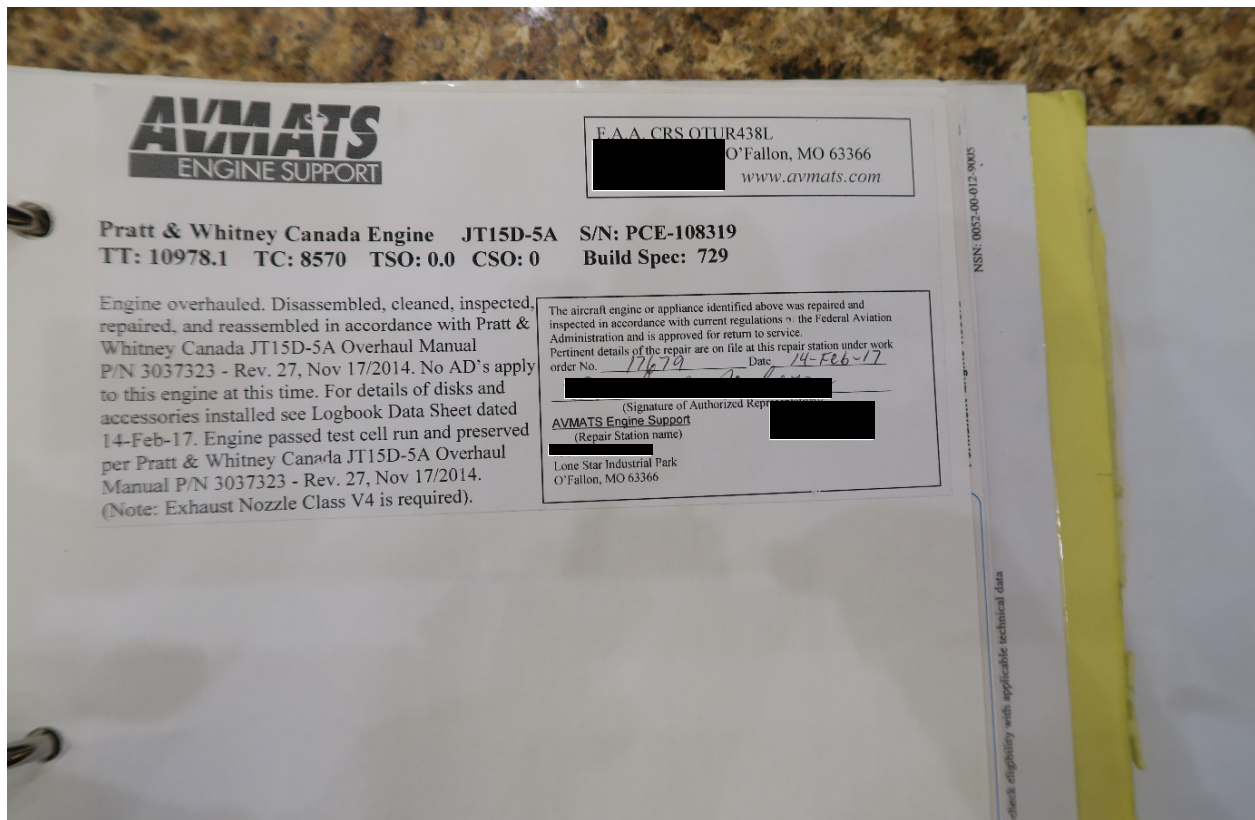
Engine Manufacturer: Pratt & Whitney Canada  
Engine Model Number: JT15D-5A  
Right Engine Serial Number: 108319  
Recent Inspection: Overhaul – TT 10,978.1 hours

Figure 1. View of most recent right engine maintenance.

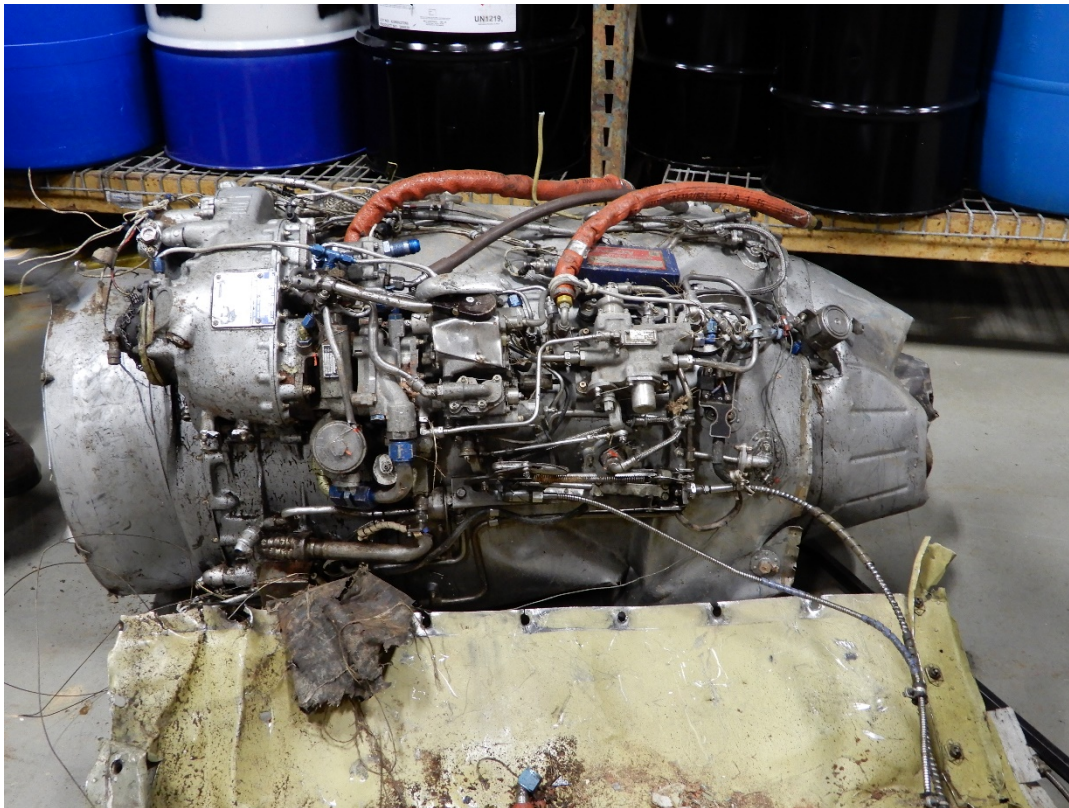
The engine was received crated and sealed. After removal of the crate, the engine was examined, and the engine cowling was removed.

Figure 2. View of right engine after being removed from the crate.

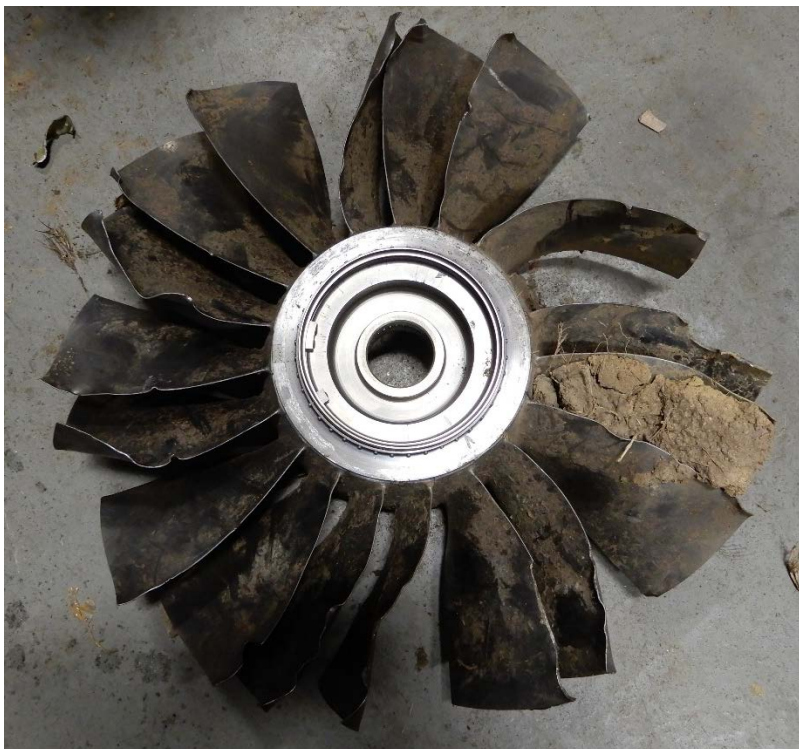
The inlet cone was removed and rotation scoring was noted on the forward facing part of the cone. The fan was removed and all blades were bent in the opposite direction of travel. In addition, several blades exhibited leading edge gouging and one blade was impact separated. Thermally damaged airframe insulation was noted in the front inner compressor stator.

Figure 3. View of right fan with all blades bent the opposite direction of travel.

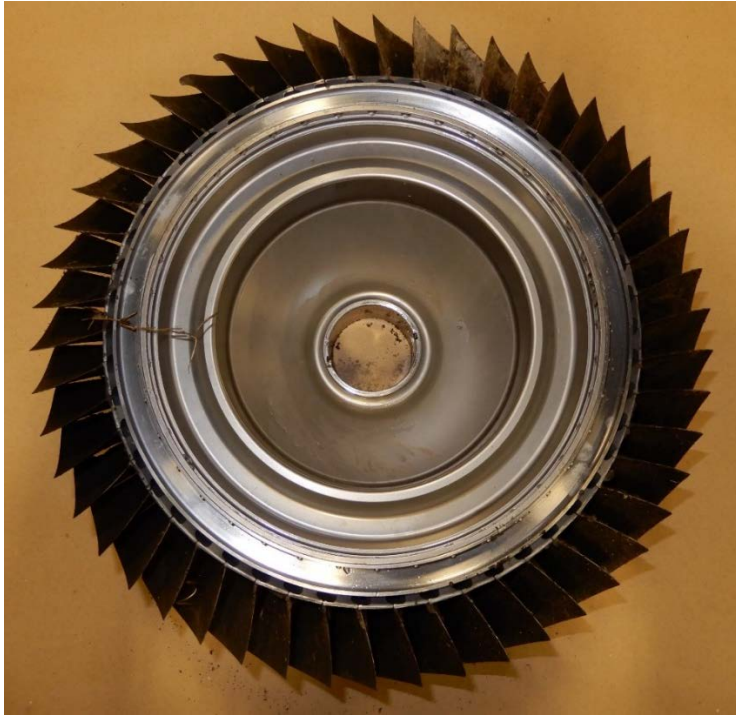
The front inner compressor and bypass stators were removed. Several boost rotor blades exhibited leading edge gouging. The low compressor shaft could be rotated by hand after the stators were removed. The boost rotor was removed and debris was noted on the rear inner compressor stator. The boost keys were sheared on the low compressor shaft. Rotational scoring was noted on the trailing edge of the boost blades.

Figure 4. Trailing edge view of boost turbine.

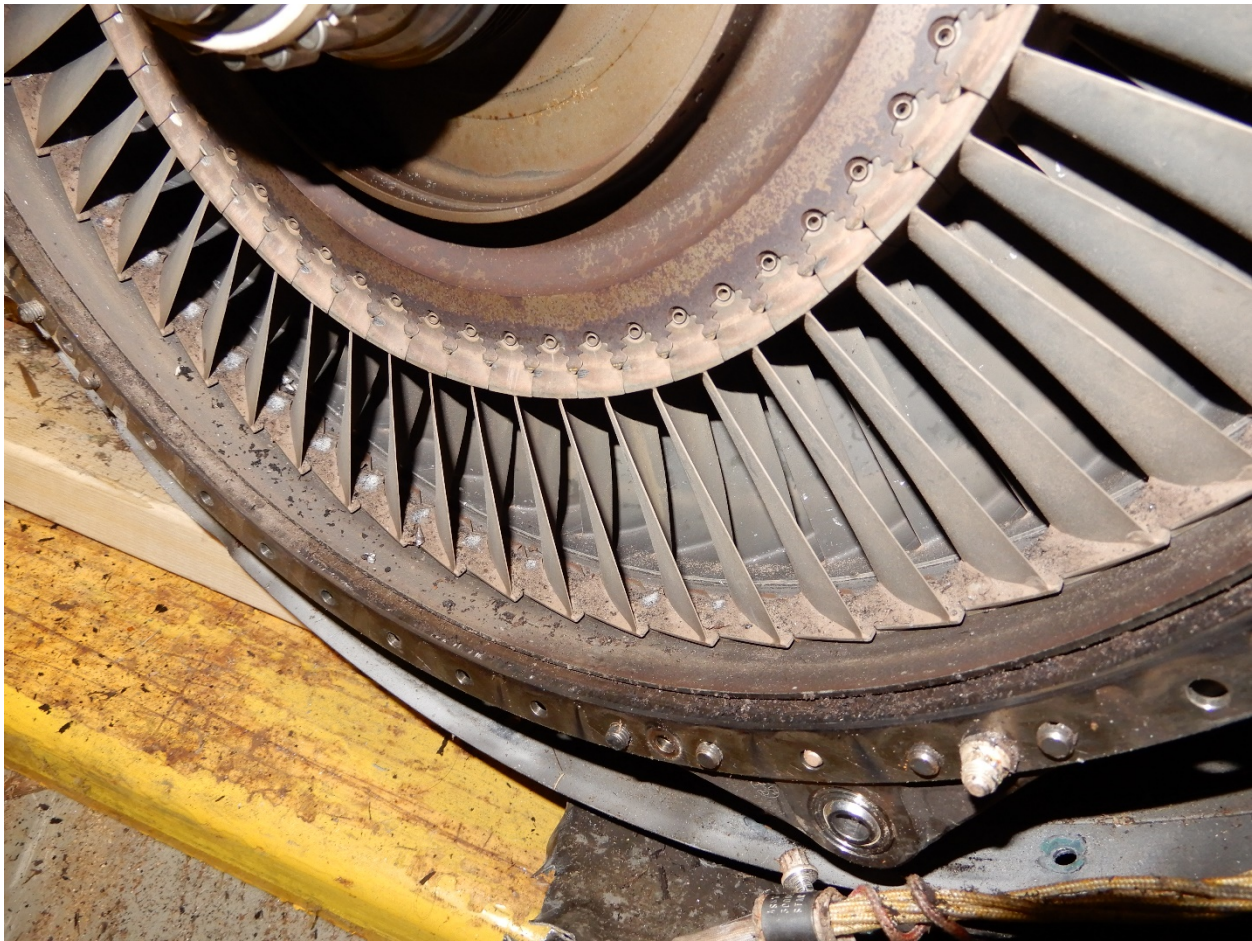
The exhaust case was removed to access the hot section of the engine. The low-pressure turbine could be rotated by hand and debris was noted on the blades. Furthermore, scoring was noted on the trailing edge of the third stage turbine blades.

Figure 5. Trailing edge view of third stage turbine. Note debris and rotational scoring.

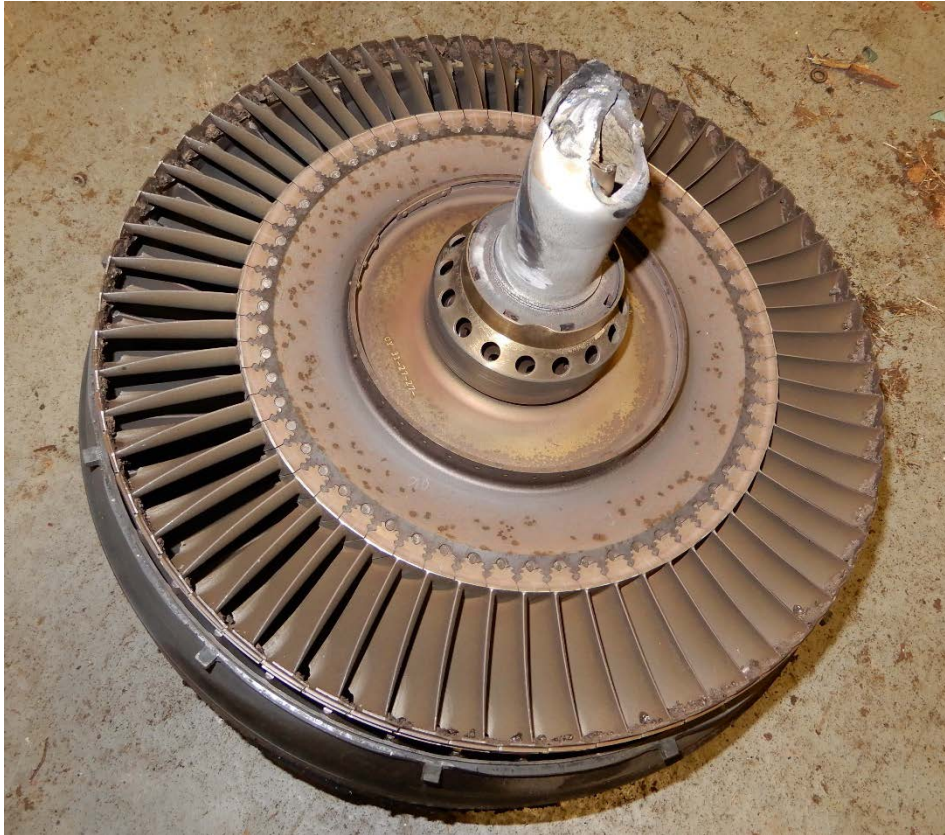
The second stage turbine, third stage stator, and third stage turbine were removed and remained attached to the low turbine shaft. The shaft was separated from the forward section of the low turbine shaft and exhibited a torsional fracture. The second stage low turbine stator was removed and rotational scoring was noted on the forward and aft portions. The trailing edge of the first stage high turbine blades exhibited rotational scoring.

Figure 6. View of second stage turbine and separate shaft.

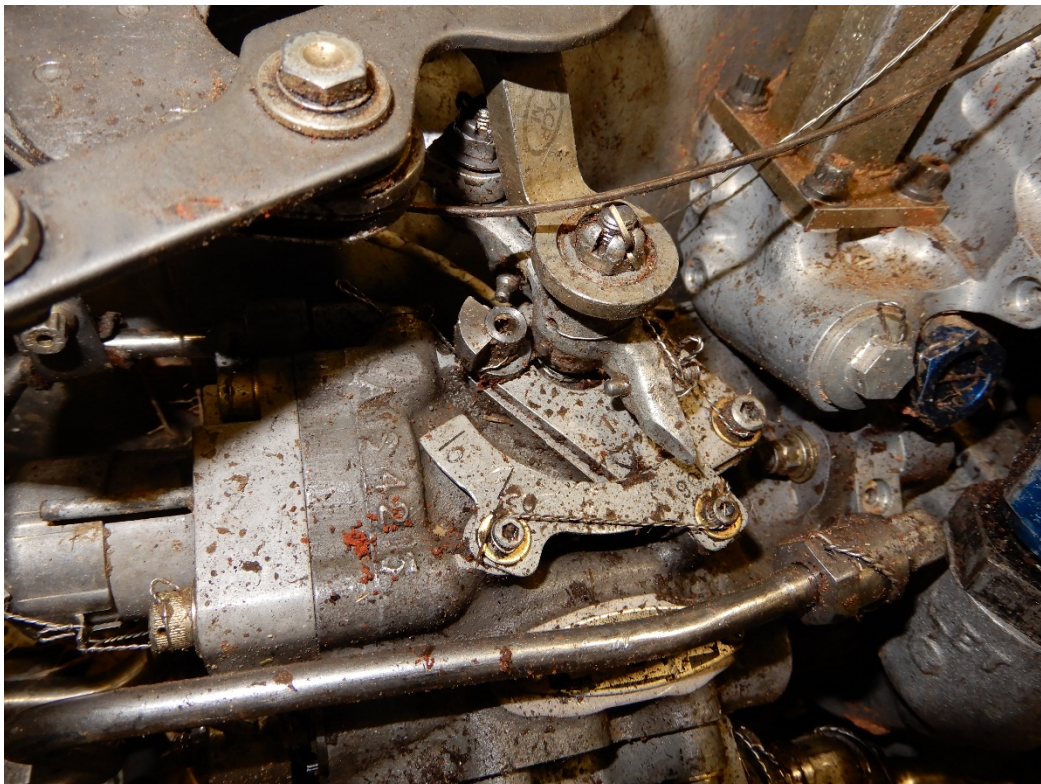
The throttle body remained attached to the engine. The throttle setting was noted at 90%.

Figure 7. View of throttle setting at 90%.

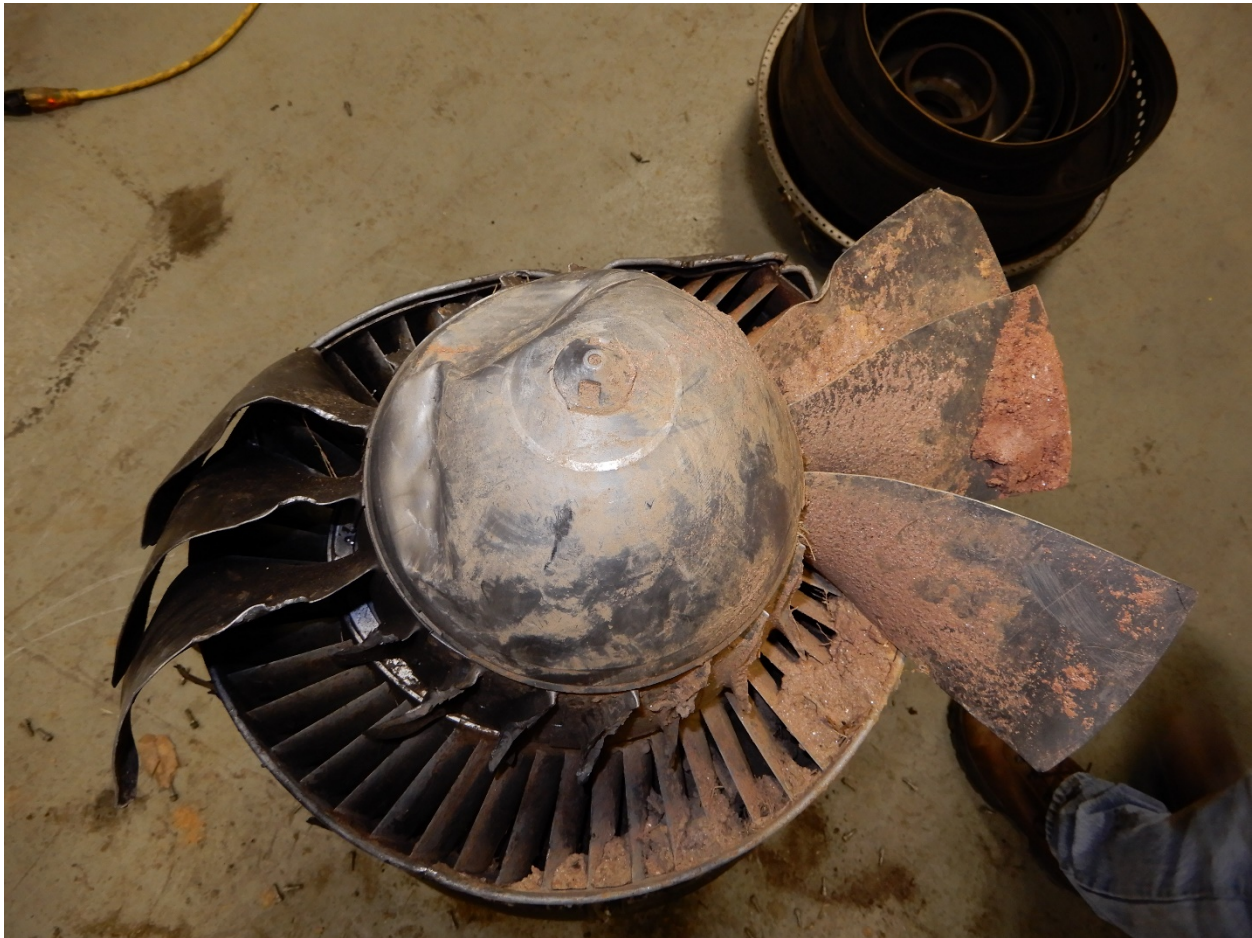
The forward section of the engine was impact damaged and several of the fan blades were impact separated.

Figure 9. View of Left Turbofan.

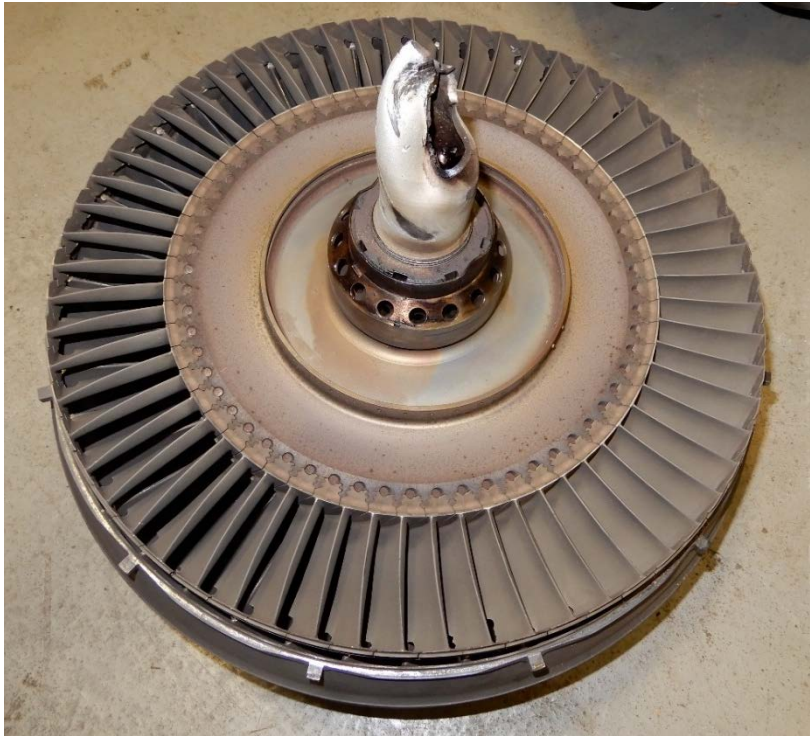
The exhaust case was removed and rotational scoring was noted on the trailing edge of the third stage low turbine. Rotational scoring was also noted on the second stage shroud. Debris and dirt was noted on the inside of the engine near the third stage turbine. The low turbine shaft was separated and exhibited a torsional fracture.

Figure 10. View of left engine shaft fracture.

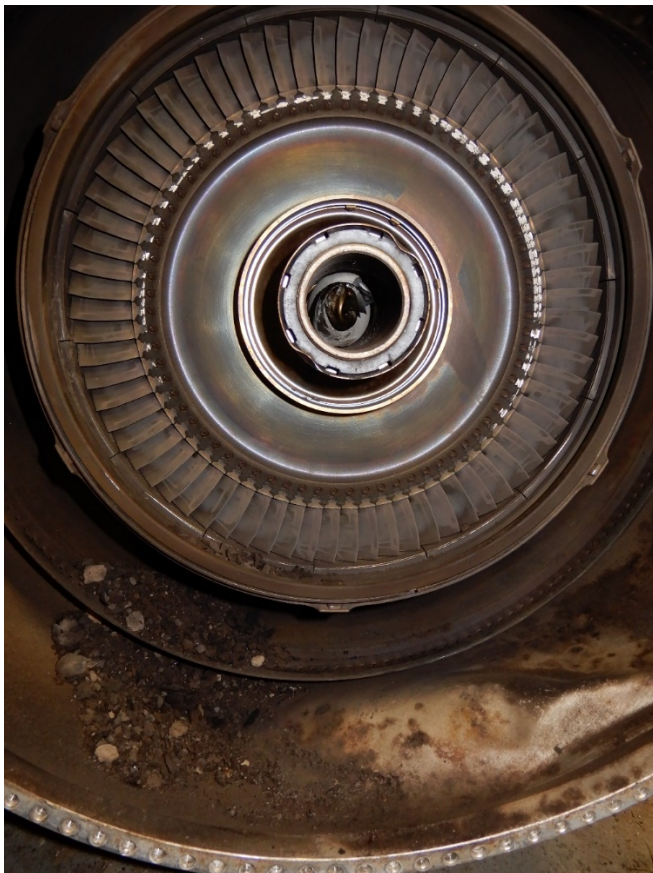
The second stage stators and second stage turbine were removed and scoring was noted on the second stage stator. The trailing edge of the first stage high turbine blades exhibited rotational scoring. Debris was noted inside the engine case below the first stage high turbine.

Figure 11. Trailing edge view of first stage turbine. Note debris inside engine and rotational scoring on turbine.

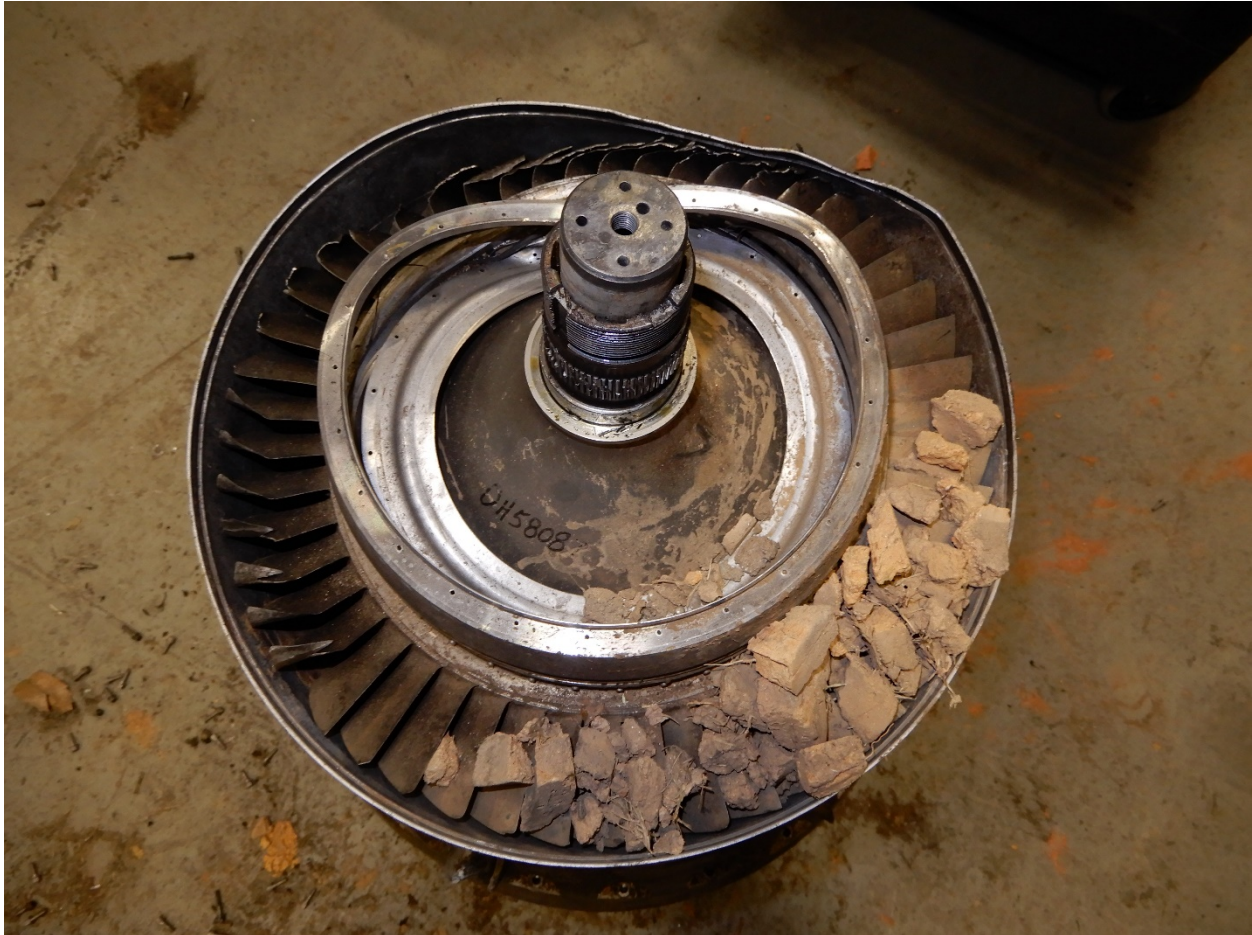
The boost turbine was examined and several blades were bent in the opposite direction of travel. All but two of the number 1 bearing housing bolts were separated. The inlet cone shaft was bent and could not be rotated.

Figure 12. View of boost turbine. Note blades bent the opposite direction of travel.

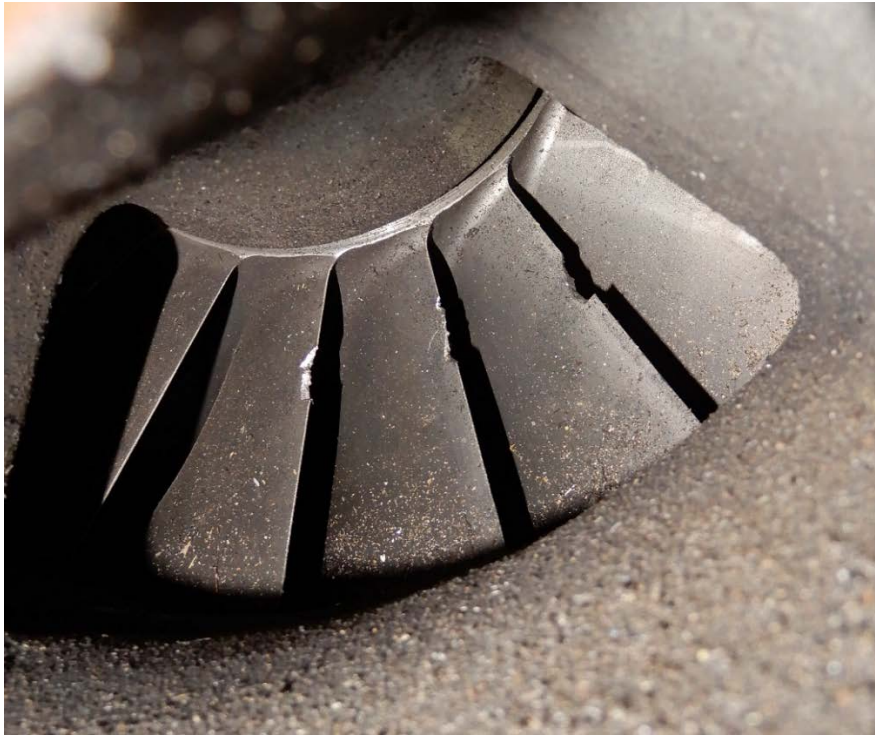
Leading edge gouging was noted on several blades of the impeller. Fan shaft and the HP rotor had limited rotation.

Figure 13. View of left engine impeller.
