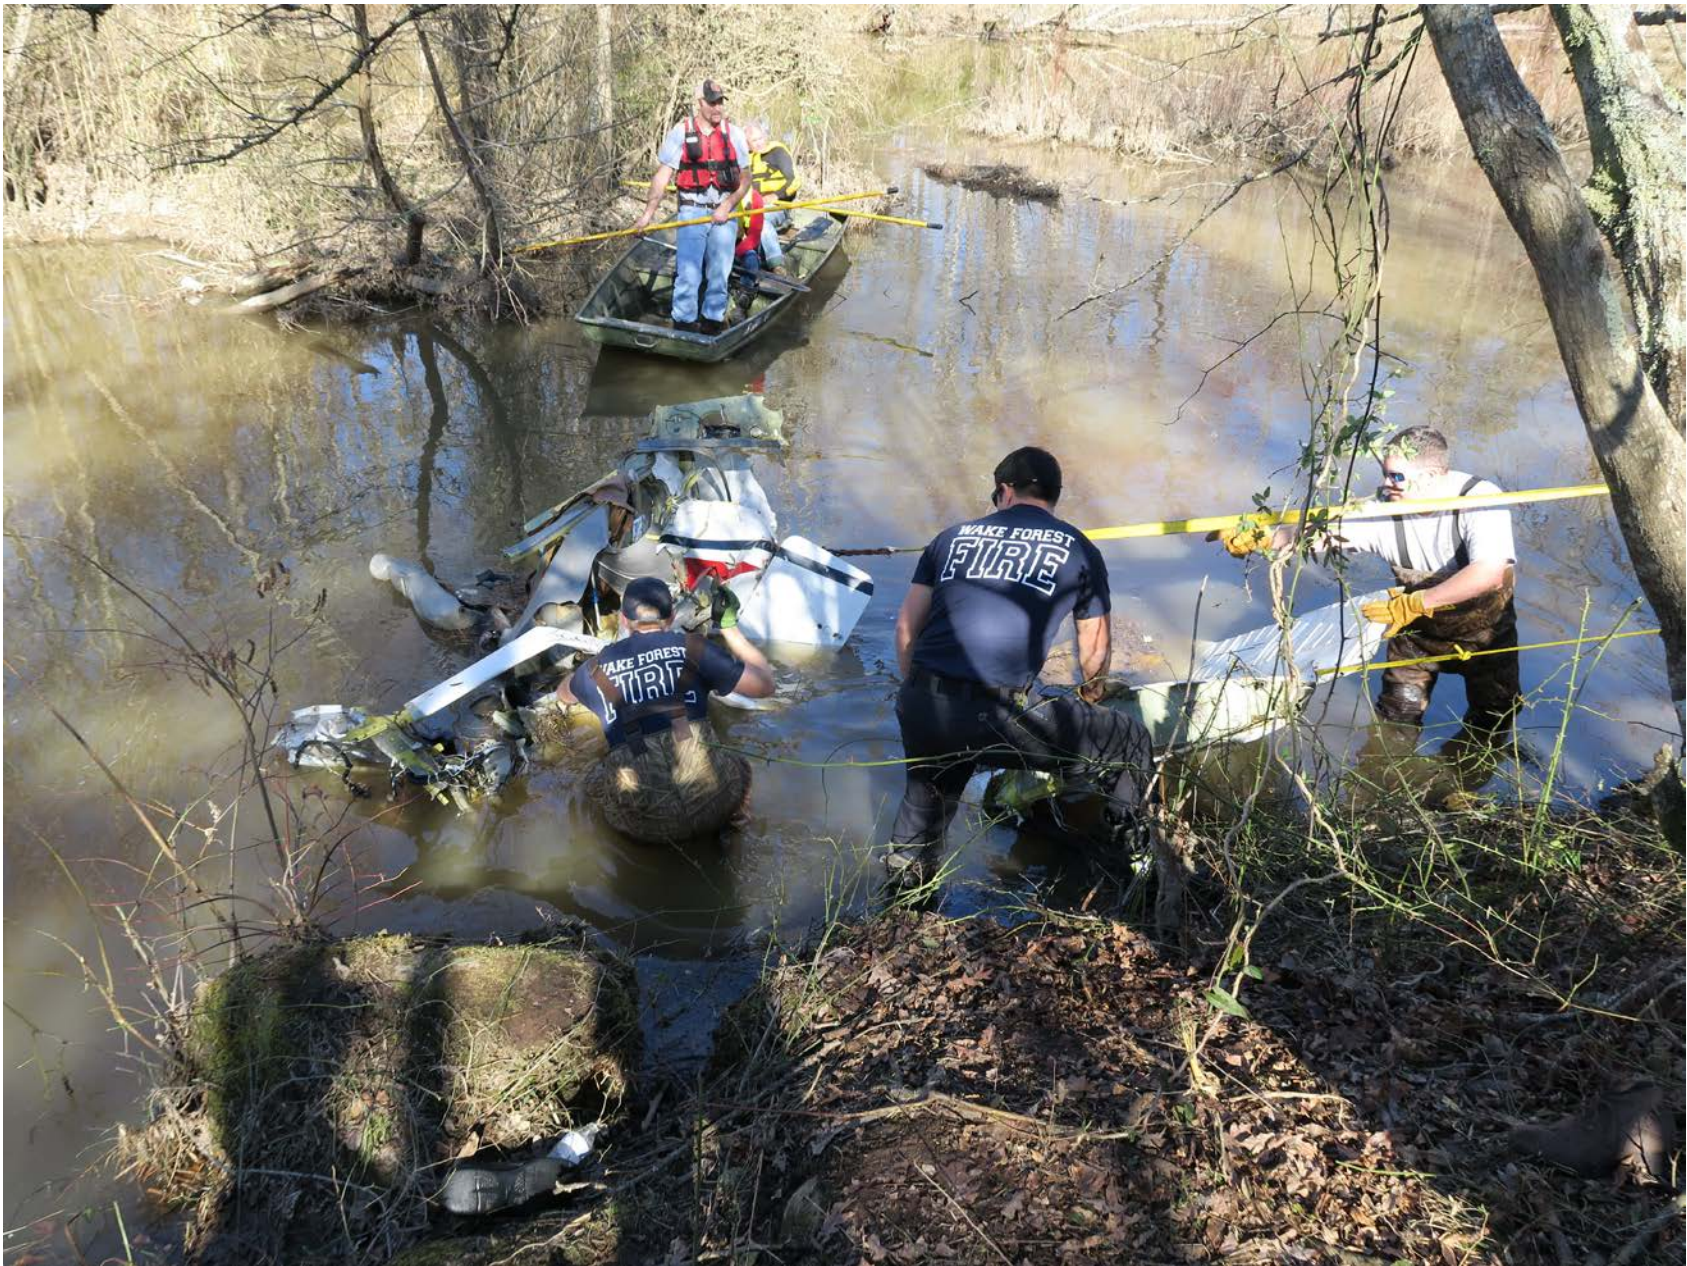
**Photo 1 – Aircraft Wreckage as Found (Textron)**

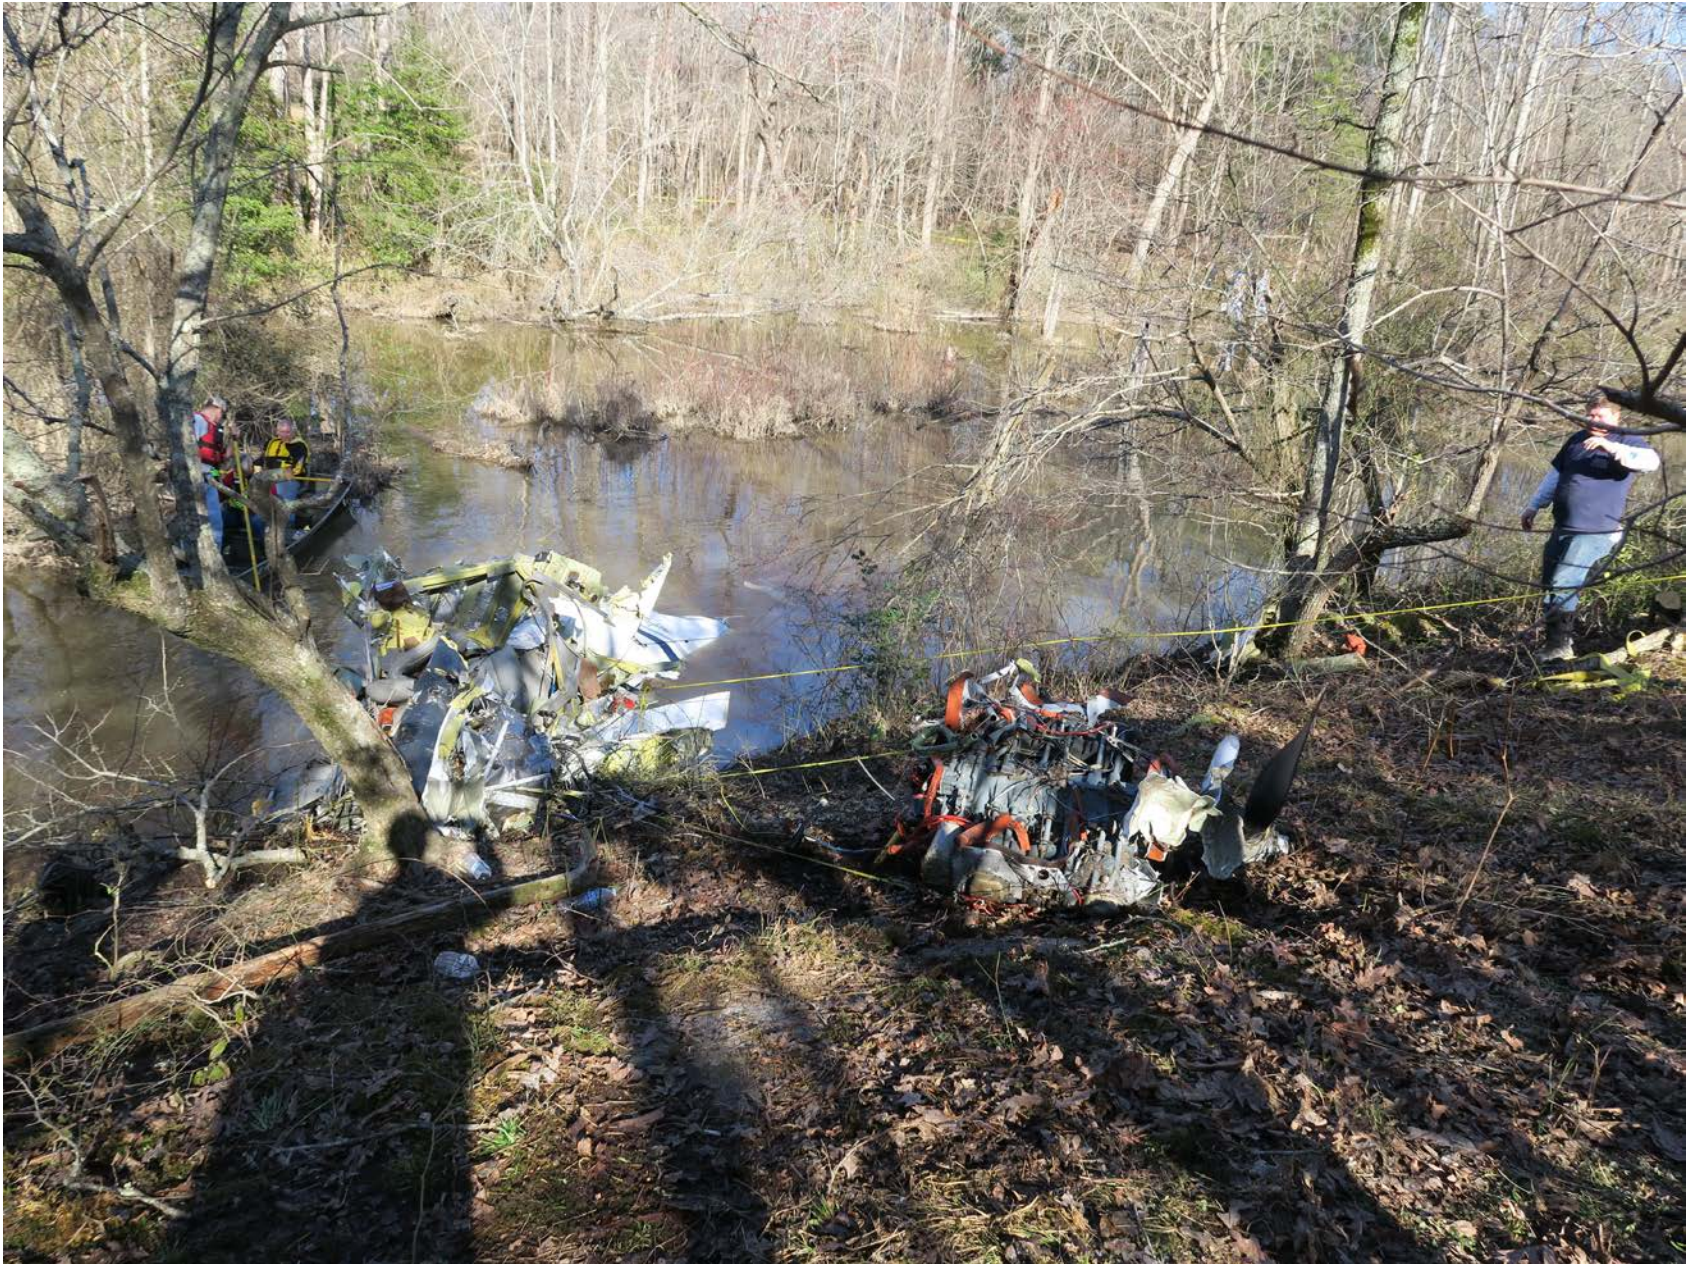
**Photo 2 – Aircraft Wreckage During Recovery (Textron)**

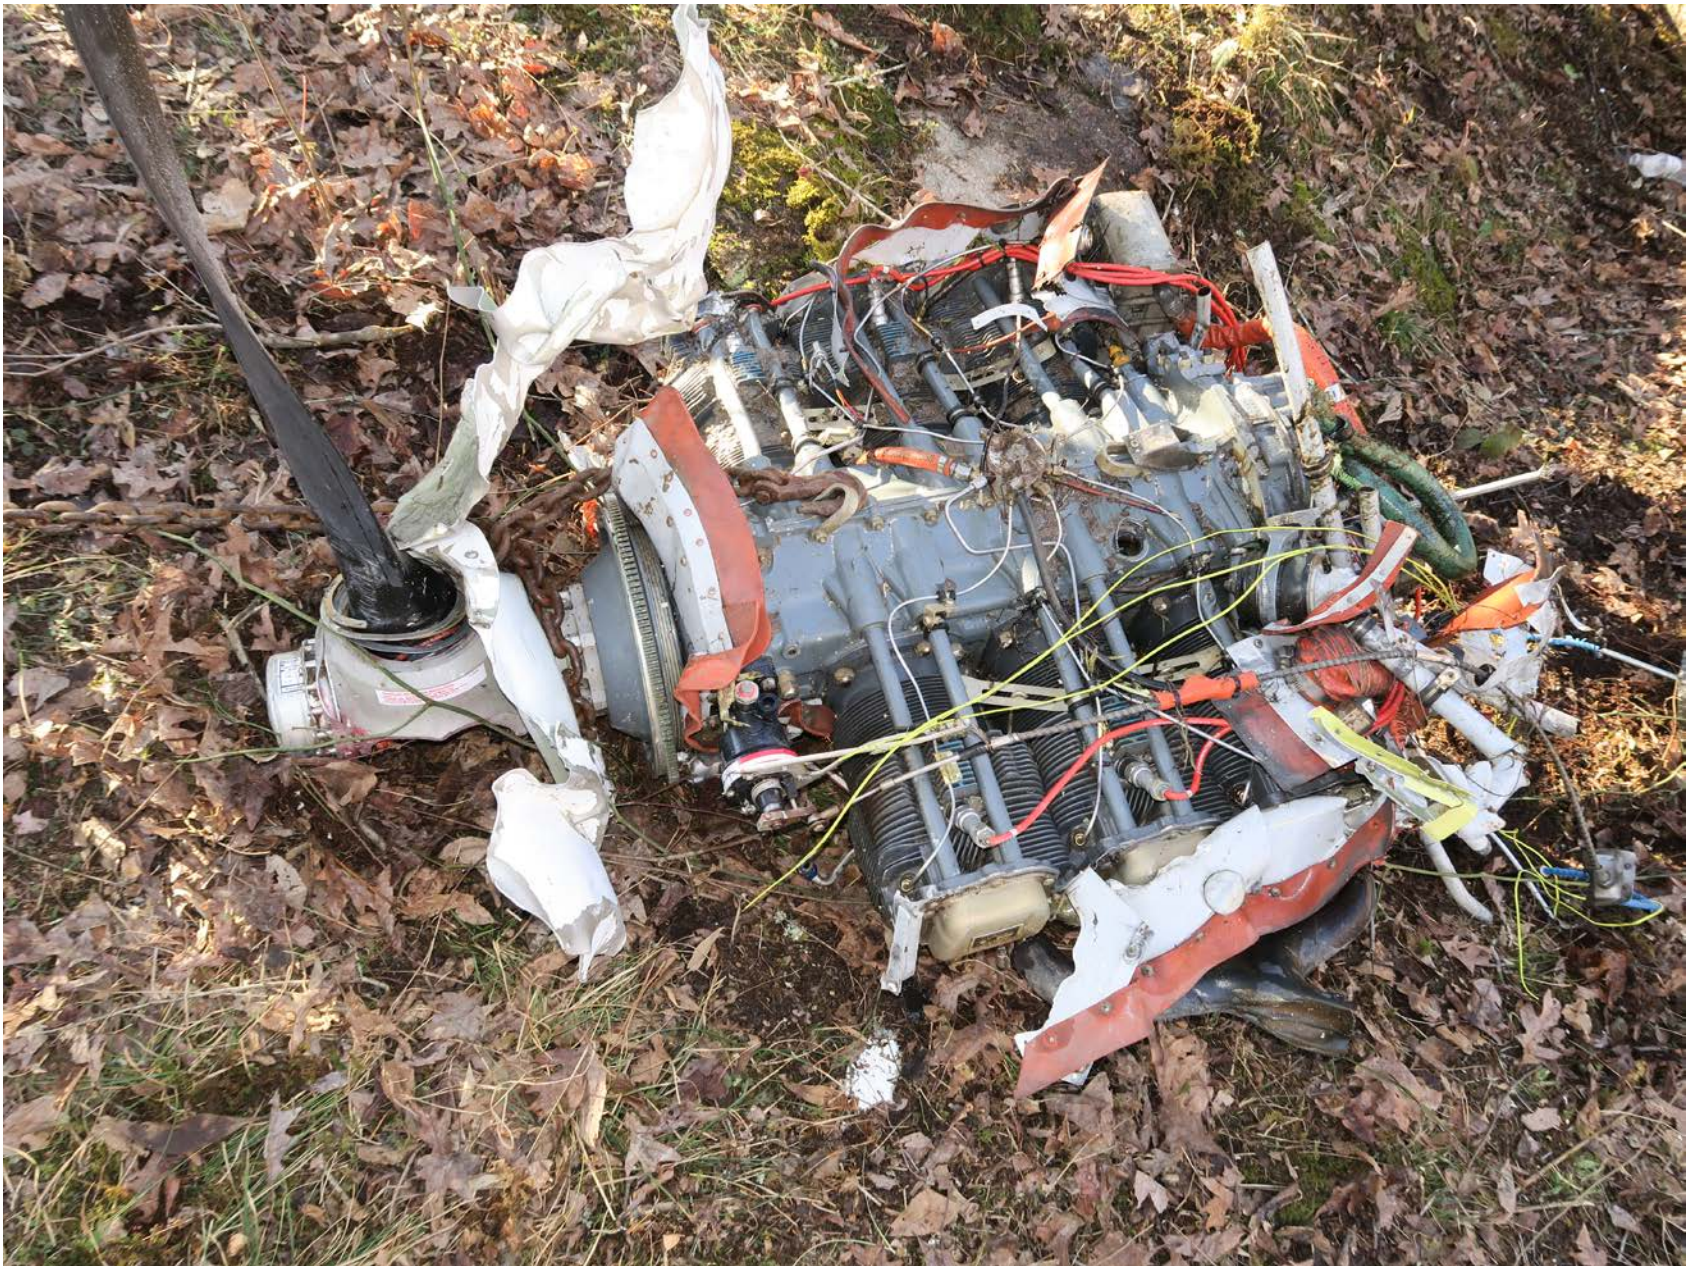
**Photo 3 – View of Engine after Recovery (Textron)**

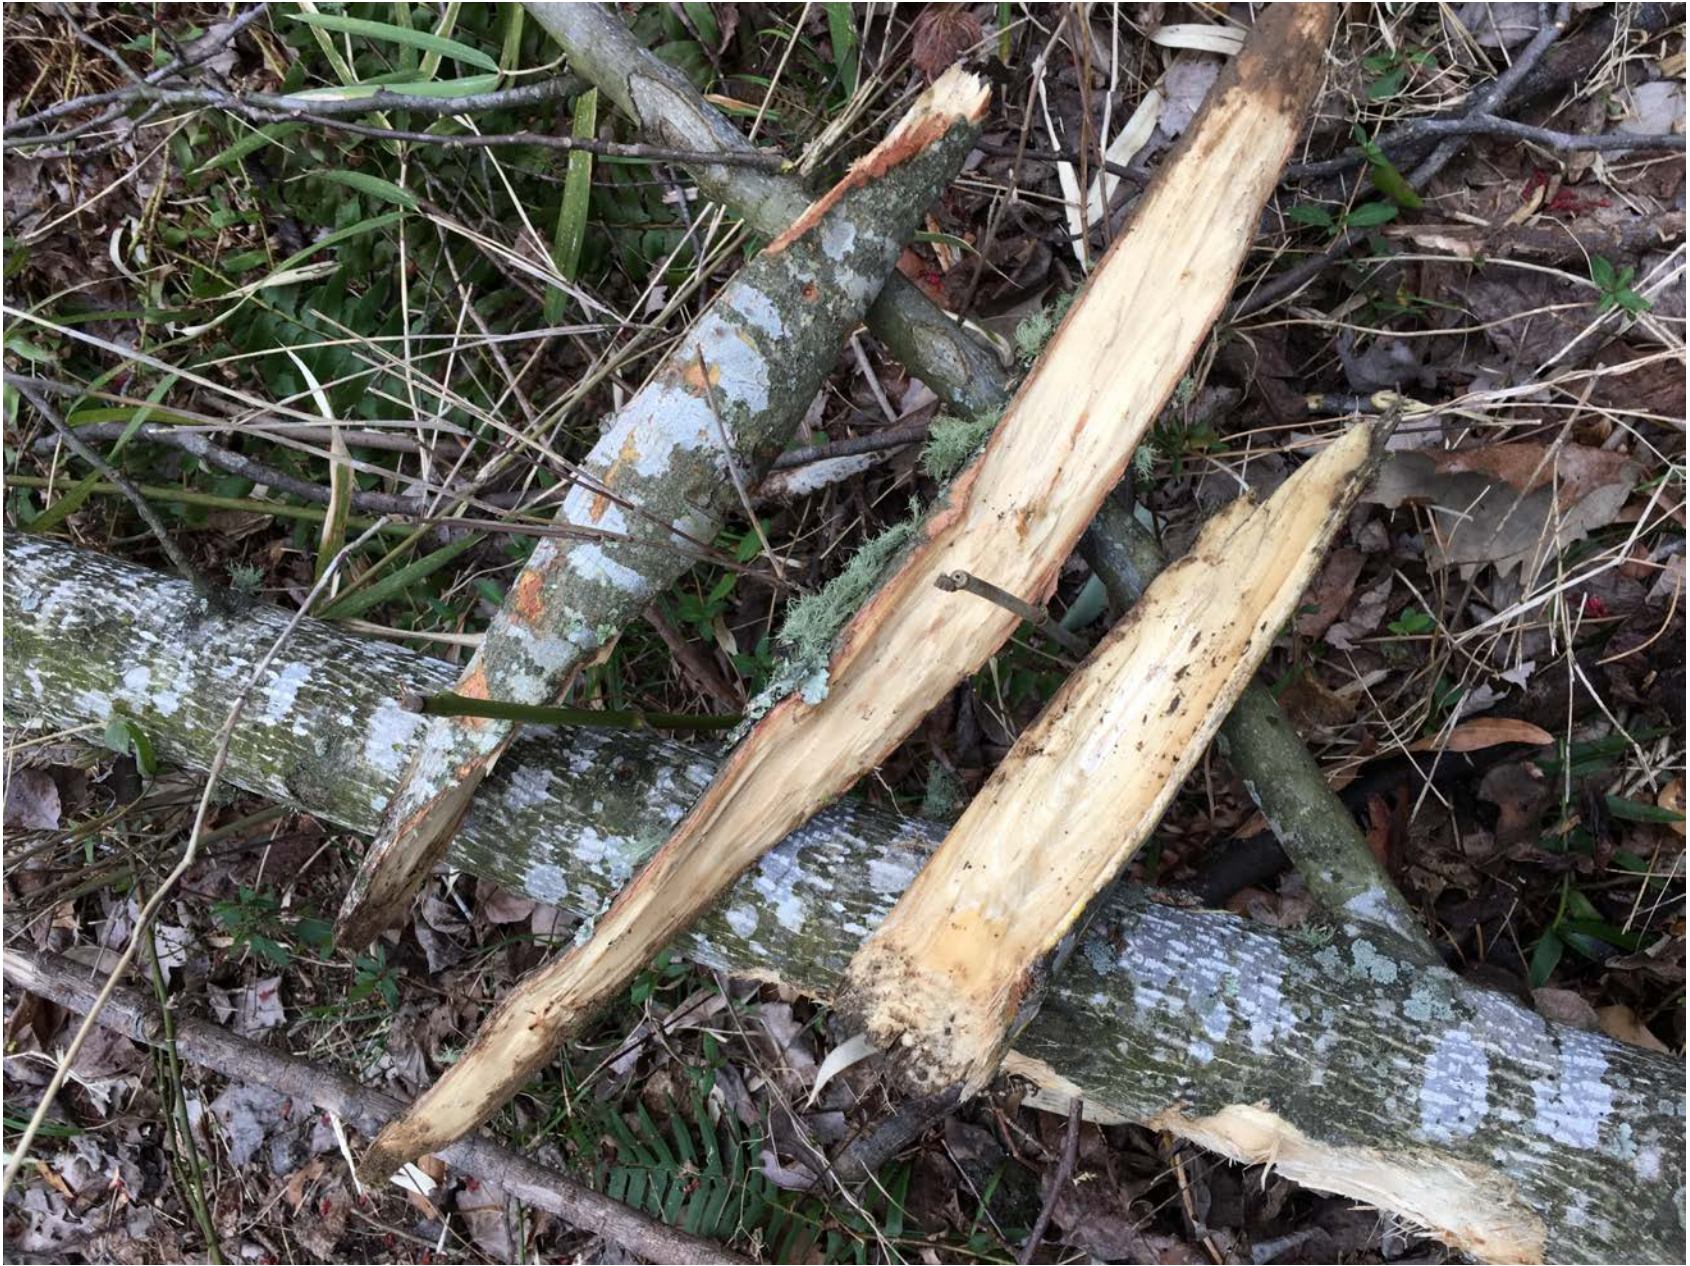
**Photo 4 – View of Angularly Cut Wood at Accident Site**

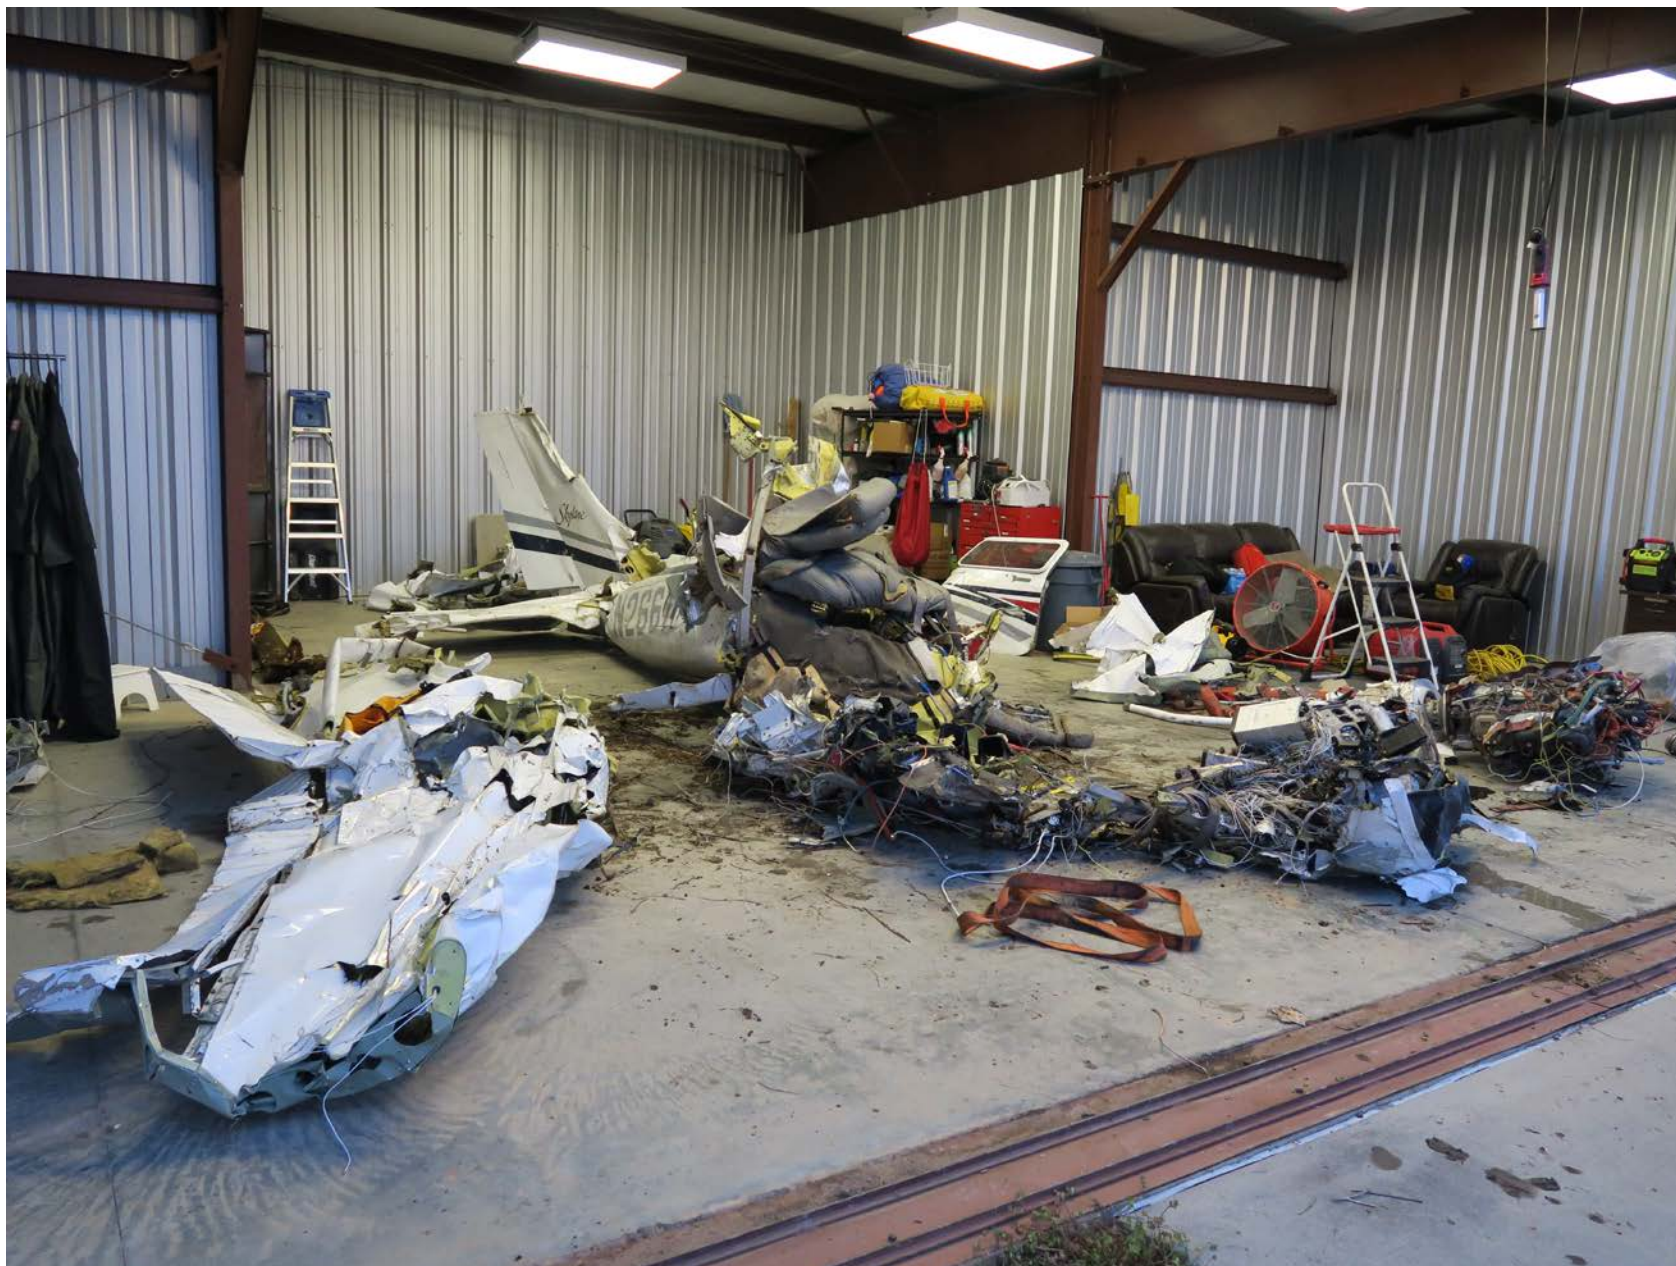
**Photo 5 – View of Wreckage Examination Layout (Textron)**

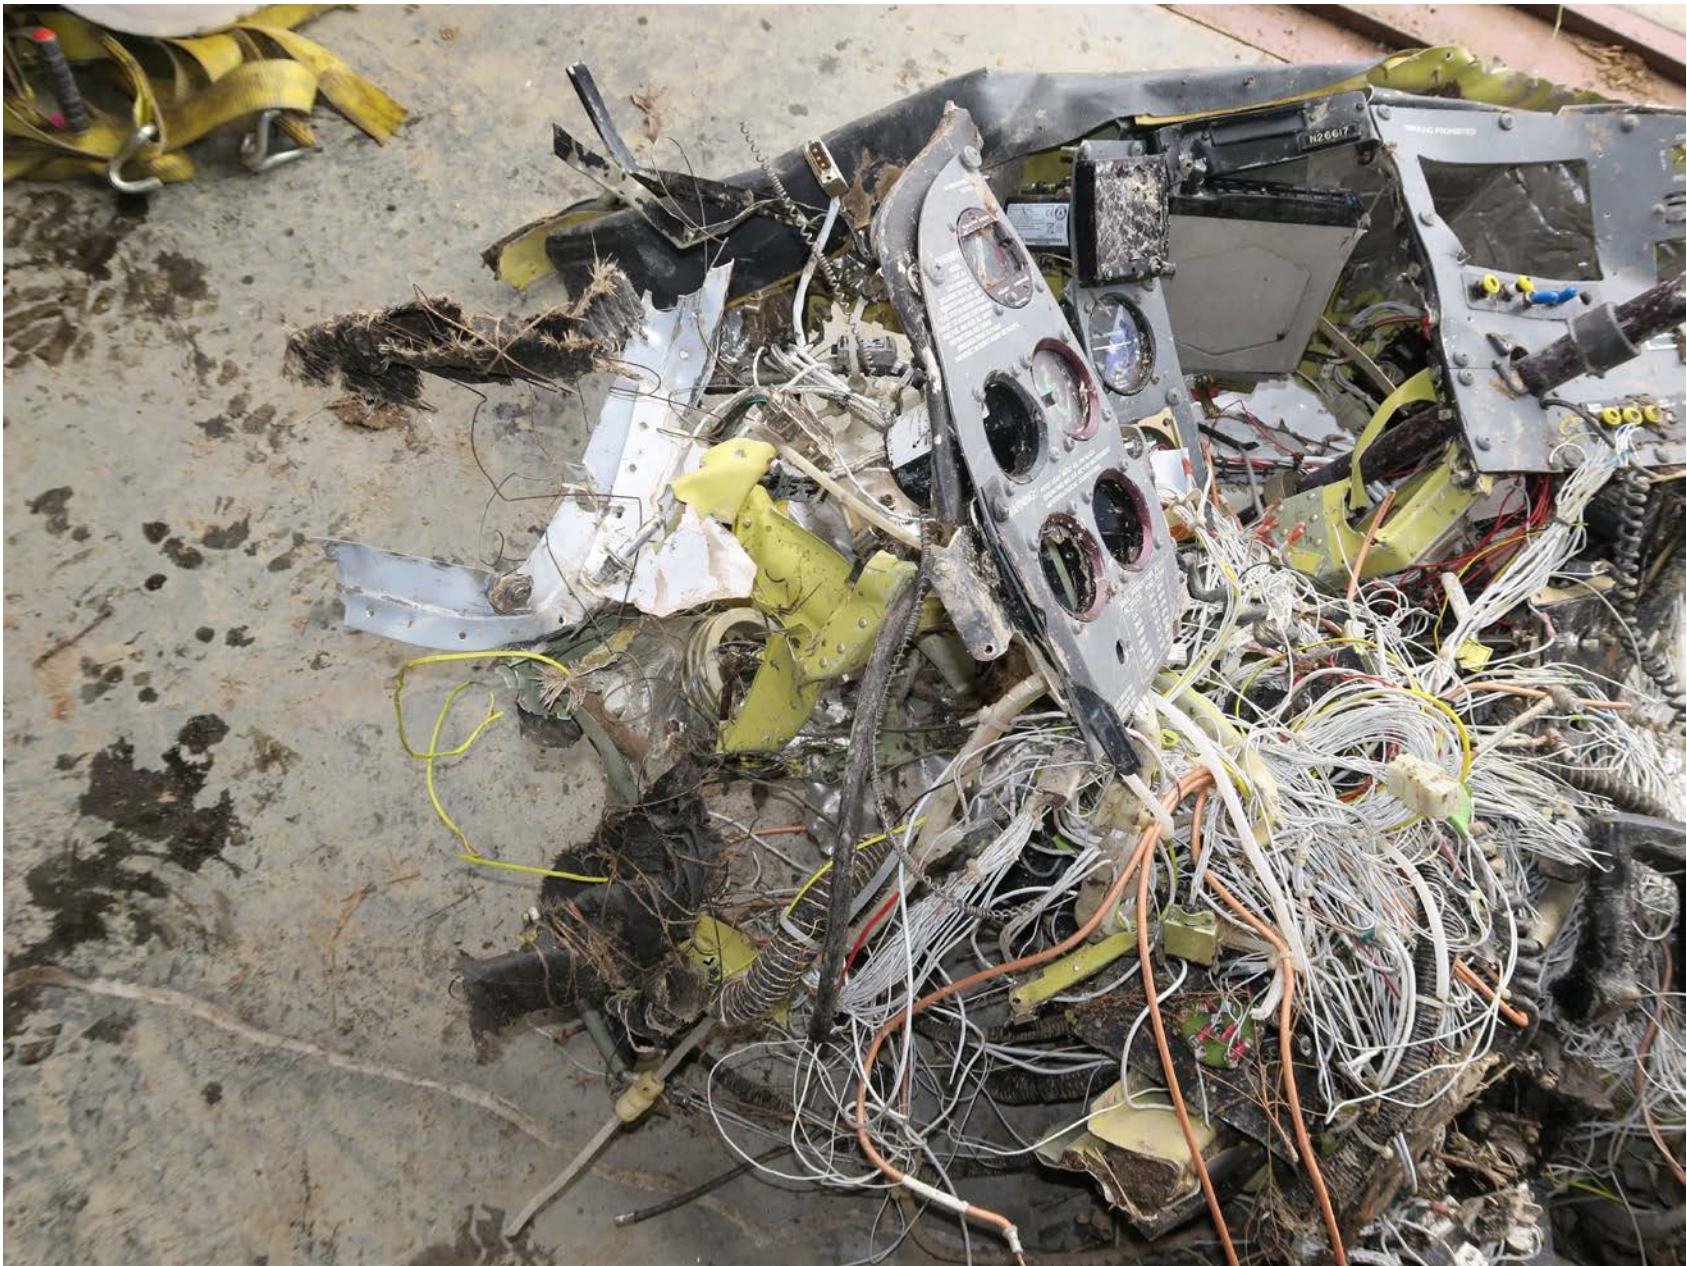
**Photo 6 – View of Instrument Panel (Textron)**

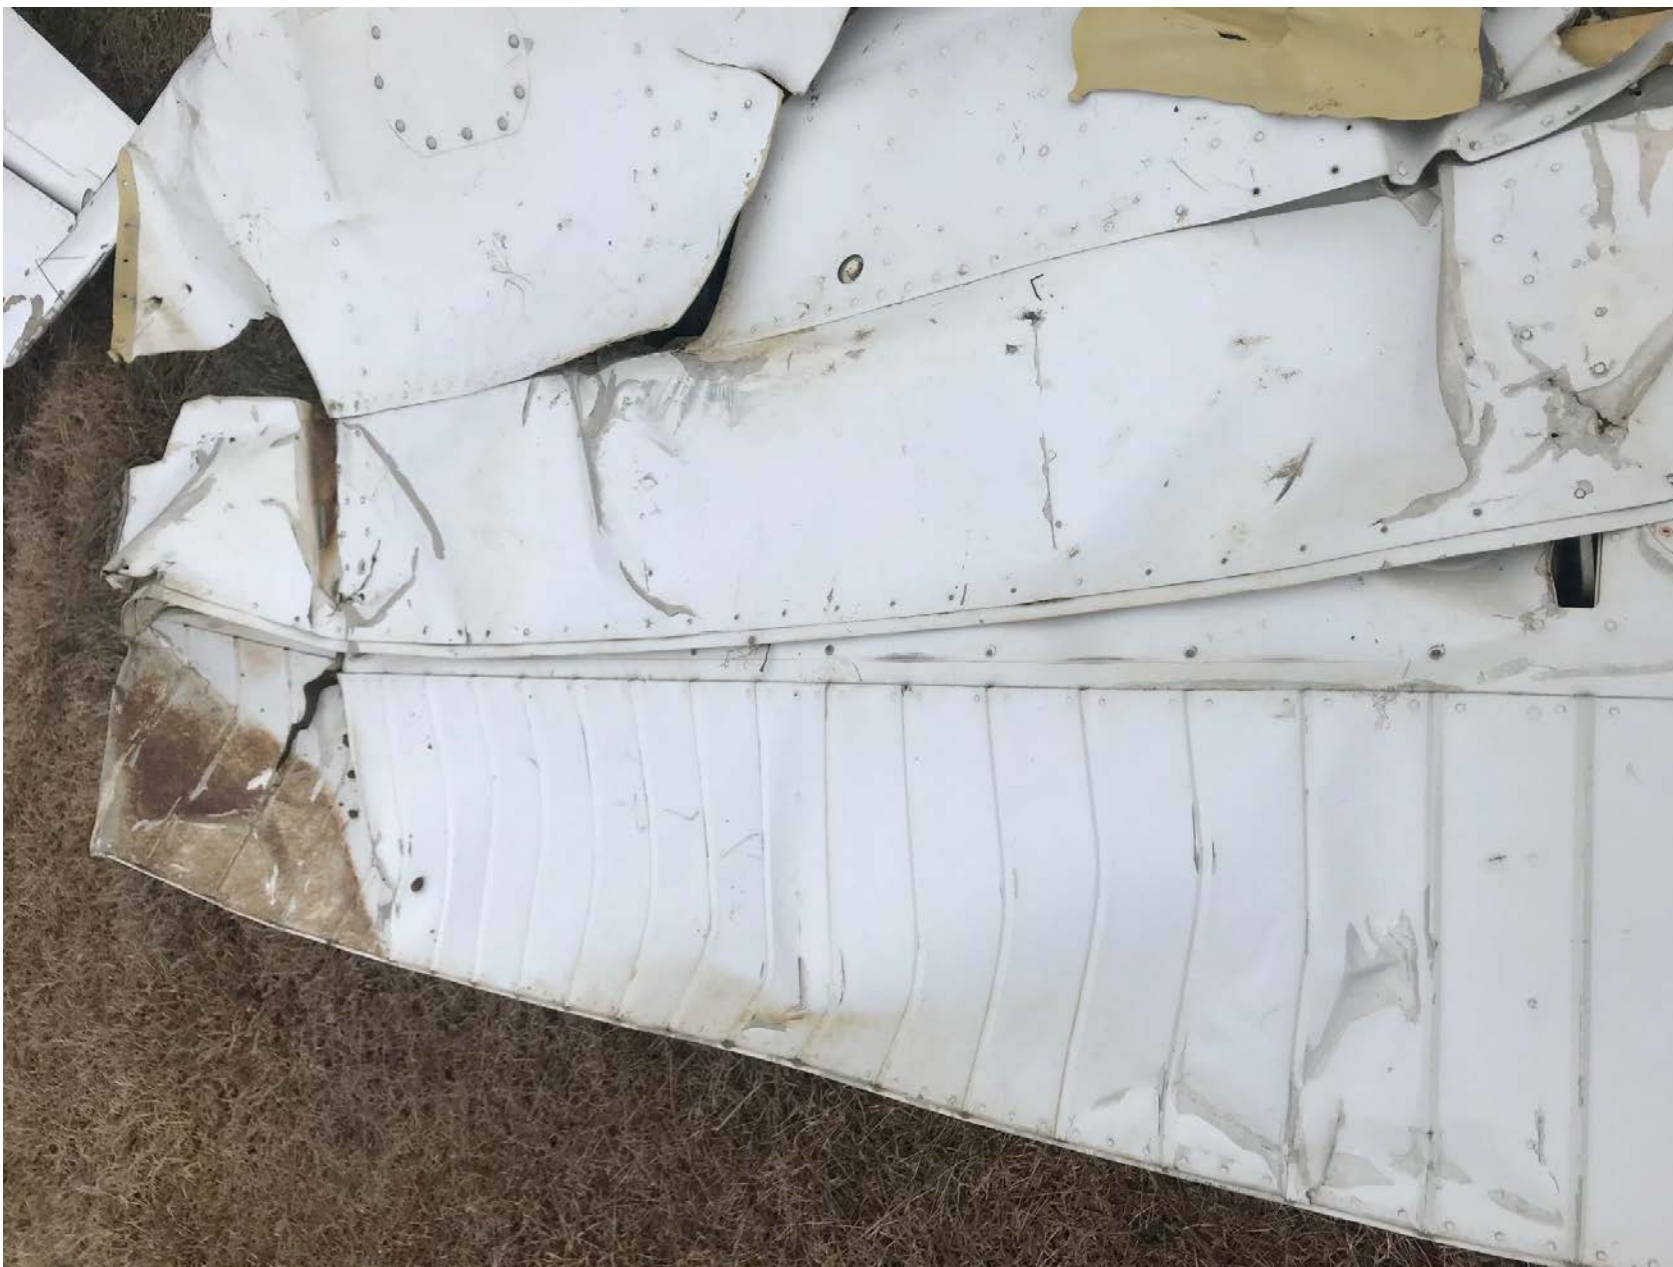
**Photo 7 – View of Wing and Flap (AMF Aviation)**

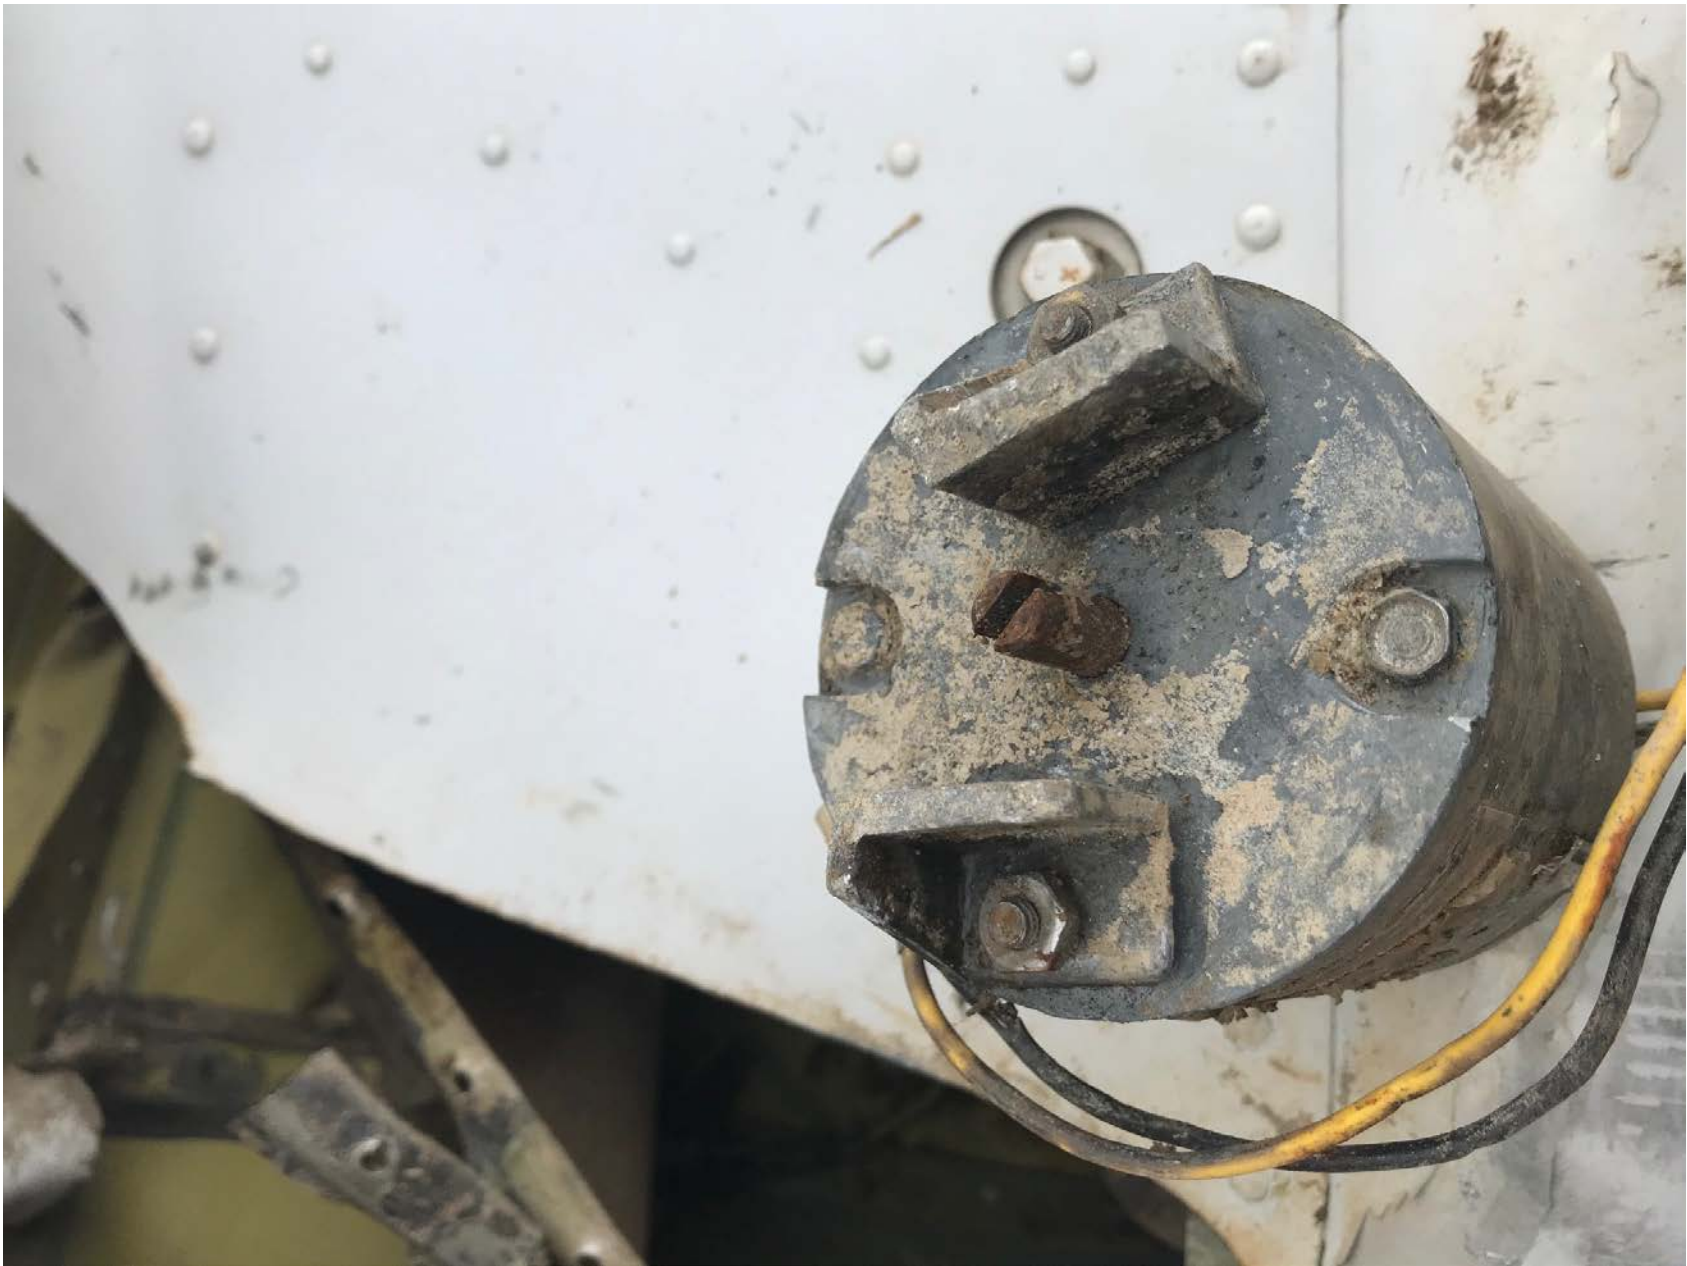
**Photo 8 – View of Flap Actuator Motor (AMF Aviation)**
