# NATIONAL TRANSPORTATION SAFETY BOARD

Office of Research and Engineering  
Materials Laboratory Division  
Washington, D.C. 20594

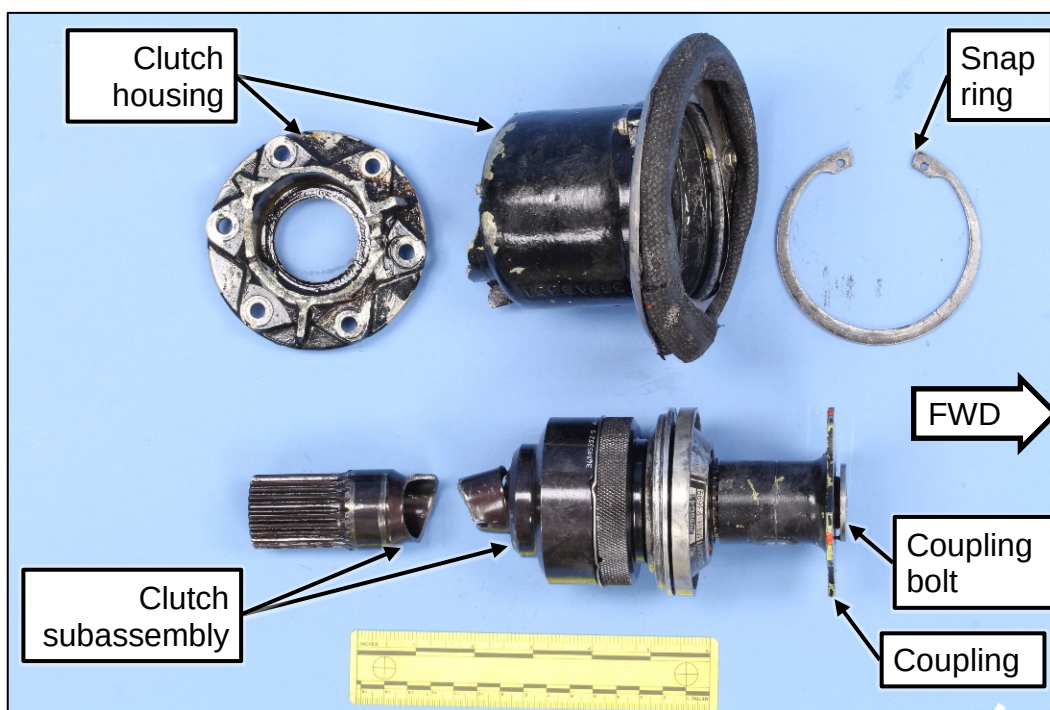
Figure 1. Overall view of the submitted overrunning clutch assembly as received with the housing disassembled from the subassembly.

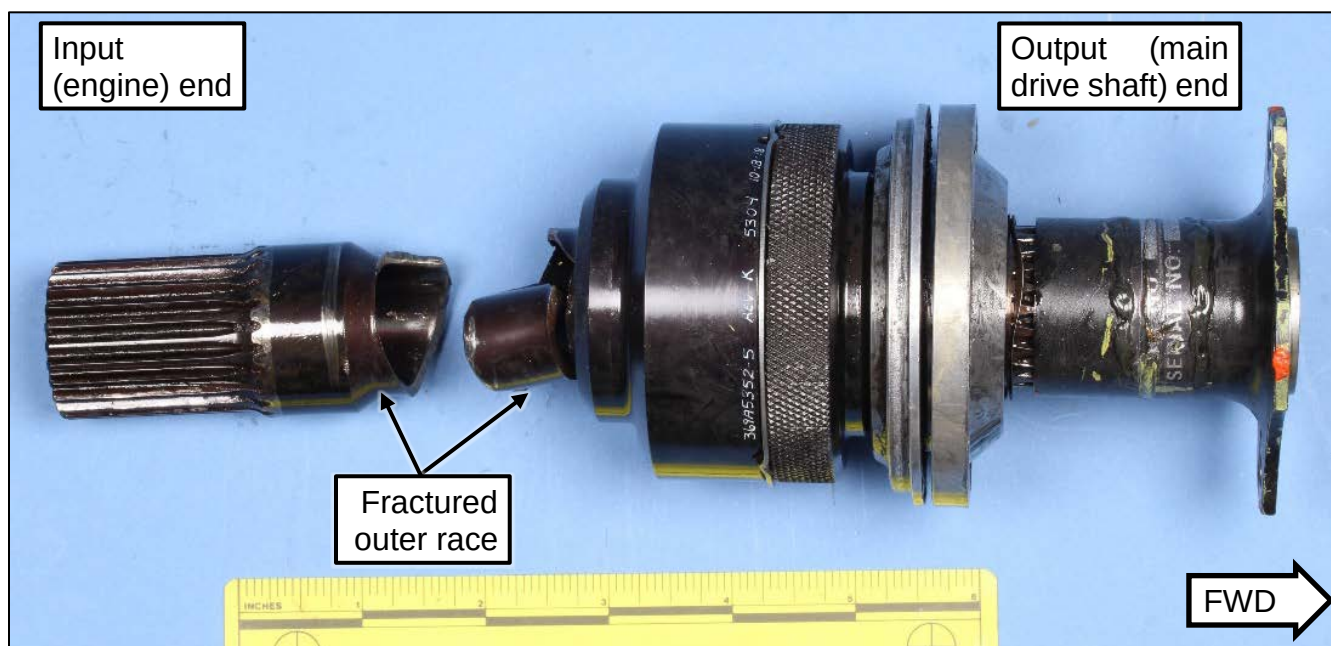
Figure 2. Closer view of the overrunning clutch subassembly showing the fractured outer race photographed as received.

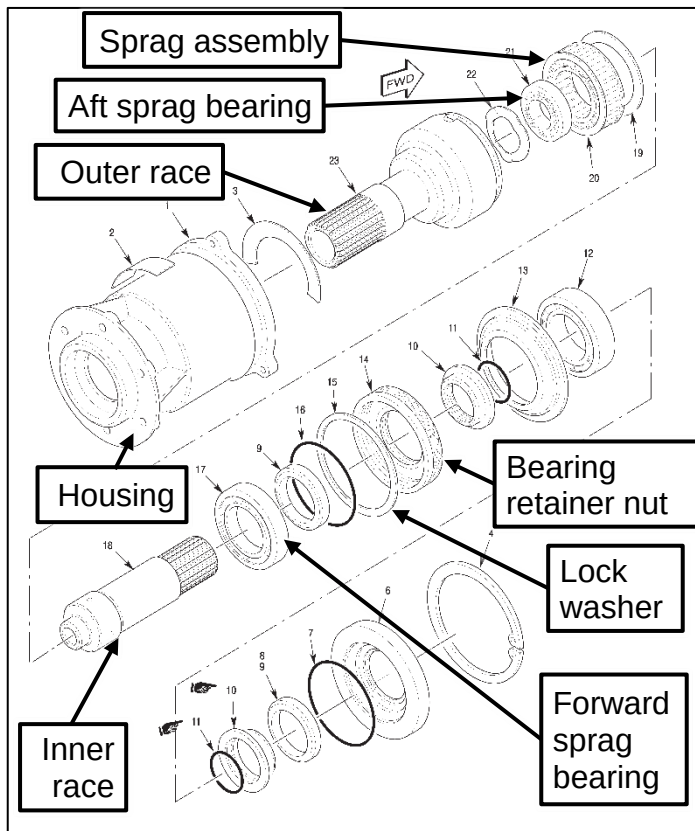
Figure 3. Parts diagram for the overrunning clutch assembly with selected components labeled. (Diagram from the Component Overhaul Manual provided courtesy of MD Helicopters, Inc.)

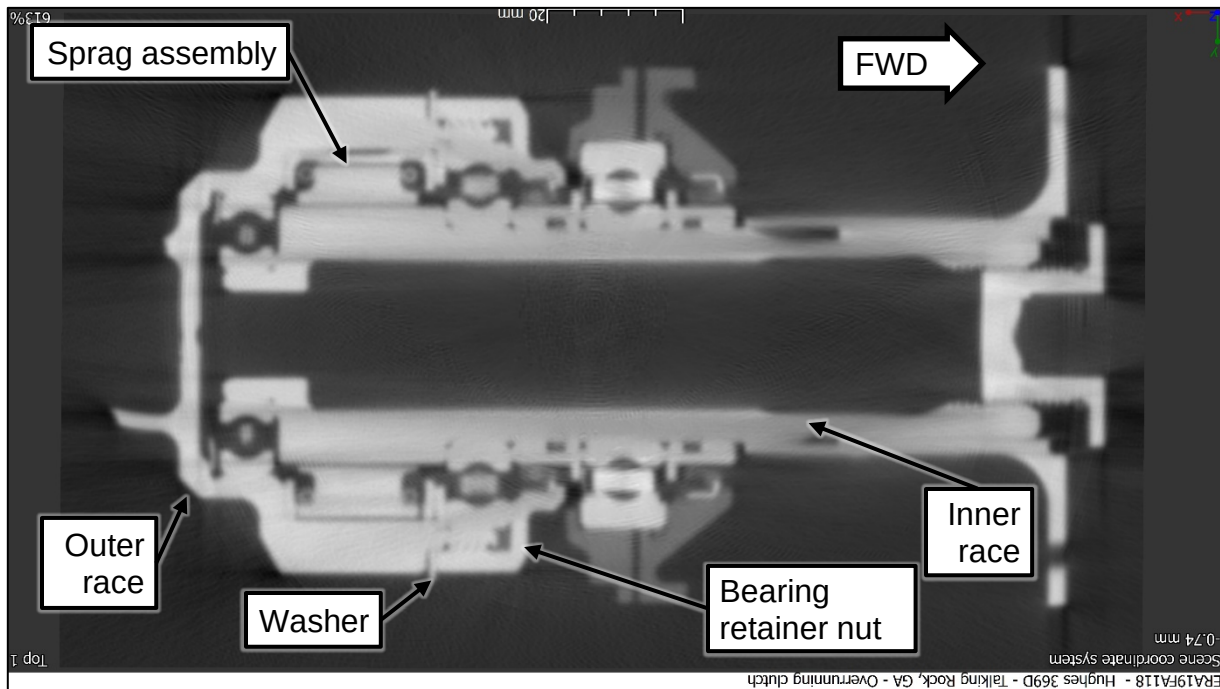
Figure 6. Cross-sectional image from an X-ray CT scan of the overrunning clutch subassembly before the subassembly was disassembled.

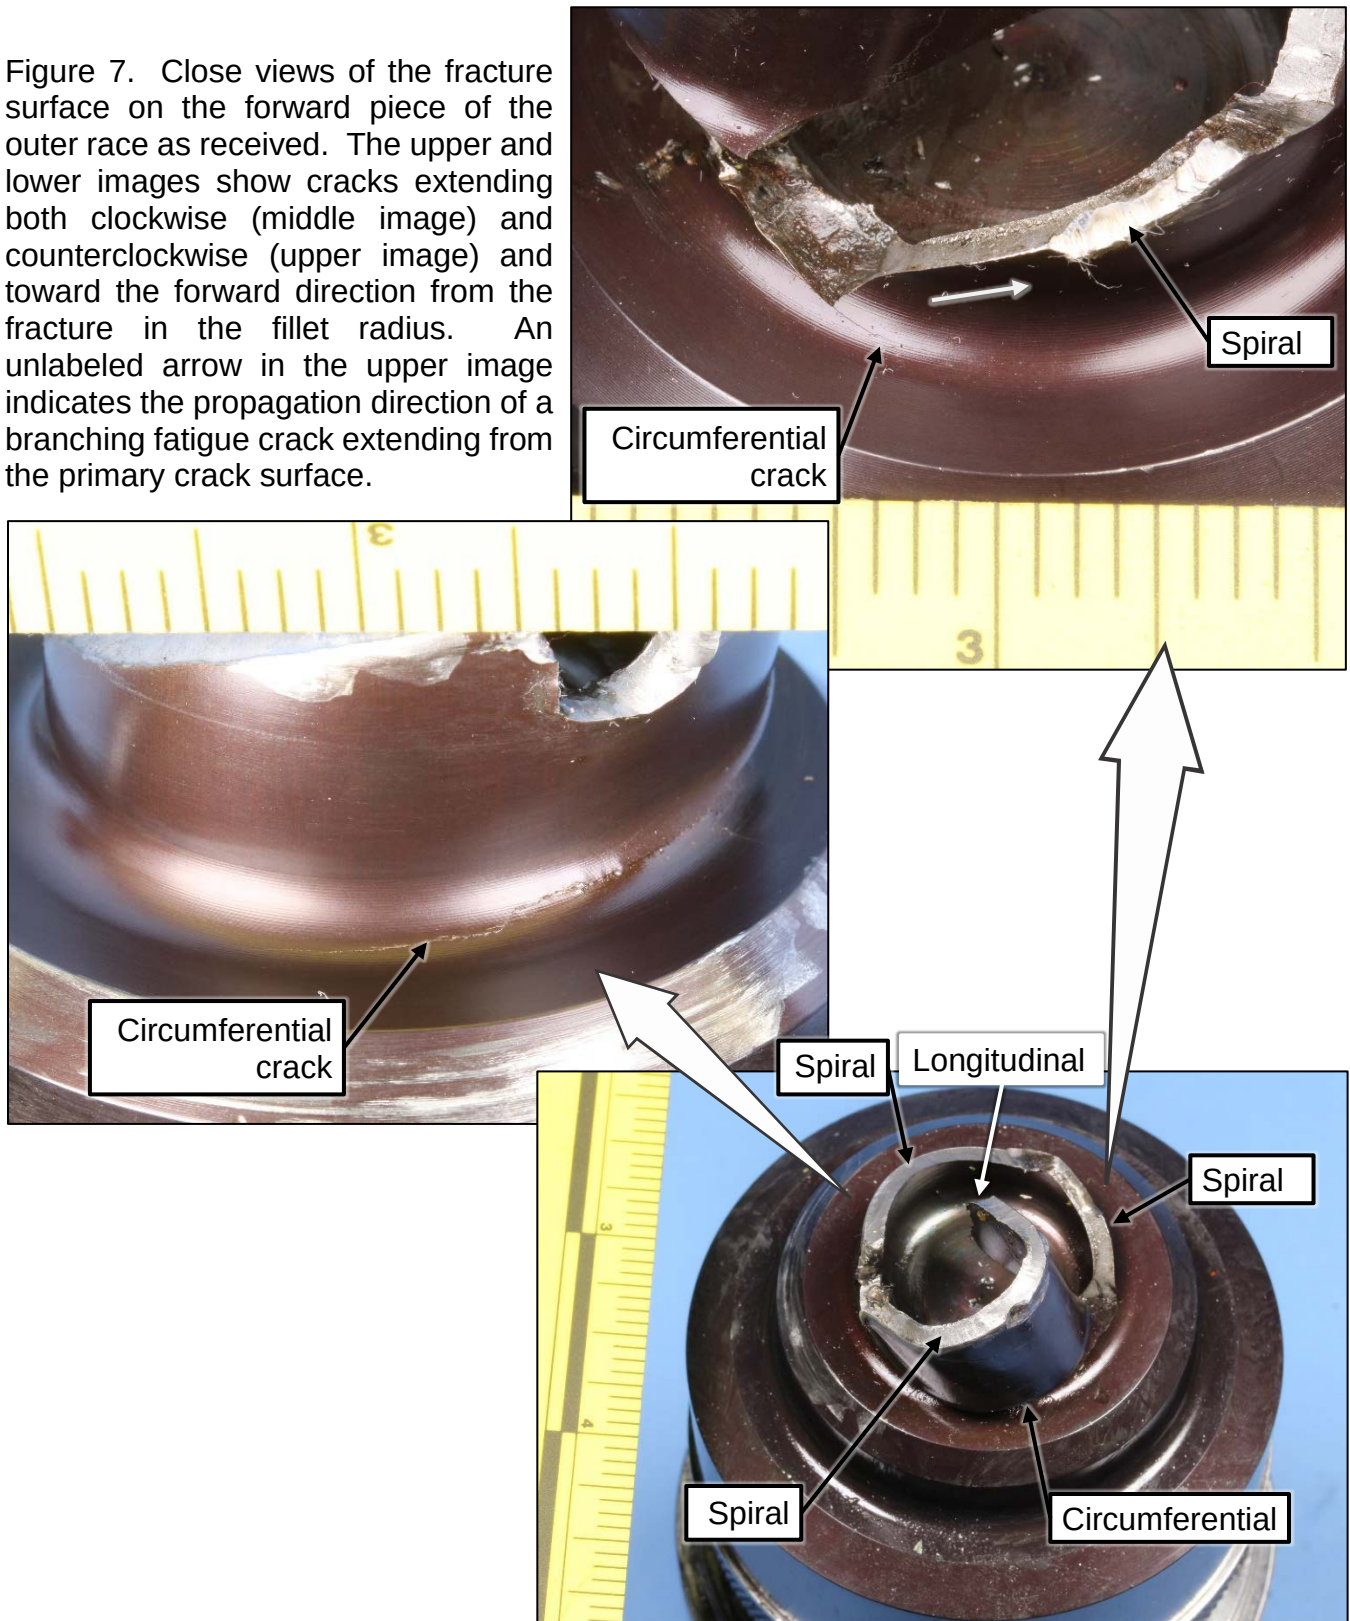
Figure 7. Close views of the fracture surface on the forward piece of the outer race as received. The upper and lower images show cracks extending both clockwise (middle image) and counterclockwise (upper image) and toward the forward direction from the fracture in the fillet radius. An unlabeled arrow in the upper image indicates the propagation direction of a branching fatigue crack extending from the primary crack surface.

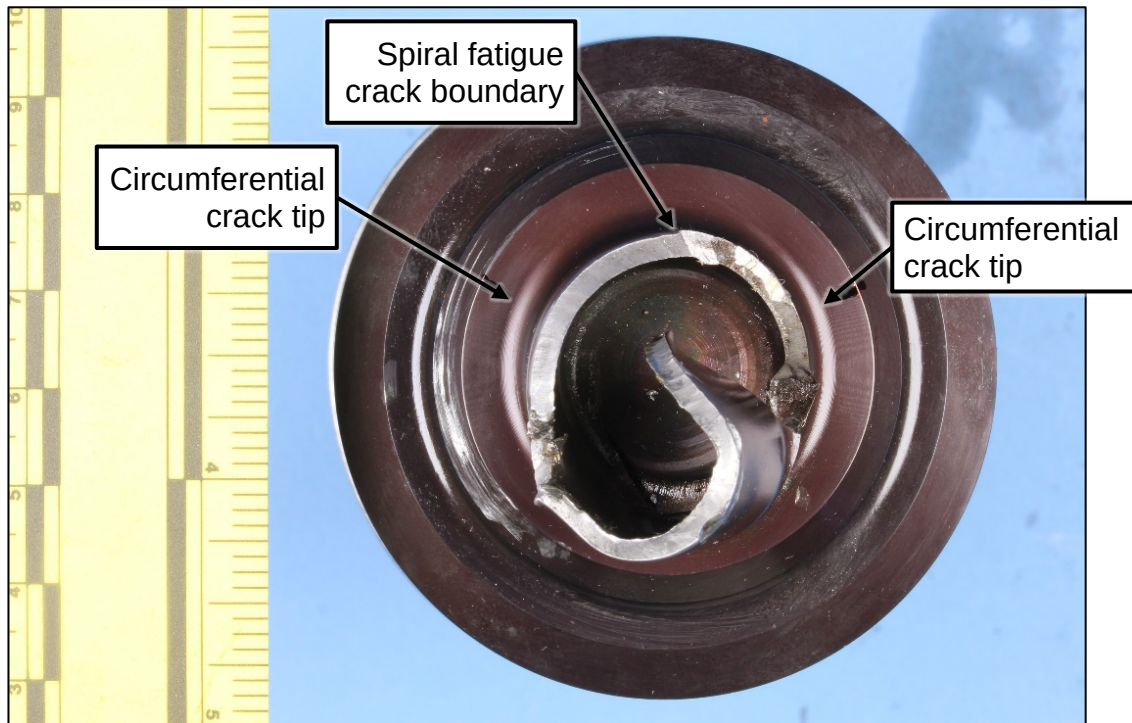
Figure 8. View looking forward showing the crack tips for the primary crack which extended around approximately 2/3 of the circumference and the boundary of the spiral branching fatigue crack.

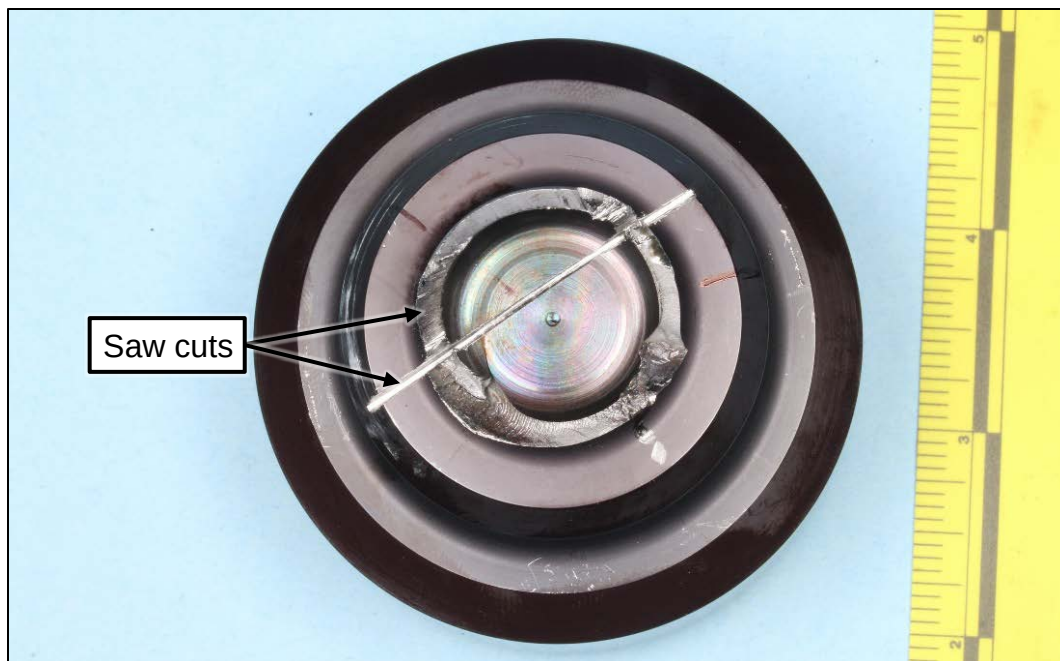
Figure 9. Fracture surface after cutting to remove the piece of input shaft that obscured much of the primary crack surface from view.

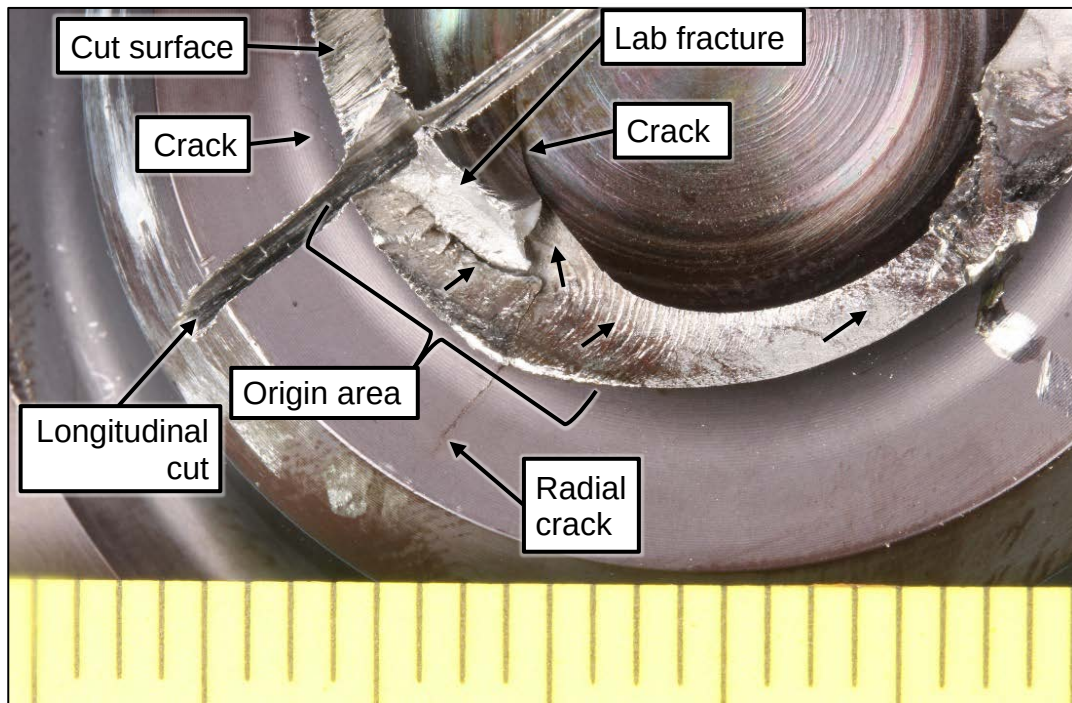
Figure 10. Closer view of the exposed origin area on the overrunning clutch. Unlabeled arrows indicate directions of crack propagation emanating from the broad origin area.

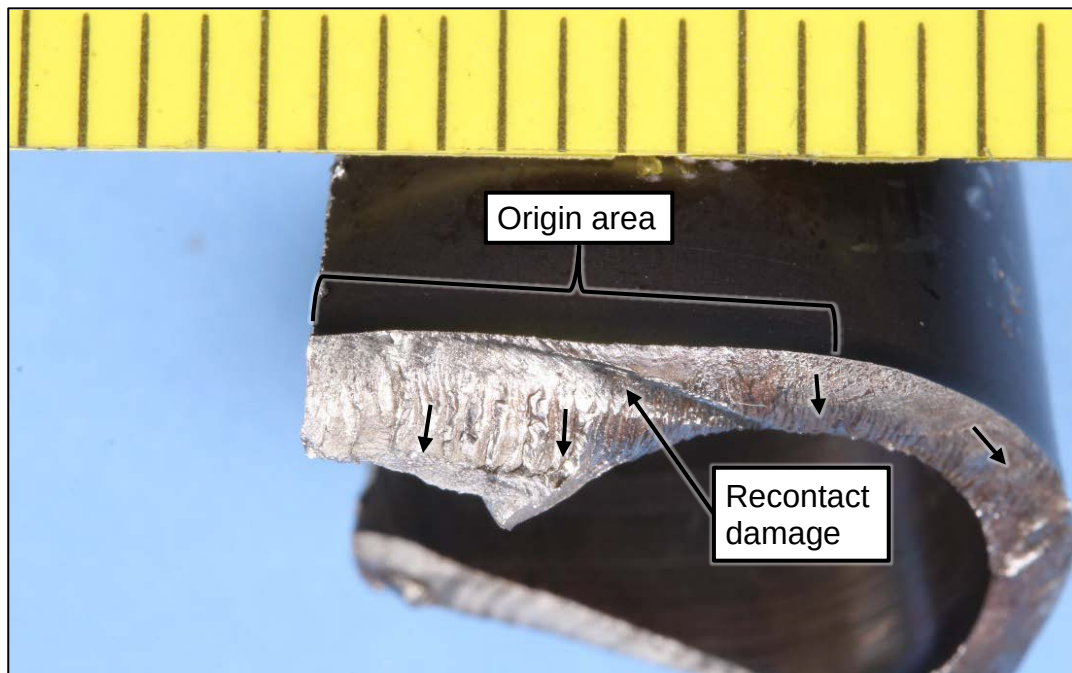
Figure 11. Origin area on the mating side of the fracture. Unlabeled arrows indicate crack propagation directions.

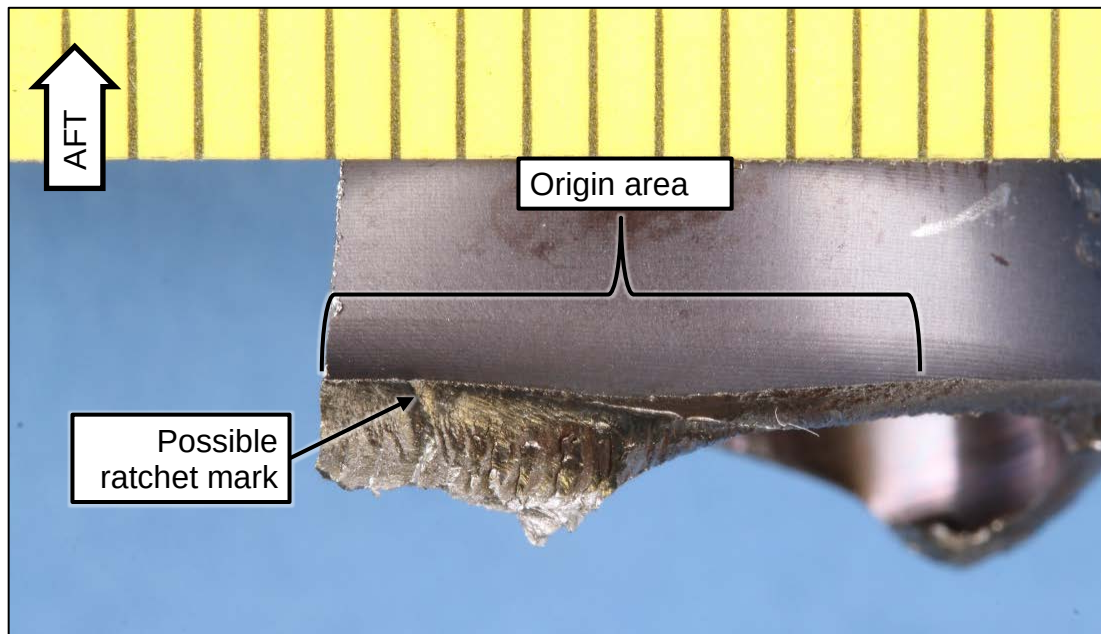
Figure 12. View of the shaft surface adjacent to the fracture at the origin area.

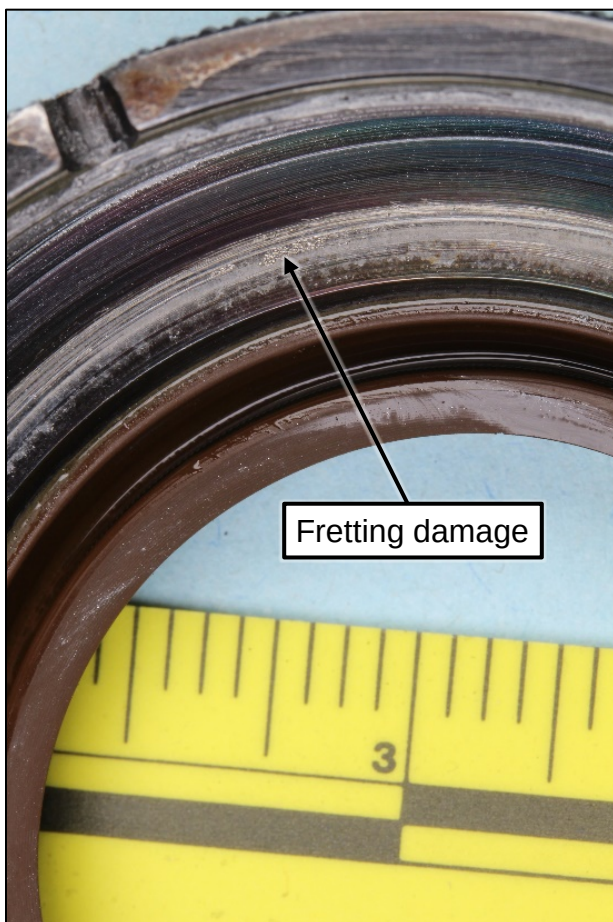
Figure 13. Fretting contact damage on the interior face of the bearing retainer nut.

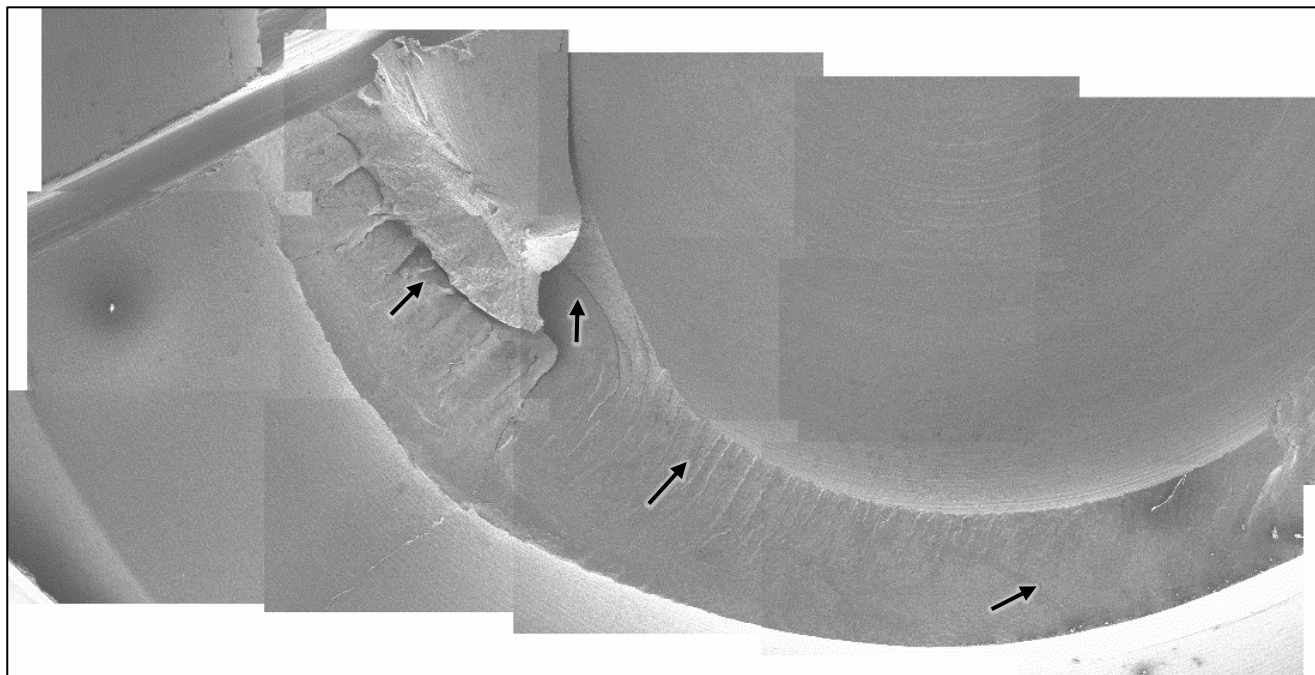
Figure 14. Mosaic SEM image of the origin area. Unlabeled arrows indicate local fatigue crack propagation directions.

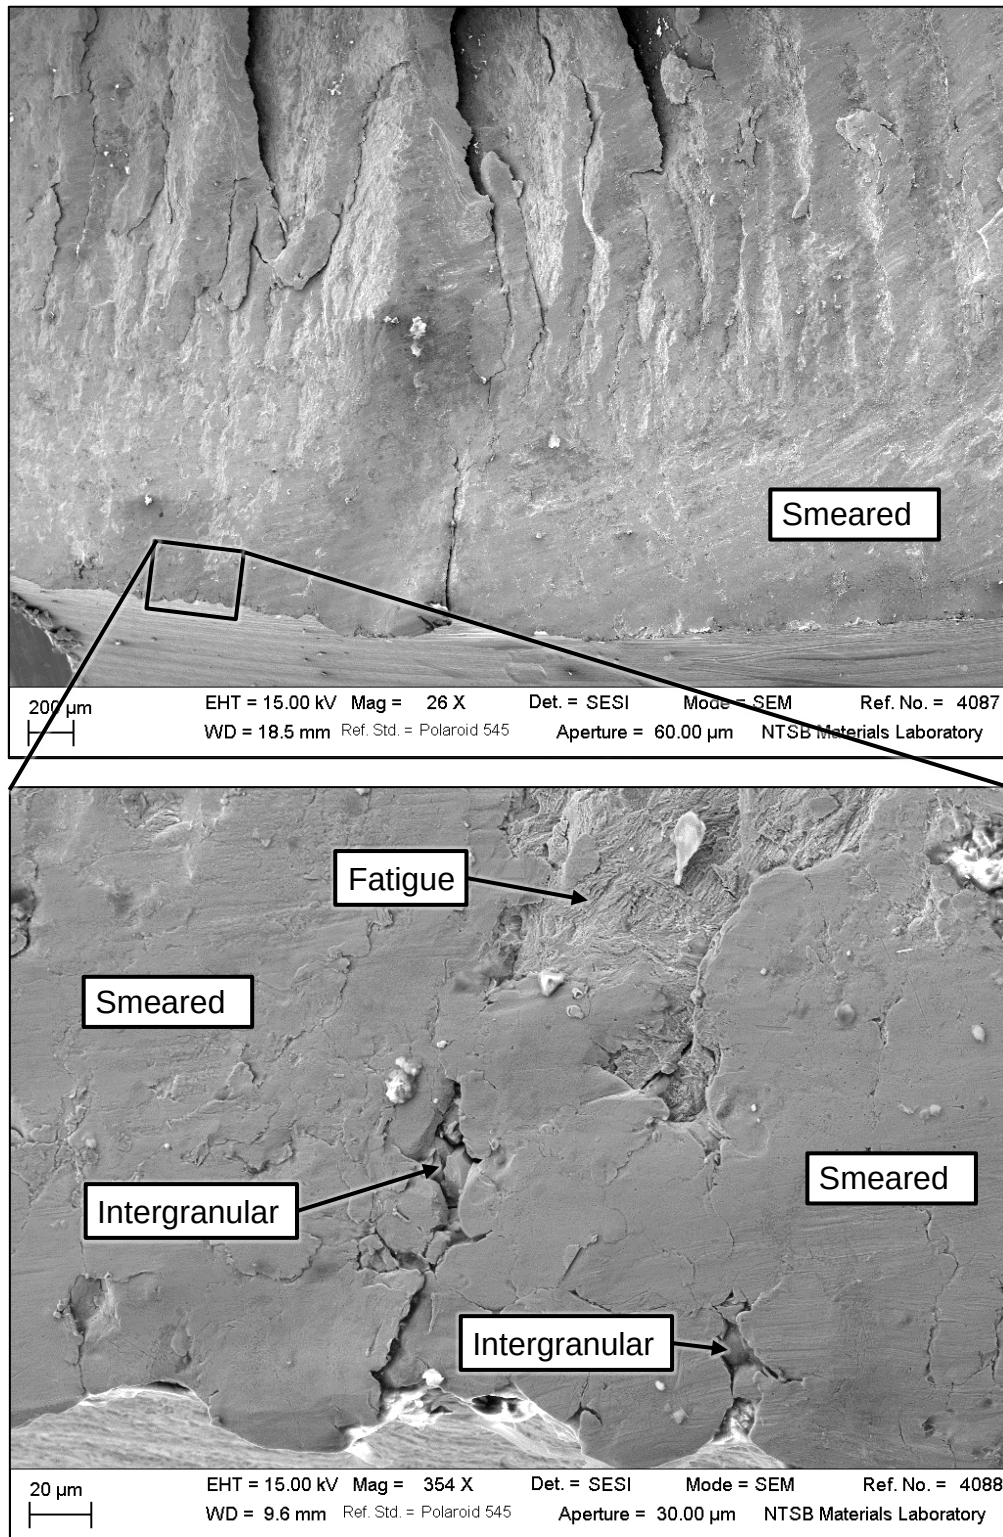
Figure 15. SEM images of the origin area.

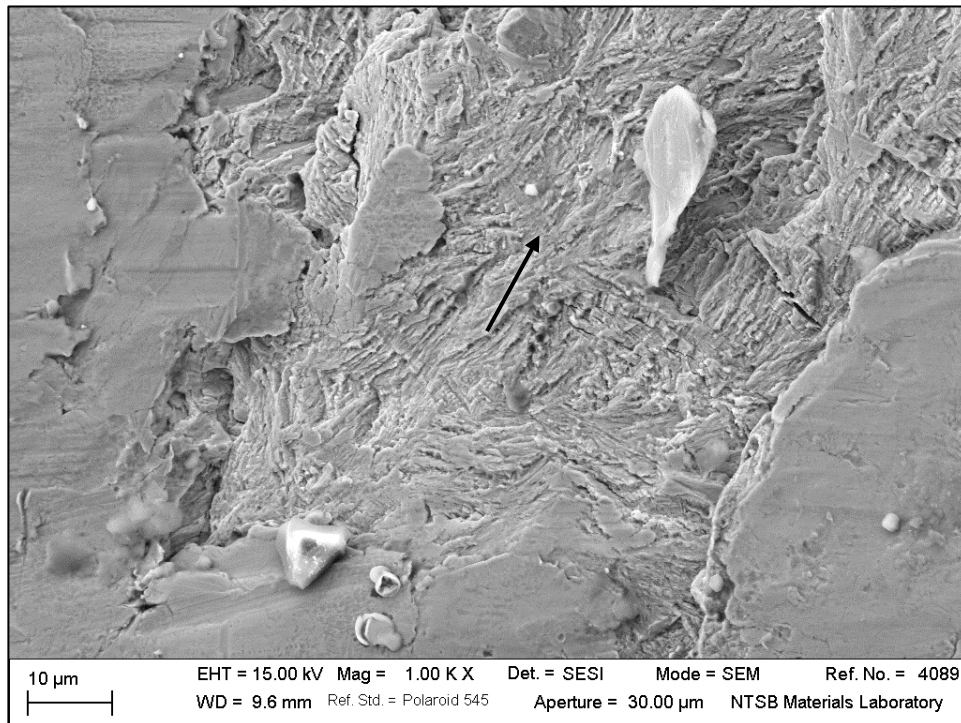
Figure 16. Closer view of fatigue features shown in the previous figure near the origin area. An unlabeled arrow indicates the general direction of fatigue crack propagation.

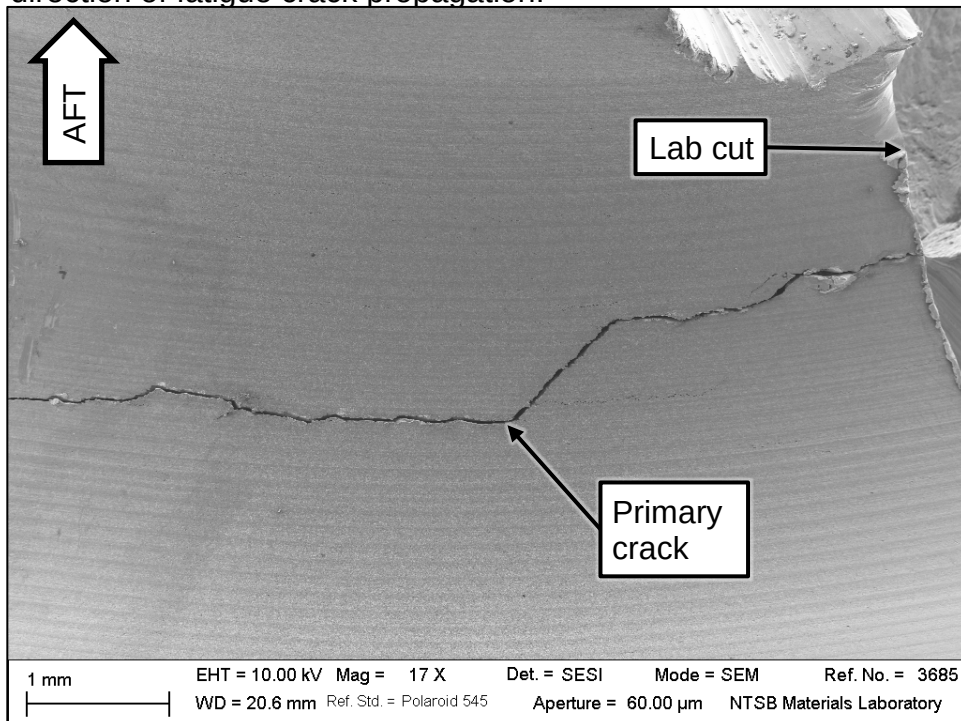
Figure 17. SEM image of the outer race fillet radius showing a portion of the primary crack clockwise of the lab cut.

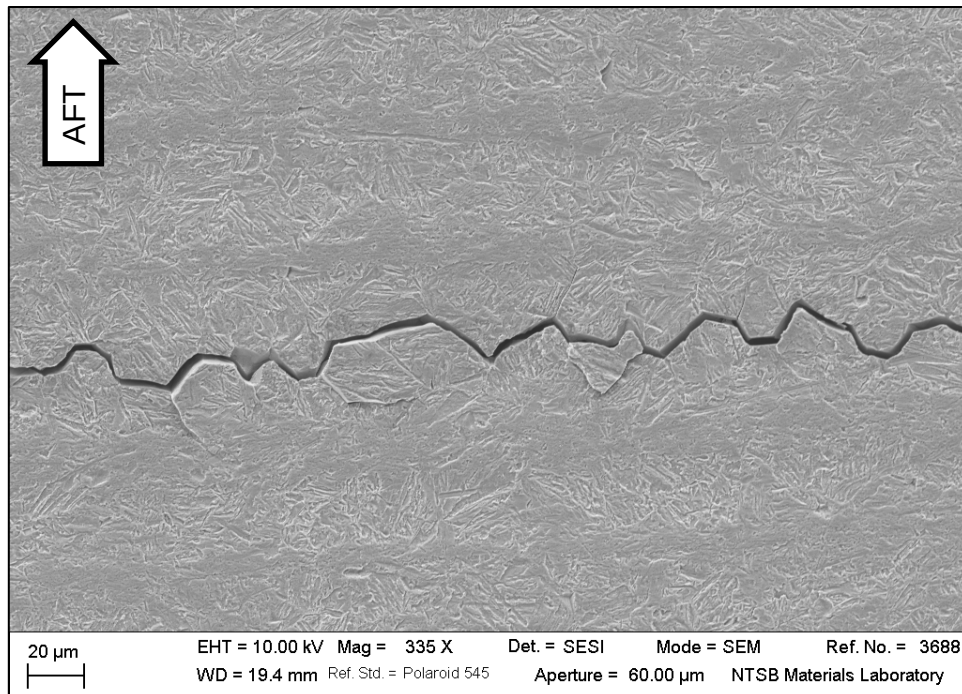
Figure 18. SEM image of the outer race fillet radius at higher magnification showing a portion of the primary crack clockwise of the lab cut.

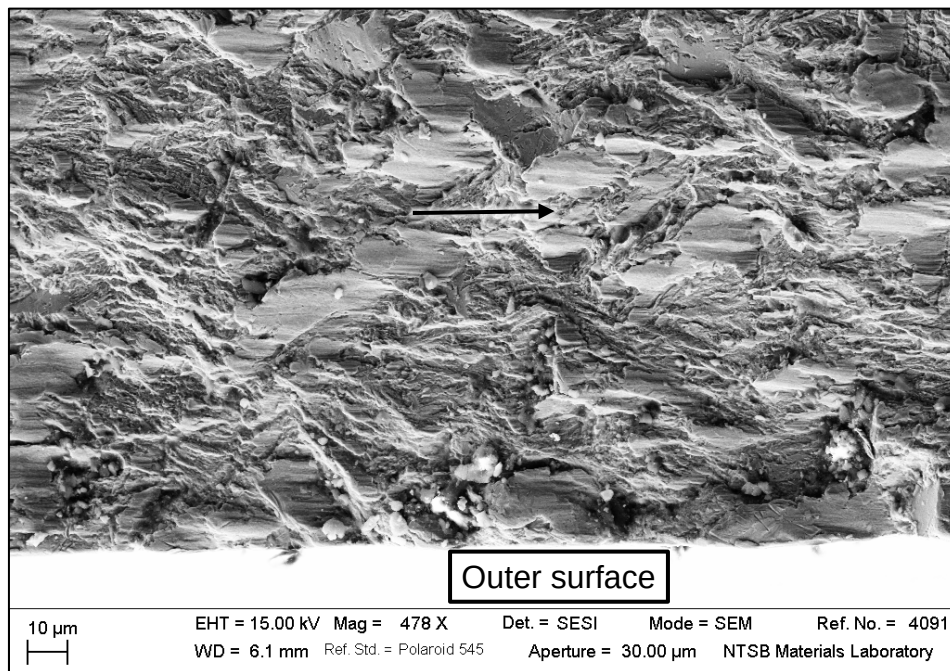
Figure 19. SEM image of fatigue fracture features near the outer surface further counterclockwise from origin. An unlabeled arrow indicates the general direction of fatigue crack propagation.

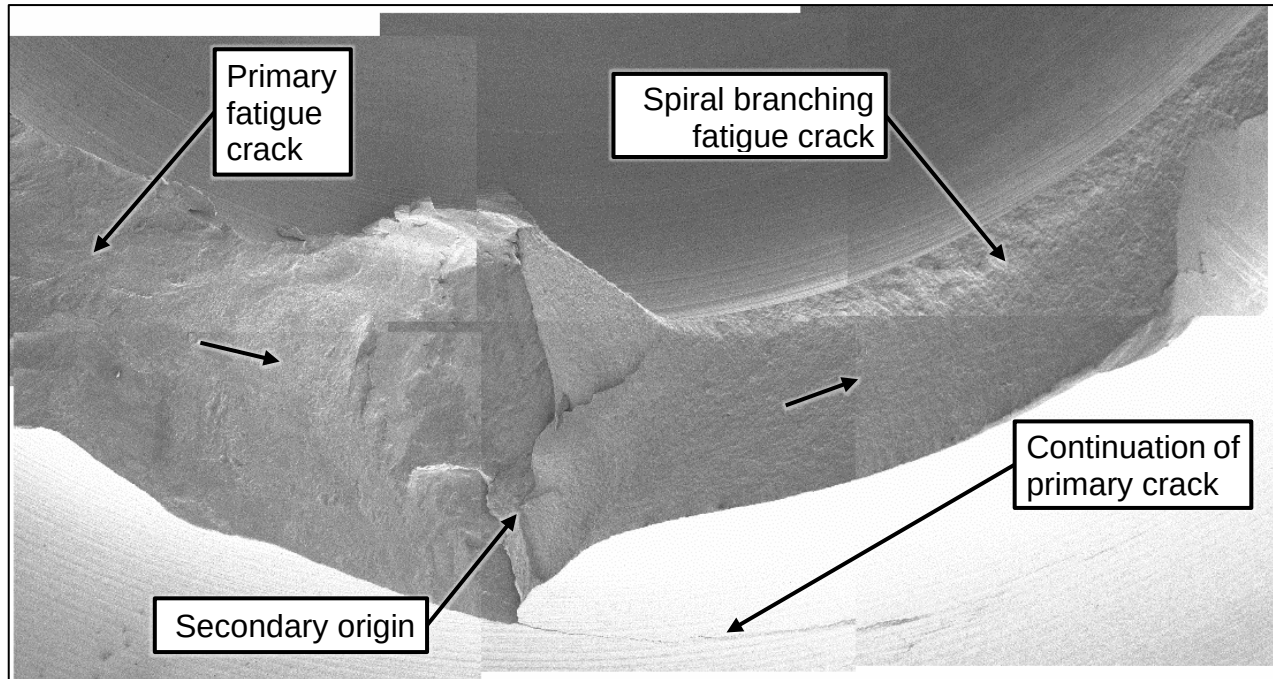
Figure 20. Mosaic SEM image of the secondary origin area associated with the spiral branching fatigue crack. Unlabeled arrows indicate local crack propagation directions.

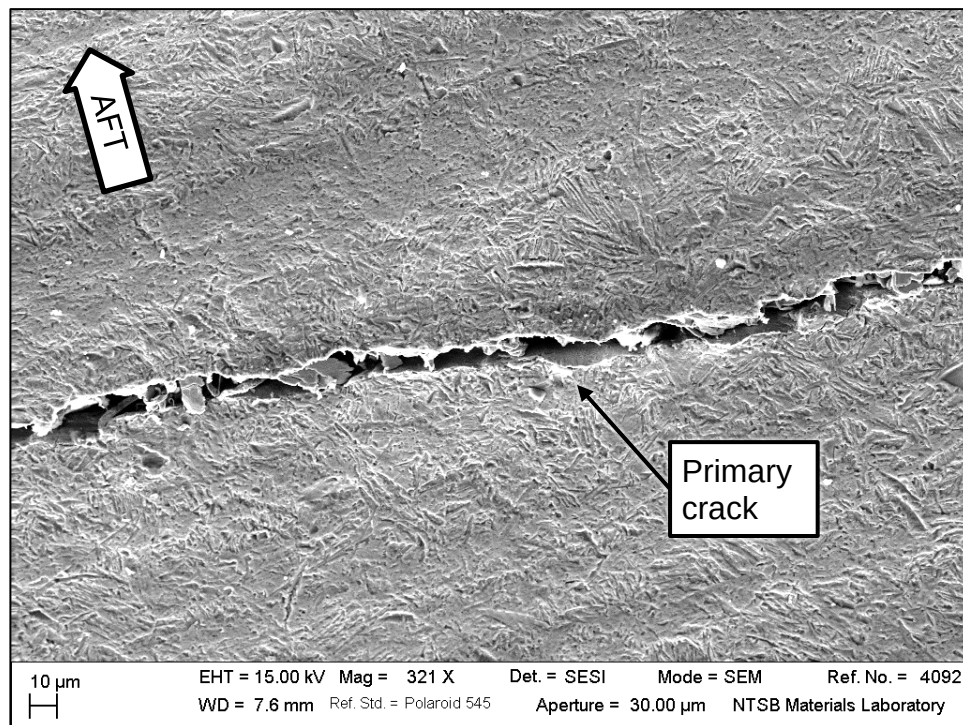
Figure 21. SEM image of the outer race fillet radius showing a portion of the primary crack counterclockwise of the branching spiral crack origin.

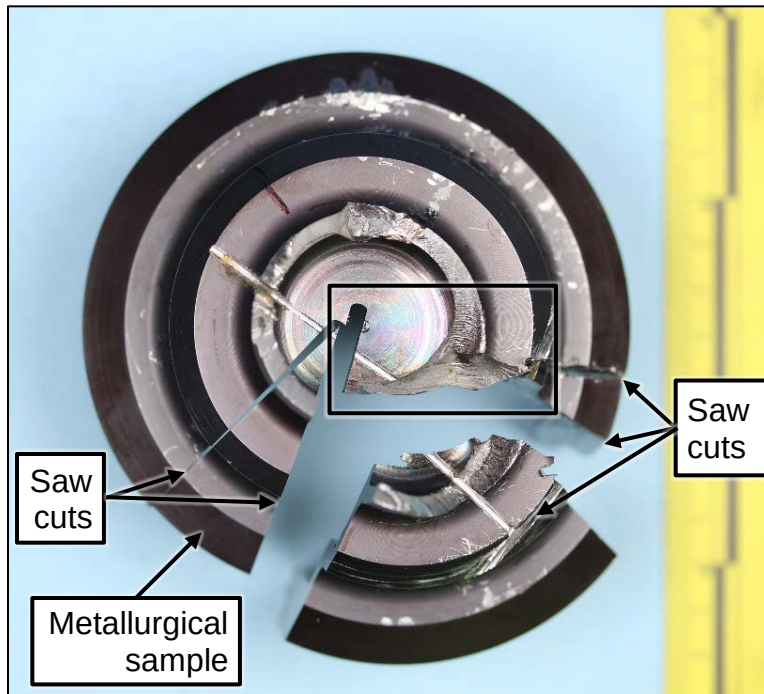
Figure 22. Overall photograph (upper image) of the overrunning clutch fracture surface after additional cuts were made to expose the radial branching crack and to prepare a sample for metallurgical examination. The area of the exposed radial crack outlined in a rectangle in the upper image is shown in the lower image, where unlabeled arrows indicate crack propagation directions and a secondary origin area on the radial crack fracture surface.

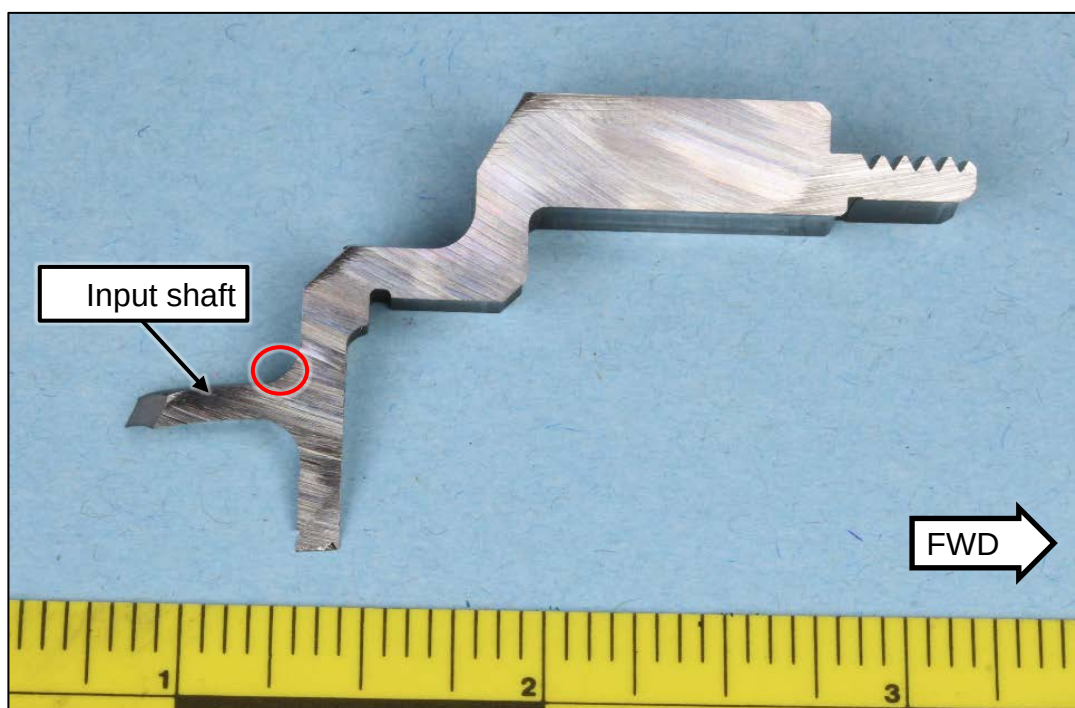
Figure 23. Cut sample of the outer race before mounting for metallurgical examination. The fillet radius associated with the primary fracture is circled.

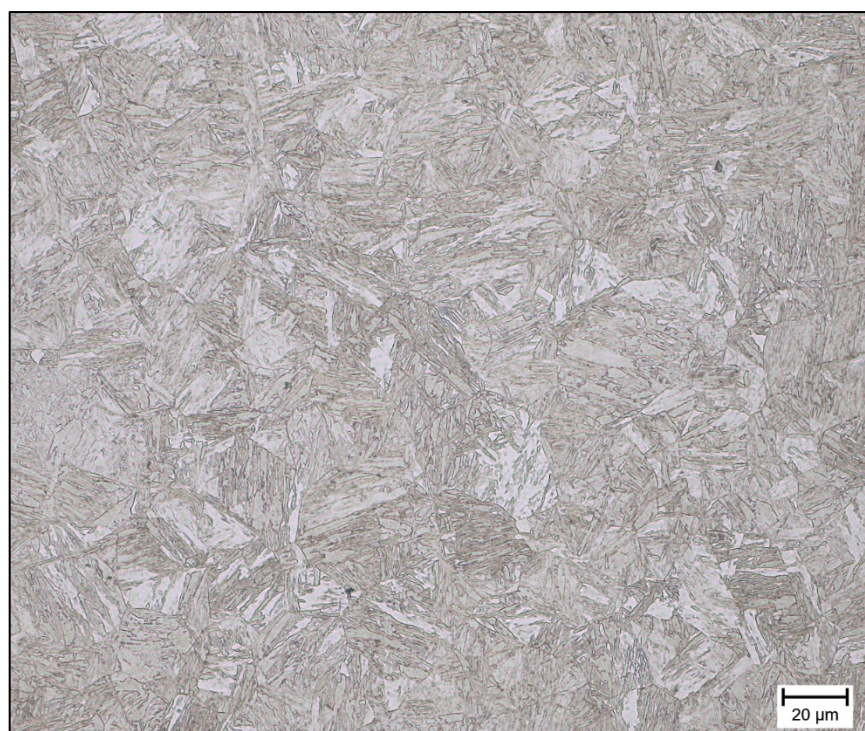
Figure 24. Typical microstructural features consistent with tempered martensite in the shaft (etched with 2% nital).

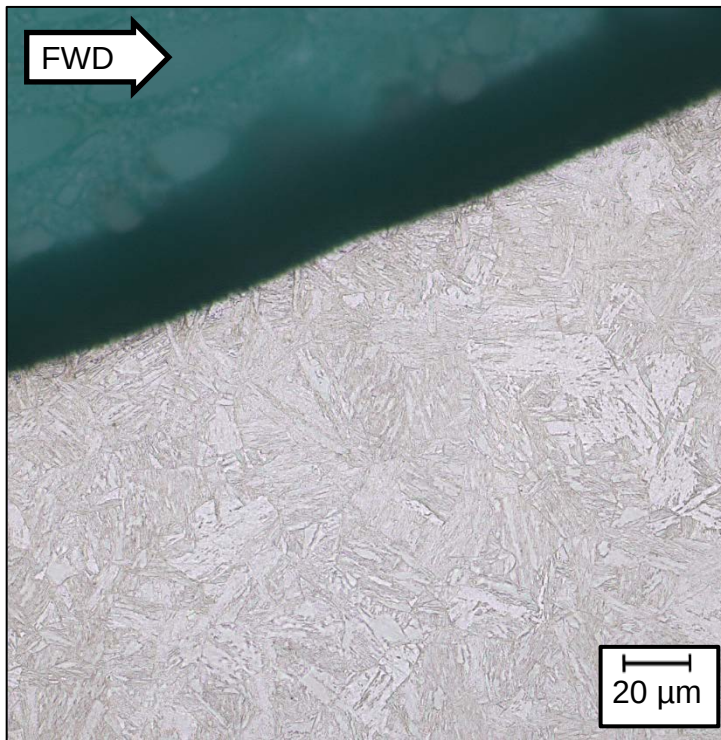
Figure 25. Etched cross-section showing typical microstructural features consistent with tempered martensite at the outer surface in the fillet radius at the forward end of the input shaft (etched with 2% nital).

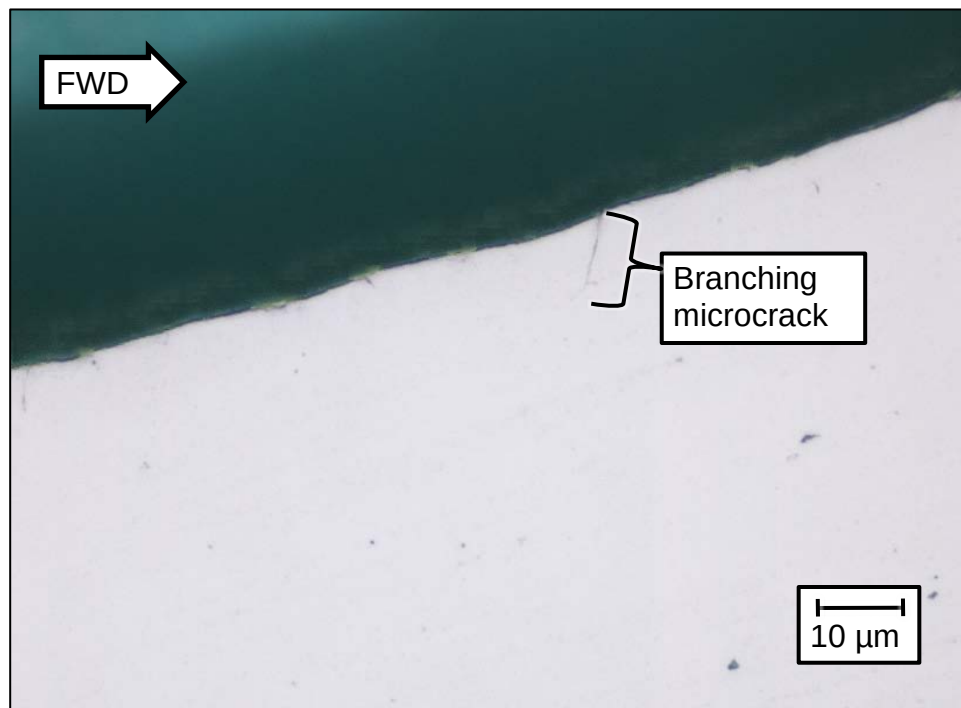
Figure 26. Fillet radius at the forward end of the input shaft showing a branching microcrack emanating from the outer surface on the as polished cross-section.
