**NATIONAL TRANSPORTATION SAFETY BOARD**

**Computed Tomography Specialist's Factual Report**

ERA19FA118

Location: Talking Rock, Georgia  
Date: March 5, 2019  
Time: 1130 eastern standard time  
Airplane: MD Helicopters (Hughes) 369D, N89ZC

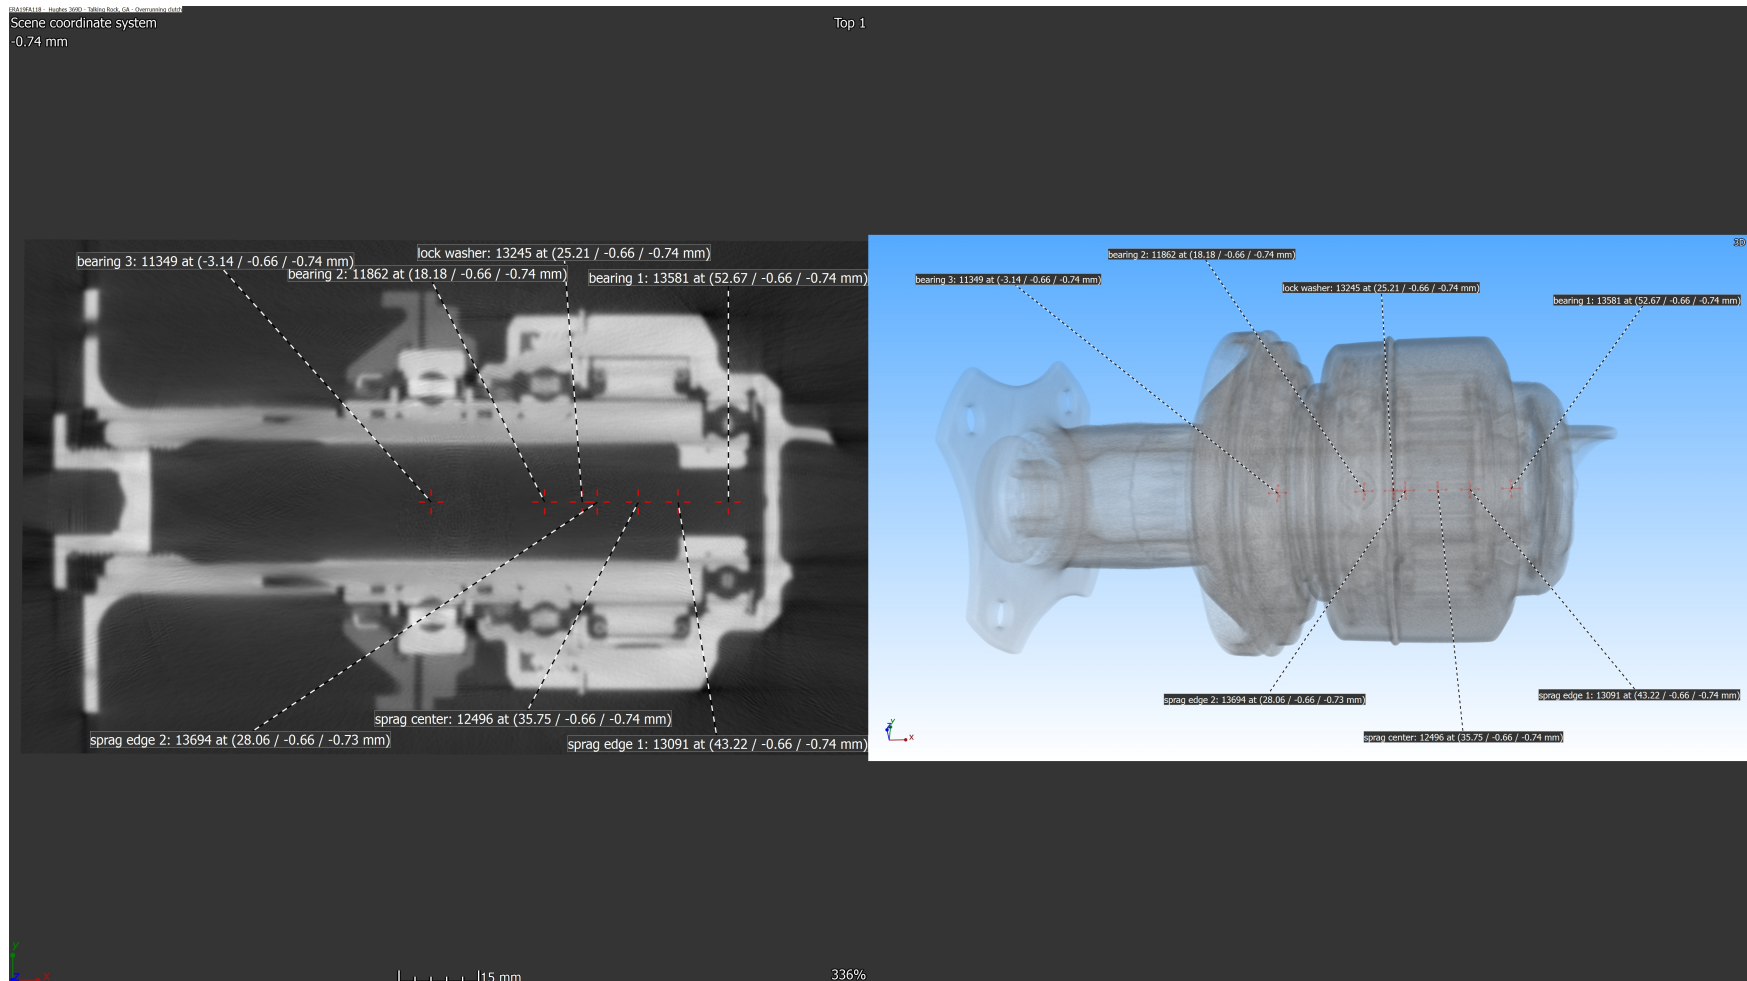
Figure 1  
Overrunning clutch – overview

The computed tomography (CT) results for the components are shown in figures 1 through 10. Review of the images indicated that, when the scans were conducted, there were no indications of missing or broken components, blockages, or other abnormalities.
