# NATIONAL TRANSPORTATION SAFETY BOARD

## MATERIALS LABORATORY FACTUAL REPORT

Report No. 19-057

Place : Talking Rock, Georgia  
Date : March 5, 2019  
Vehicle : Hughes 369D, N89ZC  
NTSB No. : ERA19FA118  
Investigator : Chihoon Shin, AS-40

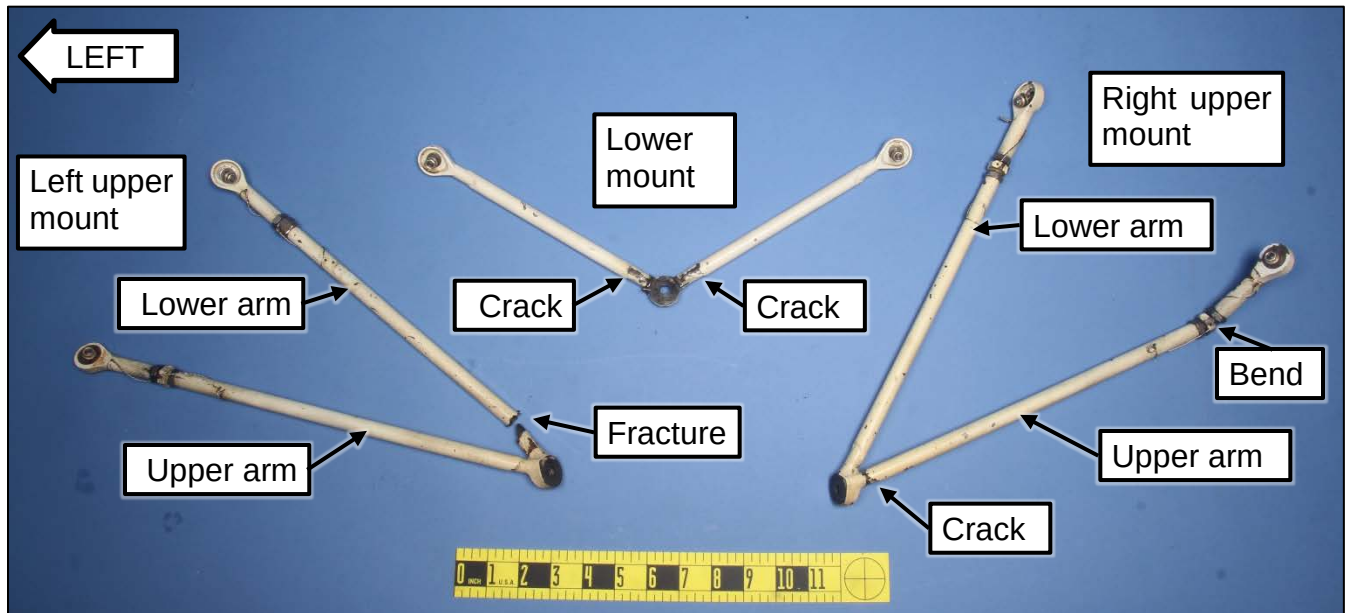
An overall view of the submitted engine mounts is shown in figure 1. The lower arm of the left upper engine mount was fractured, and the upper arm of the right upper engine mount was bent and cracked. Cracks were also observed in the lower engine mount. In the accident, the helicopter reportedly came to rest on its right side. The helicopter had also struck a power transmission line on August 22, 2018.<sup>1</sup> The helicopter reportedly developed a large vibration in the rotor system after the power line strike, and the pilot reported searching for and finding a suitable landing site. The helicopter had 328 hours time in service since the power line strike with no mention of a hard landing after the power line strike or in other records reviewed by investigators.

As indicated in figure 1, the upper arm of the right upper engine mount was bent near the outboard end of the arm and was cracked near the inboard end. The adjustment bolt for attaching and positioning the outboard fitting on the upper arm was bent, and the outboard end was bent in the forward direction. At the inboard end of the upper arm, the crack was located in the fitting on the forward side of the arm. Parallel tension cracks were present in the paint adjacent to the crack on the forward side of the arm, consistent with bending deformation in the aft direction. The overall damage pattern of the upper arm with forward bending at the outboard end and aft bending at the inboard end was consistent with compression overload failure.

As indicated in figure 1, a crack was present near the engine attachment location at the inboard end of the right upper engine mount. Using a handheld hacksaw, a transverse cut was made on the side of the fitting opposite the crack, and the crack was opened by squeezing the cut surfaces together. The resulting lab fracture is shown in figure 15. The fracture surface had a matte gray appearance consistent with ductile overstress fracture with no evidence of orange oxides on the surface.

Figure 1. Overall view of the submitted engine mounts photographed as received.

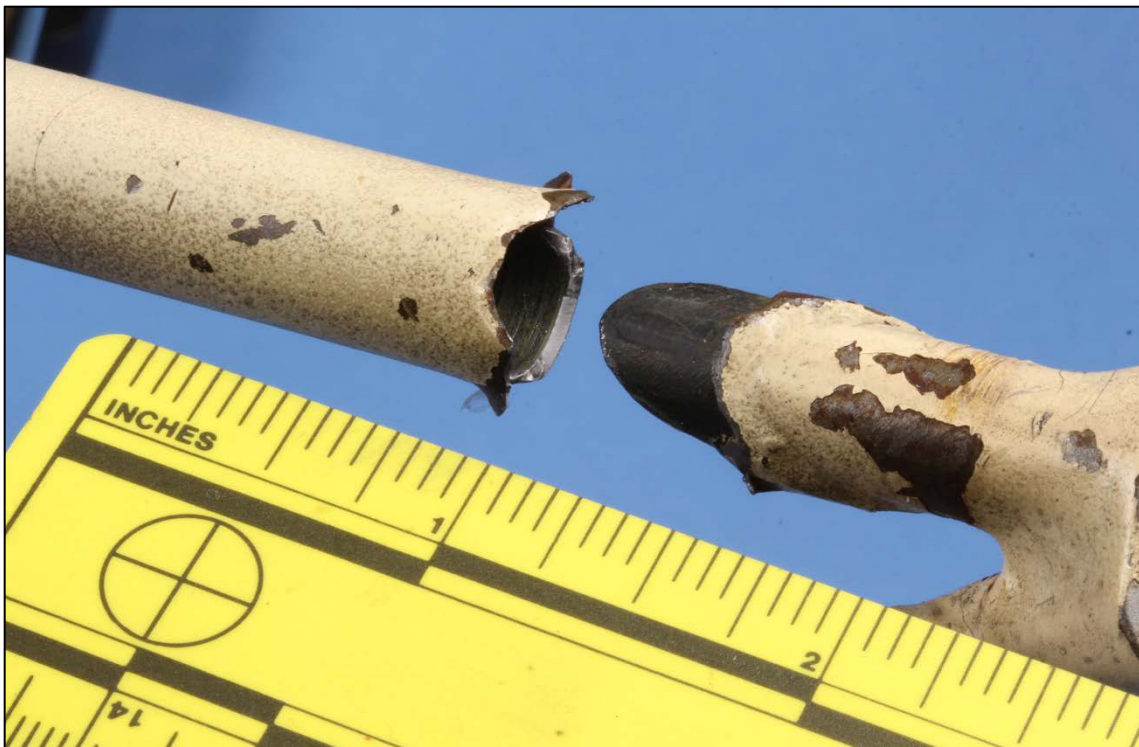
A close view of the fracture in the lower arm of the left upper engine mount is shown in figure 2. Fracture surfaces were on slant angles and had a matte gray appearance consistent with ductile overstress fracture. The overall fracture pattern was consistent with fracture under tensile load. Portions of the fracture surface on the outboard side of the fracture were splayed outward, and adjacent areas of the fracture were shiny and smooth as well as areas on the mating inboard side of the fracture, features consistent with post-fracture recontact between the mating sides of the fracture.

Figure 2. Closer view of the fracture in the lower arm of the left upper engine mount.

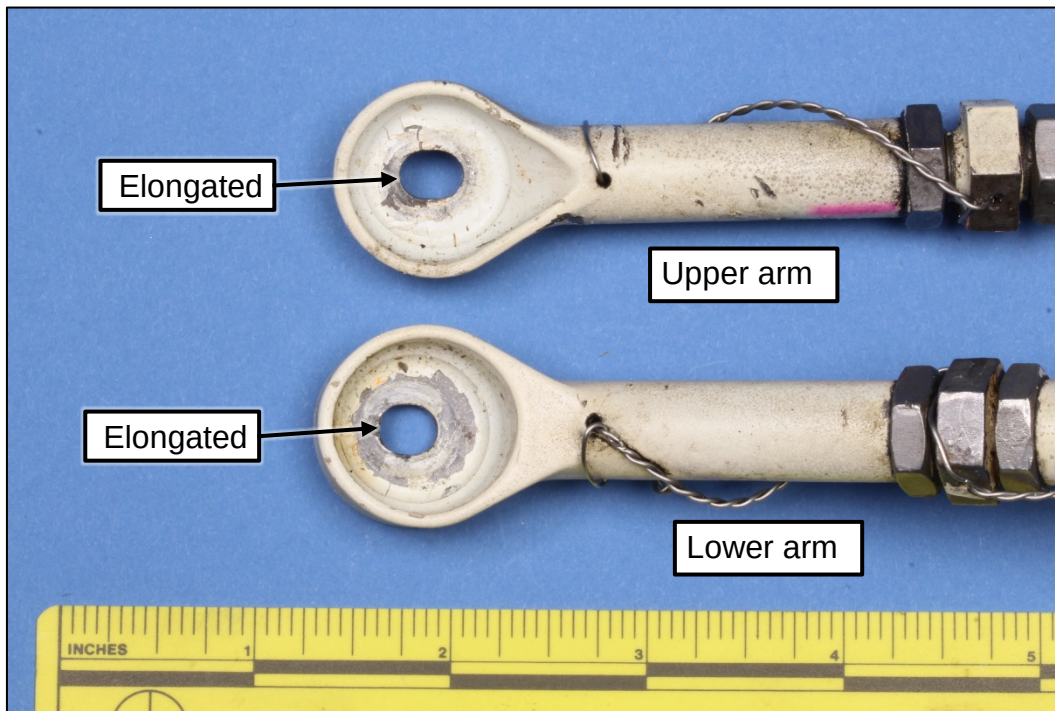
The attachment bolts at the outboard attachment locations on the left upper engine mount were removed, and a view of the outboard attachment fittings after the bolts were removed is shown in figure 3. The attachment holes on both the upper and lower arms were deformed with an elongated axis parallel to the longitudinal axis of each arm as

indicated in figure 3. The hole deformation was on the outboard side of each attachment hole, consistent with a tensile overload on each arm. The faying surface on the lower arm was deformed with a convex shape, also consistent with a tensile overload on the lower arm. Corresponding shear deformation to the shanks of the attachment bolts were also observed as shown in figure 4.

Figure 3. Attachment fittings at the left end of the left upper engine mount after the attachment bolts were removed showing elongated attachment holes.

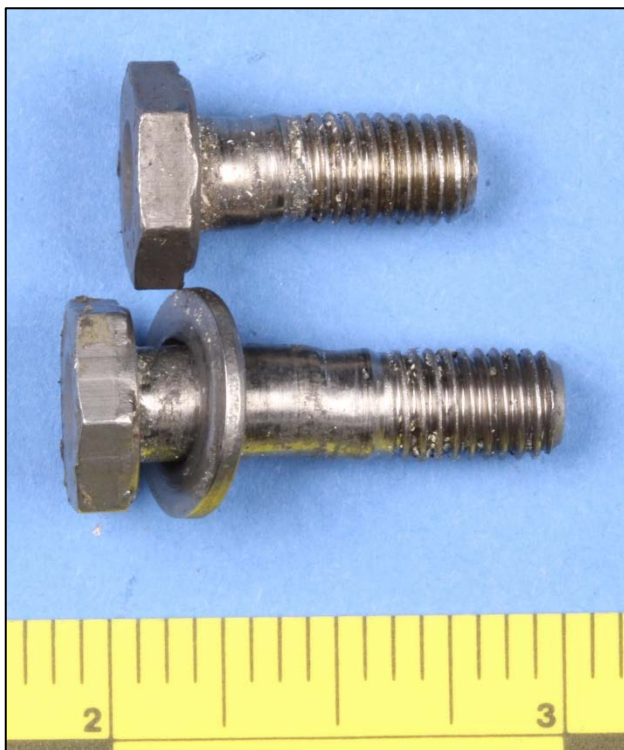
Figure 4. Attachment bolts with deformed shanks from the left end of the left upper engine mount.

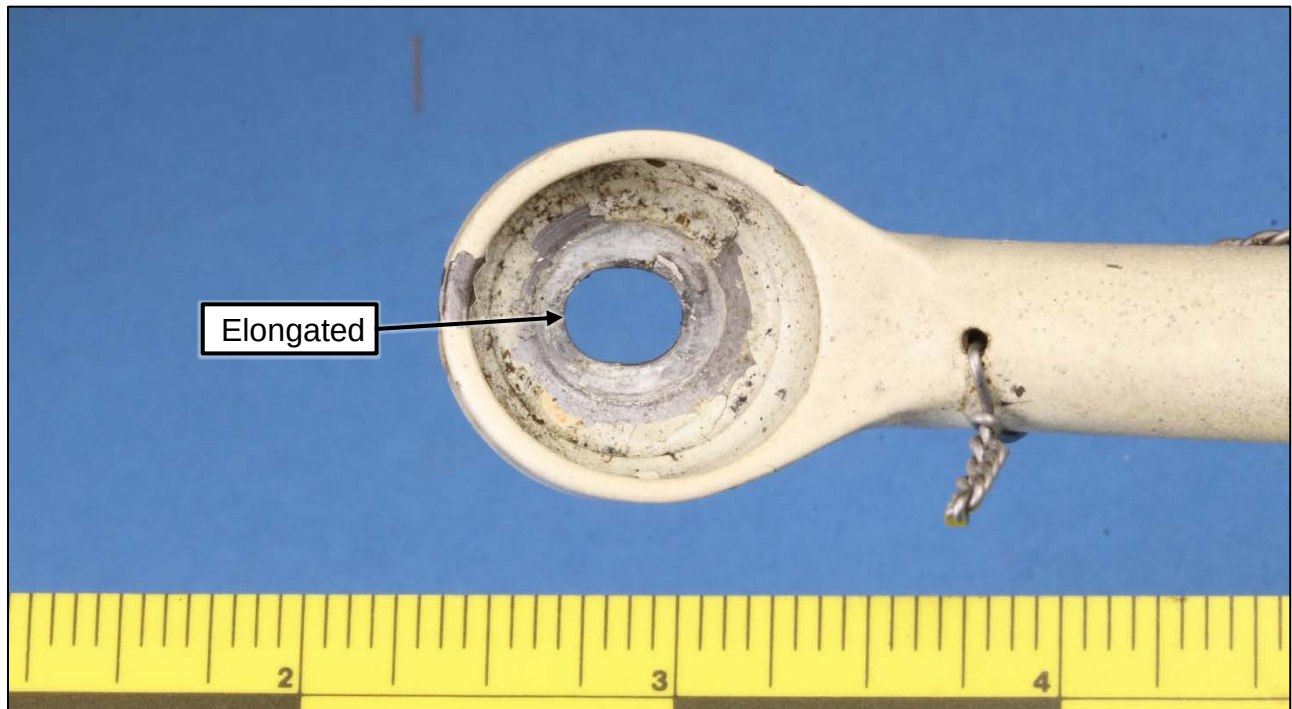
A view of the lower attach fitting at the outboard end of the right upper engine mount is shown in figure 5. The attachment hole was deformed with elongation toward the outboard edge of the fitting, consistent with tension overload. The faying face of the fitting was deformed to a convex shape, also consistent with tension overload along the arm axis.

Figure 5. Attachment fitting at the right end of the lower arm from the right upper engine mount after the attachment bolts were removed showing an elongated attachment hole.

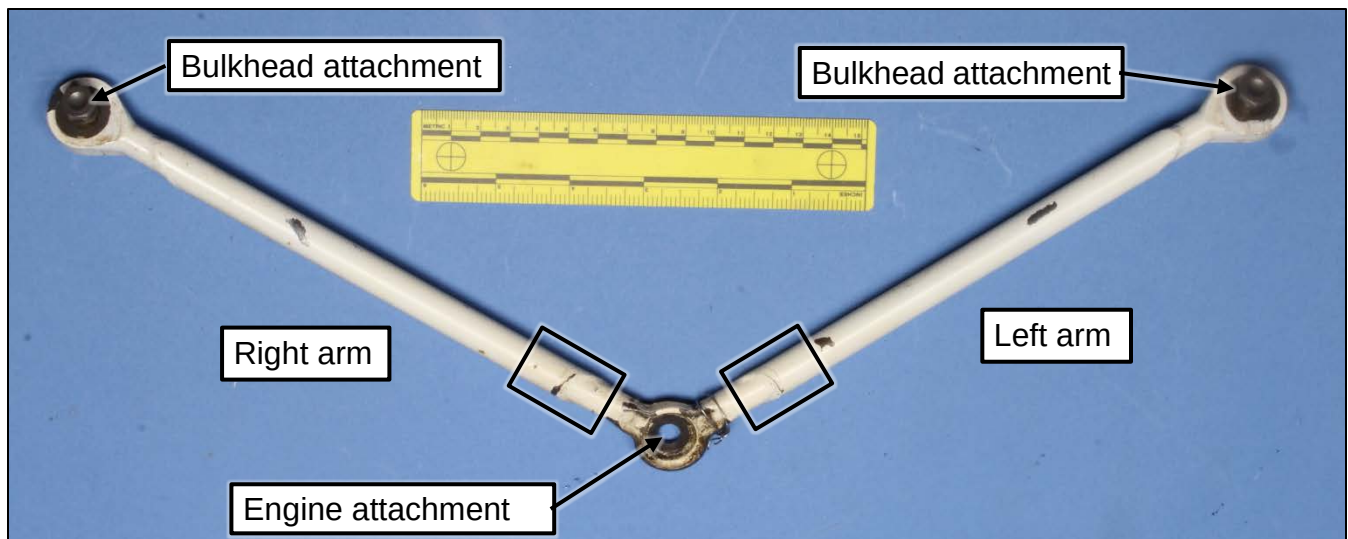
An overall view of the lower engine mount photographed looking upward and aft is shown in figure 6. Bulkhead attachment locations at the upper forward ends of the mount are indicated. The engine attachment location is located at the intersection of the left and right arms at the lower aft end of the mount. Bolts were removed from the bulkhead attachment fittings, and no evidence of hole elongation was noted in either bulkhead attachment hole or the engine attachment hole.

Cracks were observed on the lower forward side of the left and right arms of the lower engine mount near the engine attachment location in areas outlined with rectangles in figure 6. Closer views of the cracks are shown in figure 7. Inward deformation was observed on the upper aft sides of the attachment arms approximately opposite from the crack surface. The inward deformation on the right arm is shown in figure 8. The inward deformation on the left arm was similar but less pronounced.

Figure 6. Photograph of the lower engine mount looking up and aft. Cracks in the lower surface of the arms near the lower engine attachment fitting are highlighted with rectangles and are shown at higher magnification in the next figure.

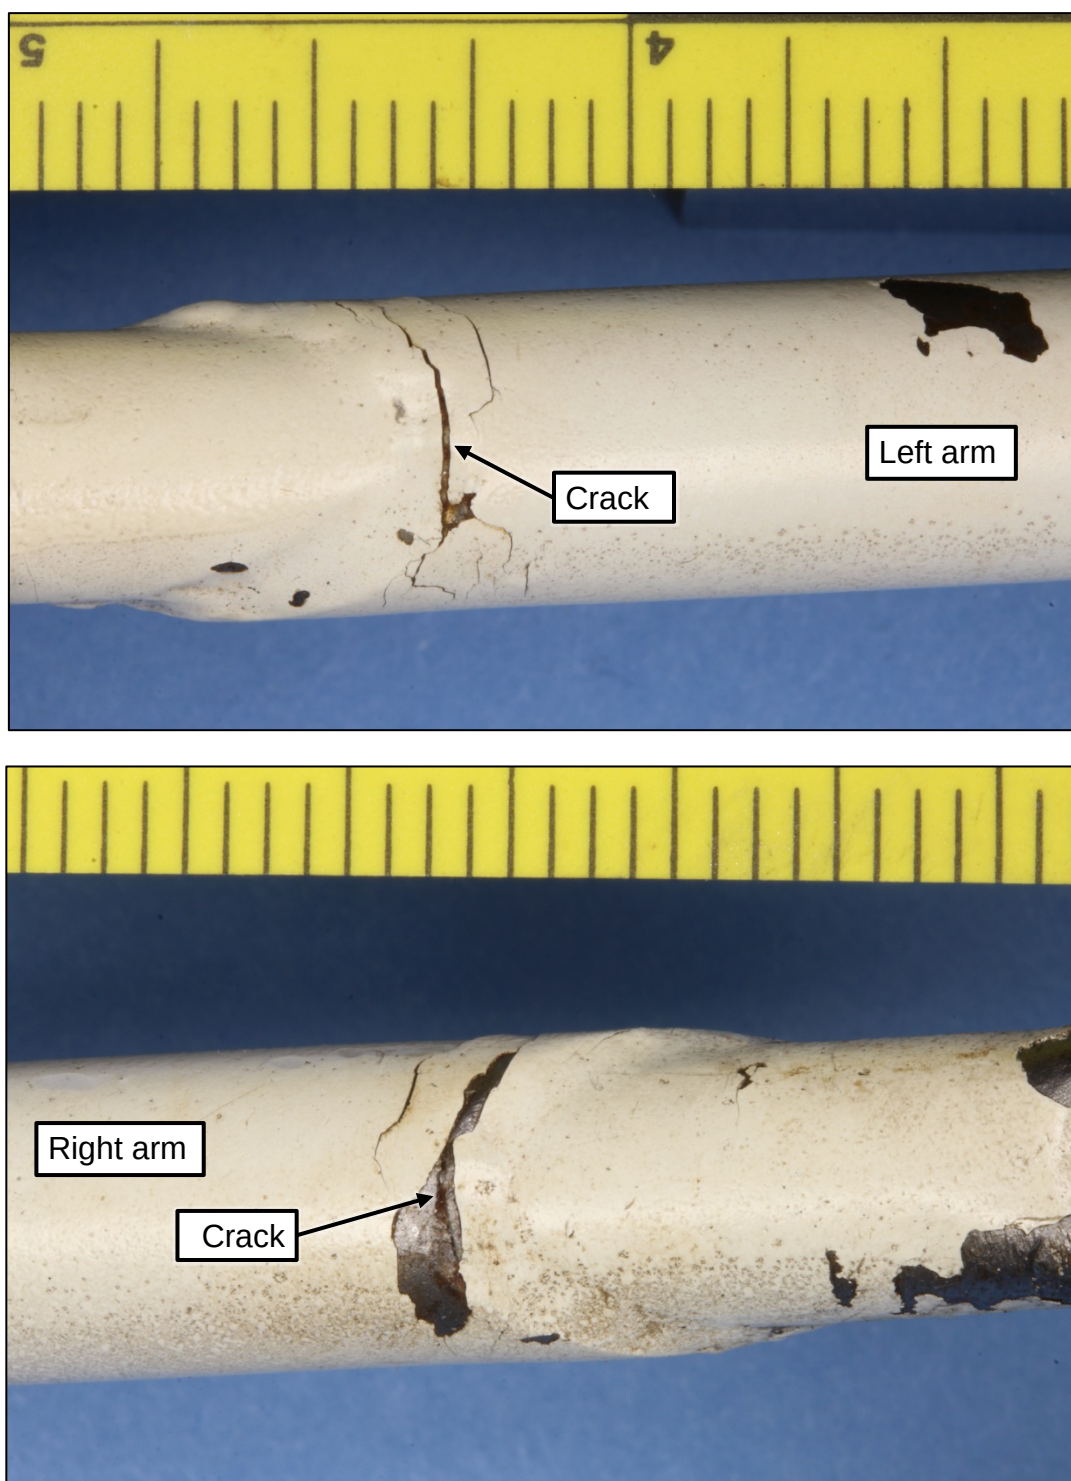
Cracks on the lower forward surface of the lower engine mount (see figure 7) were partially obscured by paint. To expose the metal surface, the center portion of the lower engine mount was covered with Cee Bee paint remover for about 30 minutes to remove paint around the cracks. The cracked areas were then examined using an optical stereomicroscope, and the extent of cracking in each arm was approximately 25 percent of the circumference. Using a handheld hacksaw, the arms were cut on the side opposite from the crack, and the cut surfaces were squeezed together to open the crack. The resulting lab fractures are shown in figures 13 and 14. Views of the inboard sides of the

Figure 7. Closer views of cracks on the lower surface of the lower engine mount near the engine attachment fitting in areas indicated with rectangles in the previous figure.

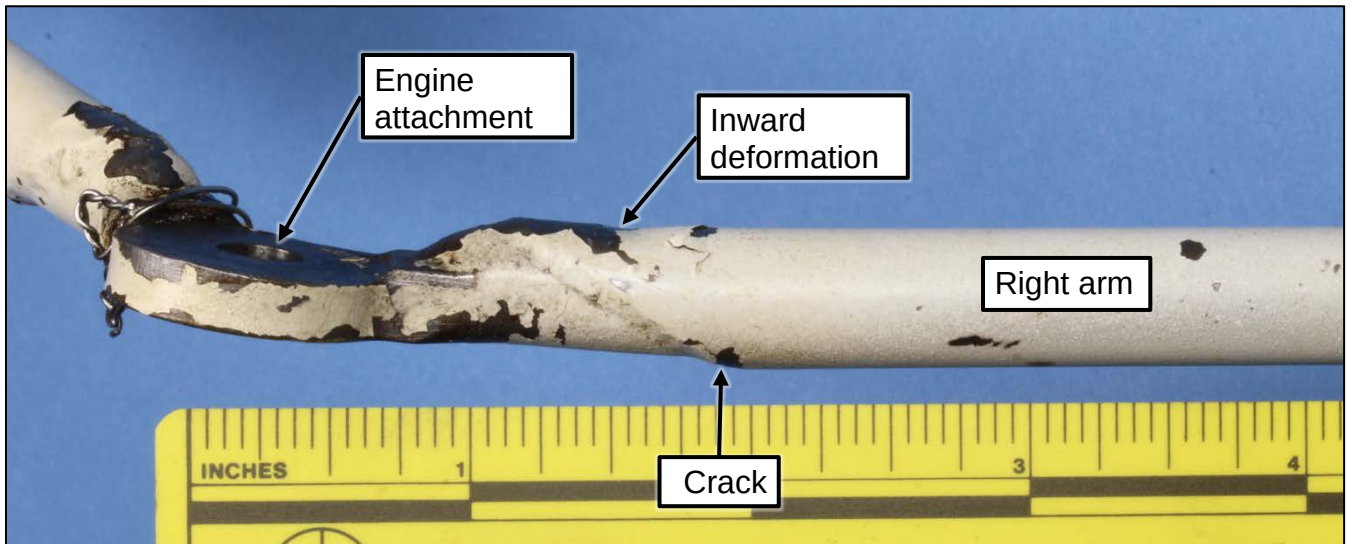
Figure 8. Side view of the lower engine mount showing inward deformation on the upper aft side of the right arm near the engine attachment fitting.

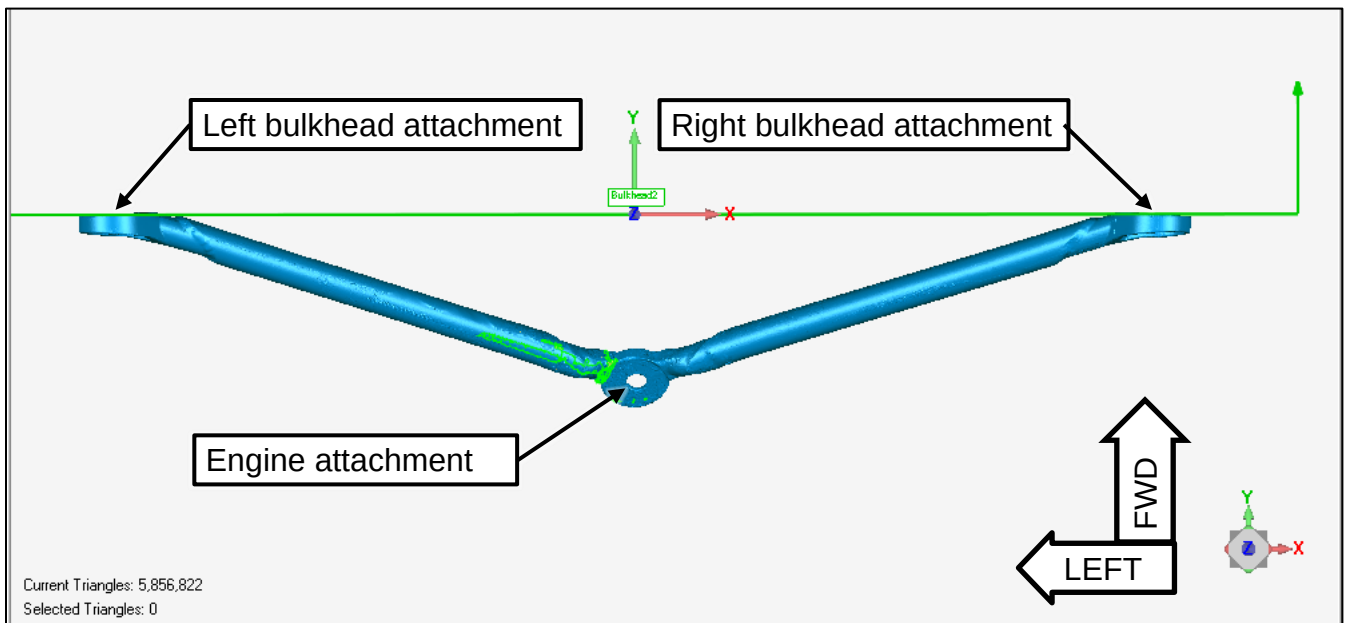
Before additional work examining the cracks in the lower engine mount was completed, a three-dimensional (3D) representation of the part was obtained using a Faro EDGE FaroArm coordinate measurement device fitted with a Faro Laser Line Probe HD.<sup>2</sup> An overhead image of the 3D scan is shown in figure 9. For reference, the transverse plane representing the bulkhead attachments was defined by collecting points associated with the bulkhead faying surfaces on the right and left bulkhead attachment fittings and creating a plane with a best fit to the faying surfaces. The X axis was set aligned parallel to the transverse line defined by endpoints at the bulkhead attachment hole centers, and the Y axis was set perpendicular to the transverse plane representing the bulkhead (the

Figure 9. Image of 3D scan data of the lower engine mount as viewed from above. Closer views of the bulkhead attachments are shown in the next figure.

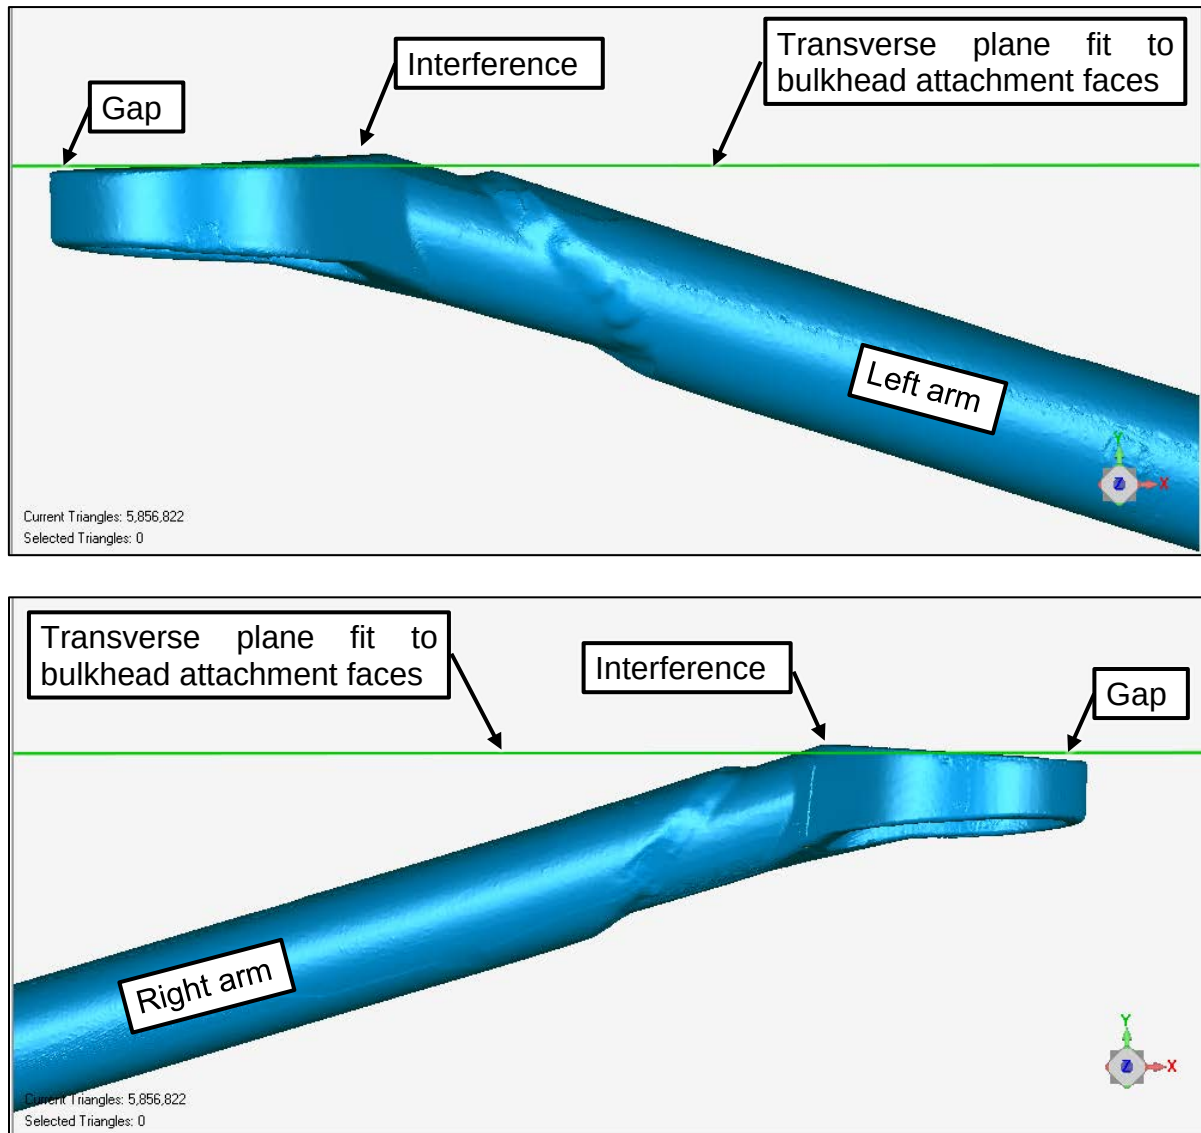
A closer view of the bulkhead attachment locations as viewed from above is shown in figure 10. The transverse plane representing a best fit to the faying surfaces for the left and right bulkhead attachments is indicated by a green line in each image in figure 10. As indicated in figure 10, a gap was present between the transverse plane and the faying surface on the outboard portion of each attachment. At the inboard portion of the faying surfaces, interference contact was apparent. The transition between interference contact and a gap occurred near the middle of the attachment hole on each side as shown in an aft-facing view of the scan presented in figure 11.

Figure 10. 3D scan images of the left (upper image) and right (lower image) bulkhead attachment locations on the lower engine mount. A green line represents the transverse plane fit to the contact faces on the left and right bulkhead attachment fittings. Interference contact areas were noted on the inboard sides of the bulkhead attachment faces, and gaps were noted at the outboard sides of the bulkhead attachment faces.

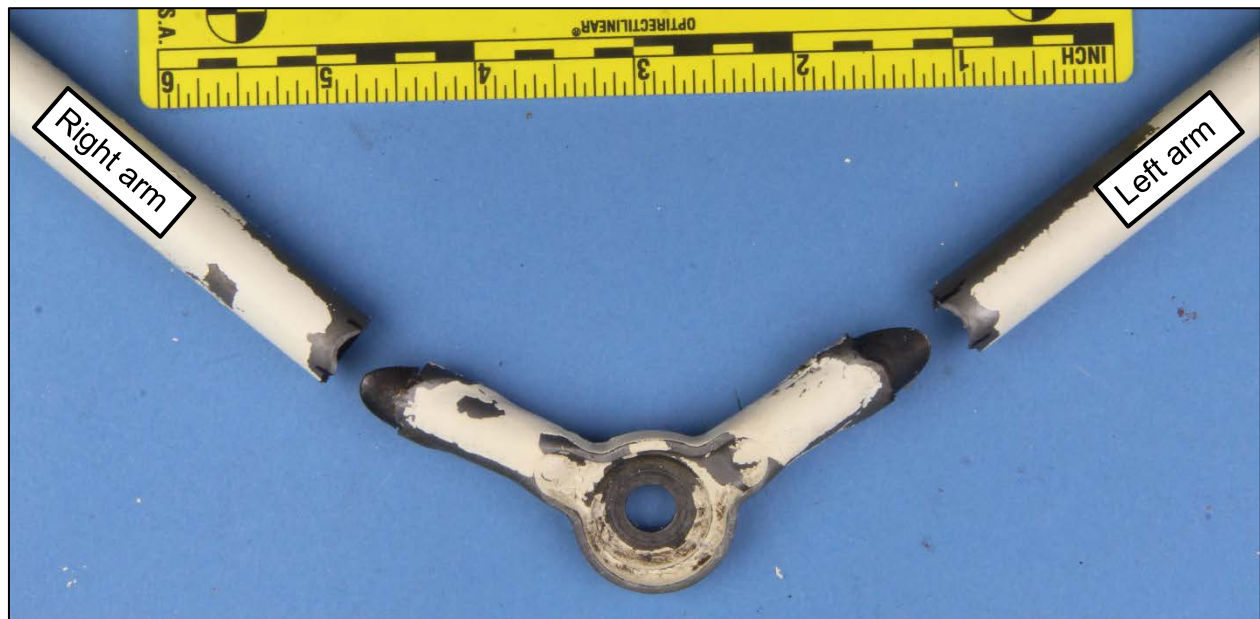
Figure 13. Lower side of the lower mount as viewed looking upward and aft photographed after cracks had been opened by lab fracture.

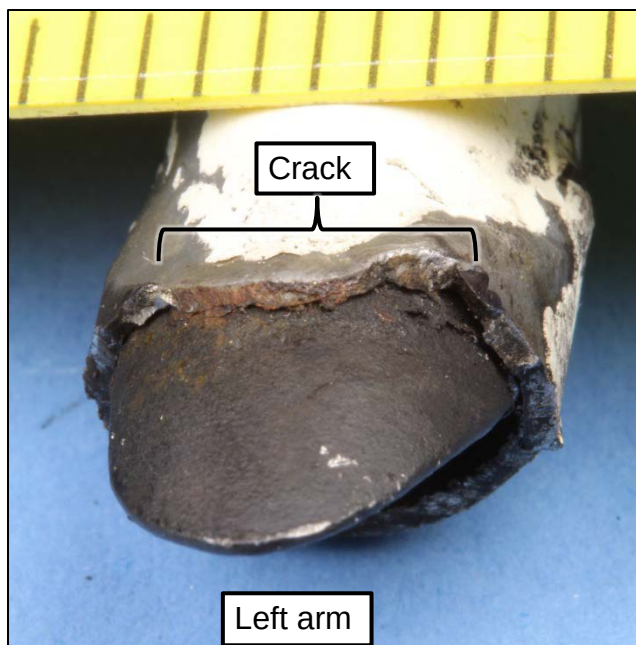
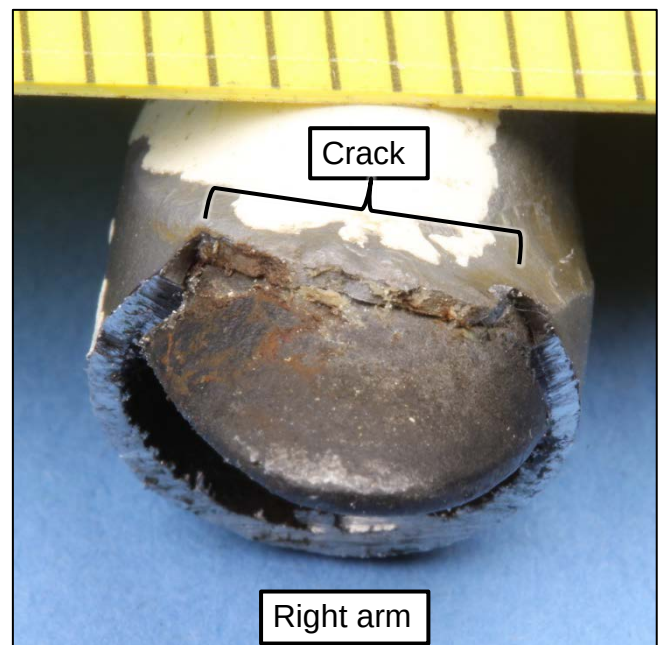
fracture surfaces for each arm are shown in figure 14 where the cracked portion is indicated. Orange oxidation covered much of the crack surfaces. Oxides on the outboard sides of the fracture surface were removed using acetate replica tape, and the surfaces were then further cleaned in a bath of acetone using an ultrasonic cleaner. The cleaned fracture surfaces were then examined using a scanning electron microscope. The crack surfaces showed ductile dimple features across most of the fracture surfaces with isolated areas of cleavage, features consistent with overstress fracture in steel including areas of weld heat affected zones. No evidence of progressive crack growth was observed.

Figure 14. Fracture features of cracks in the lower engine mount photographed after the cracks were opened in the lab.

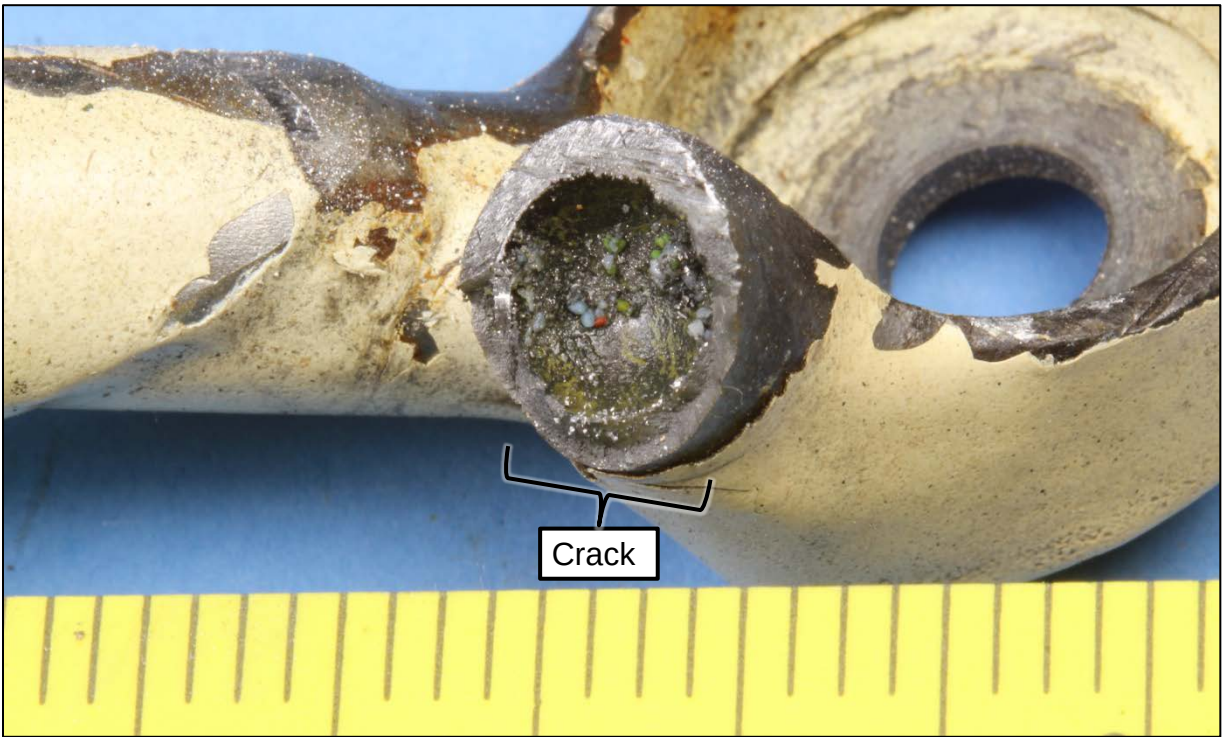
Figure 15. Fracture features of the crack in the upper arm of the right upper engine mount photographed after the crack was opened in the lab.
