**NATIONAL TRANSPORTATION SAFETY BOARD**  
**Office of Aviation Safety**  
**Washington, D.C. 20594**

**HELICOPTER SPECIALIST'S FACTUAL REPORT**

**NTSB No: ERA19FA118**

Operator: Rotor Blade LLC  
Aircraft: MD Helicopters 369D, Registration N89ZC  
Location: Talking Rock, Georgia  
Date: March 5, 2019  
Time: 1110 eastern standard time

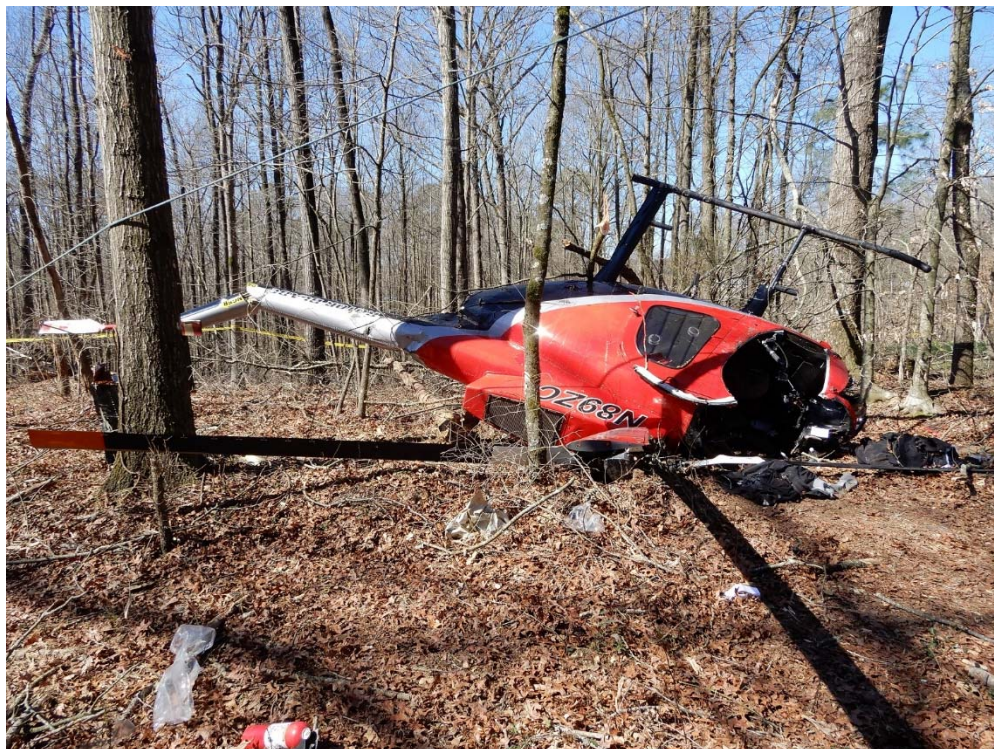
The helicopter impacted terrain at an elevation of 1250 feet mean sea level and came to rest on a heading of 037° magnetic and was laying on its right side (**Figure 1**). The right side of the main fuselage was crushed inward. The rear fairing on the right skid was damaged and separated due to impact, but the remaining landing gear components remained attached to the fuselage and exhibited minimal damage. The skid step was not installed on the helicopter at the time of the accident.

**Figure 1. The helicopter at the accident site.**

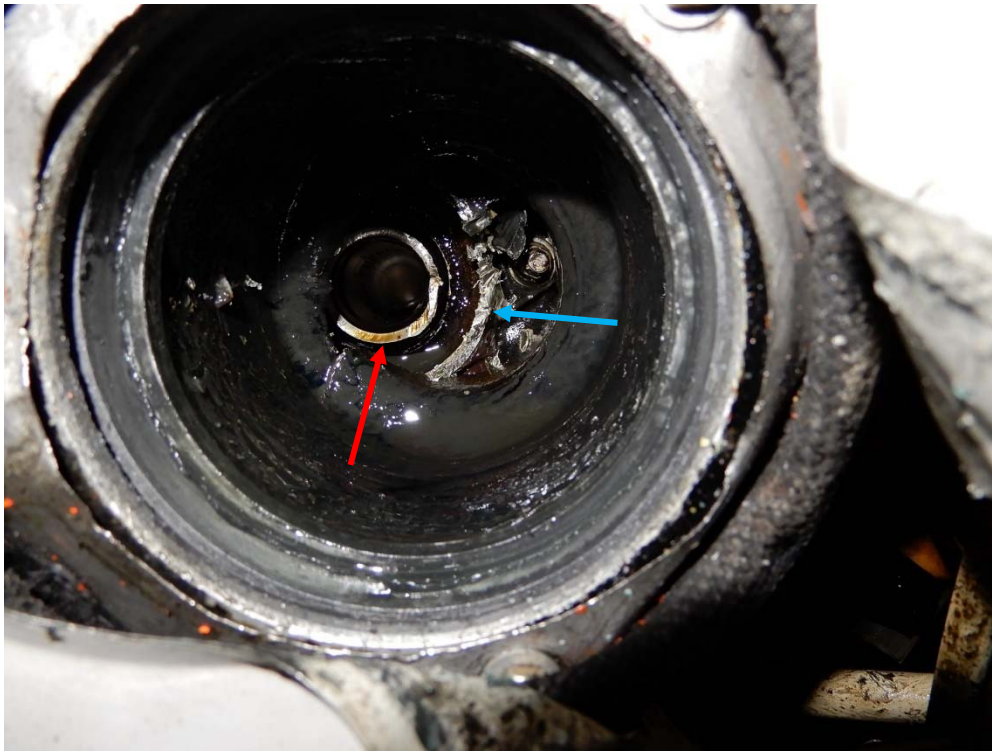
The overrunning clutch outer housing’s attachment flange to the engine gearbox was fractured at the flange (**Figure 2**). The shaft and spline end of the clutch outer race (on the engine side of the clutch) exhibited a circumferential fracture (**Figure 3**). Residual oil was found within the outer housing. Rotational scoring was observed on the interior of the outer housing near the upper bearing. Grease was observed within the upper bearing. The sprag clutch functioned normally when rotated. The snap ring was removed and exhibited tension. The overrunning clutch assembly was sent to the NTSB Materials Laboratory in Washington, DC for further examination. (See section 3.0 of this report for additional details on the overrunning clutch assembly.)

**Figure 2. A view of the fractured outer race splines (red arrow) and the aft flange of the overrunning clutch outer housing (blue arrow), both still installed on the engine gearbox. This view is looking down the inner diameter of the remainder of the clutch outer housing.**

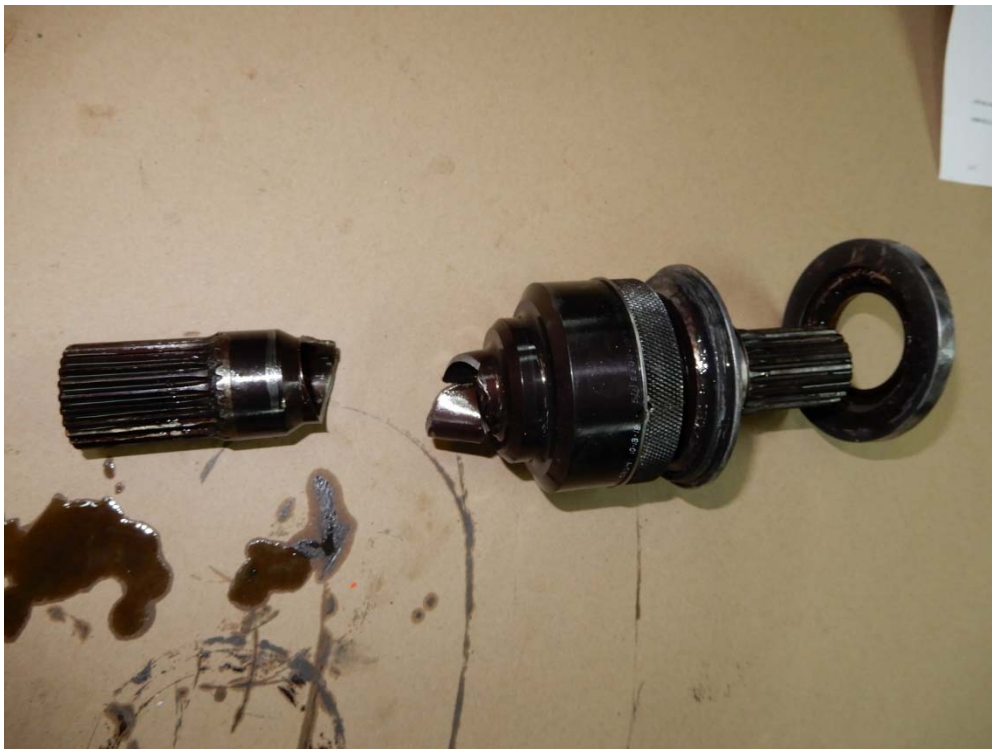
**Figure 3. The overrunning clutch subassembly after removal from the accident helicopter.**

The overrunning clutch assembly was examined by the NTSB Materials Laboratory in Washington, DC. Metallurgical examination of the clutch subassembly fracture surfaces revealed evidence of fatigue and torsional overload. Additional information on the lab examination findings for the overrunning clutch assembly can be found in Materials Laboratory Factual Report No. 19-058 in the docket for this investigation.

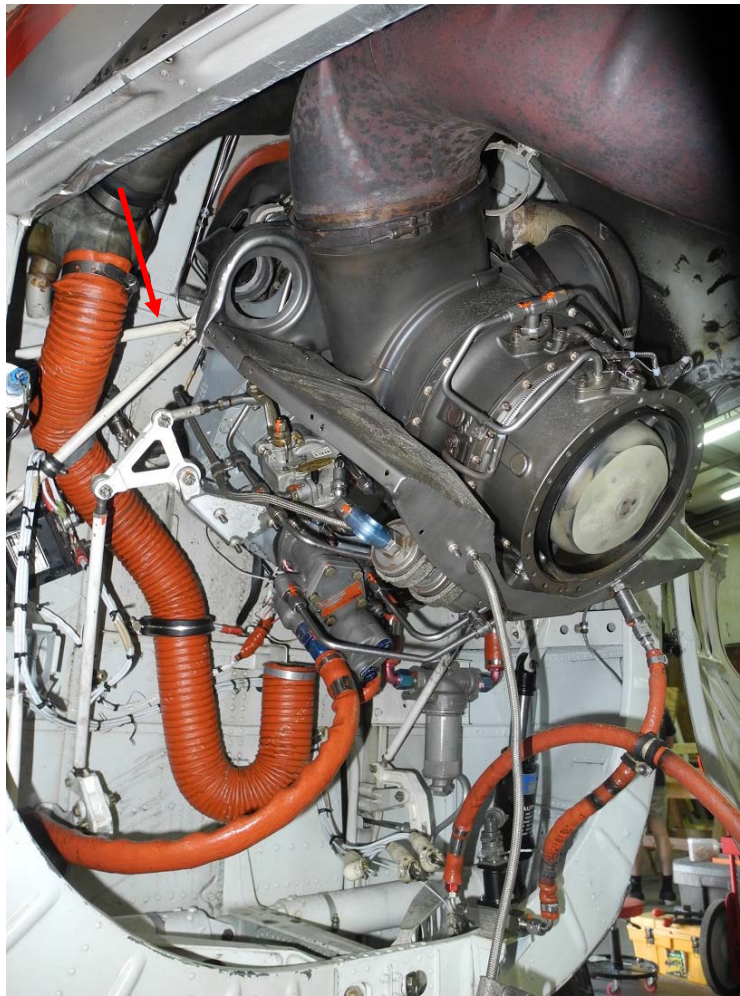
The engine was removed from the airframe to facilitate its disassembly ([Figure 4](#)). The outer combustion case and compressor discharge tubes had been previously removed from the engine. The gearbox power output splines did not exhibit anomalous wear or fractures.

**Figure 4. The engine as installed on the accident helicopter. The outer combustion case and compressor discharge tubes were previously removed. The red arrow points to the left engine mount.**

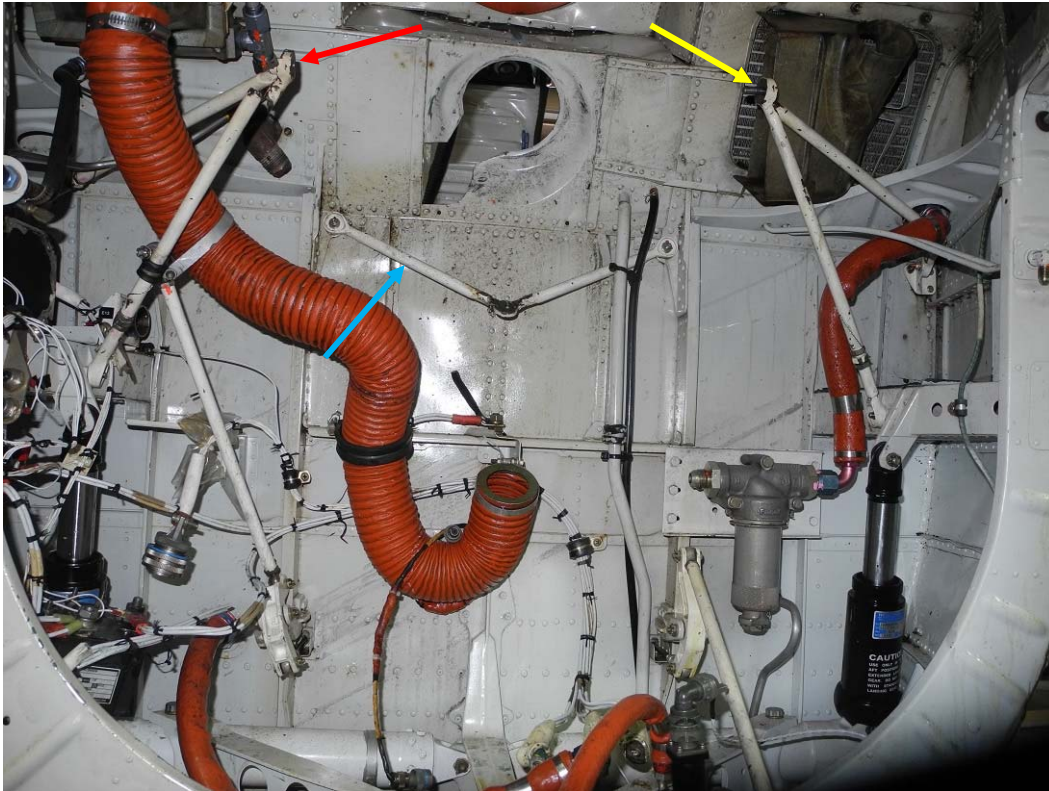
The left engine mount remained attached to the airframe and there was no evidence of looseness at its attachment points (**Figure 5**). The left engine mount's lower link was fractured on the side closest to the engine's mount pad. The airframe attaching hardware installation conformed to the MDHI 369-series aircraft maintenance manual (AMM). On the upper link's bolted connection to the airframe fitting, the bolt head was observed to be on the obtuse-angle side of the fitting while the nut was observed to be on the acute-angled side of the fitting. Additionally, the thicker washer was underneath the bolt head while the thinner washer was underneath the nut.

The right engine mount remained attached to the airframe and there was no evidence of looseness at its attachment points. The right engine mount's upper link was bent to the right at the adjustment nut connection. On the upper link's bolted connection to the airframe fitting, the bolt head was observed to be on the obtuse-angled side of the fitting and the nut was observed to be on the acute-angled side of the fitting. Additionally, the thicker washer was underneath the bolt head and the thinner washer was underneath the nut.

**Figure 5. The left (red arrow), center (blue arrow), and right (yellow arrow) engine mounts as installed on the airframe.**

The center engine mount remained attached to the airframe and there was no evidence of looseness at its attachment points. The center engine mount, while still installed on the airframe, exhibited no evidence of visible fractures. The airframe attaching hardware installation conformed to the MDHI 369-series AMM. The thicker washers were underneath the nuts and the thinner washers were underneath the bolt heads.

The engine mounts were examined by the NTSB Materials Laboratory in Washington, DC. Metallurgical examination of the engine mounts found fractures on all three mounts. The left engine mount had a fracture and deformation consistent with tension overload on both arms of the engine mount, while the right engine mount had a fracture and deformation consistent with compression overload on its upper arm and tension overload on its lower arm. The center engine mount had deformation and fractures on both arms. Additional information on the lab examination findings for the engine mounts can be found in Materials Laboratory Factual Report No. 19-057 in the docket for this investigation.

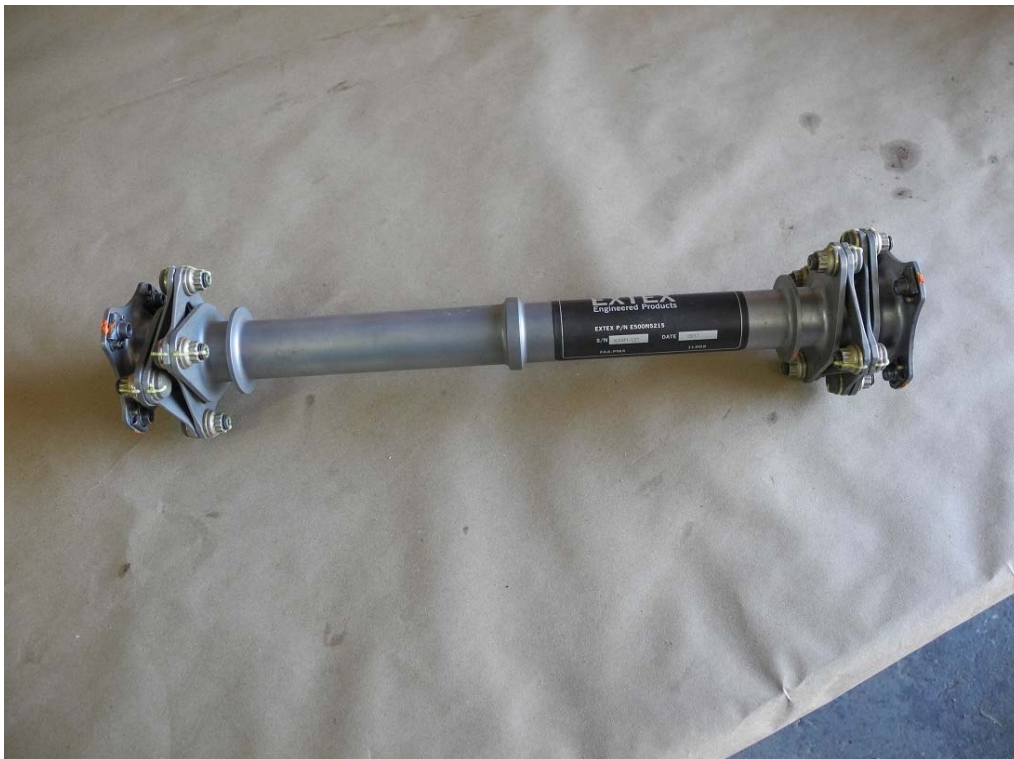
Visual examination of the driveshaft showed no evidence of fractures (**Figure 6**). The engine-to-transmission driveshaft installed on the accident helicopter was P/N E500N5215 and S/N KAM1-131. The driveshaft was installed on the accident helicopter on September 18, 2018 at an ATT of 13,342.3 hours.

**Figure 6. The engine-to-transmission driveshaft after removal from the accident helicopter.**

The engine-to-transmission driveshaft was retained by the NTSB and subsequently examined at Kaman facilities in Bloomfield, Connecticut in April 2020. Visual examination of the driveshaft showed no evidence of fractures. The driveshaft length was measured to be about 15.264 inches, which was within the allowable range of length. The driveshaft wall surrounding the anti-flail element showed evidence of contact but no evidence of transmitting torque while relying on the anti-flail element.

The perpendicularity of the driveshaft end fittings to the shaft was measured to be between 0.25-0.27 degrees. The measured perpendicularity had increased from the perpendicularity at the time of the driveshaft assembly's manufacture, which was between 0.08-0.12 degrees. The driveshaft was placed on an axial spring rate testing setup to measure load versus axial deflection and assess the functionality of the driveshaft's flexible elements. The measured axial spring rate was within 3% of the designed axial spring rate.
