## MEMORANDUM FOR RECORD

**Accident Number:** ERA19FA124

**Subject:** Summary of email correspondences with Bill Phillips

**Subject:** Summary of email correspondences with Wayne Headlough

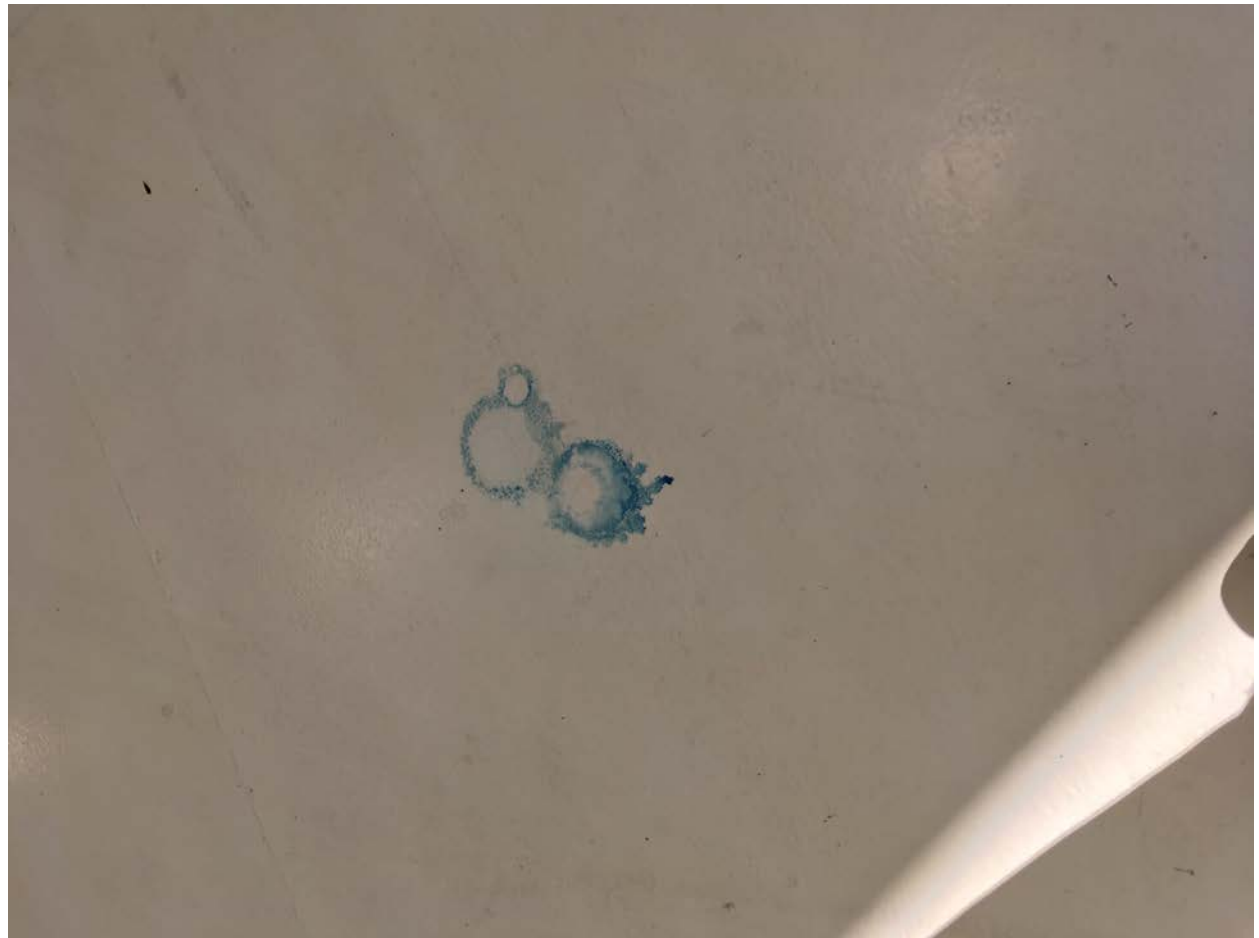
On March 30, 2019, Mr. Headlough, who had shared with me in a conversation that N400JM had a fuel leak, emailed me a photo of the fuel stains on the floor the morning after fueling N400JM (attached to this memo).
