**NATIONAL TRANSPORTATION SAFETY BOARD**

**Photo Array**

**ERA19FA124**

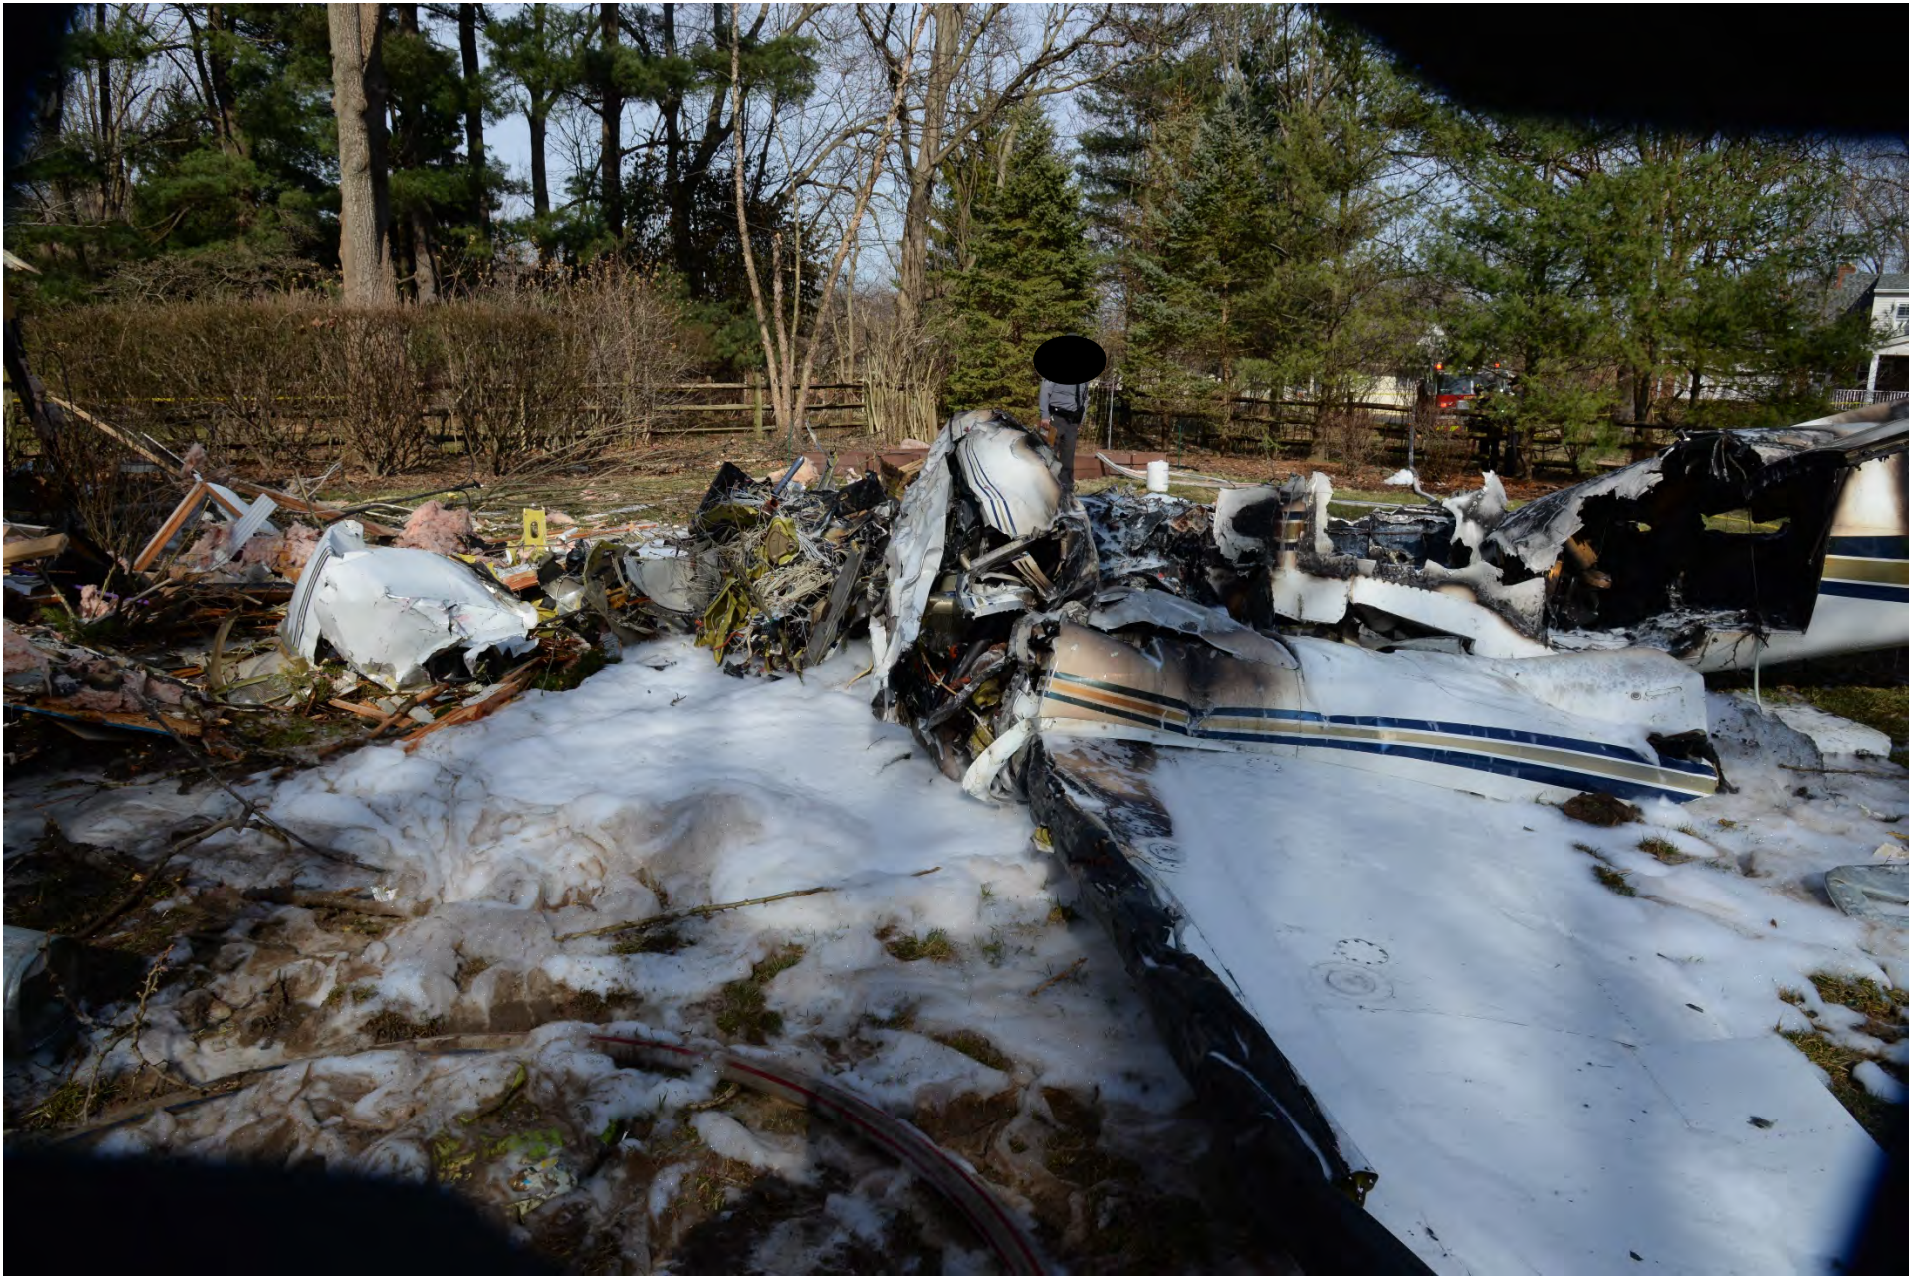
**Photo 1 – View of Airplane from Left Side (Photo Courtesy of FBI)**

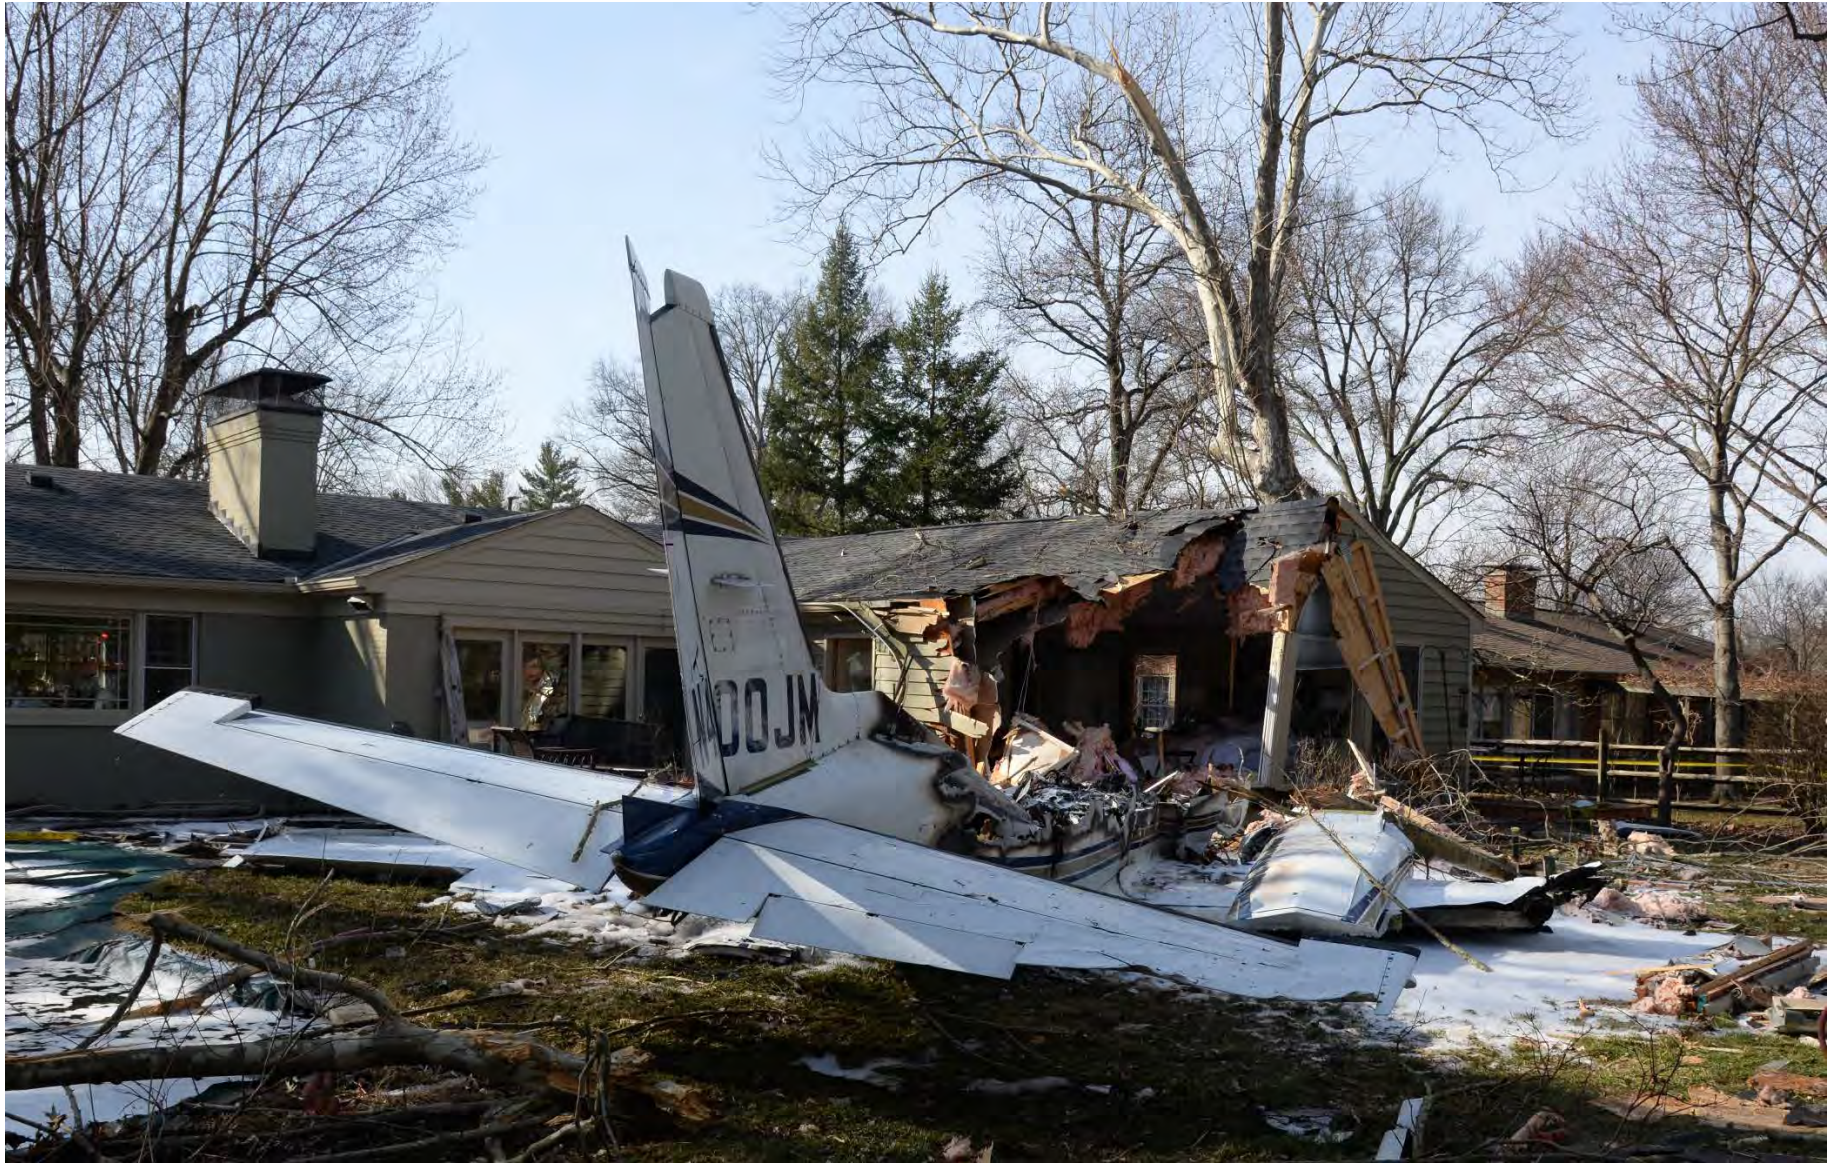
**Photo 2 – View of Airplane from Rear (Photo Courtesy of FBI)**

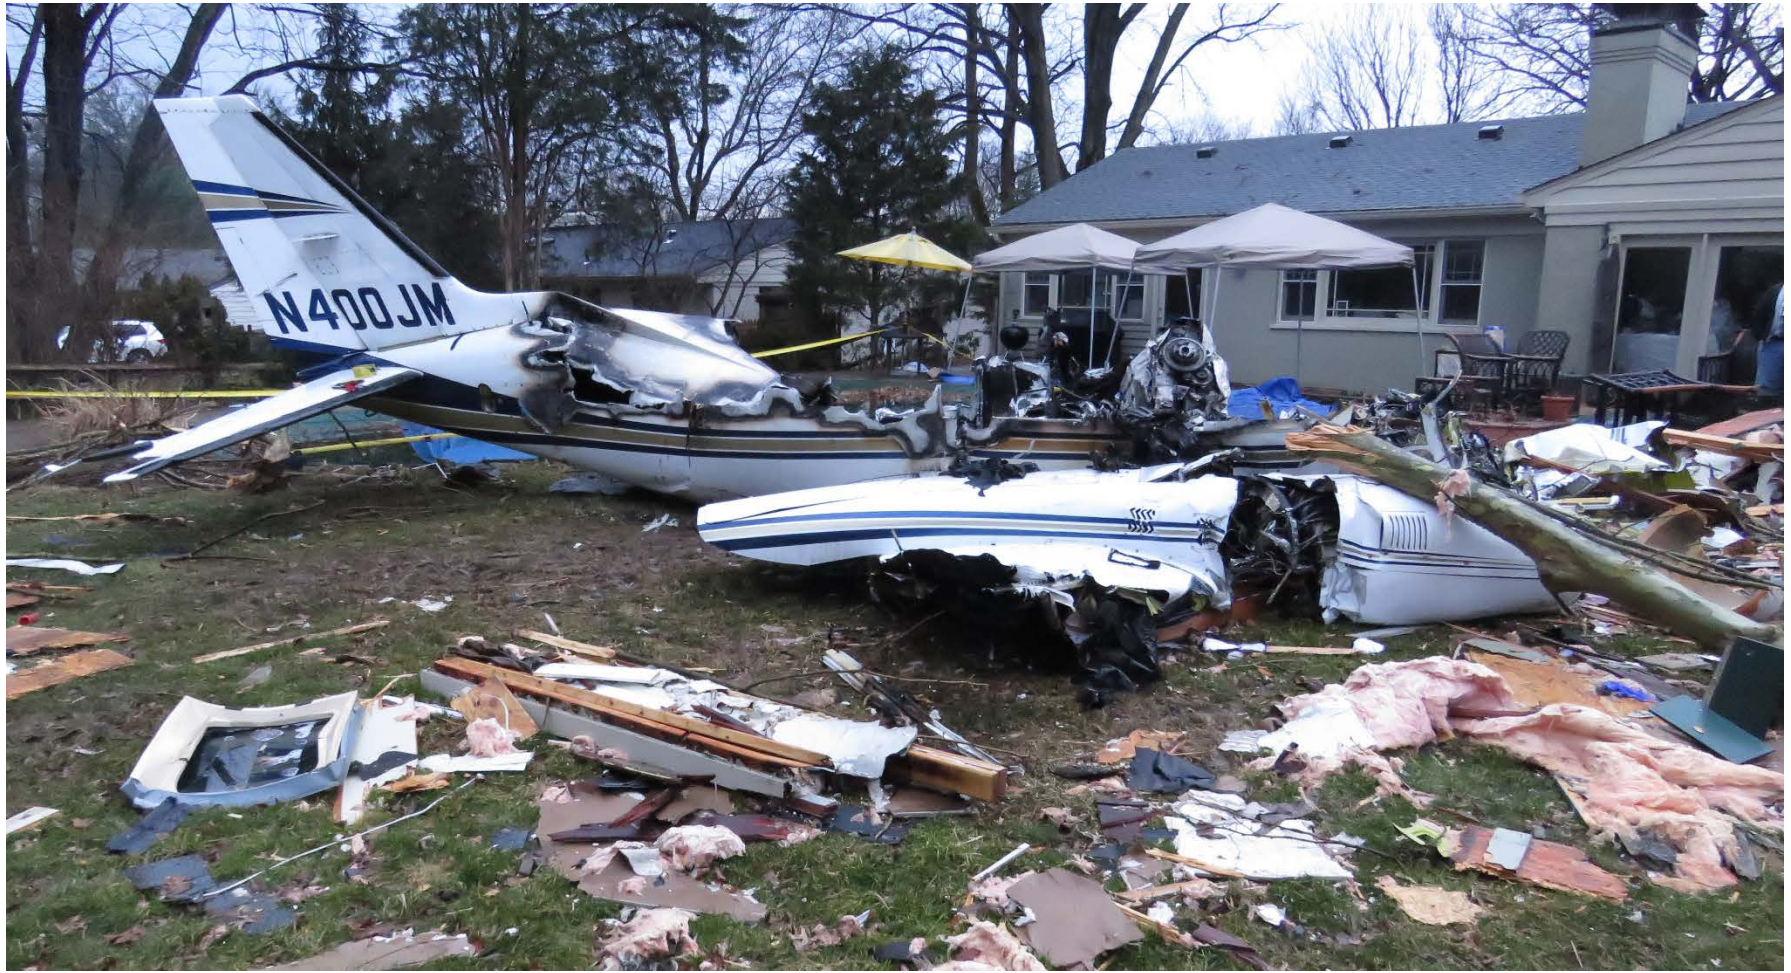
**Photo 3 – View of Airplane from Right (Photo Courtesy of Lycoming Engine)**

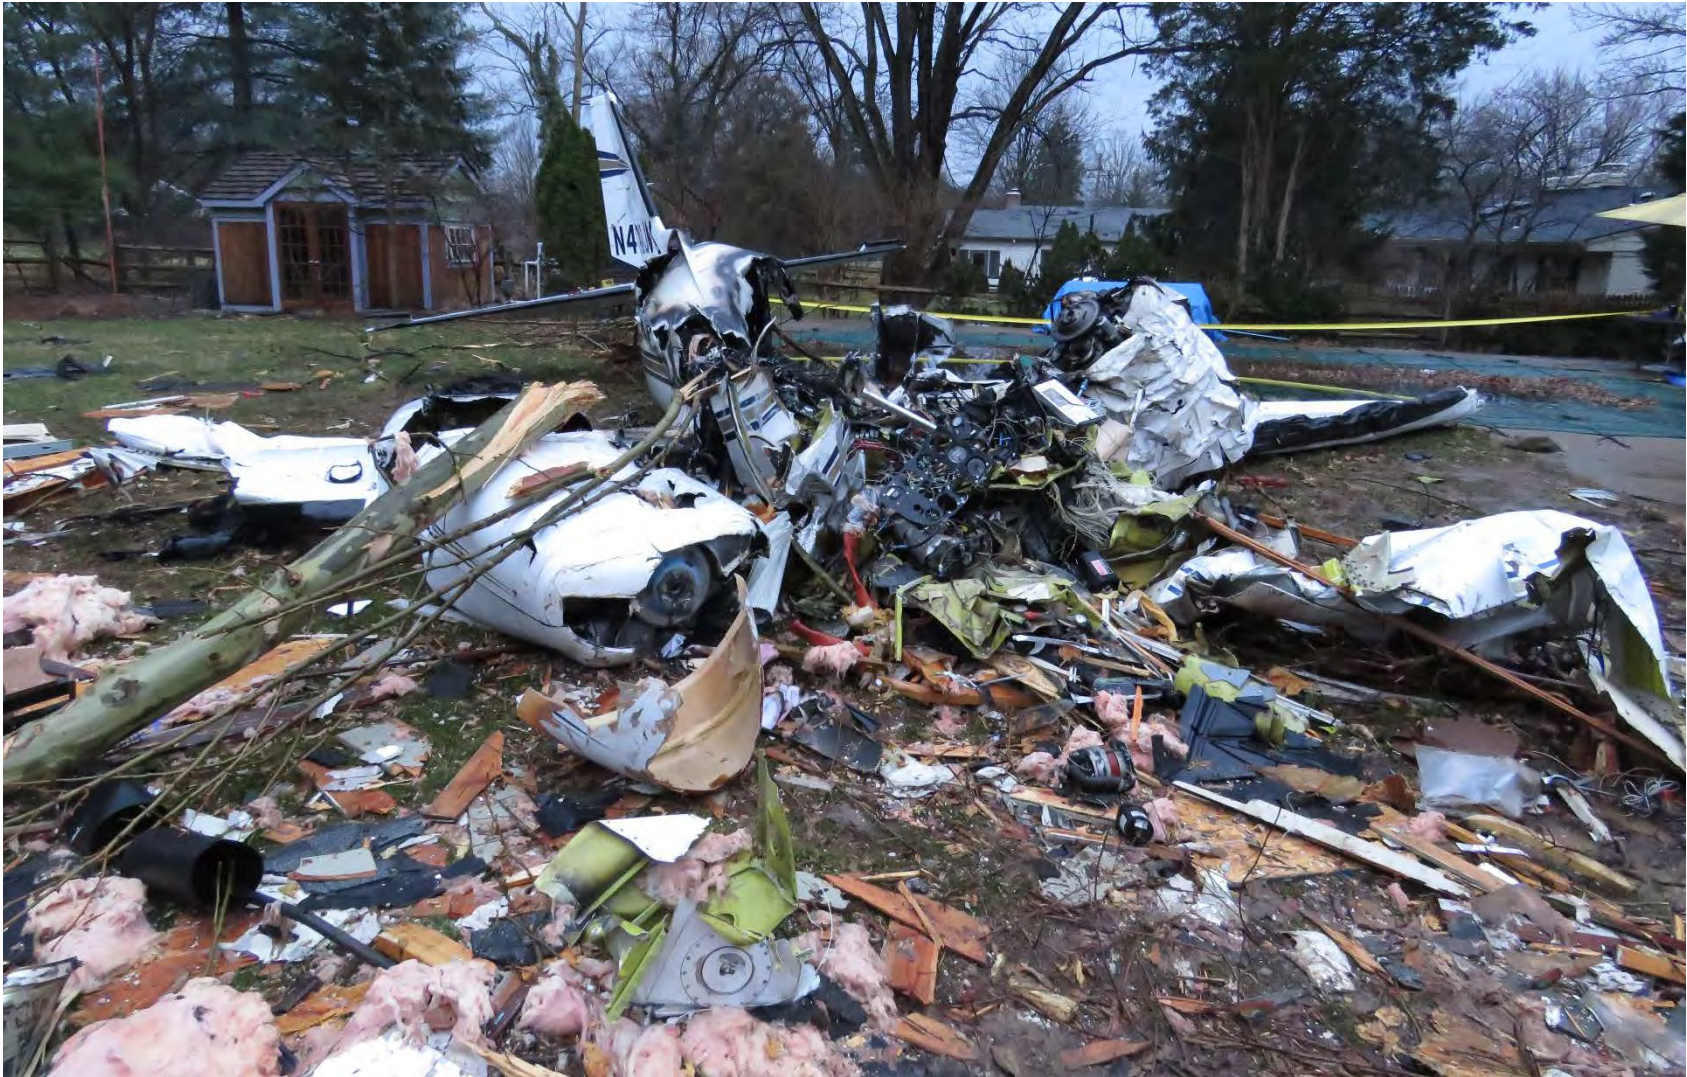
**Photo 4 – View of Airplane from Front (Photo Courtesy of Lycoming Engine)**

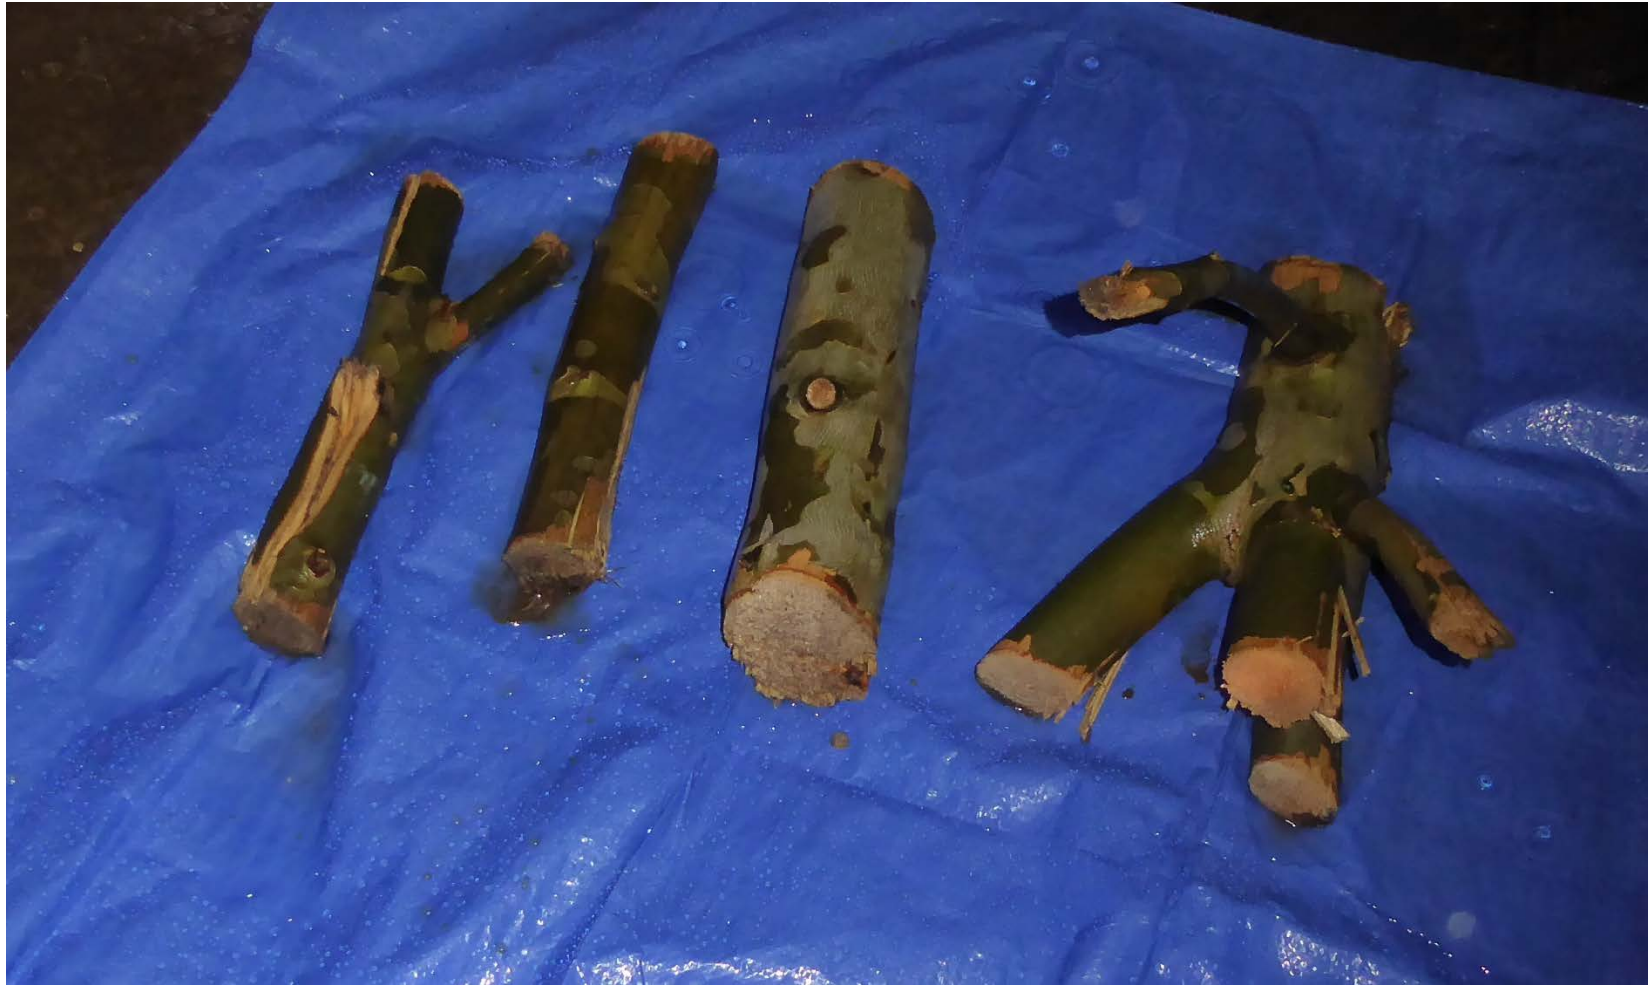
**Photo 5 – Tree Limbs Evidencing Propeller Strike Marks at Accident Site**

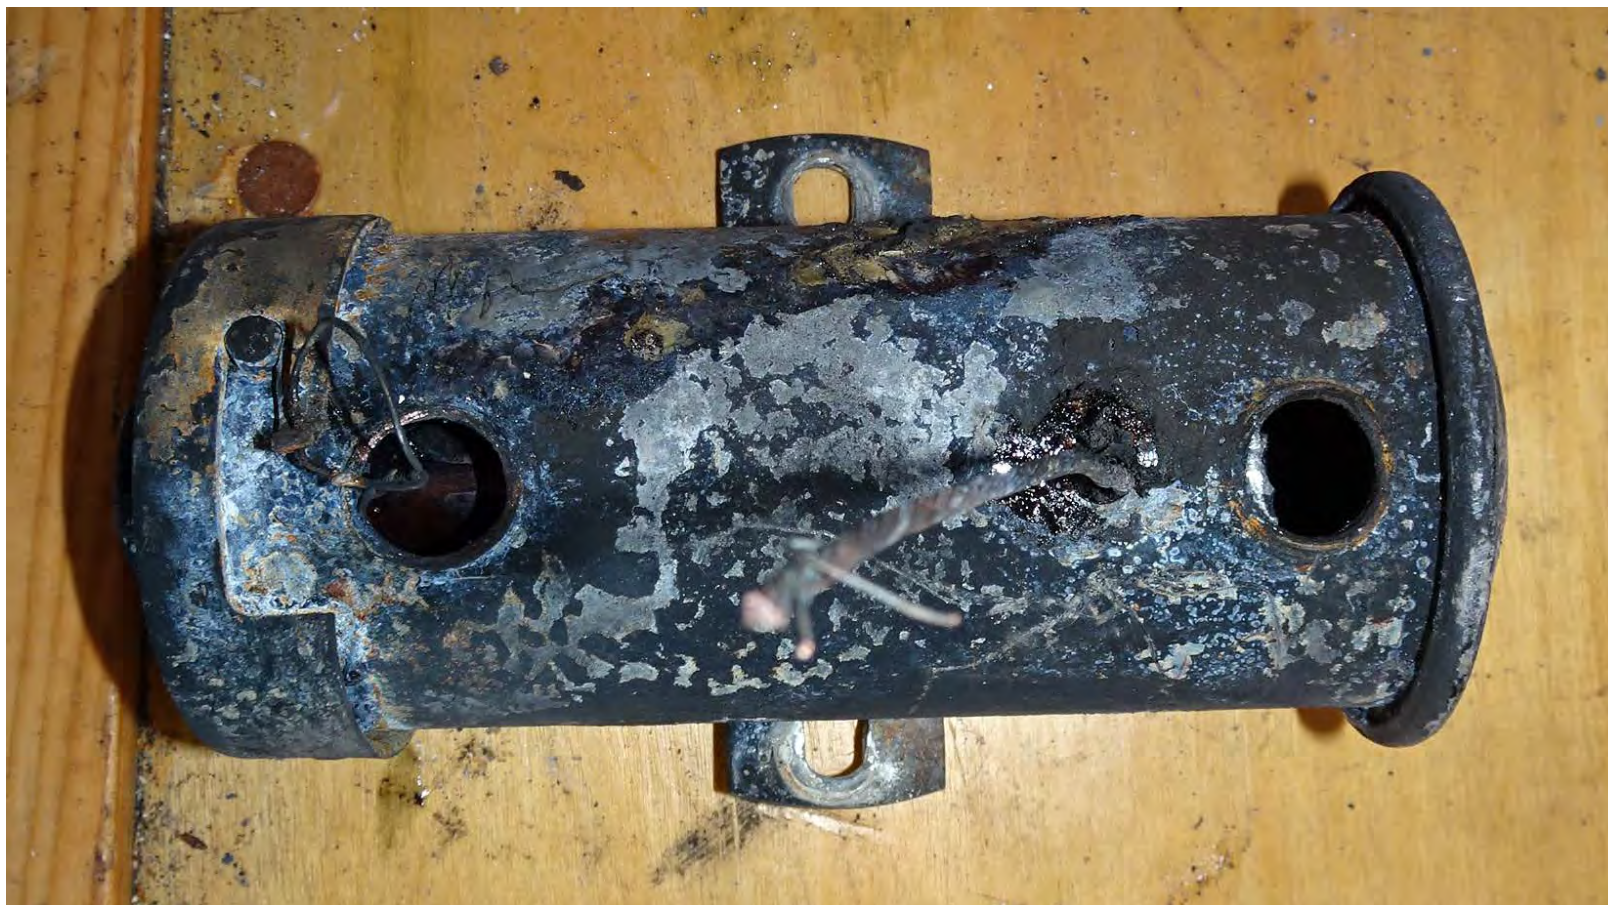
**Photo 6 – Left Engine Nacelle Fuel Transfer Pump (Photo Courtesy of Piper Aircraft)**

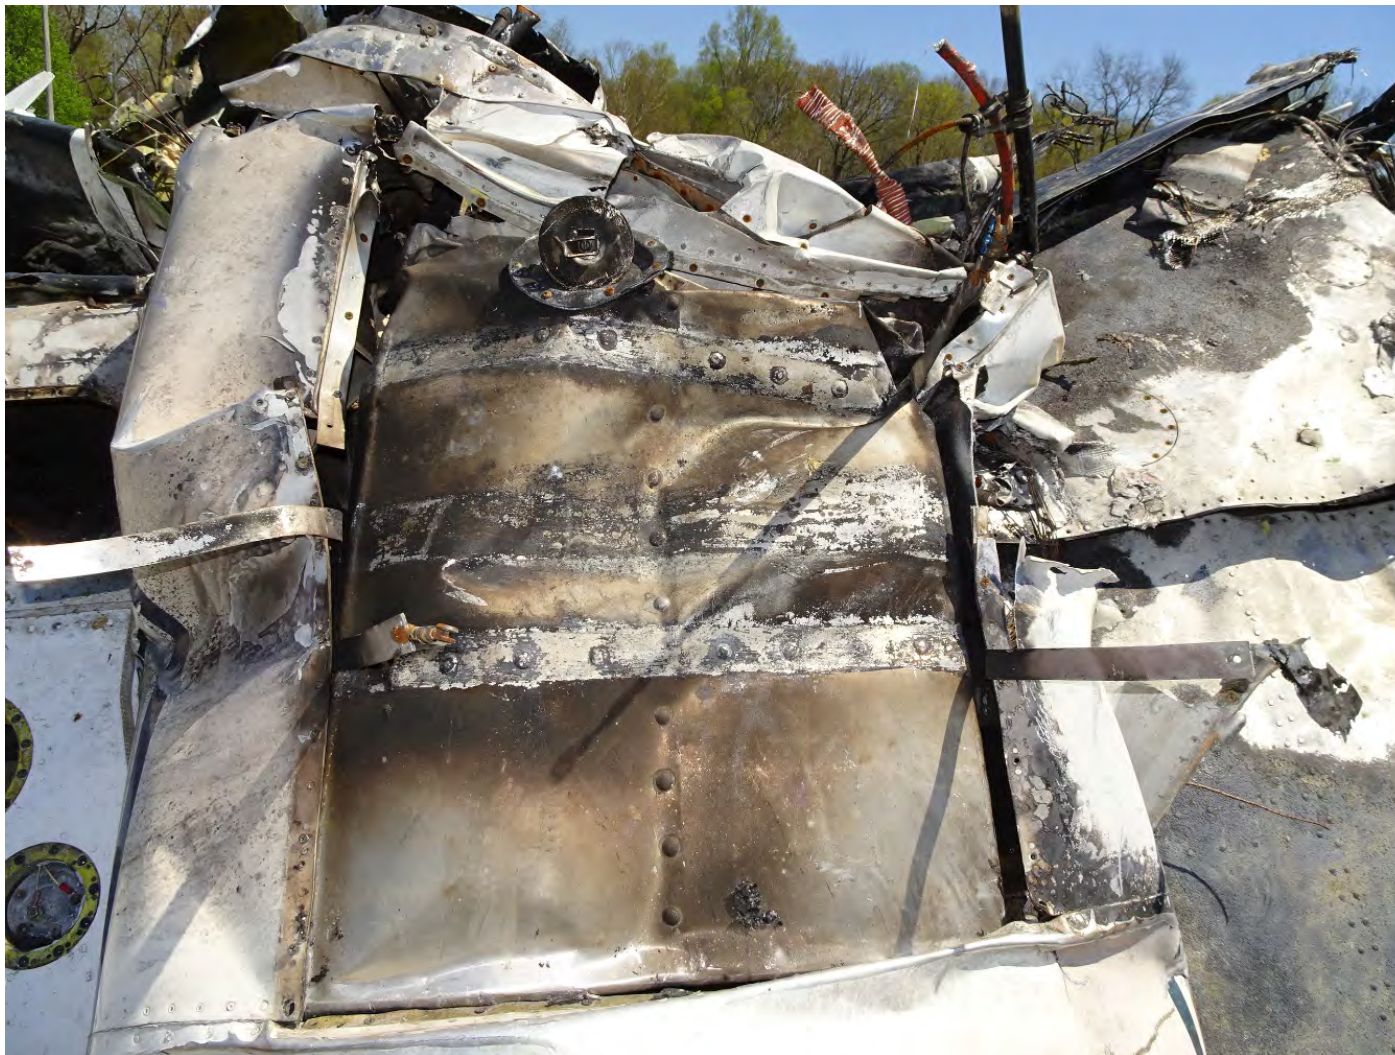
**Photo 7 – Close-up View of Left Engine Nacelle (Photo Courtesy of Piper Aircraft)**

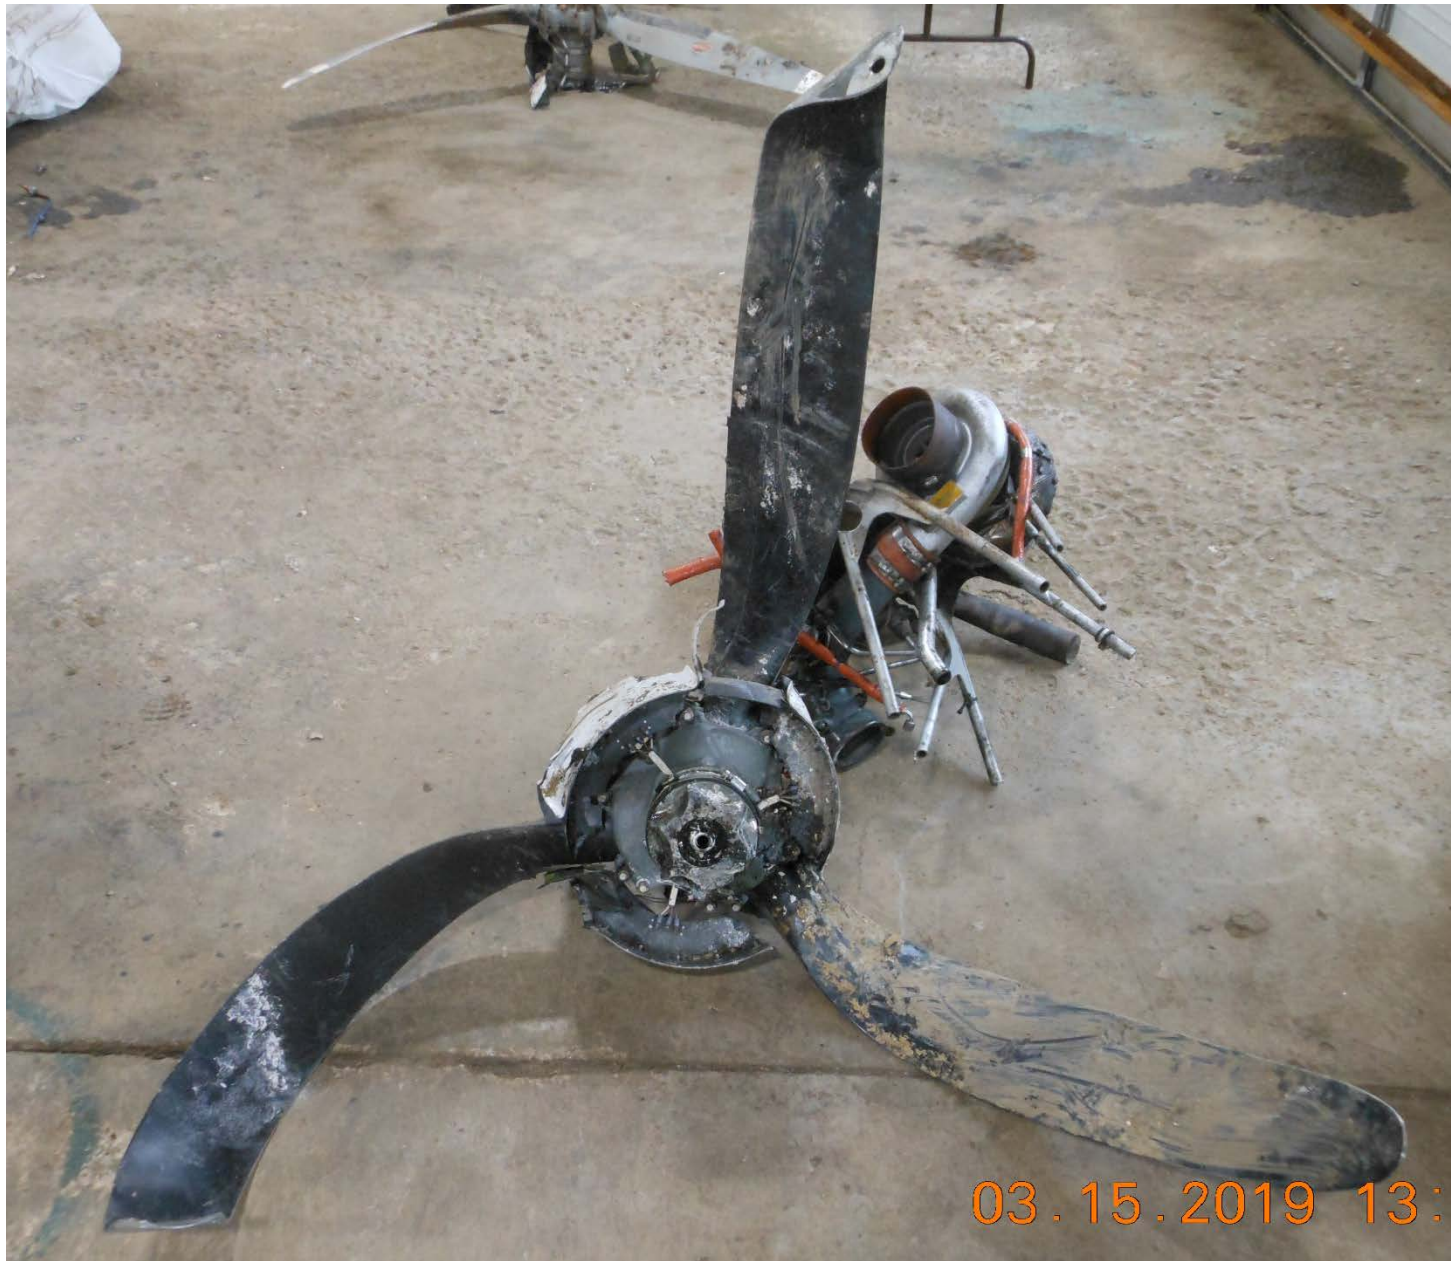
**Photo 8 – Right Propeller (Photo Courtesy of Hartzell Propeller)**

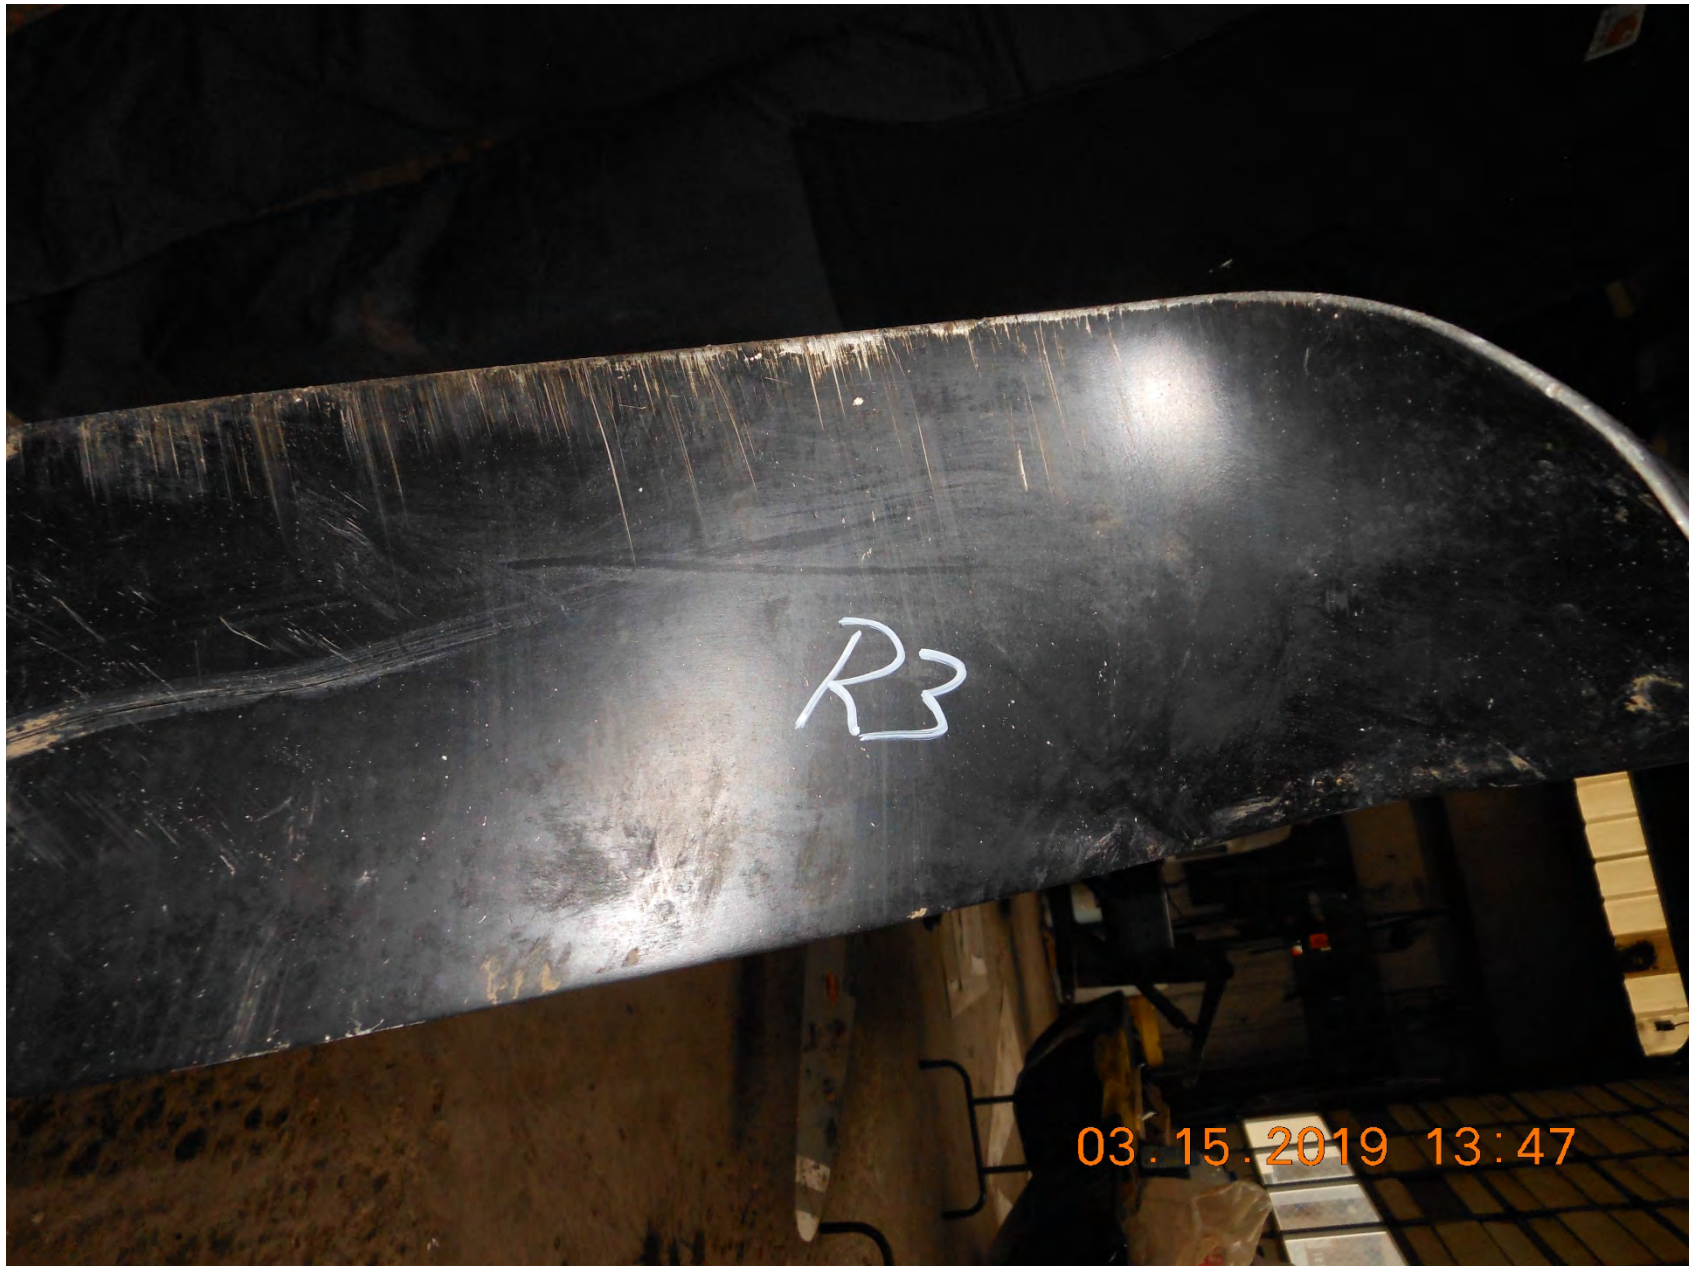
**Photo 9 – Right Propeller Blade 3 (Photo Courtesy of Hartzell Propeller)**

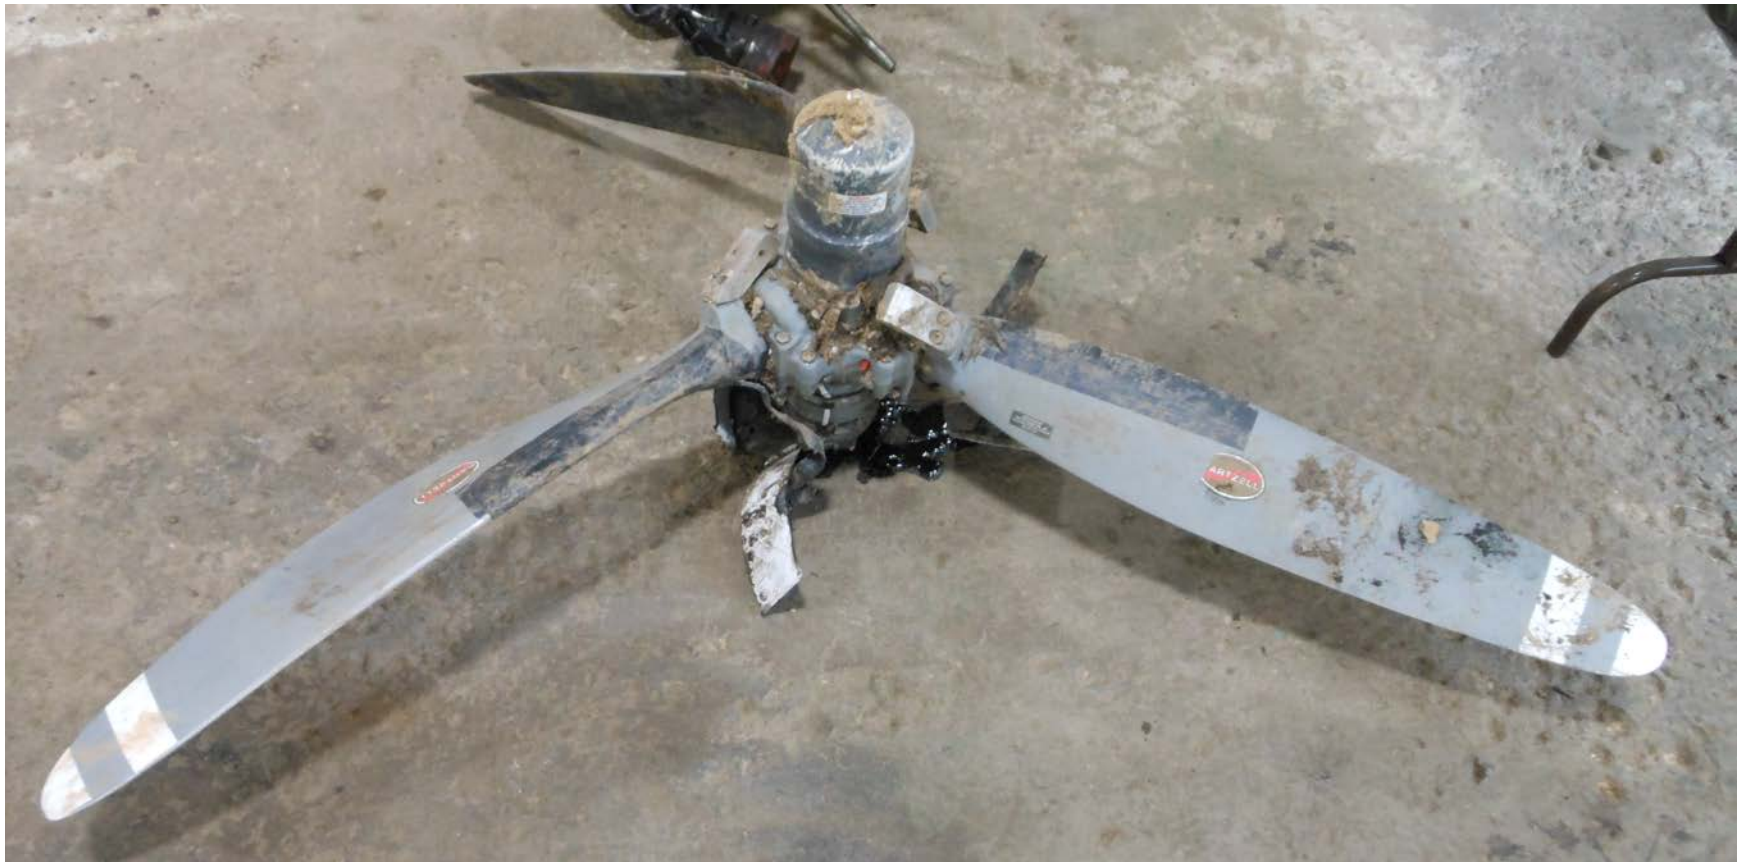
**Photo 10 – Left Propeller (Photo Courtesy of Hartzell Propeller)**
