# NATIONAL TRANSPORTATION SAFETY BOARD

## MATERIALS LABORATORY FACTUAL REPORT

Report No. 19-078

Place : Cashiers, North Carolina  
Date : March 14, 2019  
Vehicle : Mooney M20C; N6075Q  
NTSB No. : ERA19FA130  
Investigator : Eric Alleyne, AS-ERA

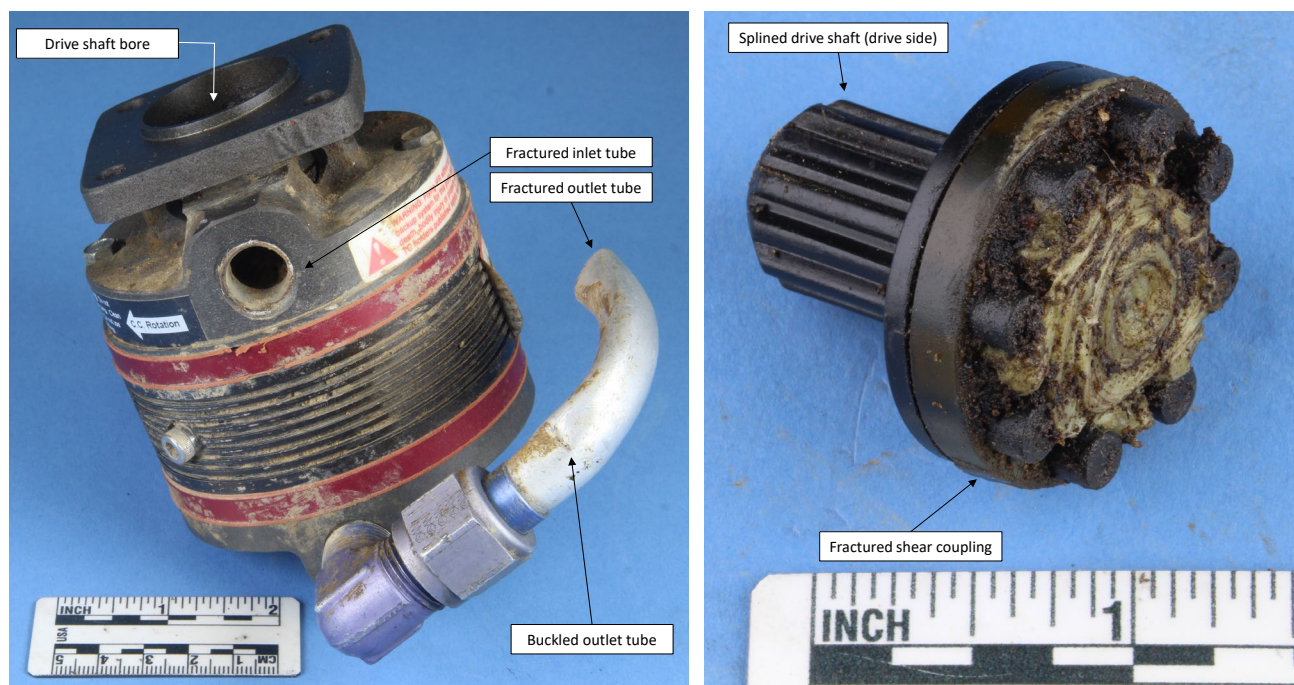
Figure 1: Photographs of the as received vacuum pump components prior to cleaning. The photograph on the left shows the vacuum pump oriented with the engine accessory case mounting flange located at the top. The photograph on the right shows the drive side of the splined two-piece drive shaft and fractured shear coupling which engaged the pump through the drive shaft bore when installed.

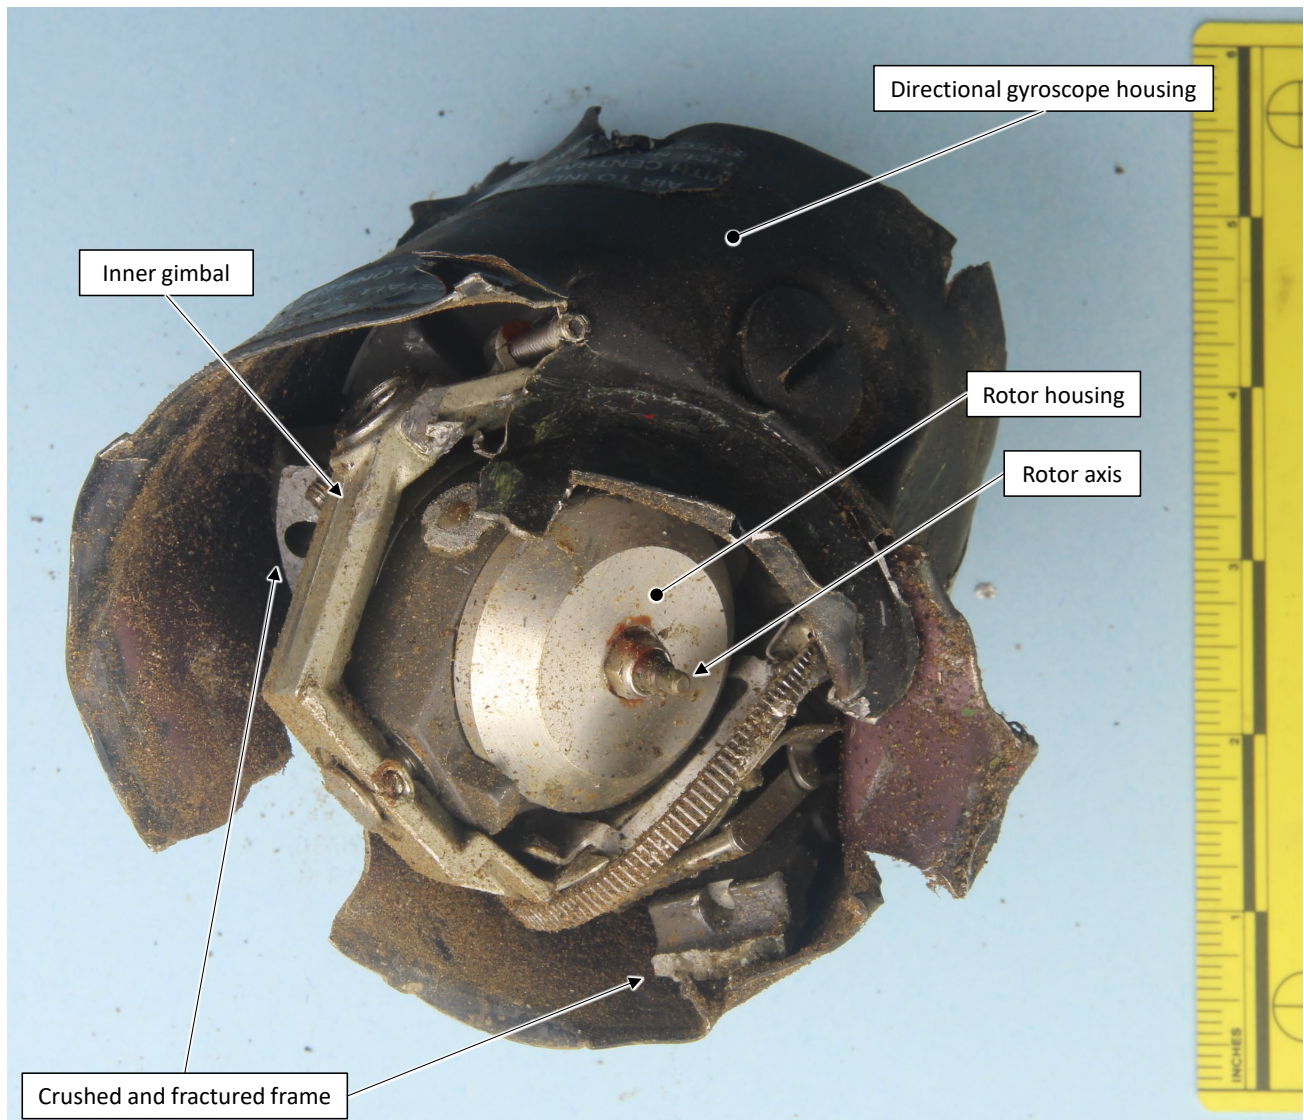
According to the heavily obscured identification placard affixed to the portion of the directional gyroscope that was received, the legible information was consistent with an Aeritalia part number 31100 C. The portion of the directional gyroscope housing was crushed around the gimbal set which was separated from the deformed and fractured frame and is shown in figure 2. The rotor housing rotated about the inner gimbal axis to the extent limited by interference with the deformed drive gear. The rotor rotated freely about the spin axis within the rotor housing when viewed through the outlet port, but a slight amount of orthogonal play was observed between the rotor axis and rotor housing.

Figure 2: A photograph of the portion of the directional gyroscope as received with crushed, buckled, and torn housing. The inner gimbal, containing the drive gear and rotor housing, was observed separated from the crushed and fractured frame.

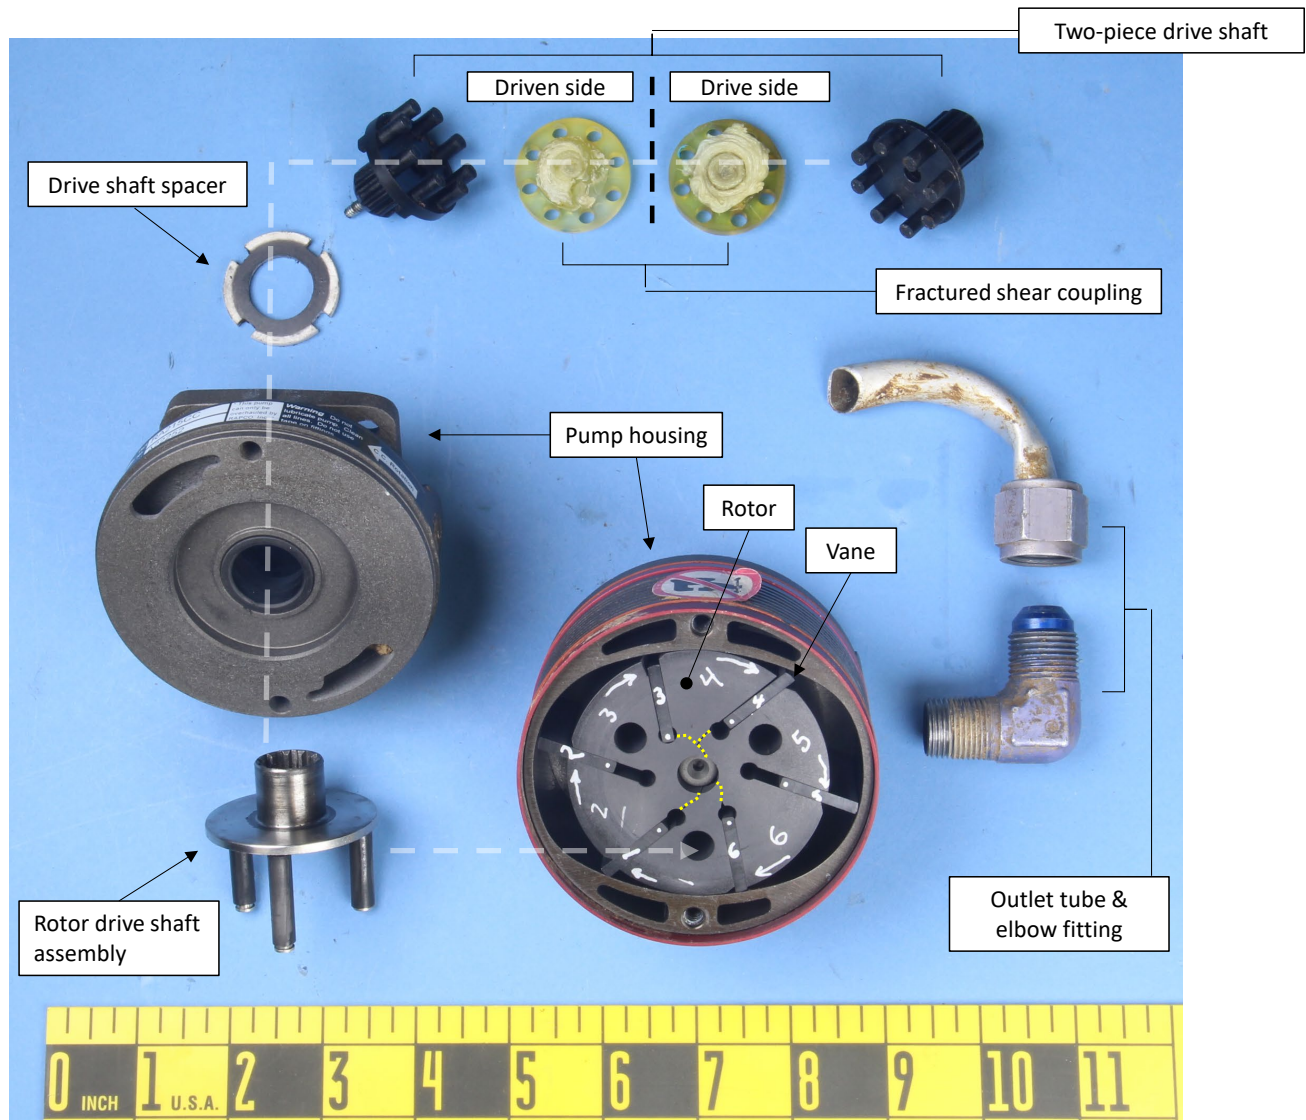
The vacuum pump was carefully disassembled to examine the interior of the housing. The outlet cover was secured by two bolts with washers, one with a purple torque stripe material applied. The inlet cover was also secured to the housing by two bolts with washers both containing a purple torque stripe material. In all observed cases, the torque stripe material exhibited a crazed appearance and was aligned on the bolt head and pump housing on the outlet side and on one of the two fasteners on the inlet side. The other bolt head on the inlet side did not contain any torque stripe as it was only present on the washer and housing. The inlet cover was removed to reveal the interior of the housing which contained the pump rotor, vanes, rotational shaft, and drive shaft assembly. Figure 3 shows an exploded view of the partially disassembled pump from the inlet side. The cylindrical pump rotor consisted of six wedge shaped fins with an approximately 0.13-inch slot in between each fin, which contained a rectangular vane, each of which was intact. The vane widths were measured in three locations: near the outlet side, near the inlet side, and at approximately mid-height. These values were recorded in table I and figure 4 shows the vanes after removal from the pump. The vane walls exhibited a parallel scratch pattern on the sidewalls consistent with radial sliding within the slots during rotor rotation. The rotor sidewall was marked with a handwritten letter "P", followed by a curved character obscured by a vane slot, followed by "# 2" on the adjacent fin sidewall and a "2" on the outlet side of the rotor on the same fin. Using the fin marked with a handwritten "2" designated as 2, the fins and vanes were each labeled 1 – 6 in the direction of rotation for the purposes of this report. There were three axial through-holes evenly spaced around the hub at approximately mid-radius which engaged with the drive shaft assembly studs. The rotor was fractured into four larger pieces around the central hub with axial cracks spanning between the internal edge of the vane slots and the central hub through-hole as highlighted by yellow dashed lines in figures 3 and 5. Several smaller fragments from the rotor were recovered from inside the pump housing after the rotor was removed. The smaller fragments were predominantly from the area of the rotor located between fins 1 and 6. The fracture surfaces of the rotor pieces exhibited a rough morphology with a dull luster—these features were consistent with overstress failure of brittle materials.

Figure 3: A photograph showing an exploded view of the vacuum pump after partial disassembly with the inlet side of the pump housing removed. The translucent white arrow indicates the connection pathway when assembled. The mating fracture surfaces of the shear coupler are visible showing the lighter swirled morphology consistent with thermal damage (melting). The dotted yellow lines at the rotor hub indicate the locations of cracks which traversed axially through the rotor. The silver arrows marked on the rotor indicate the direction of rotation and the silver numbers indicate the identification convention used for the rotor fins and vanes for the purposes of this report.

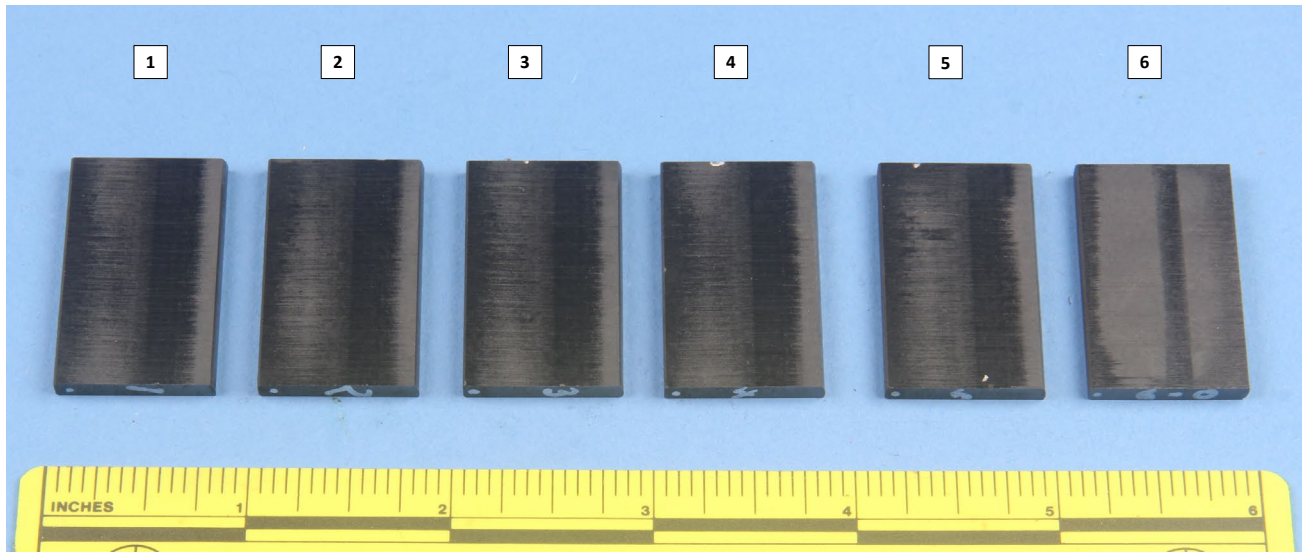
Figure 4: A photograph showing the six intact vanes removed from between the rotor slots. Vane identification numbers were assigned based on the sequential rotor fin as observed in the rotation order. Horizontal wear scratches consistent with sliding contact with rotor slot faces during rotation were observed.

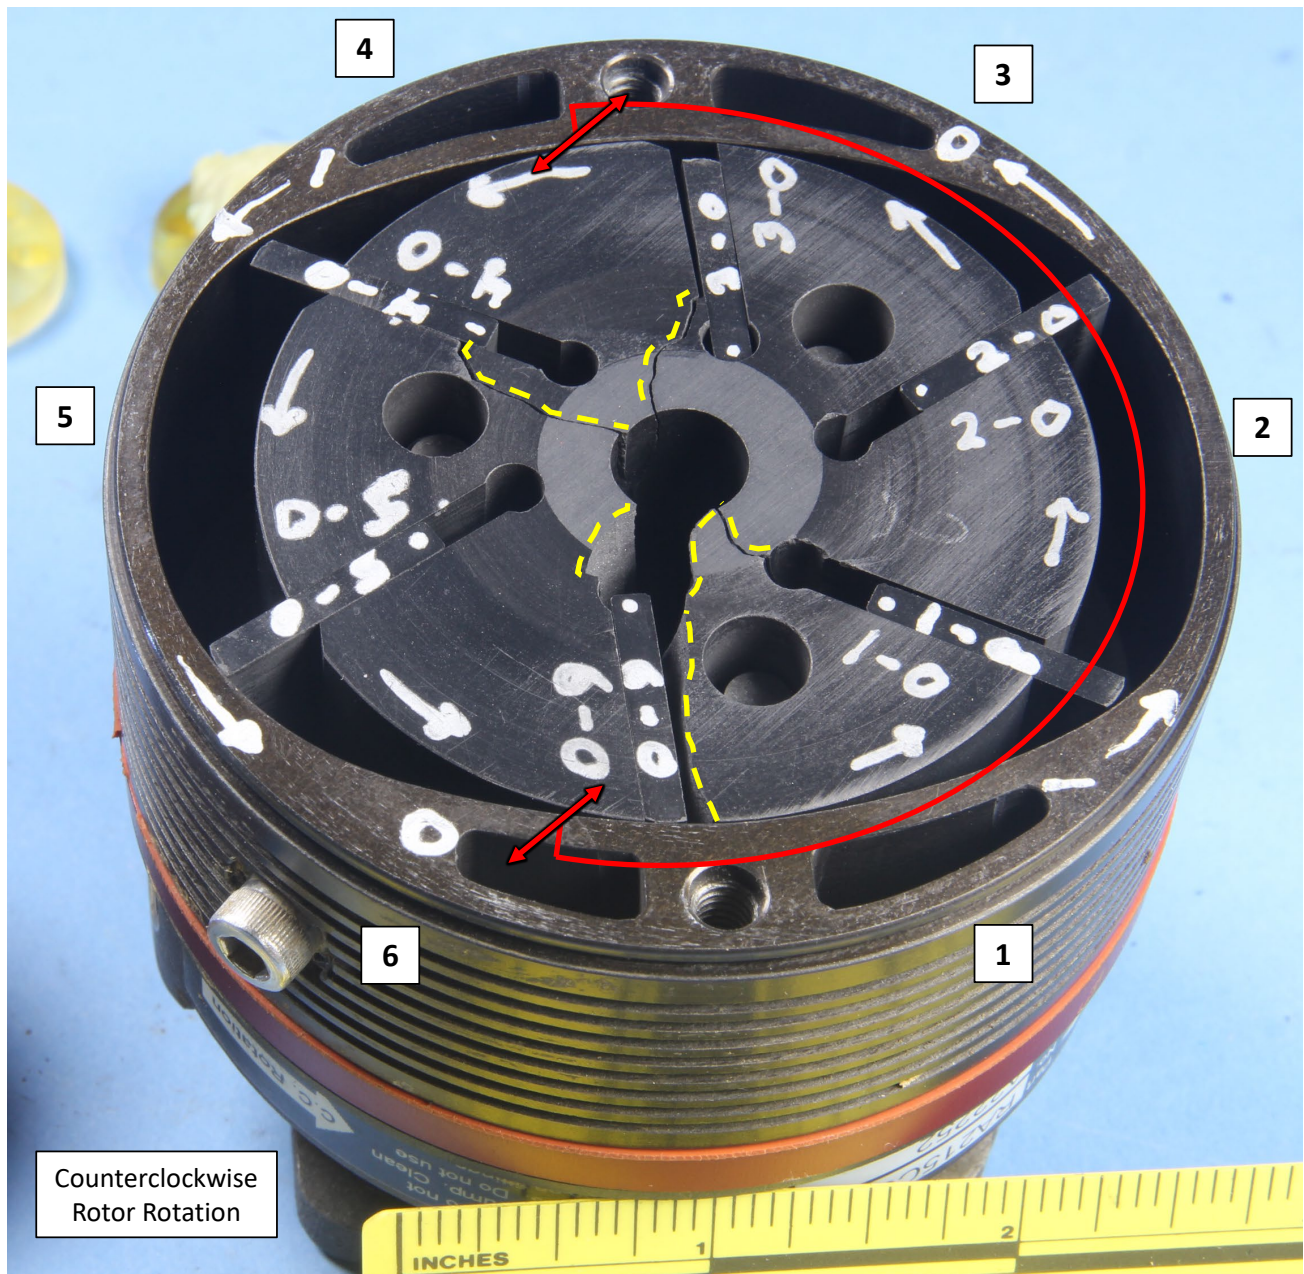
Figure 5 shows a view of the rotor and vanes inside of the pump housing with the housing cover removed from the outlet side. Cracks were observed spanning between the central hub and vane slots which traversed axially through the rotor to the inlet side and are highlighted with yellow dashed lines. A larger portion of the hub between fins 1 and 6 was fragmented into smaller pieces that were recovered from the pump housing during disassembly. The outlet side of the rotor displayed a circumferential wear pattern of fine scratches consistent with rotation, however, a linear pattern of deeper parallel scratches was observed over an area from near the leading edge of fin 6 spanning counterclockwise around the rotor to near the trailing edge on fin 4 as indicated by the

red arc. The red double arrows indicate the direction of the parallel scratches. These parallel scratches were consistent with a non-rotational, sliding wear pattern.

Figure 5: A view of the labeled rotor and vanes within the pump housing as observed with the outlet cover removed. Cracks in the rotor emanating from the central hub were observed and are highlighted by yellow dashed lines. The red arrows indicate the direction of parallel scratches consistent with sliding motion and inconsistent with rotational motion that were observed over the area of the rotor face indicated by the curved red bracket.

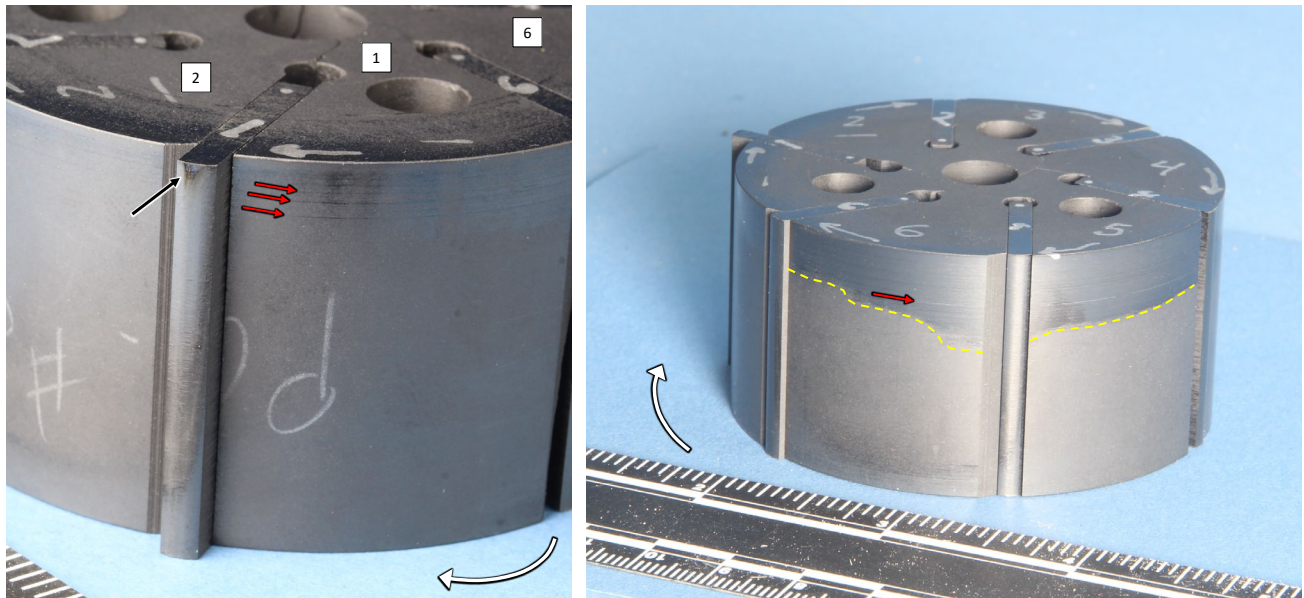
Figure 6 shows a view of the rotor removed from the housing and approximately reassembled with the inlet side facing up. The outer diameter surface of the rotor exhibited a visually non-directional surface finish except at the inlet side there were visible circumferential marks around the entire diameter. The most prominent marks were measured to be 0.041, 0.072, 0.096, 0.124, 0.171 and 0.256 inch from the inlet side of the rotor. A wider shiny band of circumferential marks was observed spanning from near the trailing edge of fin 1 through fins 6, 5, and near the trailing edge of fin 4 (listed in order by which an observer from the outside would witness the rotor fins pass by during pump rotation, as labeled in this report) which ranged from 0.26 inch to 0.46 inch from the inlet side of the rotor. The widest section of the shiny circumferential mark was observed between fins 6 and 5. The corner of vane 1, where the outer surface and inlet side surface intersected, exhibited a tinted appearance as shown in the left image of figure 6 indicated by a black arrow.

Figure 6: A pair of side views of the rotor as removed from the pump housing. The rotor rotation is indicated by the white curved arrows. The left image shows a close-up view of the rotor, oriented with the inlet side facing up, near fin and vane 1. The red arrows indicate circumferential marks measured at 0.096, 0.124, and 0.171 inch from the inlet side of the rotor face. The black arrow indicates a tinted area observed on the edge of vane 1. The right image shows a view of the entire rotor with the red arrow indicating a circumferential mark measured at 0.256 inch from the inlet side of the rotor face. The yellow dashed line highlights the boundary of the shiny band of circumferential marks.

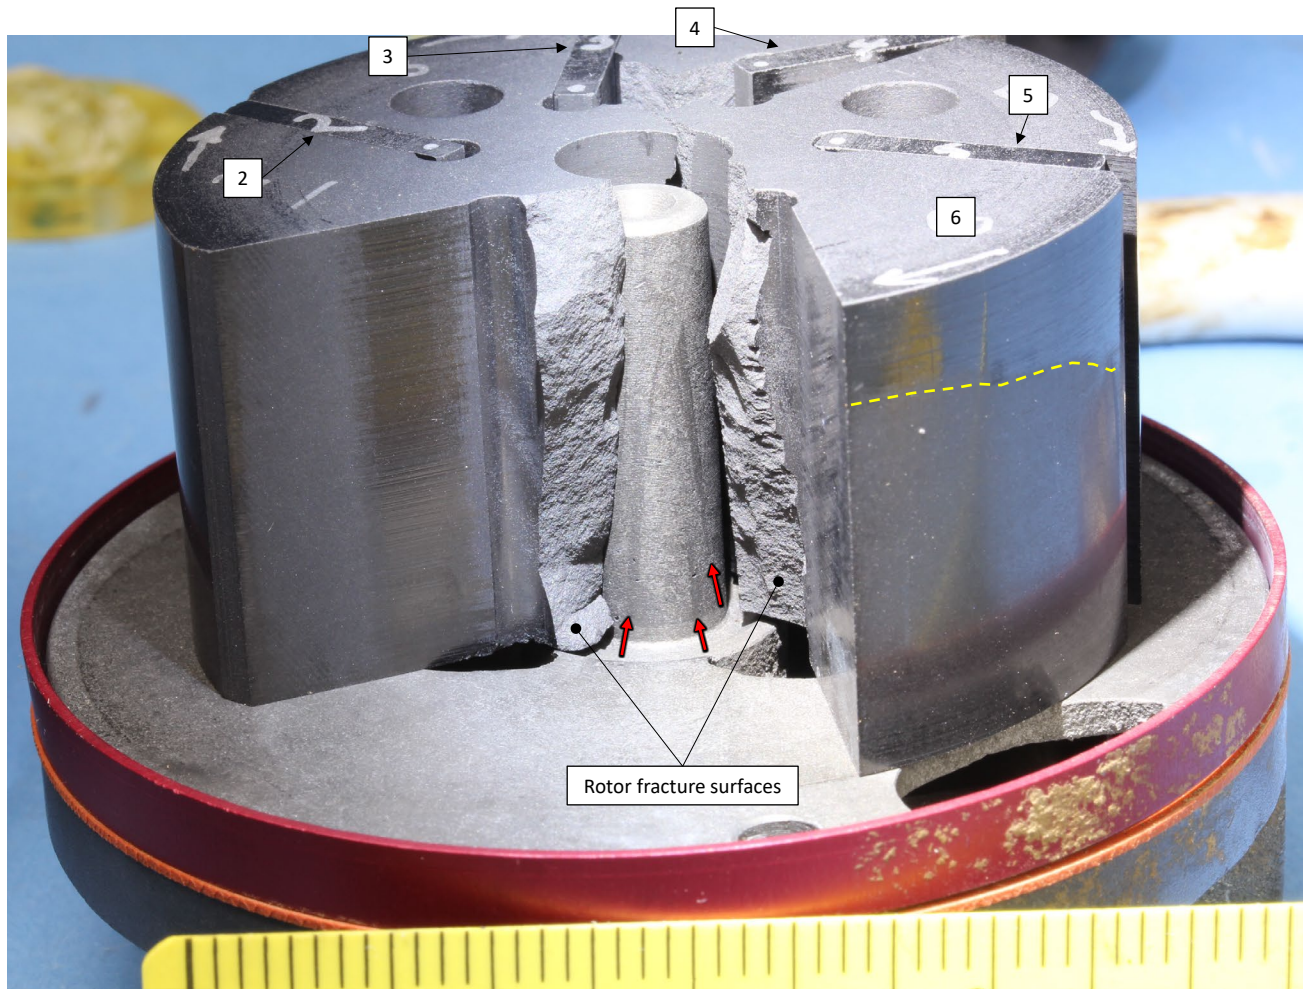
The outlet cover contained an integral shaft concentric with the rotor hub about which the rotor rotated. Closer examination of the integral shaft on the housing cover revealed witness marks that matched the profile of the fracture surface between fins 1 and 6 and between fins 1 and 2. Figure 7 shows a view of the rotor fragments partially reassembled on the housing cover and pulled away slightly from the central shaft with the portion containing fin 1 removed to reveal the dark gray witness marks indicated by red arrows which aligned with the edges of the exposed fracture surfaces.

Figure 7: A view of the fractured rotor partially reassembled on the outlet cover with the portion containing fin 1 removed (vanes 1 and 6 are also removed). The numbered labels and arrows correspond to the applicable fin and vane, respectively. The fractured pieces were pulled away slightly from the central shaft to reveal dark gray witness marks (highlighted with red arrows) that match the profile of the rotor fracture surfaces. Witness marks were consistent with impact damage. The dashed yellow line on the outer diameter surface of fin 6 marks the boundary of a shiny circumferential wear pattern.

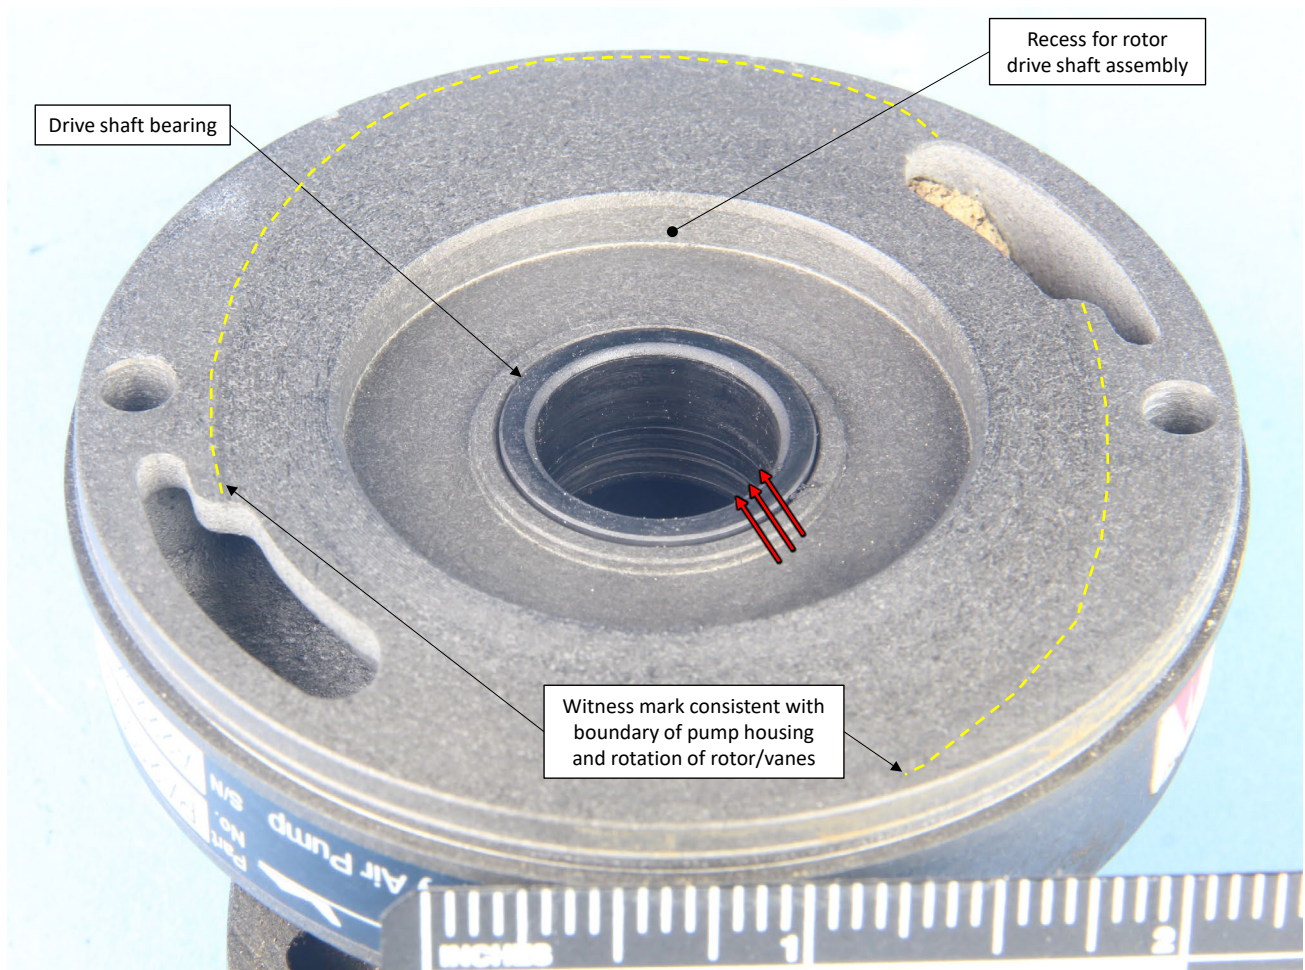
The inlet cover was examined and exhibited an elliptical area of circumferential scratches consistent with rotation of the rotor and sliding vanes. The inlet cover contained a central bearing where the drive shaft assembly passed through to engage the two-piece drive shaft. The drive shaft bearing exhibited multiple circumferential score marks around the end nearest the pump mounting flange as indicated in figure 8 with red arrows.

Figure 8: A view of the inside of the pump housing on the inlet cover with the sidewall of the housing, rotor, and rotor drive shaft assembly removed to reveal the drive shaft bearing. A yellow dashed line marks the inner boundary of the elliptical sidewall of the housing, within which, circumferential marks were observed. Red arrows highlight circumferential scars observed on the inner surface of the drive shaft bearing.

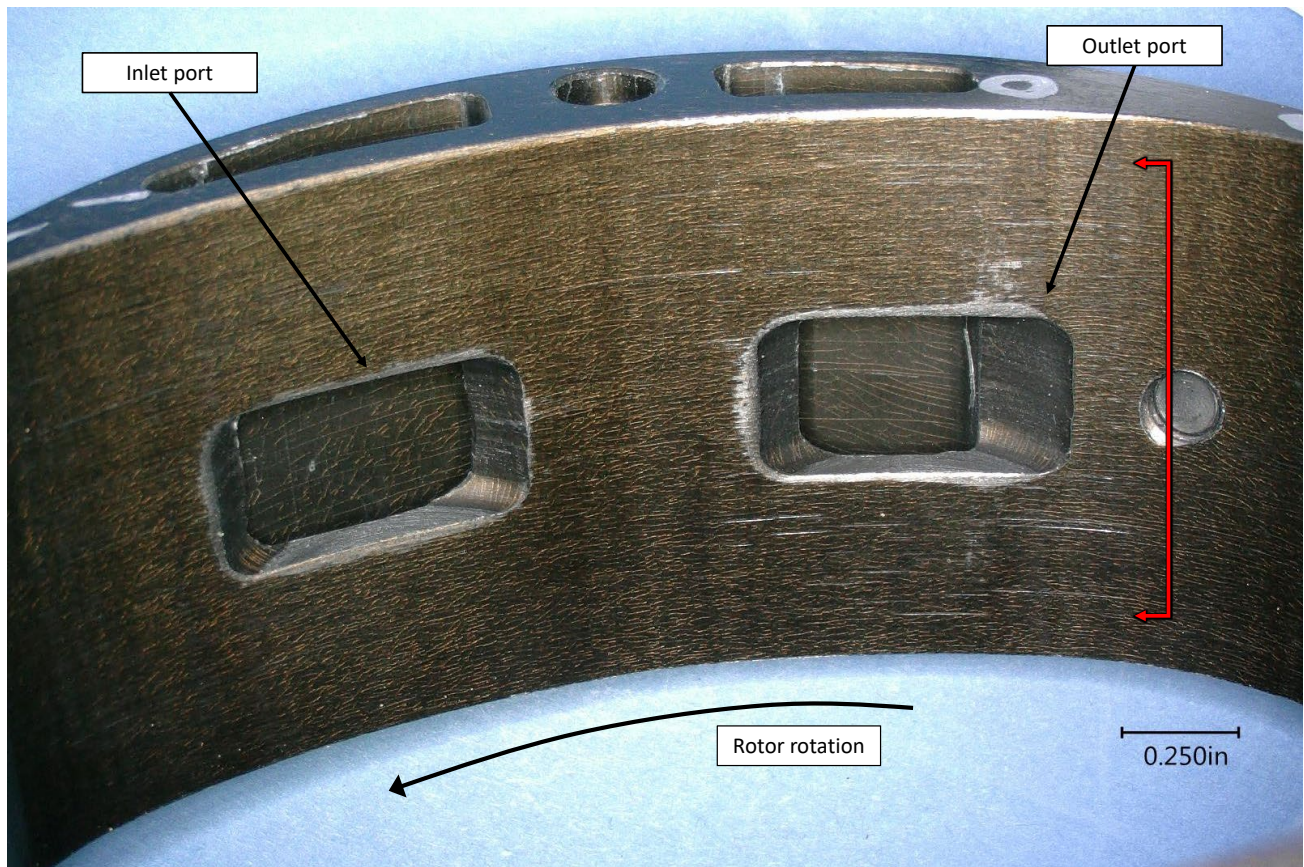
The interior surface of the pump housing sidewall was visually examined and exhibited a translucent brownish-gold appearance which was crazed throughout, consistent with the presence of an anodic coating. Figure 9 shows a digital microscope image of one side of the interior of the pump housing along the minor diameter of the elliptical shape. Circumferential scars which revealed bare base metal were observed and examples are highlighted with red arrows. Figure 10 shows a digital microscope image of one side of the interior of the pump housing along the major diameter of the elliptical shape. Axial bands, along the full height of the sidewall, of circumferential wear scars were observed around the housing wall, consistent with impact and dragging of sliding vanes being forced radially outward and inward relative to the rotor rotation within the elliptical housing shape.

Figure 9: A view of the inside of the pump housing along the minor diameter showing the crazed brownish-gold coating layer. Circumferential scratches were also observed, and typical examples are the horizontal silver streaks observed within the area highlighted by the red brackets. The area surrounding the rectangular shaped inlet and outlet ports also exhibited coating wear and circumferential scratches.

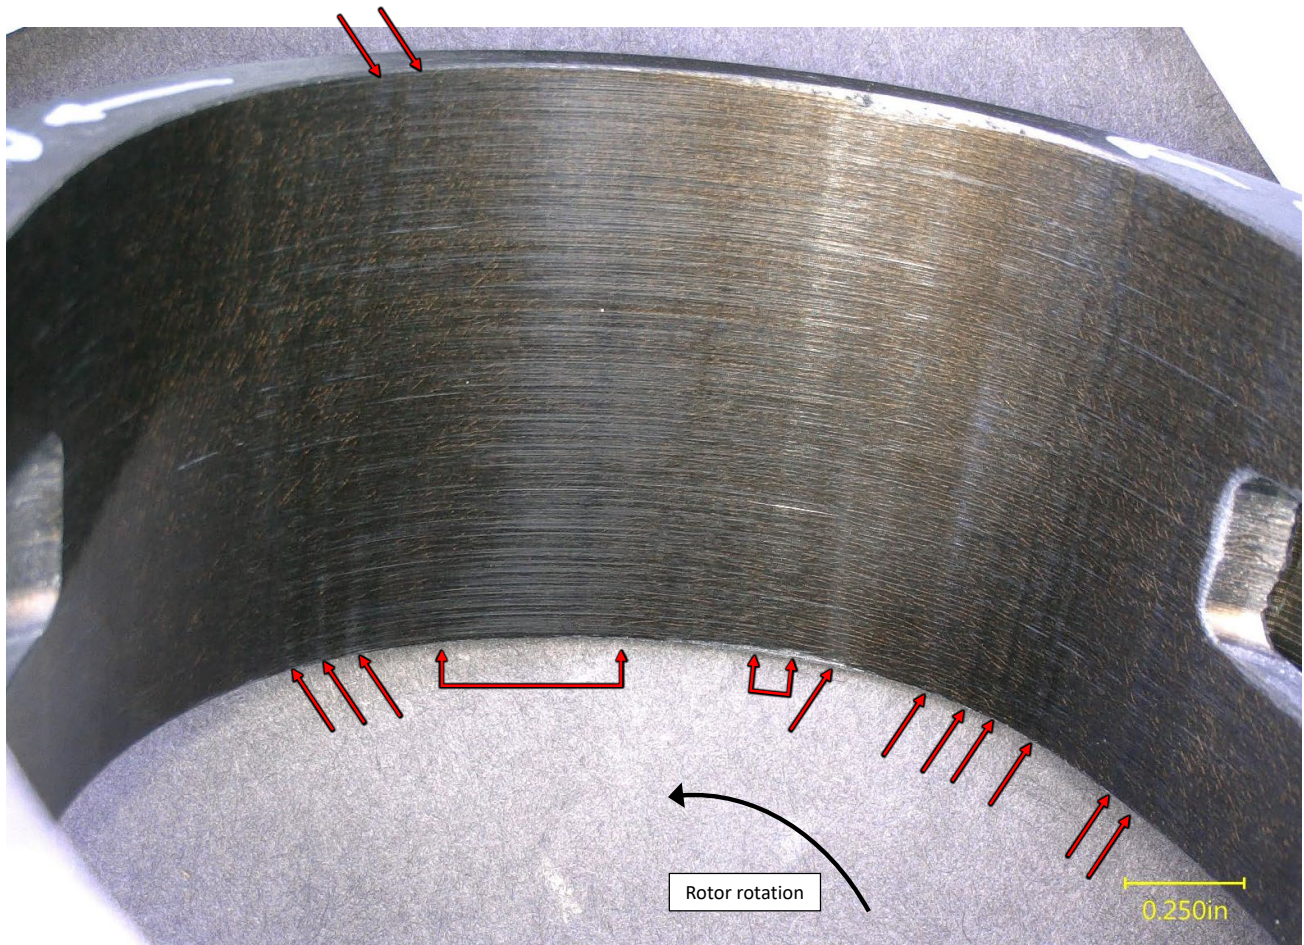
Figure 10: A view of the inside of the pump housing along the major diameter with the rotor and both covers removed. Red arrows and brackets highlight vertical bands of horizontal scratches consistent with vane edge impact and dragging from radial sliding during rotor rotation.

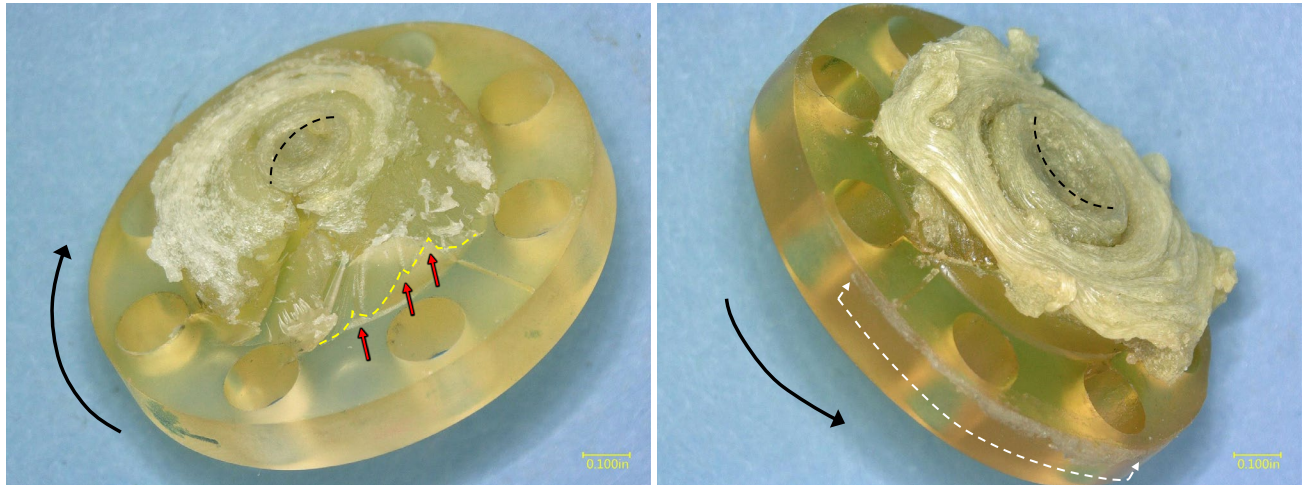
shown in figure 11. The flanges on both sides of the reduced section each contained a circular pattern of 8 through-holes which were keyed to each portion of the split drive shaft. The flange of the drive side exhibited an approximate 90° section of edge damage consistent with impact and abrasive wear. The reduced section of the urethane shear coupling was fractured transversely into two pieces and exhibited post fracture mechanical and thermal damage. The fracture surface features were heavily obscured by a swirled circumferential pattern of stringy and flowing opaque whitish-gold material consistent with melted and resolidified shear coupler material. A circular cup-shaped burnished region was observed locally around the center axis of rotation on the fracture surface of the drive side of the coupler and a corresponding cone shaped region was observed on the pump side of the fractured coupler and both exhibited circumferential material flow lines consistent with thermal stresses which exceeded the melting temperature of the shear coupler and contact during rotation, after separation. A small undamaged area on the fracture surface of the pump side of the shear coupler displayed slanted crack planes formed by radial marks<sup>2</sup> which produced a stepped profile with the adjacent surface of the outer diameter of the reduced section, consistent with torsional loading during fracture, as highlighted by red arrows and a dashed yellow line in figure 11. The surfaces of these fracture planes exhibited faint river patterns<sup>3</sup> consistent with a radial fracture direction near the edge of the part.

Figure 11: Digital microscope images showing side views of the fractured and partially melted and resolidified shear coupling with the driven side interface on the left and the drive side interface on the right. The black arrows indicate rotation direction. The yellow dashed line on the driven side highlights the slanted edge between the fracture surface and adjacent surface of the reduced section. Red arrows indicate step shaped features corresponding to radial marks. Faint river patterns were observed on the undamaged area of the fracture surface at this location. The dashed white bracket on the right photograph highlights an area of the shear coupling flange where damage consistent with impact and abrasive wear was observed. The black dashed lines highlight the cup profile (right photograph) and the cone profile (left photograph) observed at the central region of the fractured shear coupling.

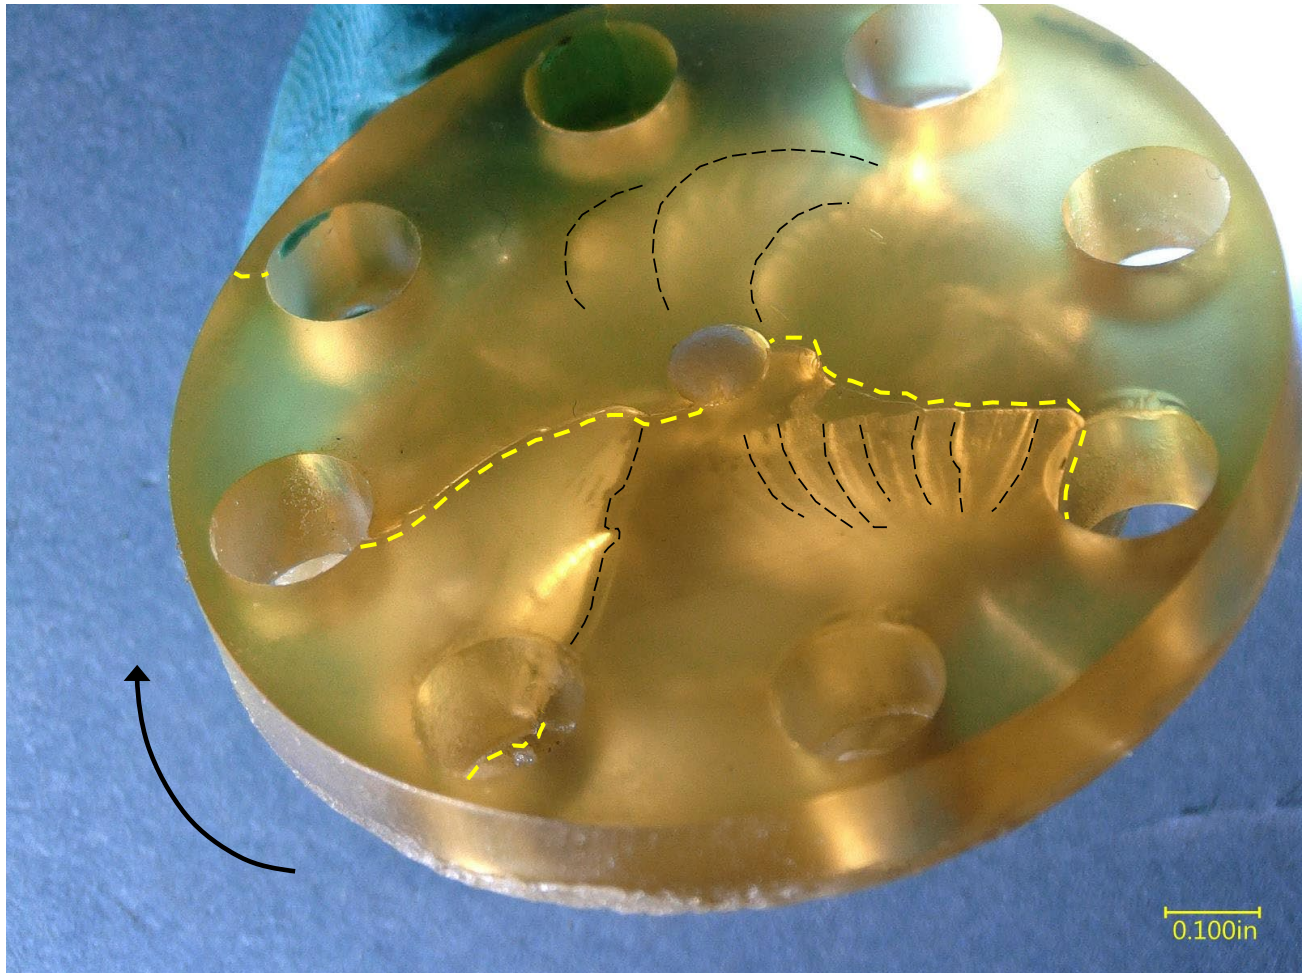
When the drive side portion of the translucent shear coupler was observed from the flanged end using transmitted illumination as shown in figure 12, multiple radially oriented internal fracture planes were observed slanted at approximately 45° from the axis plane, consistent with torsional loading during fracture. Two of these cracks were observed on the flange surface spanning between the center hub and outer holes and are highlighted with dashed yellow lines. Examples of internal radial marks and crack arrest lines that were observed are highlighted with dashed black lines. Multiple complexly oriented fractures were observed.

Figure 12: A digital microscope image of the opposite side of the drive side interface of the shear coupling shown in figure 11 (right photograph). The black arrow indicates rotation direction. Yellow dashed lines highlight cracks observed on the surface of the shear coupling spanning between the central hub and outer flange holes. Black dashed lines highlight internal crack arrest and radial marks visible through the translucent shear coupling. Crack orientations were slanted approximately  $45^\circ$  relative to the rotation axis.

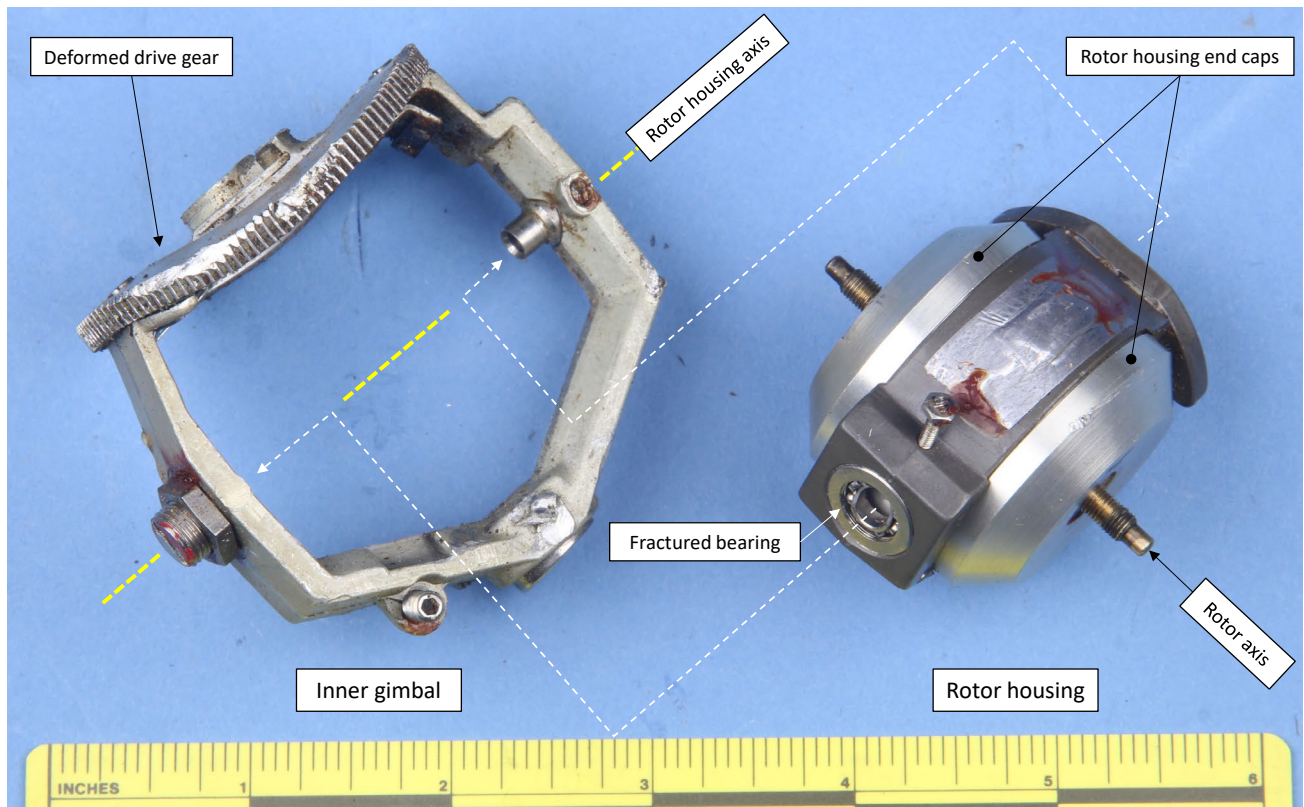
The gyroscope housing was disassembled to examine the rotor and interior of the housing. Figure 13 shows the rotor housing as removed from the inner gimbal which exhibited deformation and mechanical damage consistent with crushing due to impact. Figure 14 shows a closer view of the rotor housing. One of the housing end caps which supported the rotor axis, shown on the left in figure 14, was easily removed by hand from the housing, the other end cap, shown on the right in figure 14, was slightly deformed, wedged tightly in the housing, and was not removed. A scar was observed on the corner of this end cap, consistent with mechanical impact damage. The inner race of one of the bearings about which the housing rotated was fractured, as indicated in figure 14. The fracture surface exhibited a dull, rough appearance, consistent with overstress separation at impact.

Figure 13: A photograph of the partially disassembled directional gyroscope internal gimbal and rotor housing. White dashed arrows indicate the assembled position where the rotor housing rotated about the axis indicated by the yellow dashed line. The drive gear and gimbal frame were mashed and deformed, consistent with crushing damage at impact. The inner race of one of the rotor housing bearings was fractured, a closer view is shown in figure 14.

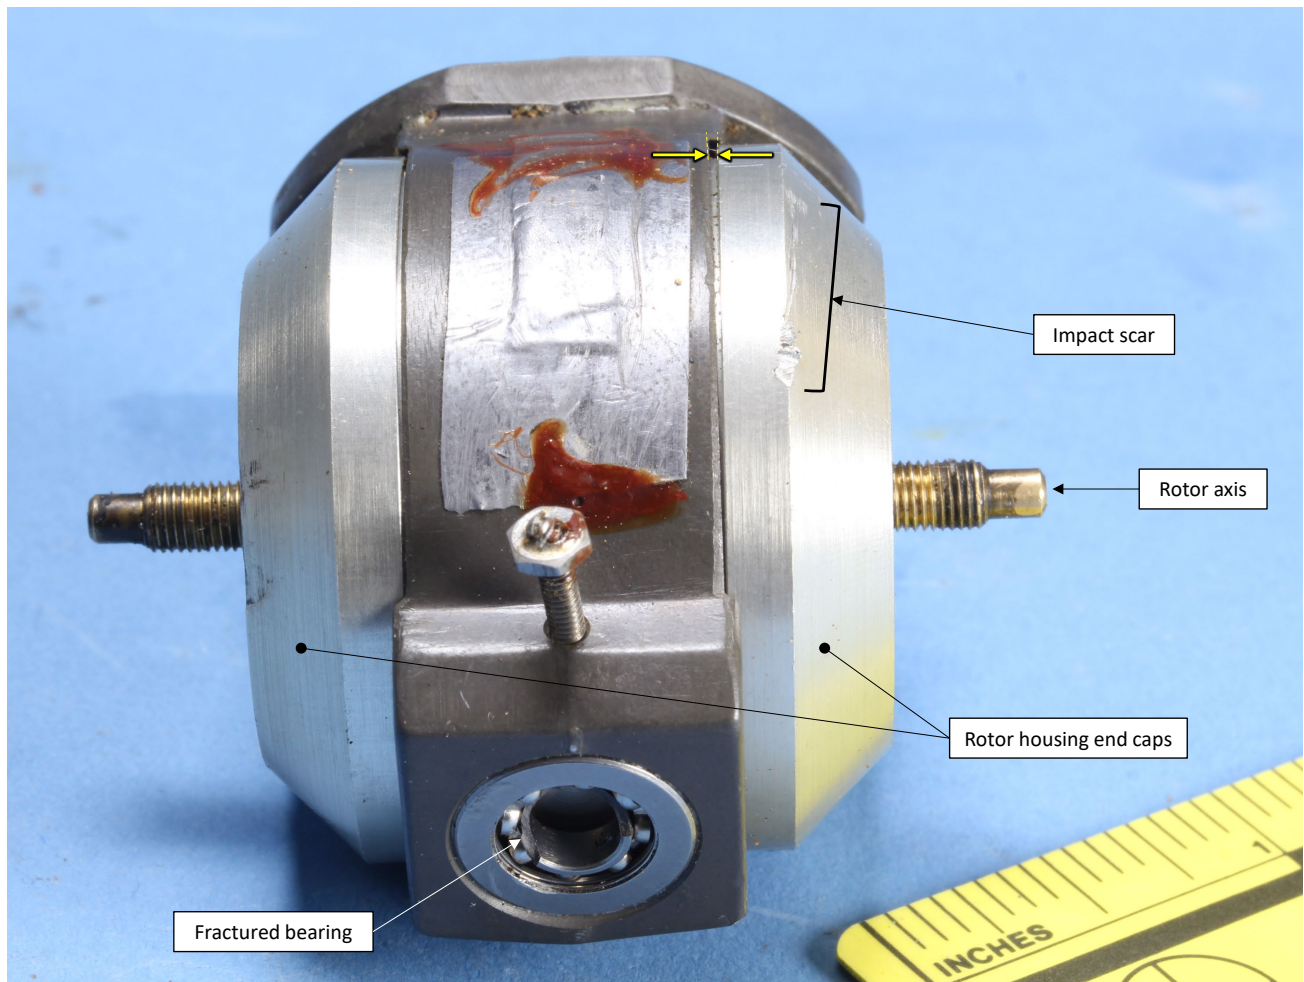
Figure 14: A closer view of the rotor housing, with the fractured bearing shown at the bottom. The fracture surface was dull and rough, consistent with overstress due to crushing at impact. The yellow arrows and dashed lines indicate a wedge-shaped gap observed between the housing end cap and sidewall, the cap was seized within the sidewall and unable to be removed. An impact scar was observed on this endcap as shown bounded by the black bracket. The cap on the left side of the photo exhibited a uniform gap at the interface with the sidewall and was easily removed by hand during subsequent disassembly.

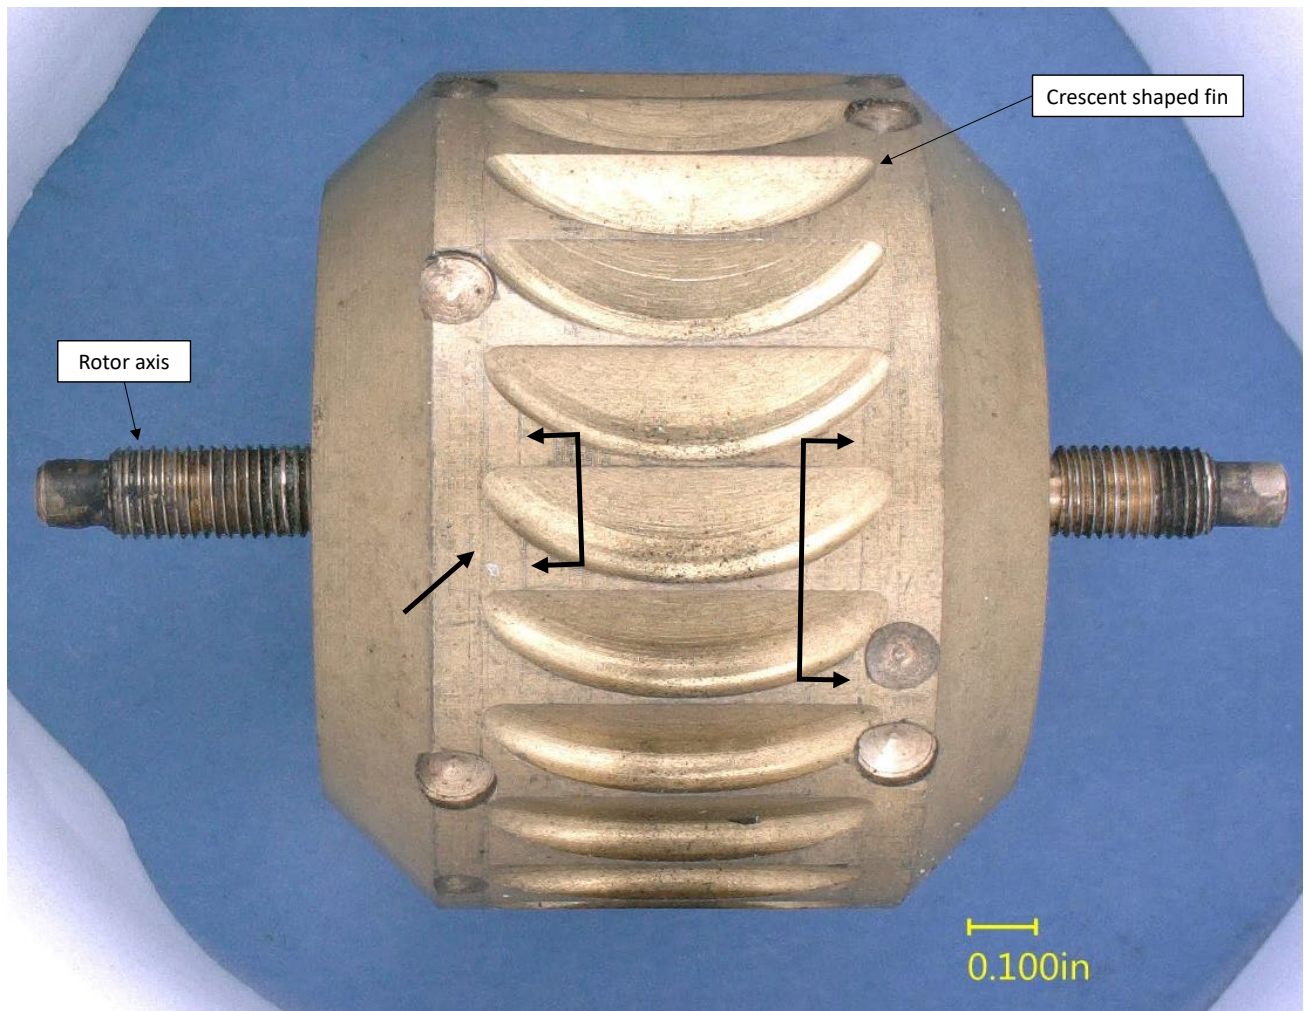
The rotor, as shown in figure 15, exhibited faint circumferential scarring around the outer diameter surface. The scar highlighted with the single arrow was apparent around the entire circumference and was closely aligned with the edge of the housing end cap that was easily removed during disassembly. The two other scars highlighted with black brackets were not continuous around the entire rotor. The crescent shaped fins on the rotor had a dark speckled appearance near the rounded end. The interior surface of the housing exhibited evidence of circumferential scoring as highlighted by yellow arrows in figure 16. One continuous circumferential score mark was observed on the inner surface of the chamfered surface of the end cap, but a corresponding mark was not observed on the rotor. The inner surface of both housing end caps exhibited a uniform circumferential machined appearance on all surfaces with alternating sectors of contrasting reflectivity observed on the surface normal to the rotor axis.

Figure 15: A digital microscope image of the rotor after removal from the housing. The single black arrow indicates a continuous circumferential score mark observed around the entire rotor which corresponded to the location of the edge of the housing cap when installed. The brackets indicate the extent of two prominent local circumferential score marks.
