# NATIONAL TRANSPORTATION SAFETY BOARD

## MATERIALS LABORATORY FACTUAL REPORT

Report No. 19-078

Place : Cashiers, North Carolina  
Date : March 14, 2019  
Vehicle : Mooney M20C; N6075Q  
NTSB No. : ERA19FA130  
Investigator : Eric Alleyne, AS-ERA

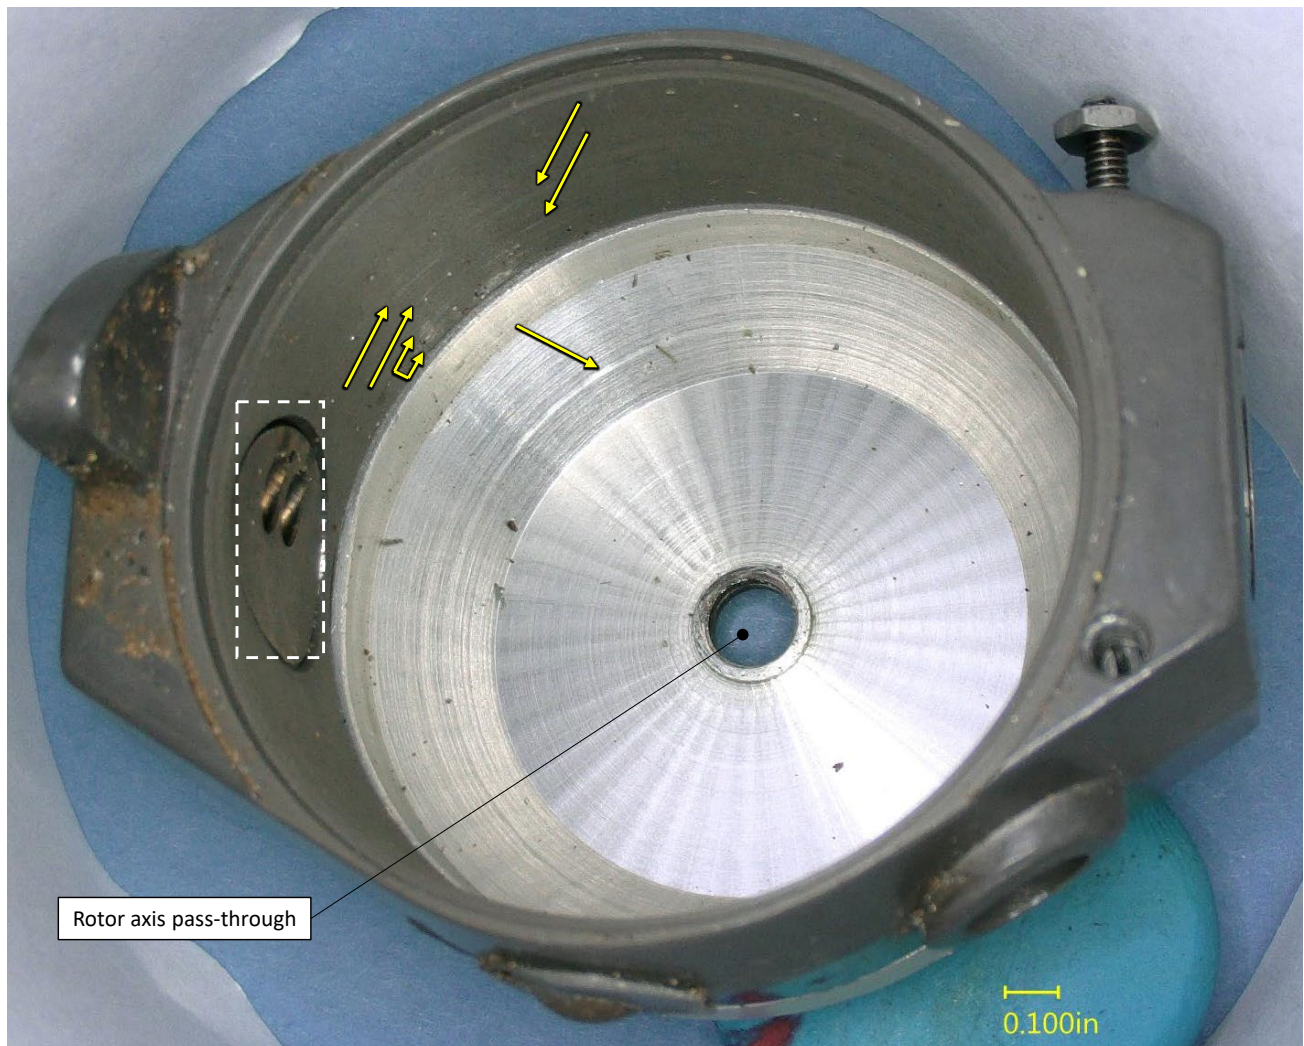
Figure 16: A digital microscope image of the inside of the rotor housing with one of the end caps removed. Yellow arrows indicate circumferential scratches observed on the housing sidewall and end cap. The indicated circumferential mark on the end cap was continuous around the chamfer surface. A corresponding mark was not observed on the rotor. The pattern observed on the interior surface of both caps consisted of circumferential machining marks and sectors of alternating reflectivity on the surface normal to the rotor axis. A closer view of the area within the white dashed box is shown in figure 17.

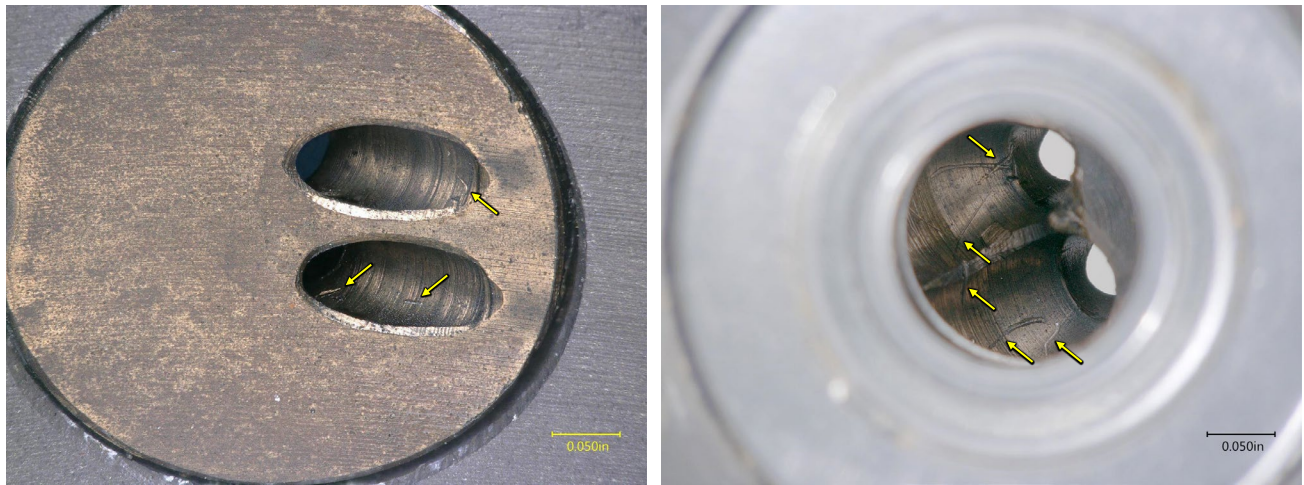
Closer examination inside of the air inlet port of the rotor housing revealed small gouges consistent with tool marks or foreign debris damage and inconsistent with laminar flow damage/wear. Figure 17 shows views of these gouges from both inside and outside of the housing.

Figure 17: A digital microscope image of the directional gyroscope rotor housing air inlet port from the interior (left) and exterior (right) of the housing. Yellow arrows indicate irregular shaped gouges observed on the flow surfaces.
