# NATIONAL TRANSPORTATION SAFETY BOARD

## MATERIALS LABORATORY FACTUAL REPORT

Report No. 19-046

Place : Tampa, Florida  
Date : April 4, 2019  
Vehicle : Robinson R44 II, N4046J  
NTSB No. : ERA19FA142  
Investigator : Daniel Boggs, ASI-ERA

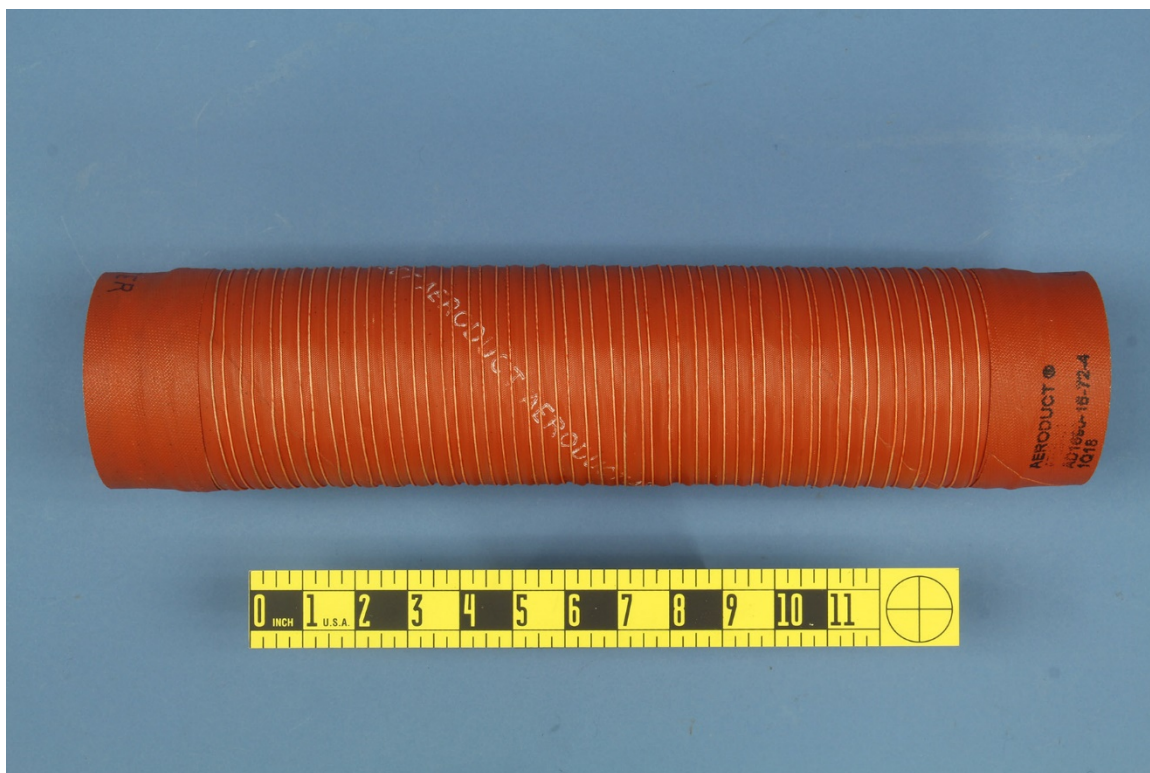
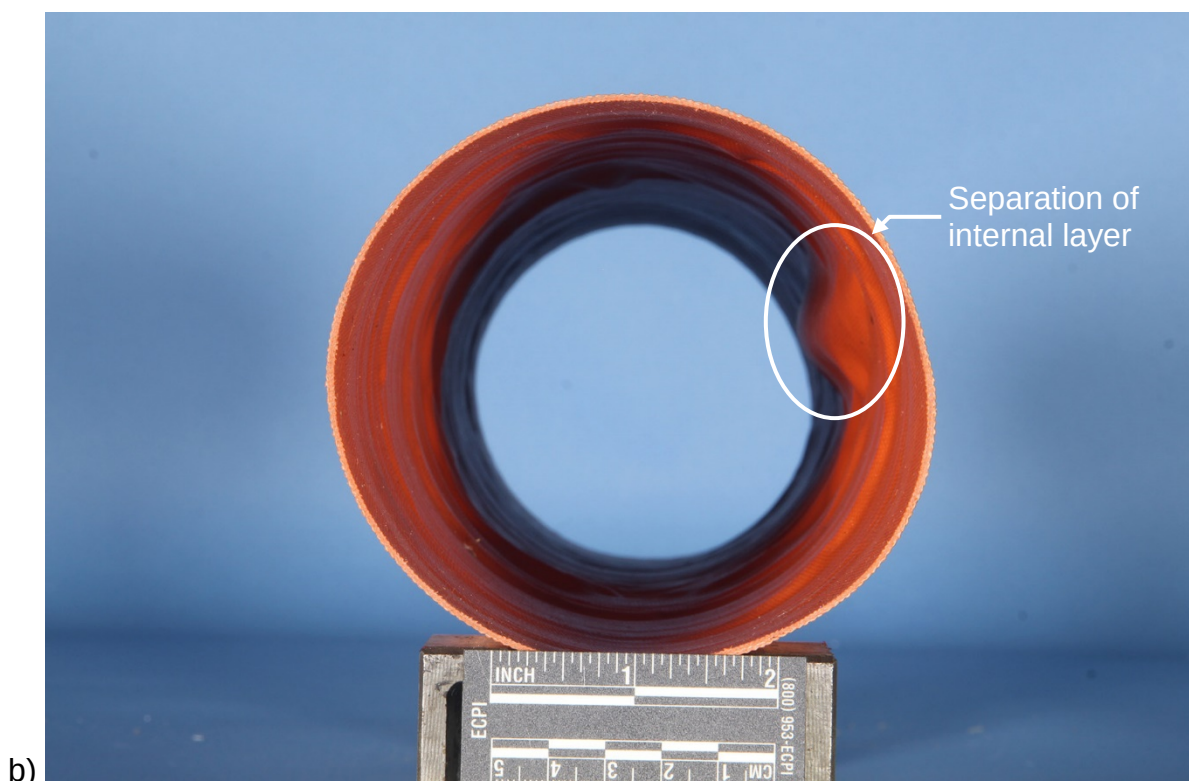
An air intake duct from the aircraft referenced above was submitted to the NTSB Materials Laboratory for examination as shown below in figure 1. The on-scene examination of the duct revealed that the inner rubberized fabric liner had partially collapsed, obstructing the interior volume of the duct.

Examination of the accident duct revealed a region where the inner layer was protruding into the internal volume of the tube, as indicated in figures 1b and 3a. Further examination revealed internal surface wrinkles and smaller unbonded regions as shown in figures 3a – 3d.

**Figure 1:** Images of the air intake duct as received: a) side view and b) axial view.

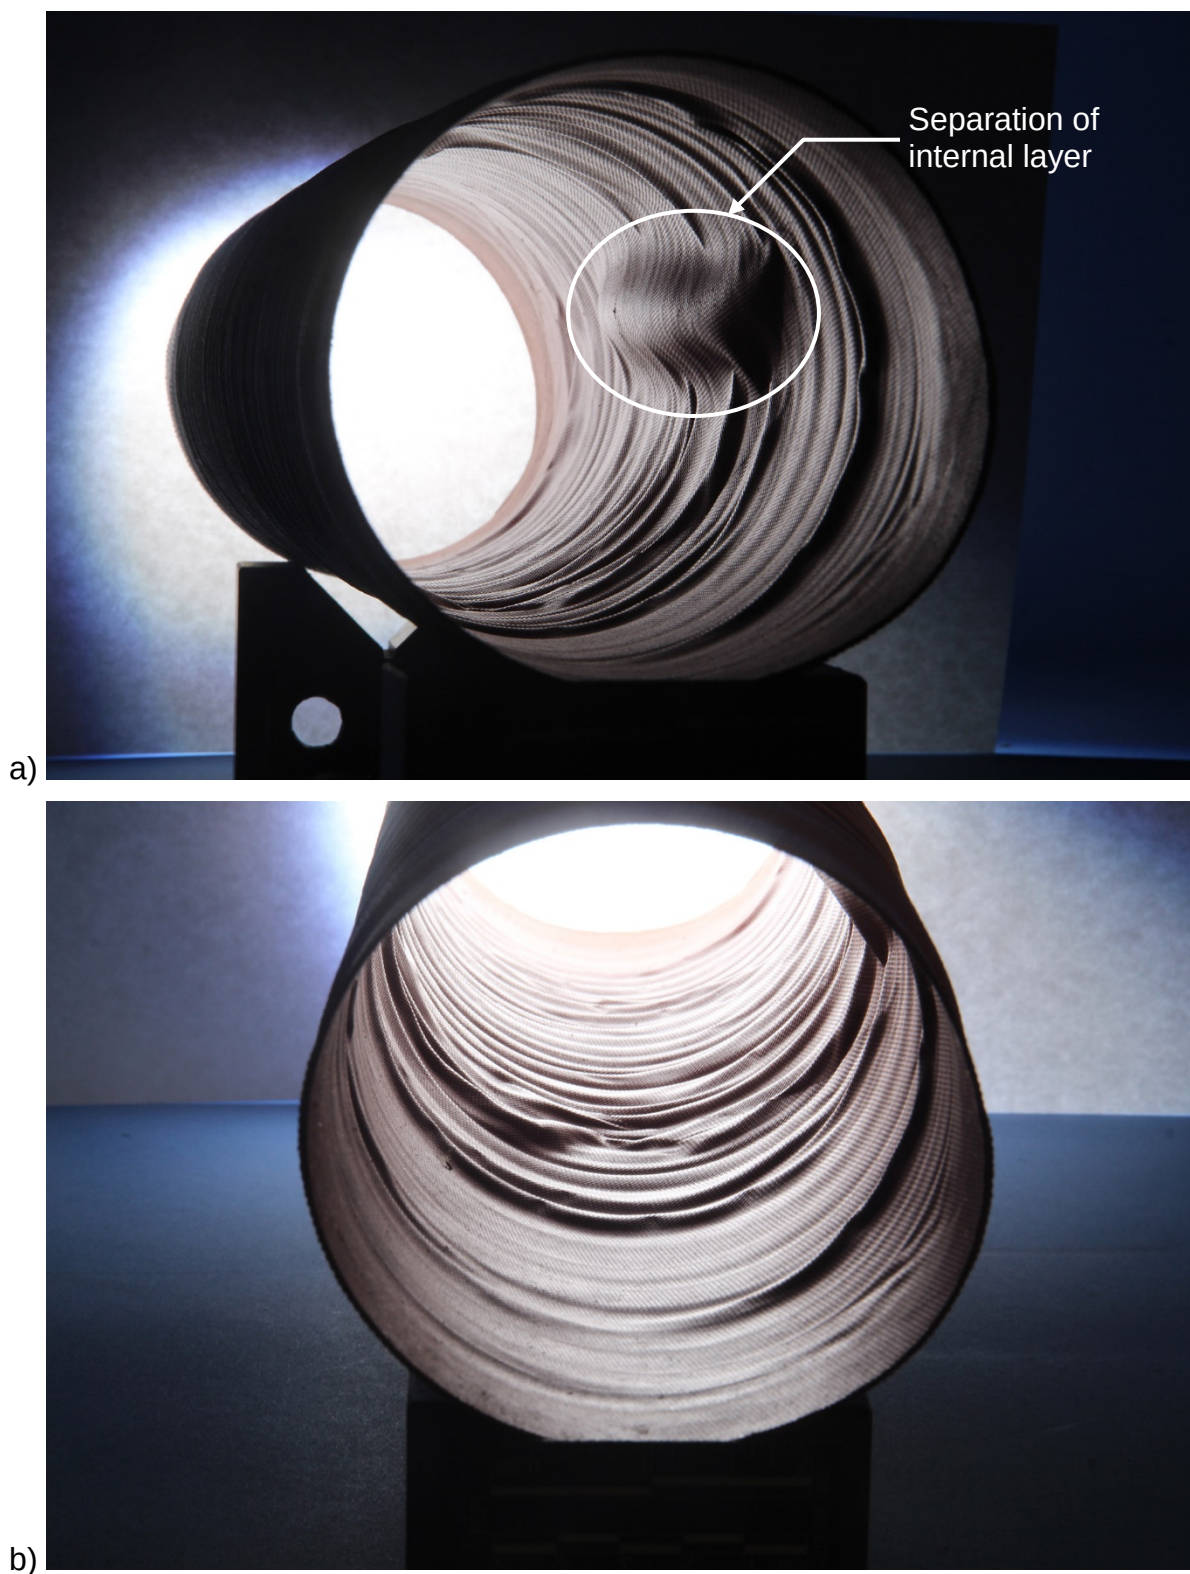
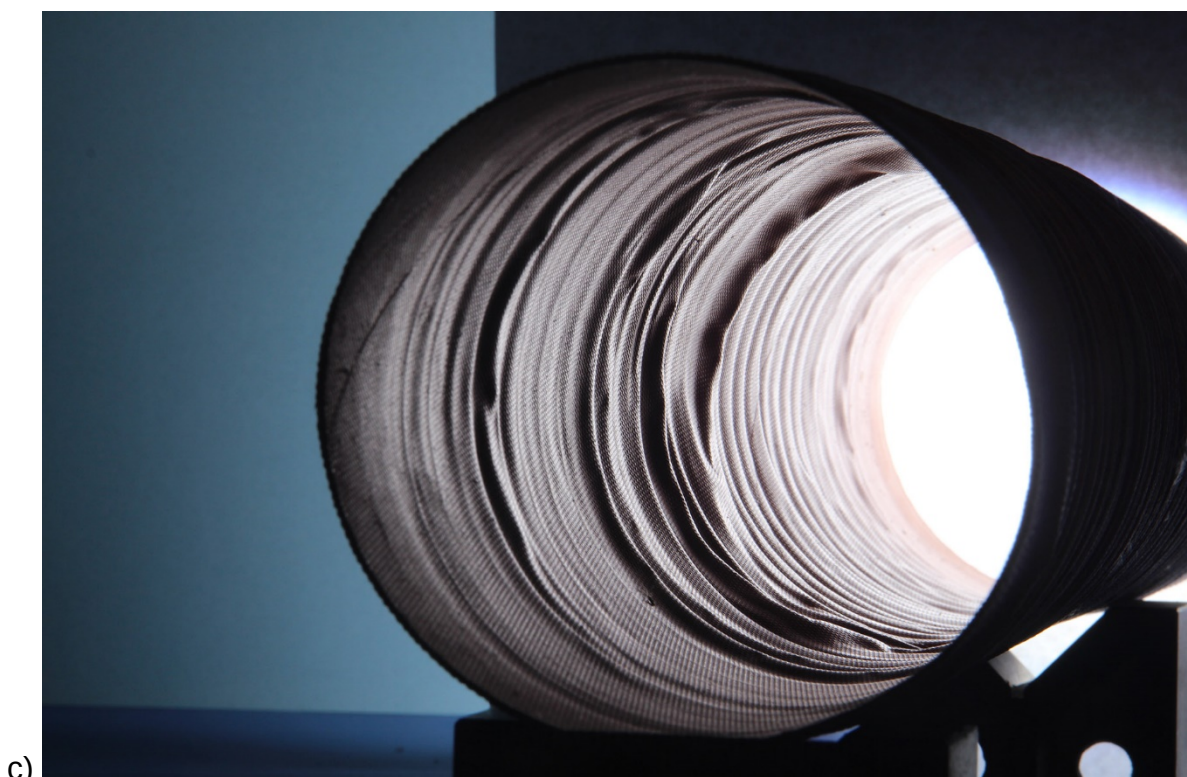
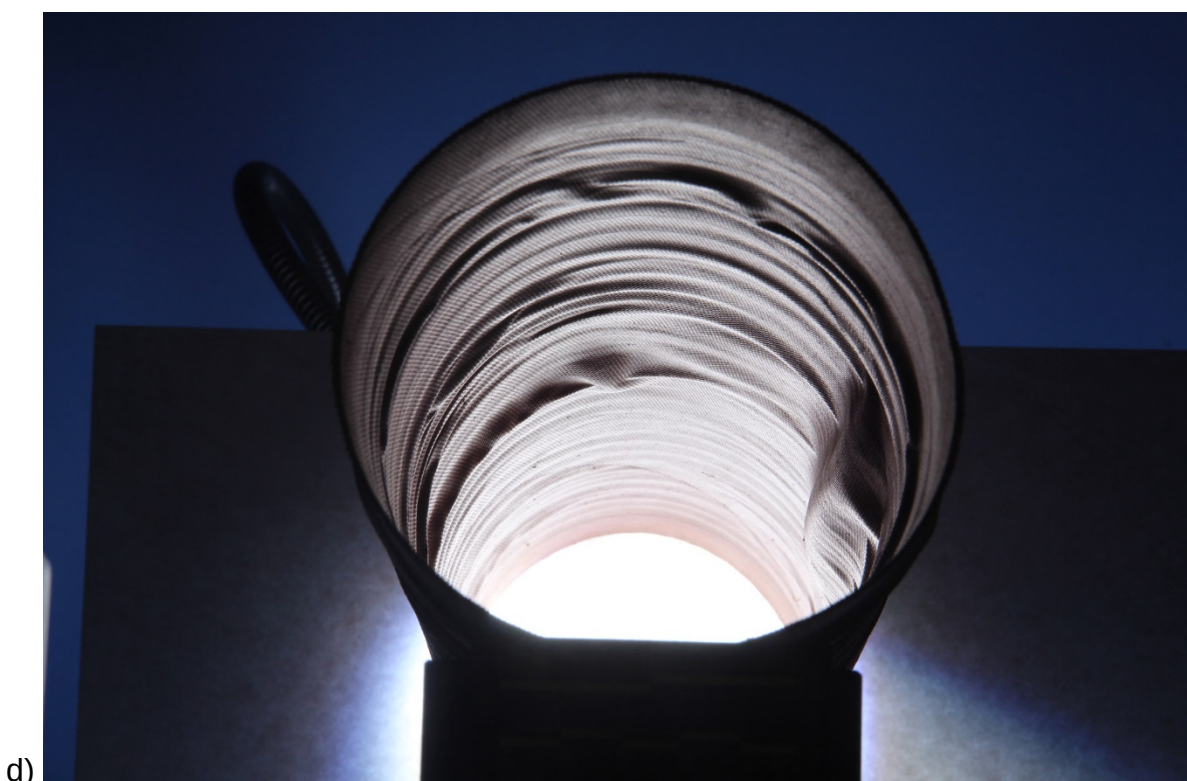
**Figure 3:** Images of the internal volume of the duct backlit to highlight separations and wrinkles: a) right side as oriented; b) lower side as oriented;

**Figure 3 (cont.):** c) left side as oriented; and d) upper side as oriented.

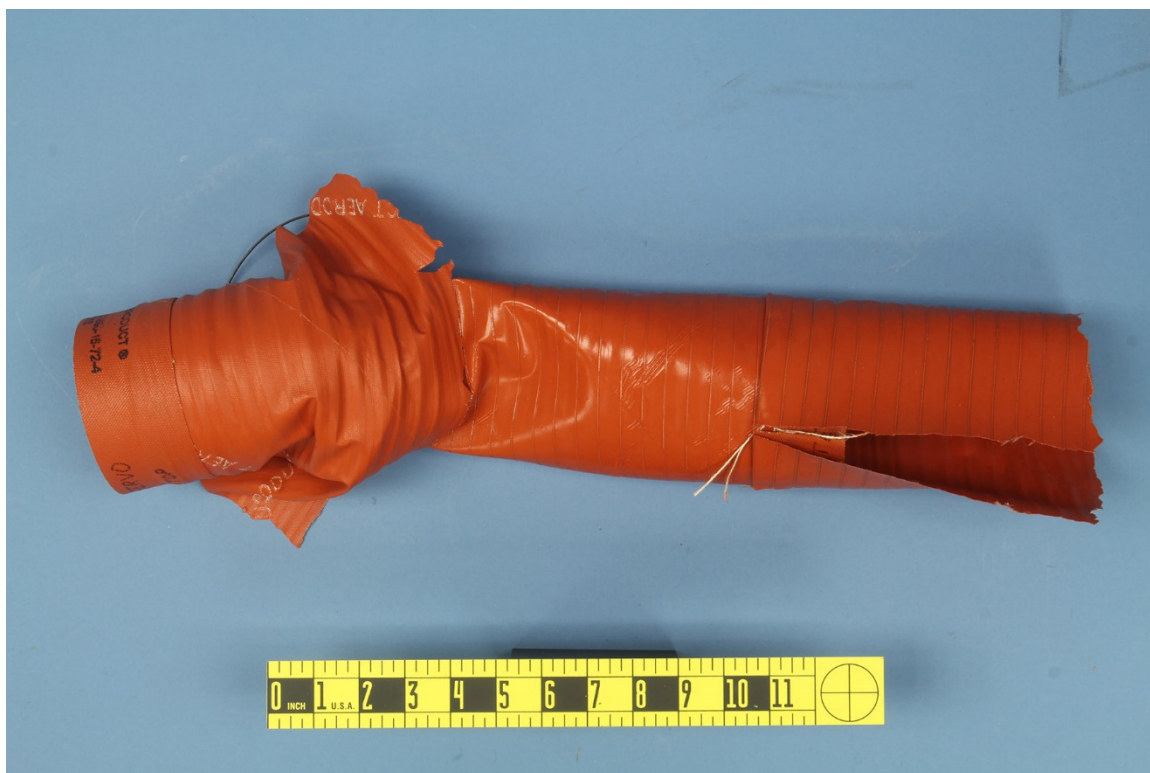
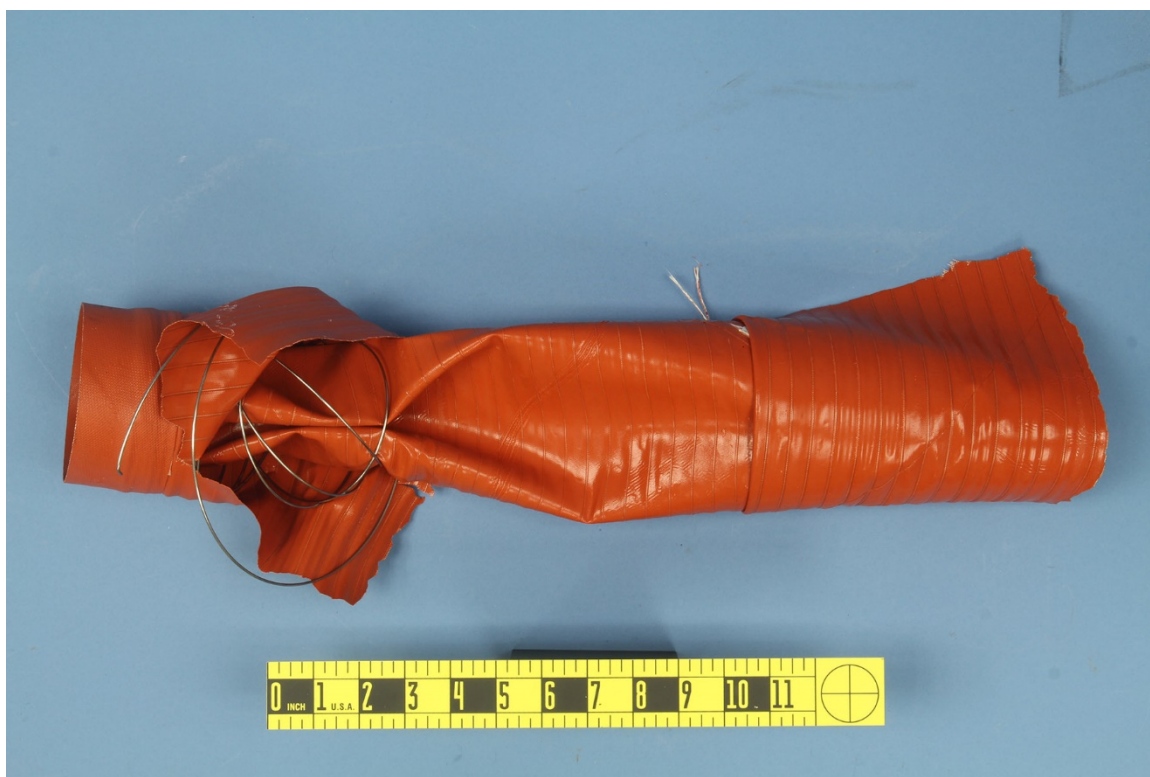
The duct was dissected to examine the condition of the internal surfaces of the inner and outer layers and the steel wire. A utility knife was used to cut the outer fiberglass cords. They were then unwound and removed from the duct. The outer layer was then cut using the utility knife, first circumferentially, and then in each longitudinal direction. The coiled wire was cut in half and one half was detached from its anchor under the cuff to aid inspection of the rubber. The duct in its dissected condition is shown in figures 4a and 4b. There were few, if any, areas where the inner and outer layers were apparently bonded to one another.

**Figure 4:** Images of the SCEET tube from the accident vehicle after dissection: a) side view from one direction and b) side view from the opposing direction.

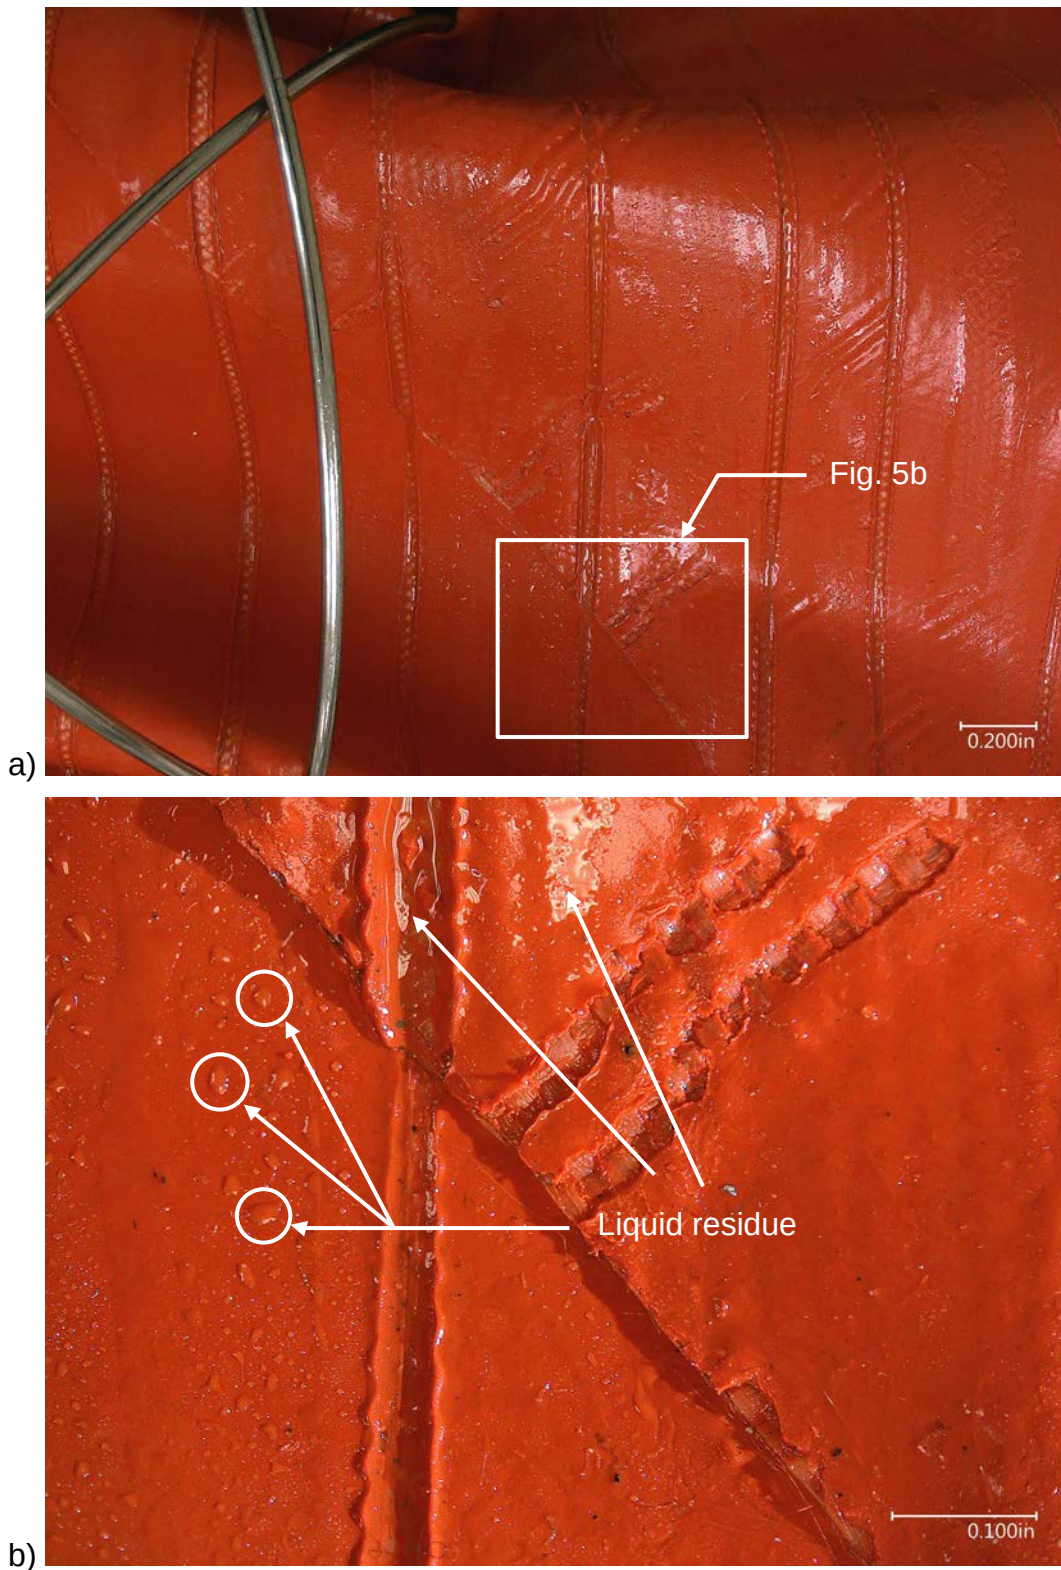
During dissection, it was noted that the rubber layers were bonded to the internal wire in some regions but not in others. One area that was not bonded is shown in figures 5a and 5b, where the internal surface of the inner layer can be seen along with the helical wire and impressions left by the wire in the rubberized cloth. The region was tacky to the touch and when viewed at high magnification, a liquid residue was observed, as indicated in figure 5b. The residue was present as discrete droplets in some areas, a film in others, and was also present in the wire impressions.

**Figure 5:** Higher magnification images of the accident duct inner layer internal surface: a) reference image of inner layer and b) higher magnification image at the location indicated showing droplets and a film of a tacky liquid residue.

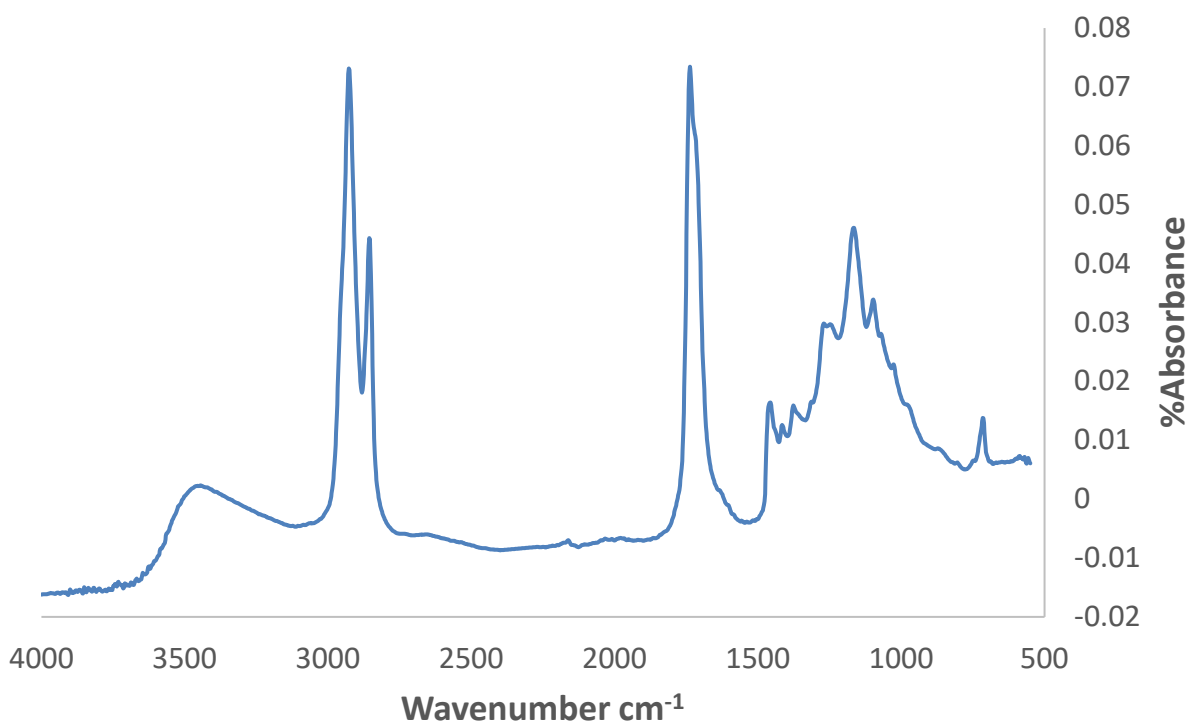
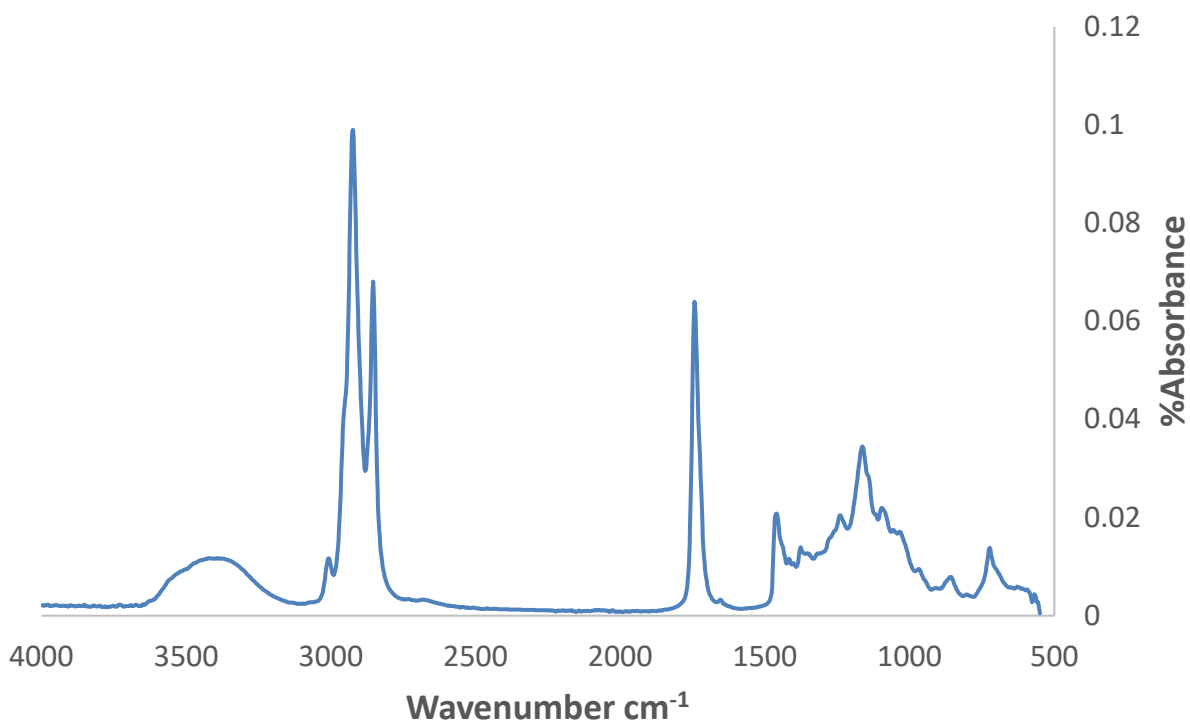
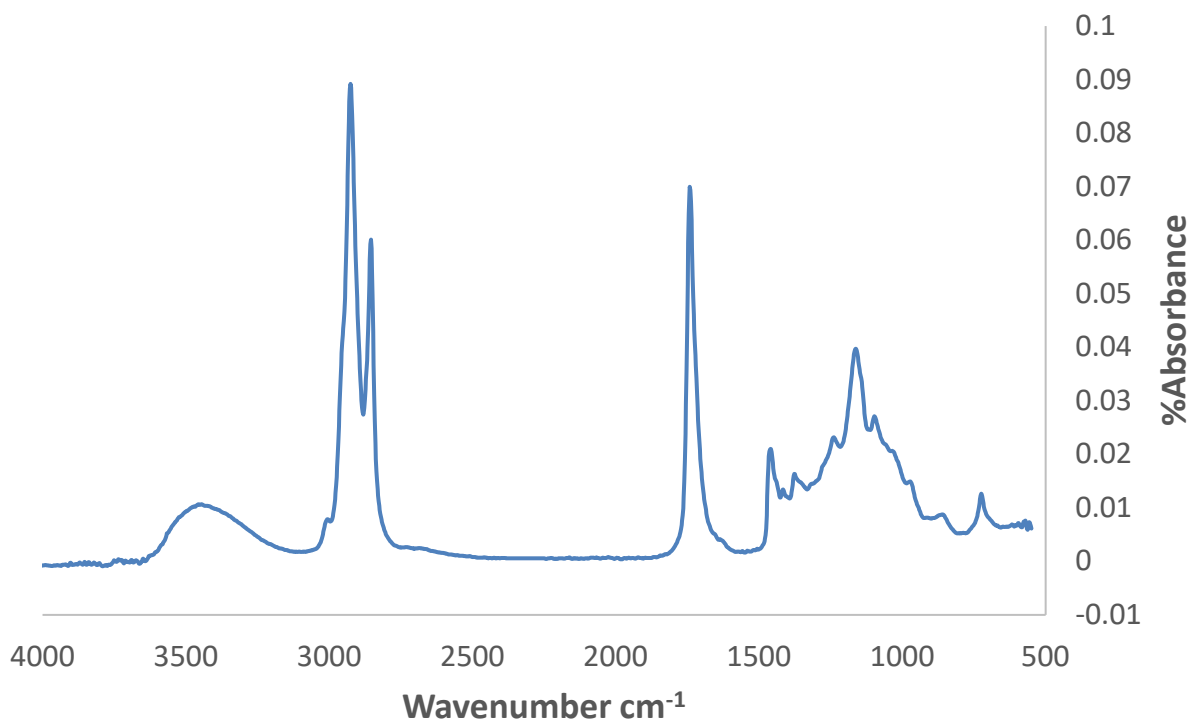
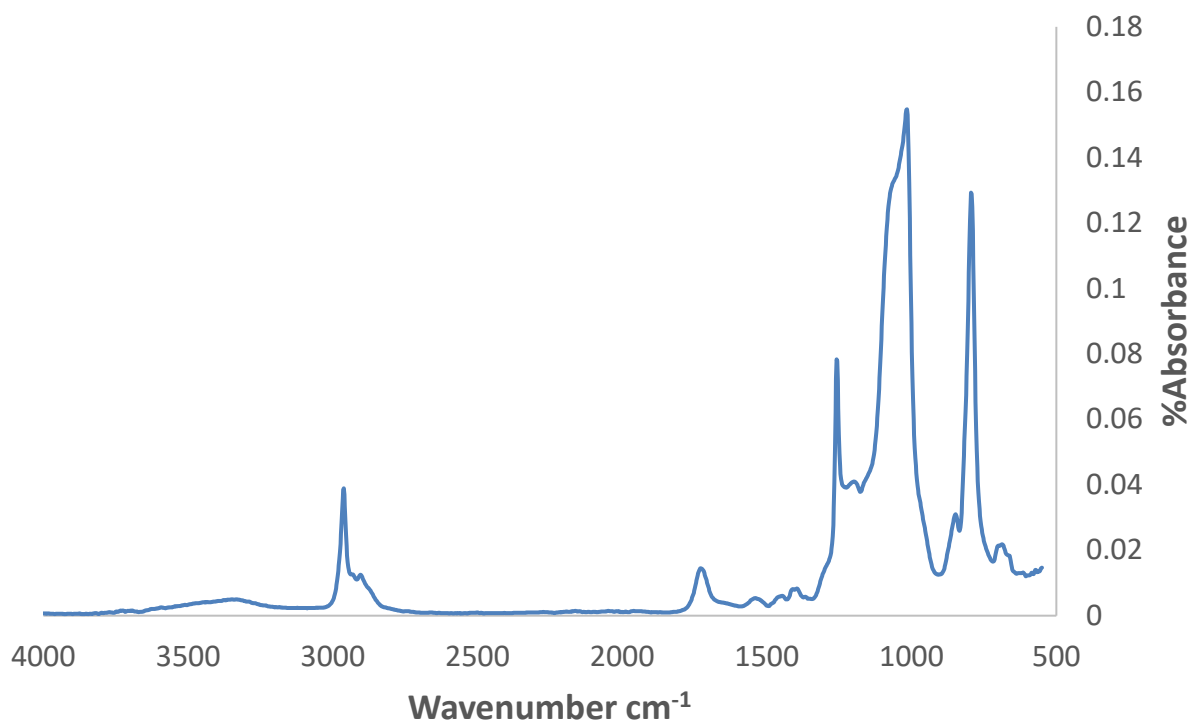
The wooden shaft of a cotton-tip applicator was carved to a knife edge and used to collect a sample of the residue from the inner liner. The sample was analyzed using Fourier-transform infrared spectroscopy (FTIR) on an attenuated total reflectance (ATR) bench accessory equipped with a single bounce diamond/ZnSe crystal. The absorbance spectrum for the unknown substance is shown in figure 6a. A search for the spectrum identification using an online library of reference spectra returned best matches for several oxidized vegetable oils including castor oil.

The oven-exposed castor oil spectrum indicated that the oven exposure resulted in an attenuation of the small peak near  $3,000\text{ cm}^{-1}$  and a broadening of the peak near  $1,740\text{ cm}^{-1}$ . The spectrum for the water-based material exhibited strong peaks near  $1,020\text{ cm}^{-1}$  and  $796\text{ cm}^{-1}$  and was not comparable to the residue spectrum.

**Figure 6:** FTIR/ATR spectra as follows: a) residue from accident duct; b) castor oil as received;

**Figure 6 (cont.):** c) castor oil after 2 hr at 140 °C; and d) water-based release agent.

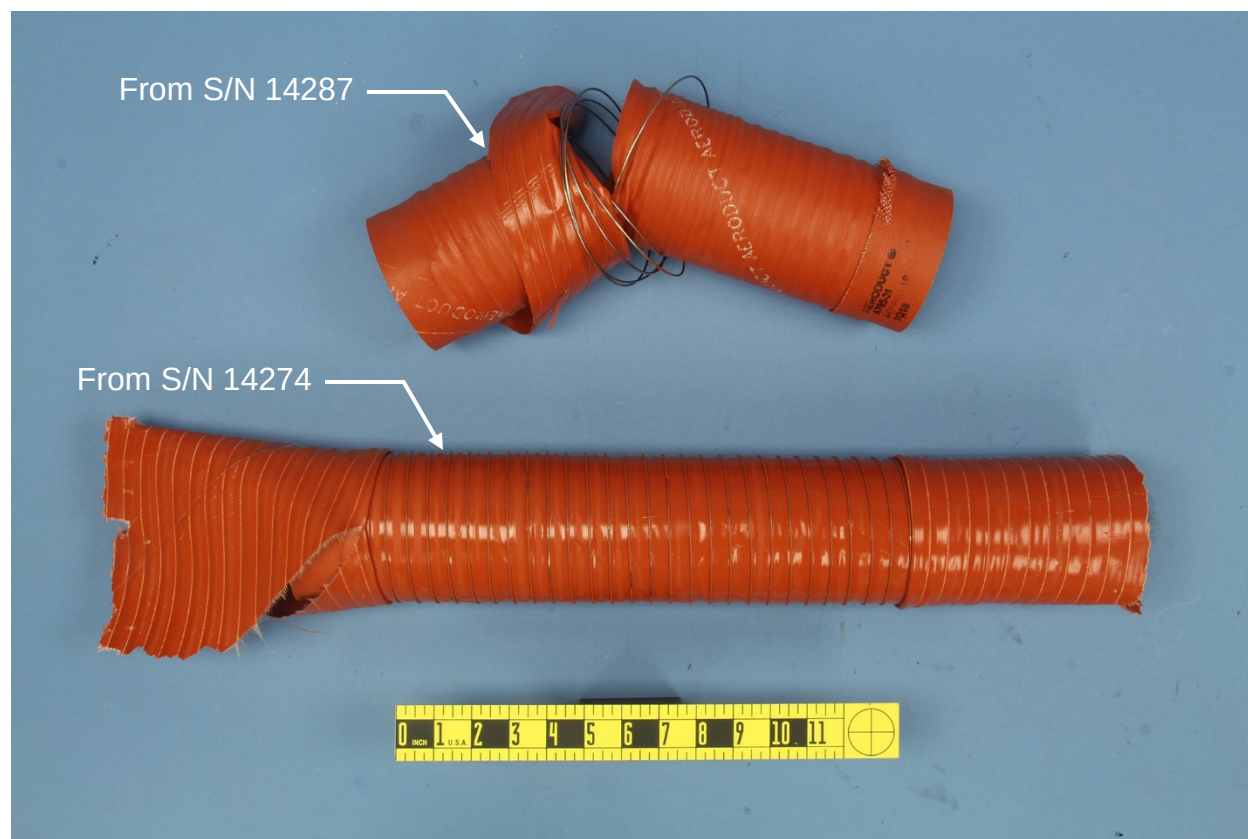
Three exemplar ducts were submitted to the lab for examination. Two of the ducts had the same 1Q18 lot number as the accident duct and a third duct had a 1Q19 lot number. The two 1Q18 lot number ducts are shown in figure 7. The duct in the top part of the image was removed from aircraft serial number 14287 and the duct in the bottom part of the image was removed from aircraft serial number 14274. The 1Q19 duct was a new duct and had not been installed on an aircraft.

**Figure 7:** Image of exemplar ducts from aircraft serial numbers 14287 and 14274.

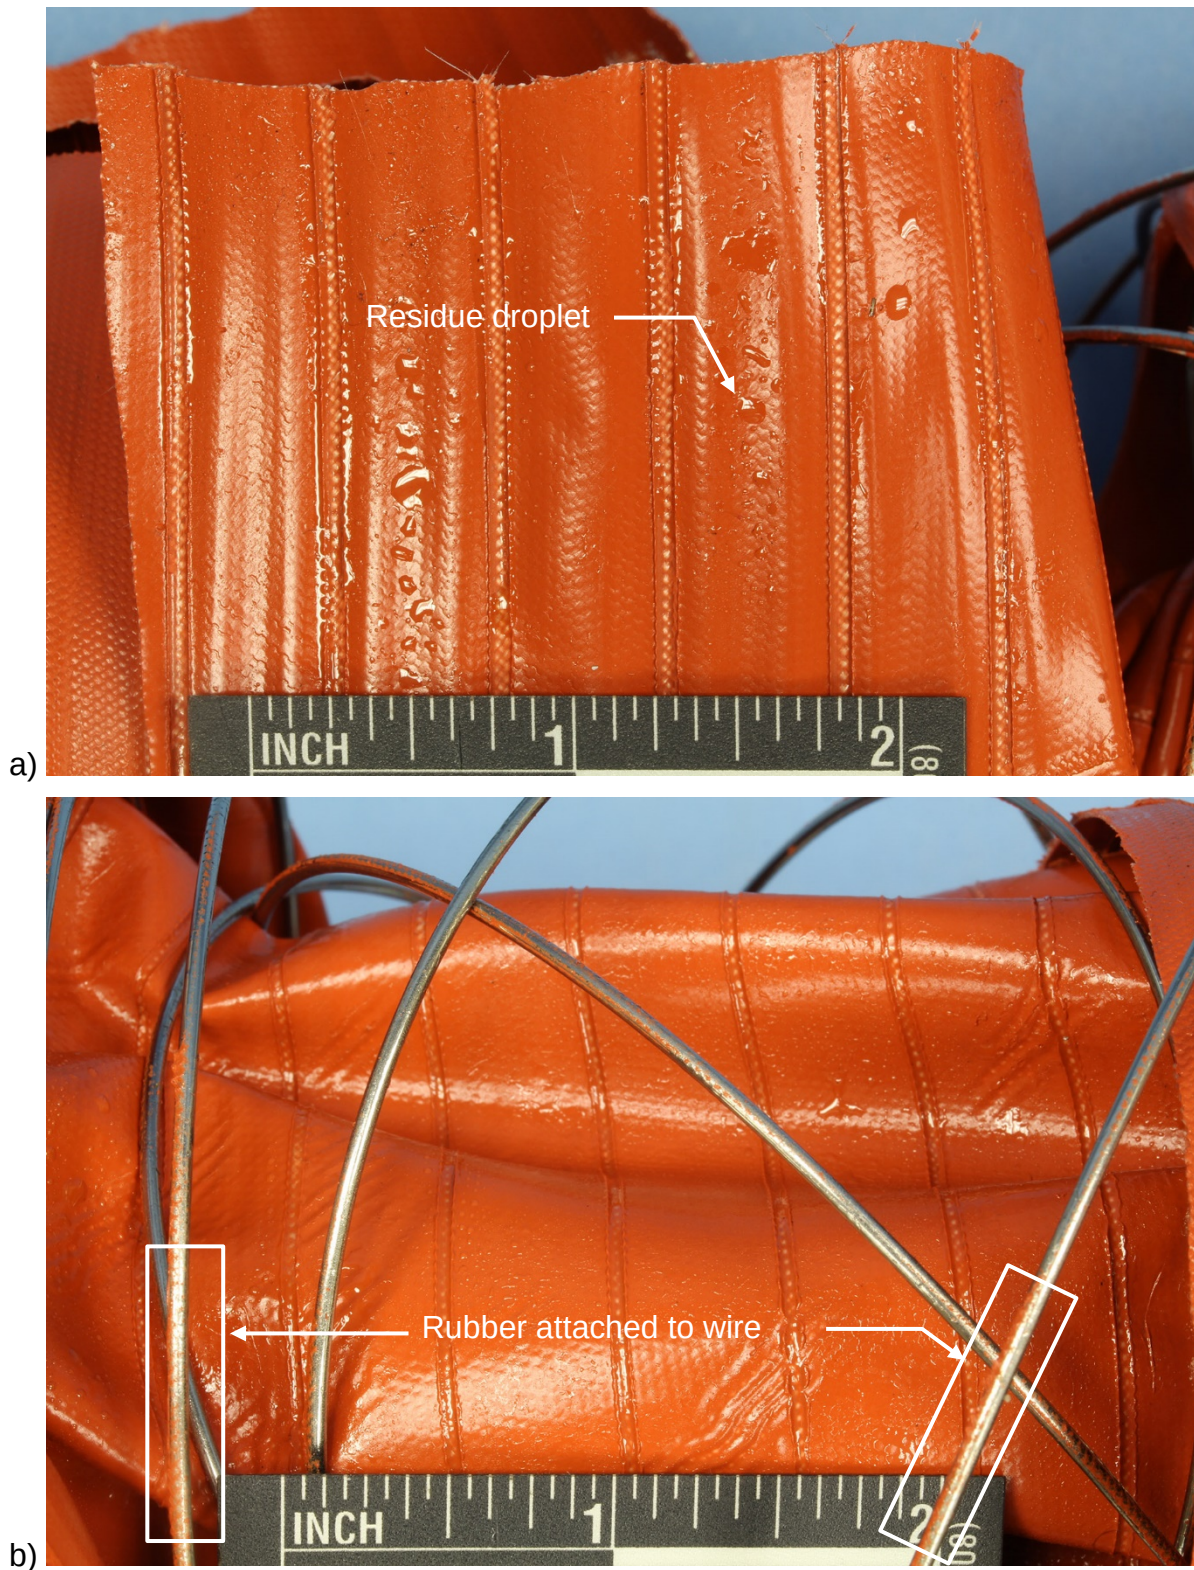
The 1Q18 ducts were dissected in a similar manner as the accident duct. The duct from S/N 14287 exhibited similar features as the accident duct and is shown in figures 8a and 8b. The inner and outer layers were not bonded to one another and droplets of the tacky residue were also present as shown in figure 8a. Traces of silicone rubber remained bonded to some of the helical wire after disassembly, as seen in figure 8b. The duct from S/N 14274 exhibited both bonding of the layers to the wire and some features consistent with co-curing of the inner and outer layer, as seen in figure 9. Visual and tactile examination did not reveal any apparent tacky residue on the internal surfaces.

**Figure 8:** Images of the exemplar duct from aircraft serial number 14287: a) outer layer internal surface showing droplets of residue and b) inner layer and helical wire showing pieces of rubber attached to the wire.

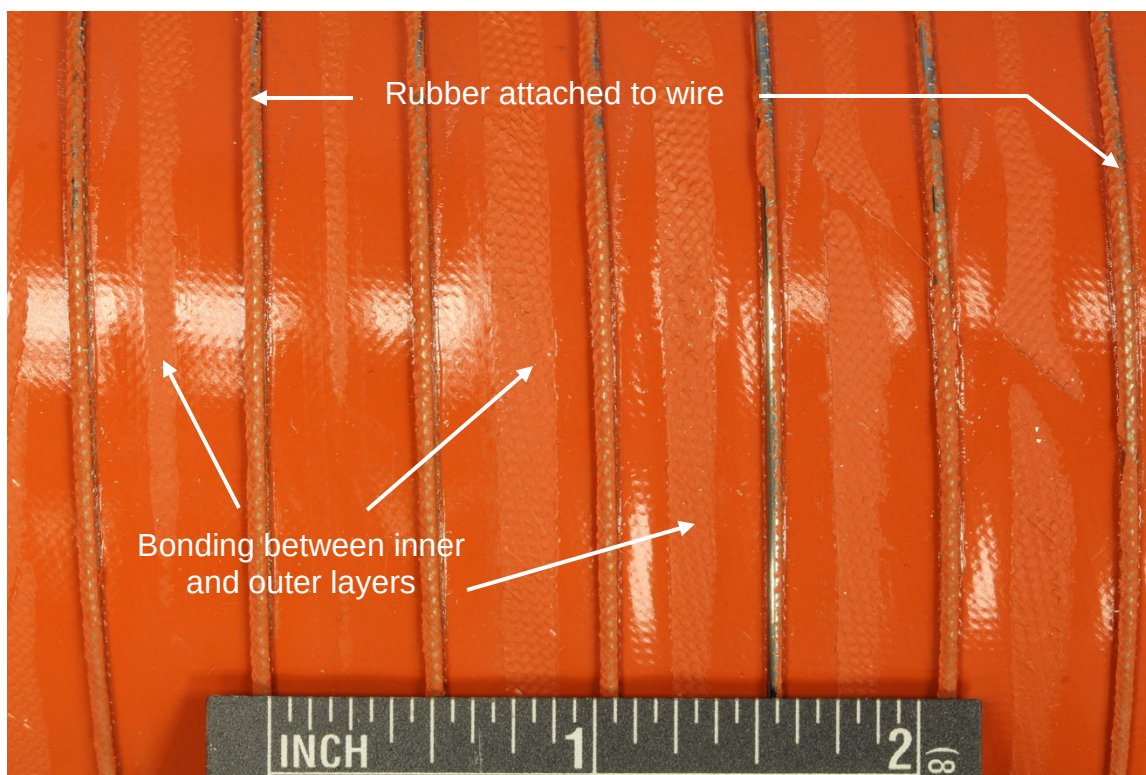
**Figure 9:** Image of the exemplar duct from aircraft serial number 14274 showing rubber attached to the wire and bonding between inner and outer layers.

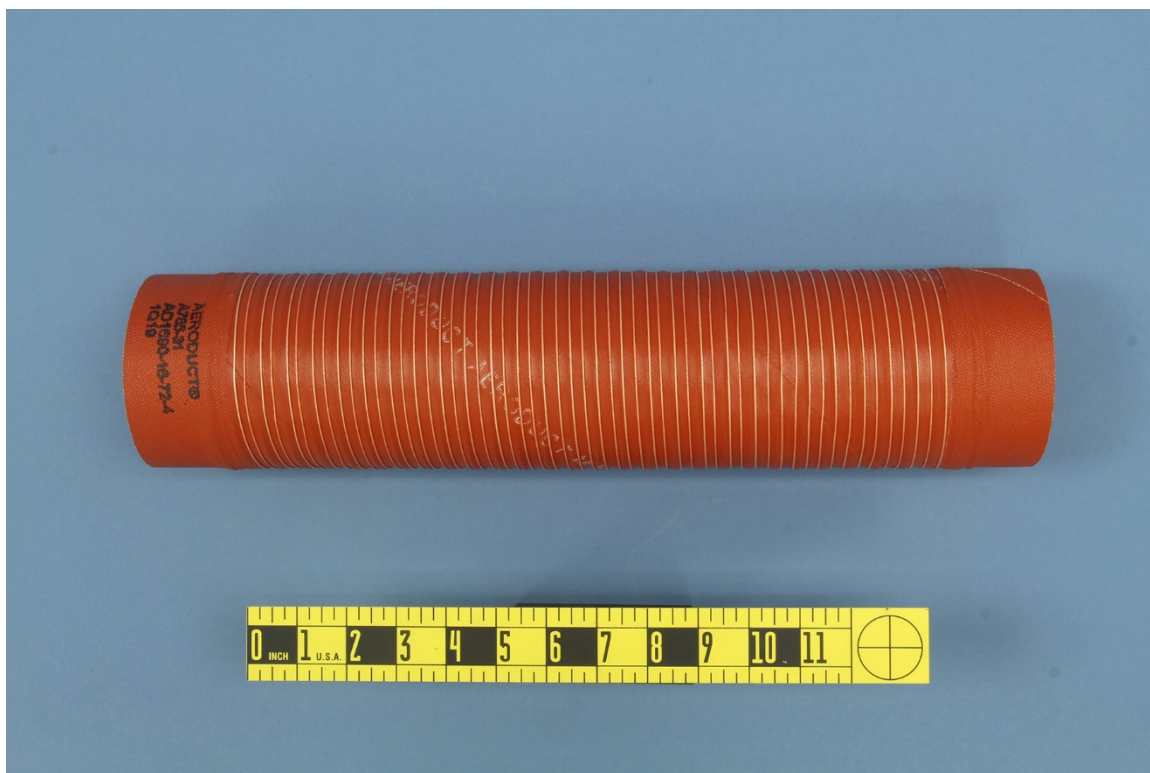
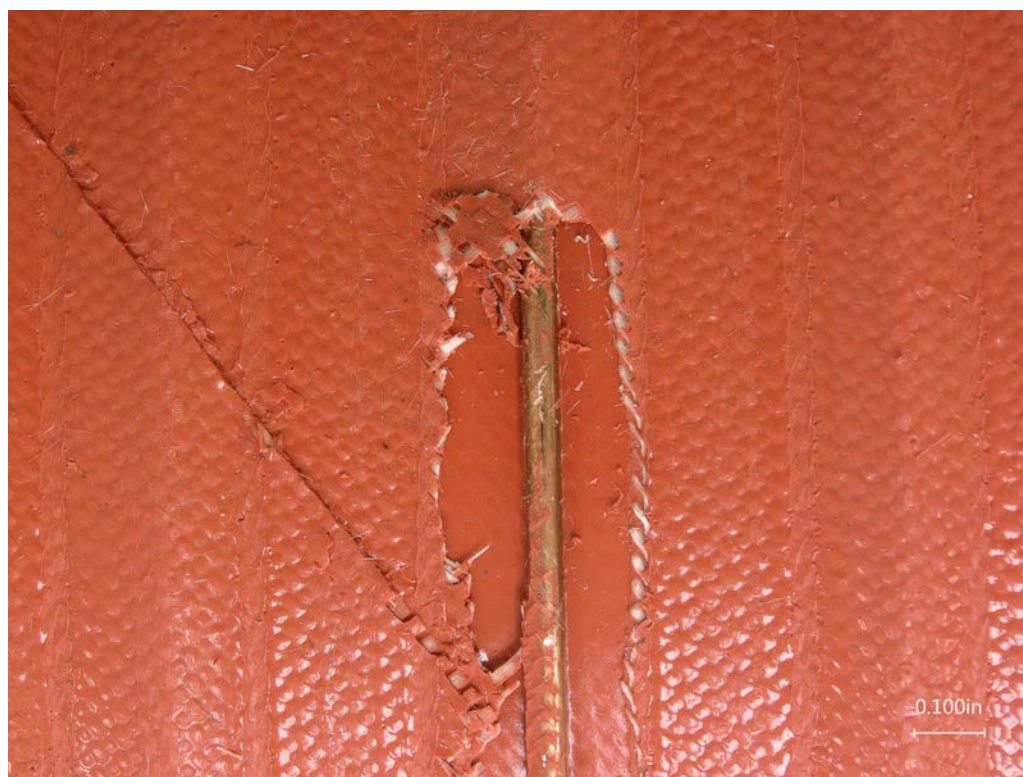
A dissection of the 1Q19 duct was attempted but it was not possible to disassemble the duct in the same manner as the 1Q18 ducts. Images of the 1Q19 duct are shown in figures 10a and 10b. The outer fiberglass cords were removed and a circumferential cut was made, but when an attempt was made to peel the outer layer back, it could not be removed due to the co-curing between the inner and outer layers. Instead the cloth fibers on the outer layer tore while attempting to peel the outer layer. Instead, cuts were made on either side of a piece of wire and a small flap of the outer layer was removed as shown in figure 10b. The outer layer was bonded to the wire, which exhibited a copper color.

**Figure 10:** Images of an exemplar duct from lot 1Q19: a) overview image and b) image of exposed steel wire and adjacent internal surface of inner layer after cutting away a section of the outer layer.
