# Technical document

## EPM examination

Document ID: **BEA2019-0208\_tec02**  
Registration number: **N572MD**  
Aircraft type: GUIMBAL - CABRI - G2  
Date of occurrence: 4th May 2019  
Place of occurrence: Near Kent Island (Maryland)  
Equipment examined:

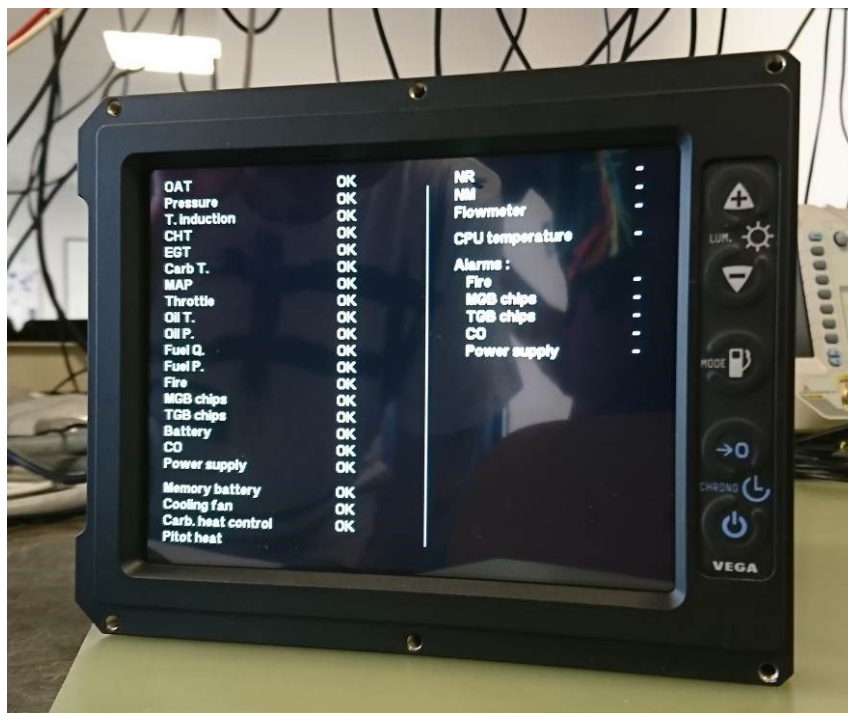
The alarms and sensors page was labelled “OK” for every sensor that is monitored by the EPM. Thus, no sensors failure was recorded during the last power-on of the device (see Appendix 2).

The power-up of the EPM showed that the memory component was functioning properly at the time of the event. No failure of the different sensors was recorded for the last flight.

*Figure 2: Picture of the alarms and sensors page of the EPM*
