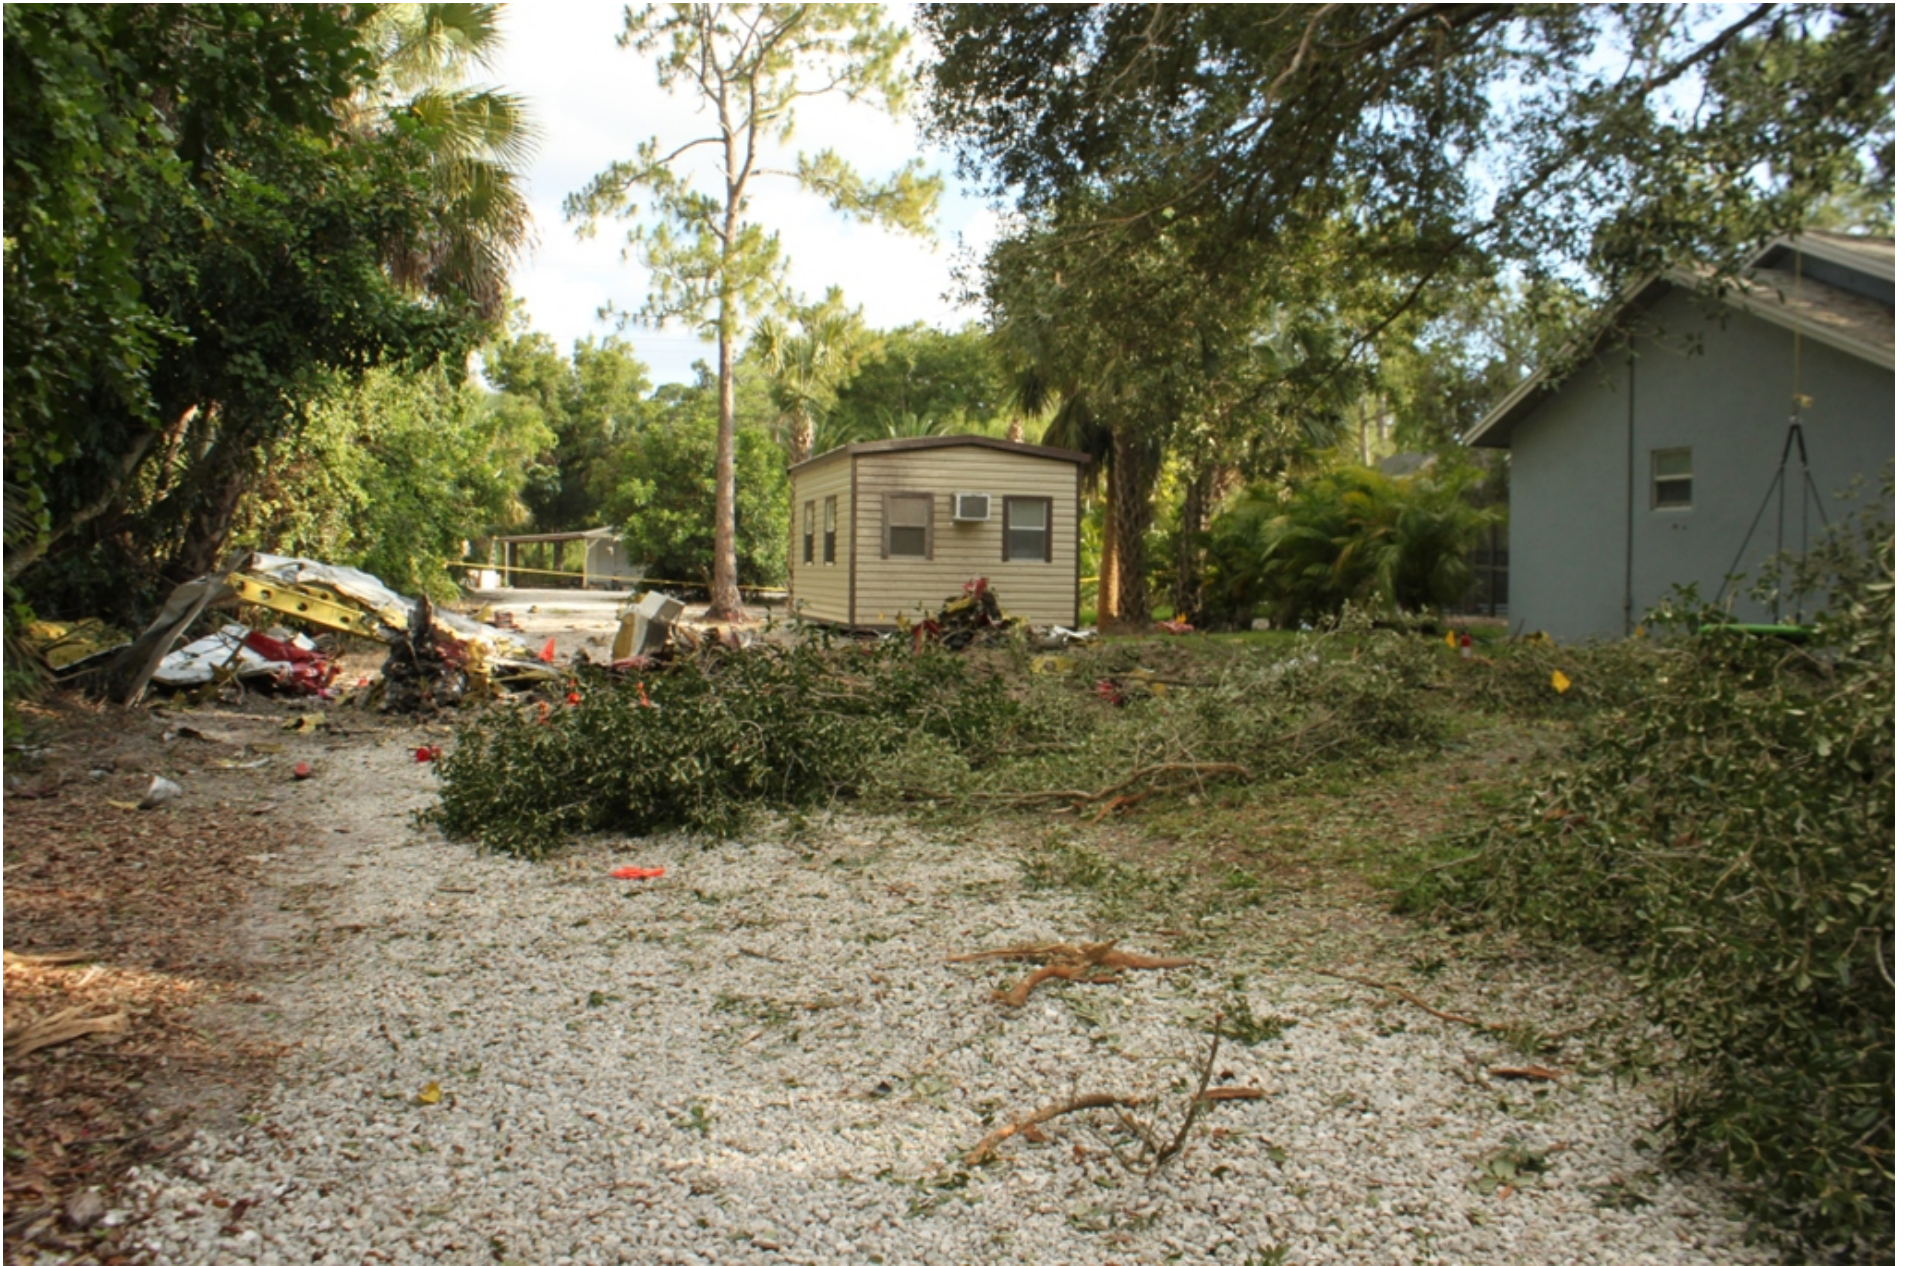
**Photo 1 – NTSB Digital Photograph. View taken Adjacent from Ground Impact Point Looking South. Note the Wreckage in the Background, and Downed Tree Limbs.**

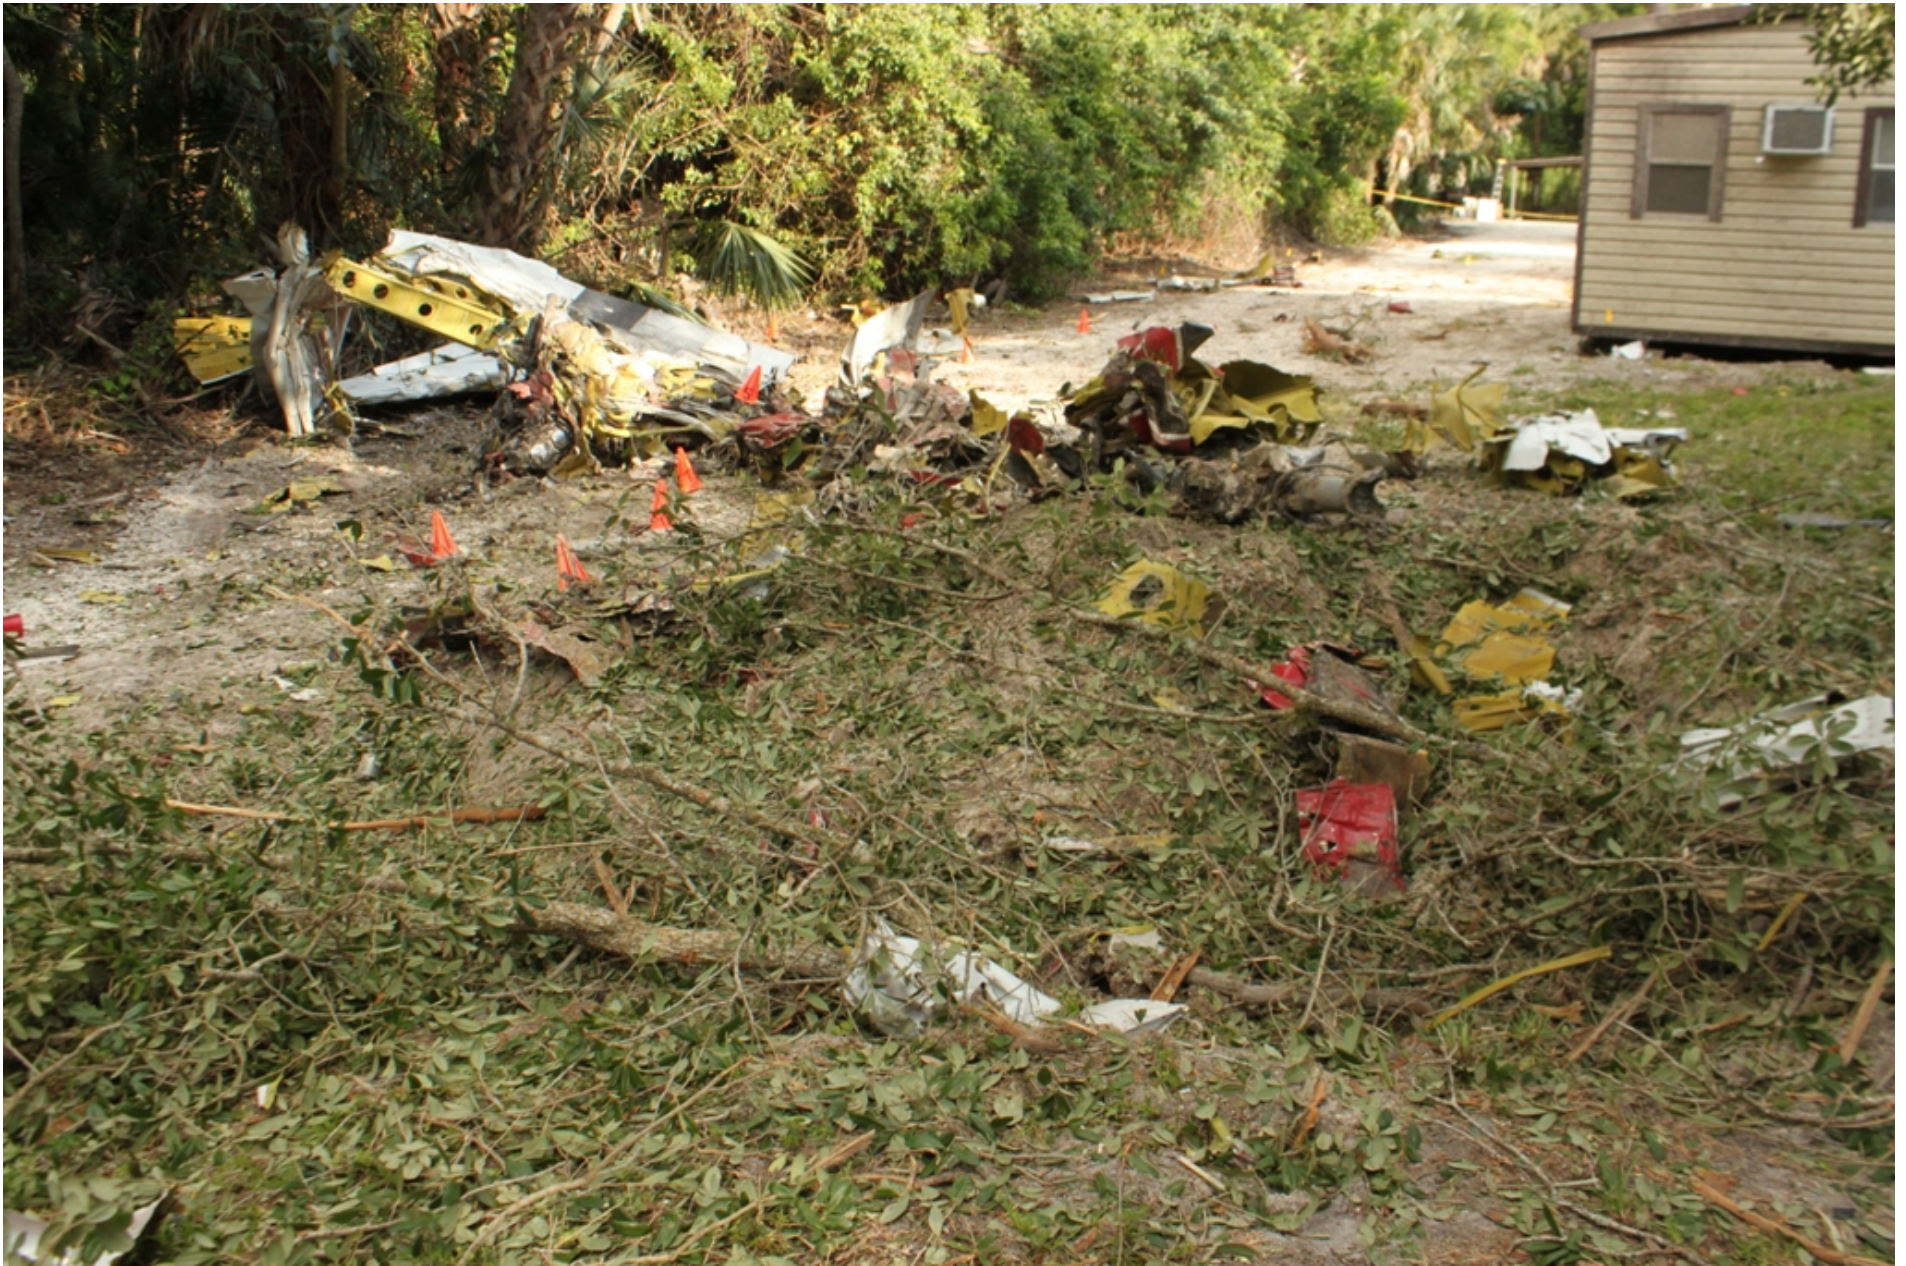
**Photo 2 - NTSB Digital Photograph. View taken Adjacent from Ground Impact Point Looking Southeast. Note the Wreckage in the Background, and Downed Tree Limbs.**

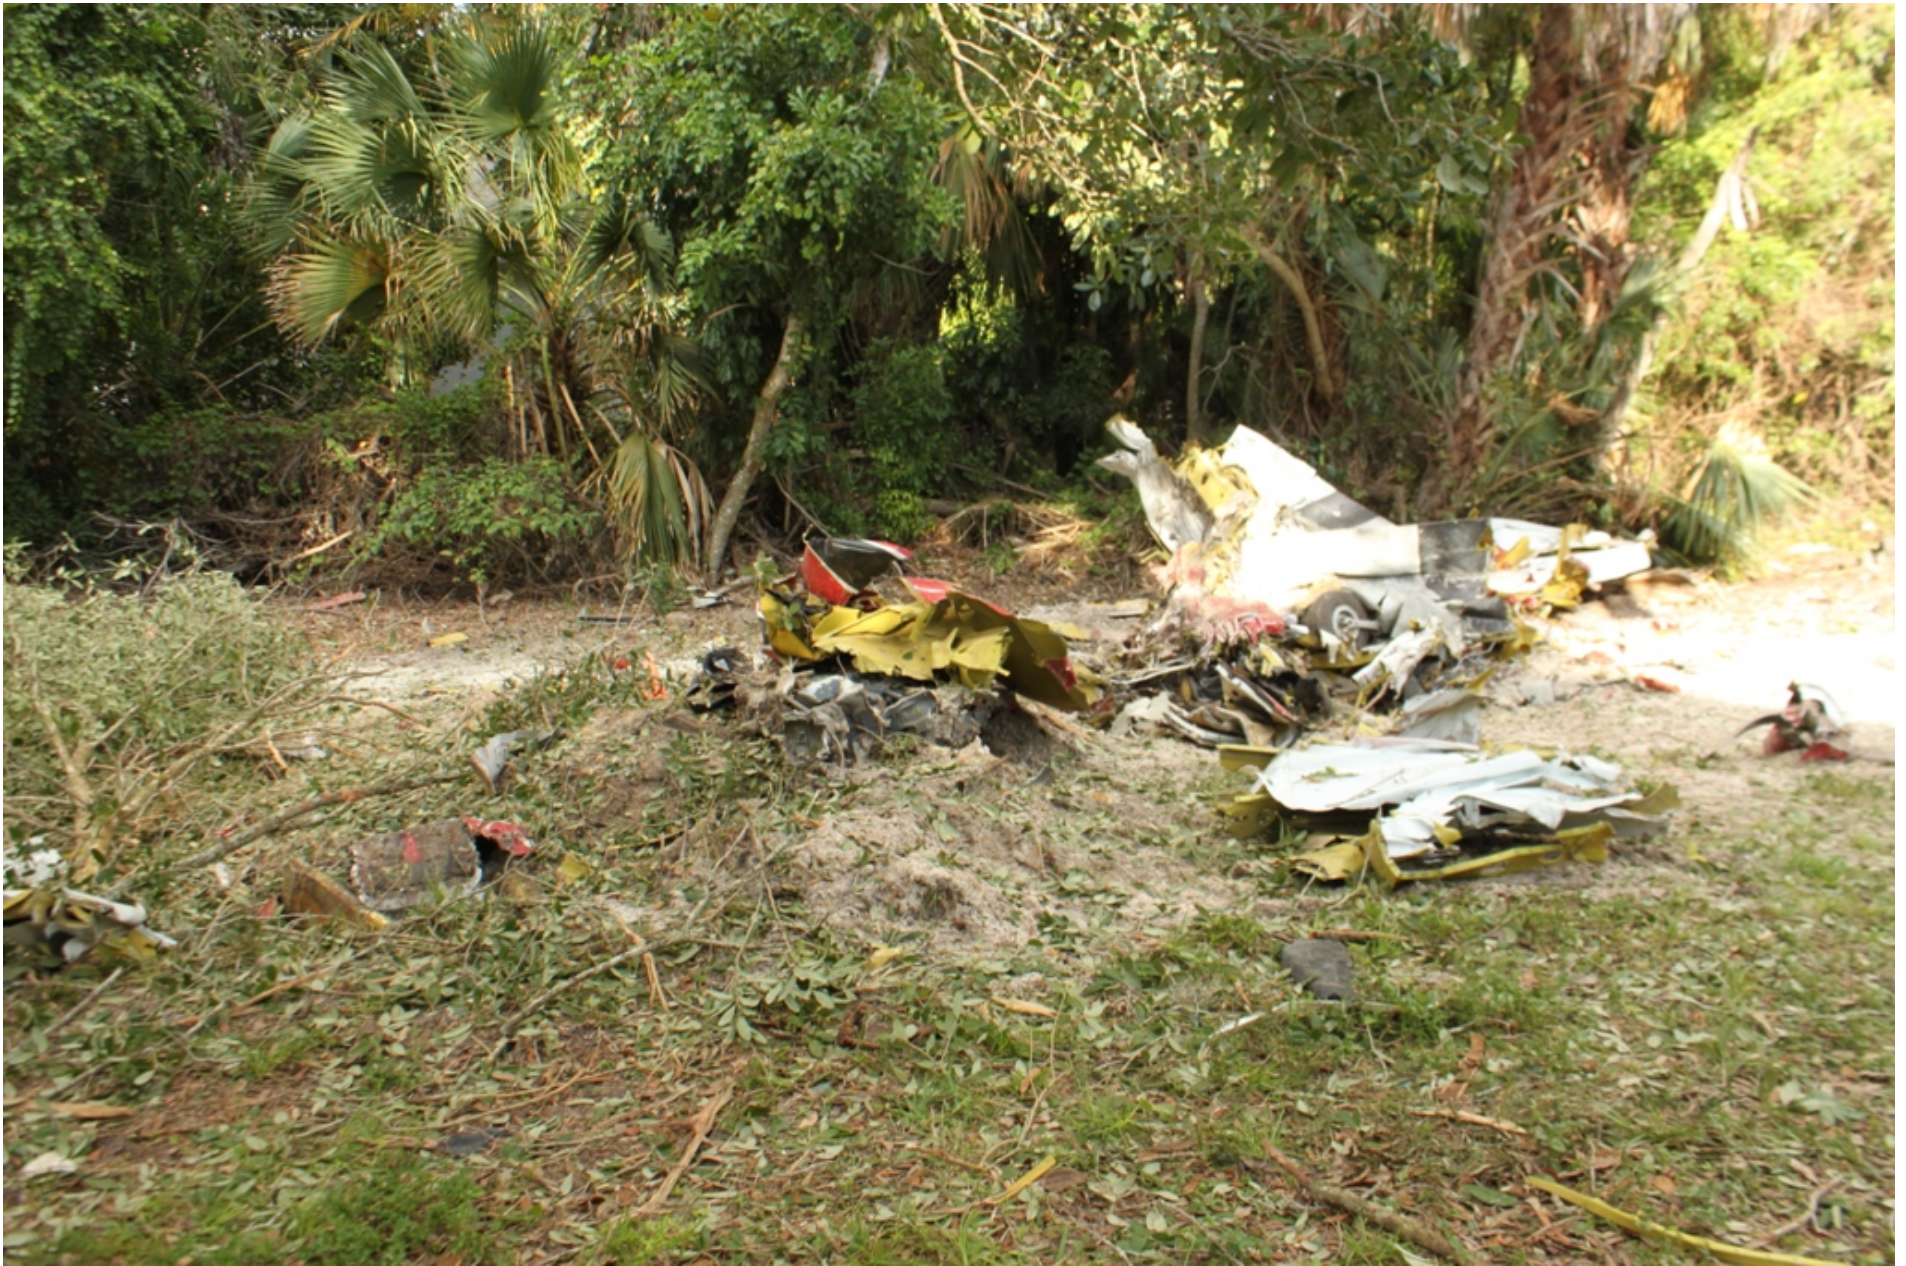
**Photo 3 – NTSB Digital Photograph. View taken Adjacent from Ground Impact Point Looking Southeast. Note the Wreckage in the Background.**

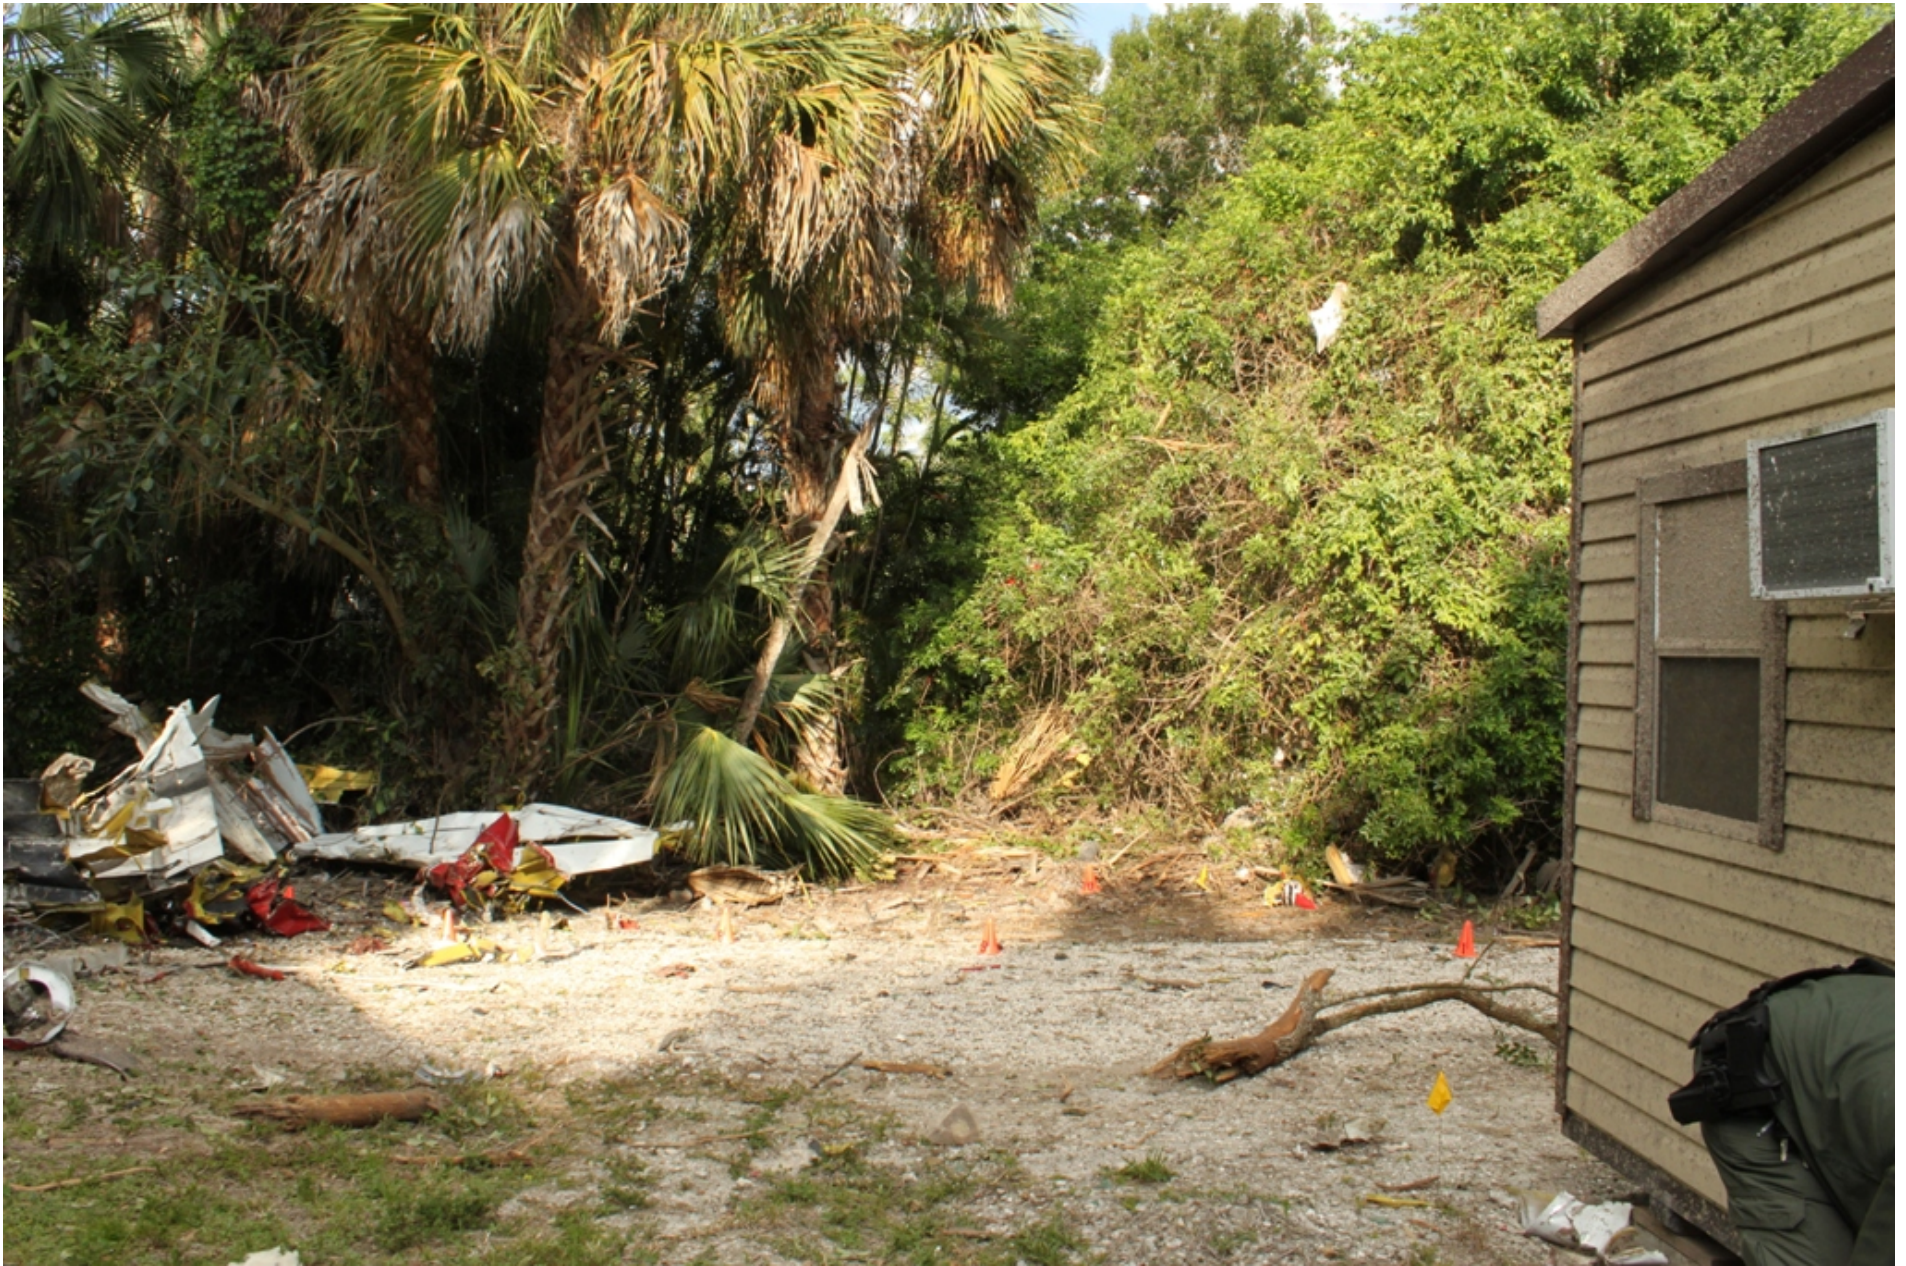
**Photo 4 - NTSB Digital Photograph. View Looking Easterly Direction. Note the Fragmented Wreckage in the Background.**

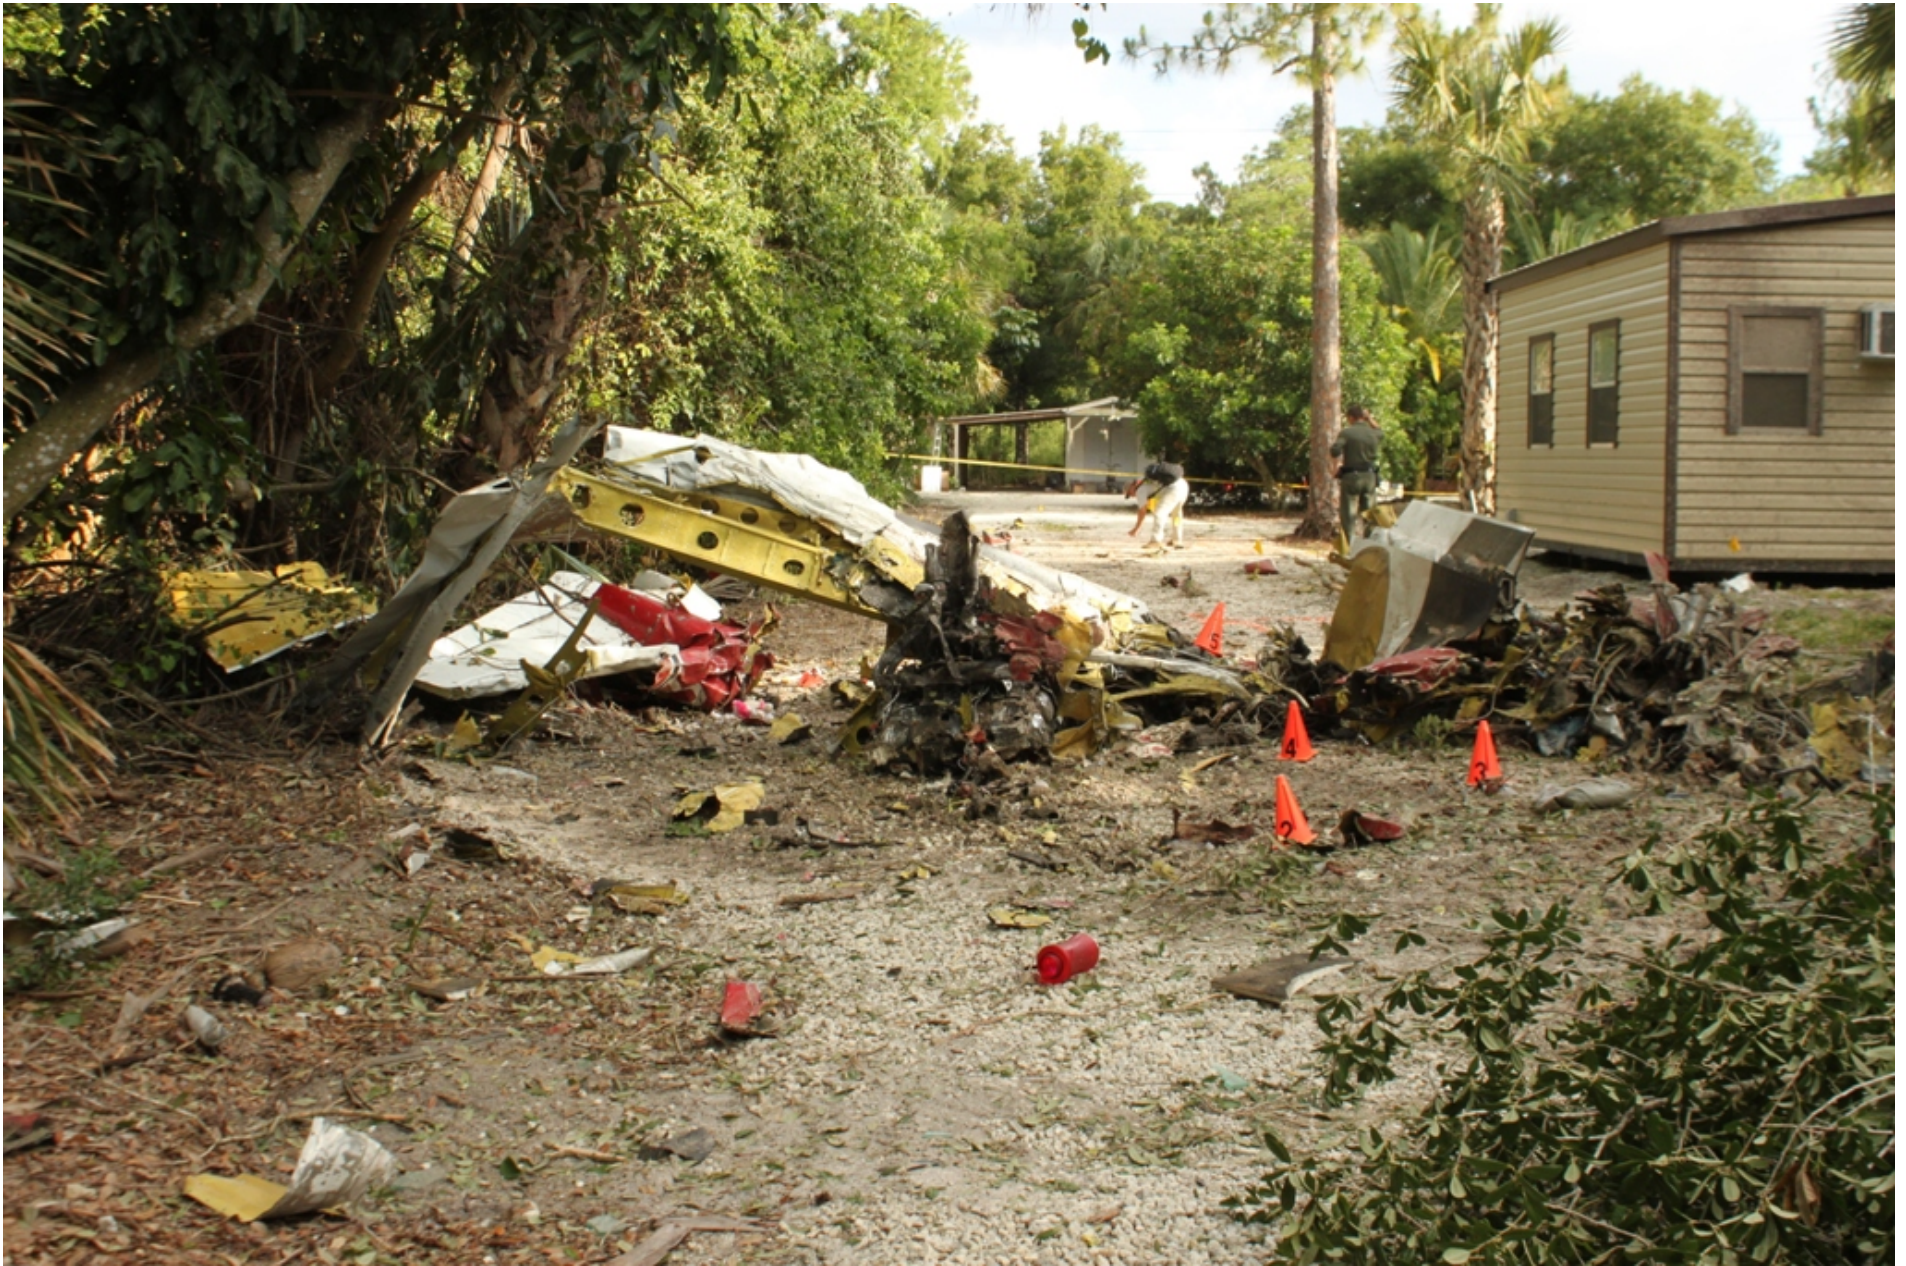
**Photo 5 – NTSB Digital Photograph. View Looking in a Southerly Direction. Note the Fragmented Wreckage including Parts of the Wings and Empennage.**

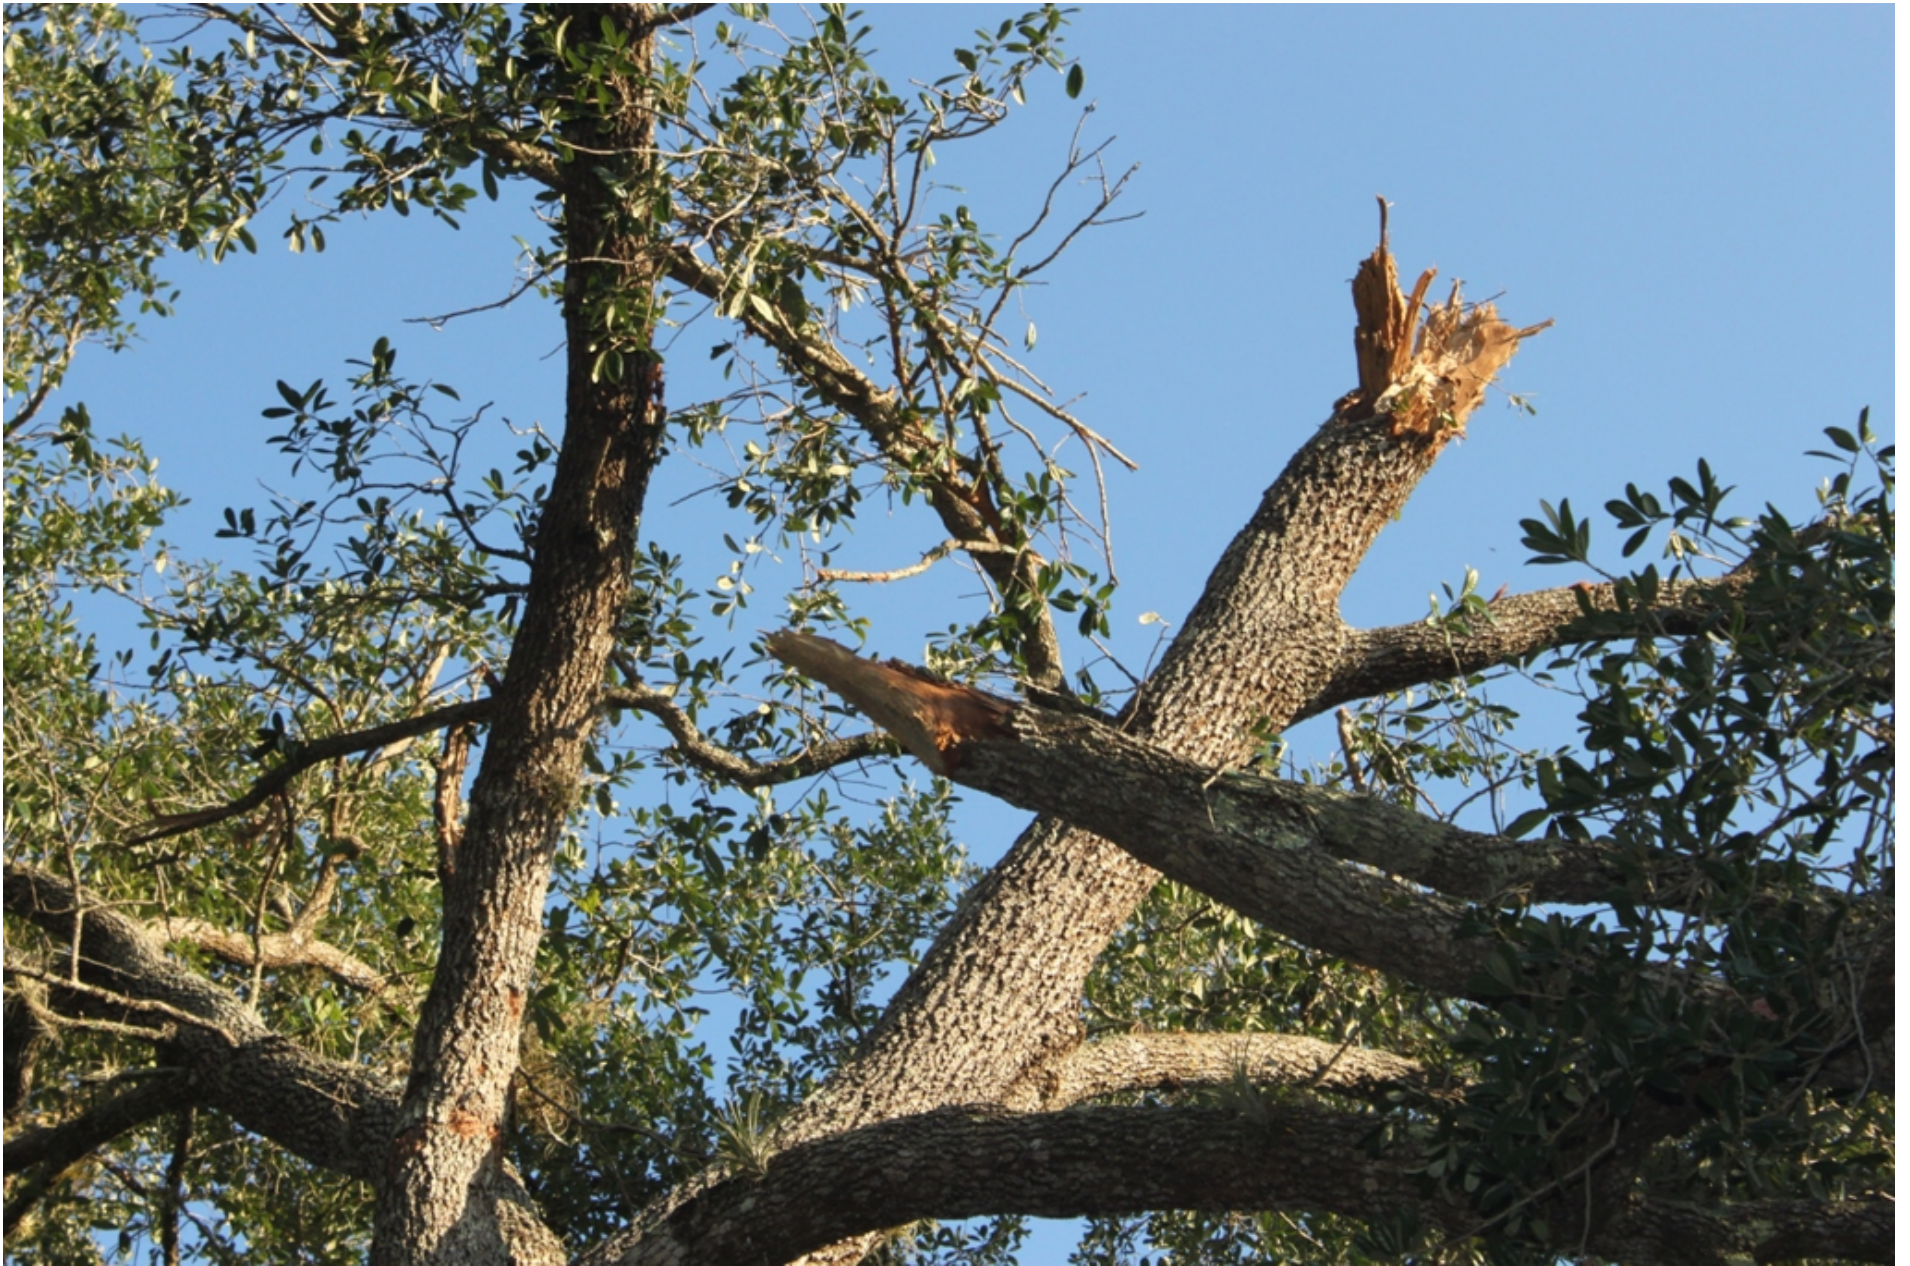
**Photo 6 – NTSB Digital Photograph. View Depicting the Fractured and Cut Tree Limbs of the Tree Adjacent to the House.**

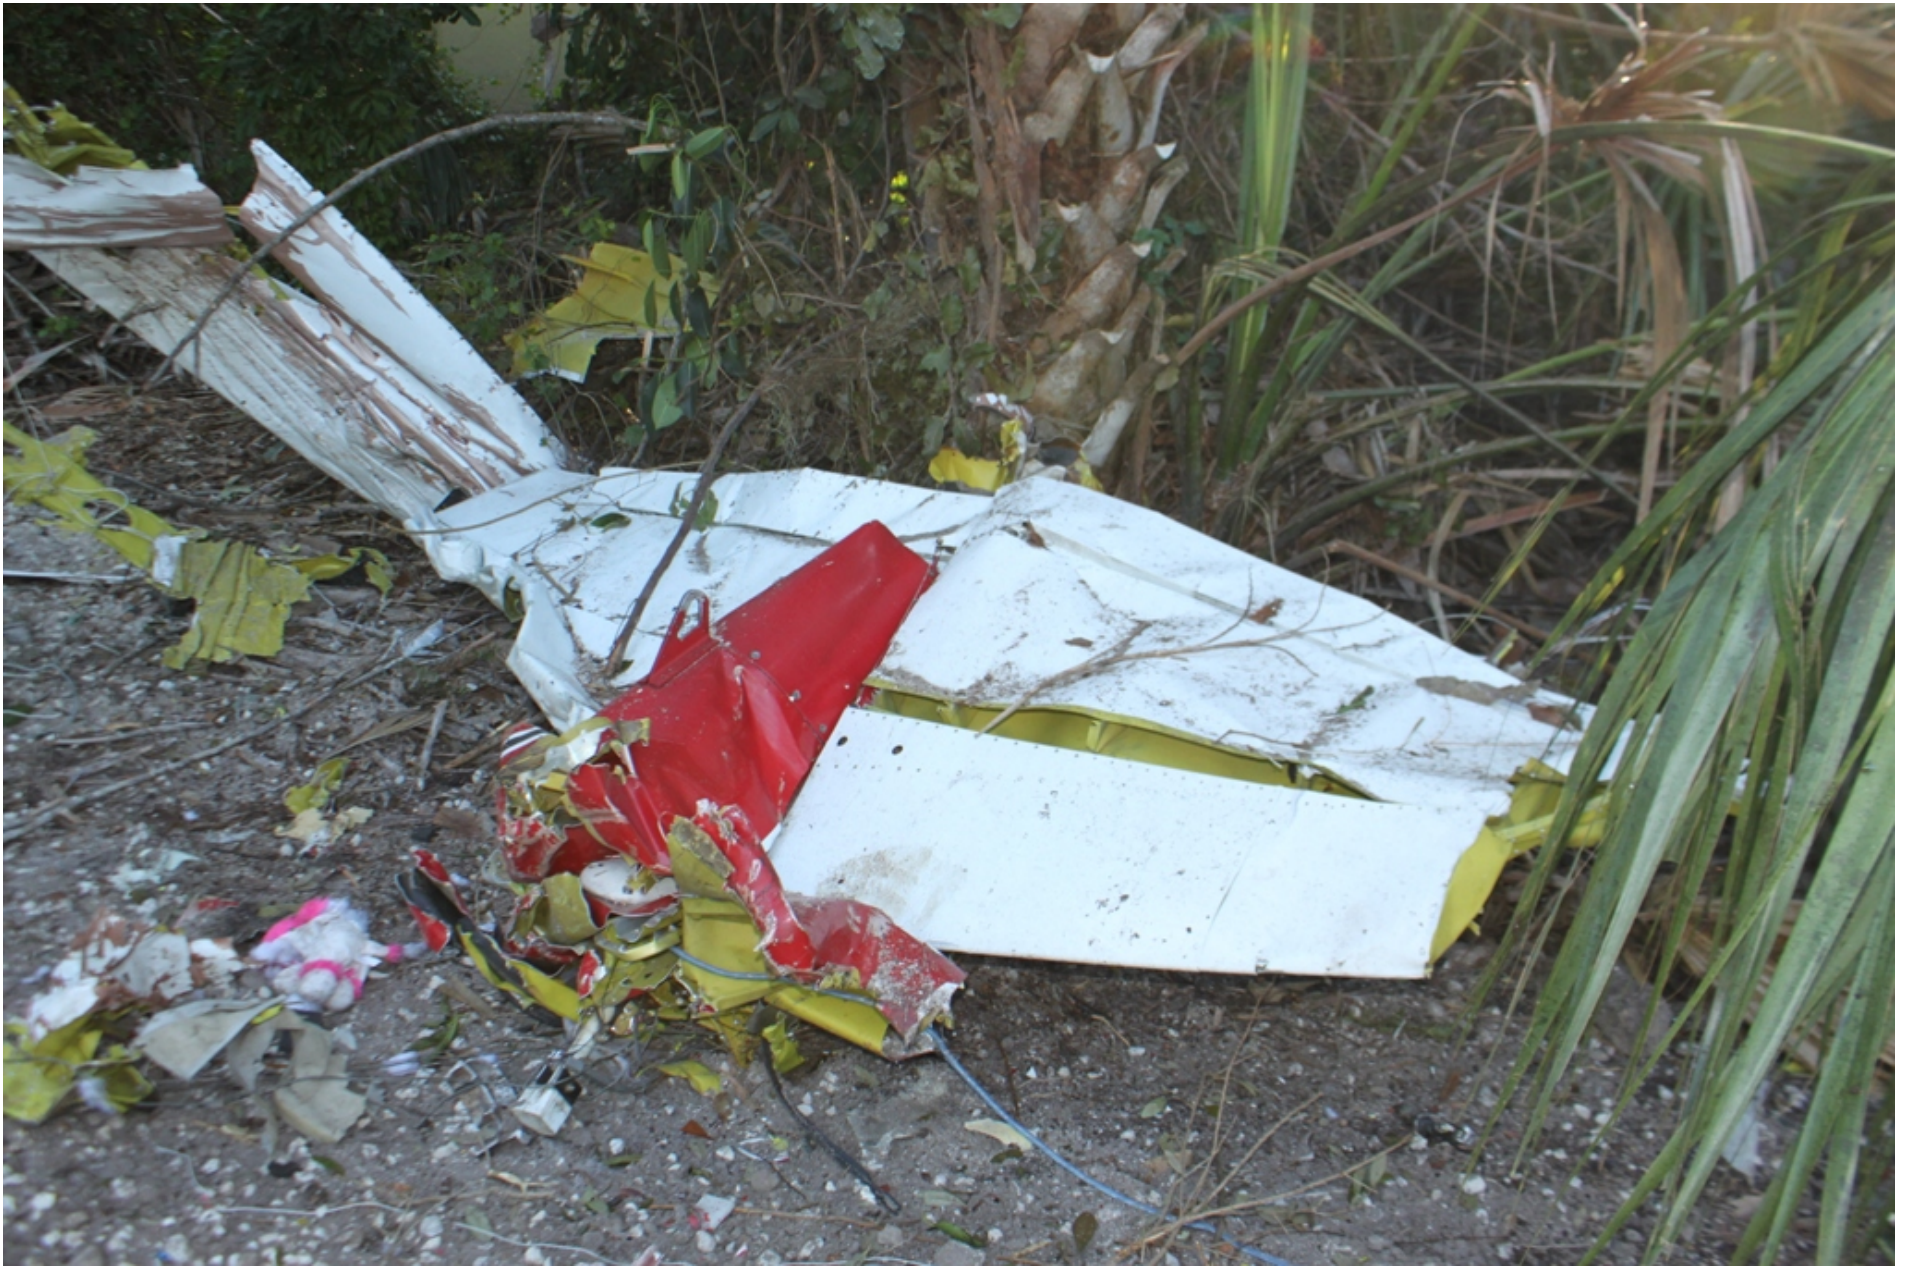
**Photo 7 – NTSB Digital Photograph. View Depicting the Separated Empennage.**

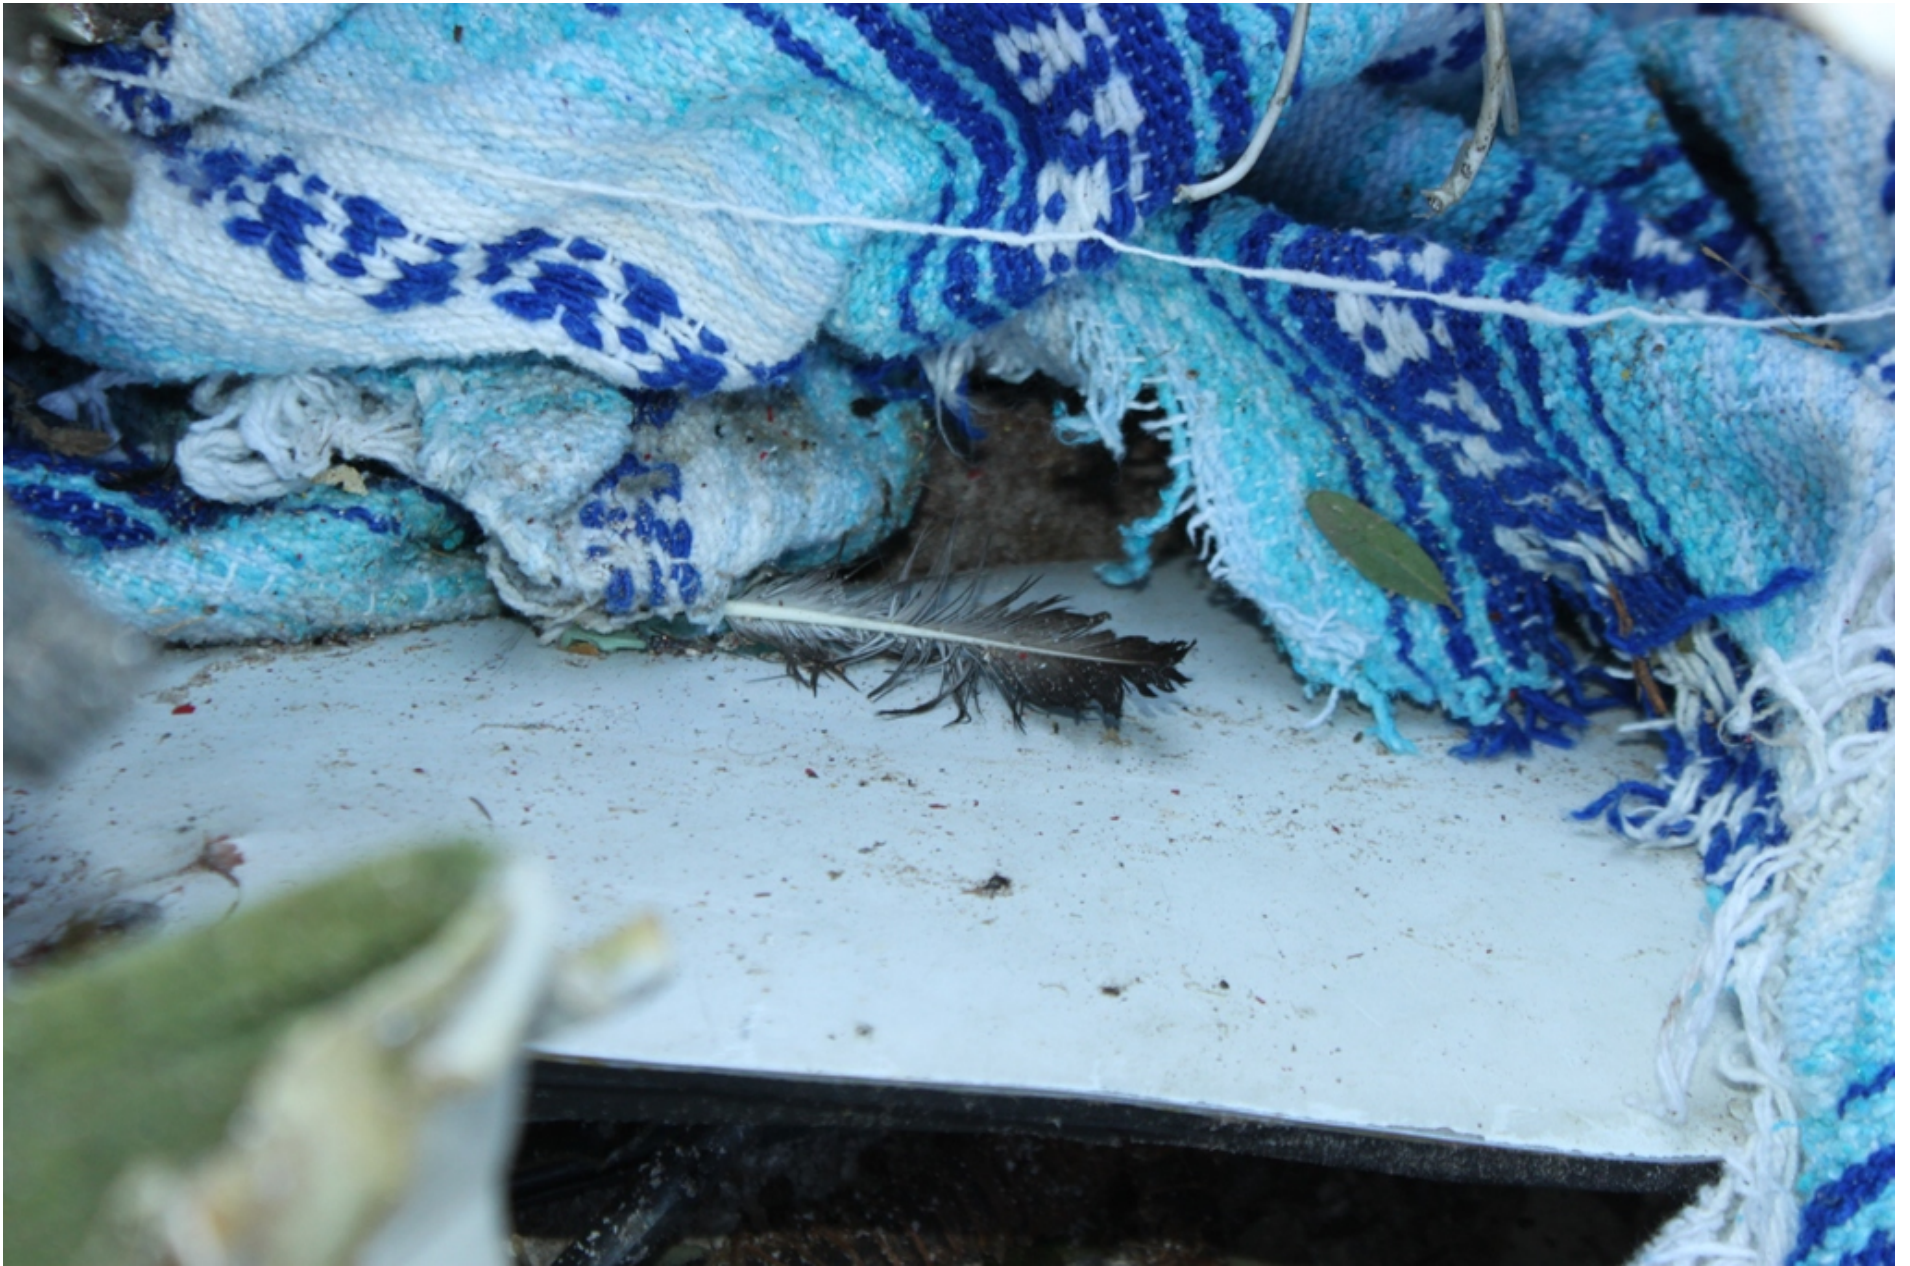
**Photo 8 - NTSB Digital Photograph. View Depicting a Feather Found Adhering to a Blanket Adjacent to the Separated Section of Right Wing.**

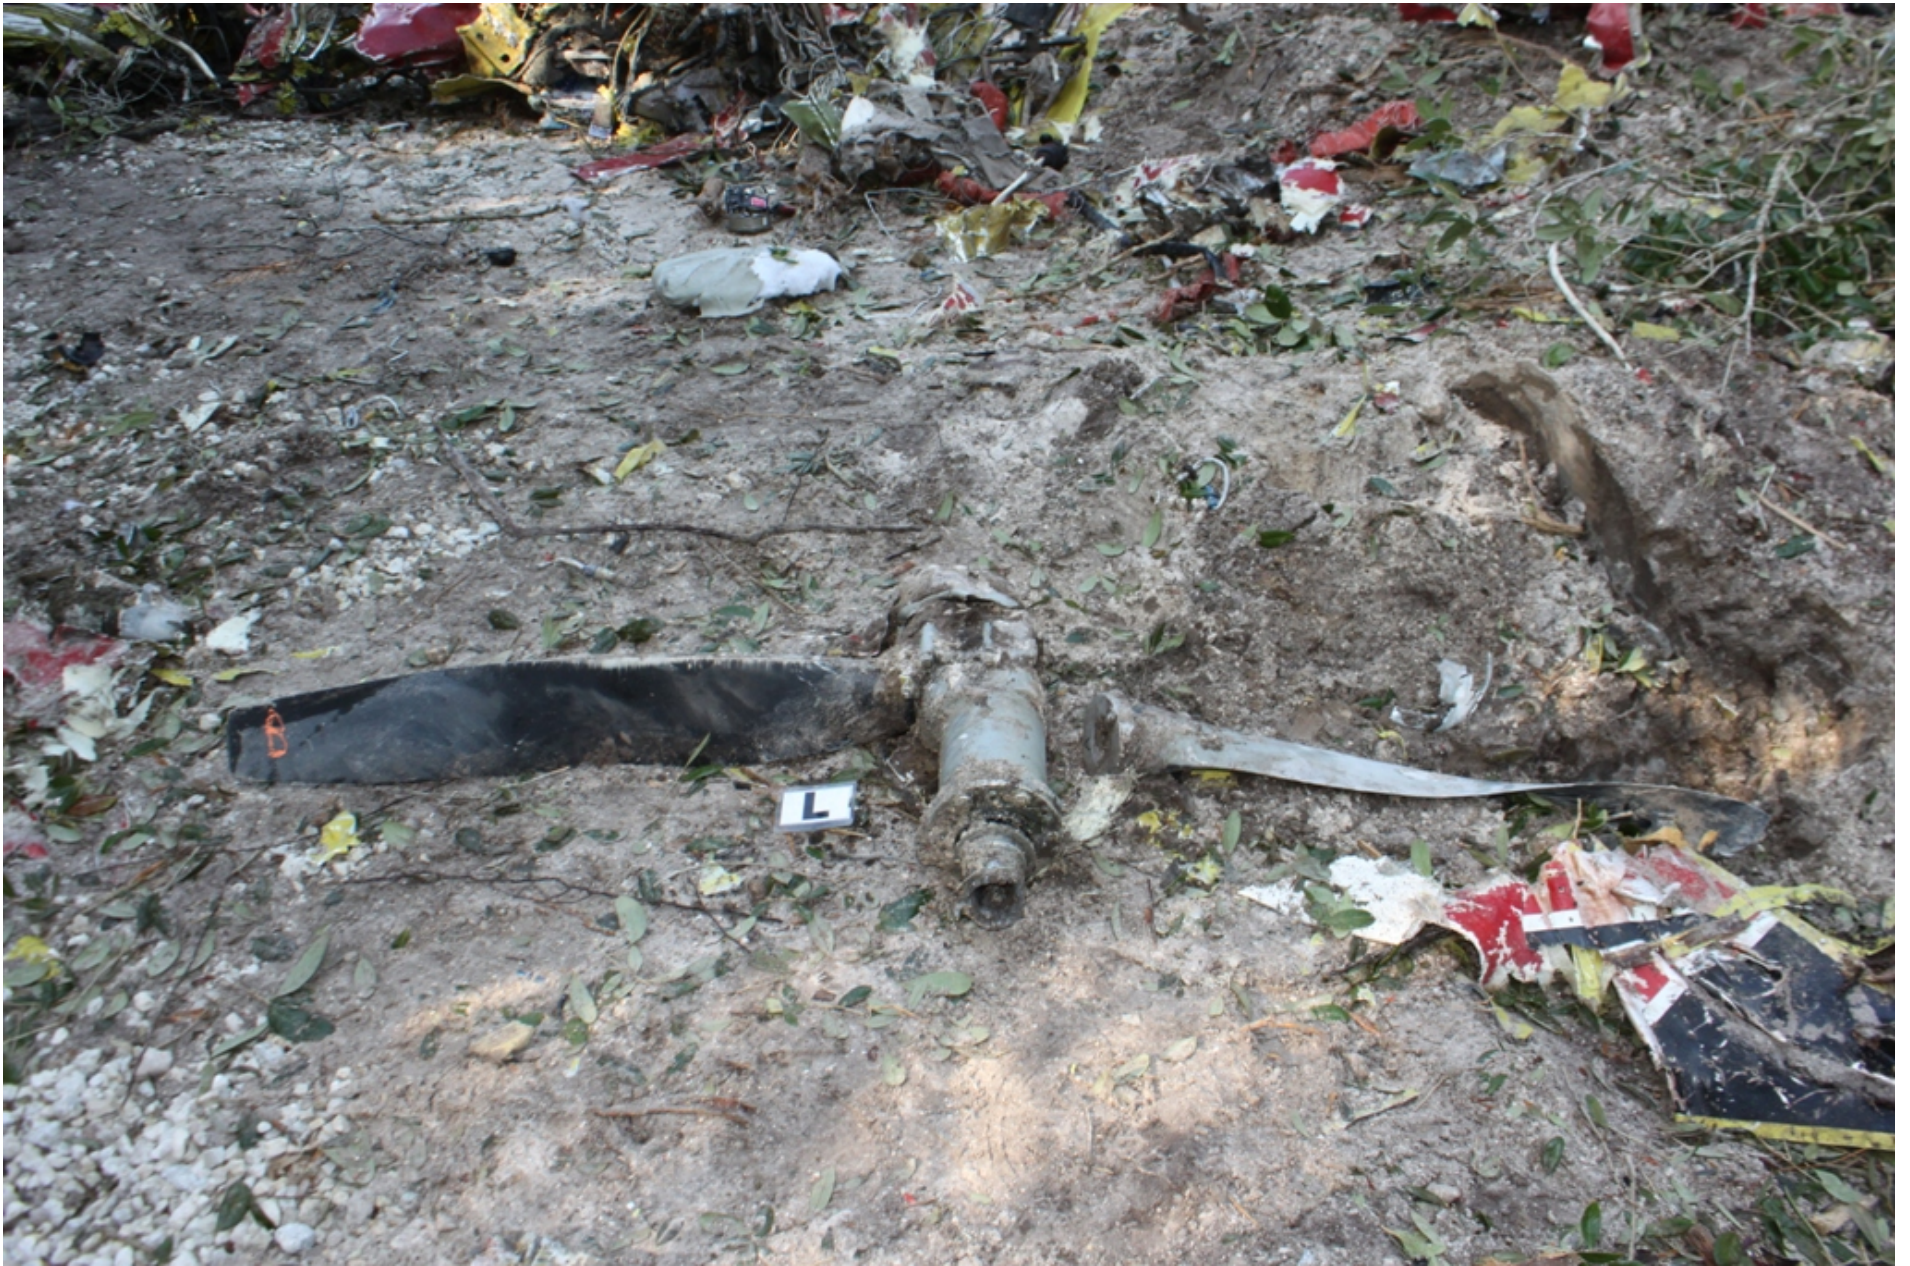
**Photo 9 - NTSB Digital Photograph. View Depicting Left Propeller. Note the Blade Bending.**
