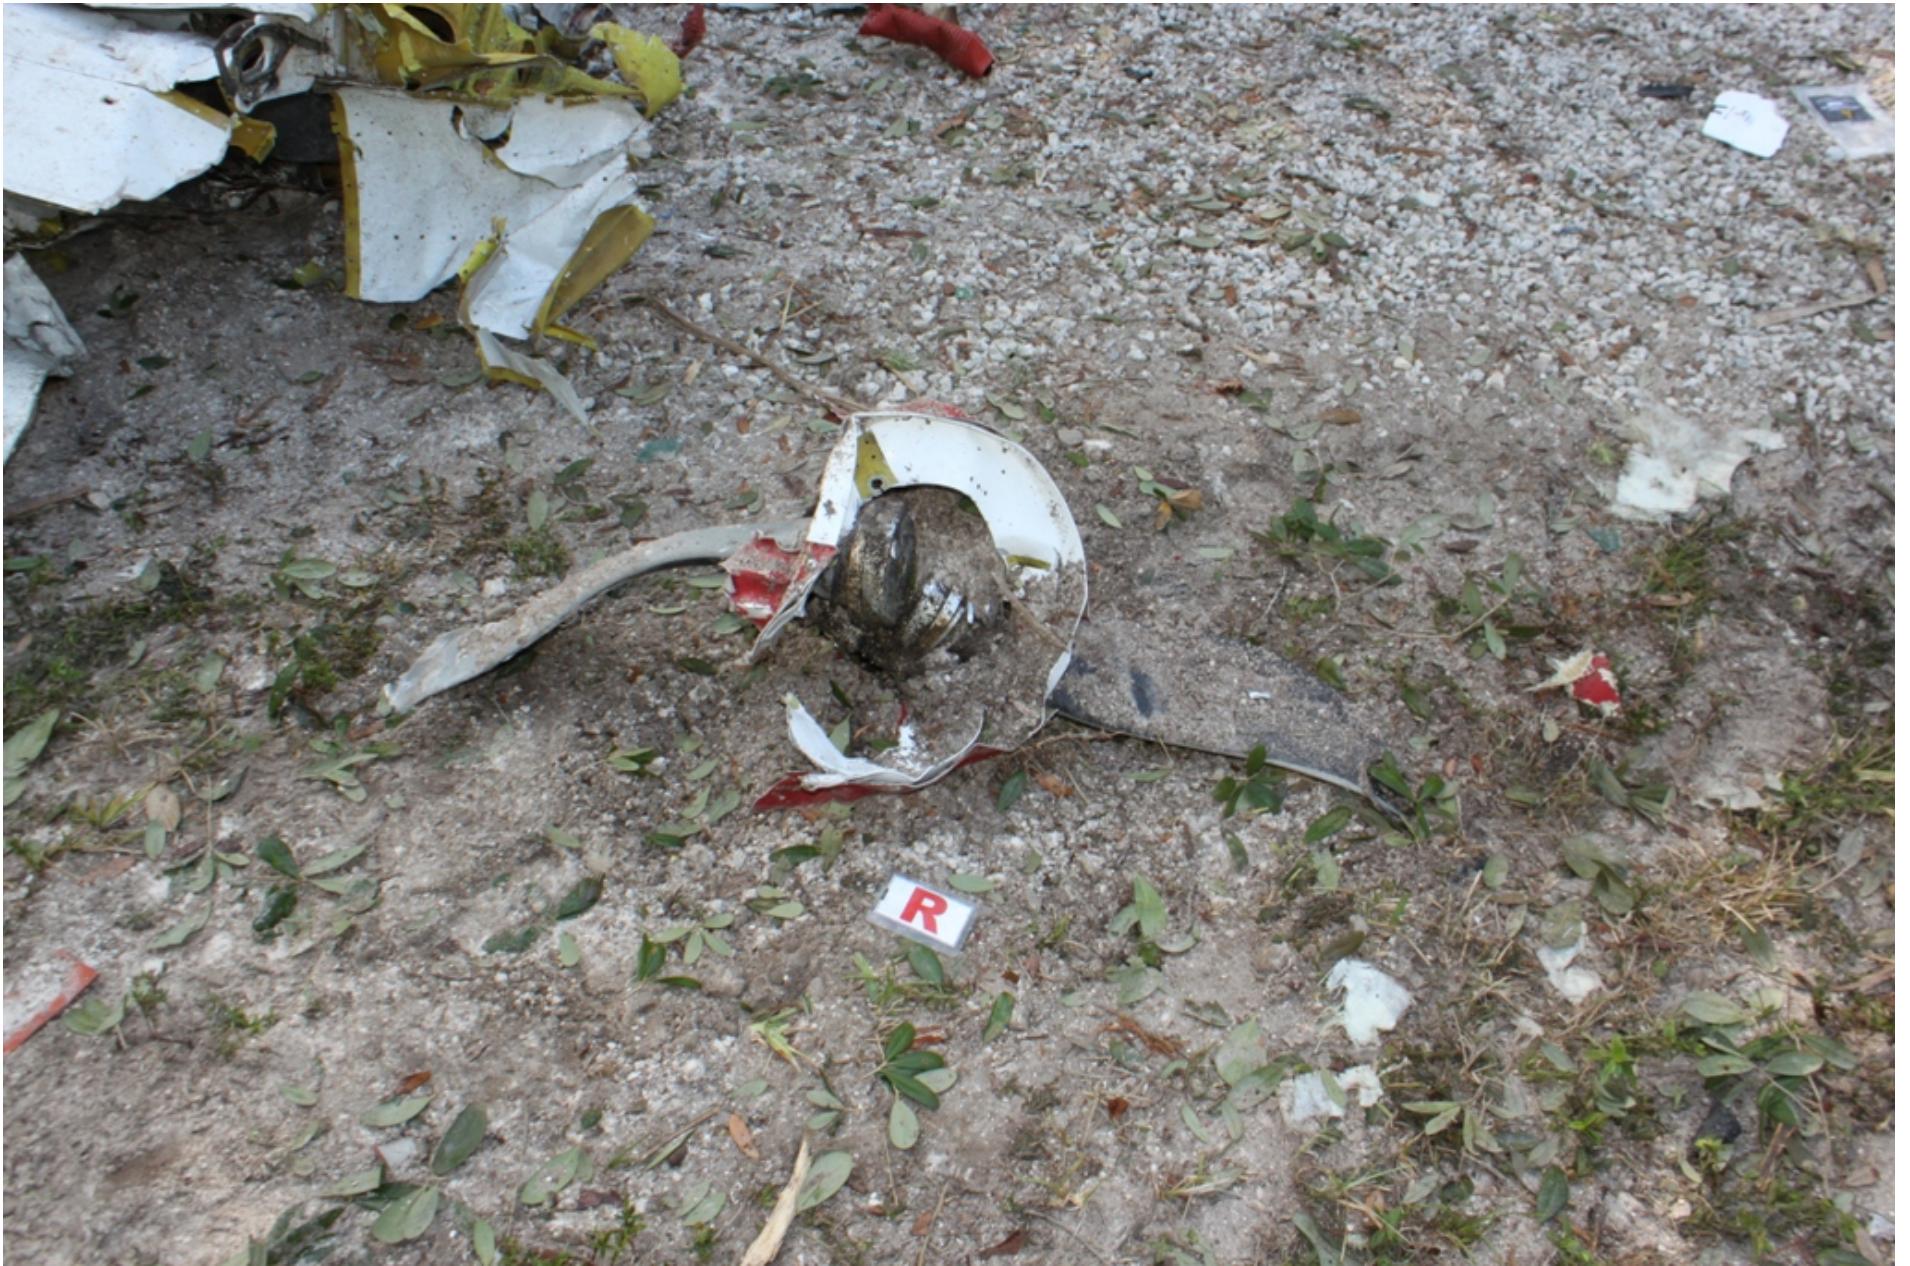
**Photo 10 - NTSB Digital Photograph. View Depicting the right Propeller.**

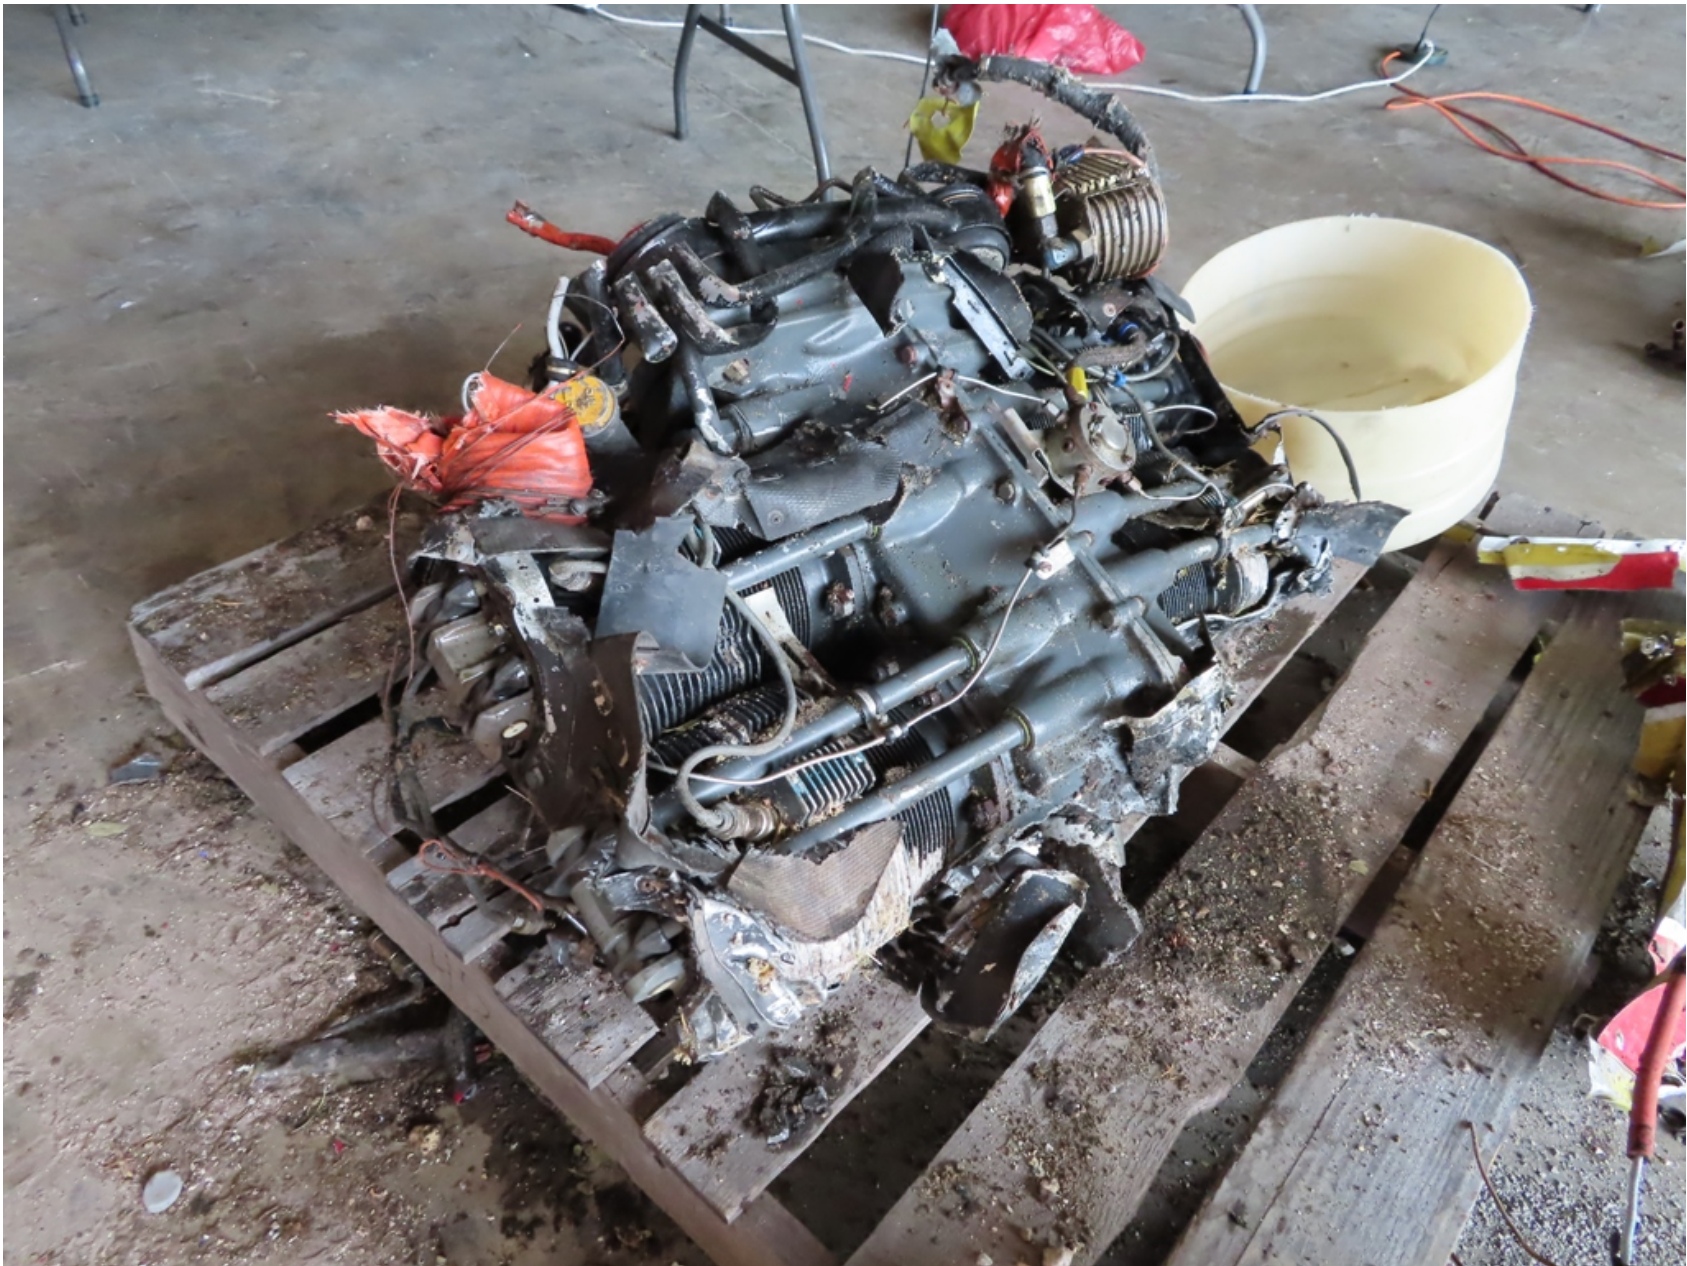
**Photo 11 – Piper Digital Photograph. View Depicting the Left Engine.**

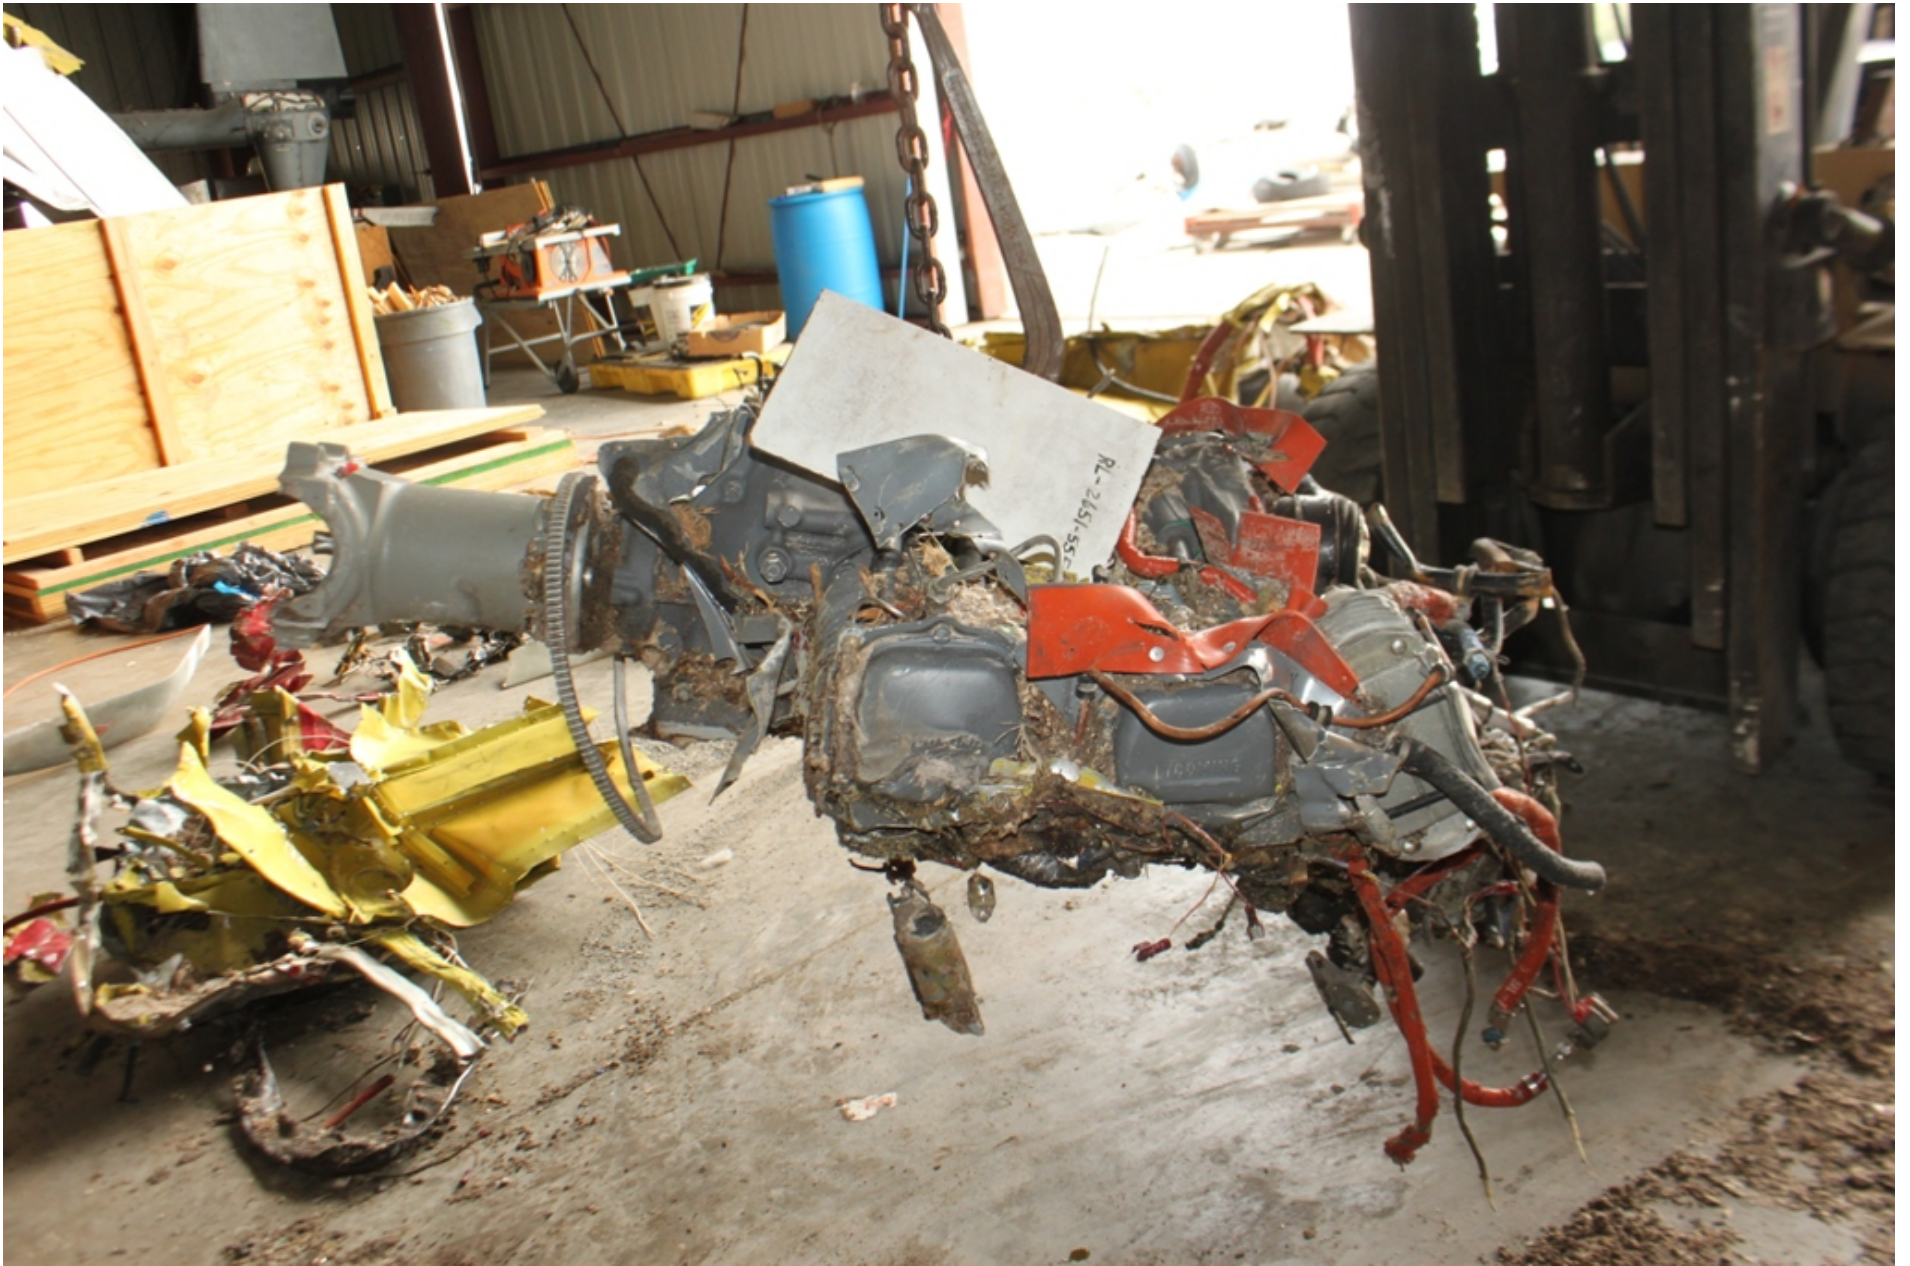
**Photo 12 - NTSB Digital Photograph. View Depicting the Right Engine.**
