# **NATIONAL TRANSPORTATION SAFETY BOARD**

## **UAS Aerial Imagery Factual Report**

### **A. ACCIDENT ERA19FA170**

Location: Naples, Fl  
Date: May 11, 2019  
Time: 1530 Eastern Daylight Time (EDT)  
Event: Crash into residential area, N7650Y, PA30

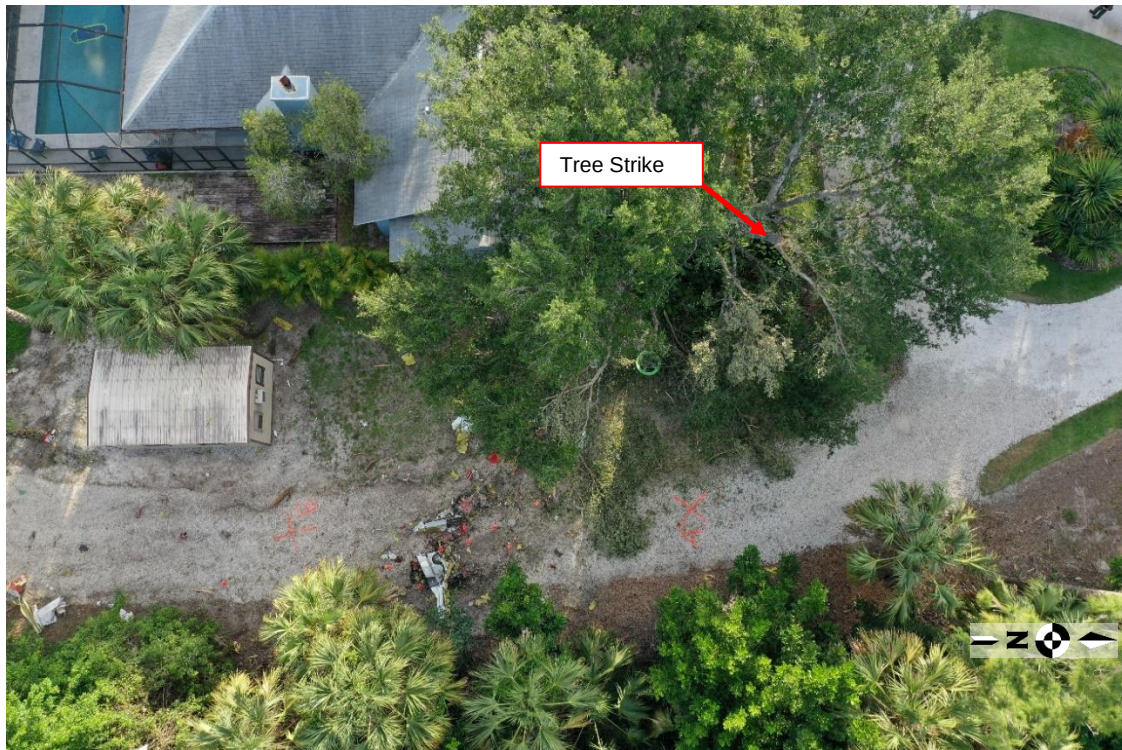
Figure 1 is a basic overhead view photo of the wreckage area. The general direction of flight of the airplane was from the upper right of the photo.

Figure 1 – Aerial photo over main wreckage site

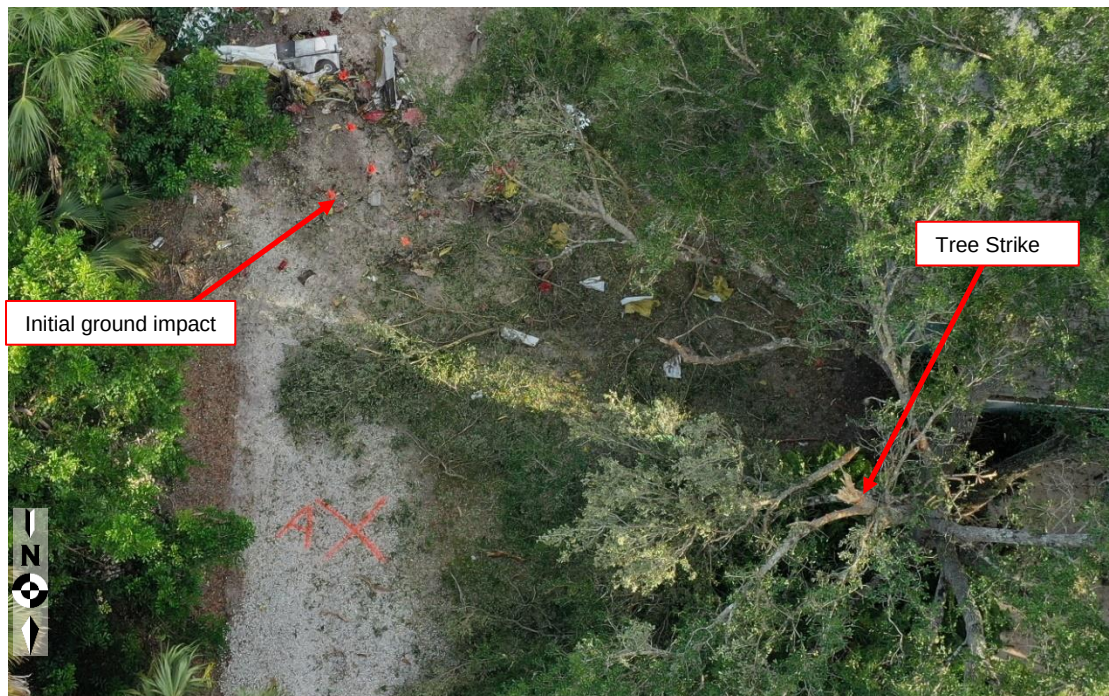
Figure 2 is a closer zoomed photo of the tree strike and main wreckage.

Figure 2 – Close up overview of tree strike

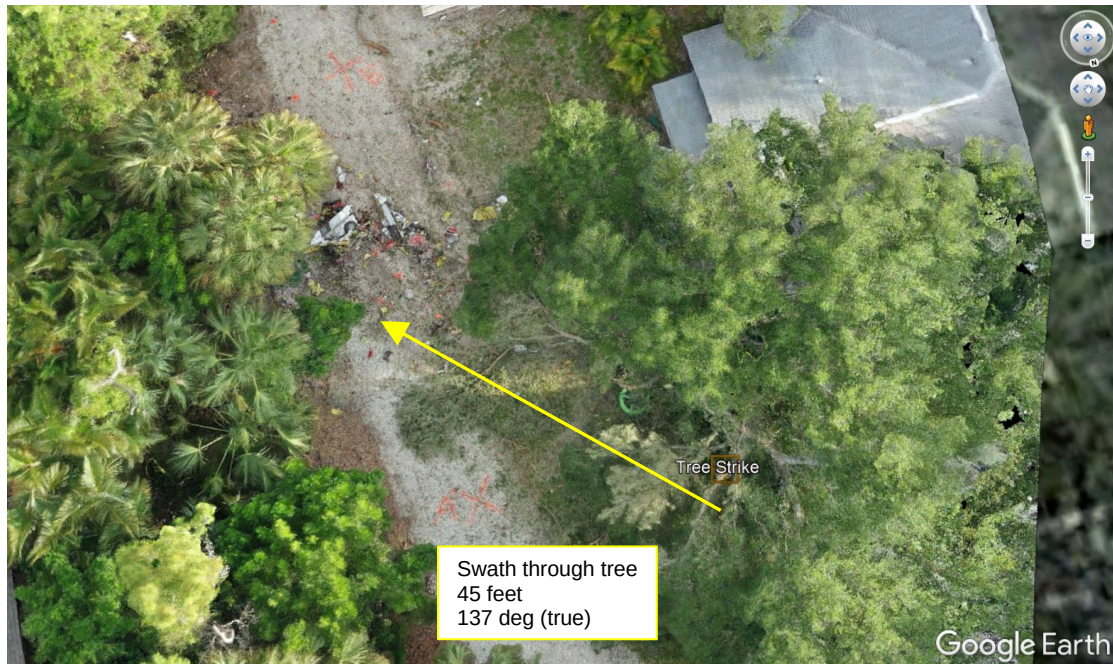
Figure 3 is an excerpt from the orthomosaic in Google Earth format with select measurements indicated. The Google Earth kmz file is in the docket.

Figure 3 – Excerpt of Google Earth orthomosaic of accident area

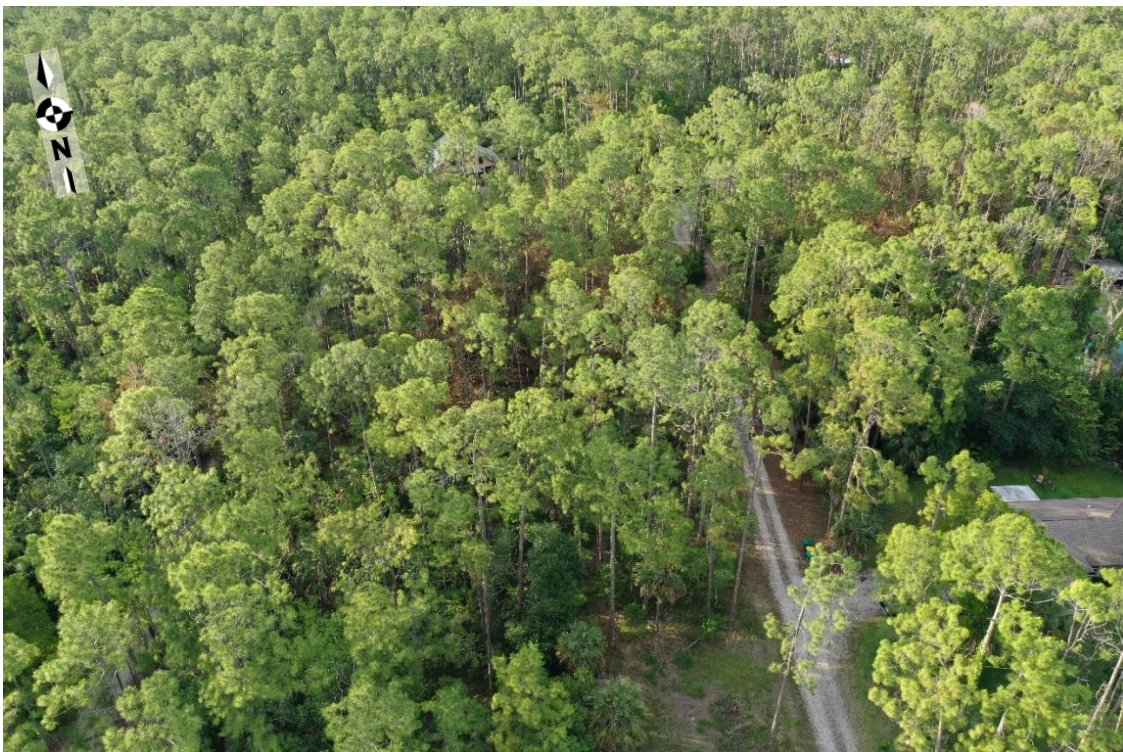
Figure 4 is an overview looking backward along the route of flight. Some smaller pieces of wreckage were found in this area.

Figure 4 – Aerial overview photo, looking north back along route where small pieces of wreckage were located.

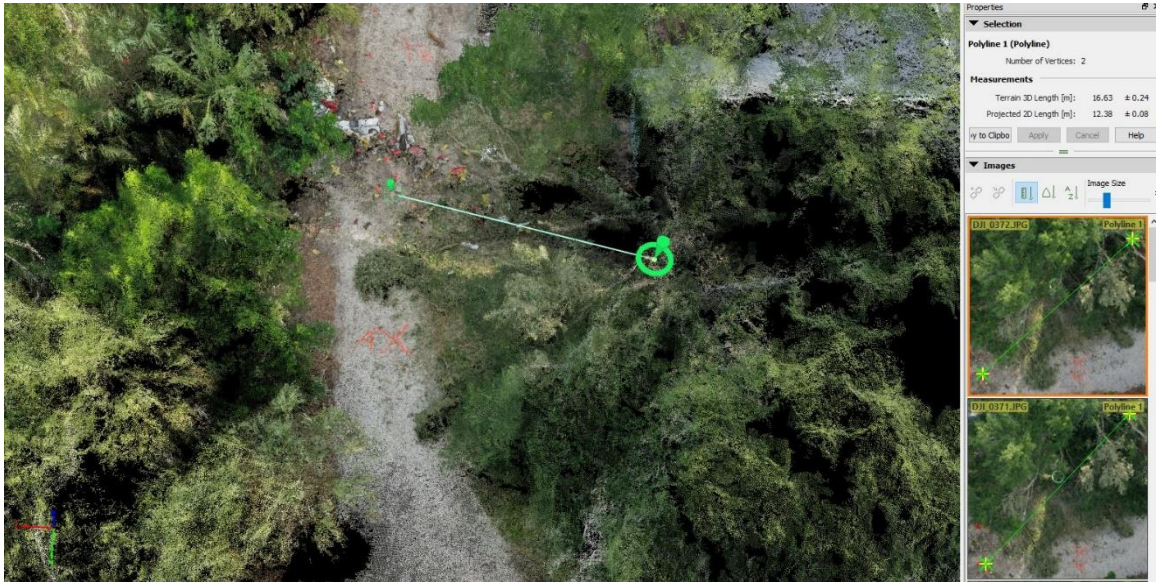
Figure 5 is a snapshot from the 3D point cloud in which the angle from the tree strike to the main impact mark can be measured. From the main break in the tree to the first evident ground impact is -41.9 degrees.

Figure 5 – 3D point cloud with angular measurement from tree strike to ground impact.
