# NATIONAL TRANSPORTATION SAFETY BOARD

MATERIALS LABORATORY FACTUAL REPORT

Report No. 19-044

Place : Southold, NY  
Date : June 8, 2019  
Vehicle : Beech A36 (N8014T)  
NTSB No. : ERA19FA189  
Investigator : Millicent Hill (AS-ERA)

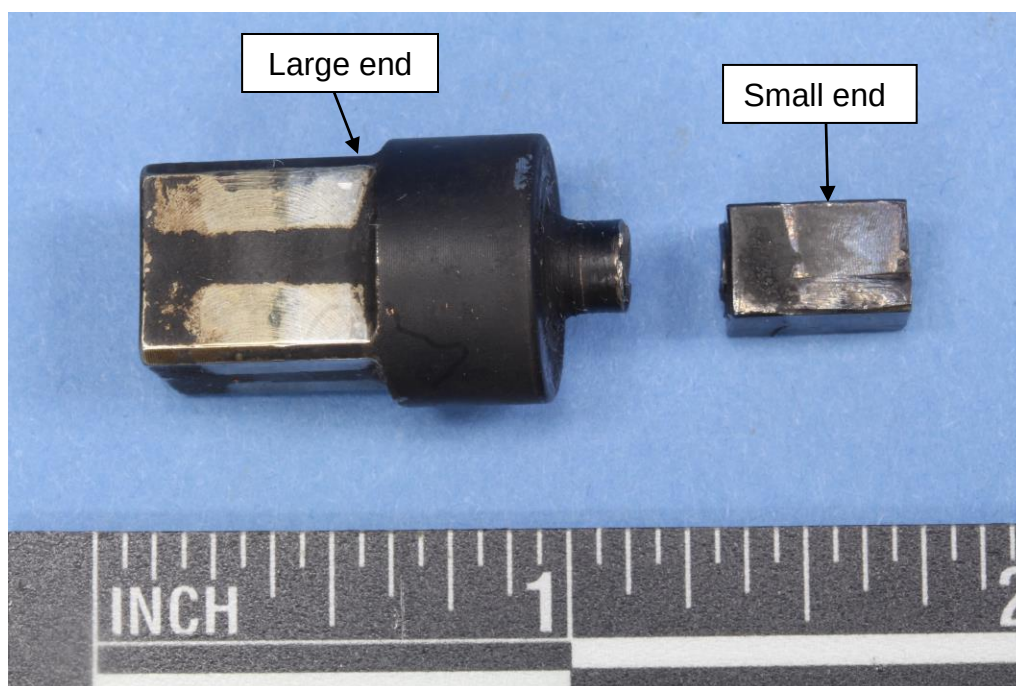
The purpose of this investigation is to evaluate the fracture surfaces of a fuel pump drive coupling from a Beech A36 aircraft. Using a Thermo Scientific Niton XL3t Hand Held Alloy Analyzer, the coupling material was found to be type 4140 alloy steel. Using a Wilson Rockwell Hardness Tester, the coupling hardness was found to be between 38.3 and 41.3 HRC. Overall views of the two halves of the submitted coupling are shown in Figures 1 and 2. The coupling had separated through the round shear section between the large and small square ends.

**Figure 1.** Overall side view of the as-received coupling halves.

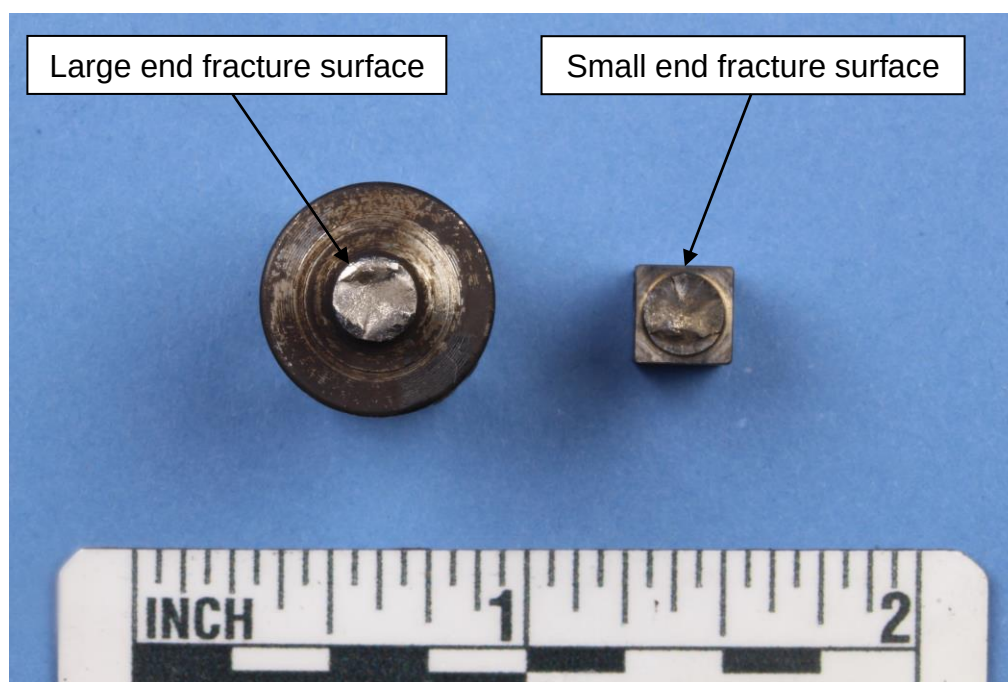
**Figure 2.** Overall top-down view of the as-received coupling halves.

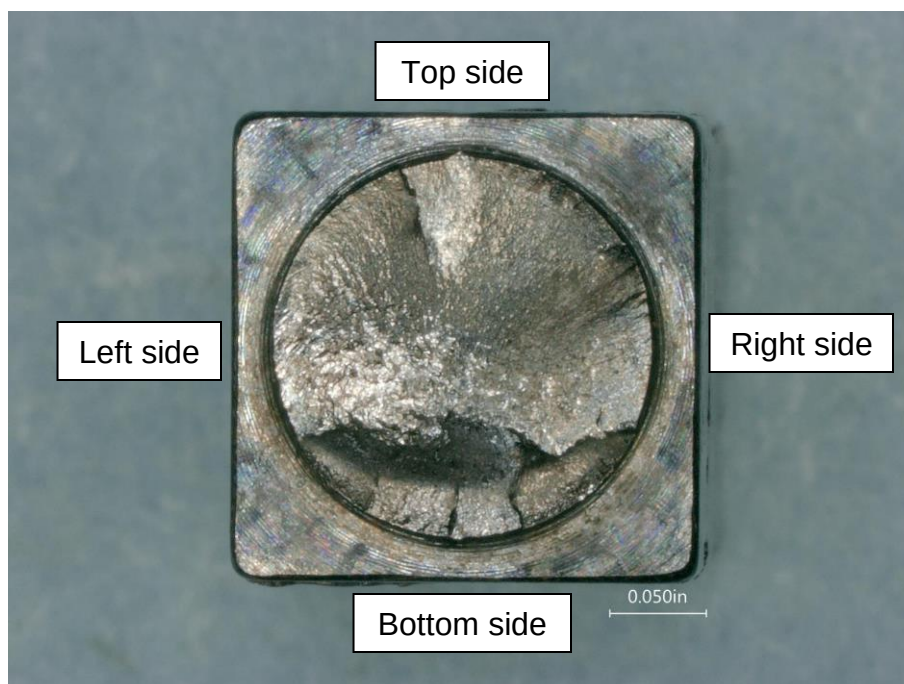
Both fracture surfaces were immersed in an acetone ultrasonic cleaning bath, then in Evapo-Rust® (Harris International Laboratories, Springdale, Arkansas) to remove any grease and corrosion product present. Figures 3 and 4 show digital microscope images of the two fracture surfaces with each of the four sides labeled. Both fracture surfaces were relatively flat. No necking or bending deformation was observed to the shear section.

**Figure 3.** Digital microscope image of the small end fracture surface with the four sides indicated.

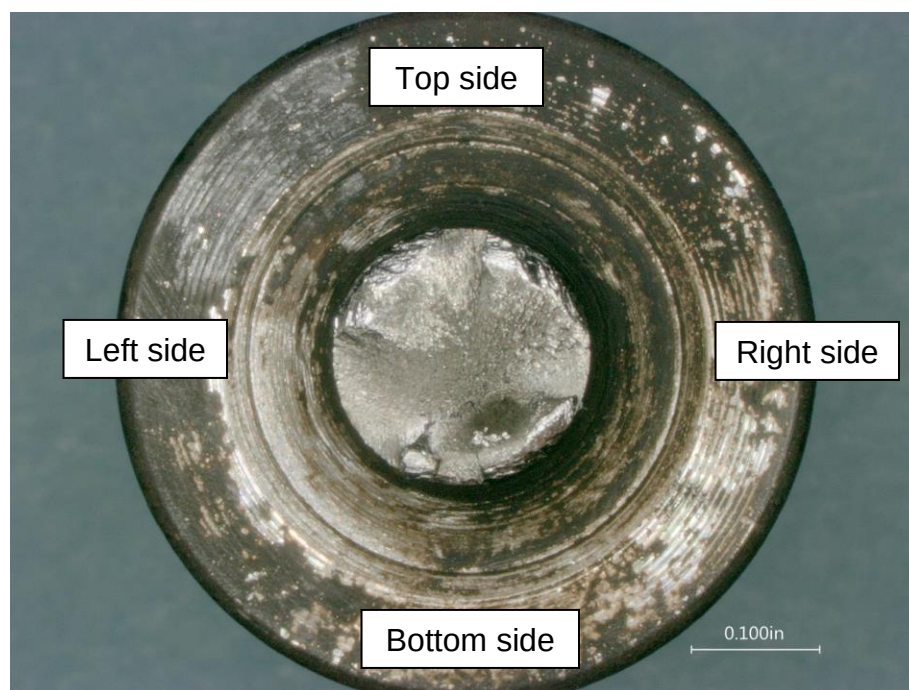
**Figure 4.** Digital microscope image of the large end fracture surface with the four sides indicated.

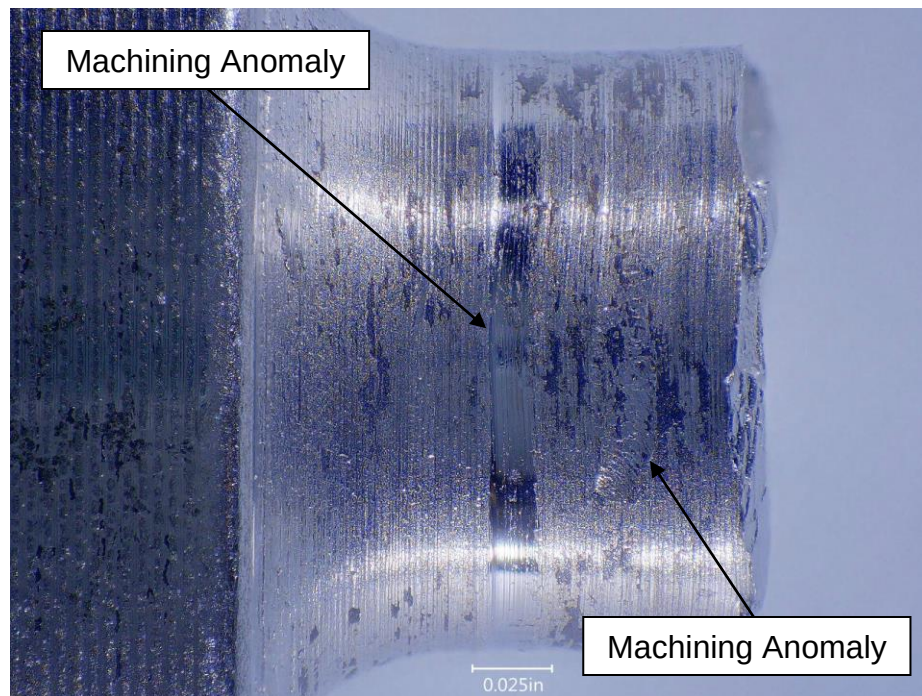
The large end of the coupling was also immersed in a toluene cleaning bath to remove grease present along the outer circumference of the round shear section. Minor anomalies were present within the machining marks on the round shear section, however they did not contribute to the failure of the part. The anomalies were most likely due to machining imperfections. Figure 5 shows a digital microscope image of the round shear section machining marks with the anomalies on the large end of the coupling. Wear marks were also present on all four sides of both ends of the coupling as shown in Figures 6 and 7.

**Figure 5.** Digital microscope image of the round shear section of the coupling showing anomalies within the machining marks.

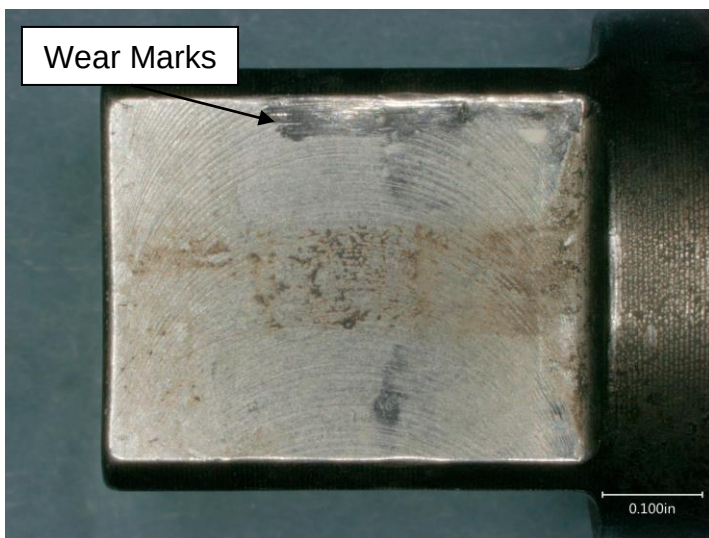
**Figure 6.** Digital microscope image of the bottom side of the large end of the coupling showing wear marks.

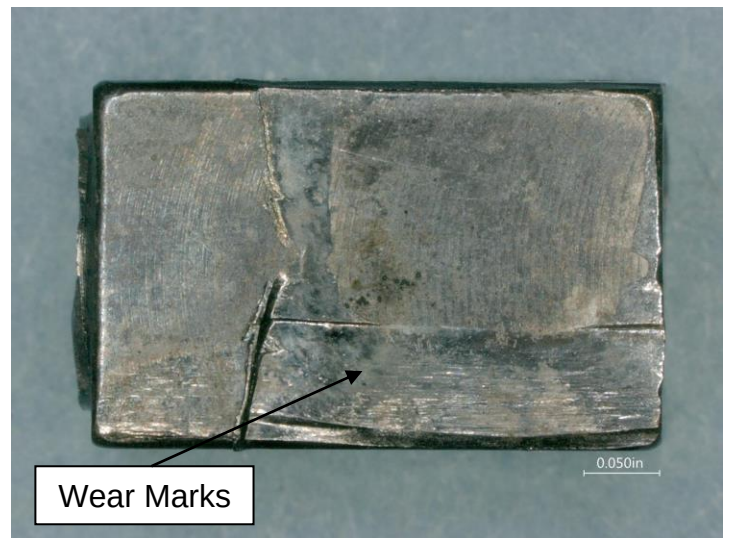
**Figure 7.** Digital microscope image of the bottom side of the small end of the coupling showing wear marks.

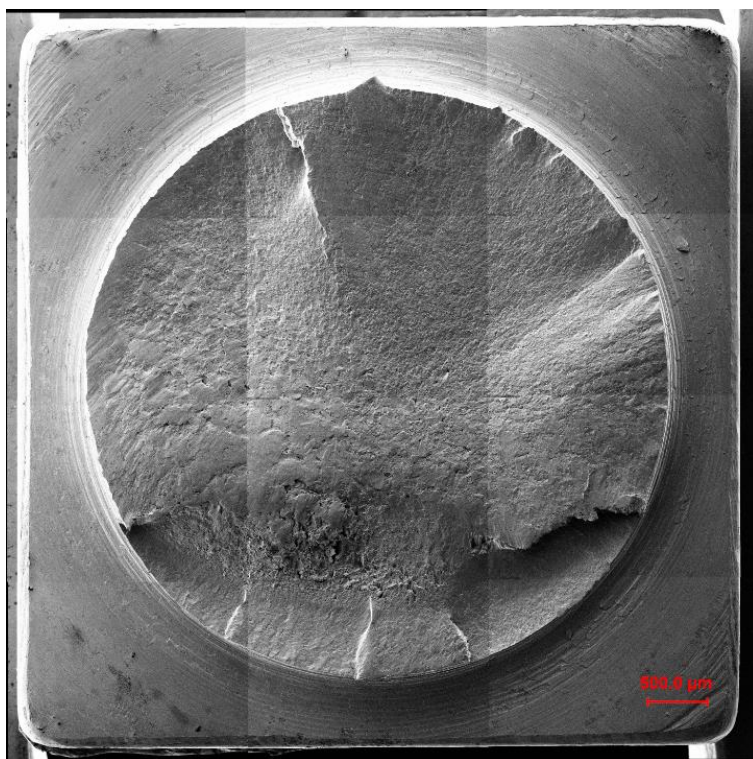
A field emission scanning electron microscope (FE-SEM) was used to examine the coupling fracture surfaces. Overall FE-SEM montage fractographs of both fracture surfaces are shown in Figures 8 and 9. There were visible ratchet marks at the outer diameter of the small end fracture surface as shown in Figure 10. The multiple ratchet marks present are consistent with multiple initiation fatigue cracking. Striations were also visible on both fracture surfaces, which is also consistent with fatigue fracture. Figures 11 and 12 show fatigue striations present on both the small and large end fracture surfaces. Microvoid coalescence was also present on both fracture surfaces consistent with overstress separation towards the center of the shear section. This is shown in Figures 13 and 14.

**Figure 8.** Scanning electron fractograph montage of the small end of the coupling.

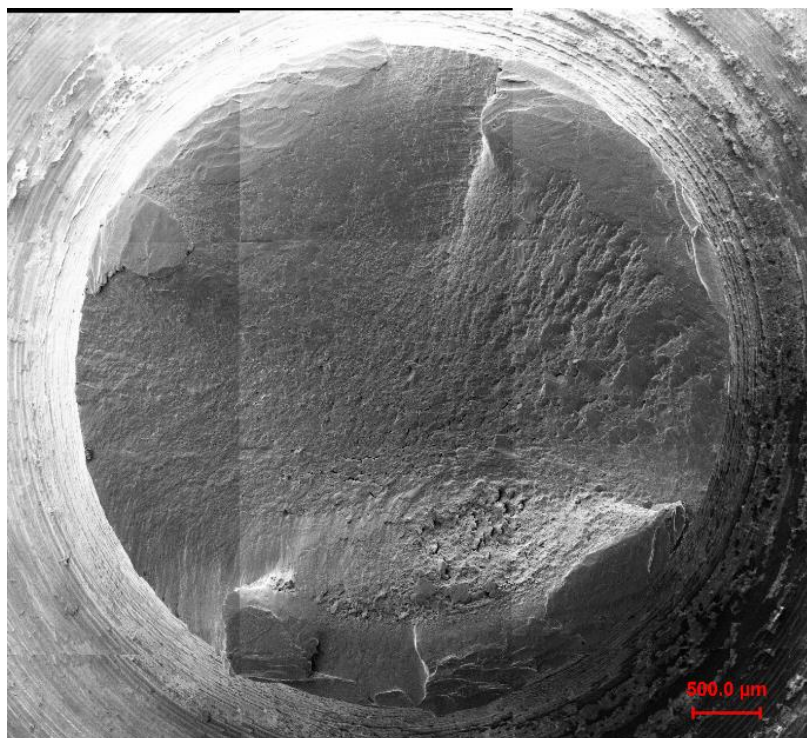
**Figure 9.** Scanning electron fractograph montage of the large end of the coupling.

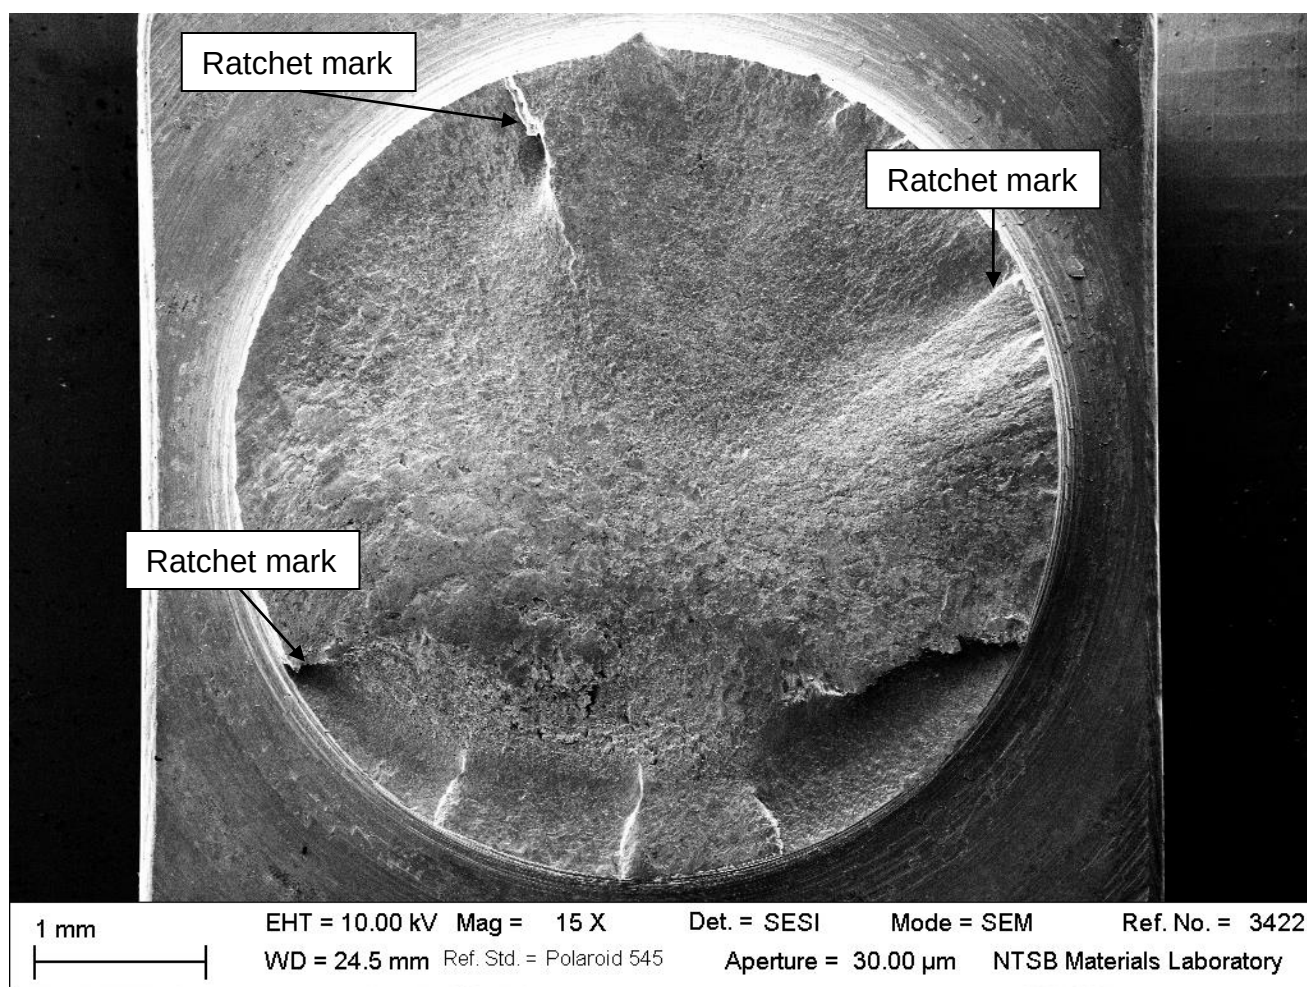
**Figure 10.** Scanning electron fractography of the small end fracture surface with ratchet marks indicated.

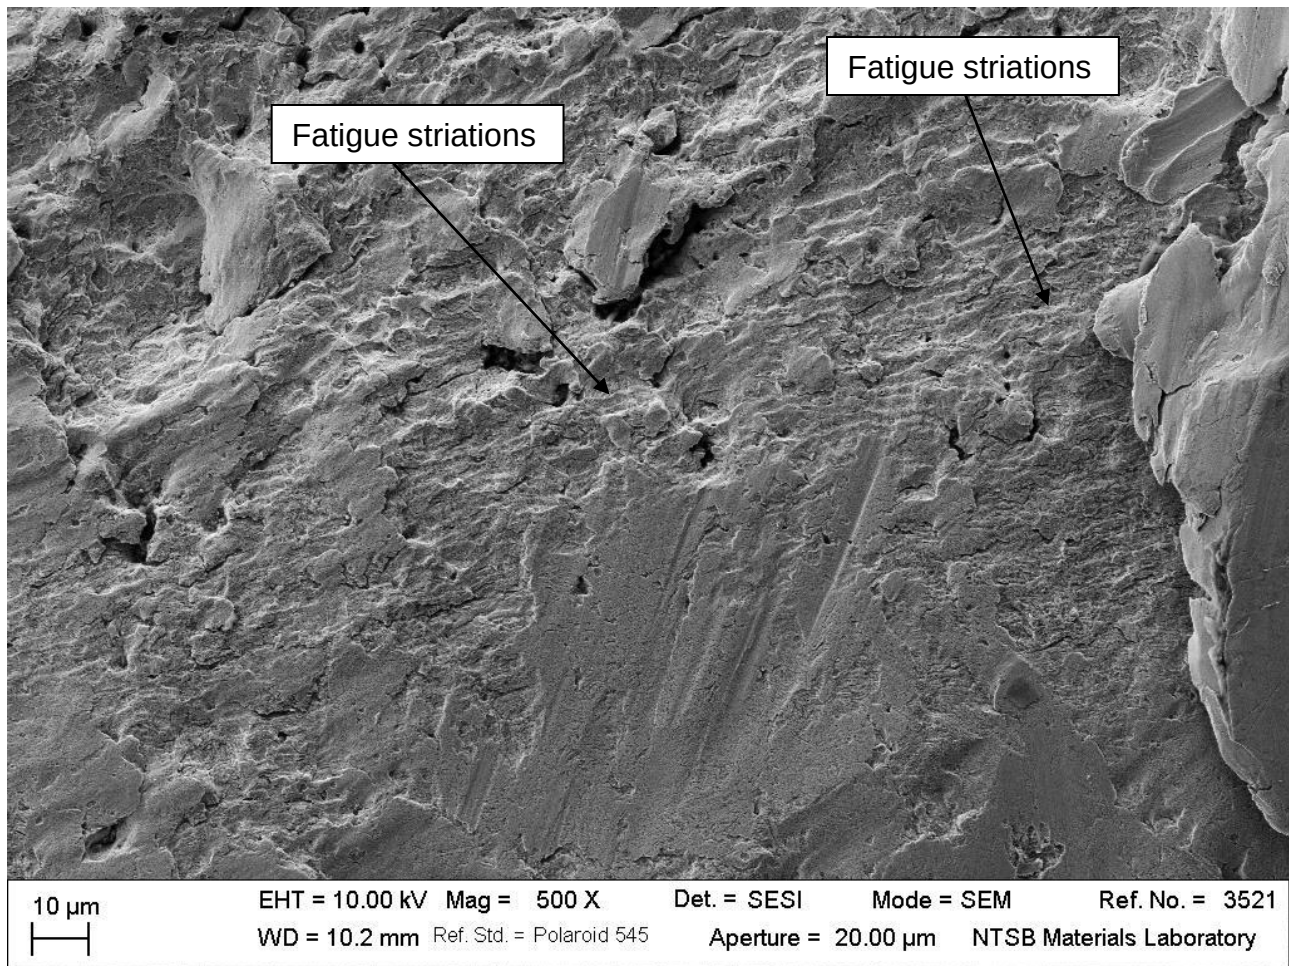
**Figure 11.** Scanning electron fractograph of the large end fracture surface showing fatigue striations.

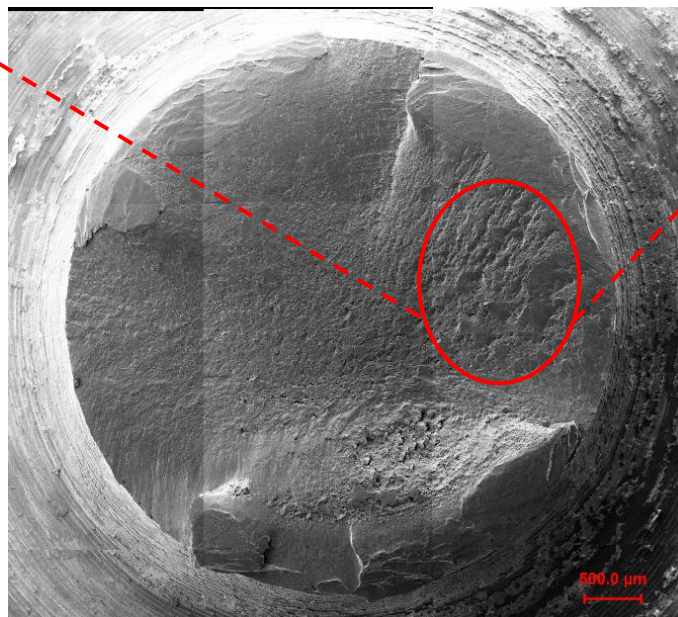
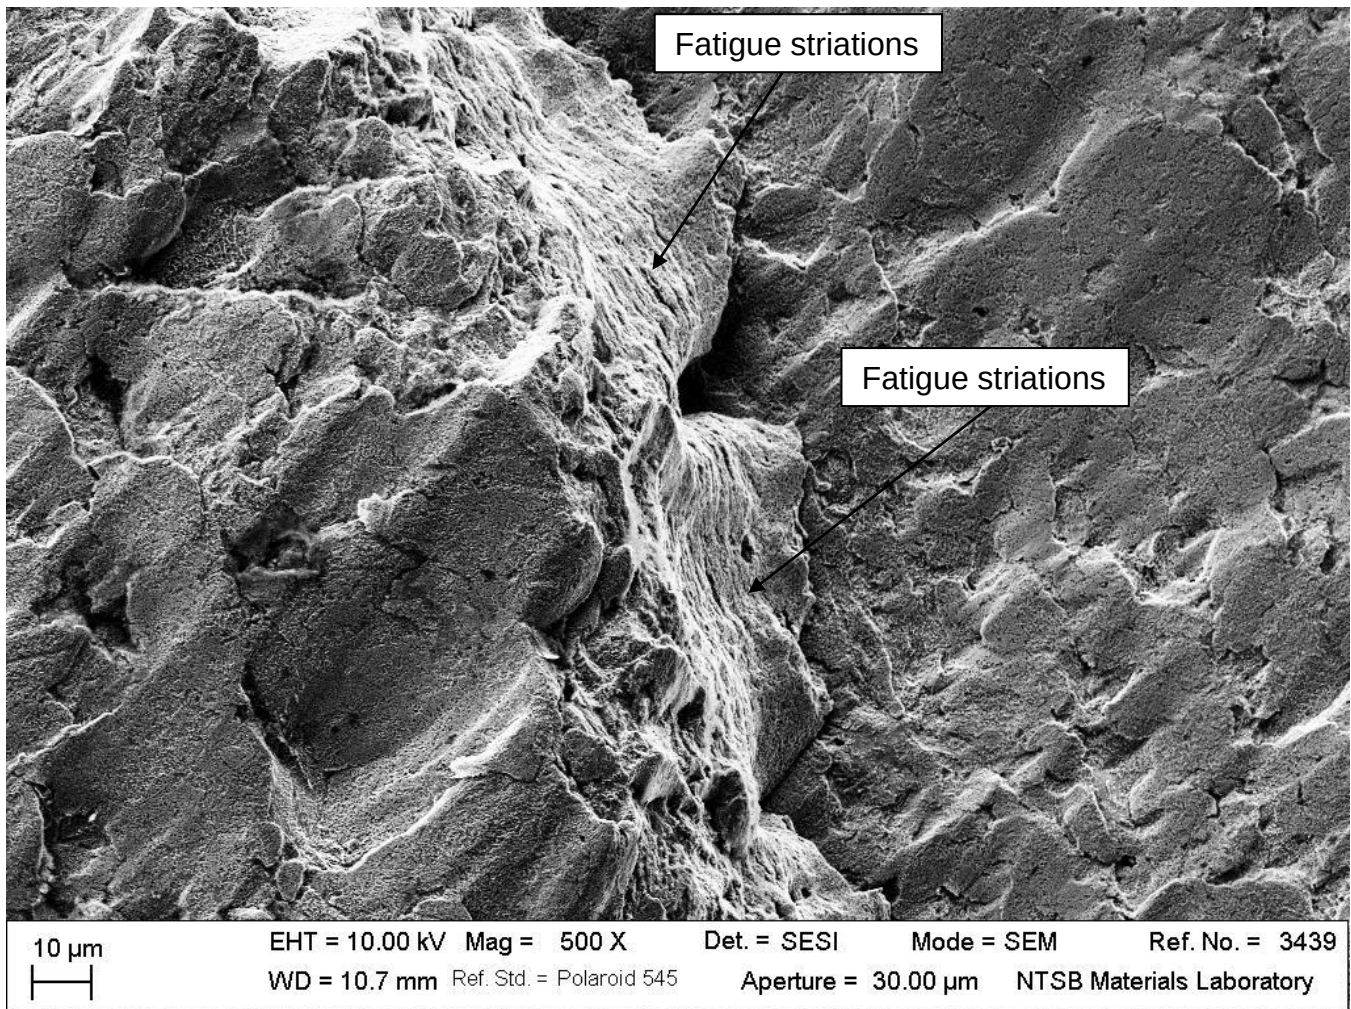
**Figure 12.** Scanning electron fractograph of the small end fracture surface showing fatigue striations.

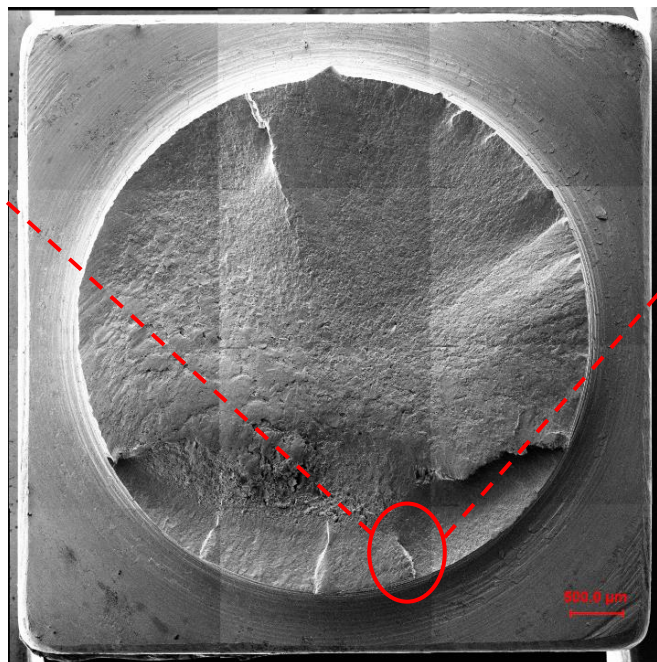
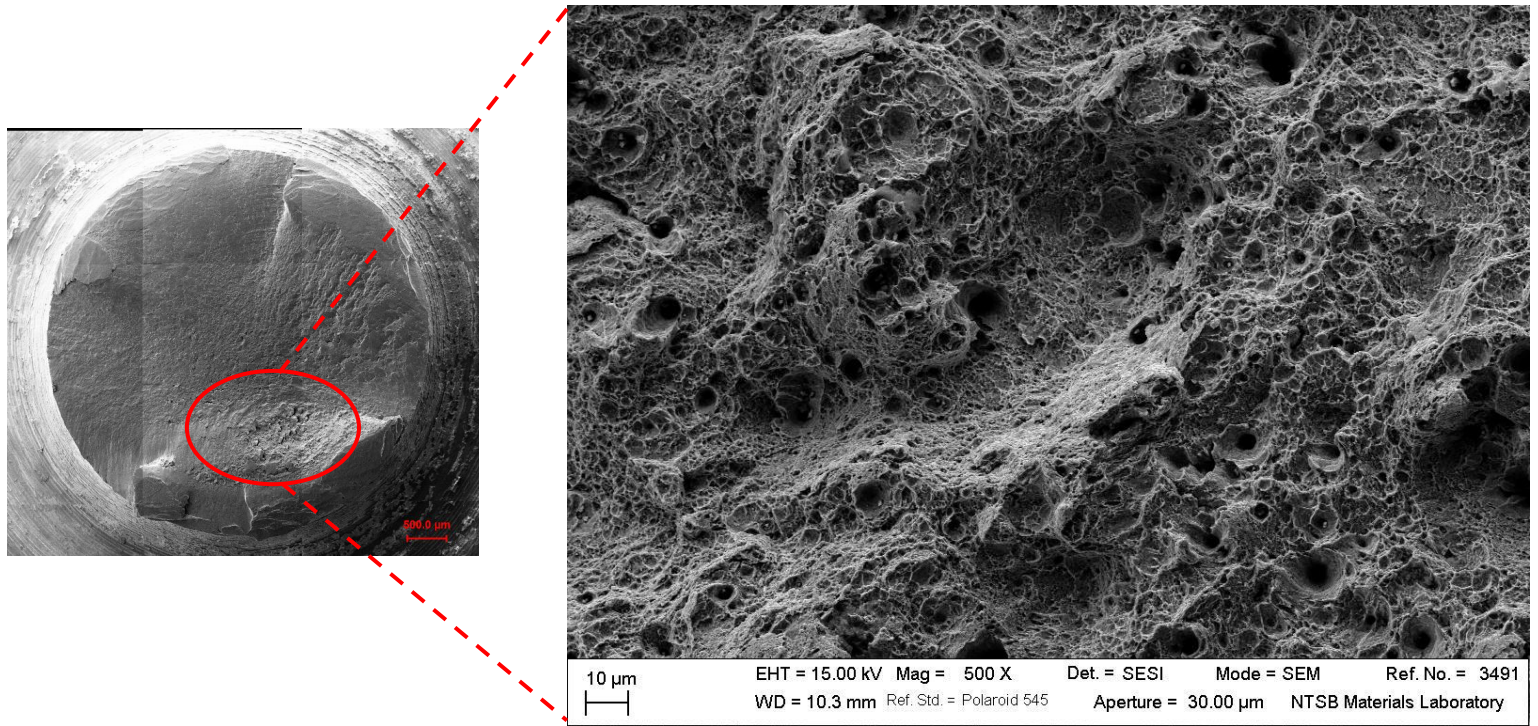
**Figure 13.** Scanning electron fractograph showing microvoid coalescence present on the large end fracture surface.

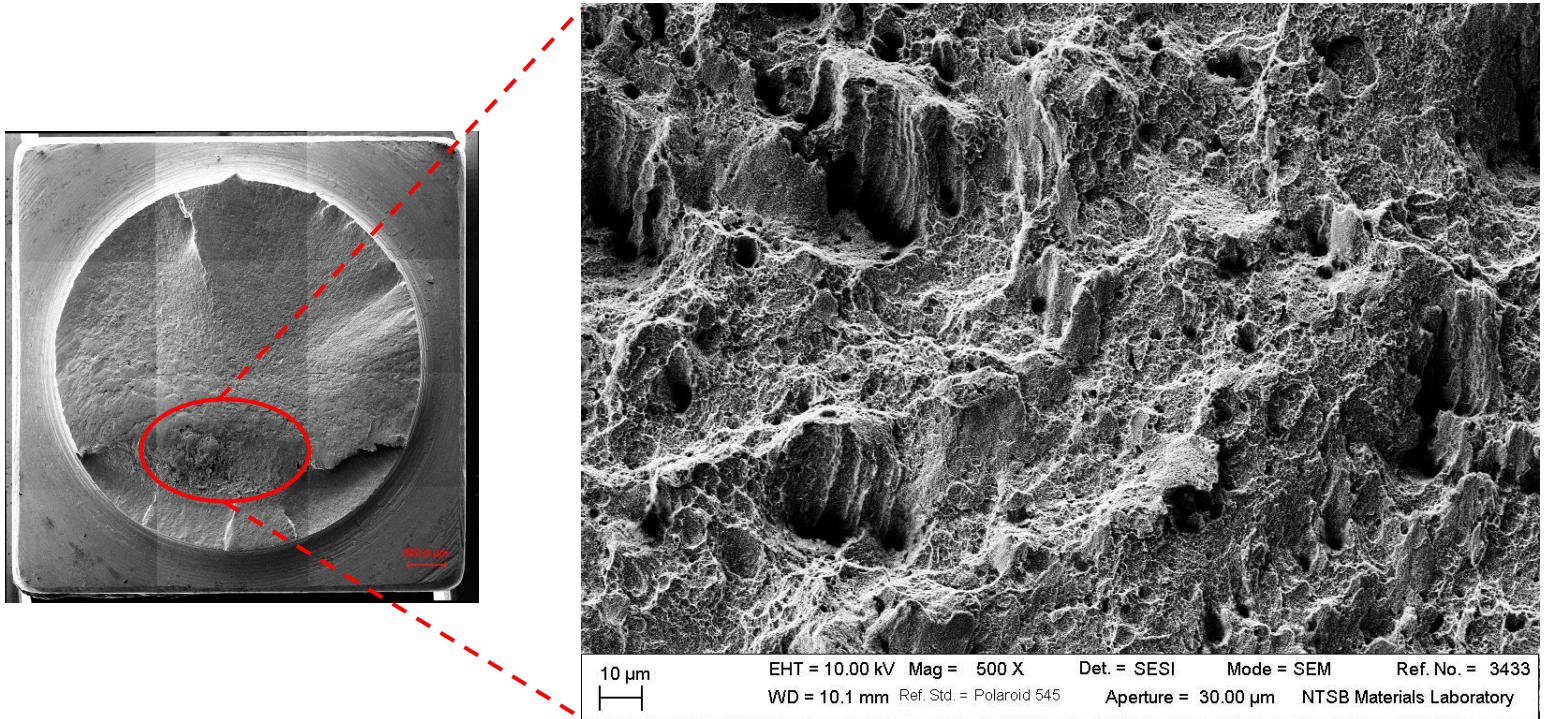
**Figure 14.** Scanning electron fractograph showing microvoid coalescence present on the small end fracture surface.
