## **MEMORANDUM FOR RECORD**

**Peter Wentz**  
**Air Safety Investigator**  
**Eastern Region Aviation**

### **Records Examination**

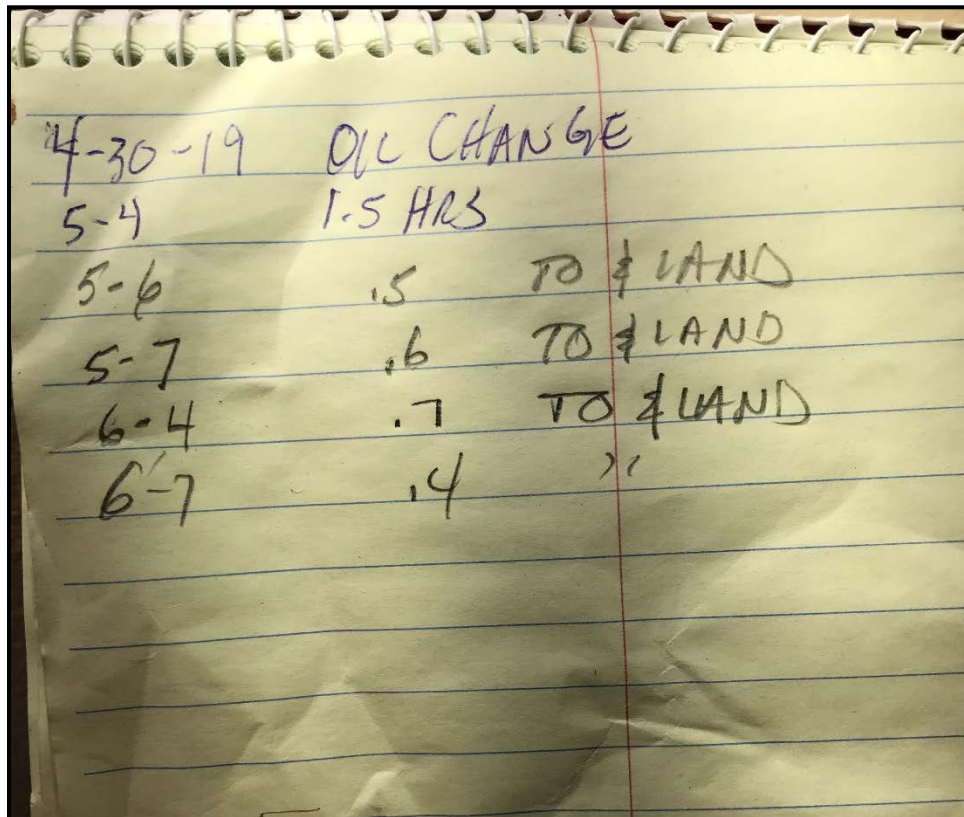
to 140 mph with no adverse tendencies. An additional 7.5 hours of flight time were logged after the high speed test. A notebook found in the airplane at the accident site listed a total flight time of 3.7 hours between May 4 and June 7, 2019.

Figure 1 - Summary of flight time between May 5 and June 7, 2019.
