## Investigative Photographs

Peter Wentz  
Air Safety Investigator  
Eastern Region Aviation

ERA19FA196

June 16, 2020

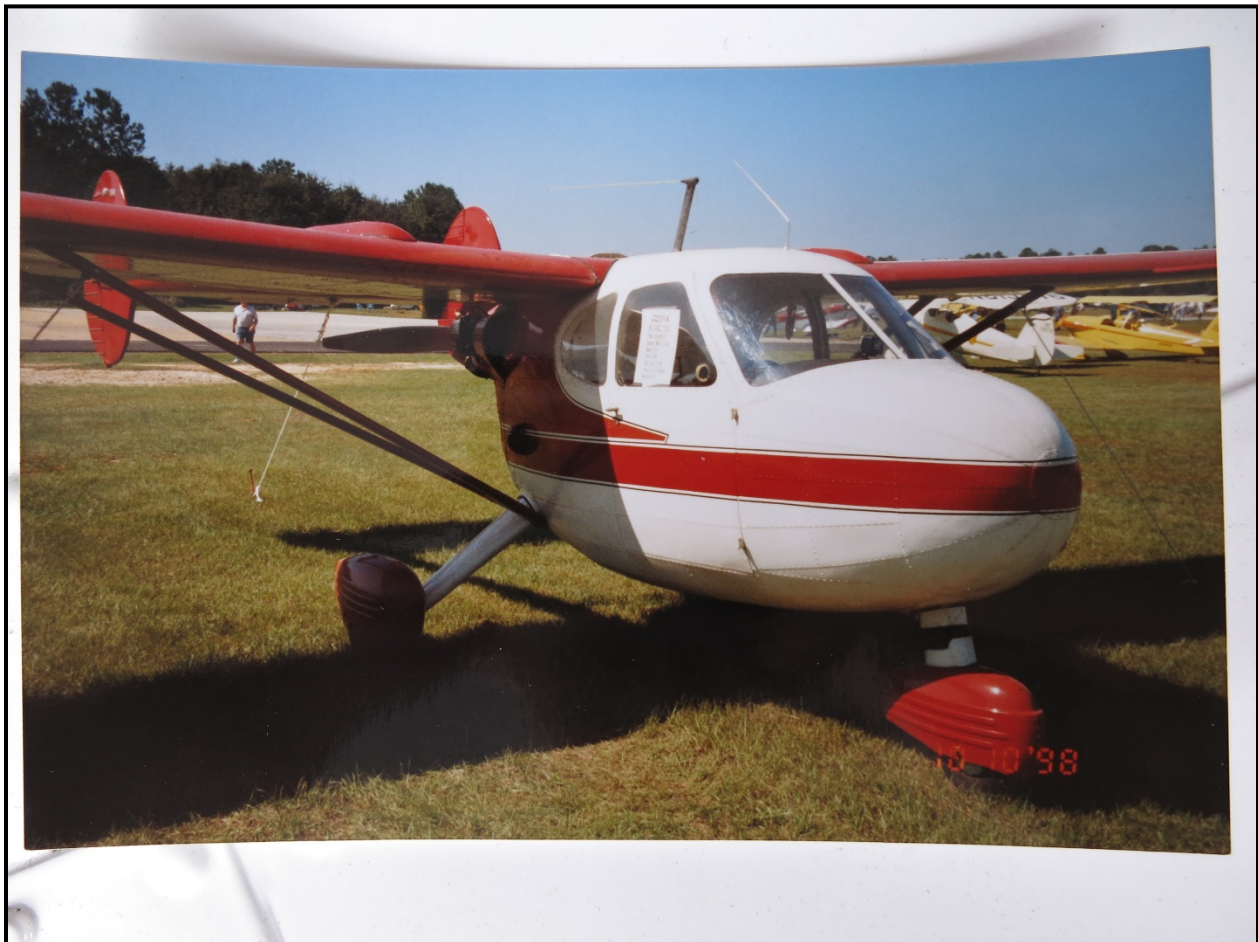
Photograph 1 – Front view of the accident airplane dated October 10, 1998.

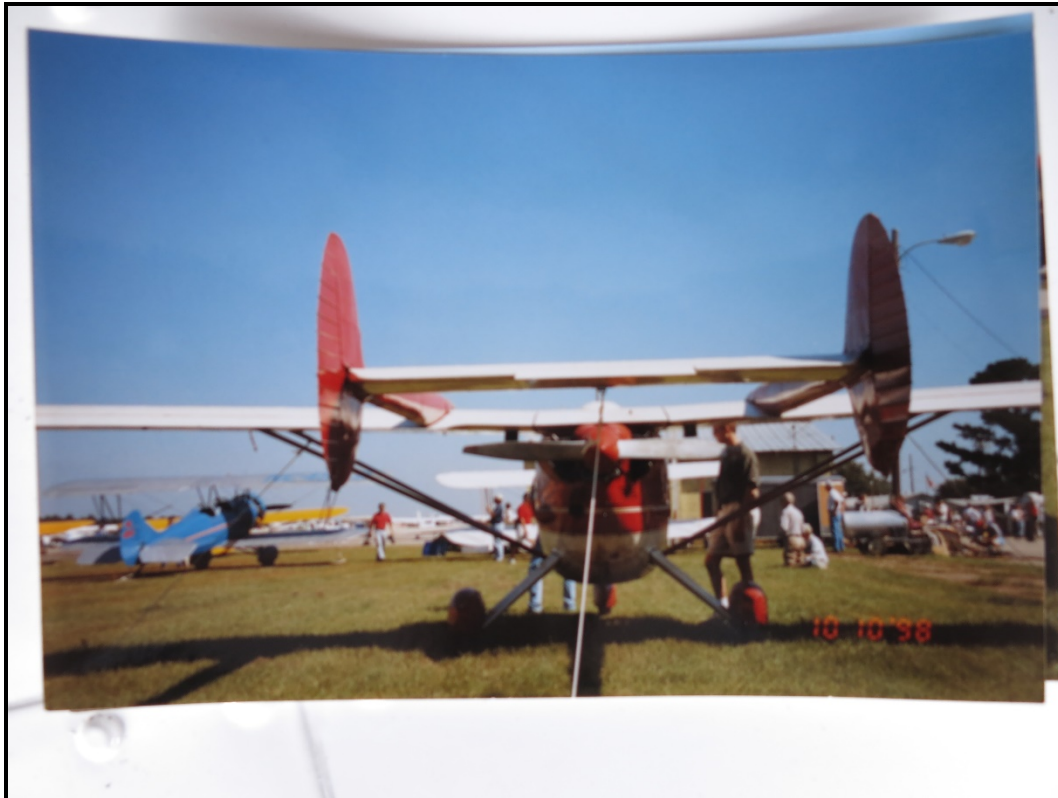
Photograph 2 – Aft view of the accident airplane dated October 10, 1998.

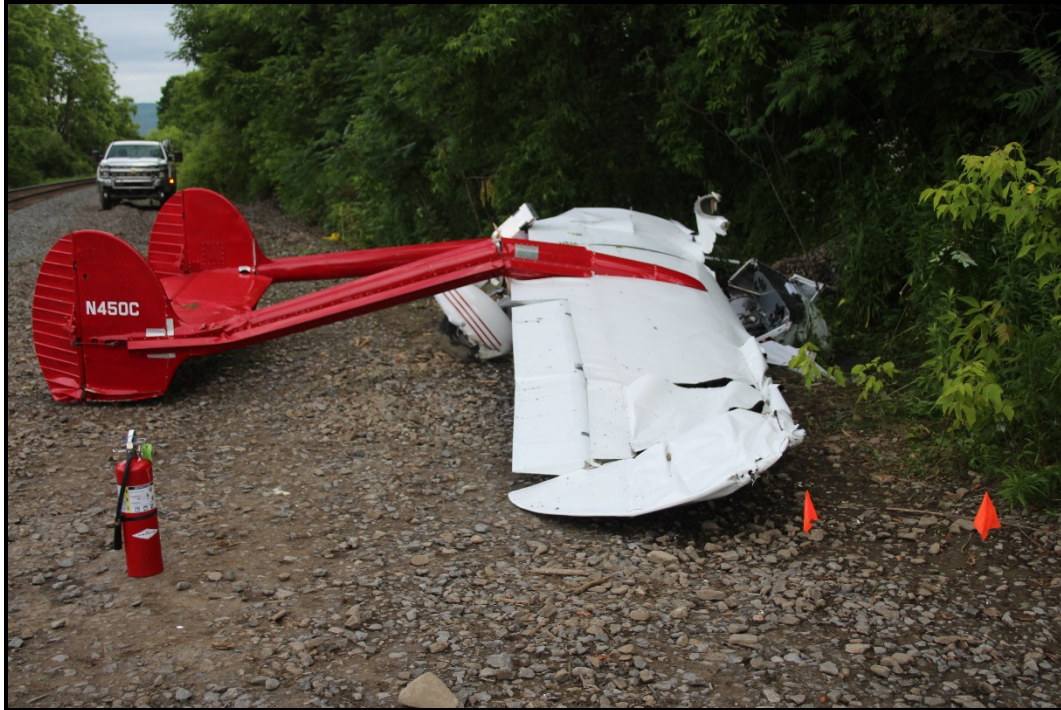
**Photograph 4 – Right side view of the accident airplane.**

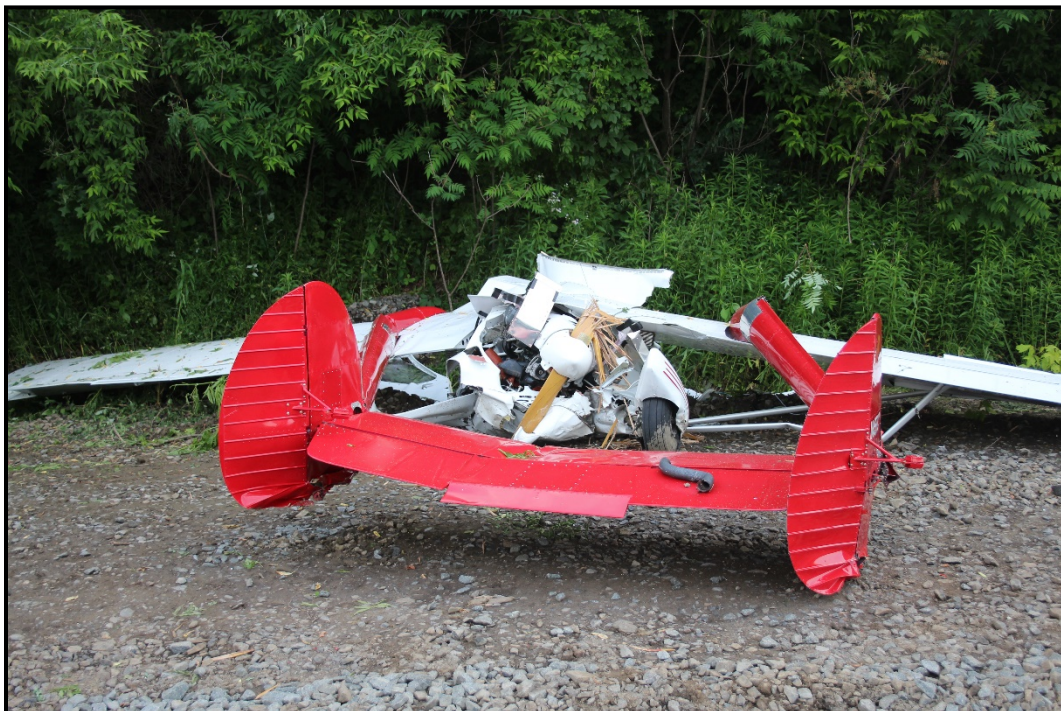
**Photograph 5 – Aft view of the accident airplane.**

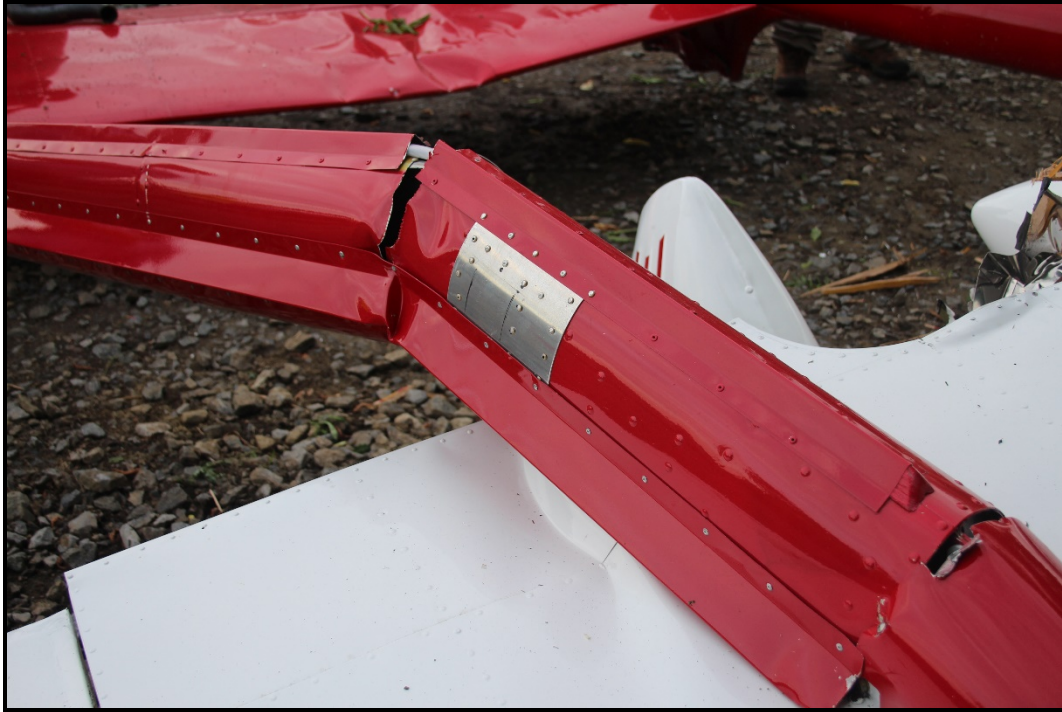
**Photograph 6 – Right side outboard tail boom.**

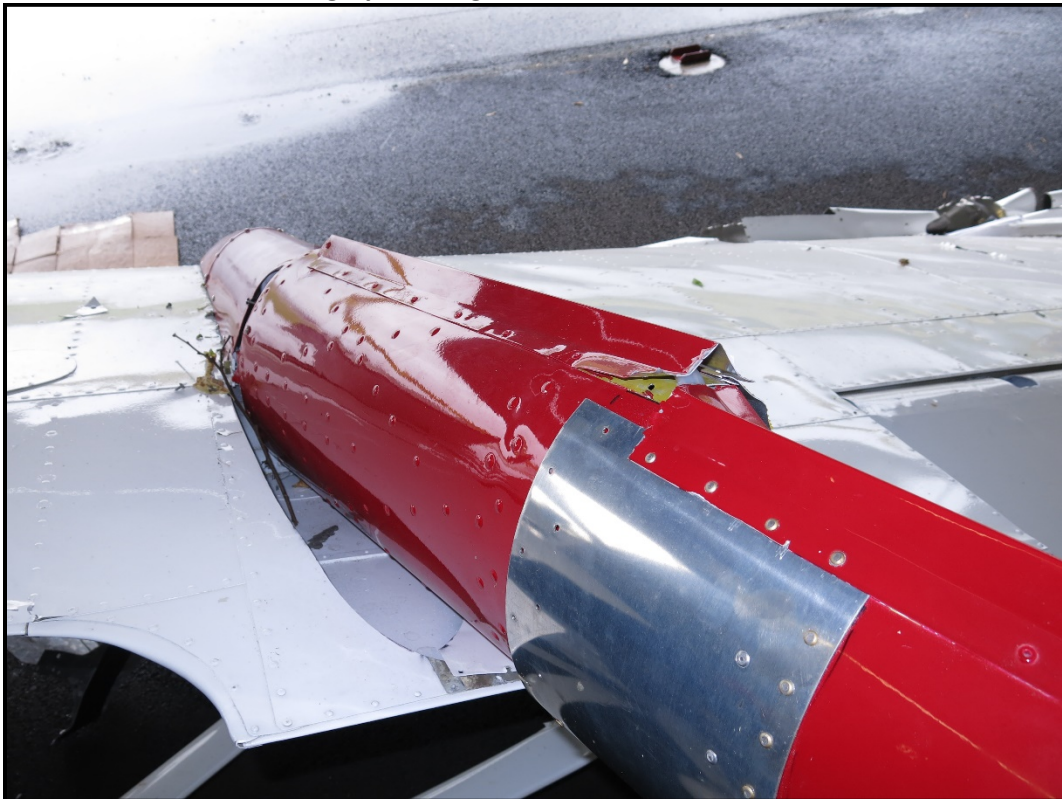
**Photograph 7 – Right side inboard tail boom.**

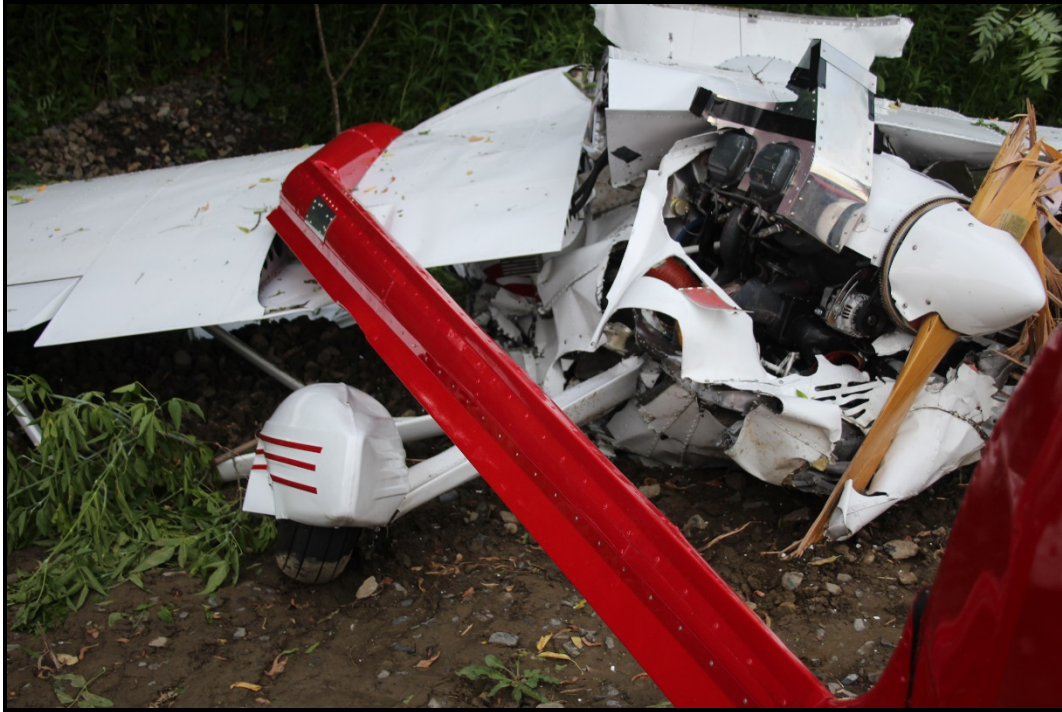
**Photograph 8 – Left side outboard tail boom and engine.**

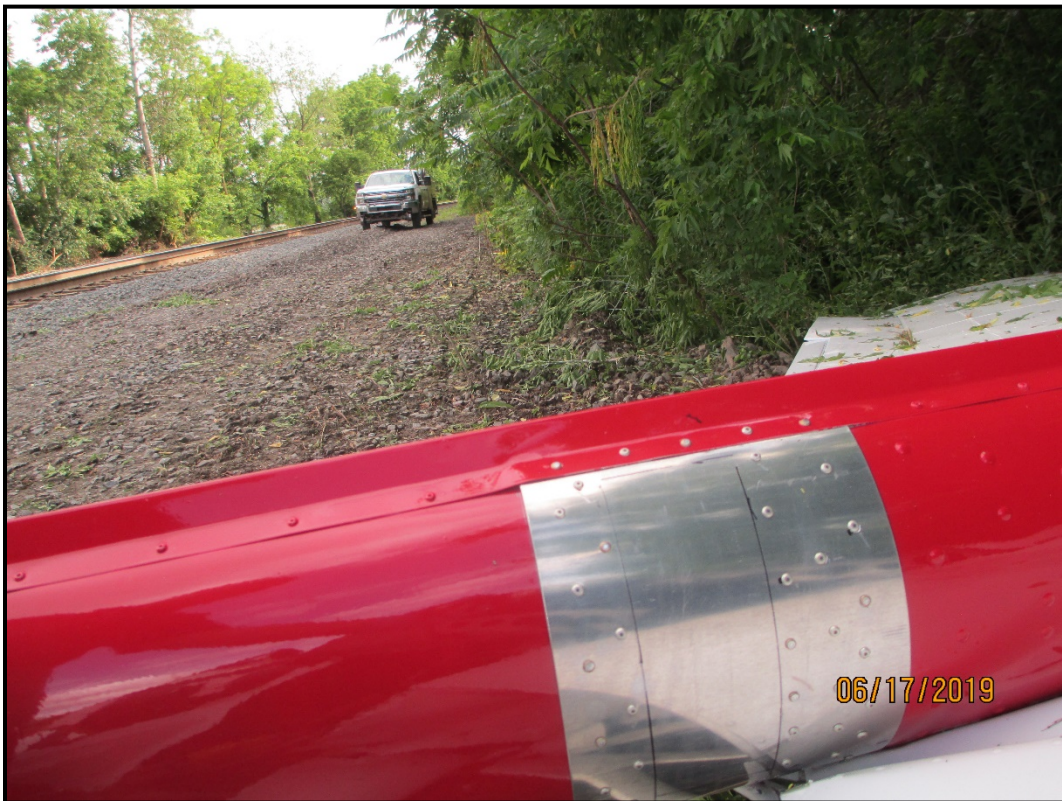
**Photograph 9<sup>1</sup> – Left side inboard tail boom.**

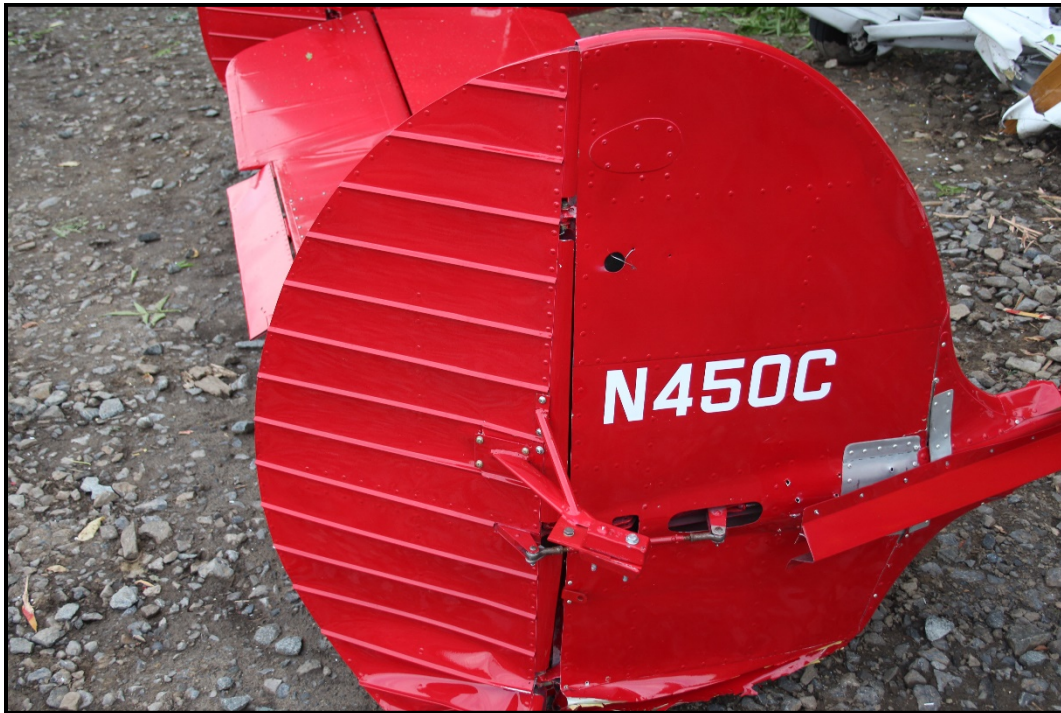
**Photograph 10 – Right side outboard vertical stabilizers.**

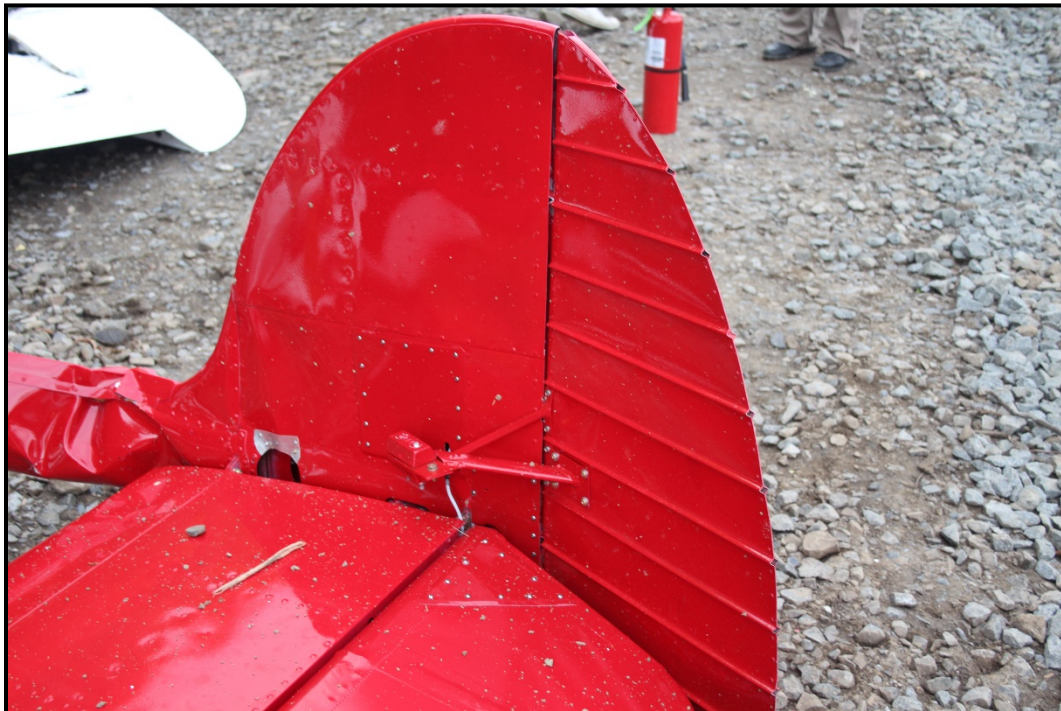
**Photograph 11 – Right side inboard vertical stabilizers.**

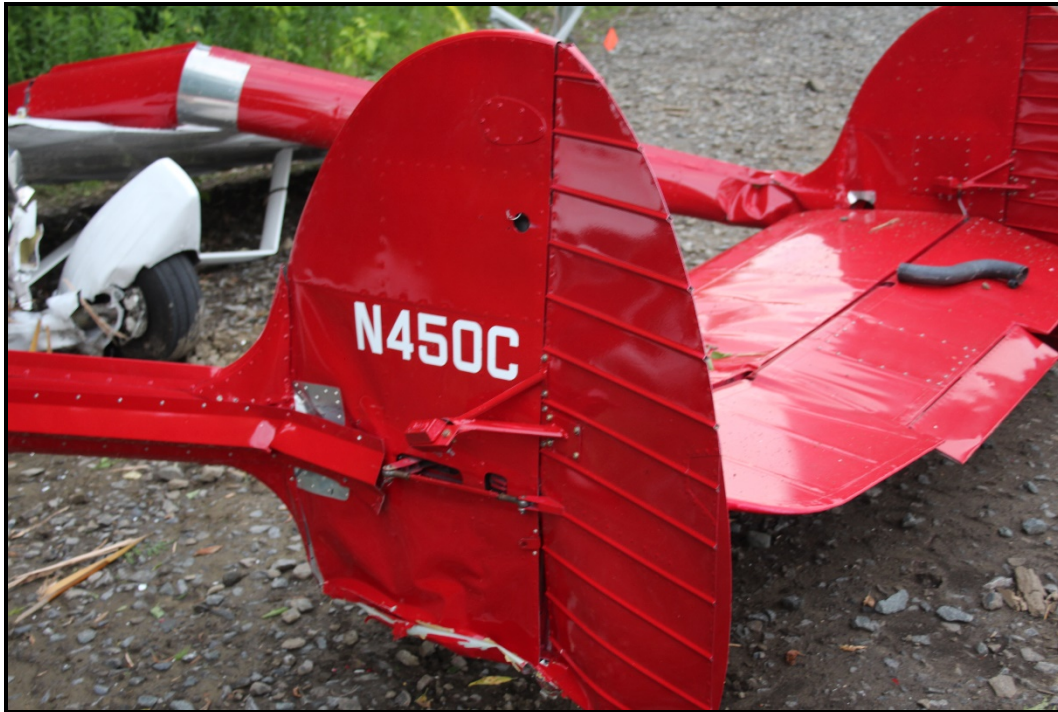
**Photograph 12 – Left side outboard vertical stabilizers.**

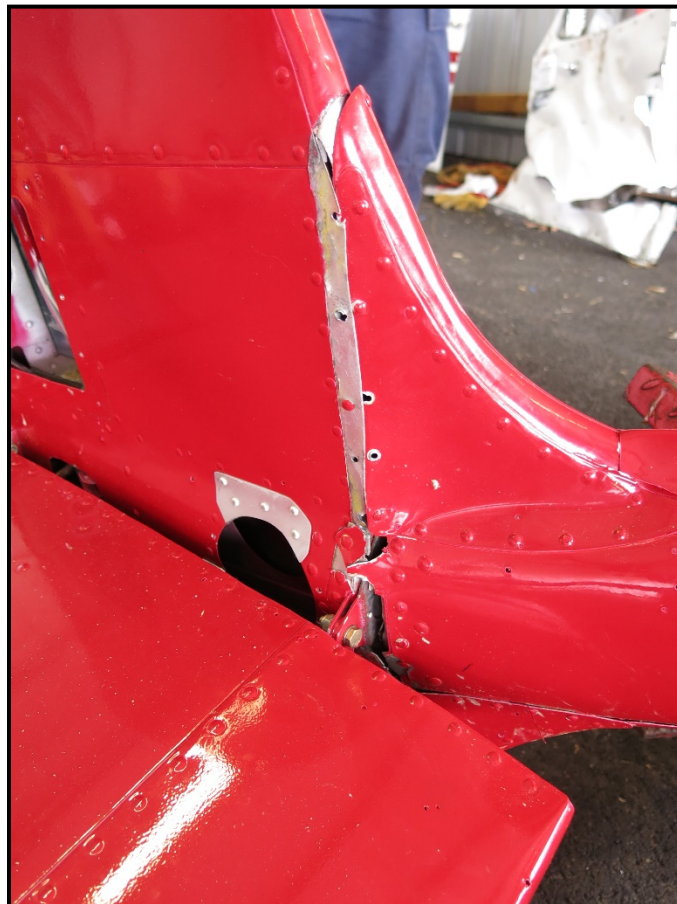
**Photograph 13 – Left side inboard vertical stabilizers.**

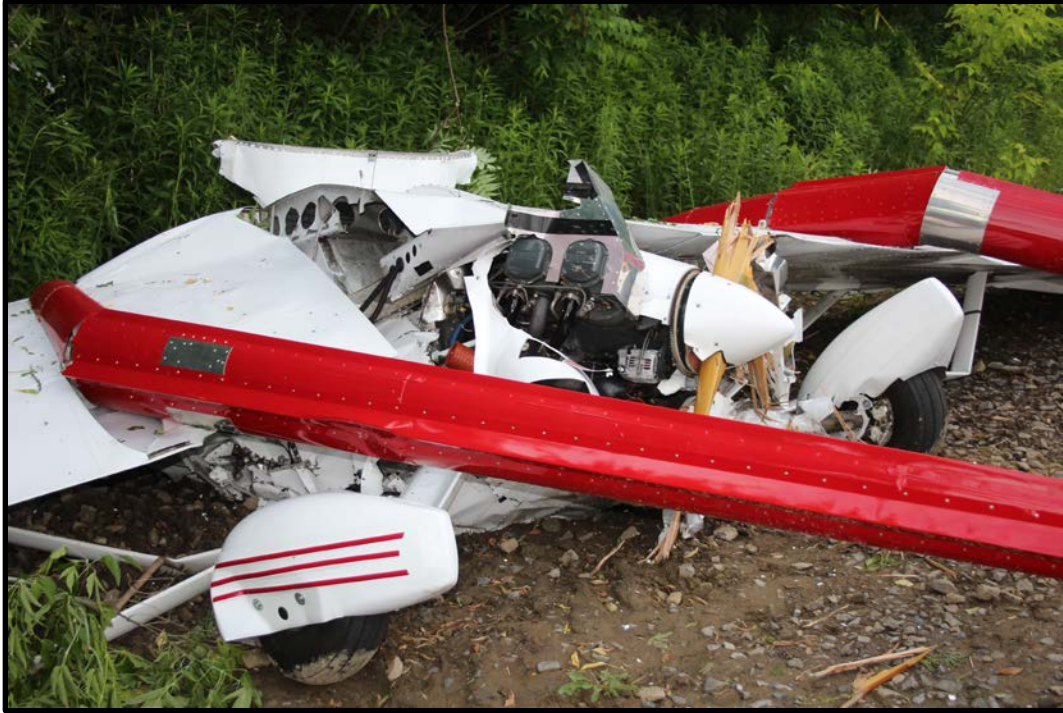
**Photograph 14 - Tail booms with external doublers and added stringers.**

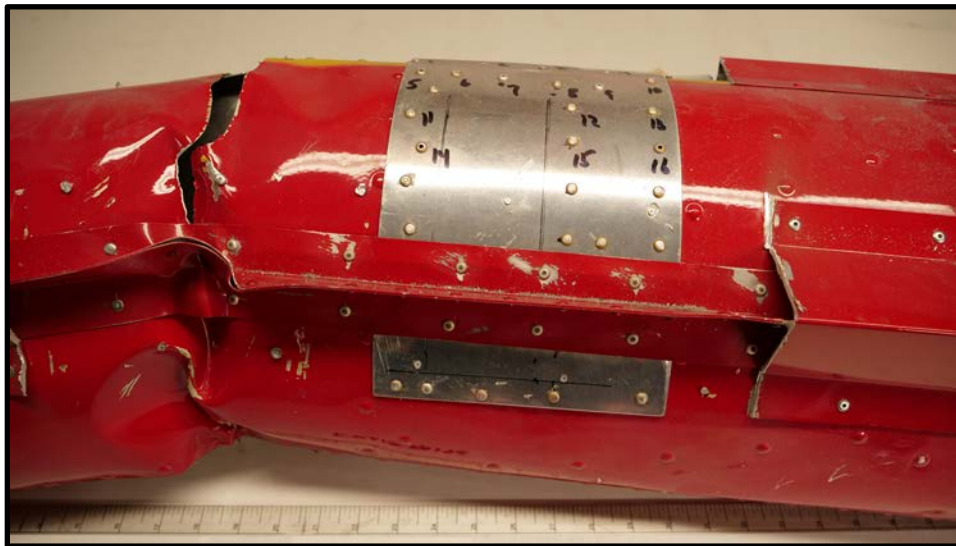
**Photograph 15 - Right tail boom outboard doubler during disassembly showing added hat and T stringers.**

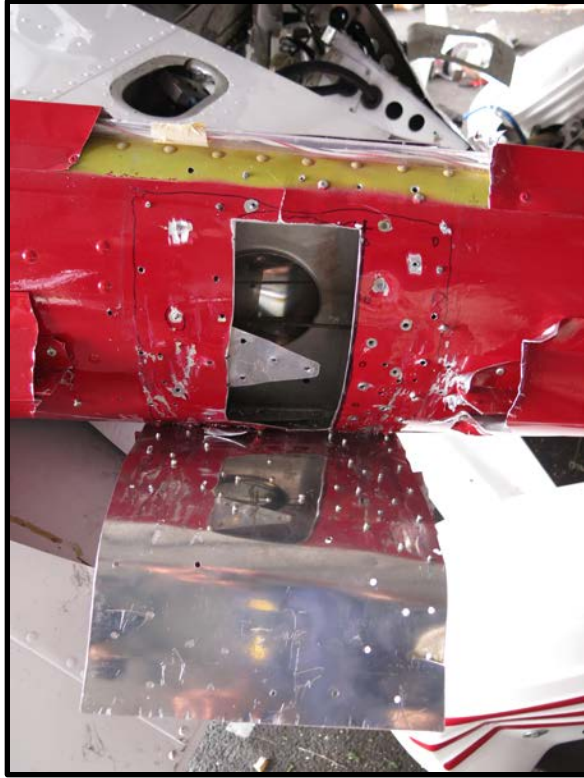
**Photograph 16 - Left tail boom outboard hole with cracks.**

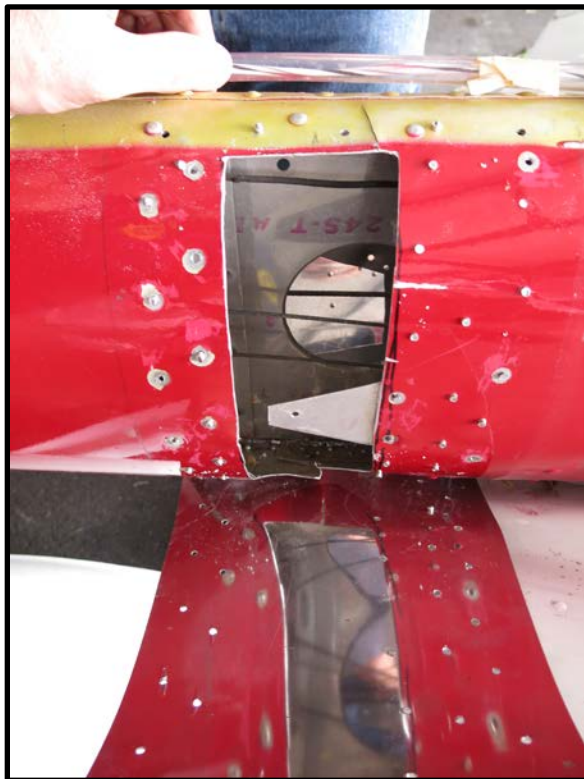
**Photograph 17 - Left tail boom inboard hole with cracks.**

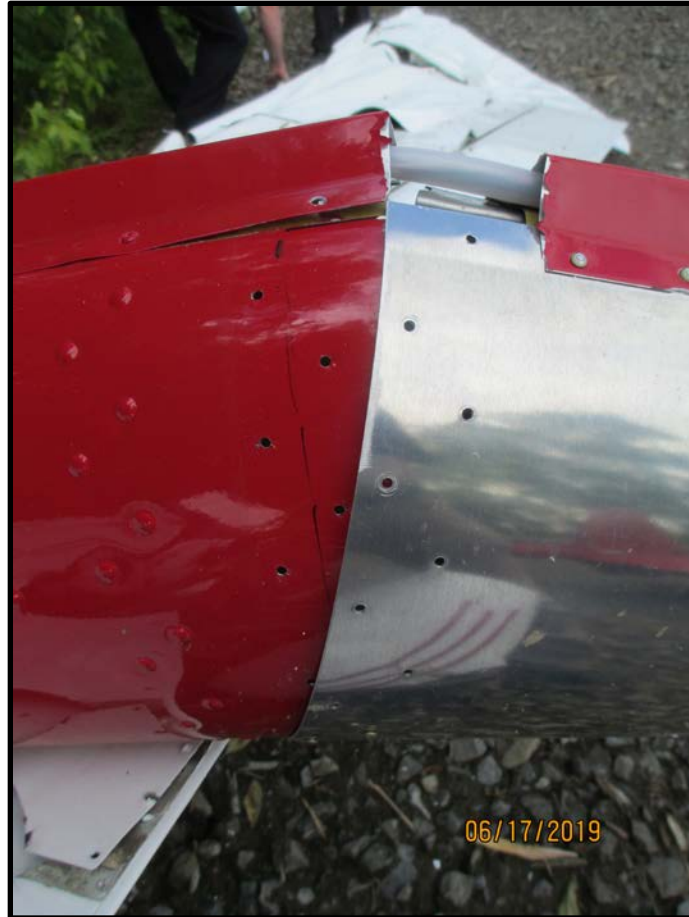
**Photograph 18<sup>2</sup> - Right tail boom inboard doubler with separated rivets.**

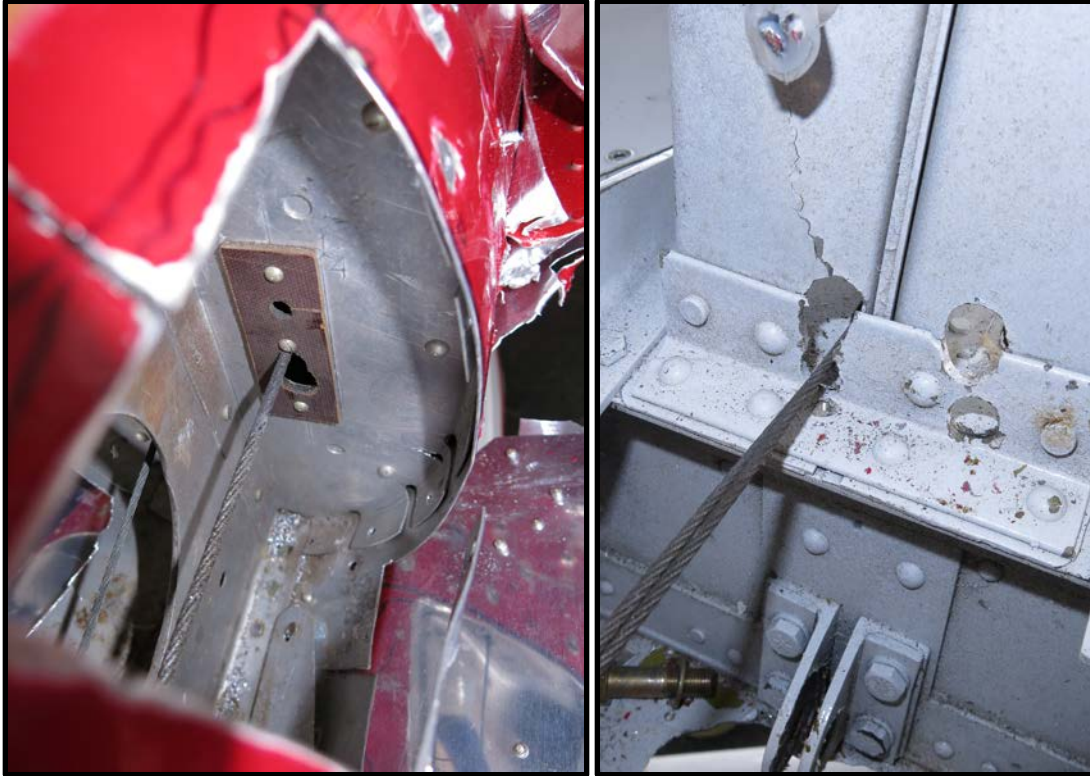
**Photograph 19 - Control cable fairlead and pass through.**

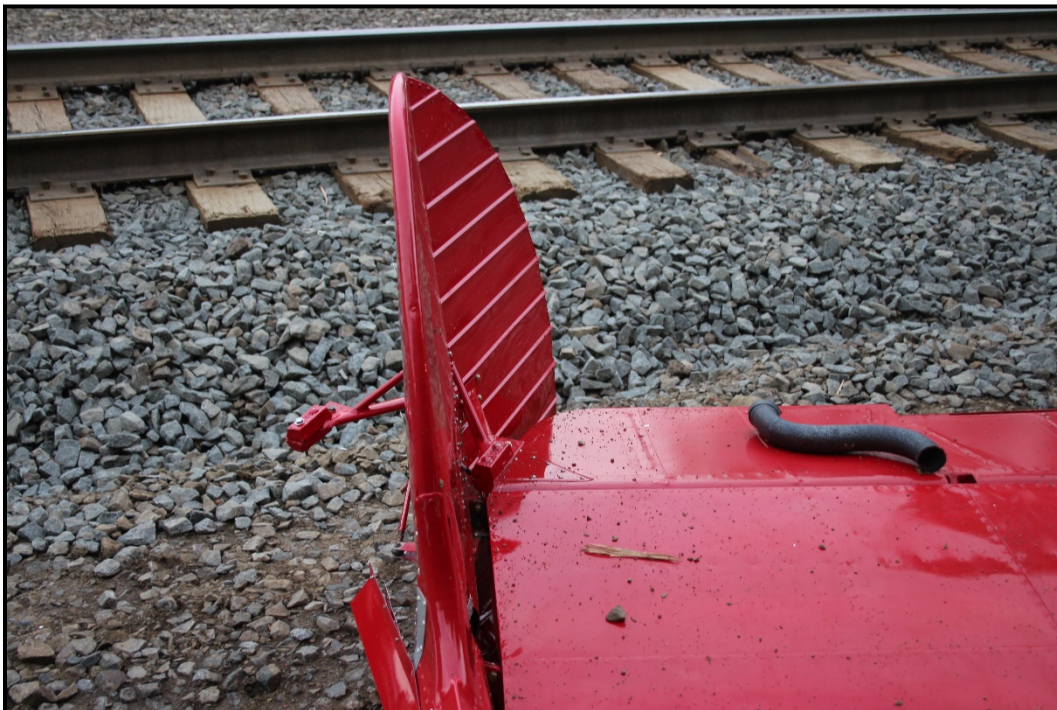
**Photograph 20 Right rudder counterweights.**
