**Photo 1 –Overview of Accident Site (Courtesy of Georgia Bureau of Investigation)**

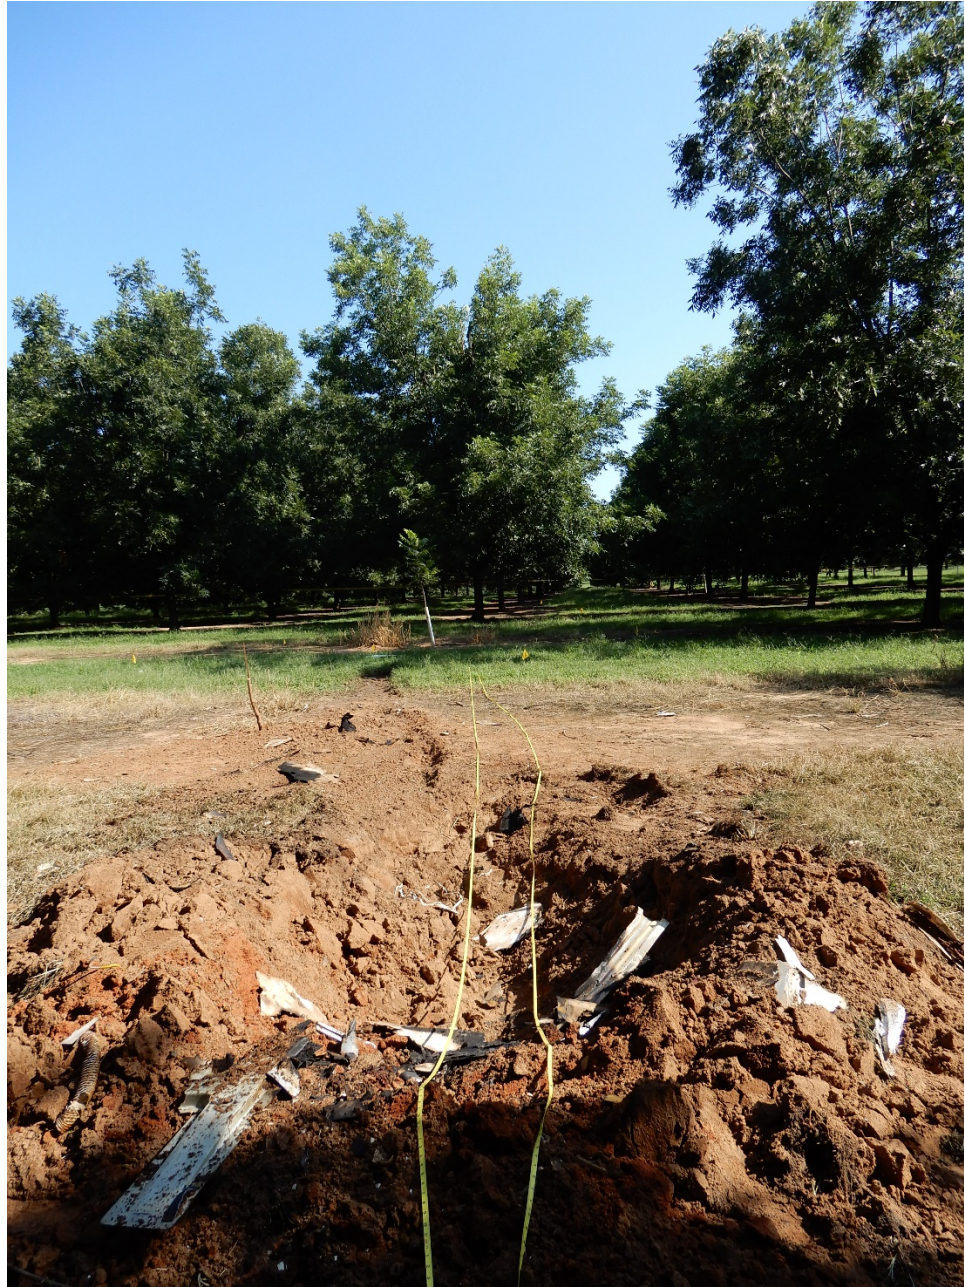
**Photo 2 – View of Impact Crater**

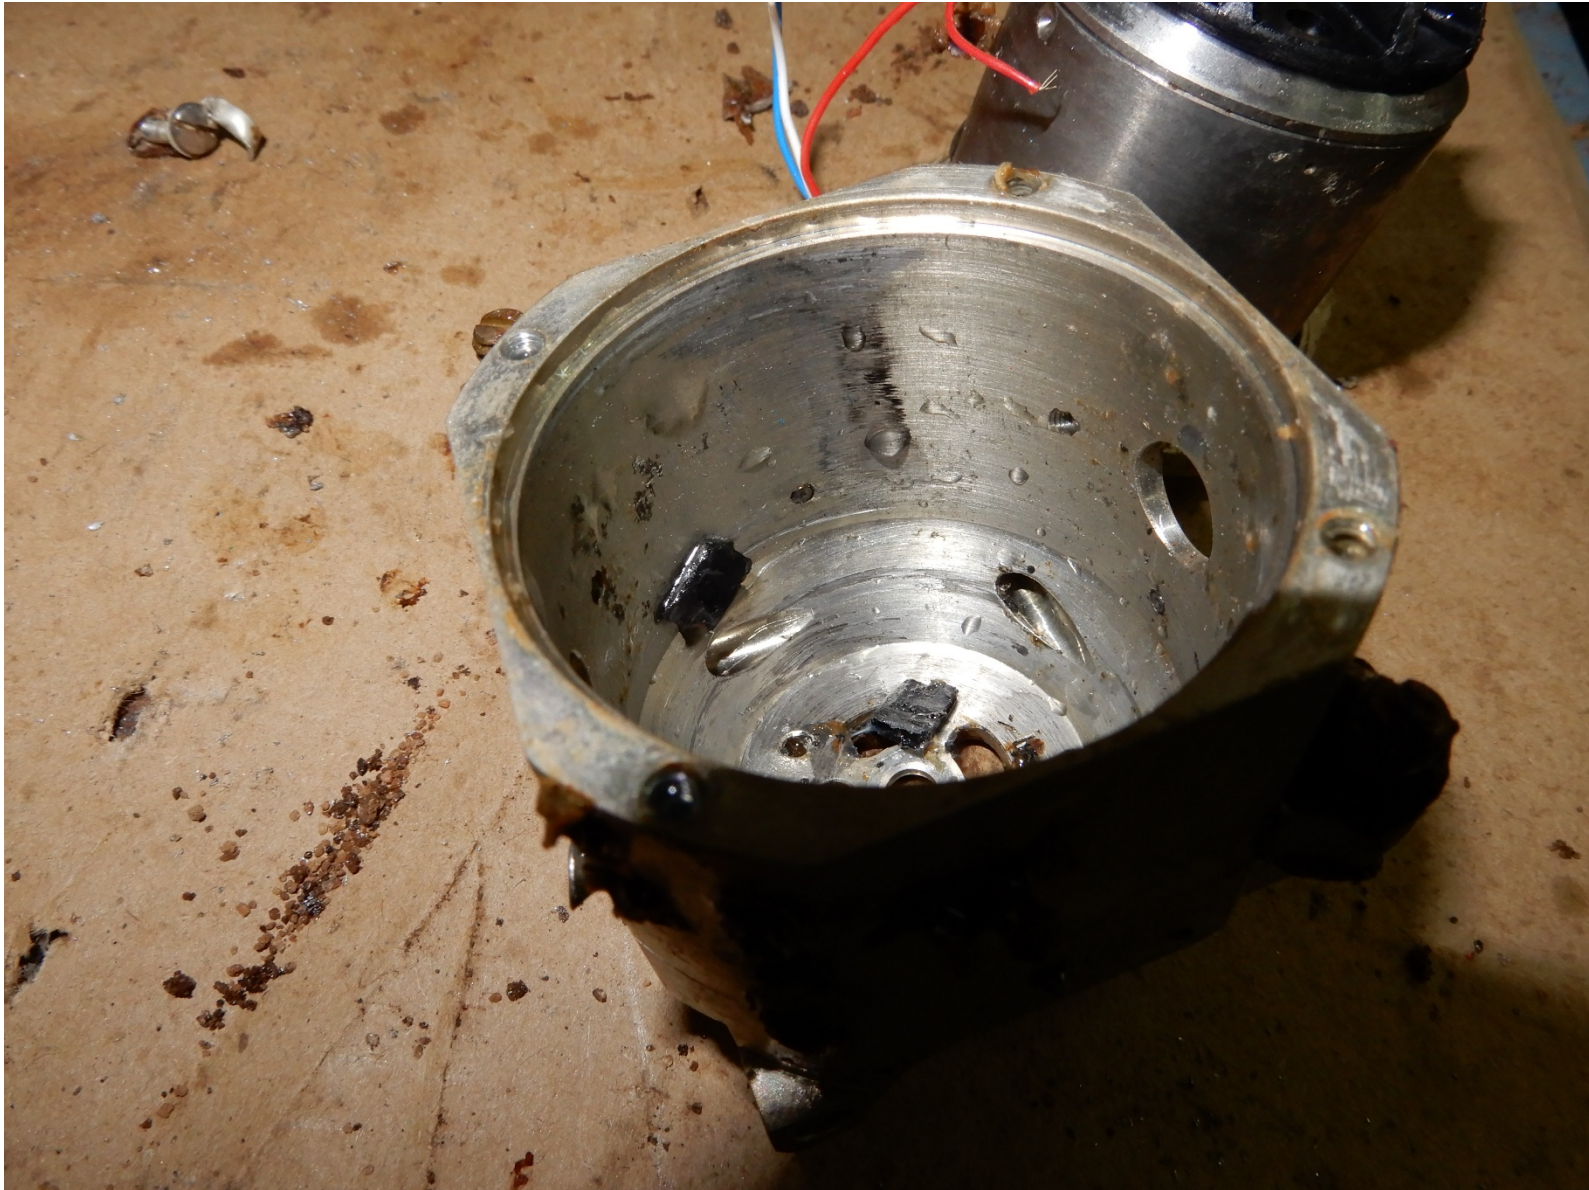
**Photo 3 – View Attitude Indicator Gyro Case**

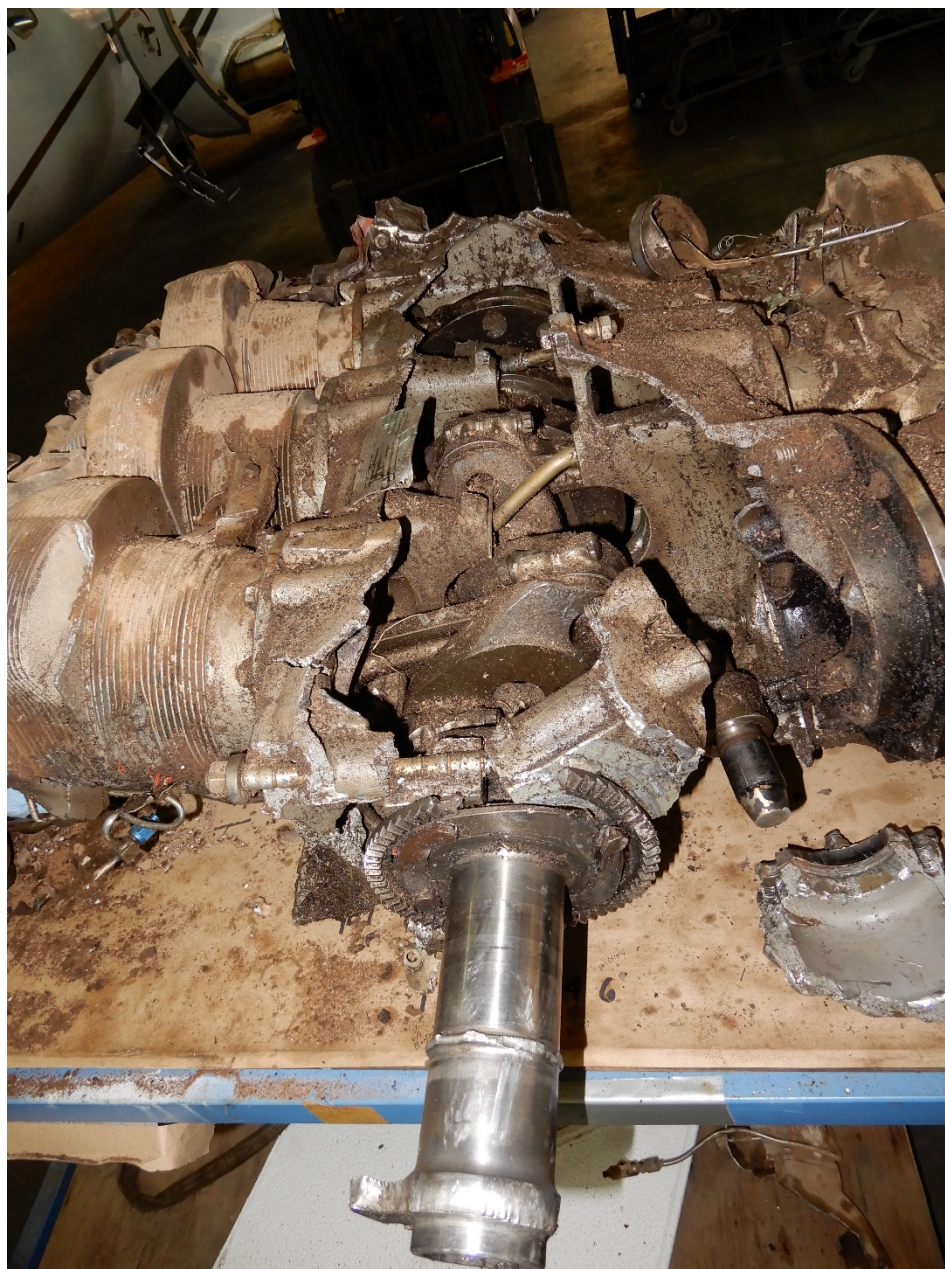
**Photo 4 – View of engine**

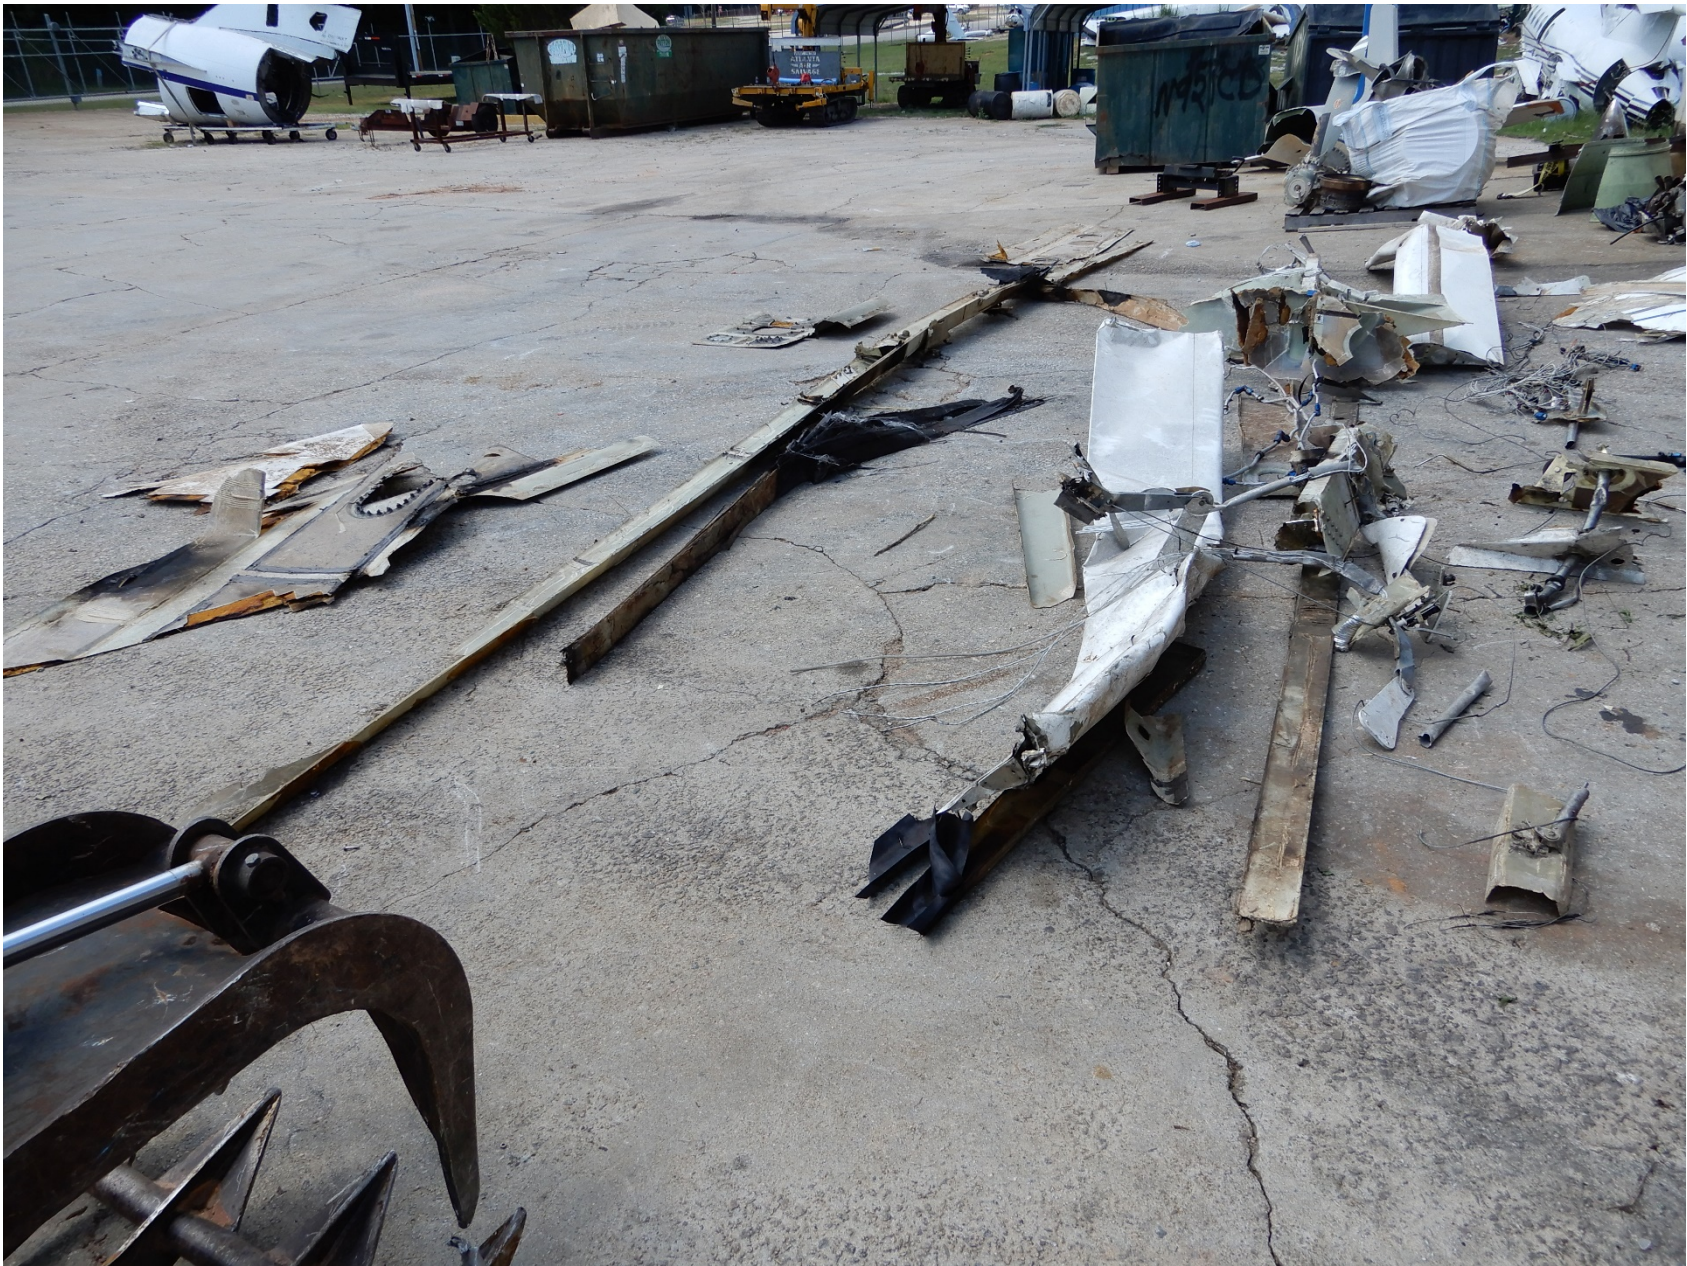
**Photo 5 – View of wing section of airplane (foreground is the left wing)**

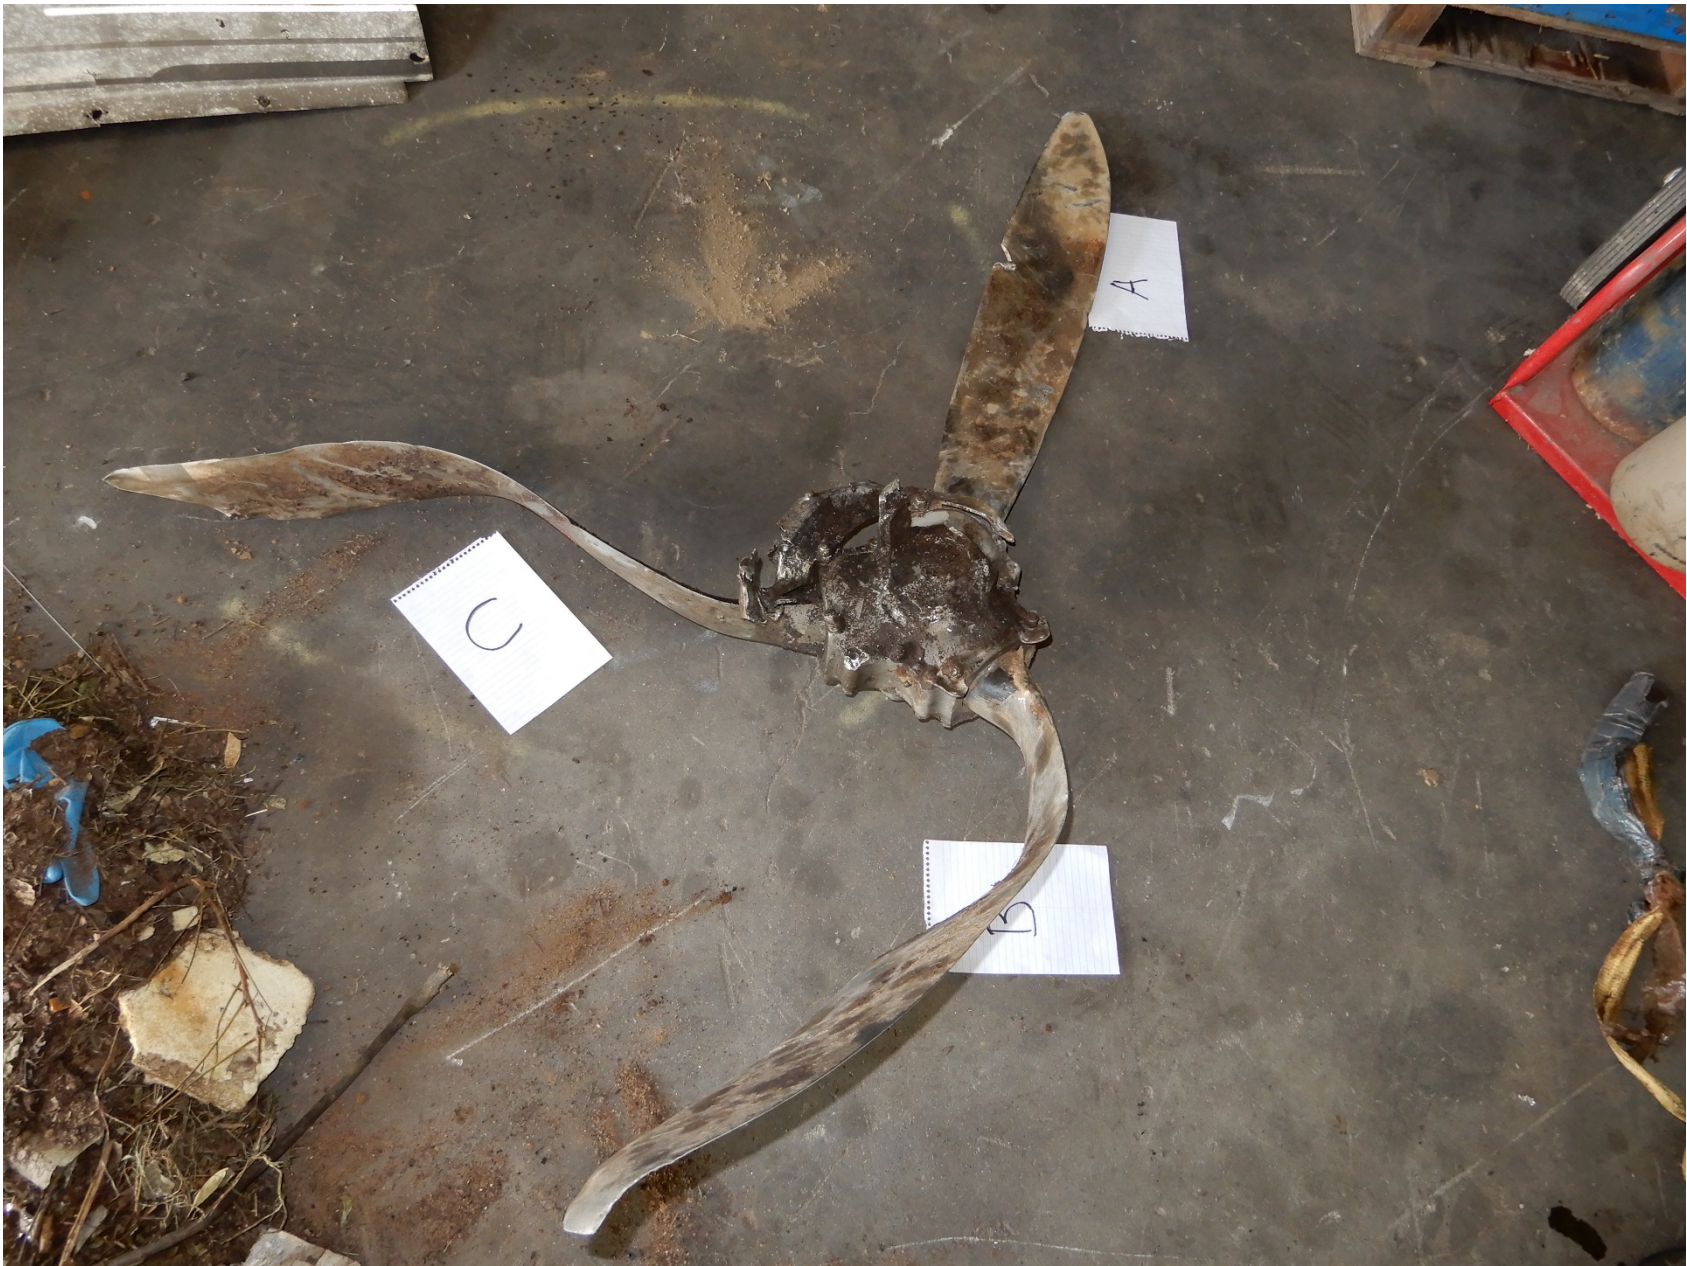
**Photo 6 – View of Propeller**

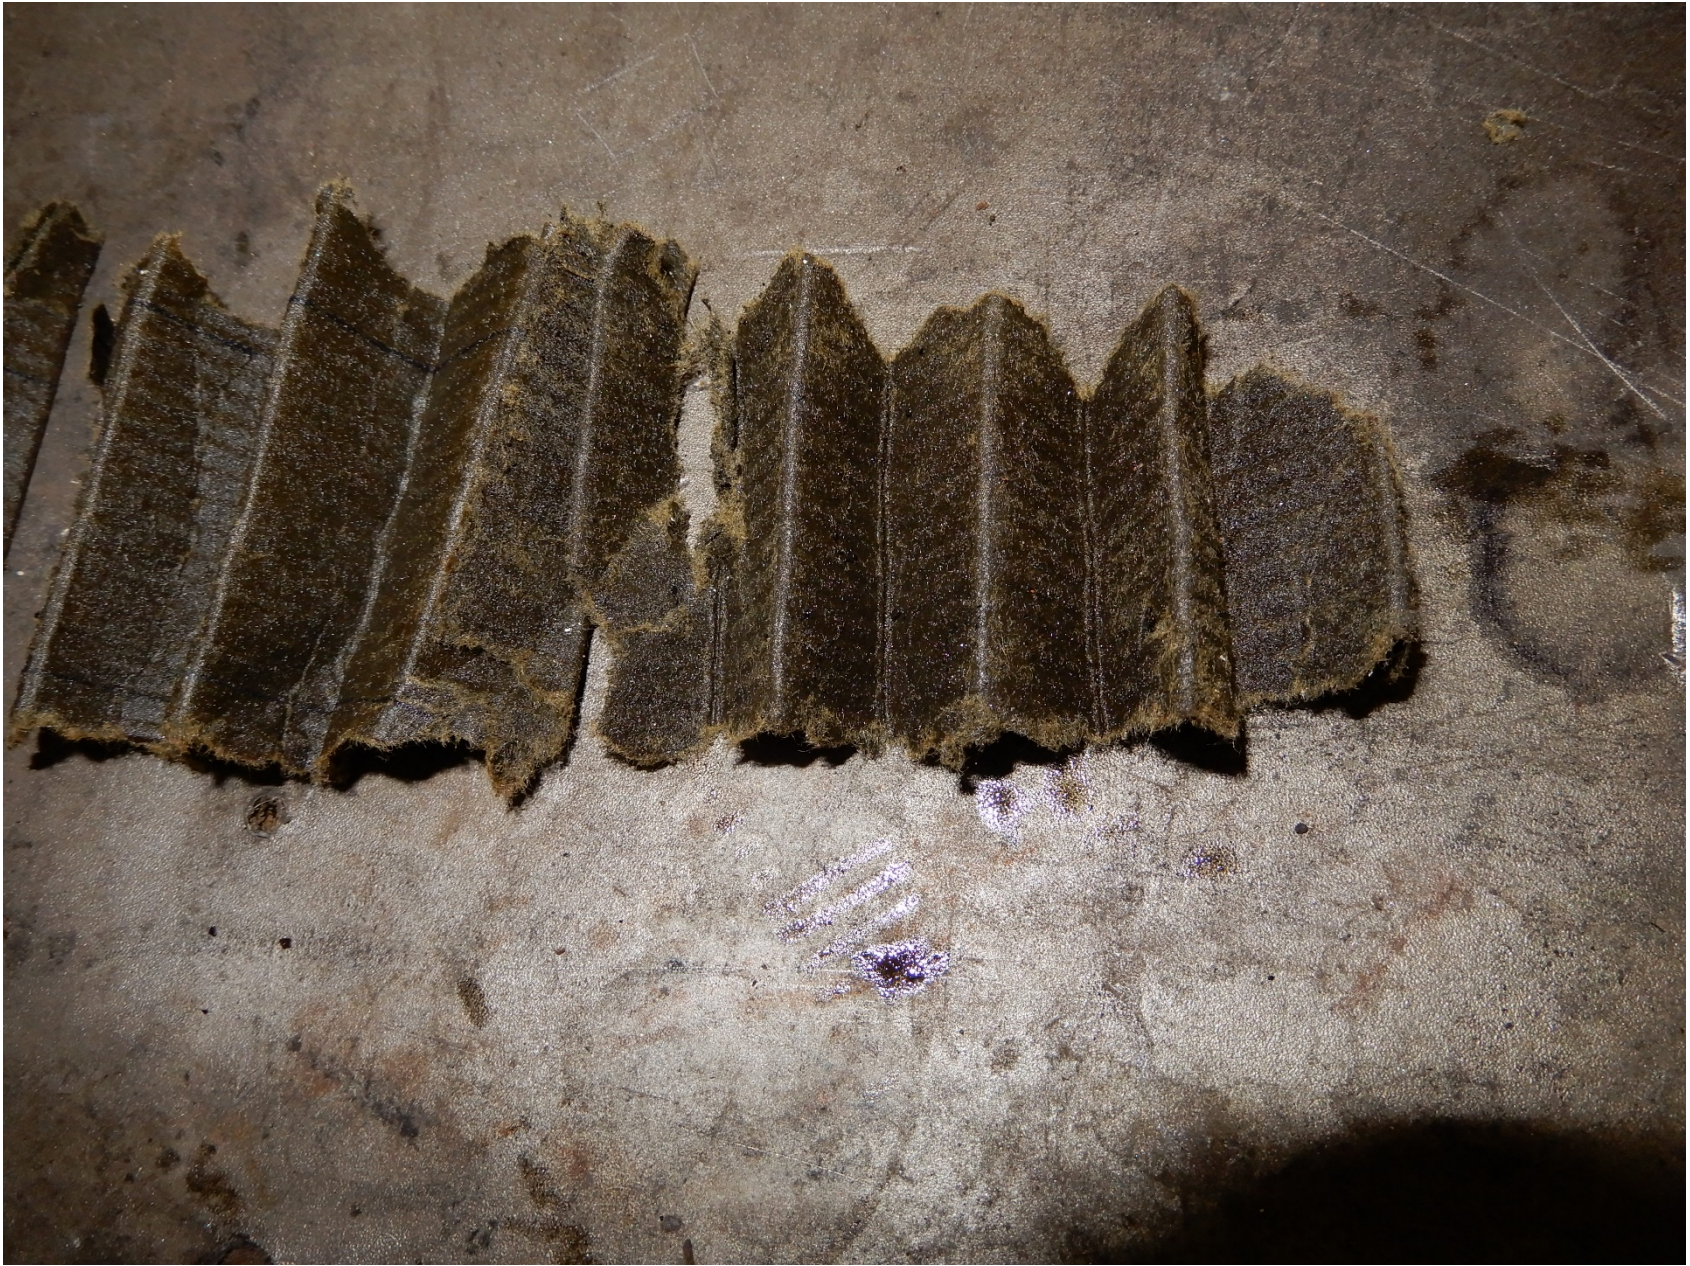
**Photo 7 – View of disassembled oil filter.**

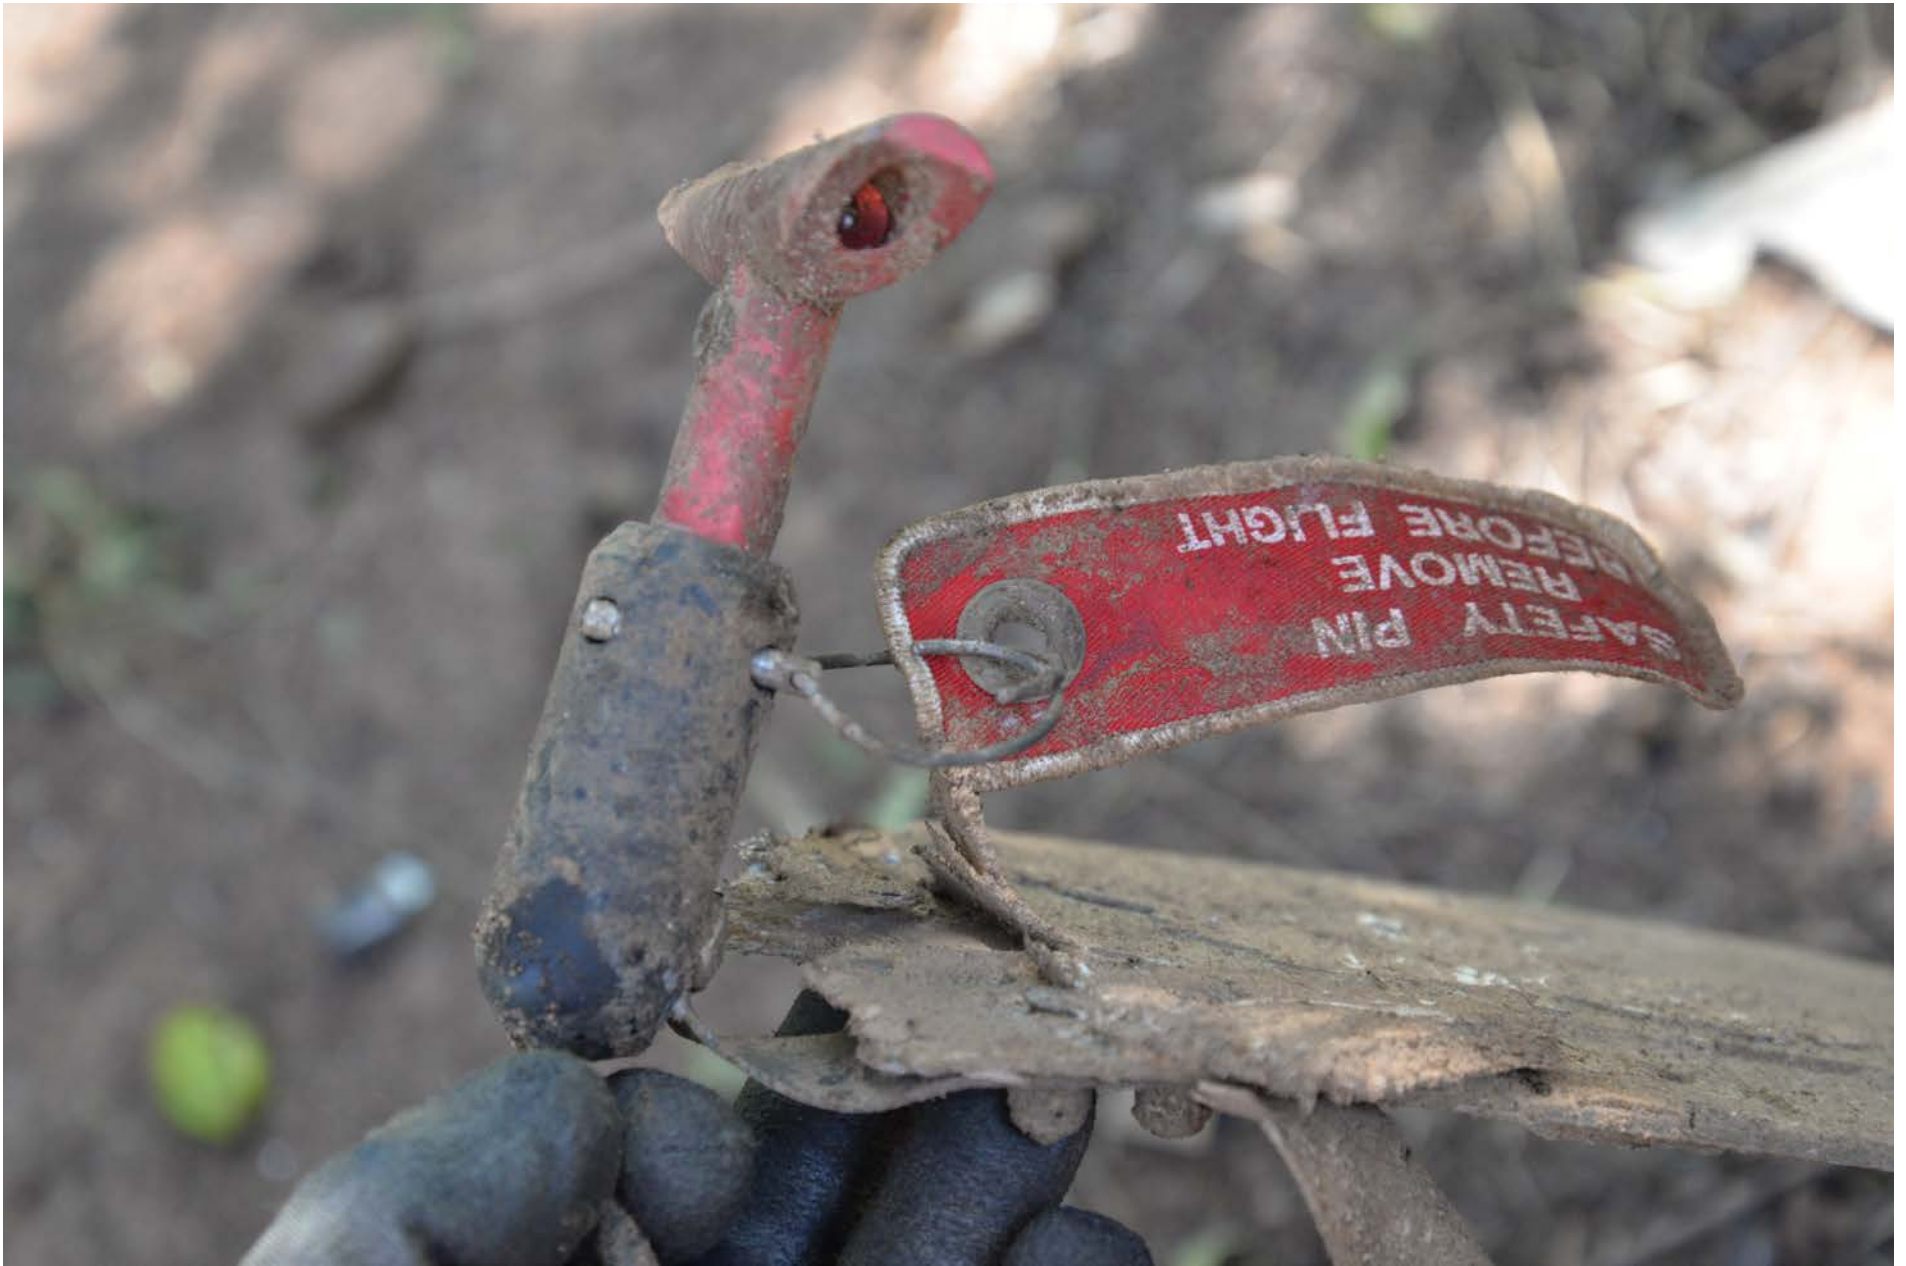
**Photo 8 – View of CAPS pin installed in handle. (Courtesy of Cirrus Aircraft)**
