# National Transportation Safety Board

## Performance Study

### Specialist Report

| NTSB Number: | ERA19FA240 |

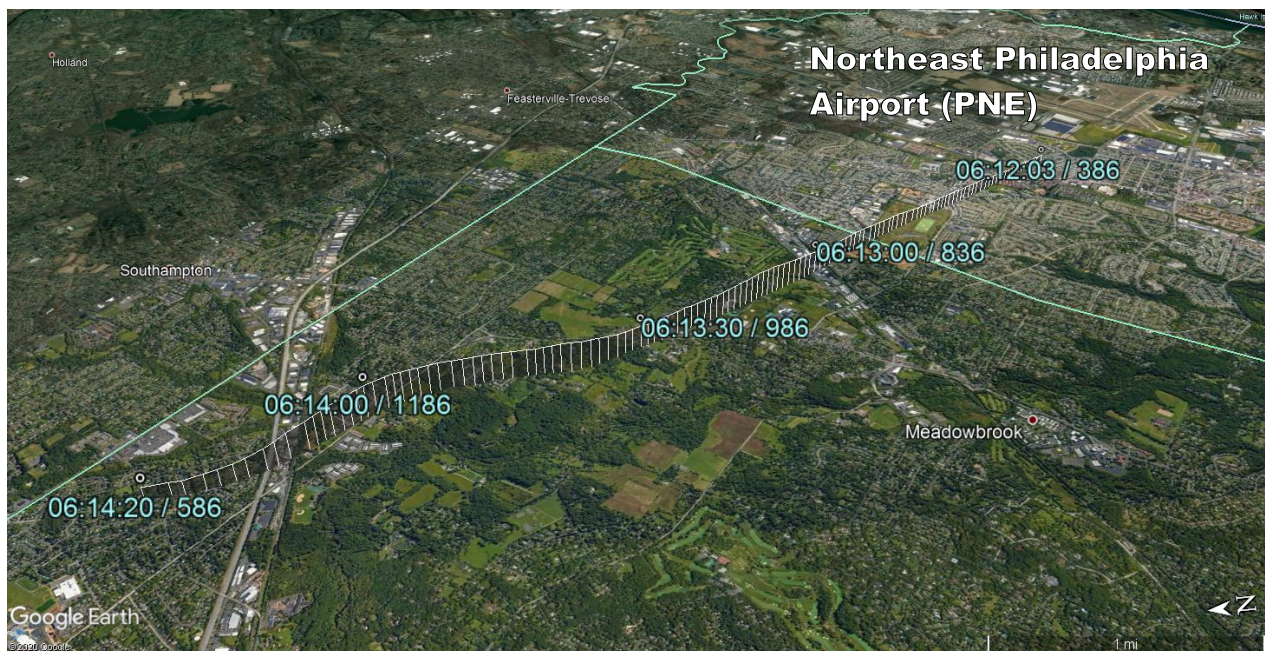
Figure 1 shows the accident flight path. The flight was approximately six nautical miles long and lasted about two and a half minutes. Figure 2 shows the altitude profile and calculated ground and

**Figure 1.** Accident flight. Annotations indicate time and altitude.

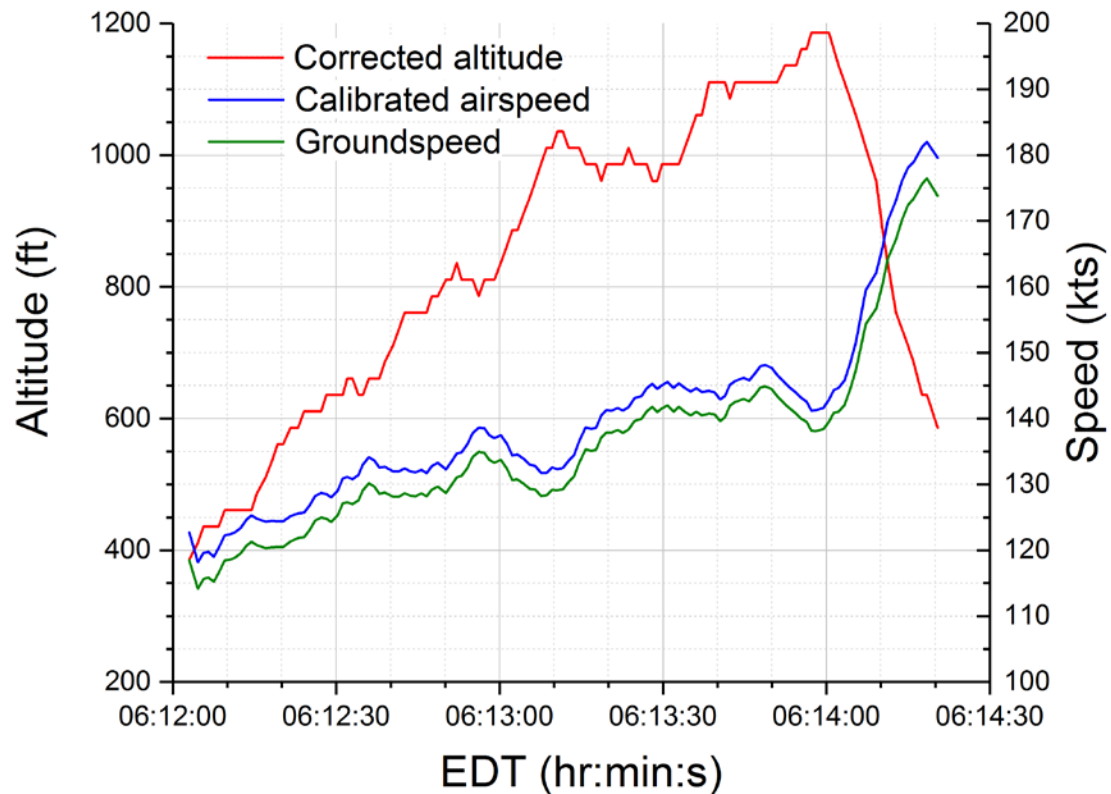
airspeeds of the flight and Figure 3 shows calculated pitch and roll attitudes of the airplane based on a basic aerodynamic model. The airplane took off from PNE, elevation 119 ft, and climbed while gaining airspeed. By 06:13:20, the airplane had reached an airspeed of 140 kts. At 06:13:30, the airplane banked right to about 15° right wing down and turned from a heading of 325° to a heading of 350°. During the climb, the airplane's pitch did not exceed 10° nose up. At 06:13:57, the airplane reached a maximum altitude of 1,186 ft and just after 06:14 it began to descend. The airplane descended at a rate of 2,000 ft/min while gaining airspeed. It banked left to approximately 20° left wing down at 06:13:55, then banked right to approximately 30° right wing down at 06:14:15, before coming back to wings level just before the end of the data. The final calculated airspeed was 180 kts and last recorded altitude, at 06:14:20, was 586 ft. Terrain elevation in the area of the impact was about 230 ft.

**Figure 2.** Accident flight altitude and calculated ground and airspeeds.

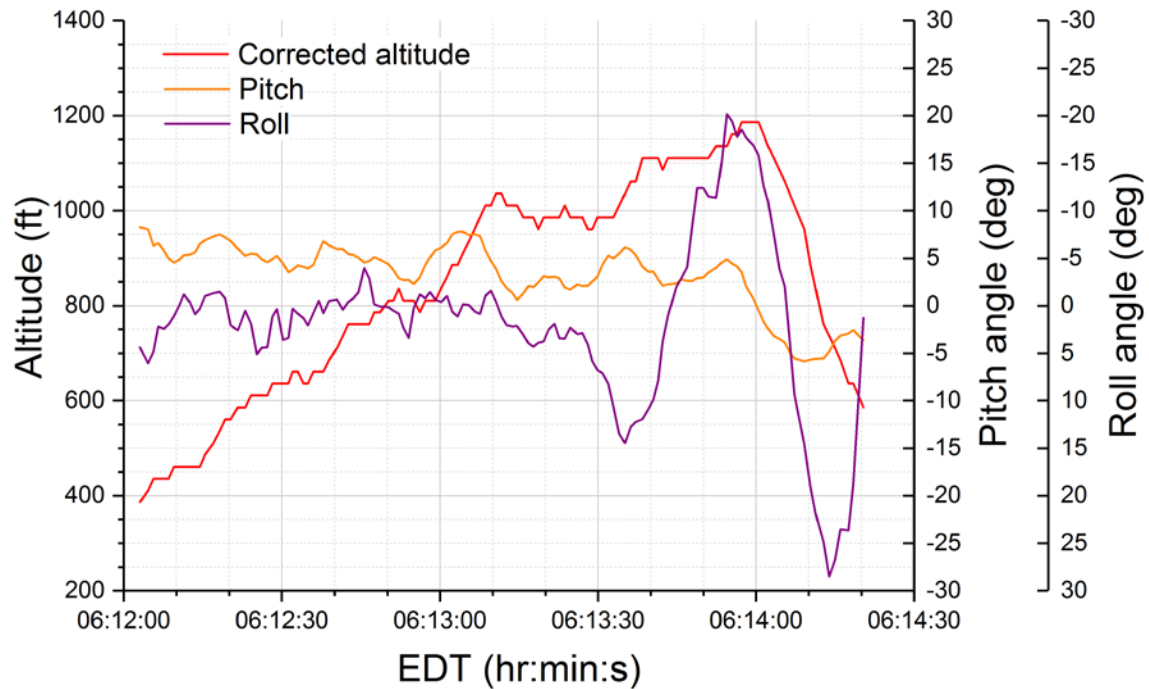
The airplane was equipped with a Garmin G5 with Electronic Stability Protection. This system automatically adjusts flight controls if the airplane exceeds attitude or airspeed limits. The system was configured to activate if roll exceeded 45°, pitch exceeded 20° nose up or -15° nose down, or the airspeed was less than 70 kts or greater than 198 kts. During this accident flight, none of these parameters were exceeded, even during the final descent.

**Figure 3.** Accident flight altitude and calculated pitch and roll.
