## ENGINE EXAMINATION REPORT

| ENGINE MODEL | IO-520-BA |
| AIRCRAFT MAKE & MODEL | Beechcraft F33A |

| EXAMINATION | | ACCIDENT DATA | |
|---|---|---|---|
| DATE | 08/09/2019 – 08/10/2019 | NTSB ACCIDENT # | ERA19FA240 |

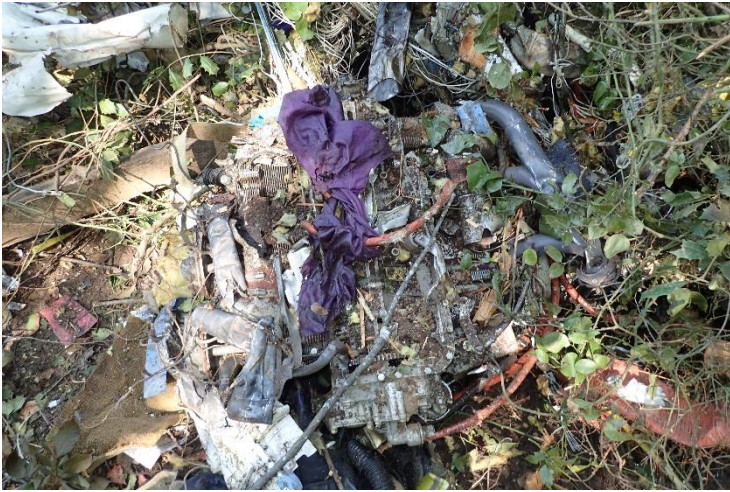
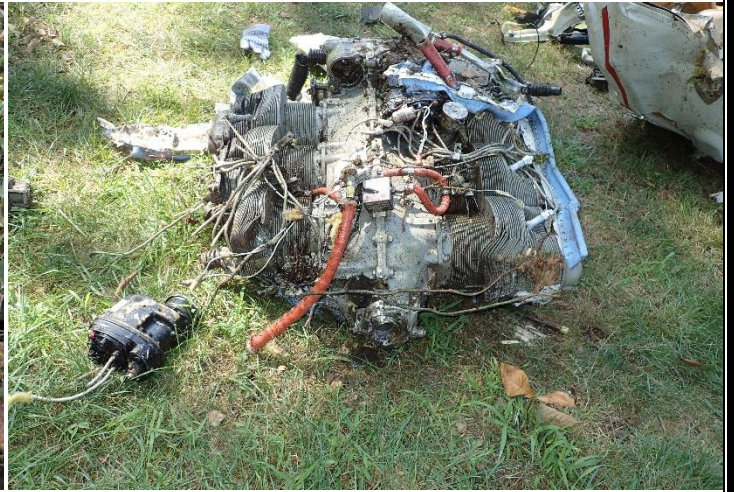
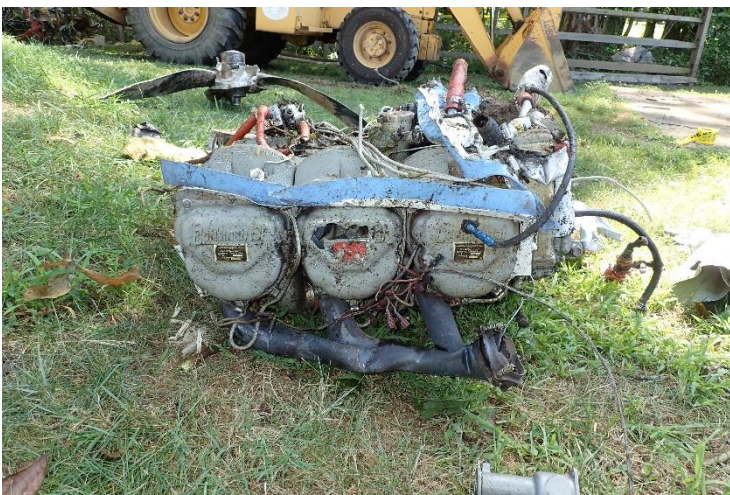
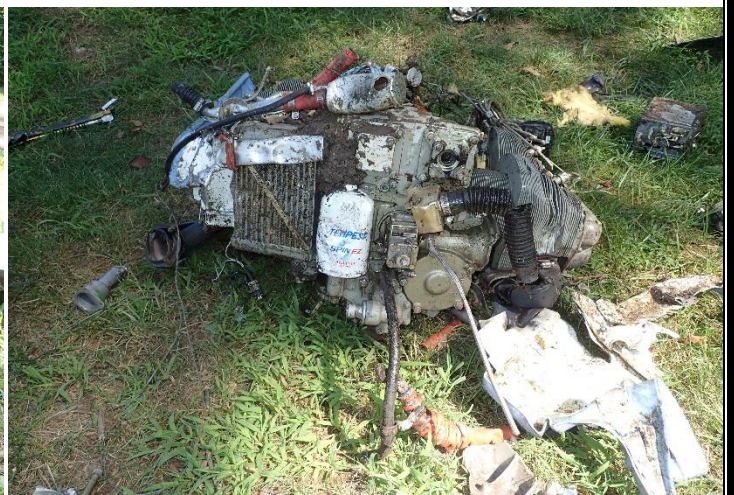
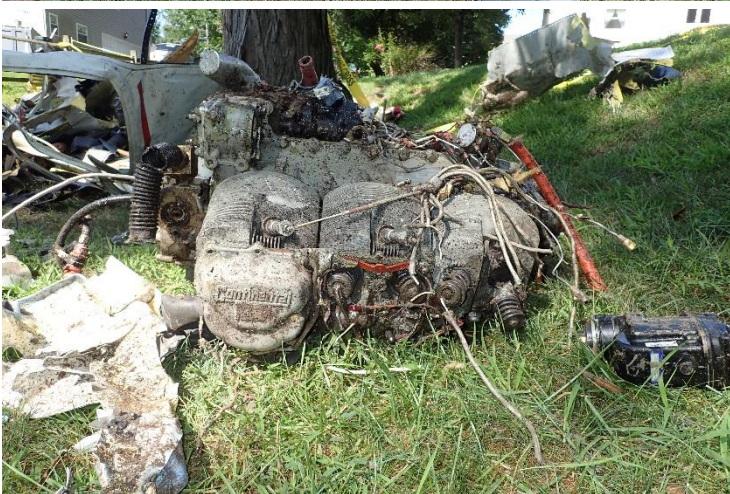
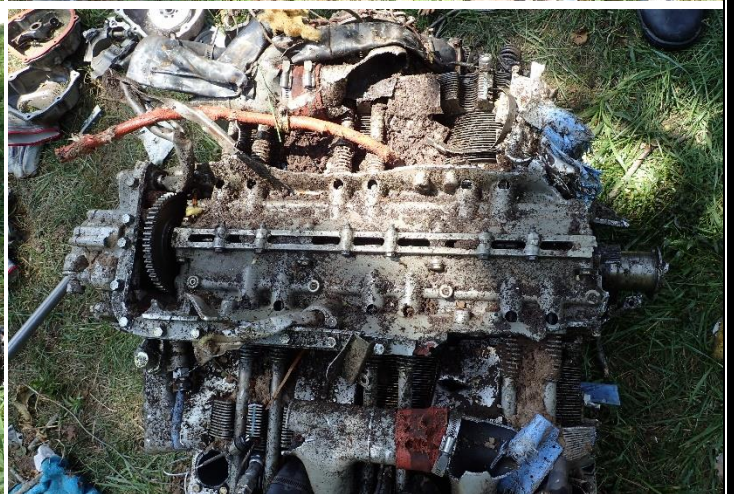
The engine was located at the primary wreckage site and displayed a significant amount of impact damage signatures. The crankcase displayed impact damage signatures with most of the damage occurring to the front of the crankcase; a large portion of the crankcase had broken free and some of the internal components were exposed. The crankcase did not display any signs of a catastrophic internal engine failure. The three-blade, constant speed propeller remained attached to the propeller flange; however, the propeller flange had broken free from the rest of the crankshaft, the damage was consistent with impact damage. All three propeller blades remained within the propeller hub and displayed impact damage signatures. The crankshaft displayed impact damage signatures; the propeller flange had broken free from the rest of the crankshaft and remained attached to the propeller hub. Portions of the internal parts of the crankshaft were visible through the broken forward crankcase. All six cylinders remained attached to their cylinder bays and displayed varying amounts of impact damage signatures.

The left magneto remained partially attached to the engine and displayed impact damage signatures, the right magneto had broken free from its installation point and displayed impact damage signatures. The ignition harness displayed a significant amount of impact damage signatures to all of the ignition leads, several of the leads were torn and severed. The #5 top spark plug had almost completely broken free from its cylinder, only the ground electrodes remained installed; the rest of the spark plugs remained installed in their cylinders and displayed varying amounts of impact damage.

The fuel pump remained attached to its installation point and displayed impact damage signatures. The throttle and metering assembly had broken free from its installation point and displayed a significant amount of impact damage; the metering assembly had broken free from the throttle body and the throttle body housing was shattered. The fuel metering assembly remained partially attached to the engine and displayed impact damage signatures. The #5 fuel nozzle had broken free from its cylinder, the rest of the nozzles remained installed in their cylinders and displayed varying amounts of impact damage. There were no signs of fuel leaks noted around any of the fuel components.

The induction system displayed a significant amount of impact damage; the majority of the intake tubes were broken and several of the tubes had broken free from the engine. The exhaust system displayed significant impact damage signatures; the risers were bent and crushed, and both of the exhaust mufflers and tailpipes had broken free from the engine.

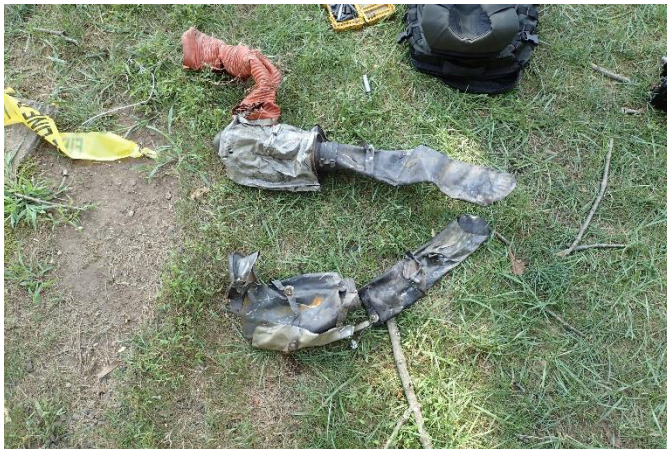
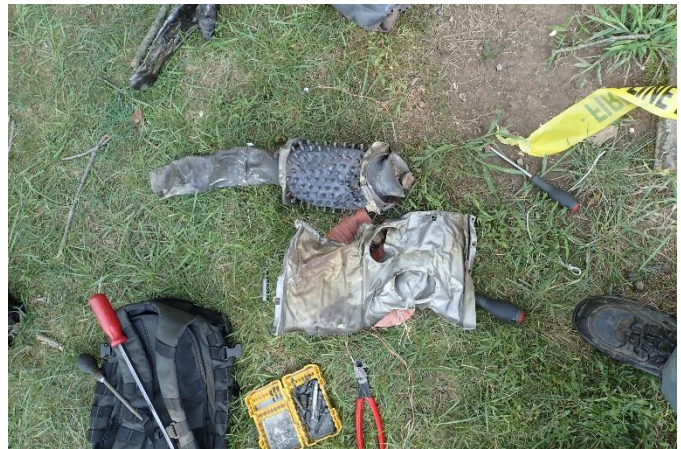
The exhaust system displayed a significant amount of impact damage; the exhaust risers displayed bending and crushing damage and both mufflers and tailpipes had broken free from their installation points. It was noted that both tailpipes were crushed almost completely flat. The exhaust heat exchanger shroud was removed and visually inspected; there were no signs of an exhaust leak noted within the shroud. There were no signs of exhaust leaks noted around any of the exhaust pipes.

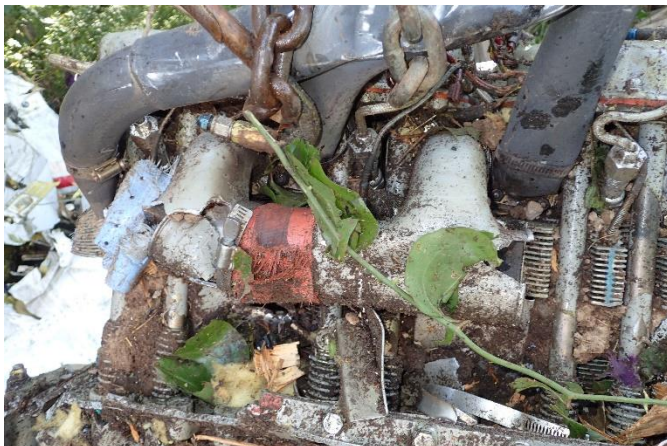
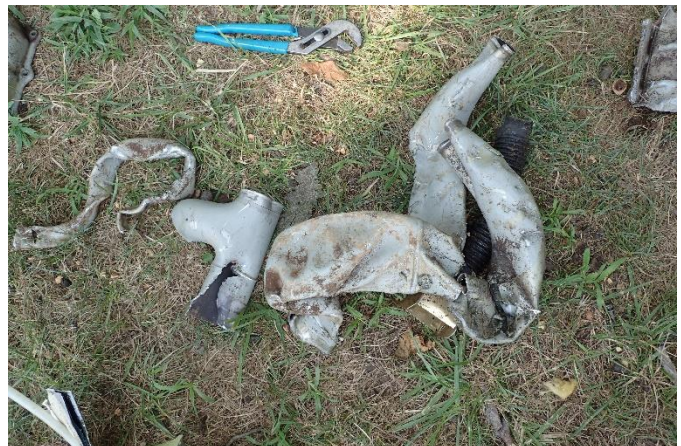
The induction system displayed a significant amount of impact damage signatures; most of the induction tubes and risers were broken and several portions of the intake system had broken free from the engine. There were no signs of induction leaks noted around any of the recovered induction tubes.

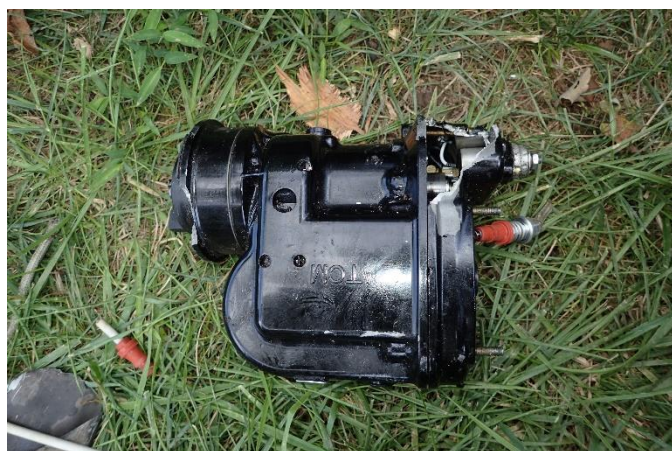
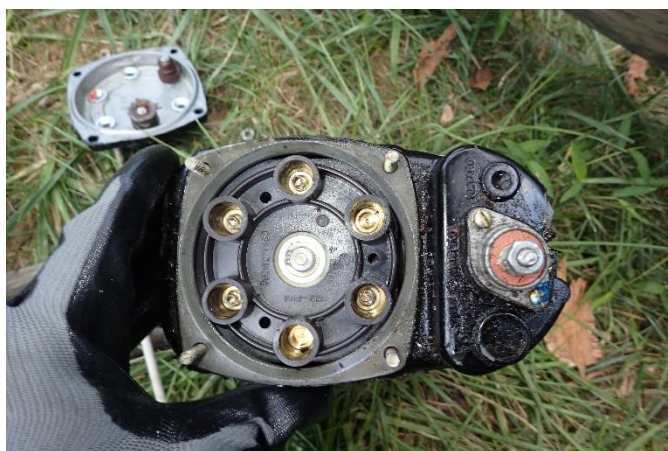
The magneto remained partially attached to its installation point and displayed impact damage signatures; a portion of the housing had broken free and the installation flange was broken. The magneto was removed and it was noted that the driveshaft was capable of rotation and the impulse coupling was capable of normal operation. During impulse coupling operation it was observed that the magneto was able to produce a spark on all six posts in the correct order. There were no anomalies observed.

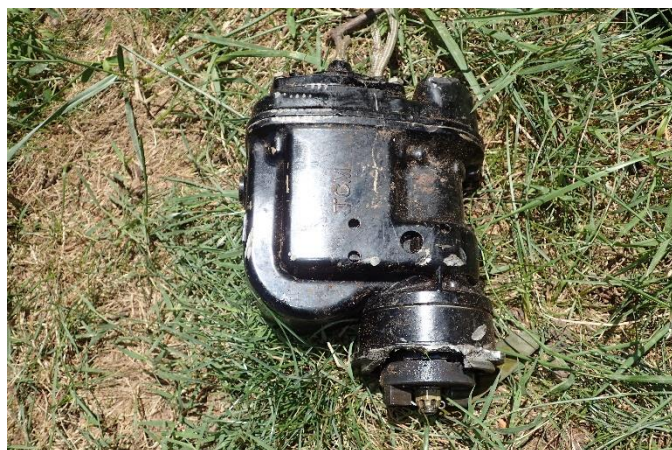
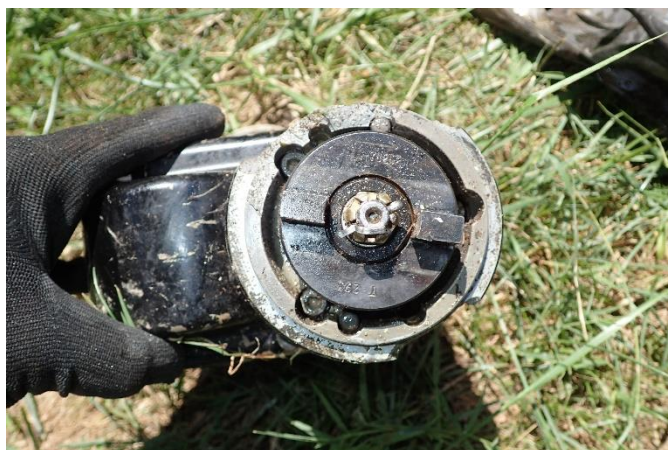
The magneto had broken free from its installation point and displayed impact damage signatures. It was noted that the driveshaft was capable of rotation and the impulse coupling was capable of normal operation. During impulse coupling operation it was observed that the magneto was capable of producing a spark on all six posts in the correct order. There were no anomalies observed.

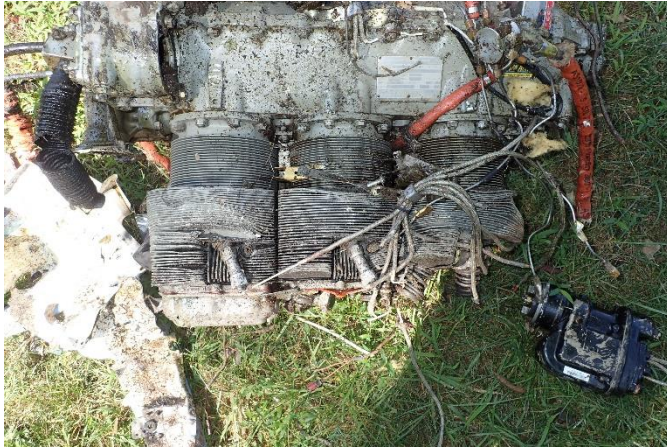
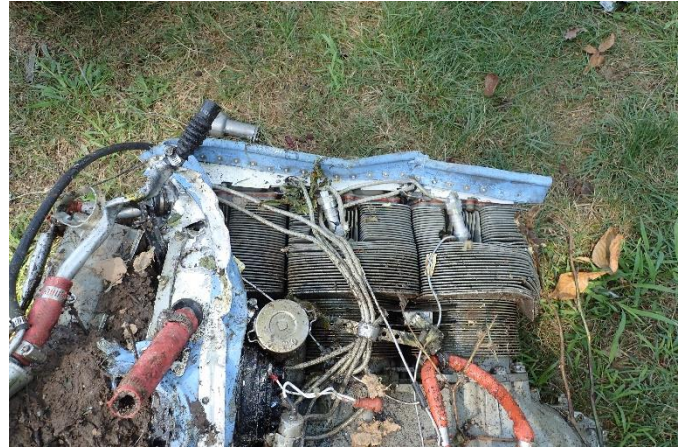
The ignition harness displayed significant impact damage; several of the leads were torn and severed. There were no anomalies observed.

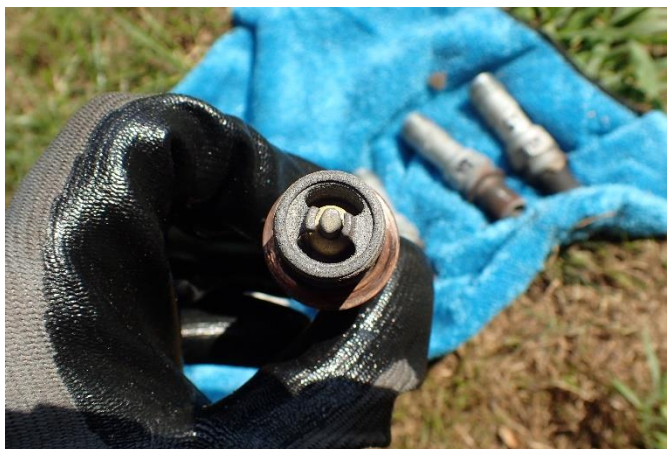
#1 Top Spark Plug

The #5 top spark plug had almost completely broken free from the engine; only the ground electrodes remained installed. The rest of the spark plugs remained installed in their cylinders and displayed varying amounts of impact damage. The top spark plugs were removed for inspection and the bottom spark plugs were inspected using a lighted borescope. The #5 bottom spark plug electrodes were obscured from view due to debris in the cylinder; the rest of the spark plug electrodes displayed normal operating signatures and most of the spark plugs were in a normal worn-out condition when compared with Champion Aviation Service Manual AV6-R. There were no anomalies noted that would have prevented normal operation.

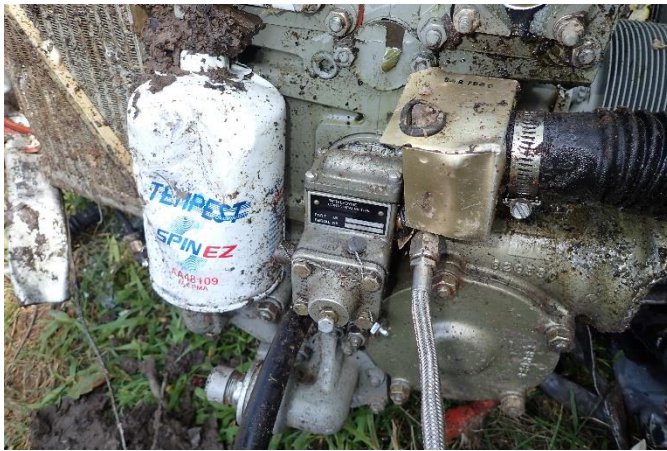
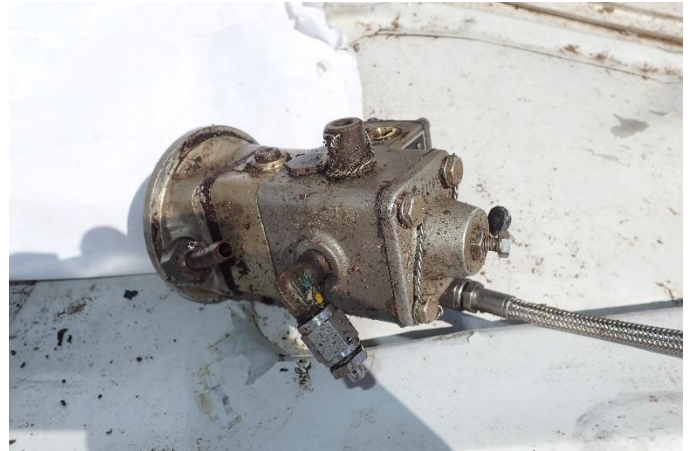
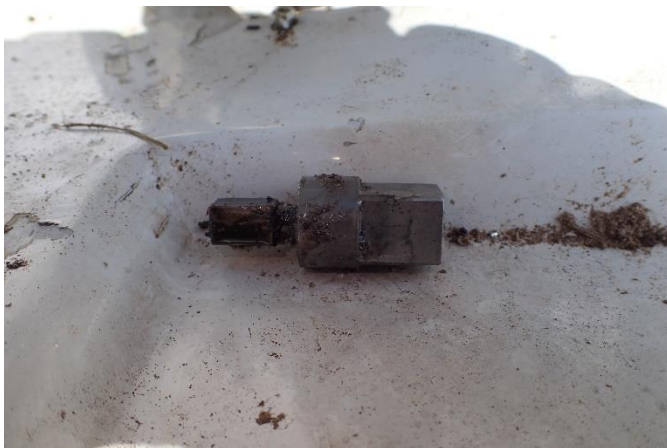
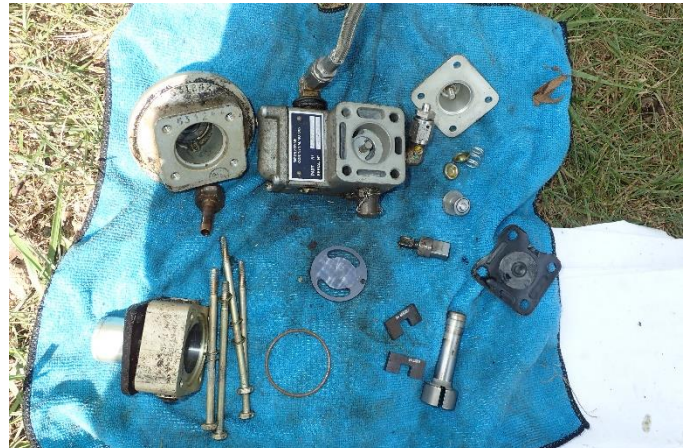
The fuel pump remained attached to its installation point and displayed impact damage signatures; there were no signs of fuel leaks around the fuel pump. The fuel pump was removed, and it was observed that the drive coupling remained intact and the driveshaft was capable of rotation. The fuel pump was disassembled, and the internal components were visually inspected; the internal components displayed normal operating signatures. There were no anomalies observed.

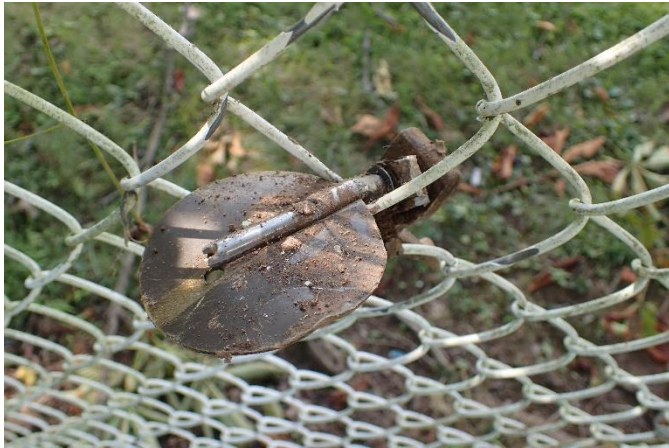
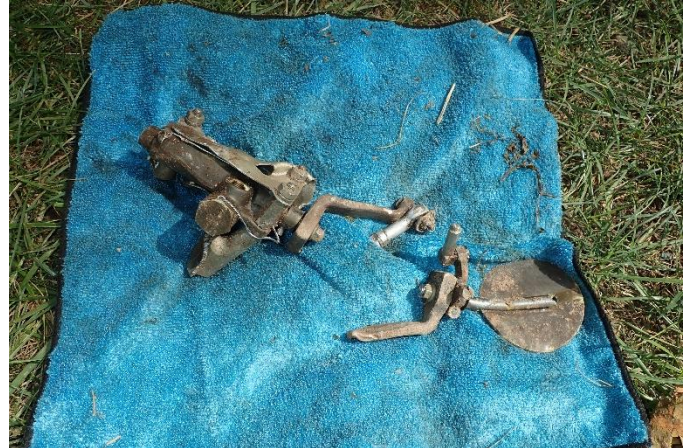
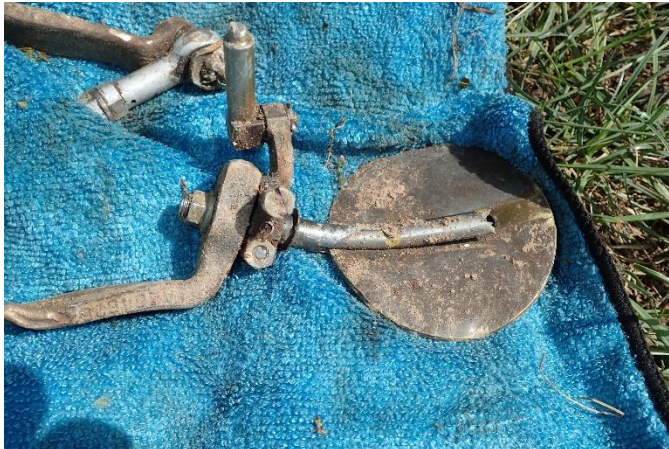
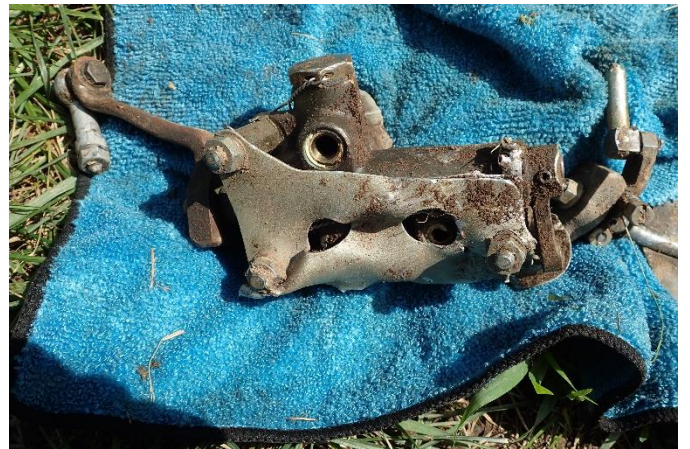
The throttle and metering assembly had broken free from its installation point and displayed a significant amount of impact damage; the metering assembly had broken free from the throttle body and the throttle body had shattered. The metering assembly was disassembled, and the internal components were visually inspected, the components displayed normal operating signatures and the fuel inlet screen was clear of any contaminants. There were no anomalies observed.

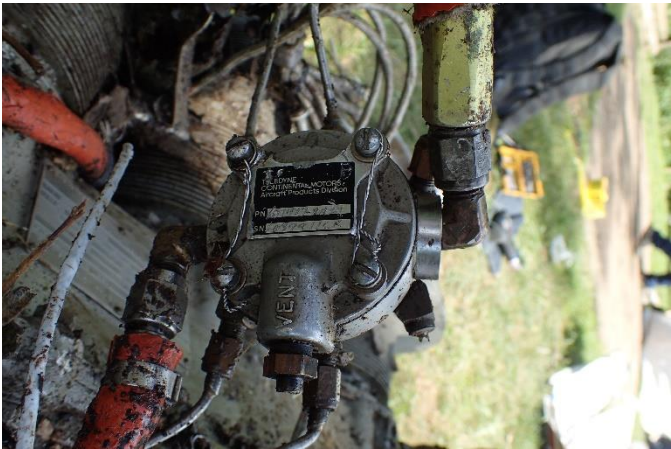
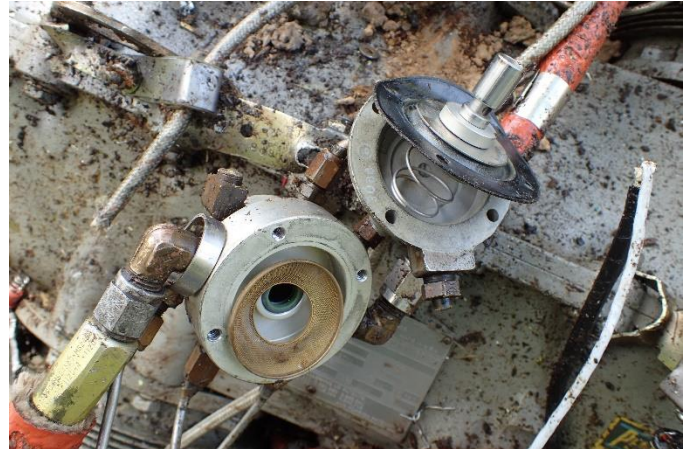
The fuel manifold valve remained partially attached to the engine and displayed impact damage signatures. The valve was disassembled, and the internal components were visually inspected, the diaphragm displayed minor dry rot signatures; however, there were no signs of the diaphragm leaking into the dry area of the manifold valve. There were no anomalies noted that would have prevented normal operation.

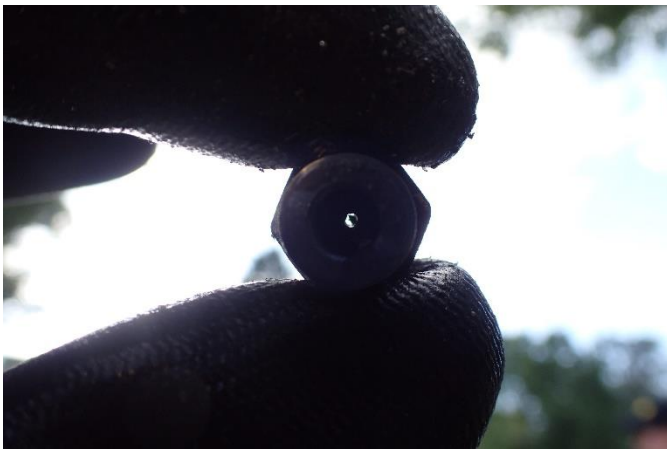
#1 Nozzle

| Position | #1 | #3 | #5 | #2 | #4 | #6 |
|---|---|---|---|---|---|---|
| Condition: | The #5 fuel nozzle had broken free from its cylinder, the rest of the nozzles remained installed in their respective cylinders. The nozzles displayed varying degrees of impact damage. The nozzles were removed and visually inspected. The #1, #3, #2, and the #4 nozzles were partially obscured and the #5 and the #6 nozzles were completely obscured consistent with the impact damage to the nozzles. | | | | | |

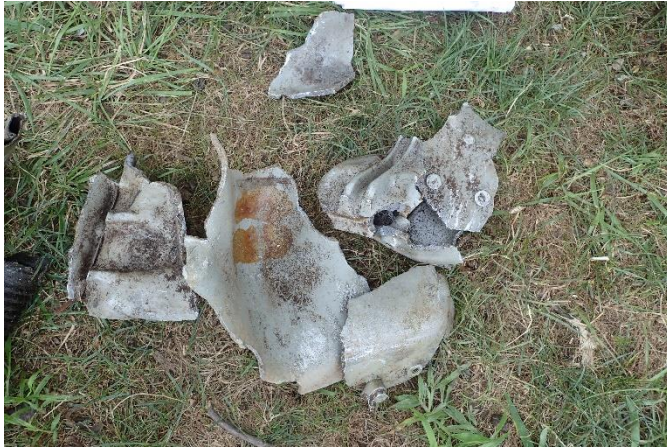
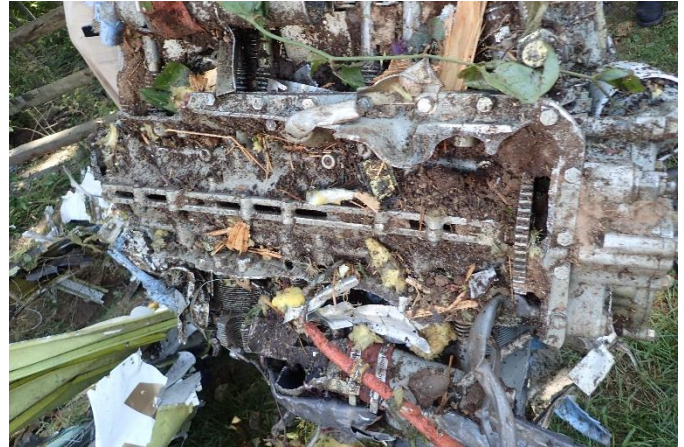
The oil sump displayed significant impact damage signatures and had broken apart into multiple pieces that were found along the wreckage path.

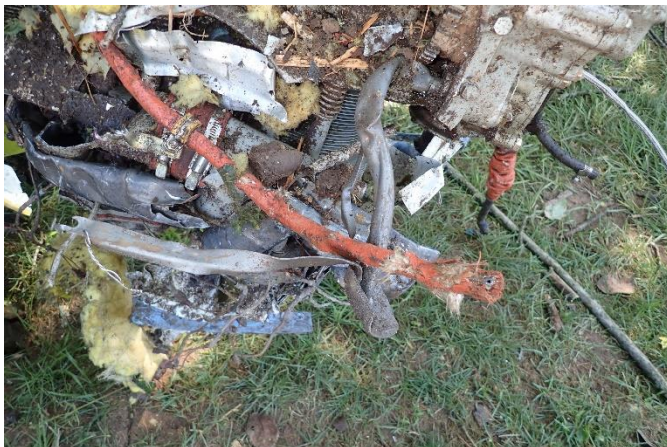
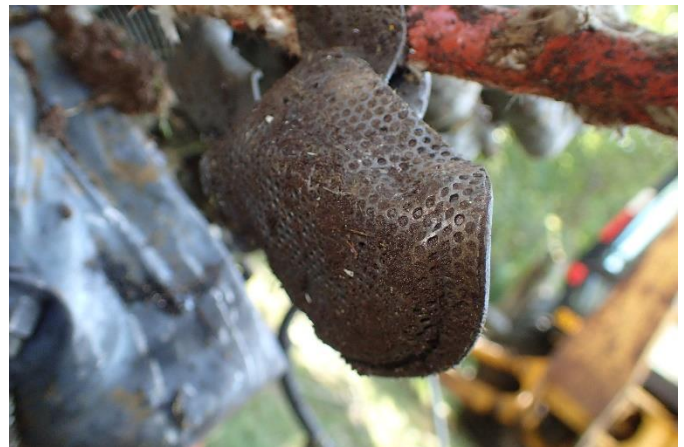
The oil pick-up tube and screen remained partially attached to its installation point and displayed impact damage signatures. The oil pick-up screen contained a significant amount of organic contaminants consistent with dirt from the accident site.

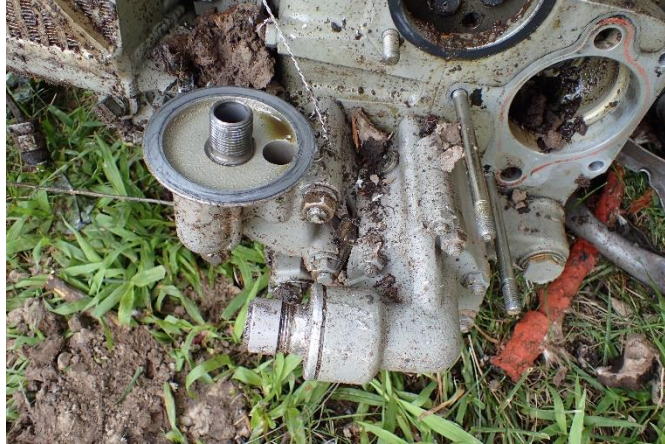
Condition: The oil pump remained attached to its installation point and displayed impact damage signatures. There were no signs of oil leaks around the oil pump.

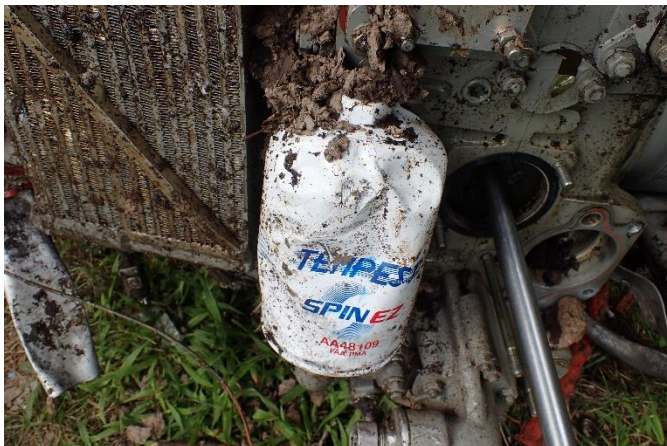
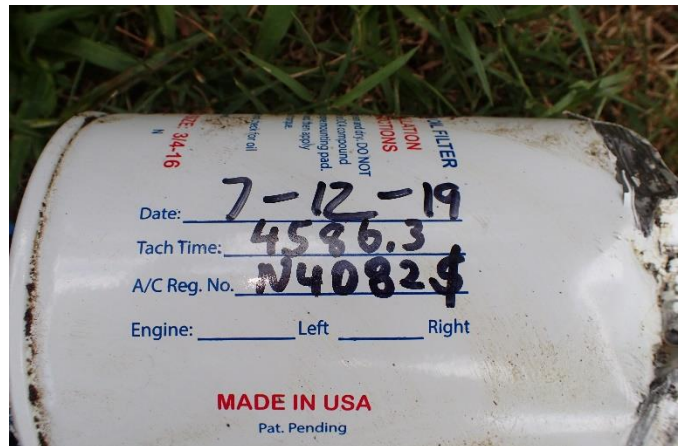
Condition: The oil filter remained attached to the oil filter adapter and displayed impact damage signatures. The oil filter was removed, and the oil filter housing was cut open. The filter pleats were visually inspected, there were no signs of metallic material within the filter pleats. There were no anomalies observed.

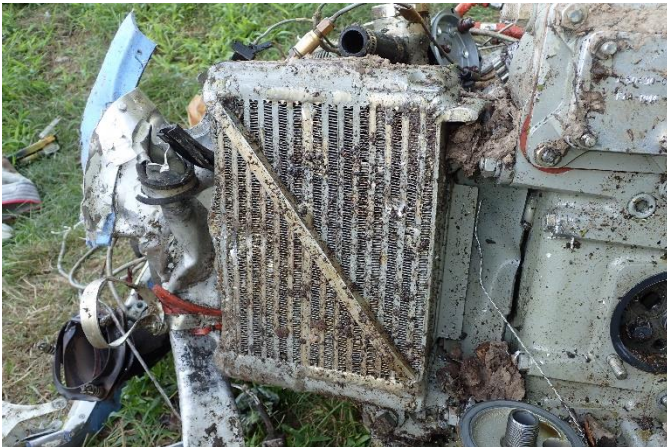
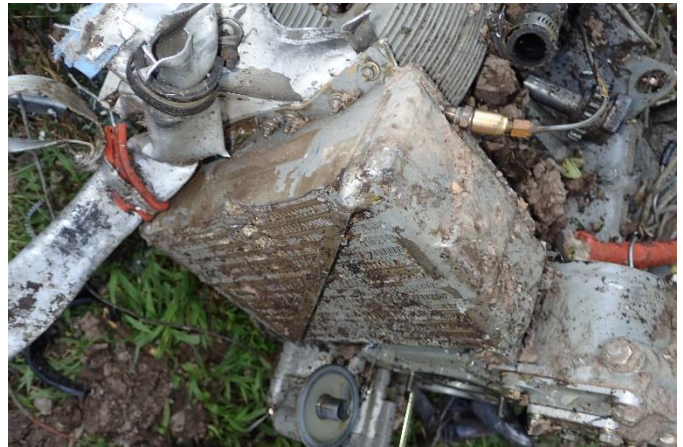
The oil cooler remained partially attached to the engine and displayed impact damage signatures. There were no anomalies observed.

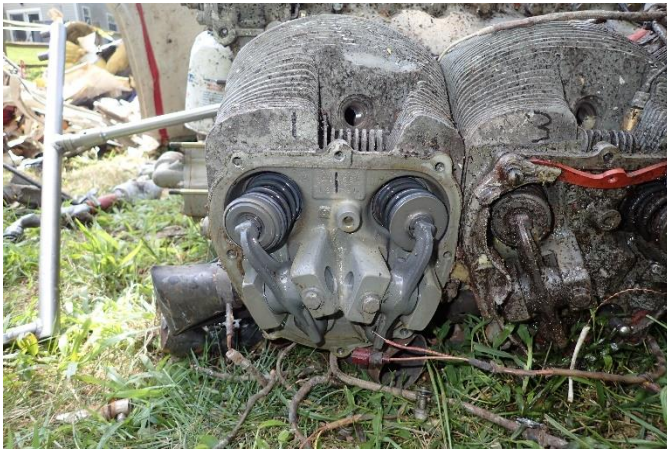
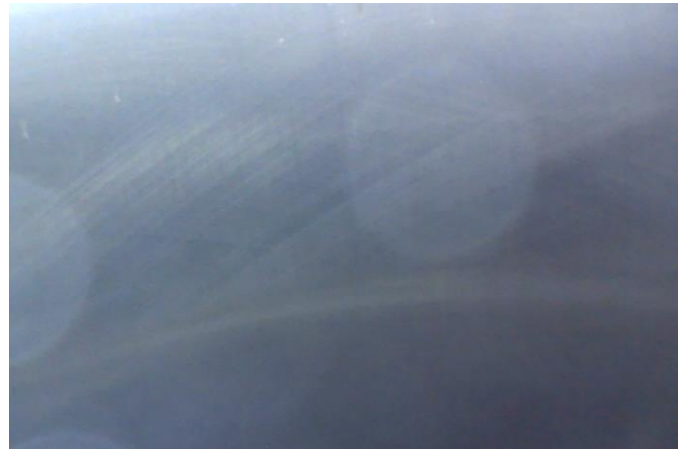
All six cylinders remained attached to the engine and displayed varying amounts of impact damage with the #5 cylinder displaying the most damage. Both rocker arms for the #5 cylinder and the intake rocker arm for the #3 cylinder had broken free from their installation points. The cylinders were inspected using a lighted borescope; the cylinder bores, piston faces, and valve heads displayed normal operating signatures. During crankshaft rotation, it was observed that the #5 cylinder did not display any compression or suction which was consistent with the impact damage to the cylinder. The #4 cylinder also did not display any compression or suction and it was observed that the exhaust rocker arm would not move and the valve was open; further examination revealed that the lifter housing contained a significant amount of material consistent with wood from the accident site and the lifter could not be moved. The #4 exhaust rocker arm was removed, and the valve seated normally, and the cylinder then displayed normal thumb compression and suction. The rest of the cylinders also displayed good thumb compression and suction and their rocker arms operated normally. The observed overhead components (rocker arms, valves, and springs) displayed normal operating and lubrication signatures.

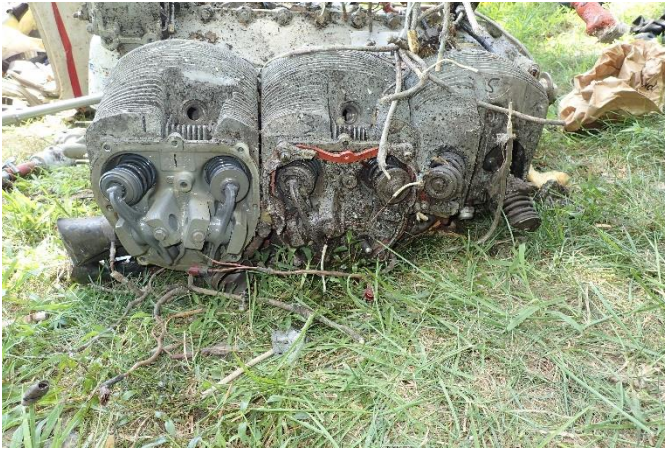
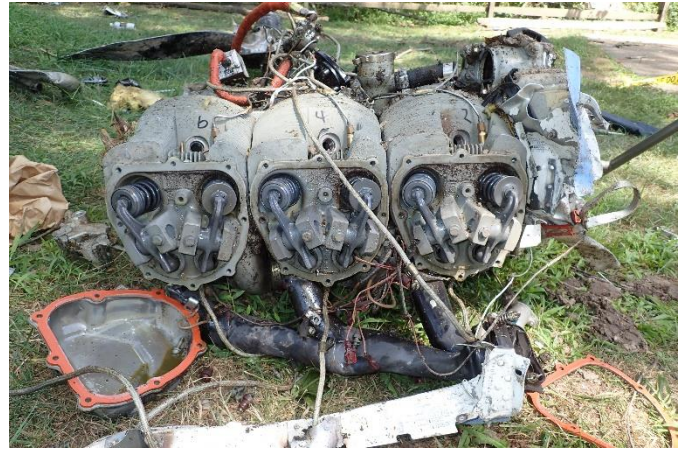
Both of the #5 rocker arms and the #3 intake rocker arm had broken free from their installation points and were not located at the time of the examination. During crankshaft rotation, all of the attached rocker arms moved normally with the exception of the #4 exhaust rocker arm. It was observed that the #4 exhaust lifter housing was impacted with material consistent with wood from the accident site. There were no pre-impact anomalies noted that would have prevented normal operation.

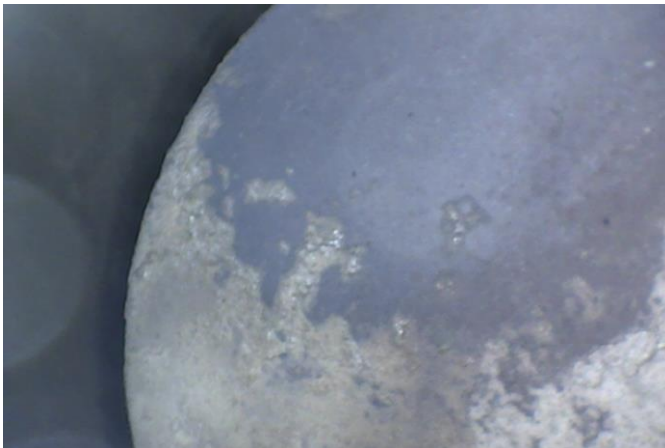
#1 Piston

The piston faces were inspected using a lighted borescope, the piston faces displayed normal operating and combustion signatures. During crankshaft rotation the pistons operated normally. There were no anomalies observed.

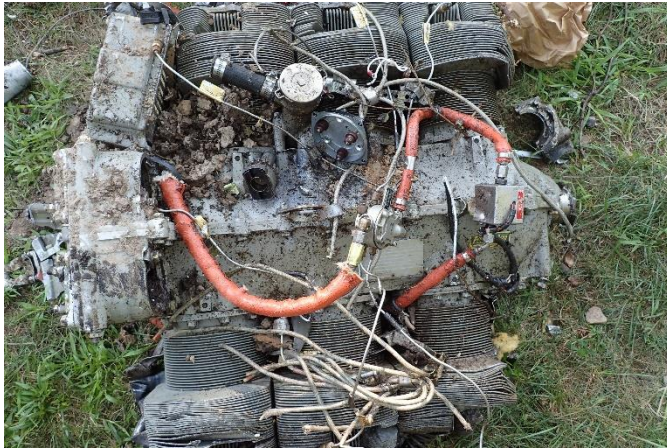
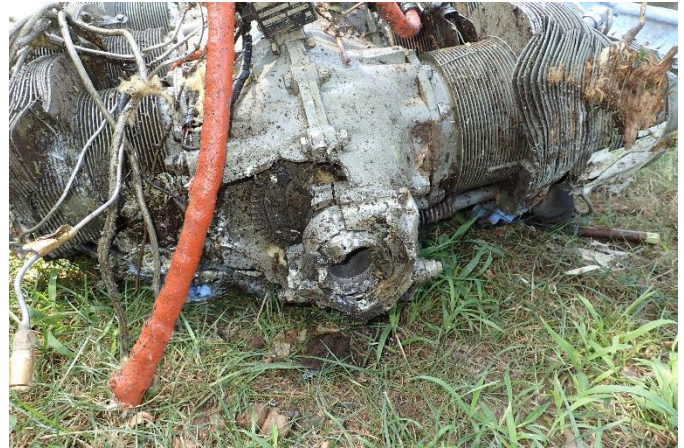
The crankcase displayed impact damage signatures concentrated to the forward portion of the crankcase; a large portion had broken free from the rest of the crankcase and portions of the internal components were visible. There were no signs of a catastrophic internal engine failure and there were no anomalies observed.

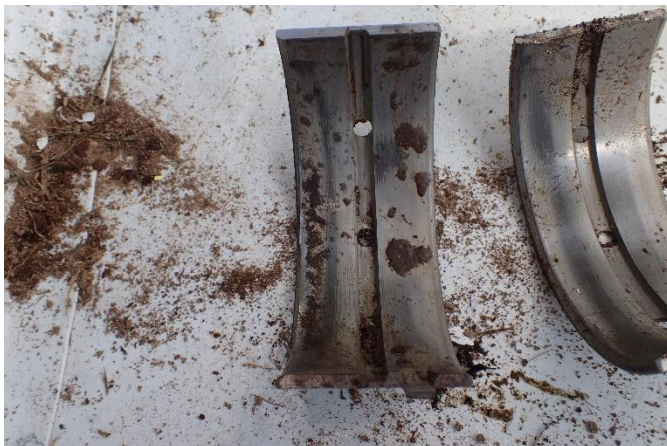
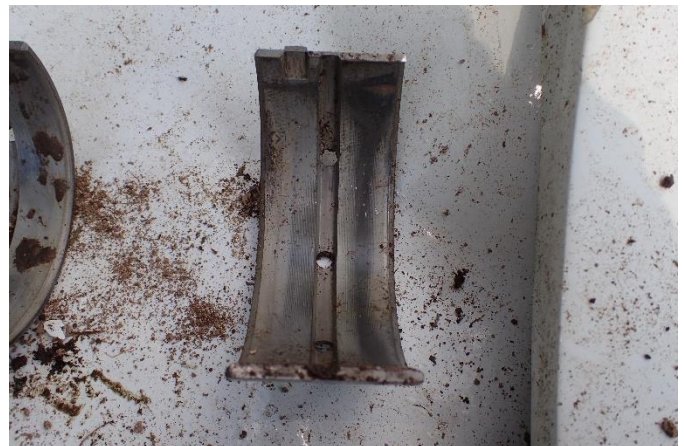
The #5 main bearings were able to be removed from the broken forward crankcase. The bearings displayed normal operating and lubrication signatures. There were no anomalies observed.

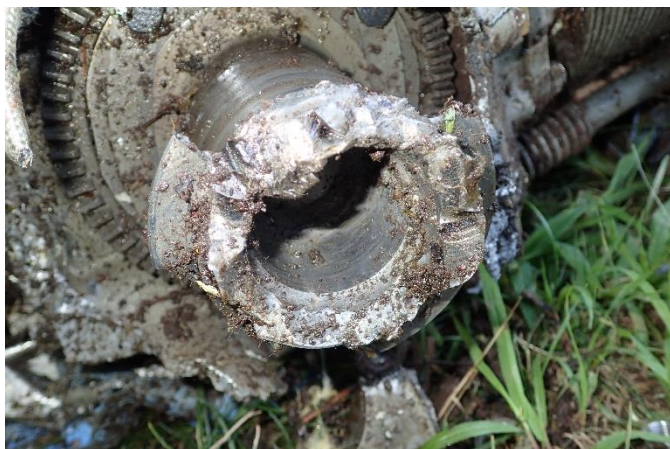
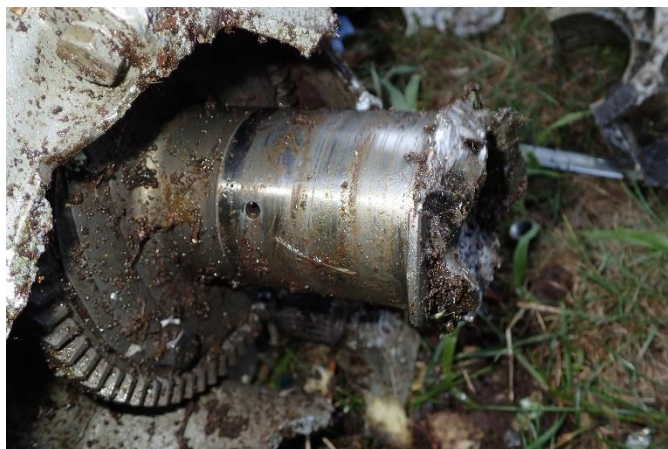
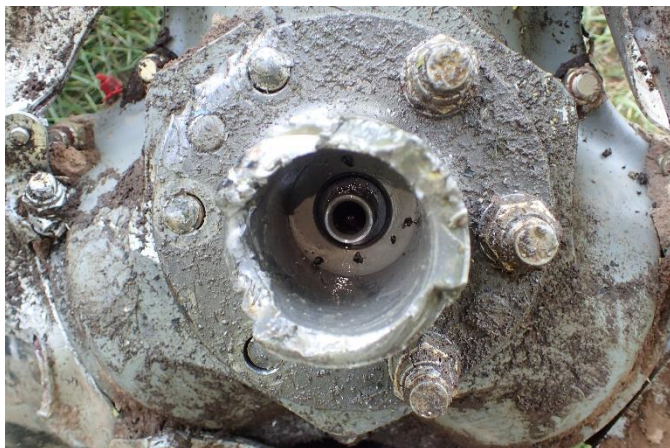
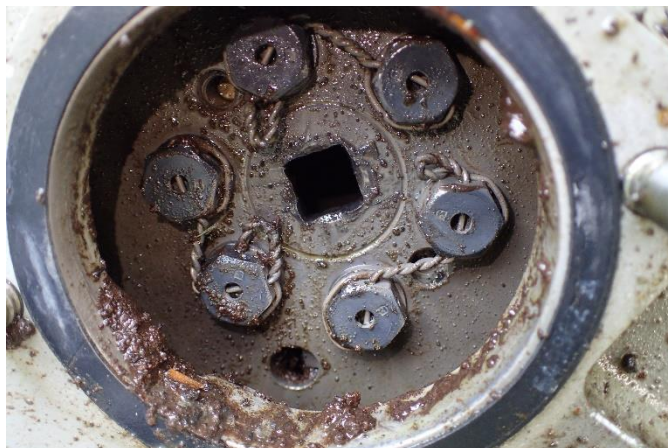
The propeller flange had broken free from the rest of the crankshaft and remained attached to the propeller hub; the damage was consistent with impact damage. A portion of the crankshaft was visible through the broken crankcase. The visible portion of the crankshaft displayed normal operating and lubrication signatures. The crankshaft was rotated by using a tool inserted into the rear of the crankshaft; continuity was established between the crankshaft, camshaft, connecting rods and associated components. There were no anomalies observed.

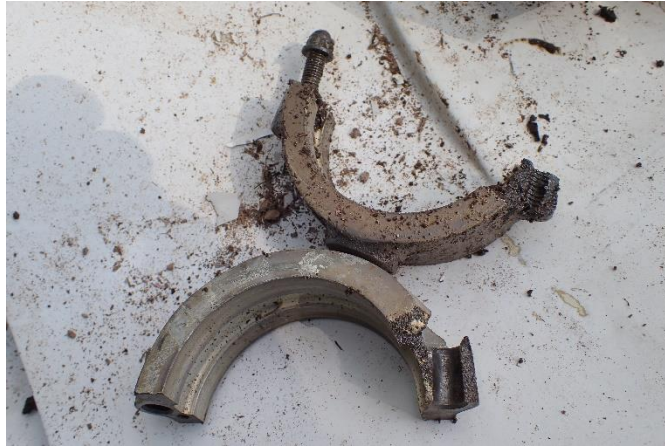
The transfer collar displayed impact damage signatures and the collar halves had separated. The transfer collar displayed normal operating and lubrication signatures, there were no anomalies observed.

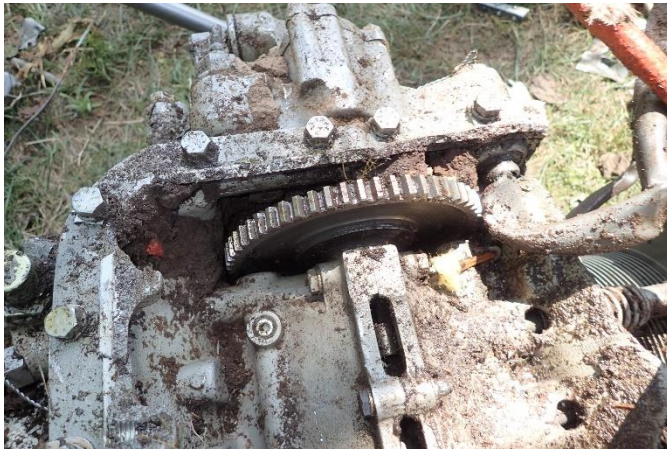
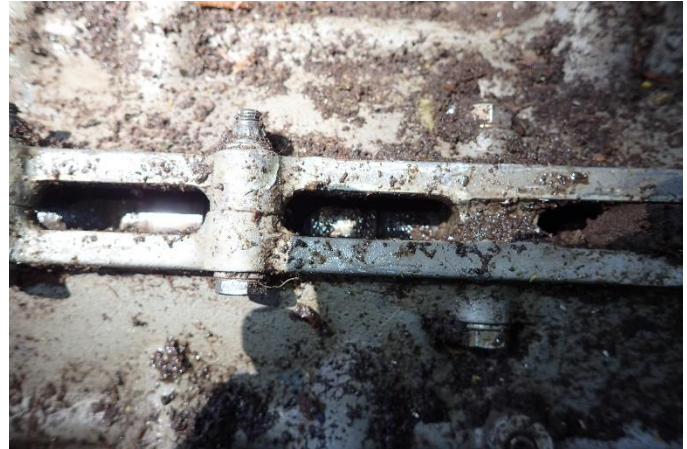
The camshaft was partially visible through the broken oil sump. The visible portions of the camshaft displayed normal operating signatures and the camshaft operated normally during crankshaft rotation. There were no anomalies observed.

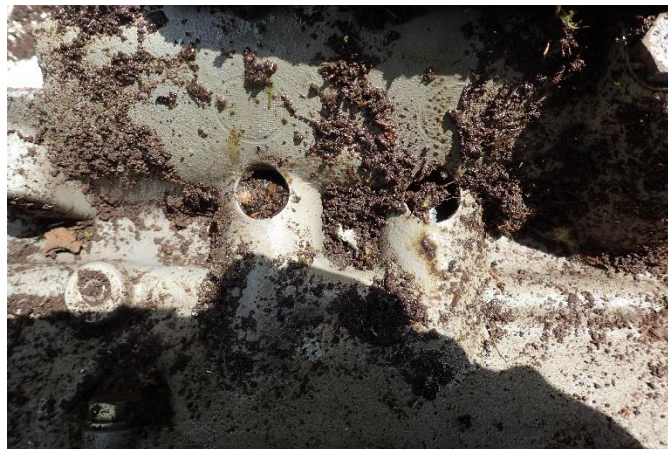
#4 Lifter Housings

It was observed that the #4 exhaust lifter would not move during crankshaft rotation; it was observed that the #4 exhaust lifter housing was impacted with material consistent with wood and dirt from the accident site. The rest of the lifters operated normally.

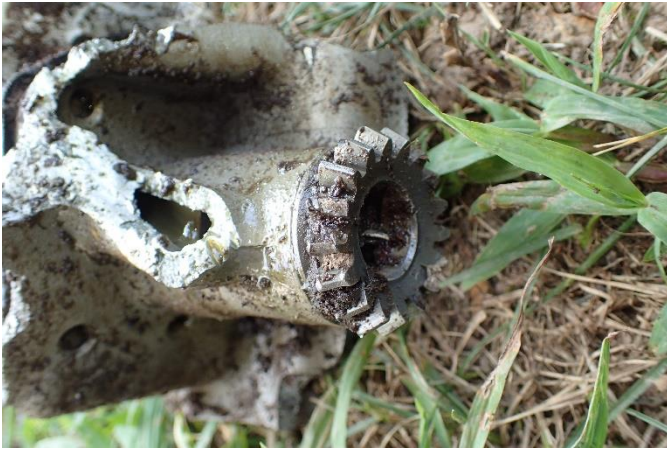
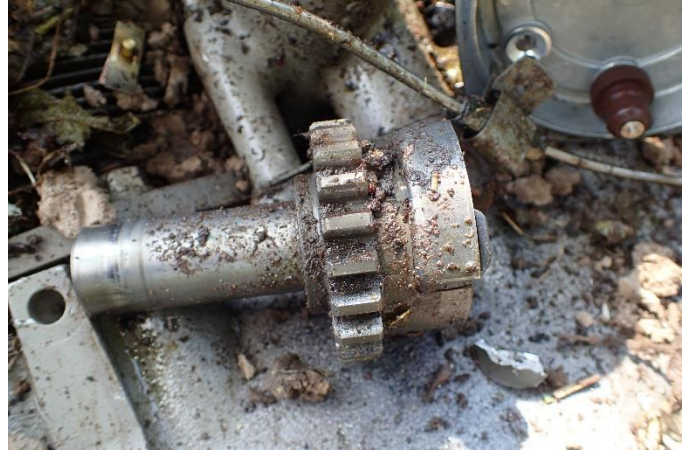
One of the magneto drive gears and the governor drive gear were located and displayed normal operating signatures. The second magneto drive gear was not observed at the time of the examination.

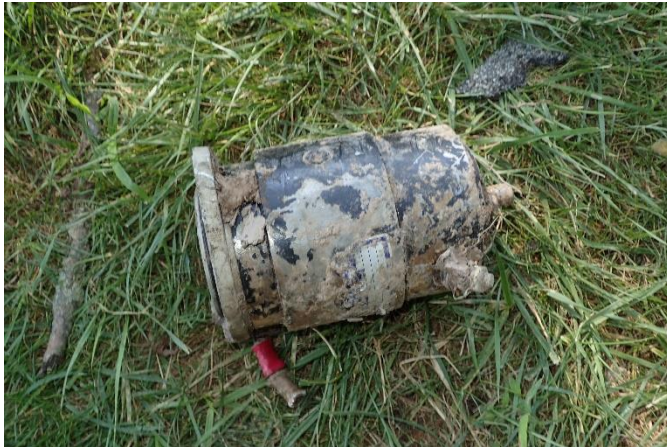
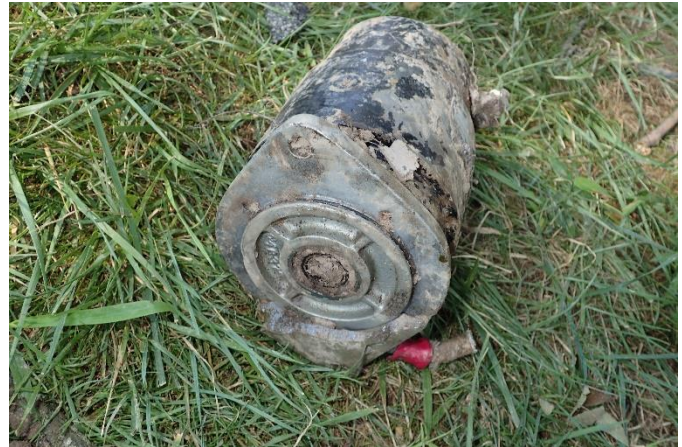
The starter had broken free from its installation point and displayed impact damage signatures.

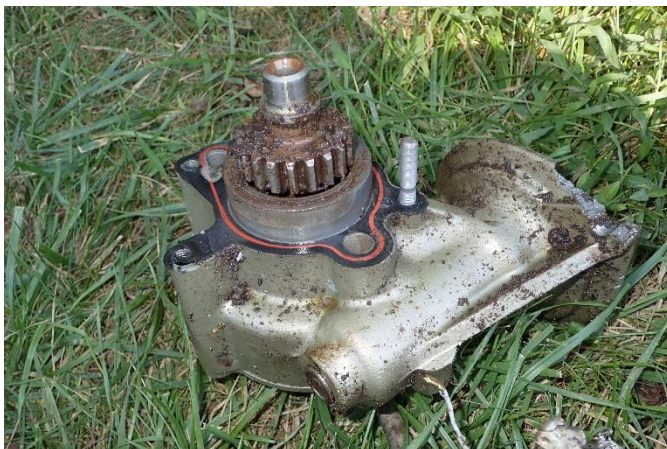
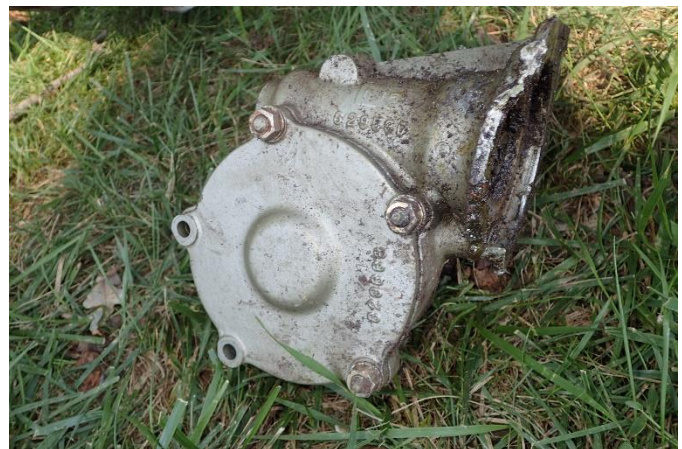
The starter adapter remained attached to its installation point and displayed impact damage signatures. The adapter was removed, and the visible gear displayed normal operating signatures and was capable of rotation.

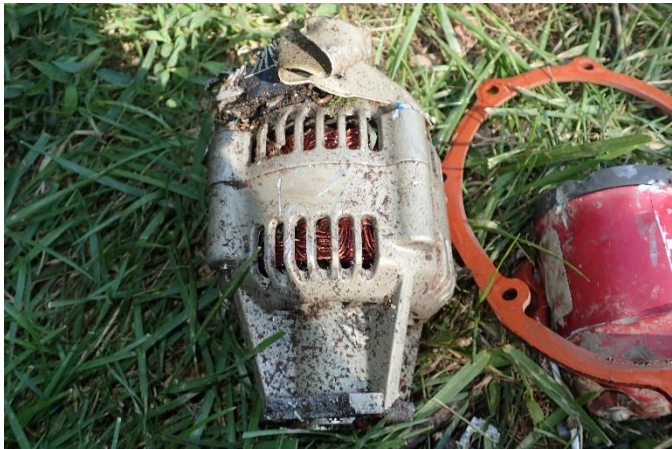
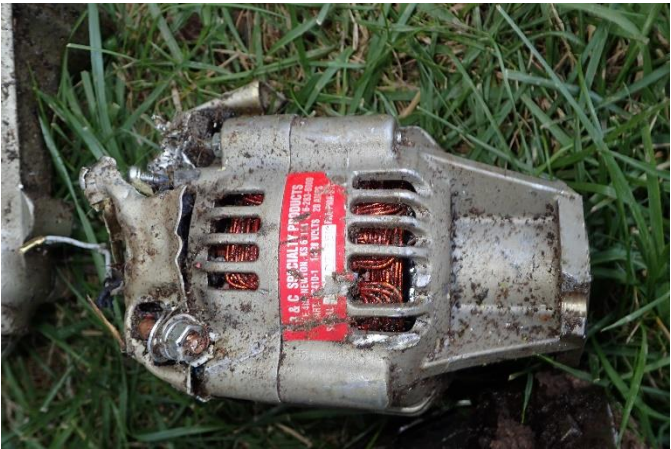
| Condition: | The standby alternator had broken free from its installation point and displayed impact damage signatures. | | |
