## ENGINE EXAMINATION REPORT

| ENGINE MODEL | IO-520-BA |
| AIRCRAFT MAKE & MODEL | Beechcraft F33A |

| EXAMINATION | | ACCIDENT DATA | |
|---|---|---|---|
| DATE | 08/09/2019 – 08/10/2019 | NTSB ACCIDENT # | ERA19FA240 |

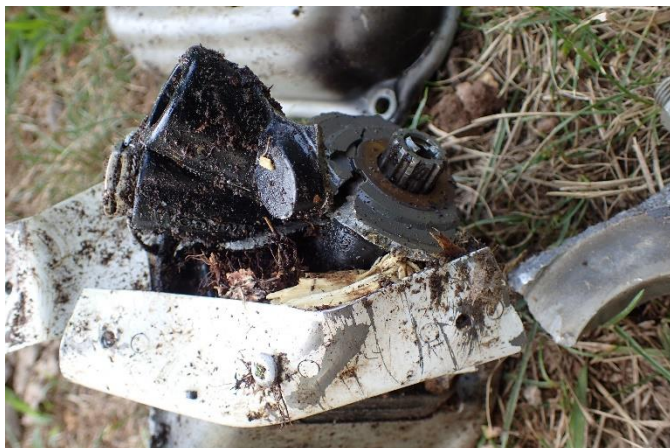
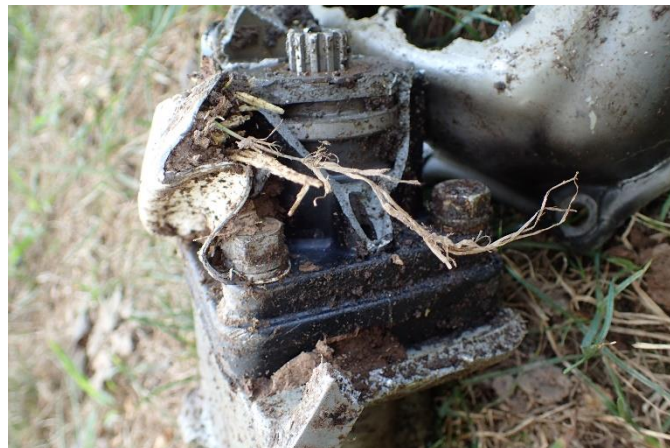
| PROPELLER GOVERNOR | Manufacturer: Woodward | P/N: Not observed | S/N: Not observed |
|---|---|---|---|
| Condition: | The propeller governor displayed a significant amount of impact damage, the governor was broken into several pieces. There were no anomalies observed with the recovered portion of the governor. | | |

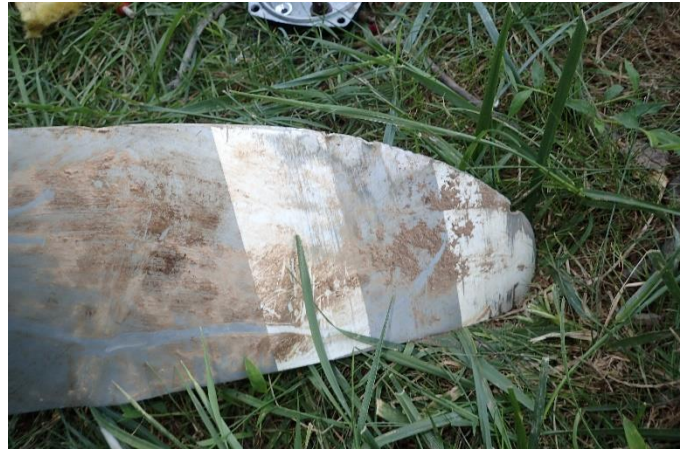
Propeller Blade "B"

| PROPELLER | Manufacturer: Hartzell | P/N: PHC-C3YF-1RF | S/N: B27551B |
|---|---|---|---|
| Condition: | The three-blade, constant speed propeller remained attached to the propeller flange; however, the propeller flange had broken free from the rest of the crankshaft consistent with impact damage. The three propeller blades remained within the propeller hub and all three propeller blades displayed impact damage signatures. The propeller blade marked "A" displayed aft bending, leading-edge gouges, and minor polishing. The propeller blade marked "B" displayed aft bending and minor twisting deformation, polishing of the blade, and chordwise scratches and a leading-edge gouge. The propeller blade marked "C" had sheared approximately in half and the blade tip was ground down; the blade also displayed chordwise scratches, blade polishing, and twisting deformation. | | |
