## Air Safety Investigations Aircraft Incident/Accident Technical Report

| <b>Aircraft Incident/<br/>Accident Information</b> | Year: 1975 | Make: Beechcraft | Model: F33A |
| | Serial number: CE-555 | | Registration: N4082S |
| Location: Hatboro, PA | | Date: 08-08-19 | Time: 0615 EDT |

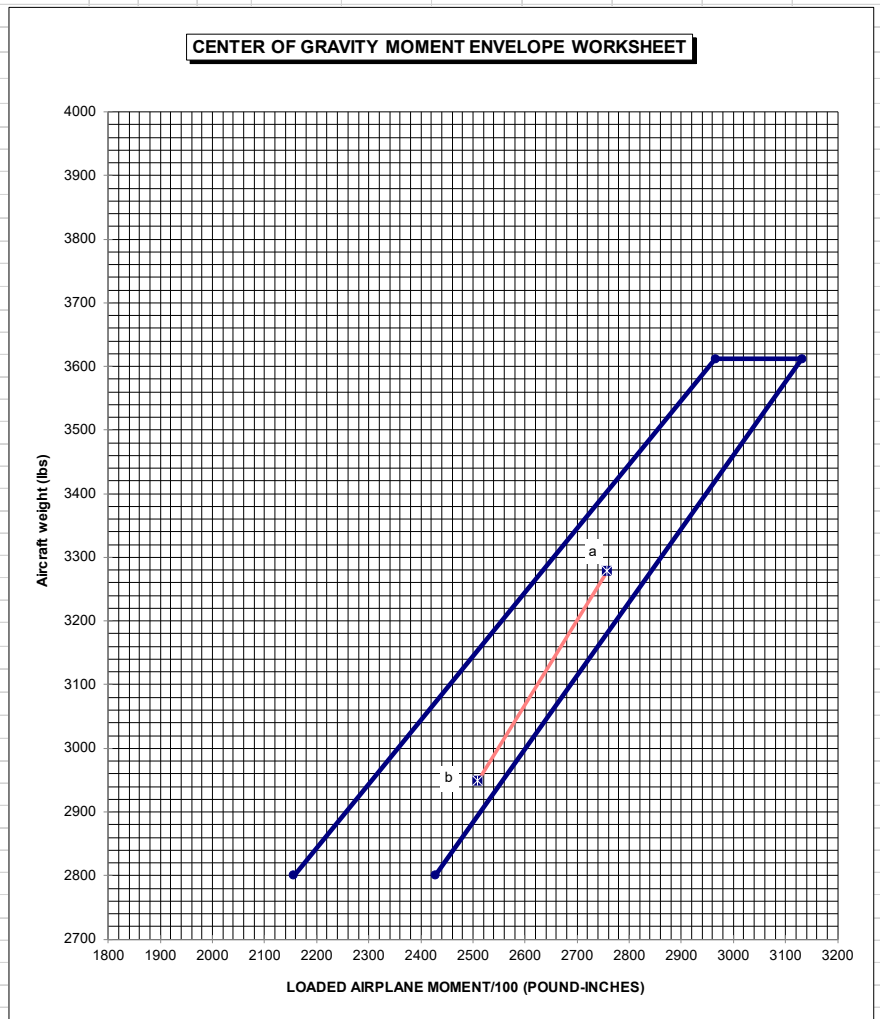
The chart above reflects the as delivered envelope, with the tip tank fuel added.
