## Investigative Photographs

Peter Wentz  
Air Safety Investigator  
Eastern Region Aviation

ERA19FA250

July 1, 2020

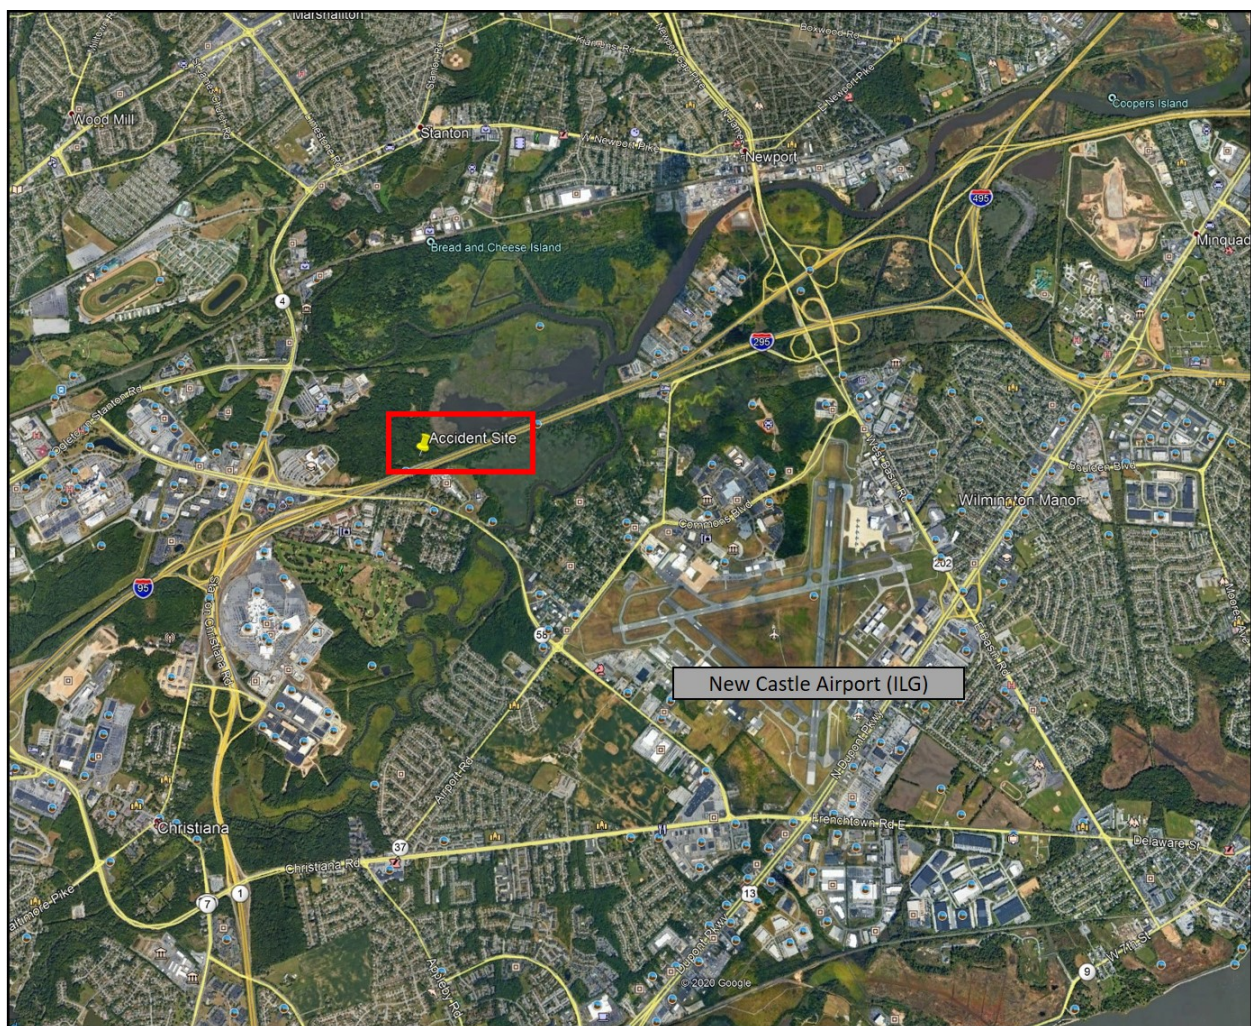
**Photograph 1 –Accident site location.**

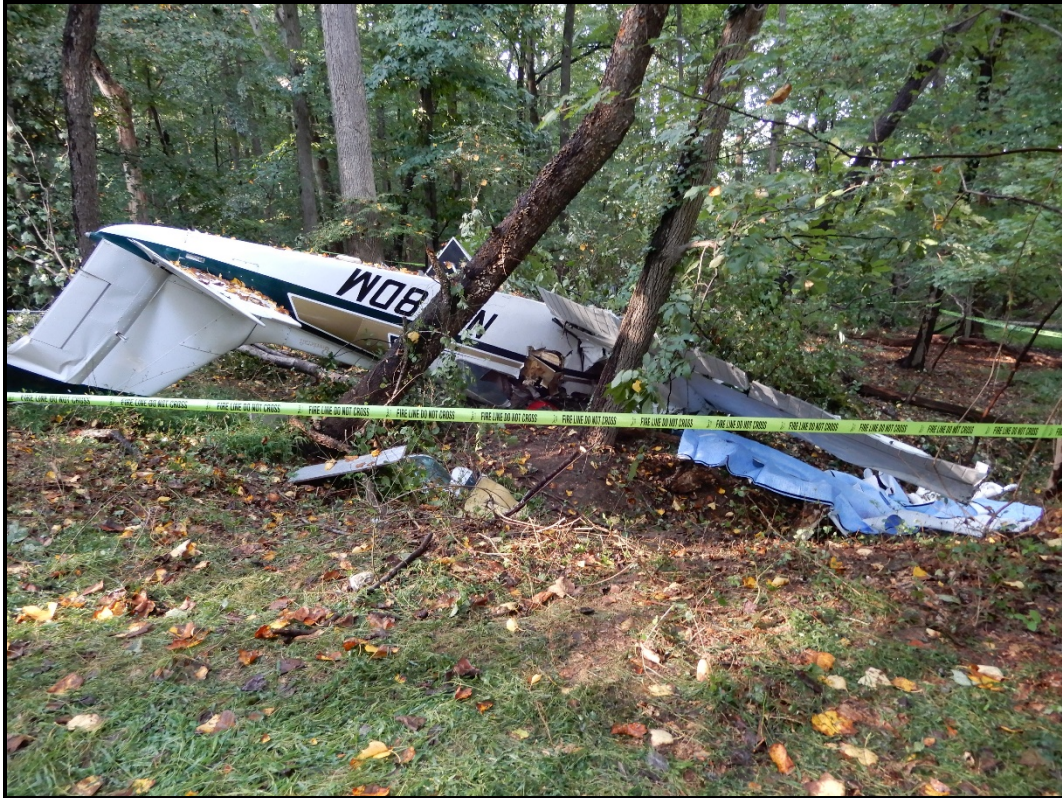
**Photograph 2 – Left side view of the accident airplane.**

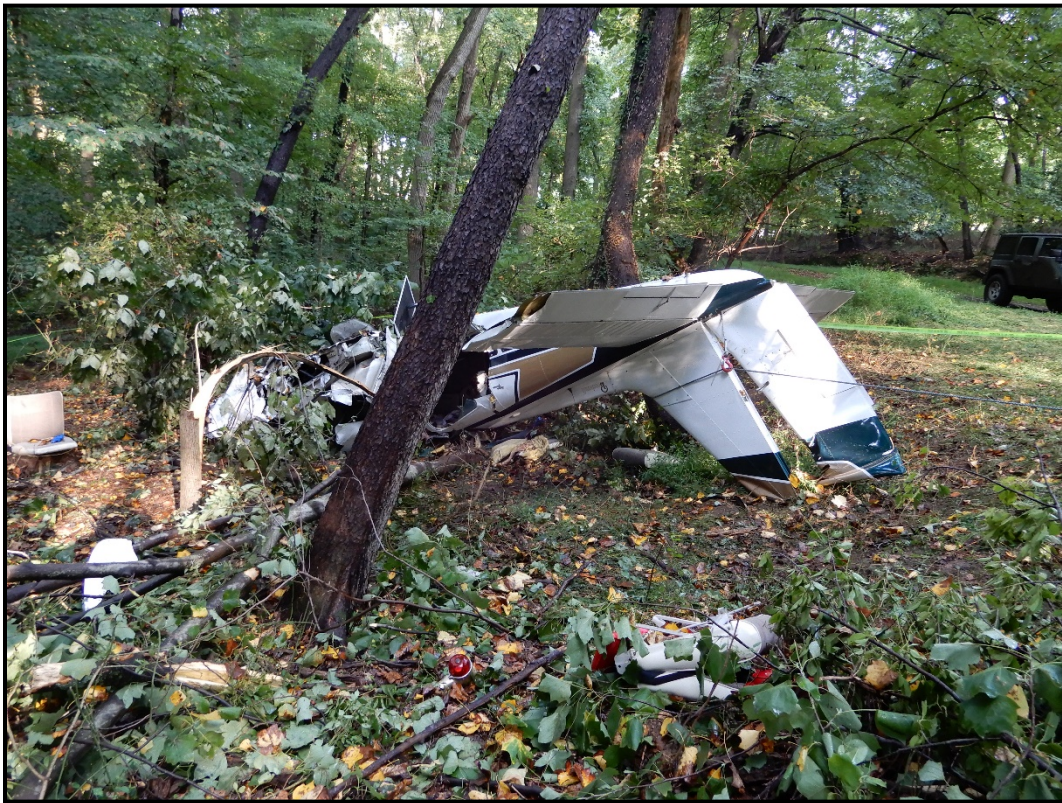
**Photograph 3 – Aft right side view of the accident airplane.**

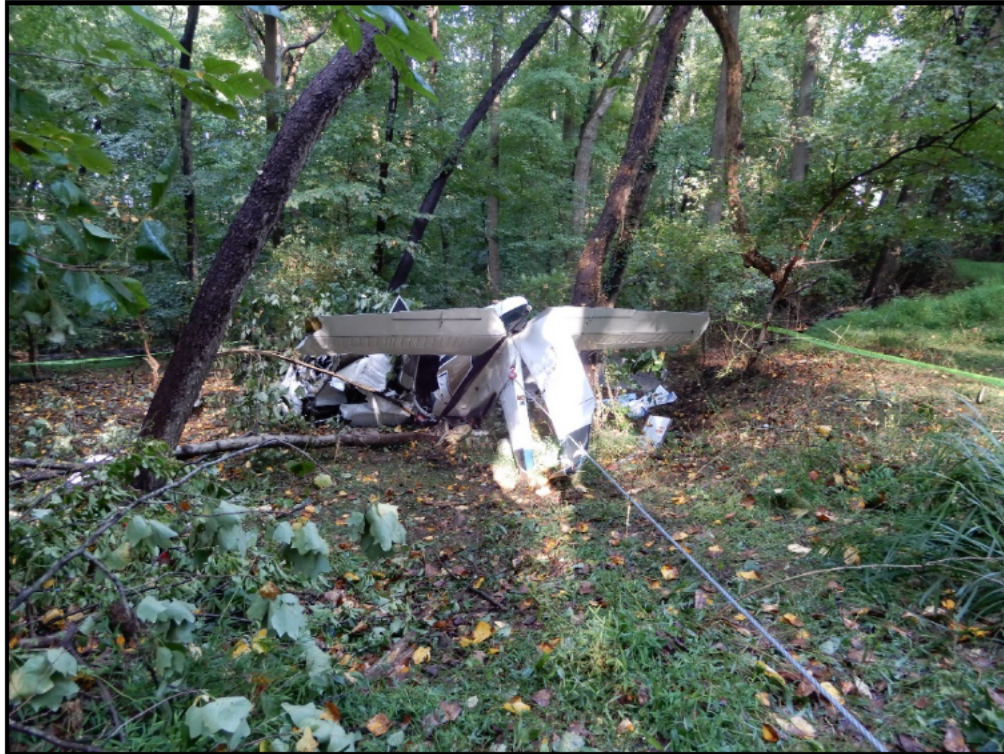
**Photograph 4 – Aft view of the accident airplane.**

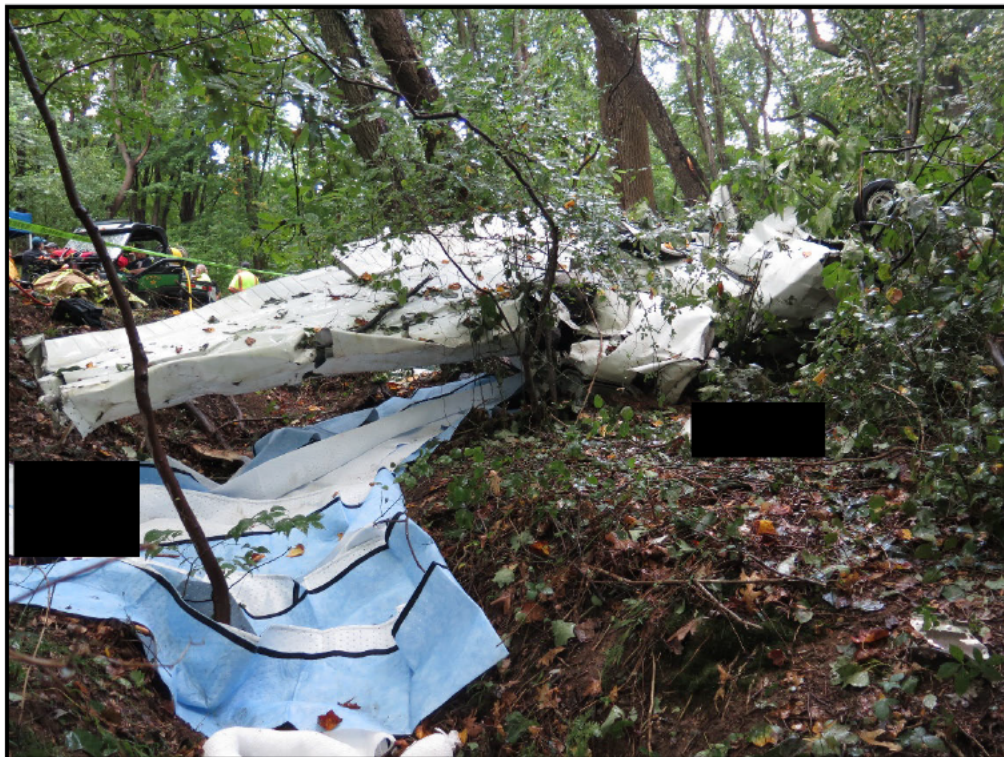
**Photograph 5 – View of the left wing.**

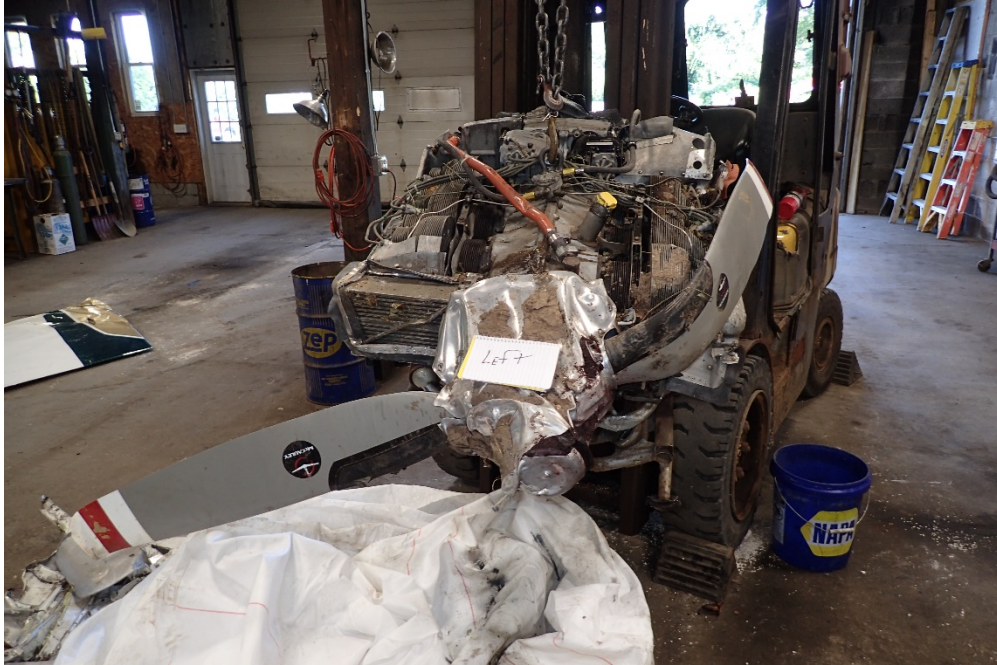
**Photograph 6 – View of the left propeller.**

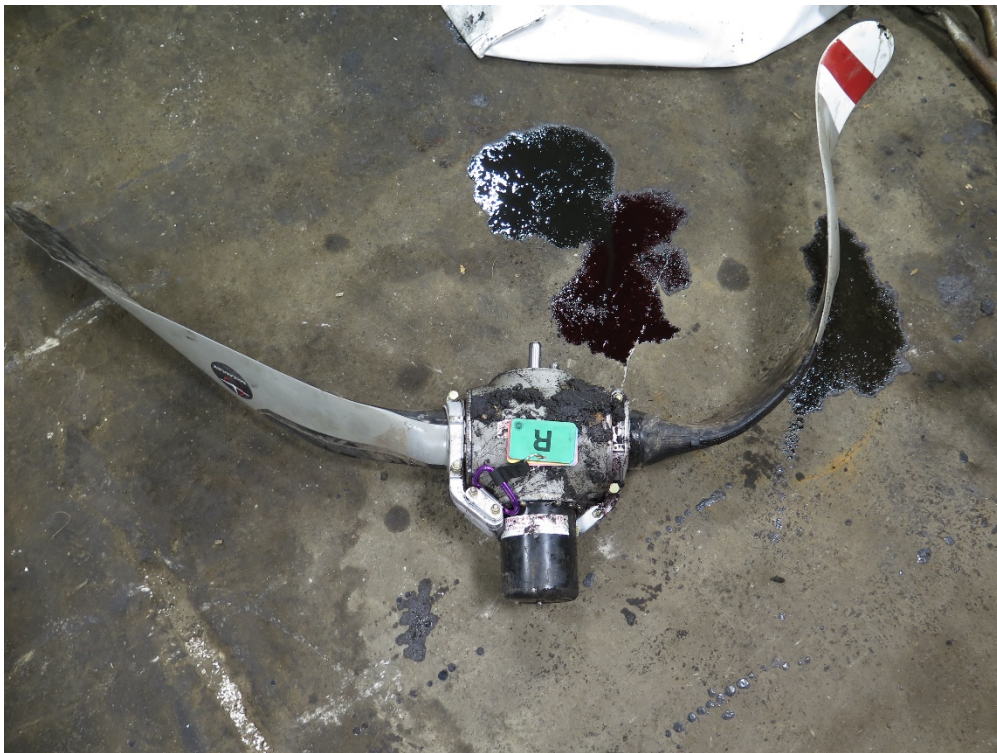
**Photograph 7 – View of the right propeller.**

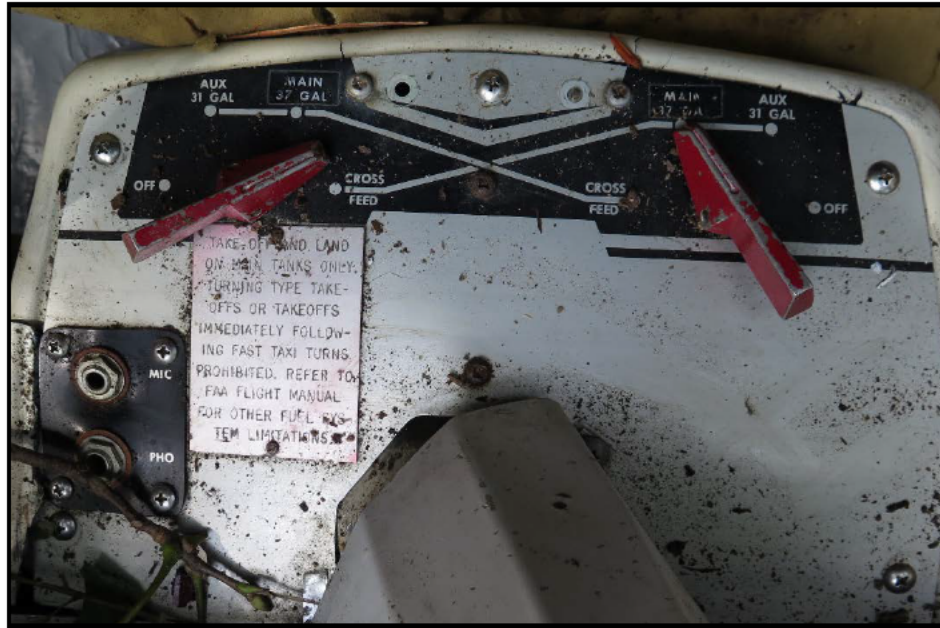
Photograph 8 – Fuel selector valve positions.

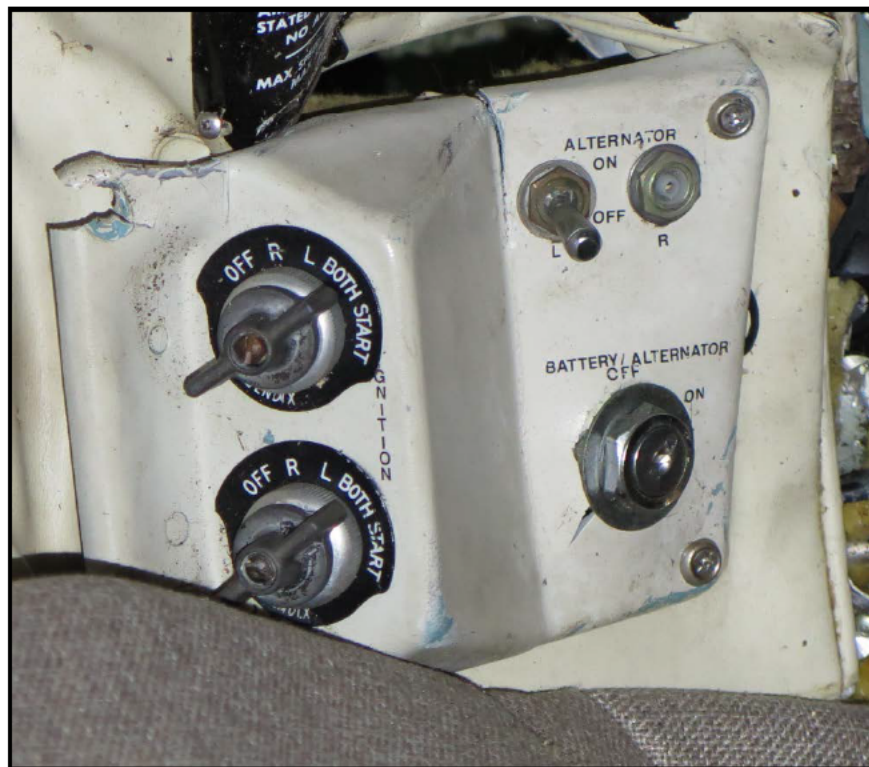
Photograph 9 – Ignition switch (magneto) positions.

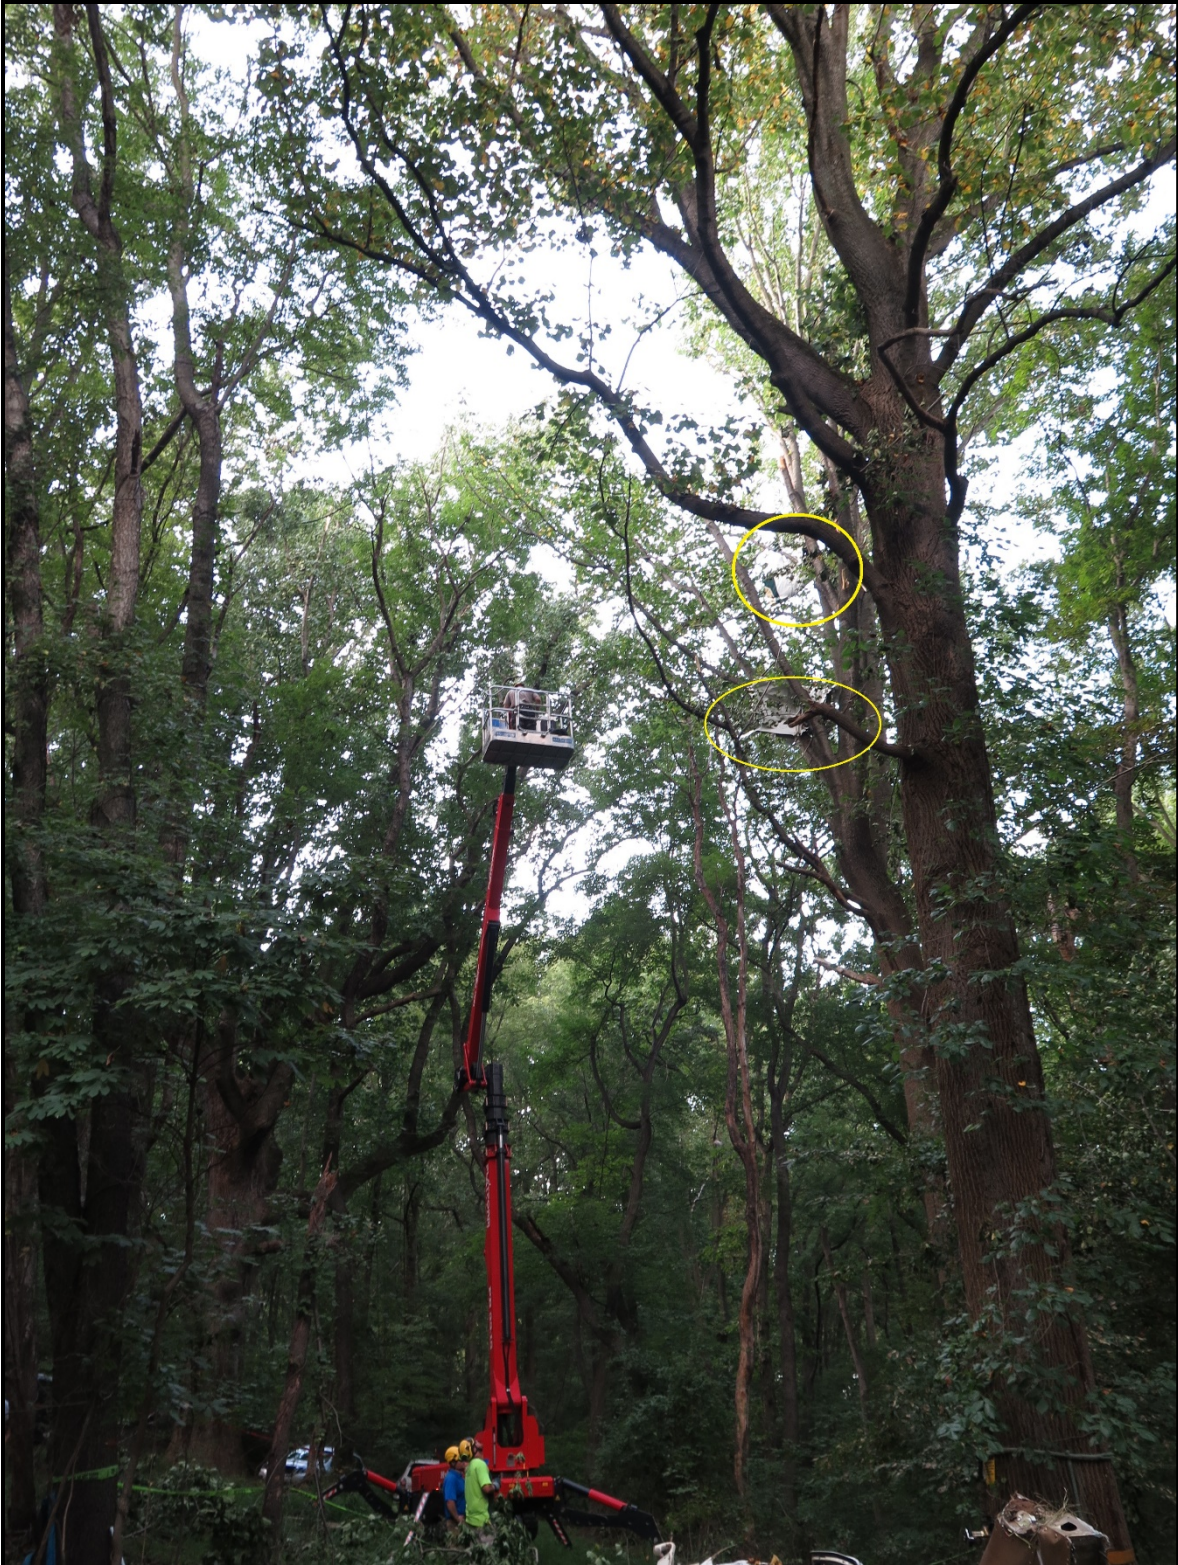
**Photograph 10 – Removing two sections of the right wing from tree canopy.**

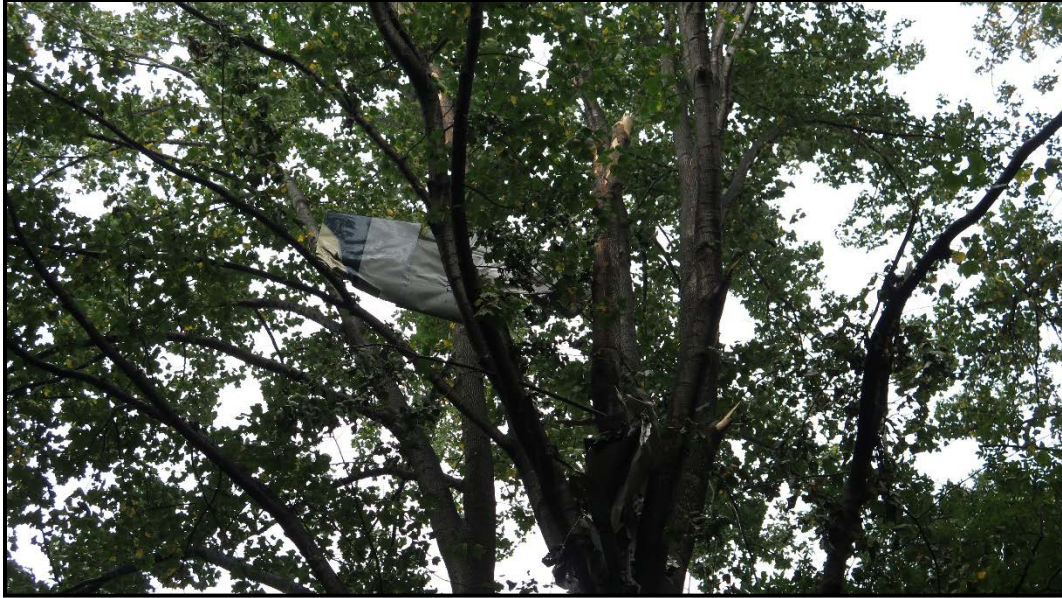
**Photograph 11 – Section of right wing lodged in tree canopy.**
