**NATIONAL TRANSPORTATION SAFETY BOARD**

**AIRFRAME AND ENGINE EXAMINATION**

**ERA19LA012**

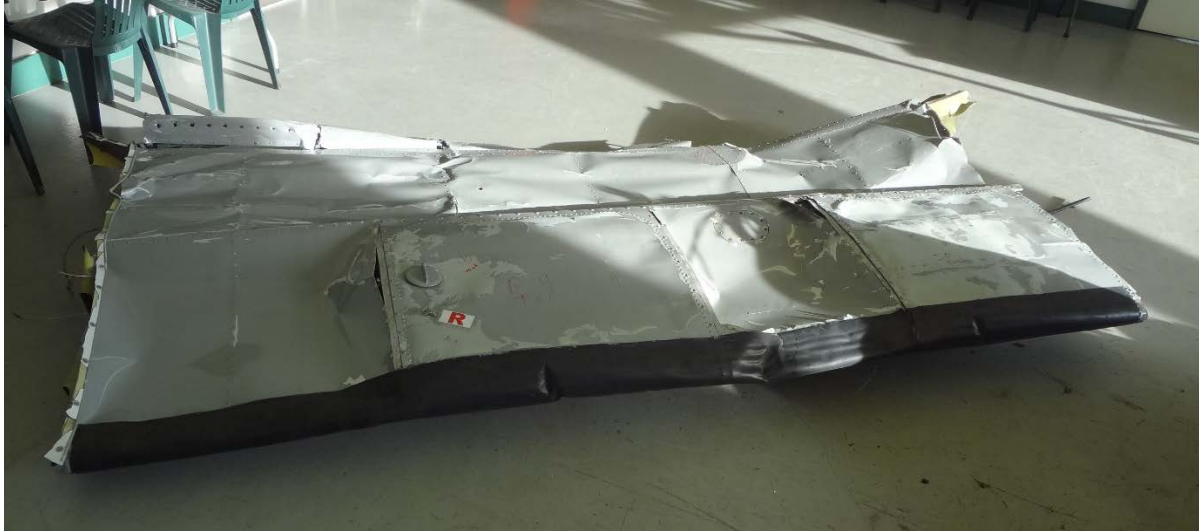
The outboard 10 ½ feet of the right wing, minus the wingtip, was examined. The remaining 6 ½ feet of inboard right wing, including the right engine, was missing. The wing was separated at station 105. Forward deformation aft of the main wing spar was observed along with a "W" shaped deformation of the leading edge. The top of the wing spar was fractured about station 104, and the bottom of the spar was fractured about station 115, both deformed downward. The fracture surfaces were consistent with overload separation. Damage to the deice boot precluded field testing. The fuel tank displayed pillowing. The pick-up screen and fuel tank vent were clear of obstructions and the fuel cap was secured. No fuel was observed in the tank. The aileron remained attached with "W" shaped deformation and multiple skin separations. The aileron's control rod was attached to the deformed bellcrank. The bellcrank's drive cable attach point arm was fractured and not recovered. There was no evidence of aileron travel to stops. The drive cable was not observed. The aileron balance cable remained attached to the bellcrank and was separated about 54 inches from the bellcrank. The cable end displayed a broomstrawed appearance, consistent with overload. The flap was pulled from its outer two hinges and was not intact/located.

Figure 1: Right Wing Upper Leading Edge View (Photo Courtesy of Piper Aircraft)

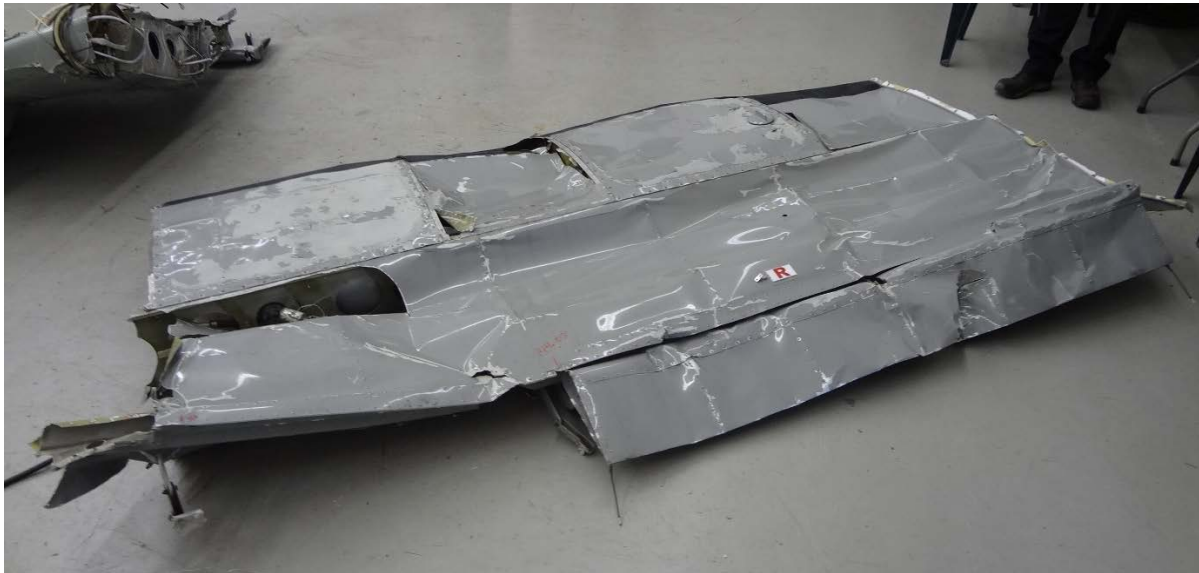
Figure 2: Right Wing Upper Trailing Edge View (Photo Courtesy of Piper Aircraft)

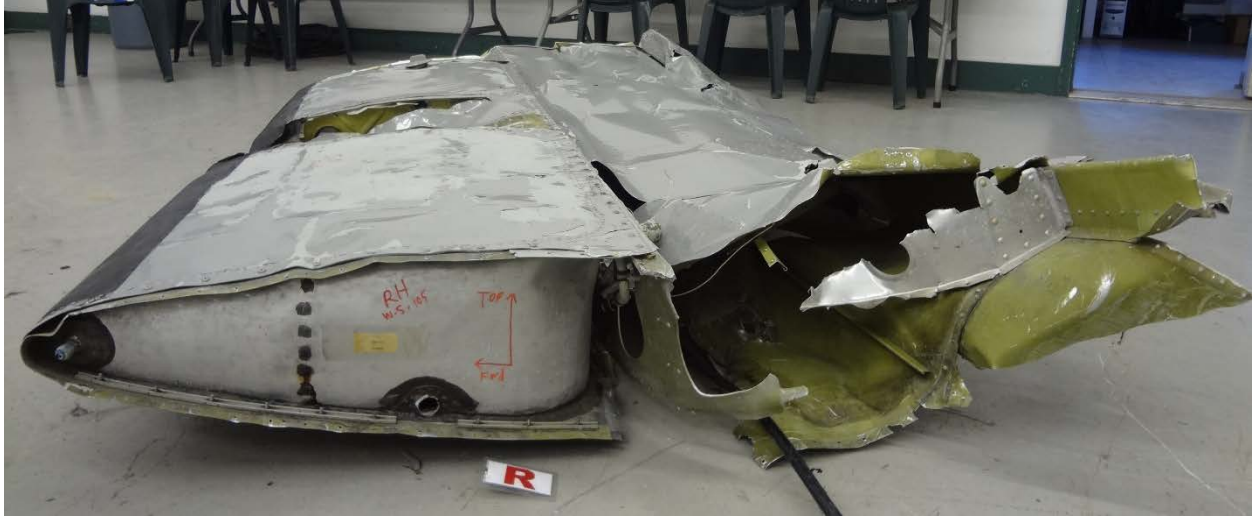
Figure 3: Right Wing Inboard Upper View (Photo Courtesy of Piper Aircraft)

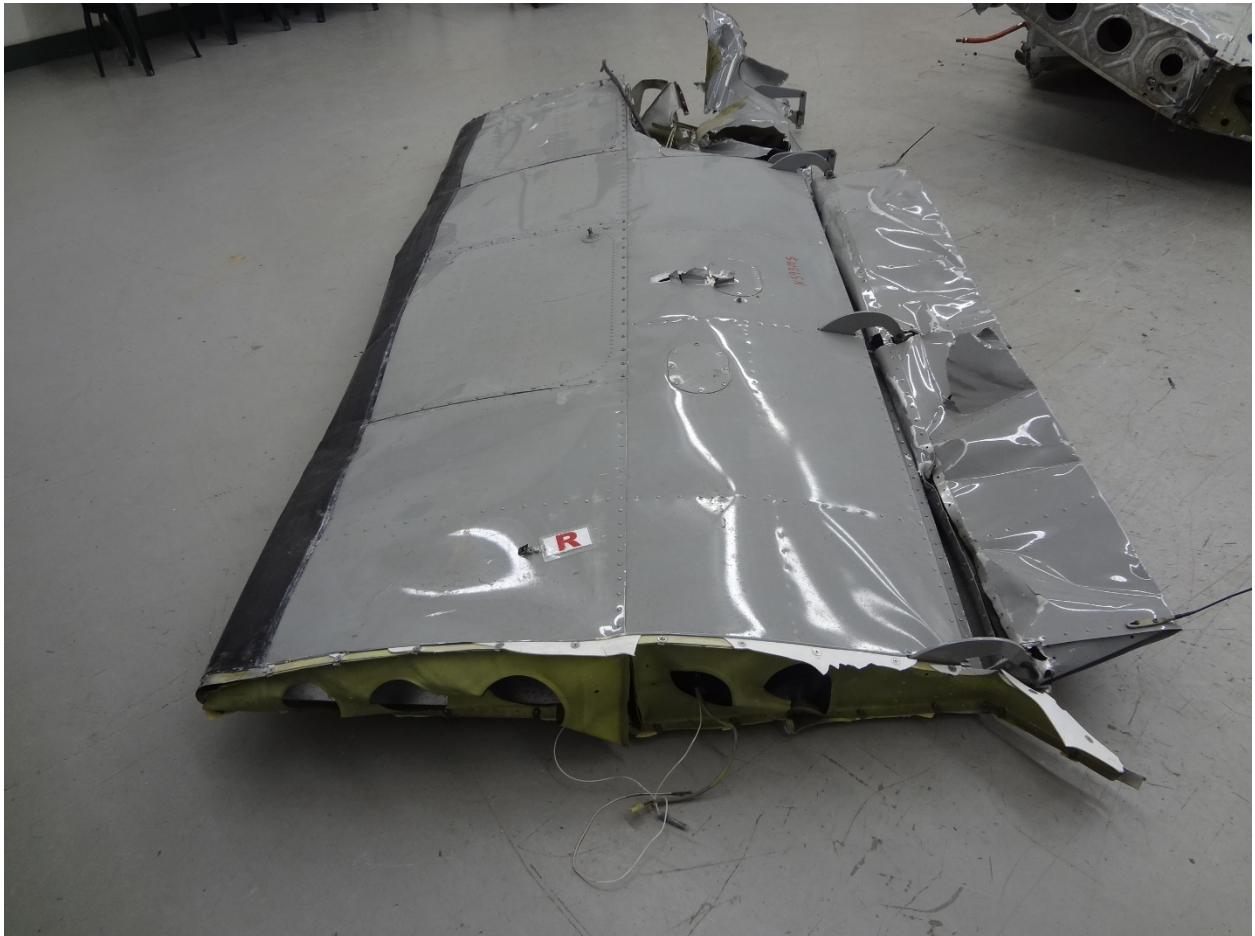
Figure 4: Right Wing Outboard Lower View (Photo Courtesy of Piper Aircraft)

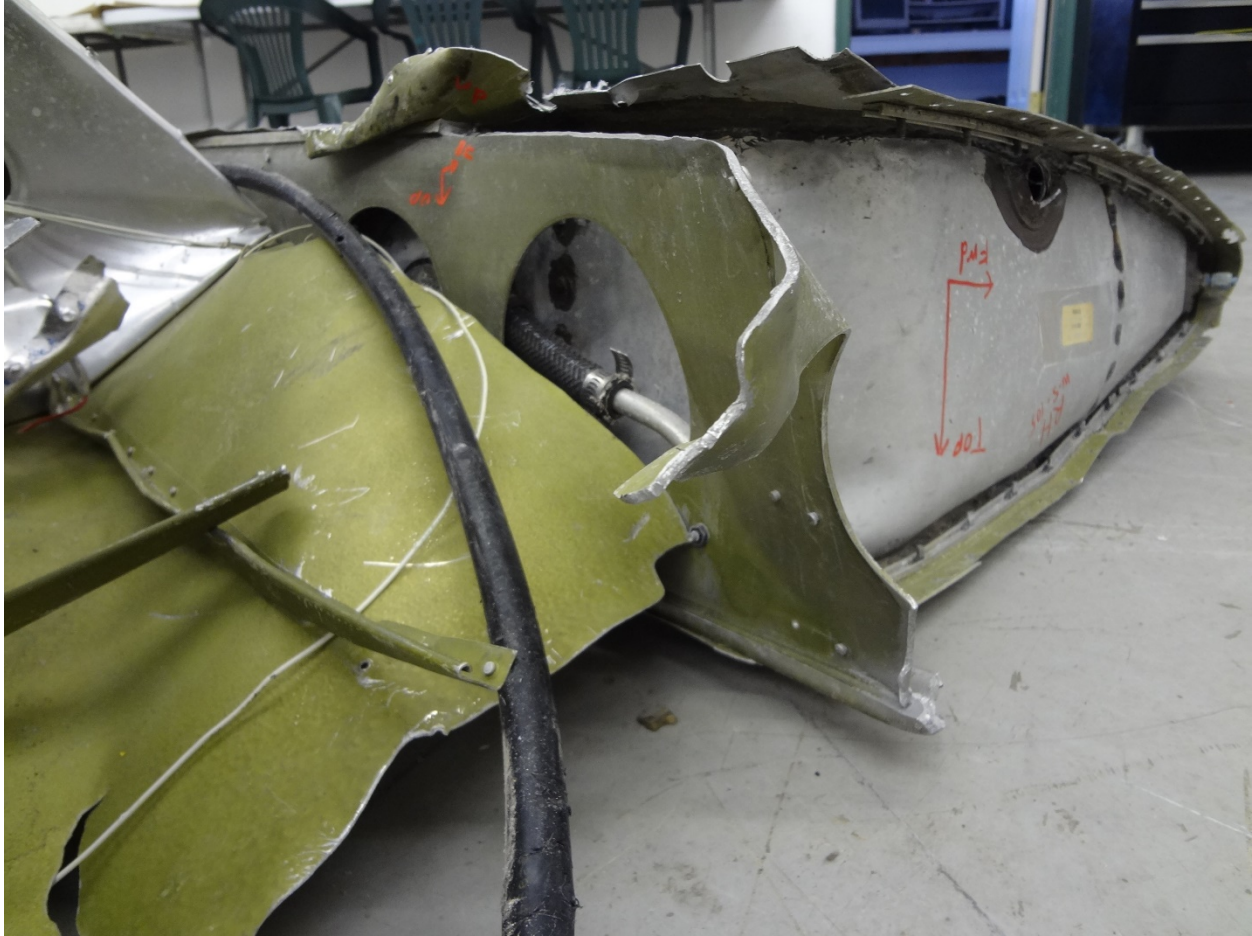
Figure 5: Right Wing Fracture Surface (Photo Courtesy of Piper Aircraft)

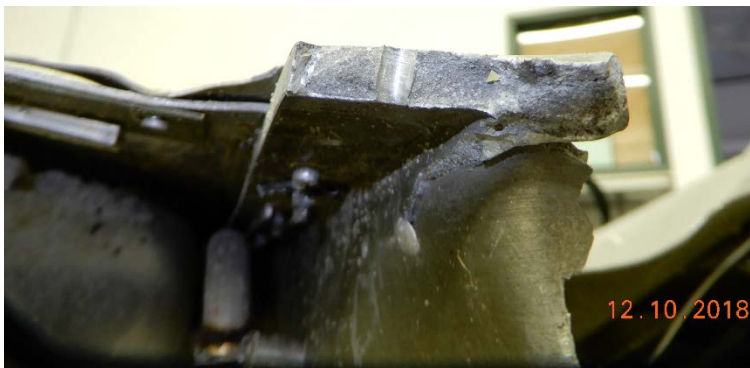
Figure 6: Right Wing Upper Fracture Surface

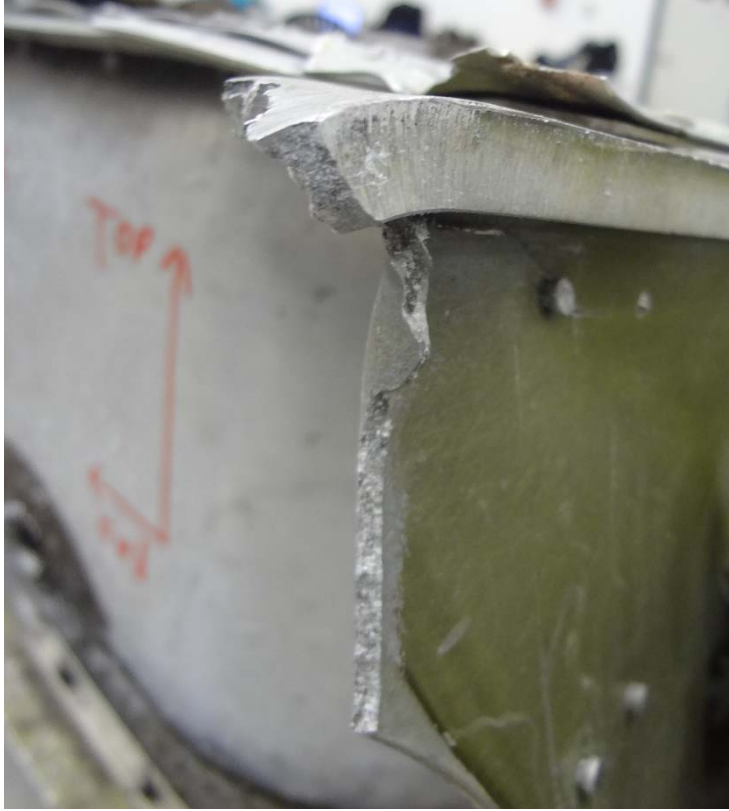
Figure 7: Right Wing Upper Fracture Surface (Photo Courtesy of Piper Aircraft)

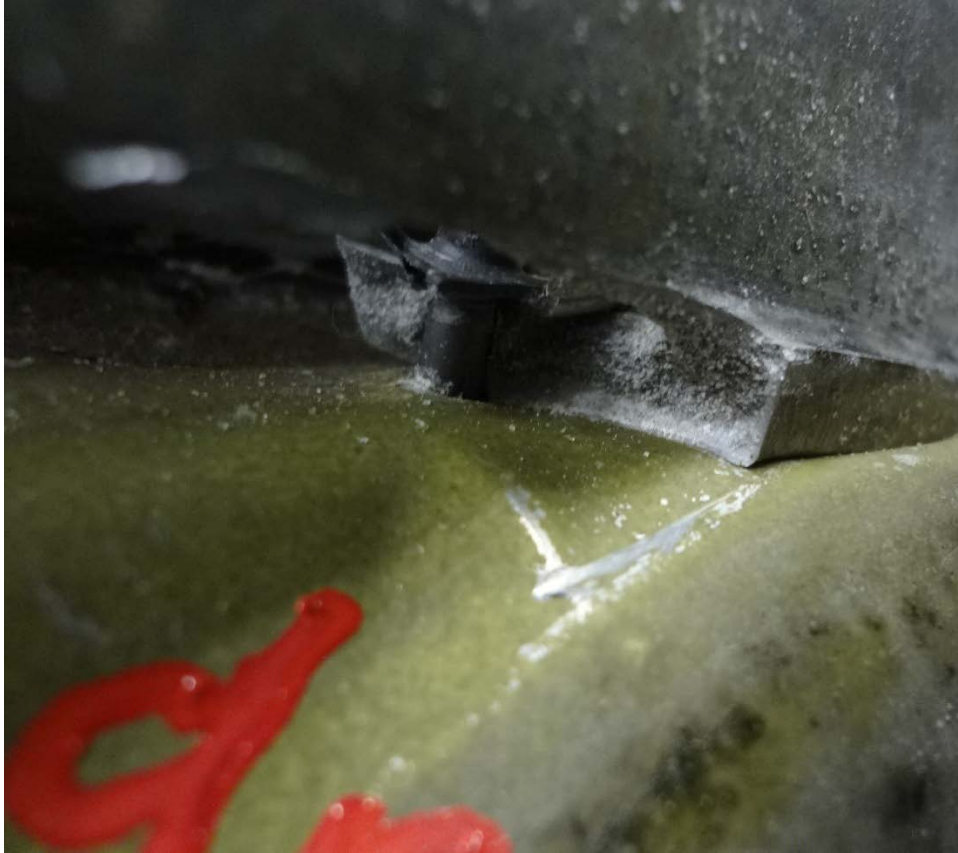
Figure 8: Right Wing Lower Fracture Surface (Photo Courtesy of Piper Aircraft)

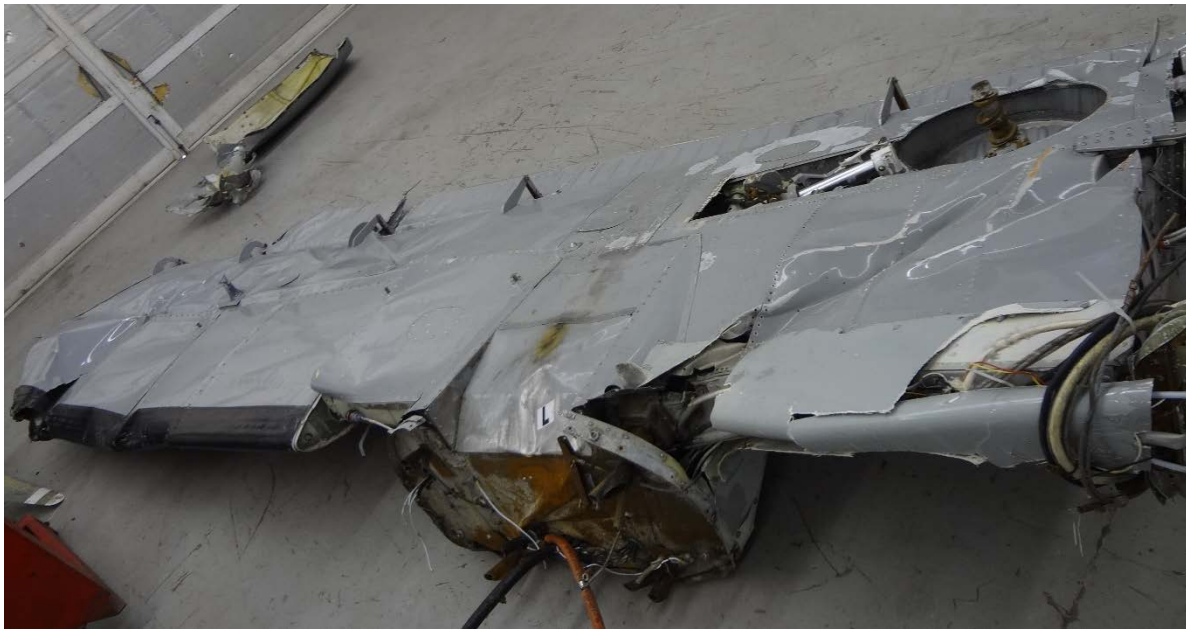
Figure 9: Left Wing Lower Leading Edge View (Photo Courtesy of Piper Aircraft)

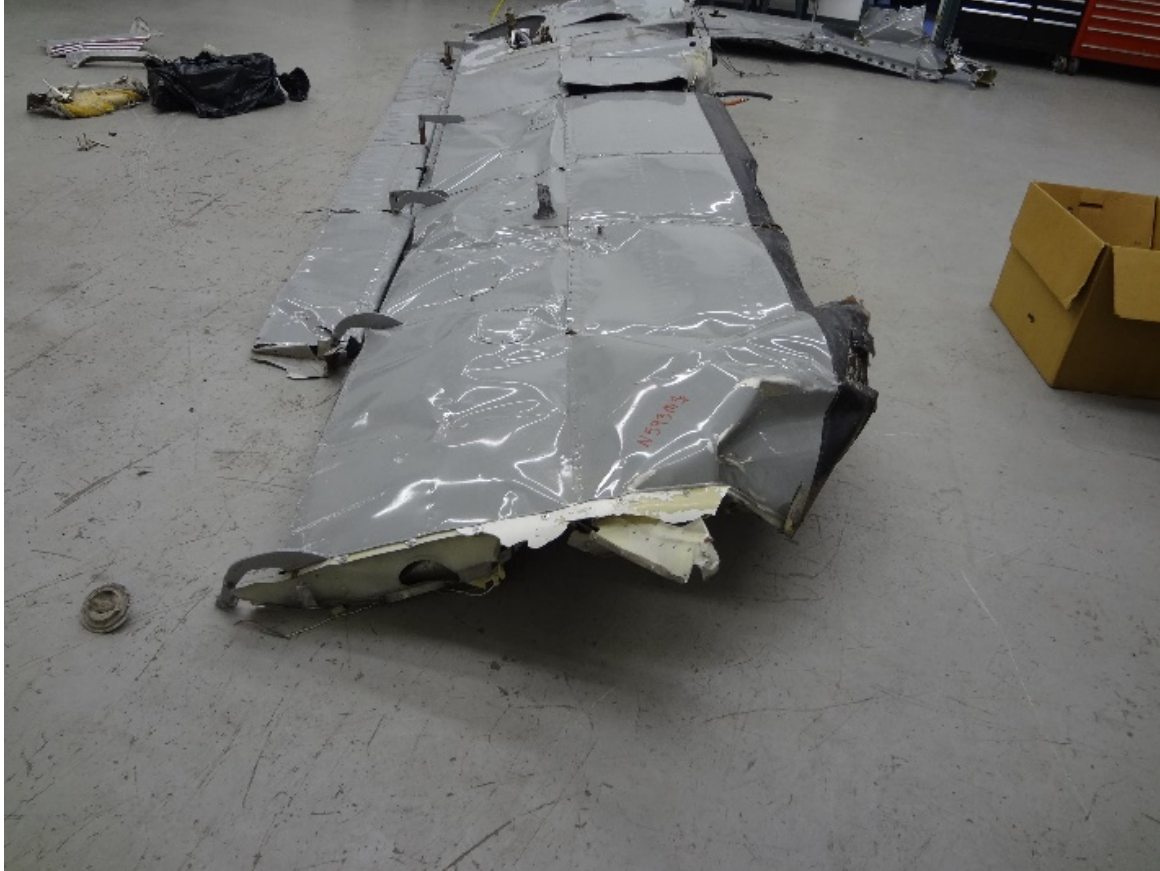
Figure 10: Left Wing Lower Outboard Lower View (Photo Courtesy of Piper Aircraft)

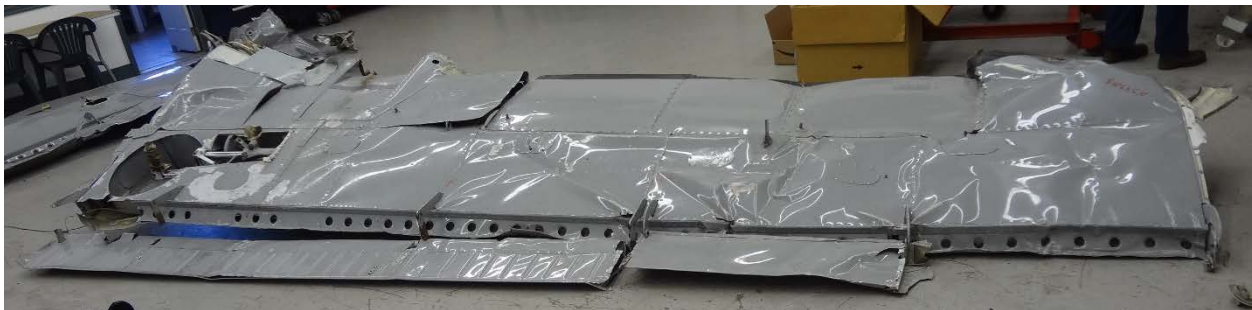
Figure 11: Left Wing Lower Trailing Edge View (Photo Courtesy of Piper Aircraft)

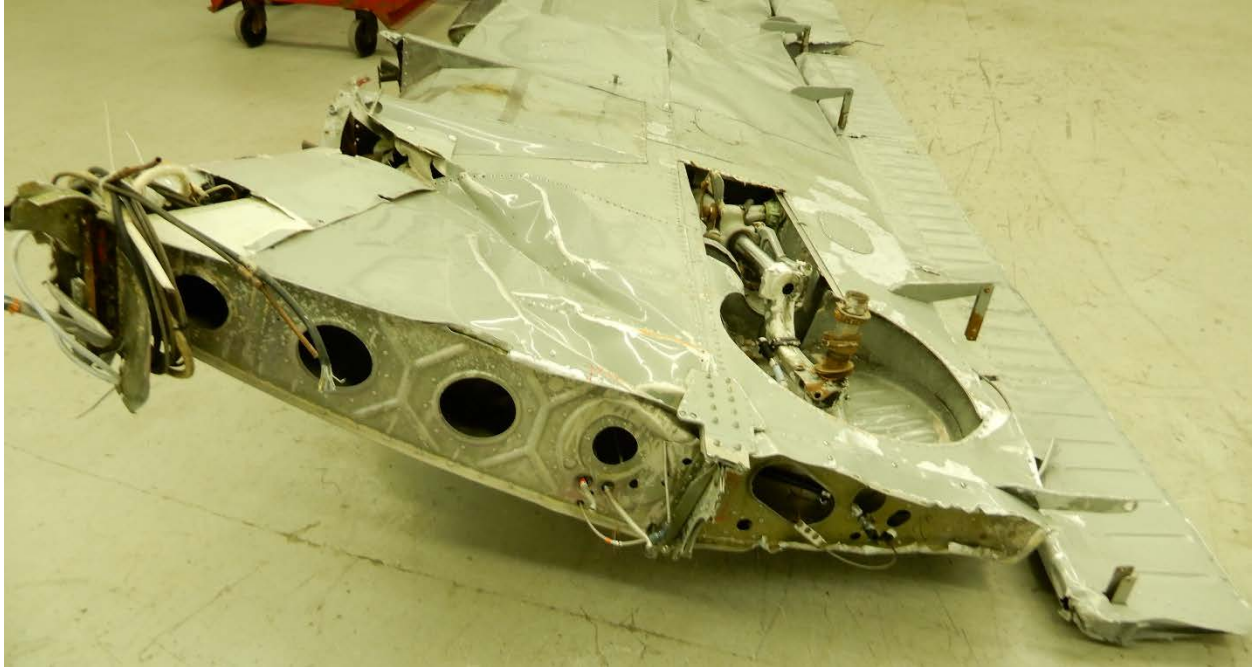
The left engine was removed for transport. The left wing's forward fuselage attach point remained attached to its fuselage attach point which was pulled from the fuselage. Its aft attach point was separated from the wing and was not recovered. The wing spar was deformed downward and separated at the attach bolts with a fracture surface consistent with overload. The wing displayed multiple skin separations and compression buckling on the lower skin at stations 158 and 125, and from the forward attach point to about station 50. About 2 feet of the outboard leading edge displayed fractures and upward deformation. The landing gear was folded in its well but could be moved to the extended position by hand. Its preimpact position could not be determined. The flap was separated from the wing and displayed skin separations and impact damage. Damage to the deice boots precluded field testing. The outboard and interconnect fuel tanks were pillowed, and no major impact damage or deformation was noted to the inboard fuel tank. The fuel vent was clear of obstruction. The gascolator bowl and filter were clear of debris, although the gascolator housing contained material consistent with sand. The fuel selector was in the 'ON' position. 38" of inboard aileron remained intact, while 37" of the outboard aileron was not intact/located. There was no evidence of aileron travel to stops. The bell crank was deformed with cables attached. The separated cable ends displayed a broomstrawed appearance consistent with tension overload.

Figure 12: Left Wing from Root

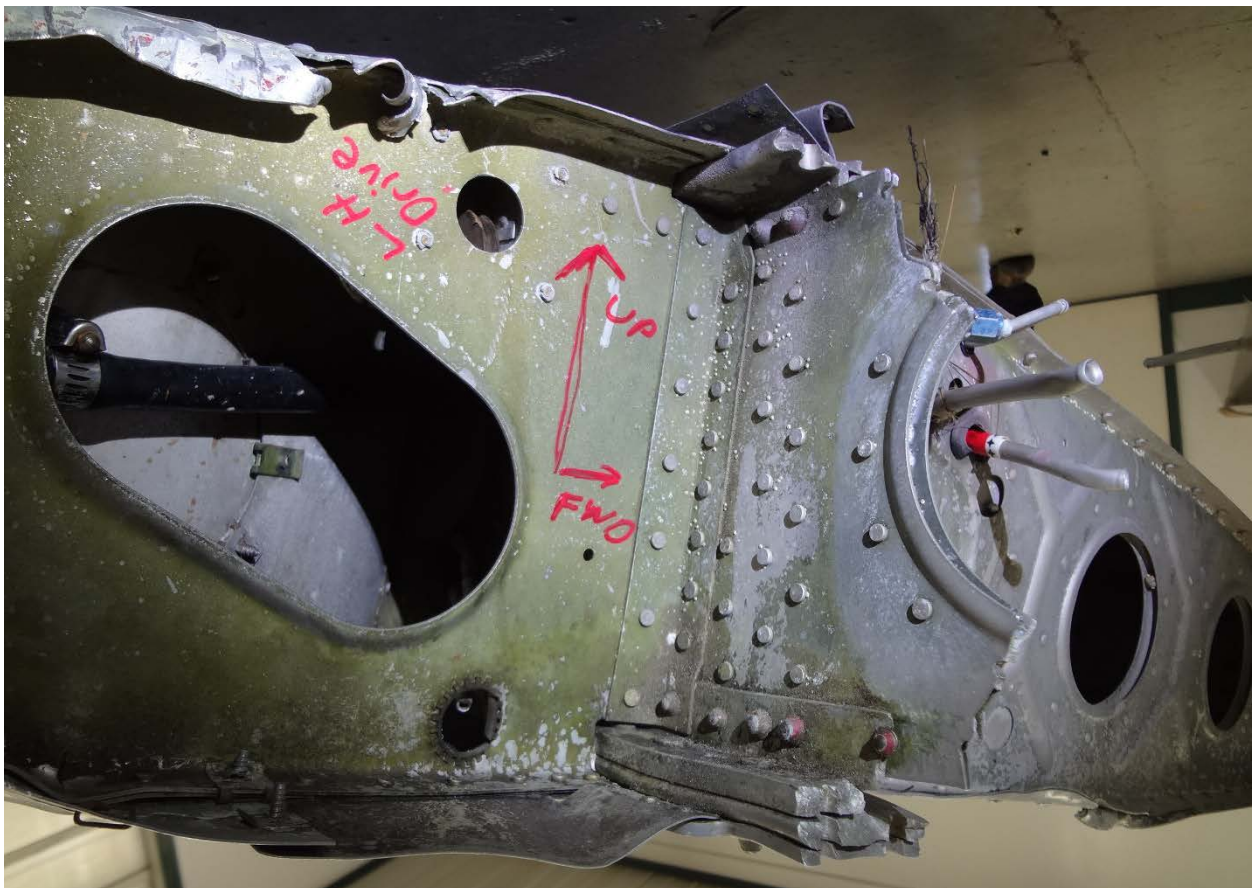
Figure 13: Left Wing Fracture Surface (Photo Courtesy of Piper Aircraft)

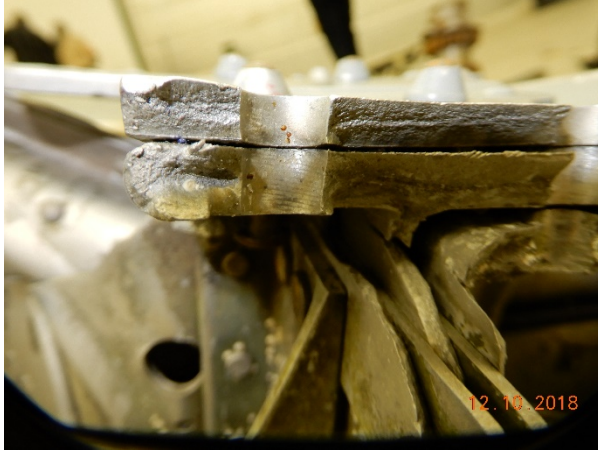
Figure 14: Left Wing Lower Fracture Surface

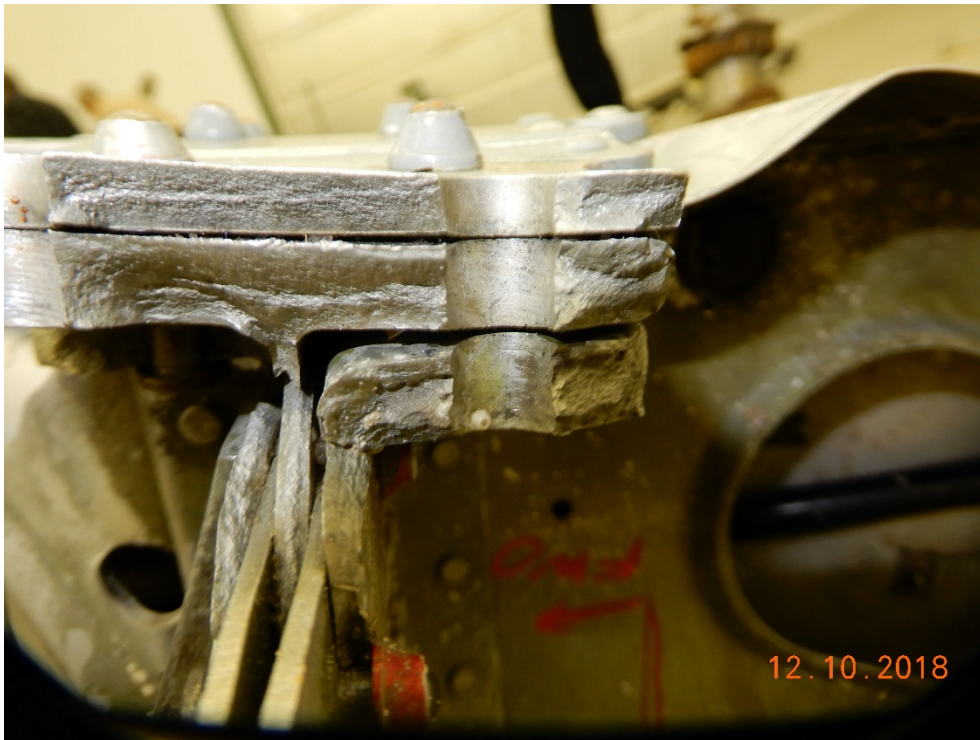
Figure 15: Left Wing Lower fracture Surface

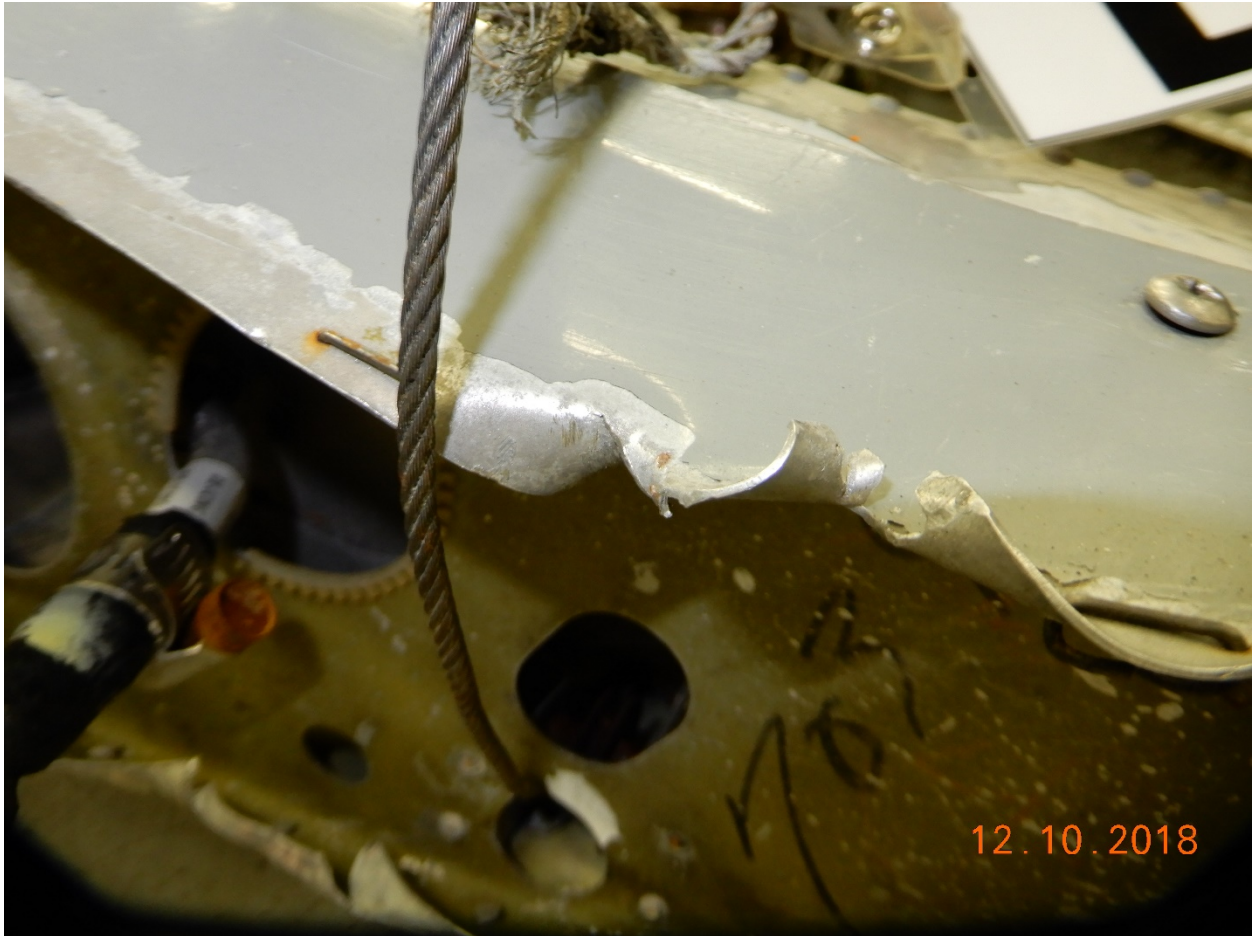
Figure 16: Left Wing Aileron Cable

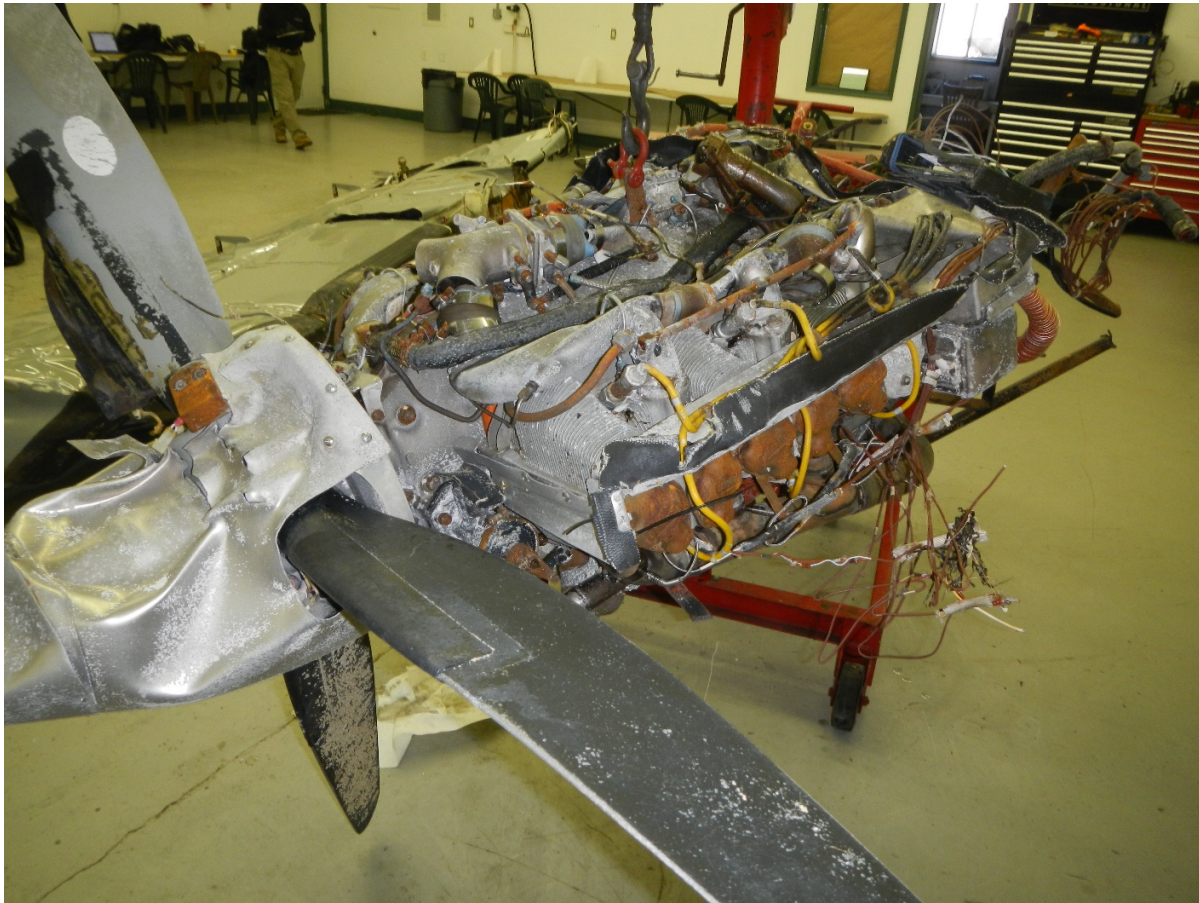
Figure 17: Engine and propeller (Photo Courtesy of Continental Motors)

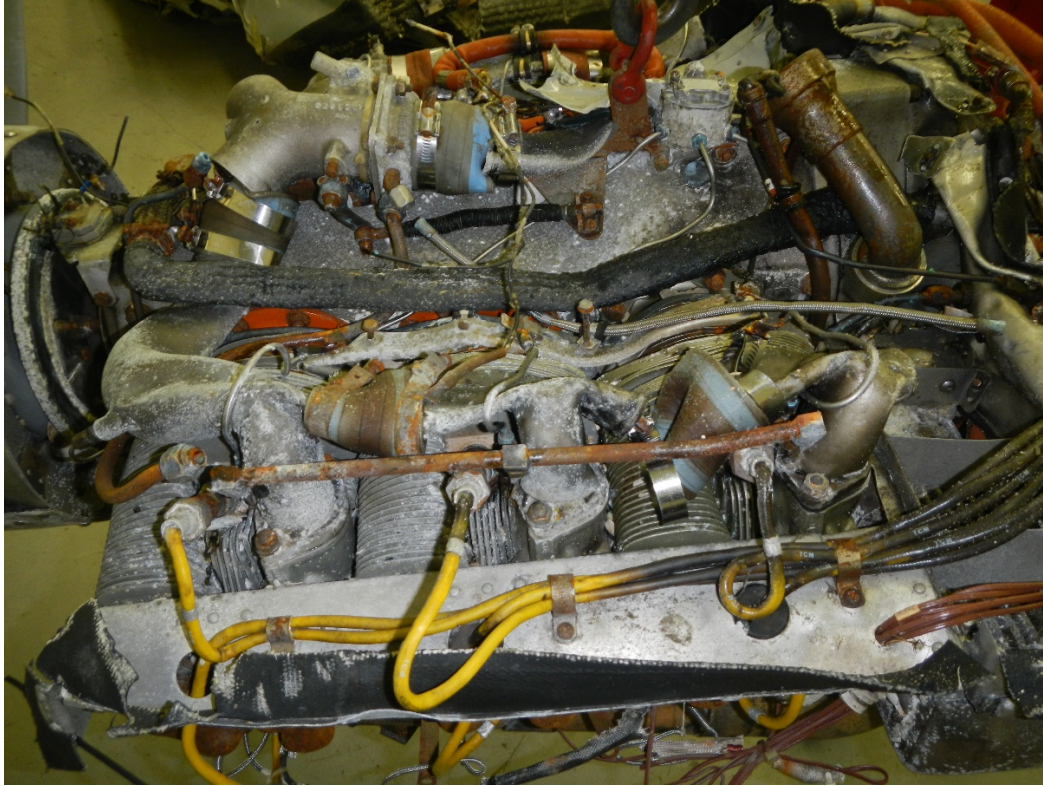
Figure 18: Top of engine with cowling removed (Photo Courtesy of Continental Motors)

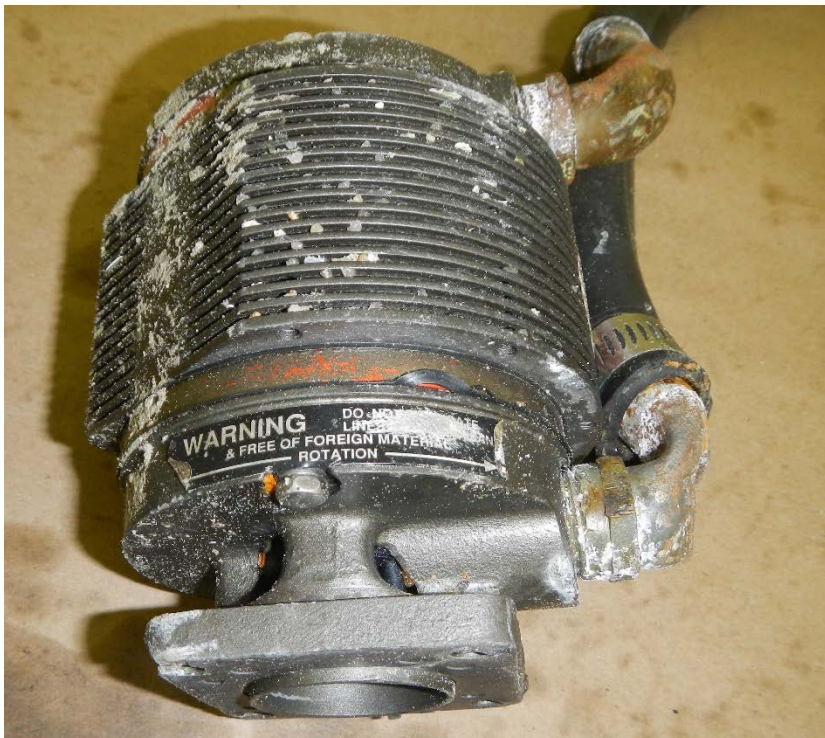
Figure 19: Vacuum Pump (Photo Courtesy of Continental Motors)

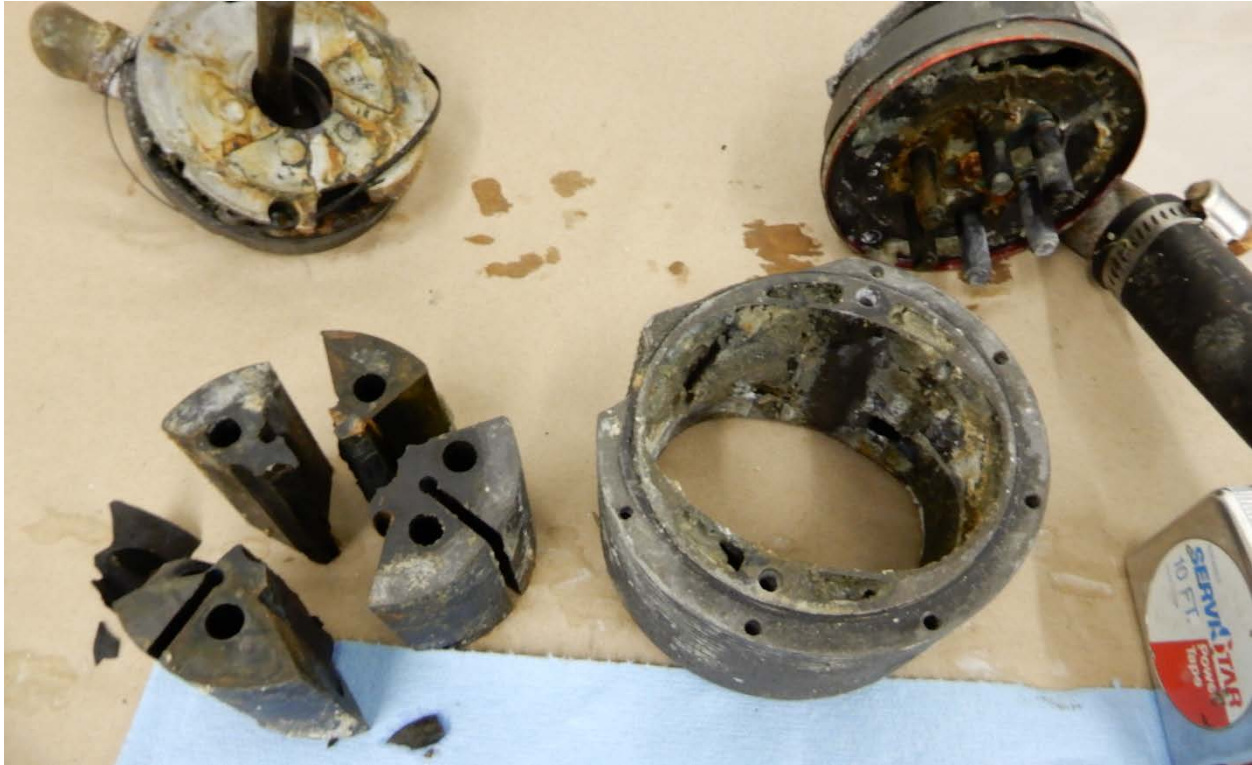
The left engine was removed for transport. The engine was equipped with a 3-bladed constant speed propeller, which remained attached. The exterior of the engine showed no evidence of preaccident anomalies. Borescope examination of the cylinders revealed no anomalies that would have precluded operation. All lifters were intact, and all cylinder rocker arms were attached. The fuel pump drive coupling was intact along with the draft shaft and vanes. Disassembly of the fuel manifold revealed a fuel smell consistent with saltwater immersion. The magneto points and distributor gear were intact. The crankshaft could not be rotated. No inductor or exhaust system anomalies were noted. The turbo charger impeller and turbines were intact and impacted with debris and sand. The disassembly of the vacuum pump revealed a fractured rotor, two fractured vanes, and a missing drive coupling.

Figure 20: Disassembled Vacuum Pump

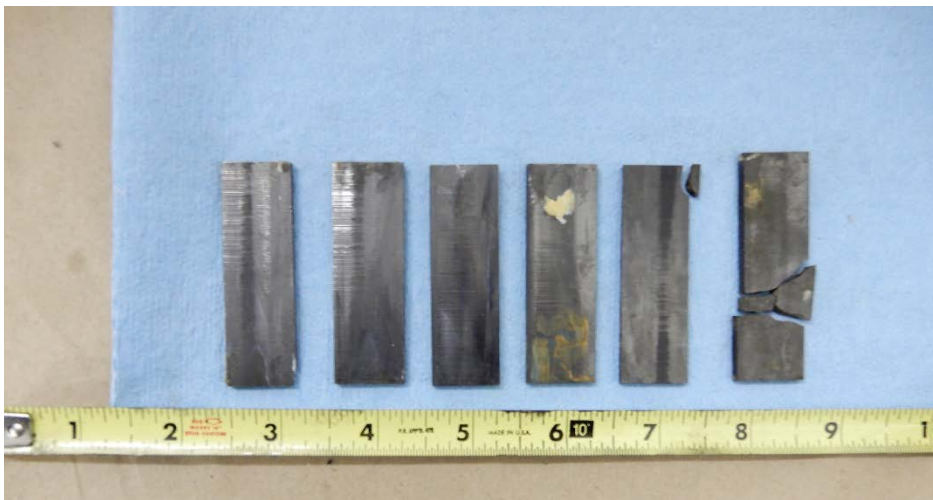
Figure 21: Vacuum pump vanes

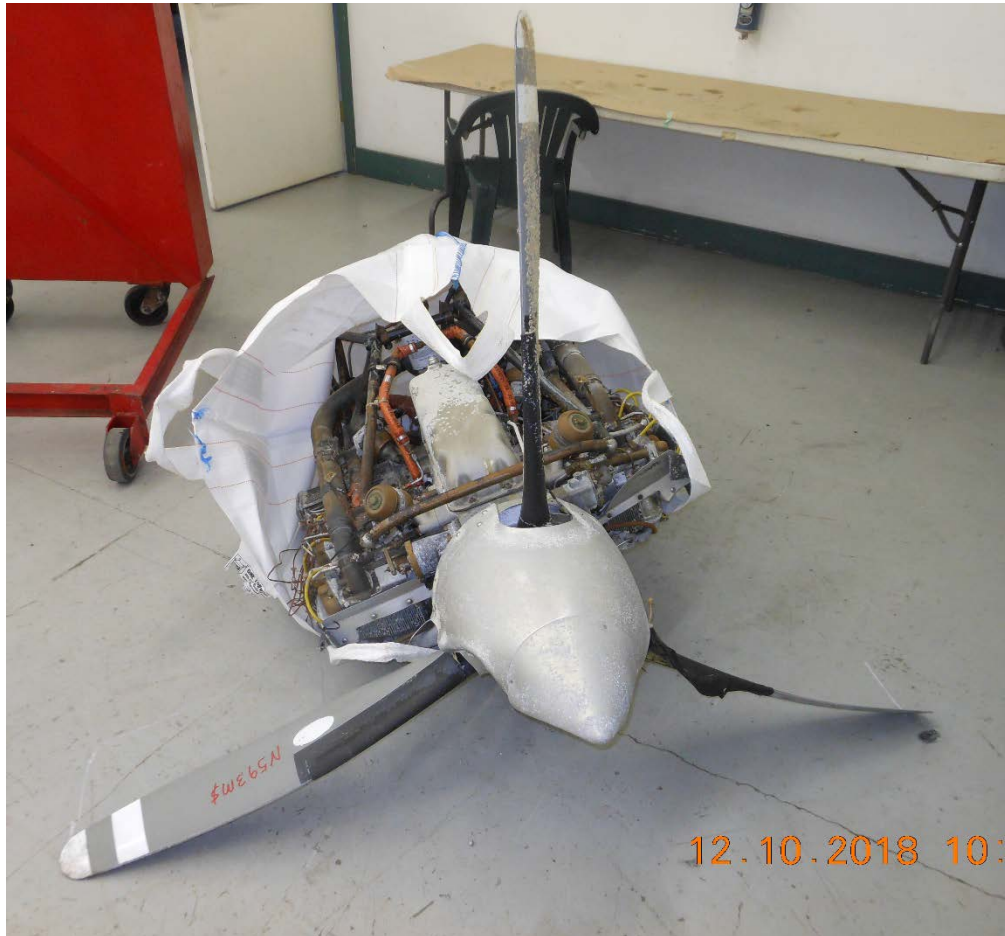
Examination of the propeller revealed that it was attached to the engine and in the feathered position. The spinner was crushed and torn adjacent to one blade. There was no indication of rotational deformation. External corrosion was consistent with saltwater immersion. One blade was bent forward, one was bent aft, and one showed no damage. There was no remarkable blade twisting or leading edge damage. Teardown examination revealed no discrepancies with the pitch change mechanism. Examination and logbook review indicate that the propeller did not

Figure 22: Propeller (Photo Courtesy of Hartzell)

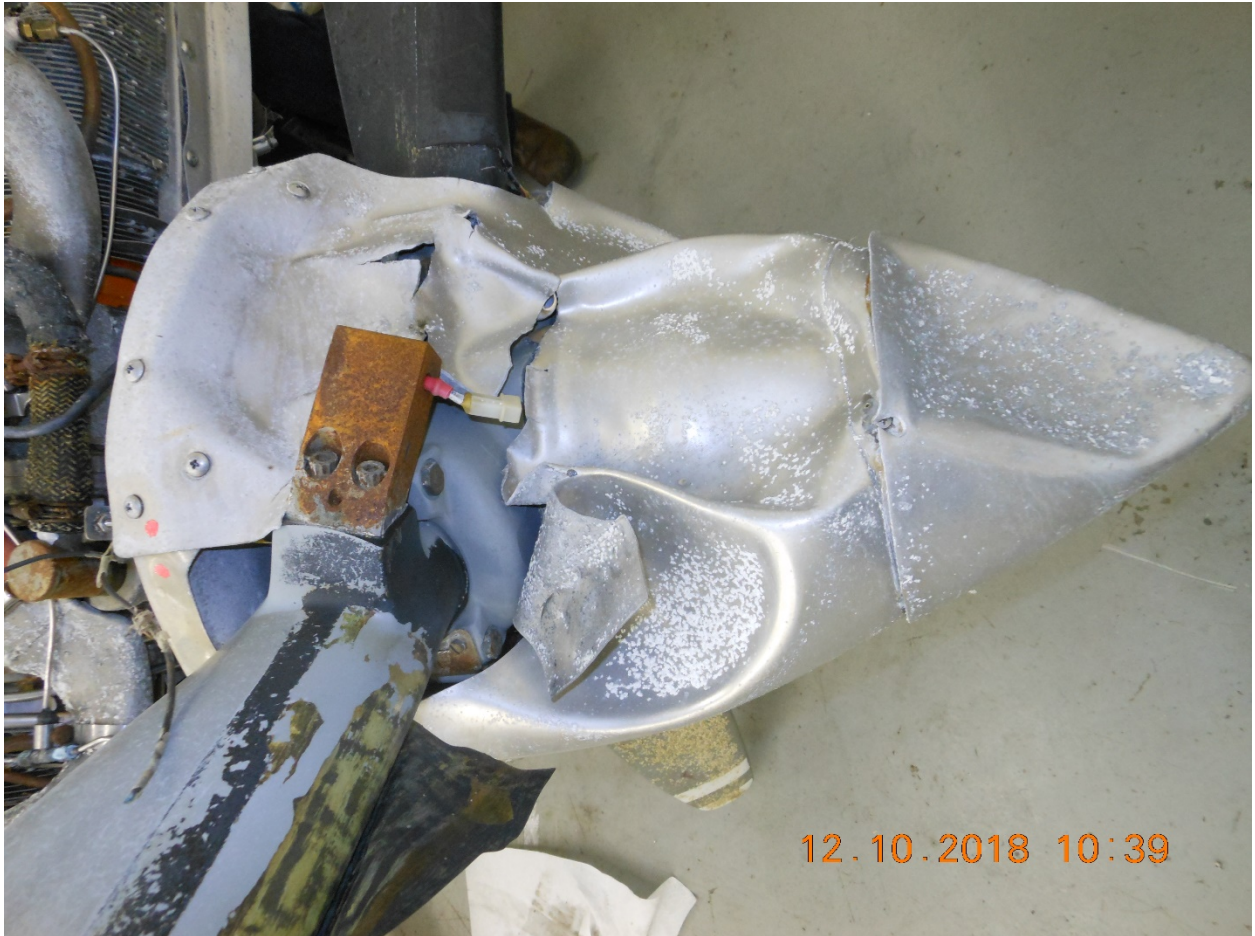
Figure 23: Spinner (Photo Courtesy of Hartzell)

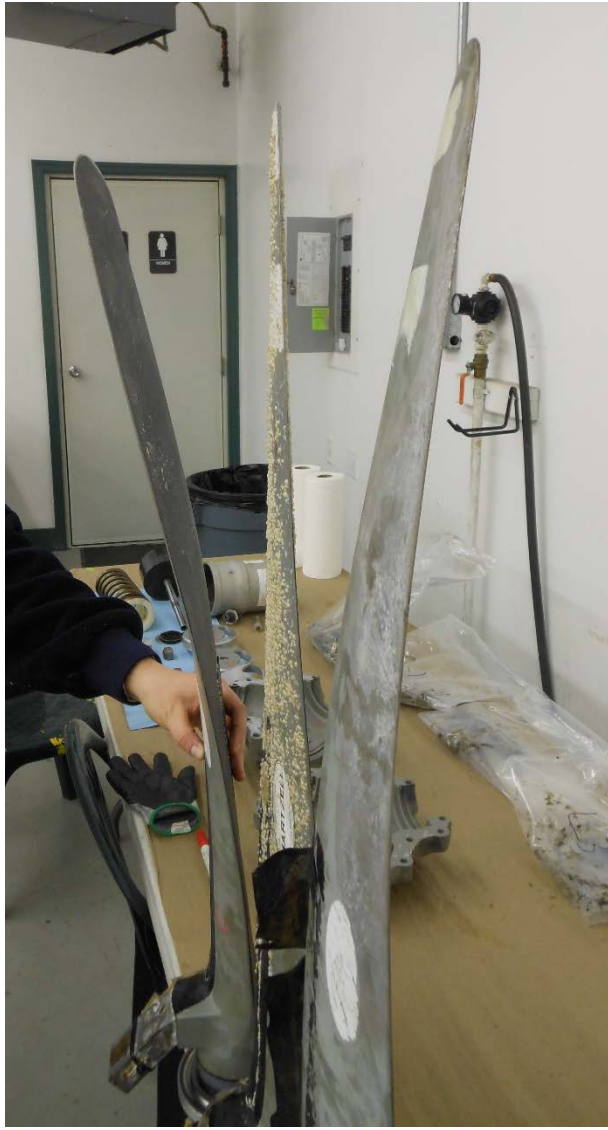
Figure 24: Propeller Blades (Photo Courtesy of Hartzell)

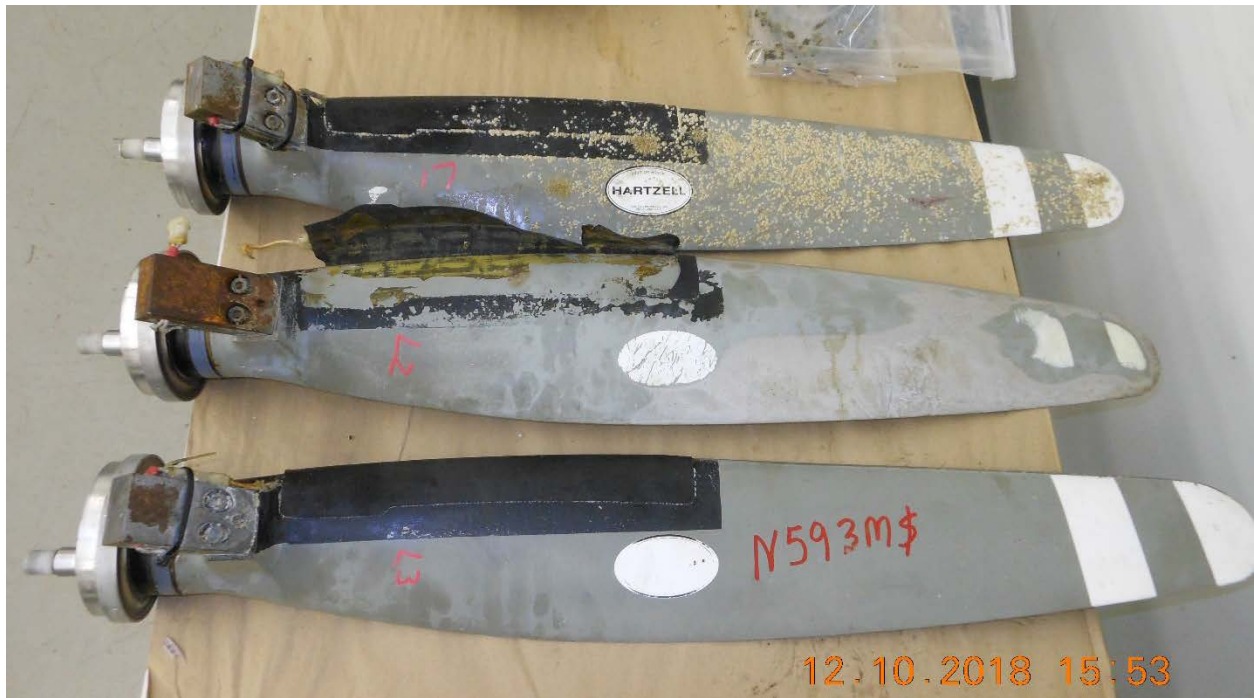
Figure 25: Propeller Blades (Photo Courtesy of Hartzell)
