# NATIONAL TRANSPORTATION SAFETY BOARD

## MATERIALS LABORATORY STUDY REPORT

Report No. 19-084

Place : Westhampton Beach, NY  
Date : October 13, 2018  
Vehicle : Piper PA34, N593MS  
NTSB No. : ERA19LA012  
Investigator : Lynn Spencer (AS-ERA)

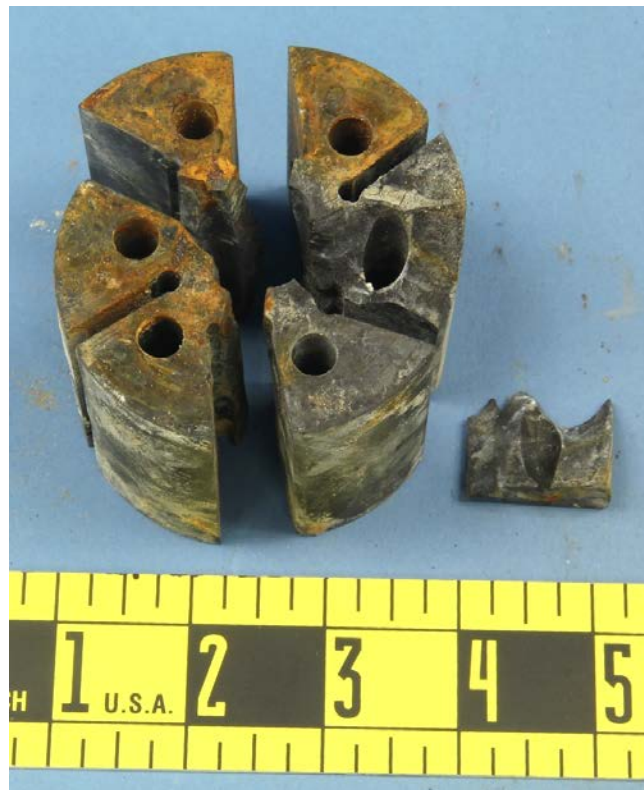
The parts from the vacuum pump recovered and assessed are shown in the top image of Figure 1. The mating shear coupling was not recovered and thus could not be examined.

The core was fractured into several pieces (bottom image of Figure 1). The fracture pattern on the core emanated from the fin slots to the center bore, which is a fracture pattern consistent with failure due to vane drag observed in previous cases. Wear was observed on the fins and the vane faces, which could have led to binding of the vanes in the slots.

the fractured core (bottom image).

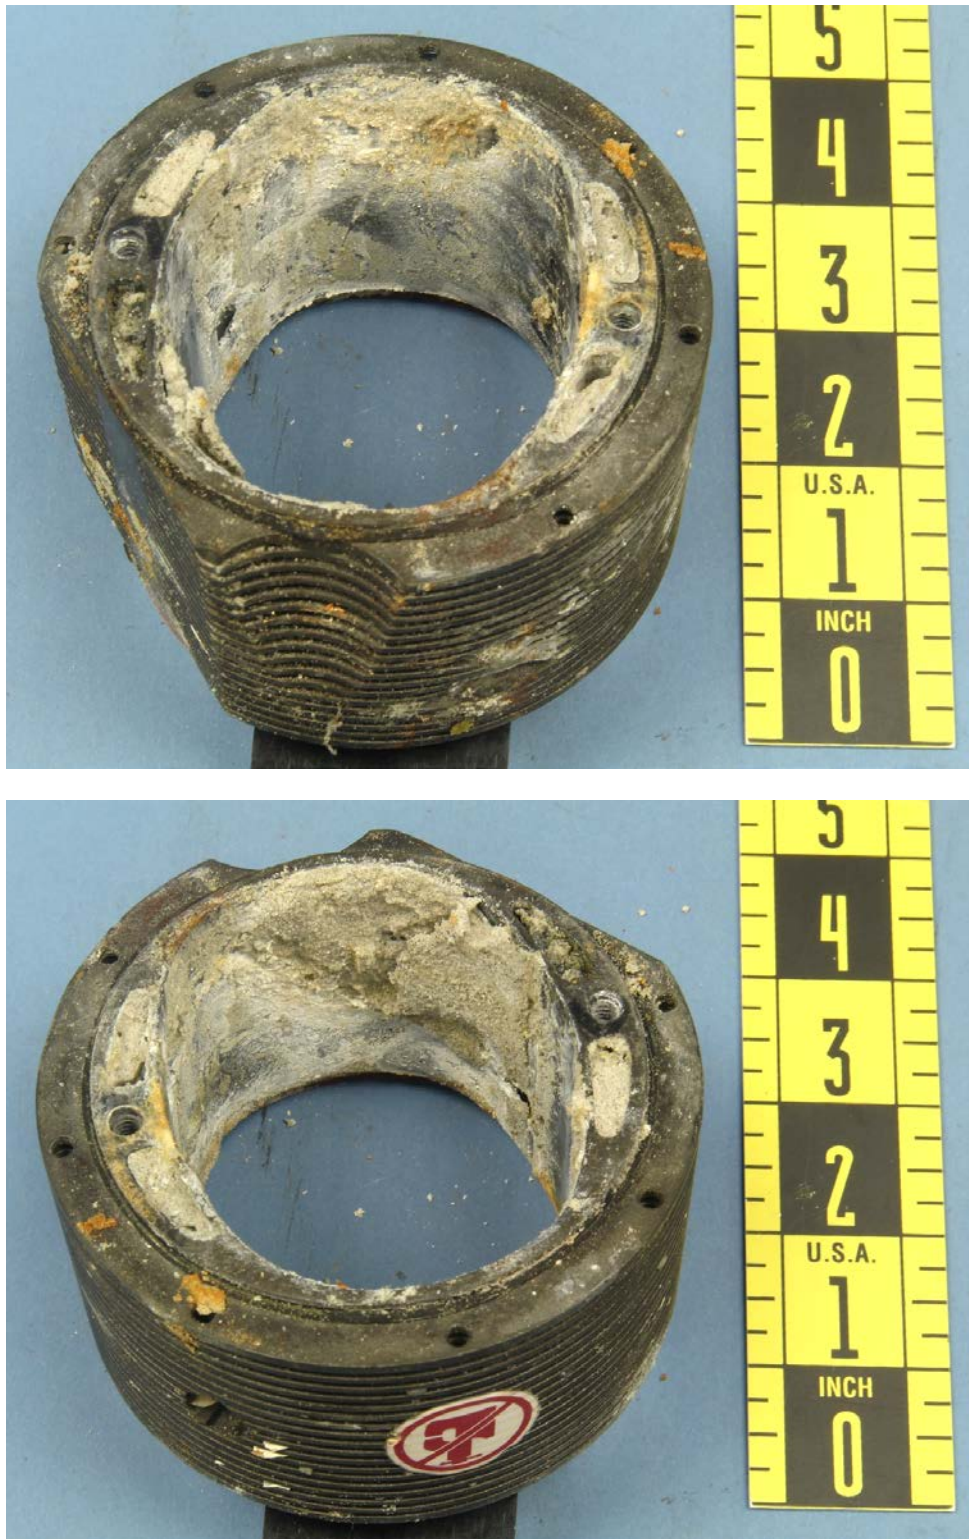
The inner diameter of the housing was caked with corrosion products, as shown in Figure 2. The housing was ultrasonically cleaned of all deposits that could be removed without heavy scrubbing, in order to preserve the surface to examine it for circumferential wear marks consistent with operation of the pump during the crash. Unfortunately, no

such marks were visible and thus the operating status of the pump at the time of the crash is inconclusive.

Figure 2: Overall photos showing the corrosion deposits on the inner diameter surface of the vacuum pump housing.
