**From:** David Carreau  
**Sent:** Friday, November 2, 2018 9:00 AM  
**To:** Kathryn Whitaker; Hicks Ralph  
**Subject:** "Update of N8132X"

I have some new investigation information concerning the accident of N8132X at 4B9 on 10/28/2018. On (11/01/2018) we inspected both the left hand and right hand main wheel brake assemblies of N8132X after the removal of the wheel brake to landing gear wheel pants. The following is a synopsis of what was uncovered during this inspection;

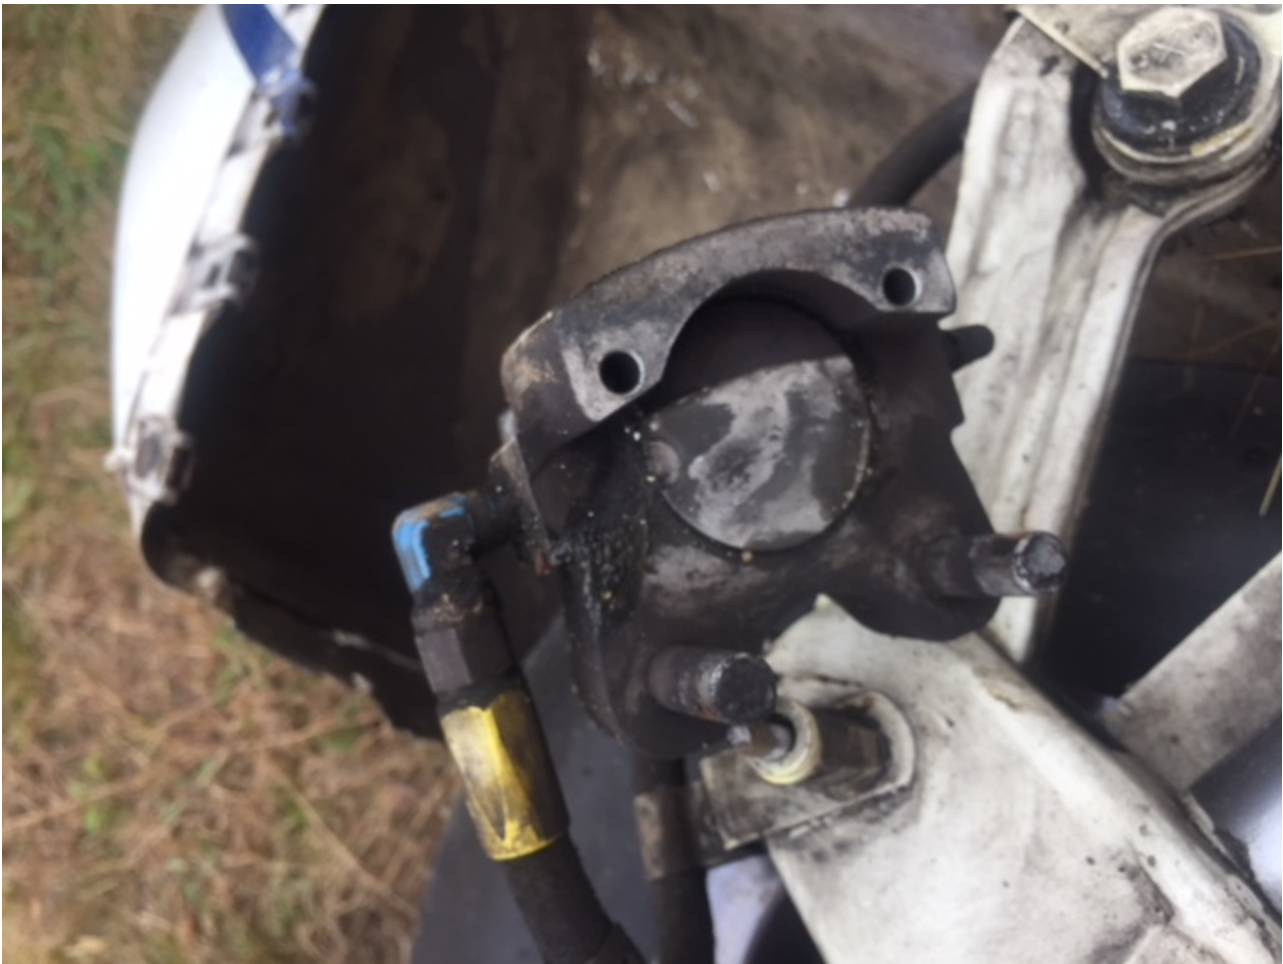
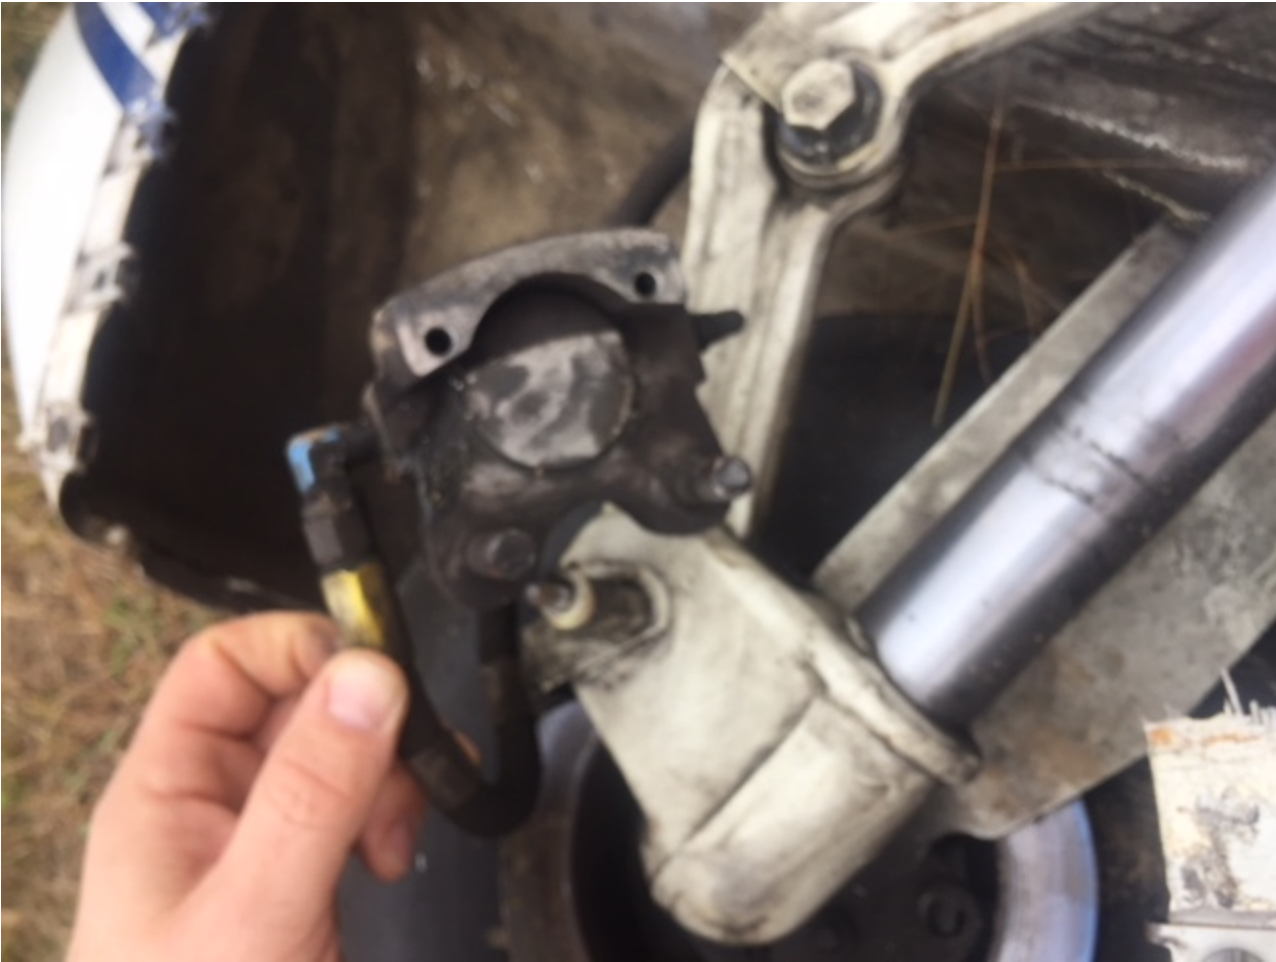
1. The left main wheel, brake and main landing gear trunnion assembly that had been detached from the aircraft during the collision with the terrain and was found with the following discrepancies;
  - a. The main brake assembly puck to brake pad showed evidence of leaking and the main hydraulic brake supply line to the brake assembly hydraulic MS fitting elbow also showed evidence of leaking hydraulic fluid.
  - b. The main brake pads inboard and outboard exhibited normal wear. The main brake assembly was attached in its normal position by two AN bolts. Please see attached pictures of these discrepancies.

L/H Main Wheel Assembly with main brake removed exhibiting evidence of hydraulic leaking at brake puck and the MS elbow hydraulic line fitting at brake hosing.

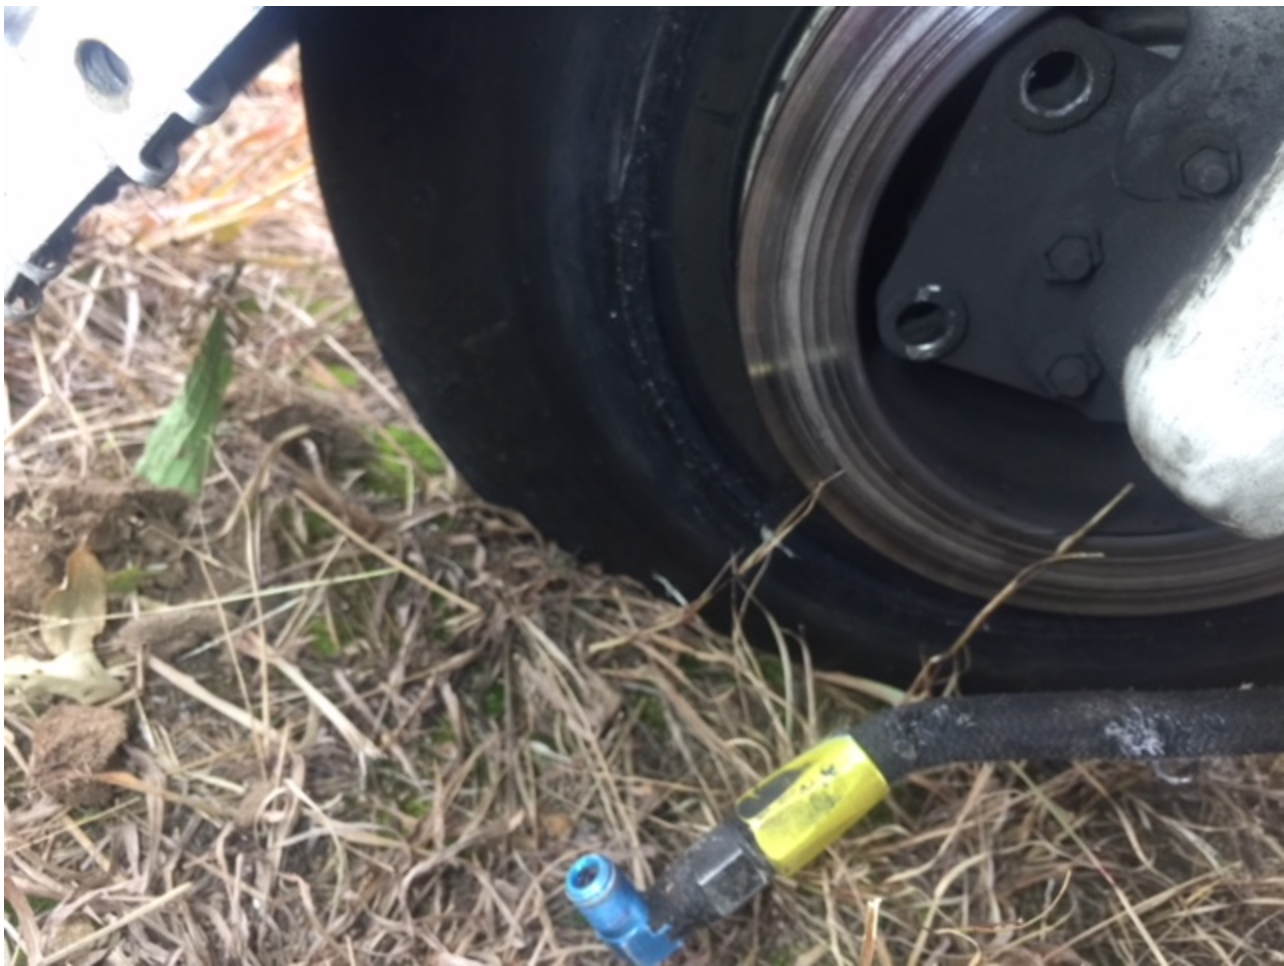
**PICTURE**  
**#1.**

hydraulic elbow MS fitting were scoured as shown in **PICTURE #2**. The inboard side of right main wheel assembly had a cylindrical mark around the circumference of the tire sidewall approximately 1 inch outboard of the wheel brake rotor as shown in **PICTURE #1 and #2**.

**PICTURE #1.;** R/H Main Landing Gear Wheel exhibiting scoring of the main brake assembly housing on the sidewall of the main tire.

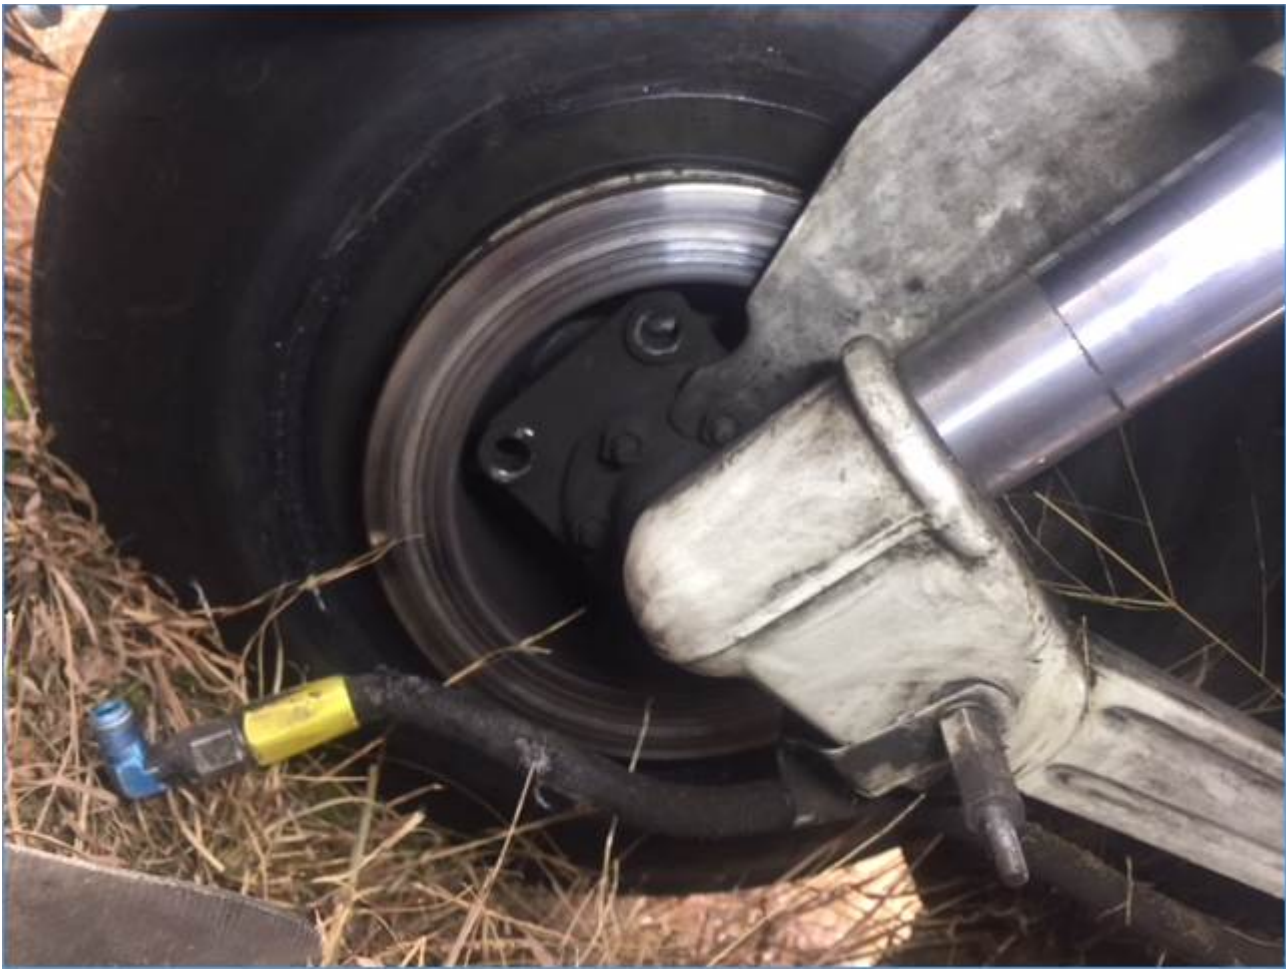
**PICTURE #2.**

**PICTURE #2;** The R/H Landing Gear Main Brake Assembly was found missing from its normal position at the main wheel brake rotor after removal of the main wheel pant.

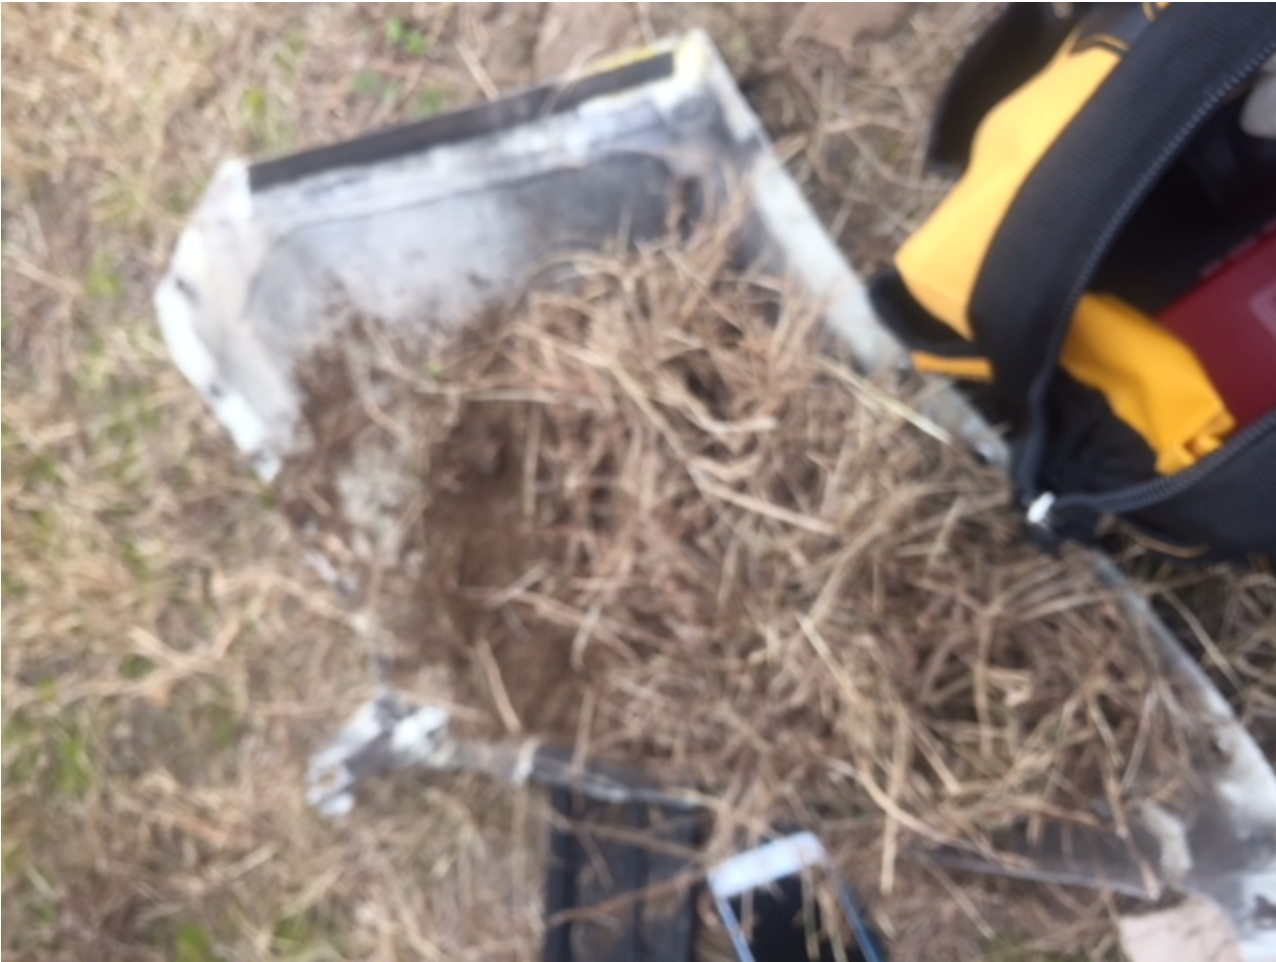
**PICTURE #3**

2. The right main wheel brake assembly and main landing gear trunnion assembly that were still attached to the main wing assembly after collision with the terrain was found with the following discrepancies;
  - a. The right main wheel skirt assembly was found with an abundant amount of grass inside the housing, apparently from the impact with the terrain. Upon removal of the right main landing gear wheel pant, the right main brake assembly was noted missing from its proper mounting position to the main landing gear trunnion. It was not installed onto the main wheel brake rotor with the two required AN mounting bolts to the main strut trunnion. The flexible hydraulic fluid line elbow with the MS fitting were present without the main brake assembly. It was noted that the last two threads of the

**PICTURE #3.;** The R/H Main Landing Gear Wheel Pant embedded with weeds from impact with the terrain.

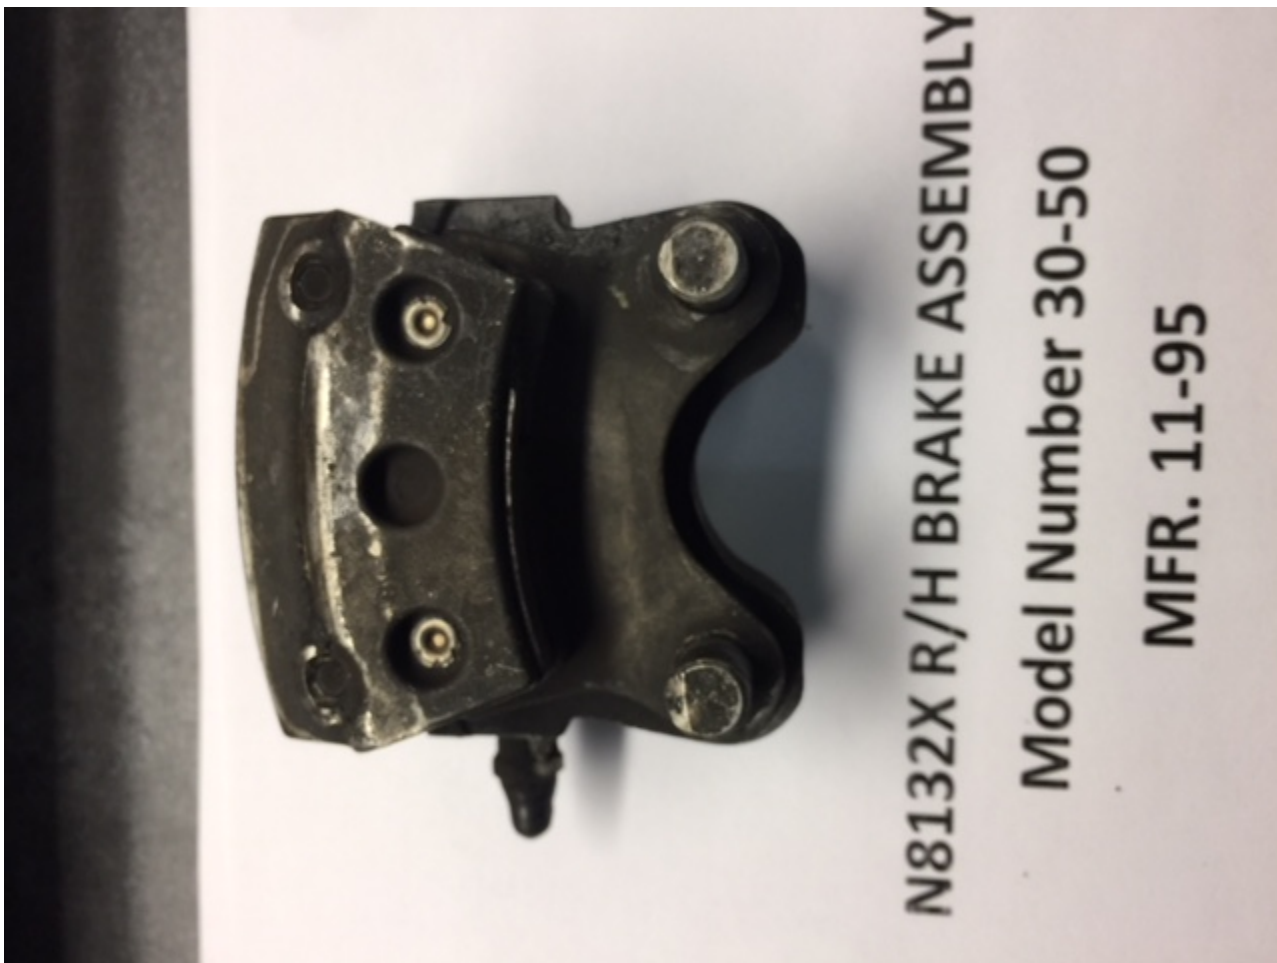
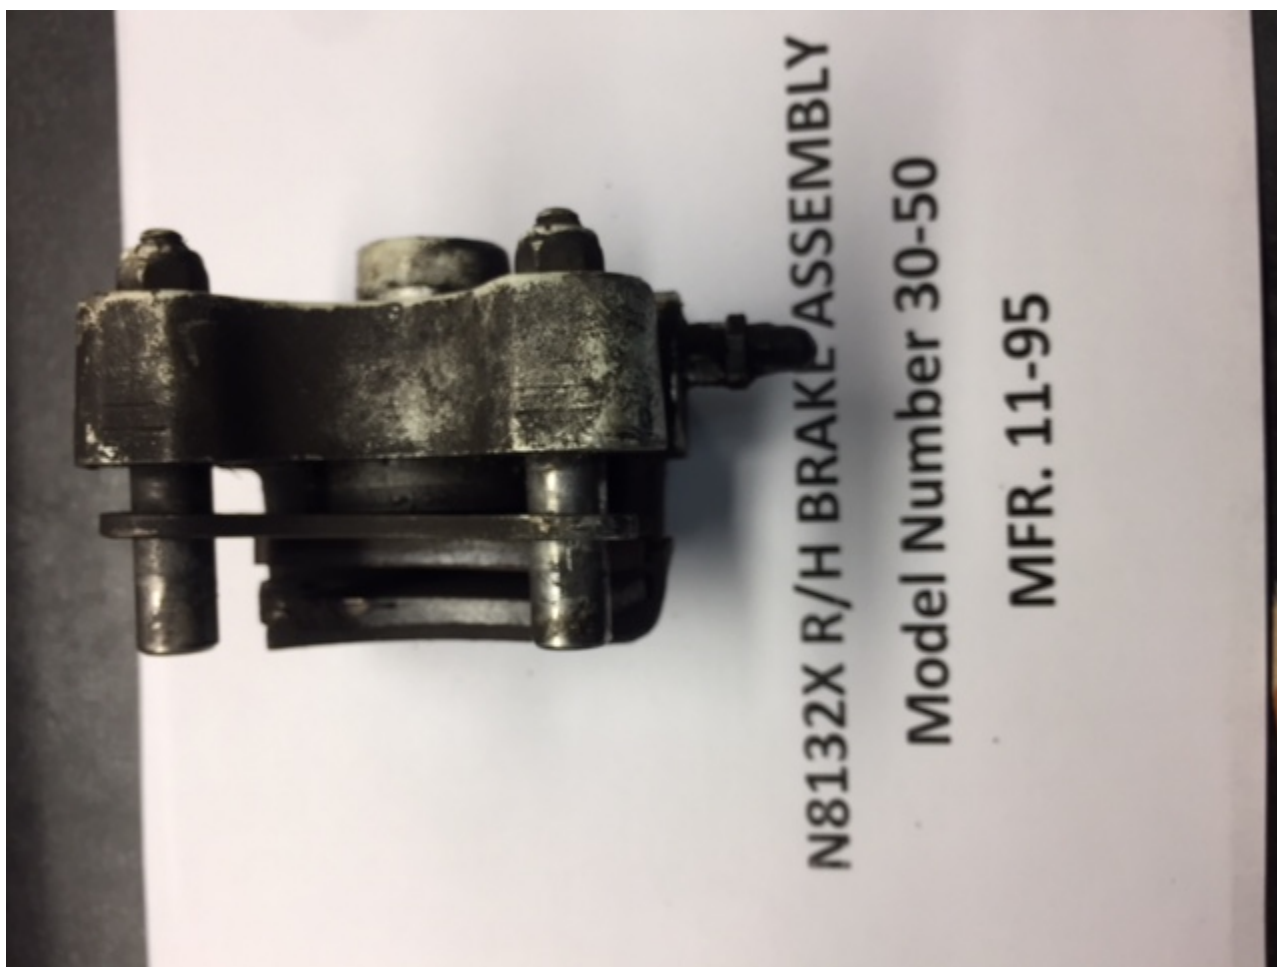
I went back on Friday and did so more investigating of N8132X. We found the main right hand brake assembly dislodged from the right main landing gear trunnion (it's normal mounting position).

Kathryn asked me to send her photos of the right hand main brake assembly. Here they are; top, side, front and rear views. There is no damage in the form of binding of the alignment pins, the brake pads are intact and there is no distortion of the assembly housing. This e-mail is number 1 of 2.
