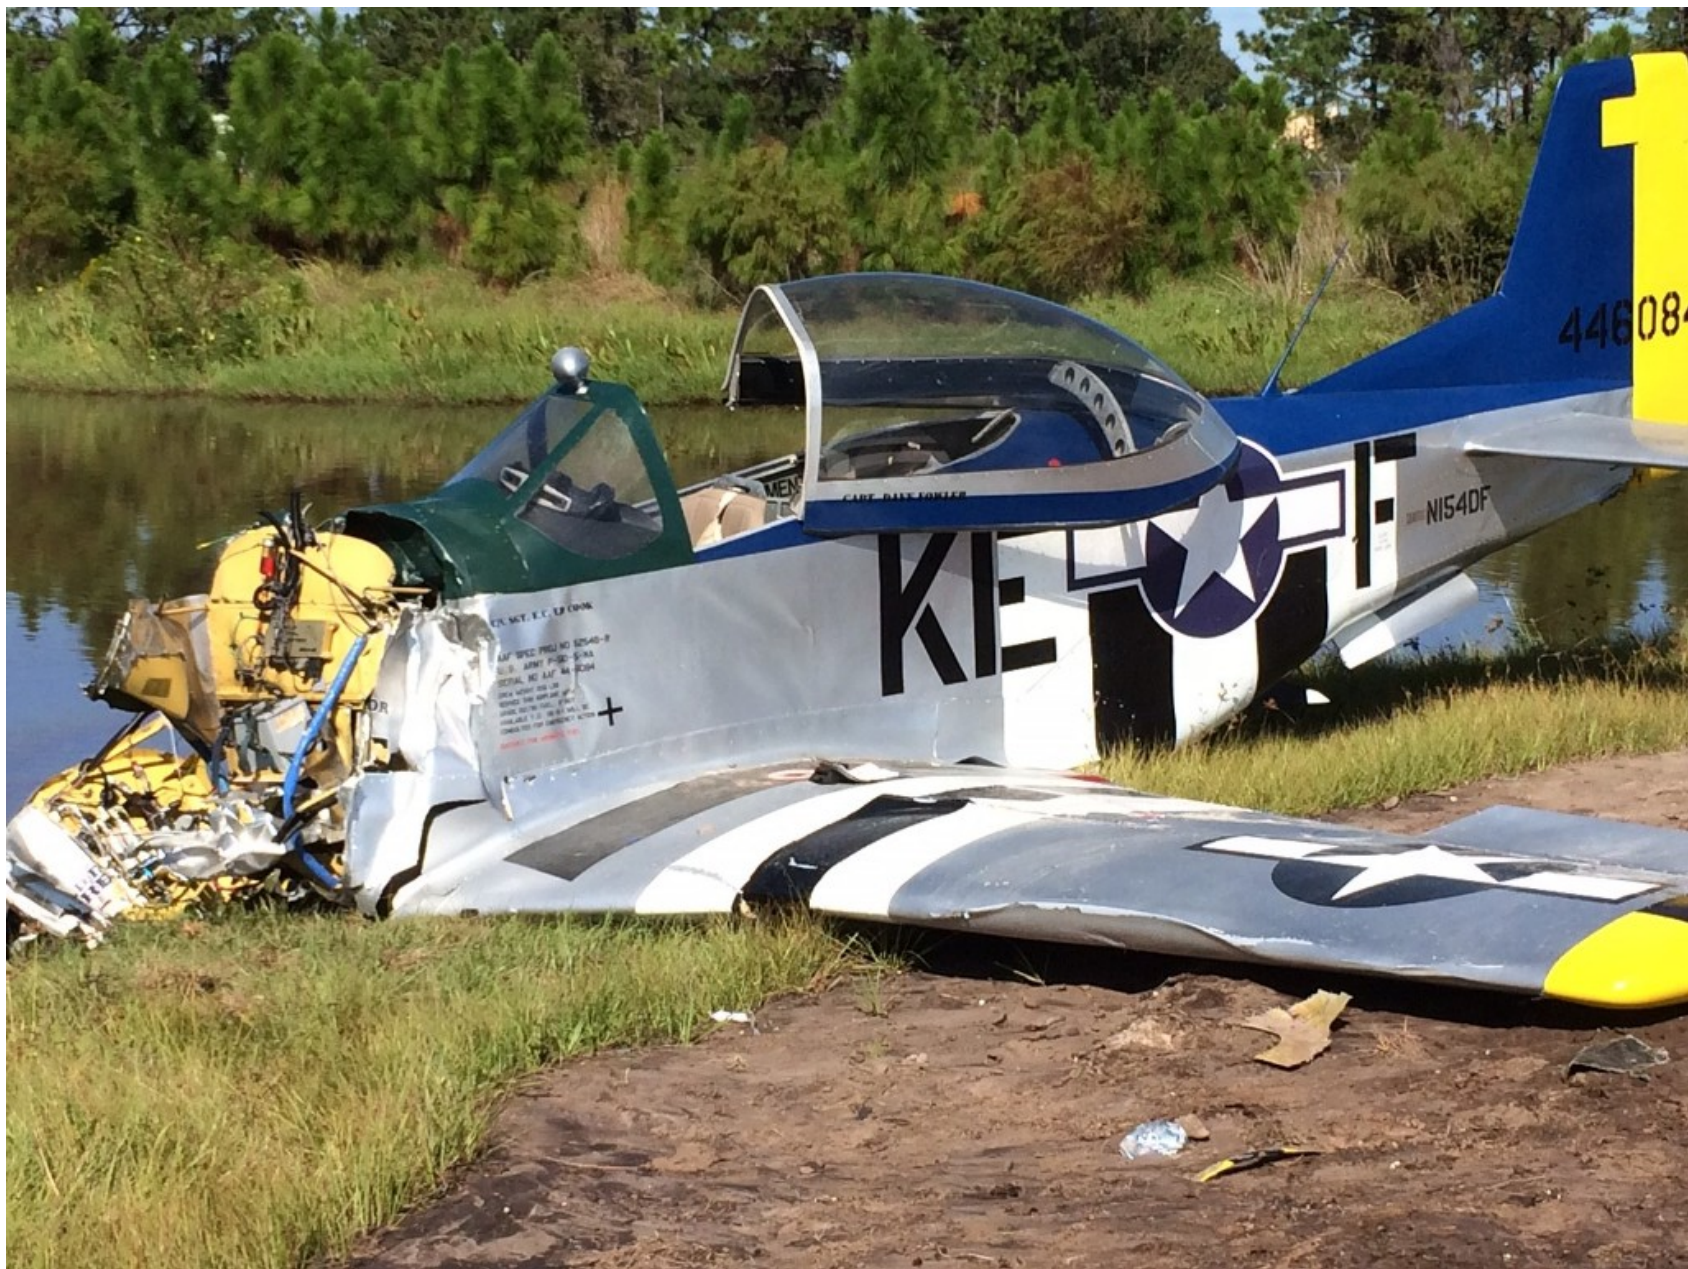
**Photo 1 – Photograph From Owner/Builder. Left Quartering View of the Airplane at the Accident Site.**

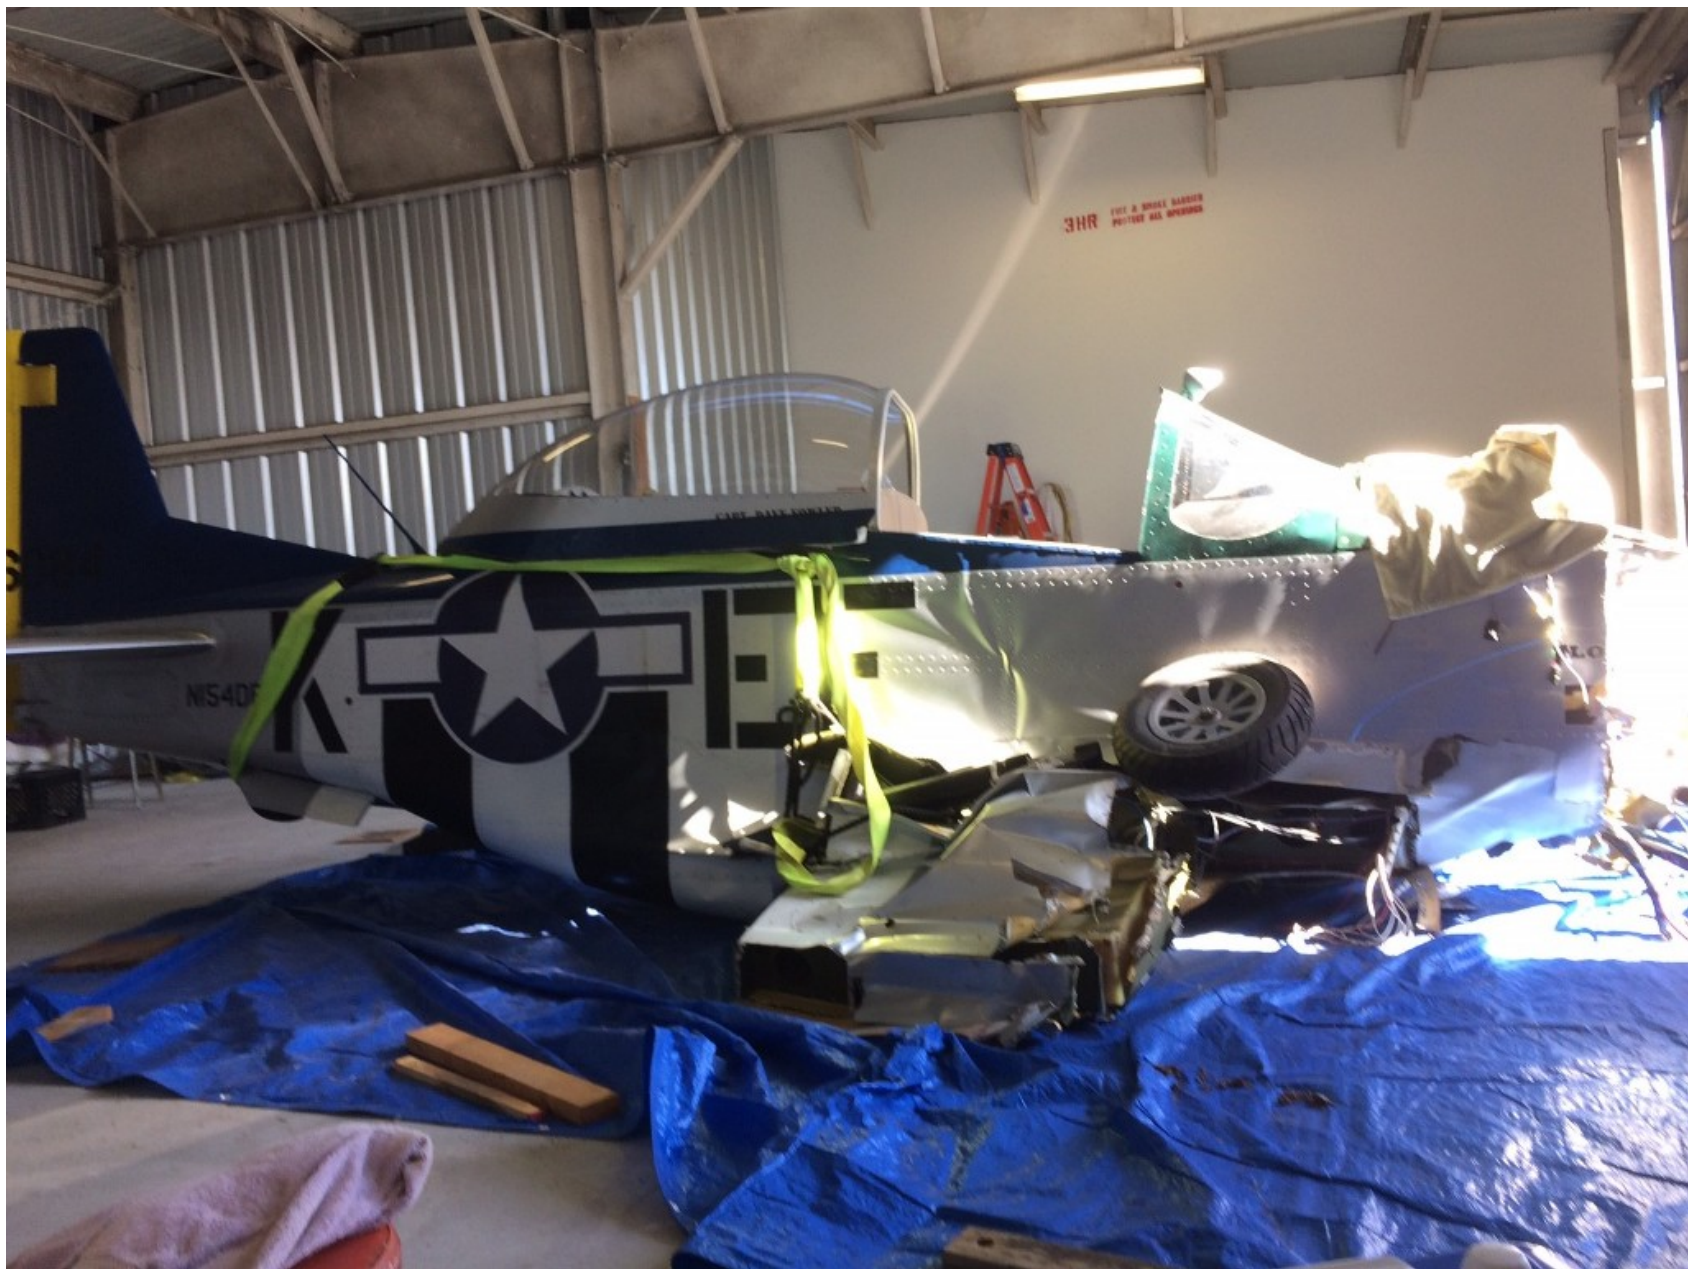
**Photo 2 - Photograph From Owner/Builder. Right Side View of the Airplane Following Recovery.**

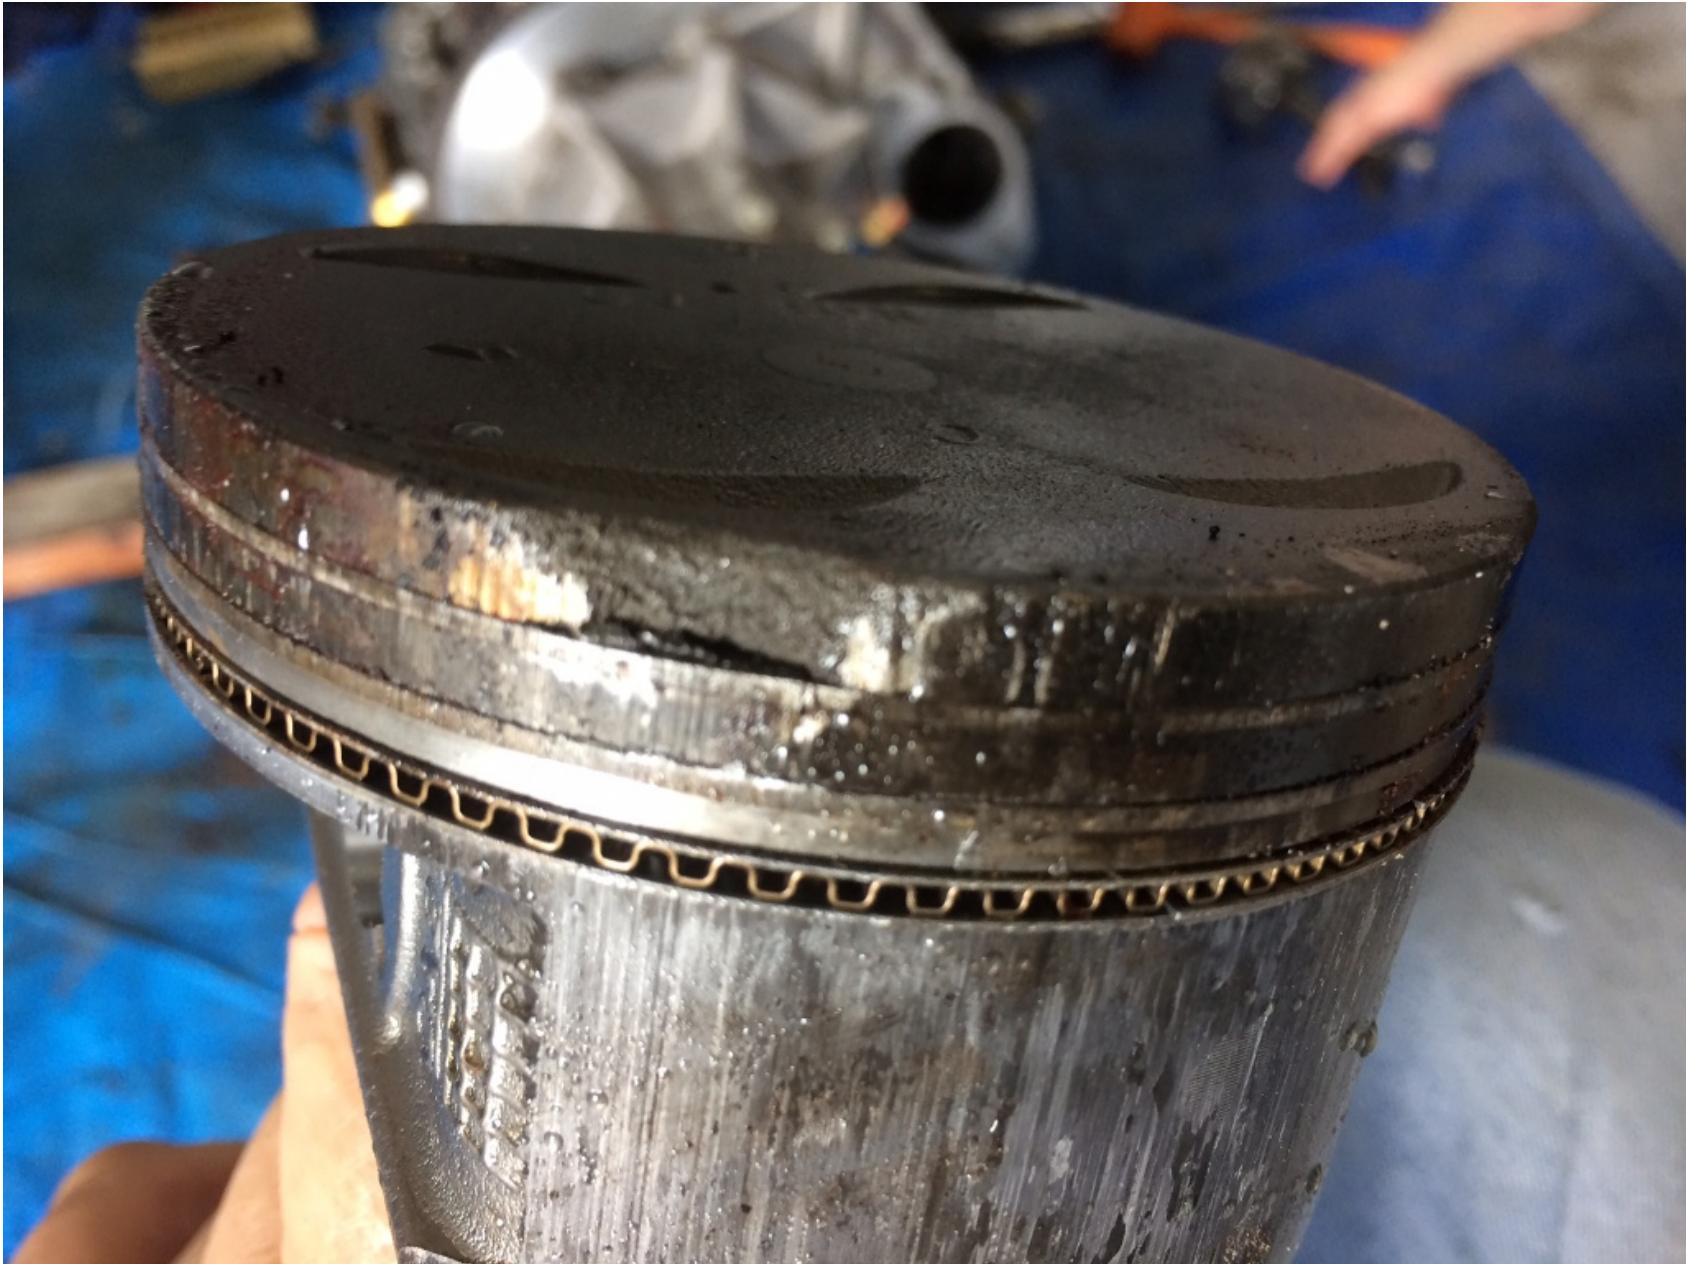
**Photo 3 - Photograph From Owner/Builder. View of the Damaged No. 2 Piston. Note the course Scoring on the Side of the Piston and the Missing Section of Piston Crown.**

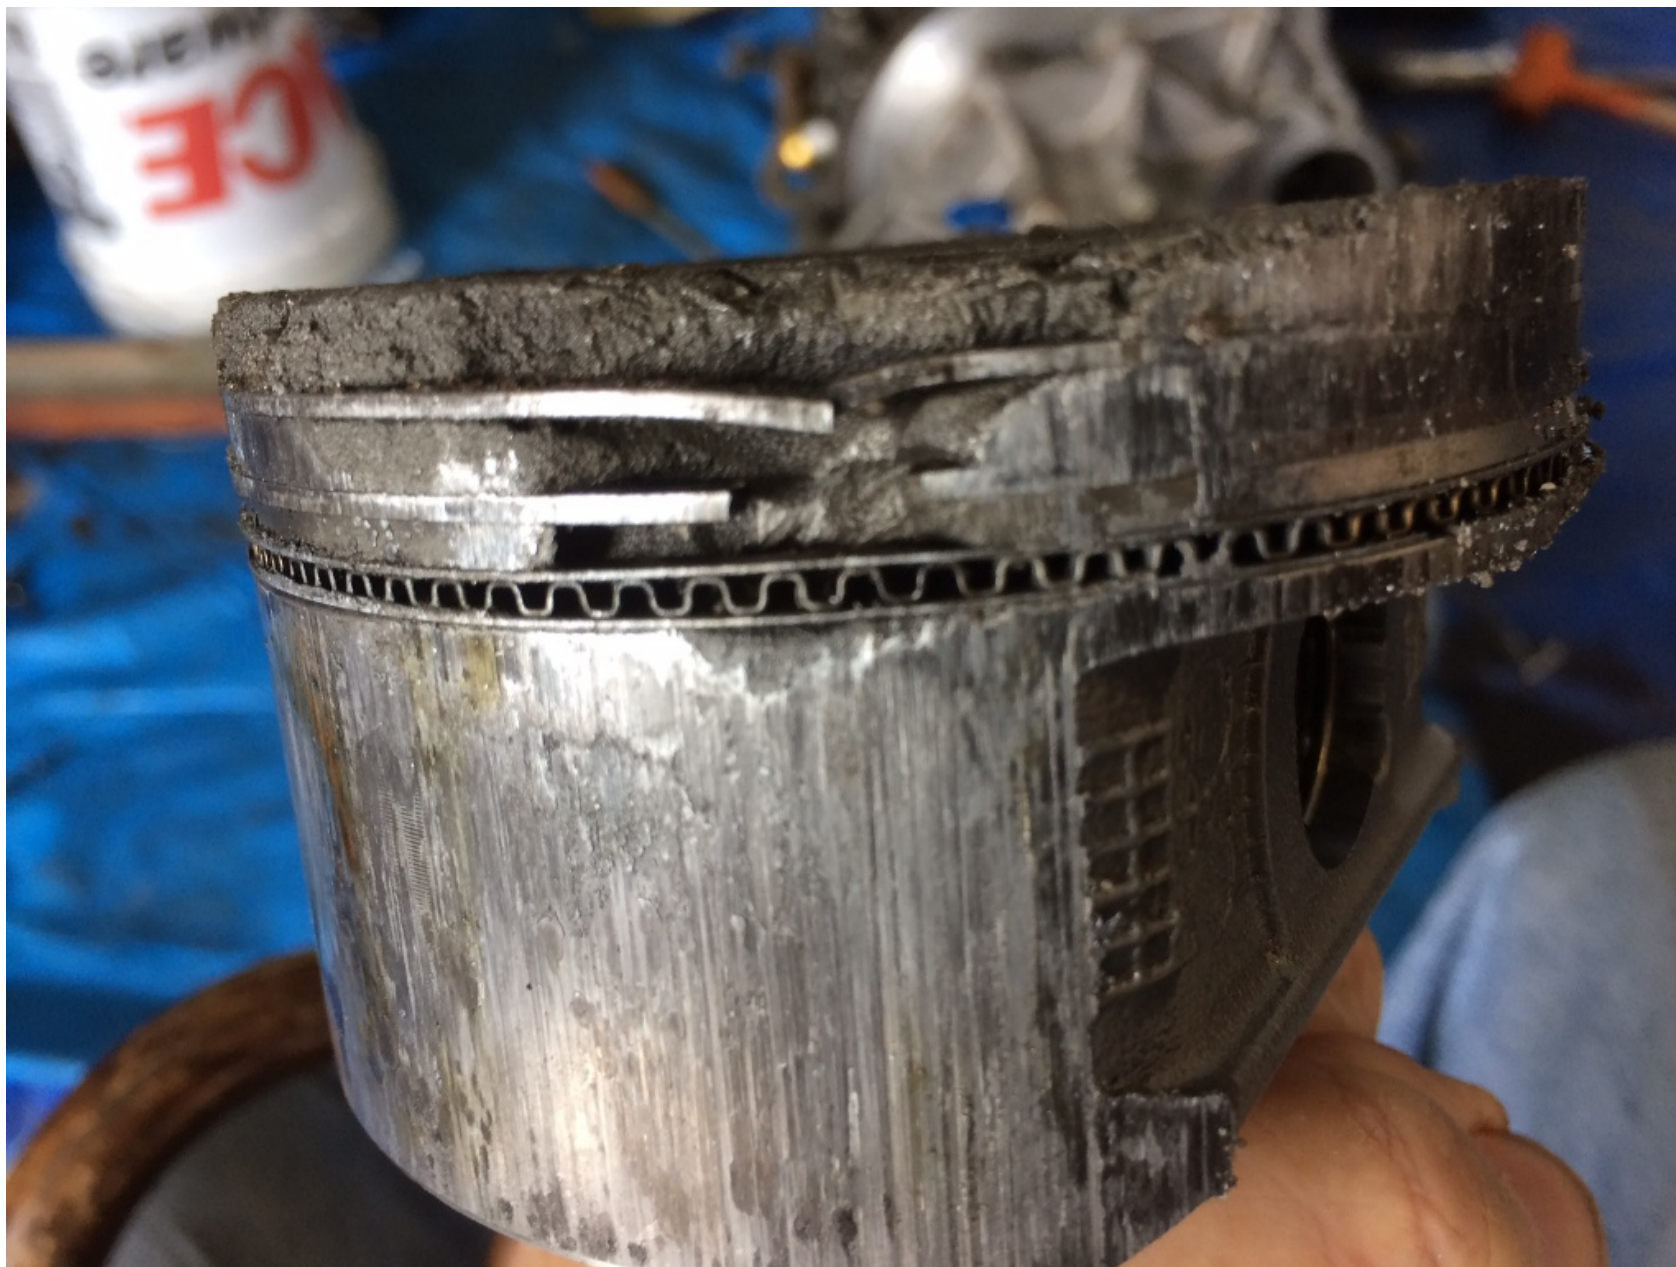
**Photo 4 - Photograph From Owner/Builder. View of the Damaged No. 5 Piston. Note the course Scoring on the Side of the Piston, Missing Section of Piston Crown, and Damaged Piston Ring Lands.**

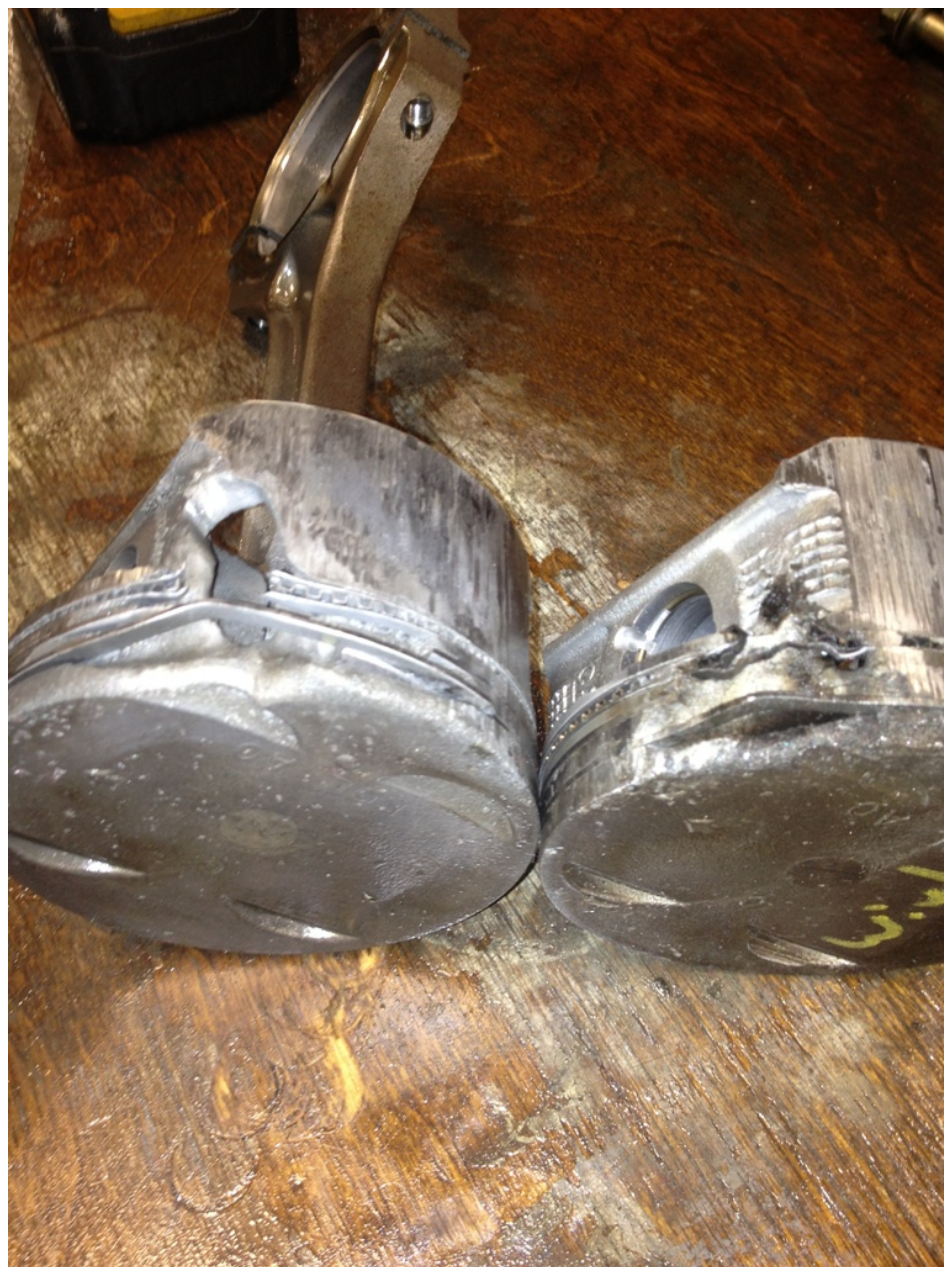
**Photo 5 – Photograph From Owner of Similar Airplane With Same Engine. View Depicting Damage to Pistons. Note Damage to the Ring Lands and also Course Scoring on the Sides of the Pistons.**
