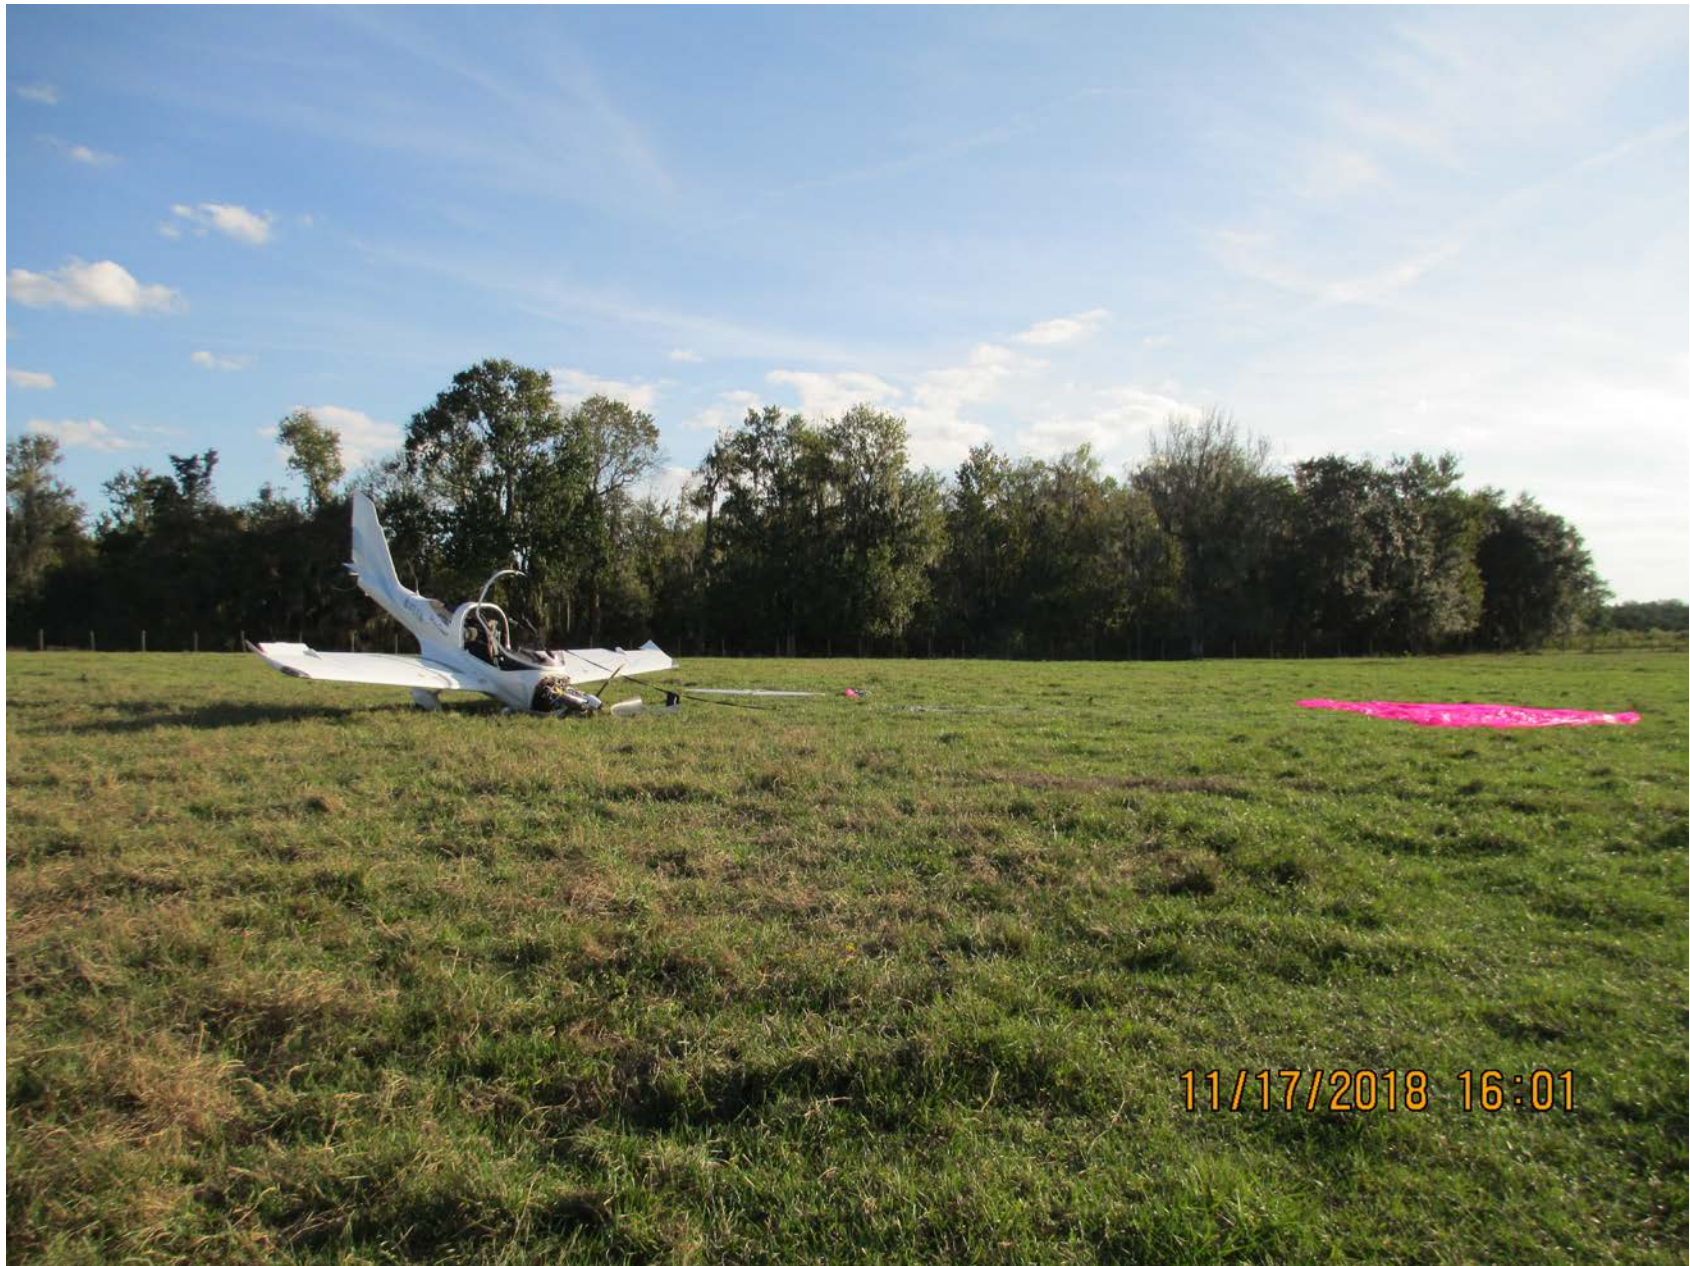
**Photo 1 – View of Airplane with Deployed BRS Parachute in Right Frame (FAA)**

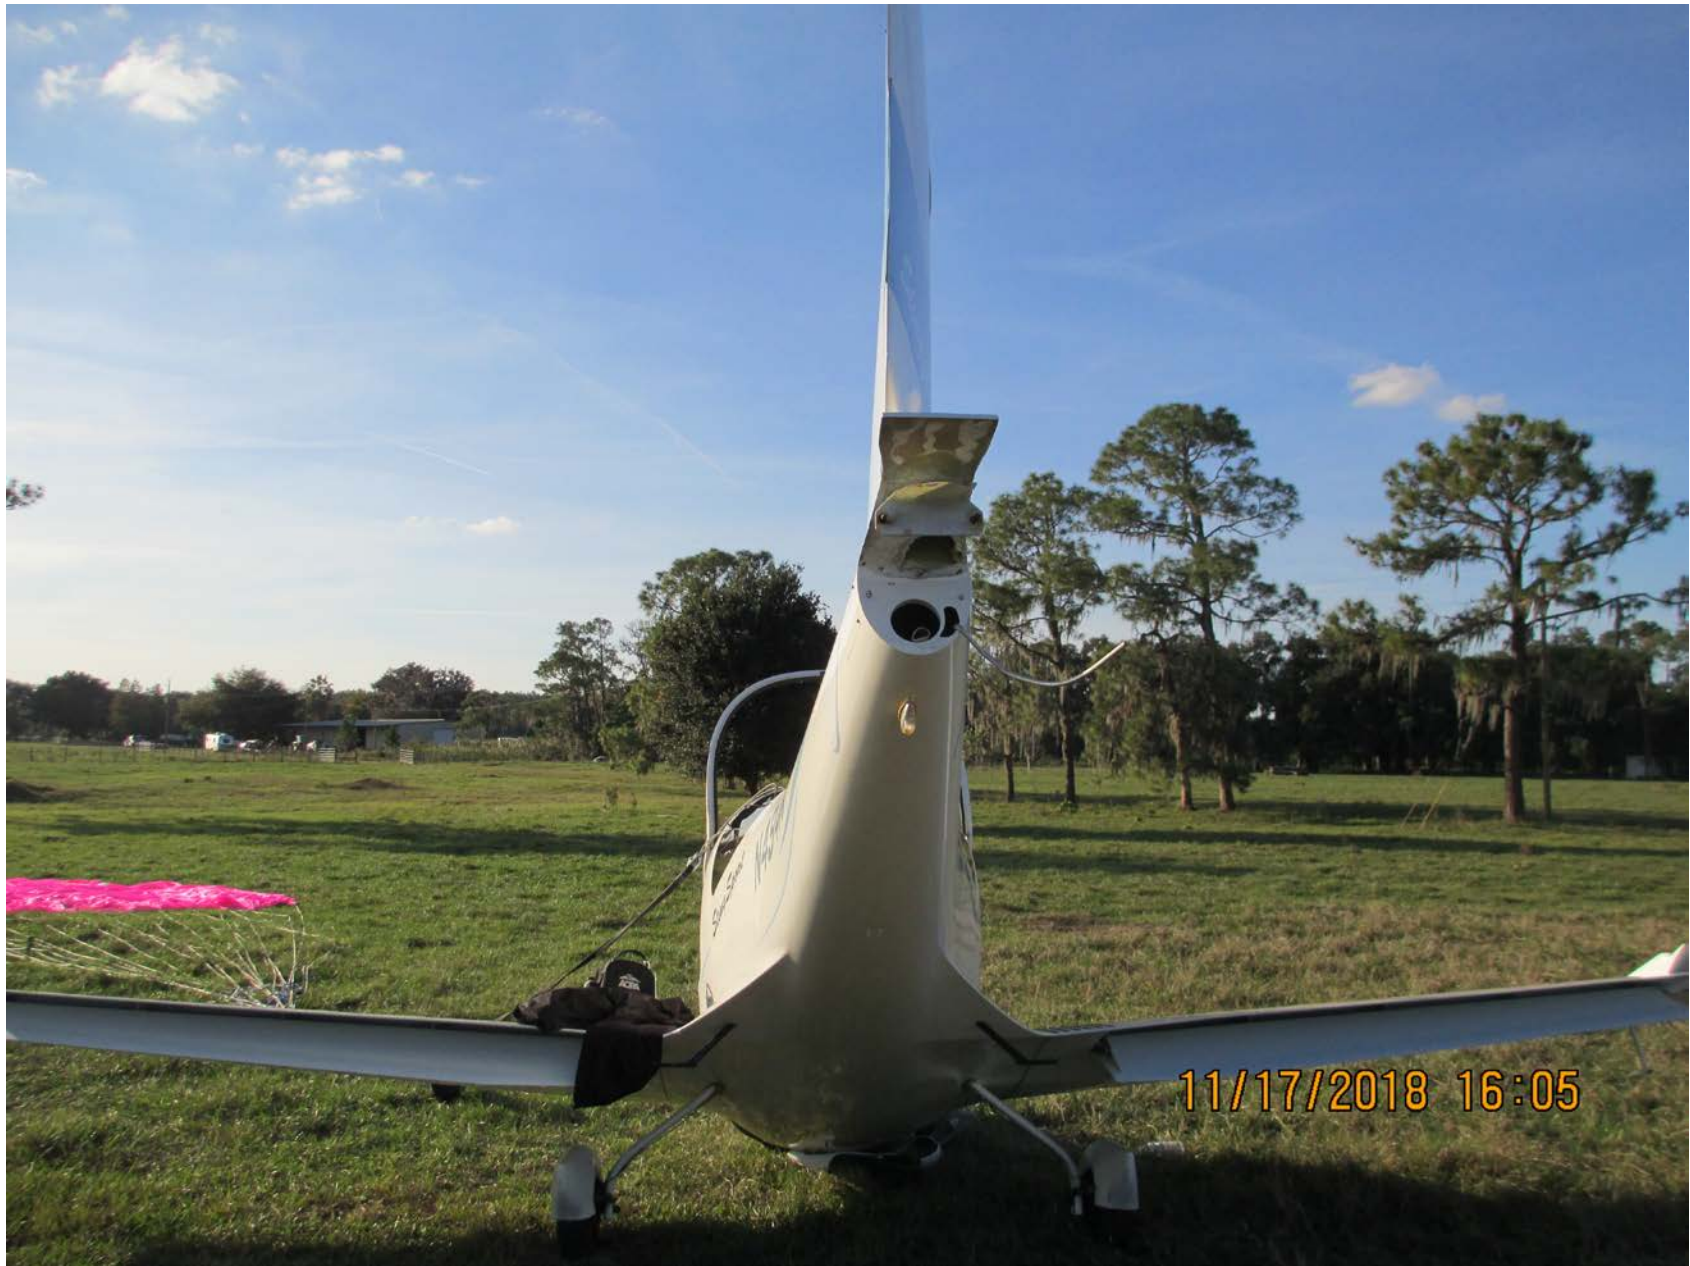
**Photo 2 – View of Fractured Horizontal Stabilizer Mount (FAA)**

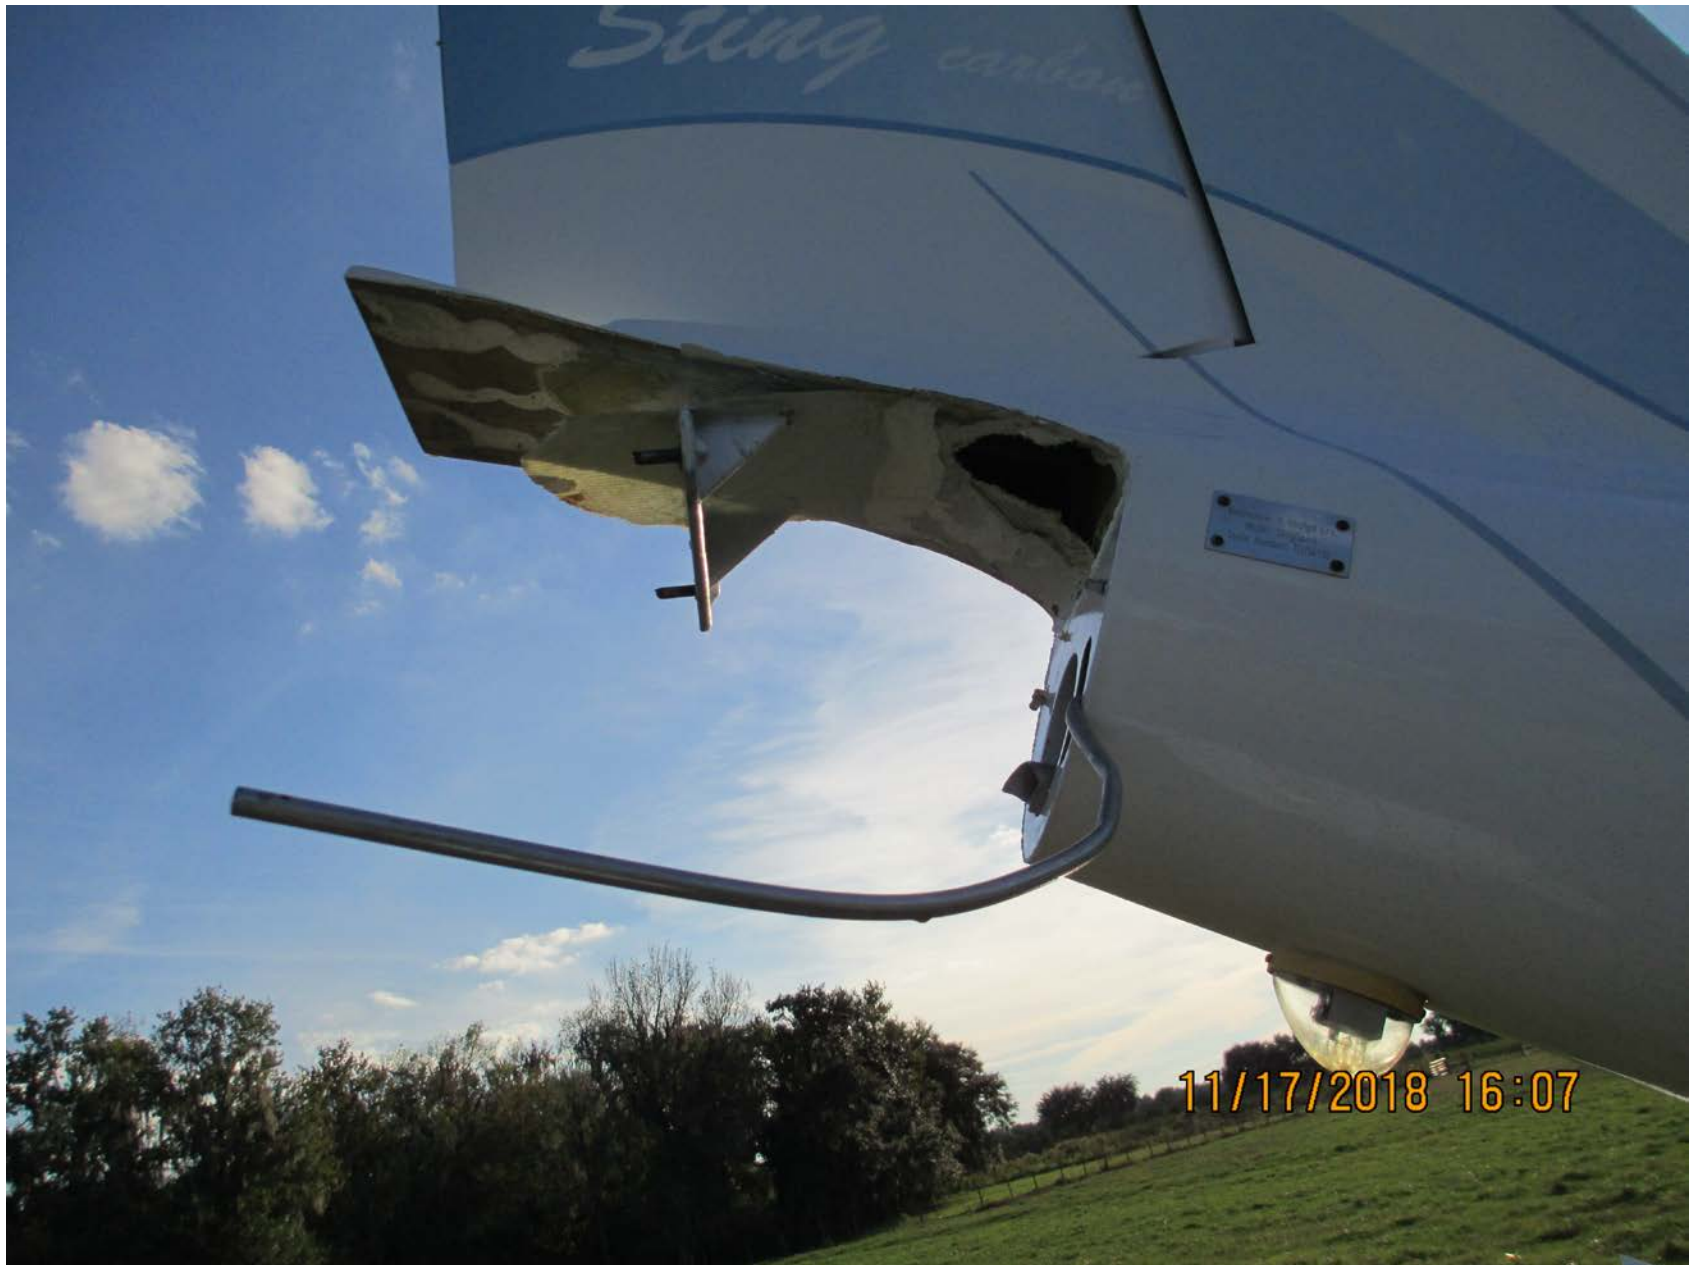
**Photo 3 View of Fiberglass Delamination and Hole in Empennage Tailcone (FAA)-**

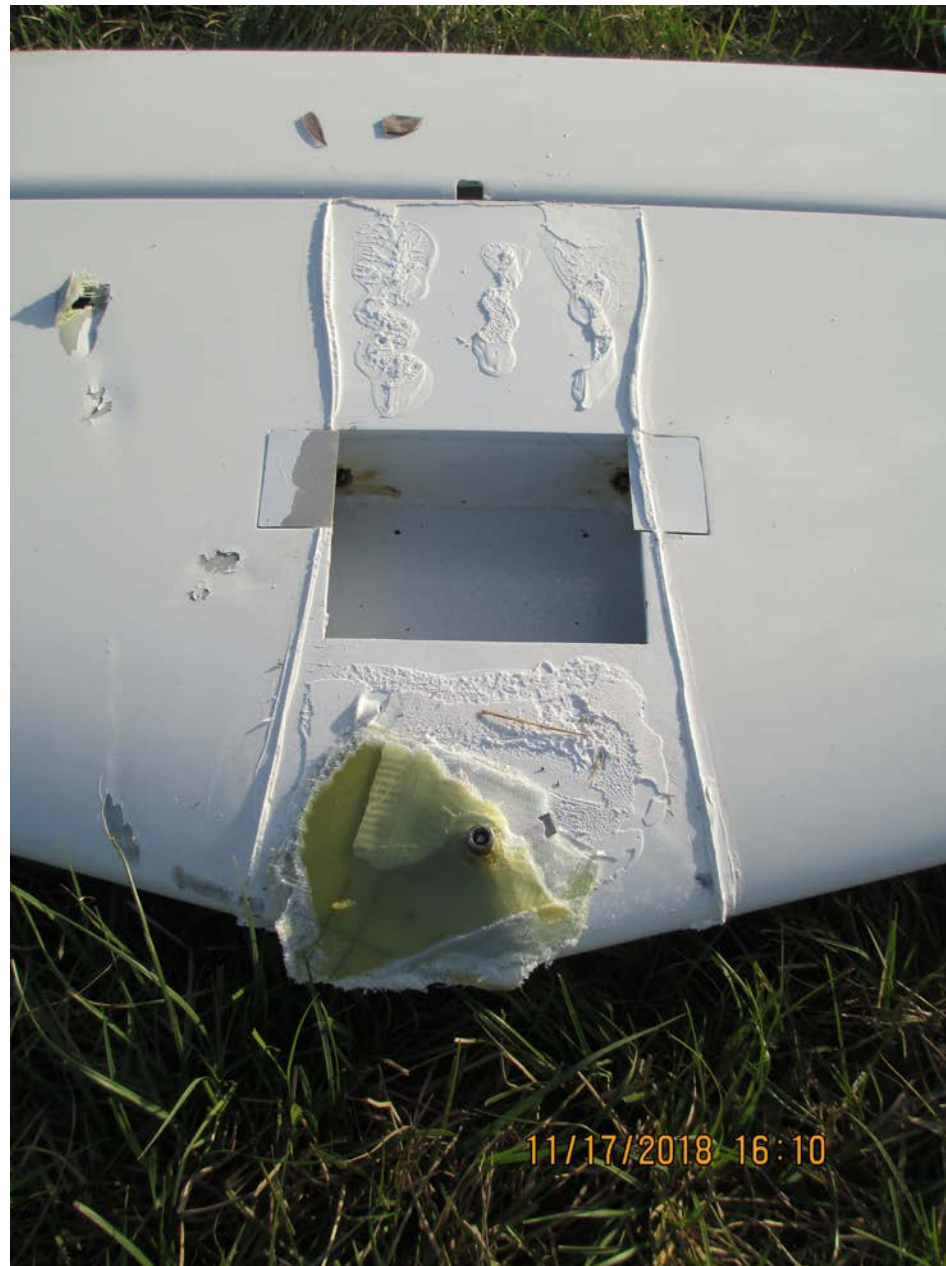
**Photo 4 – View of Separated Horizontal Stabilizer with Fractured Tailcone Structure Attached (FAA)**

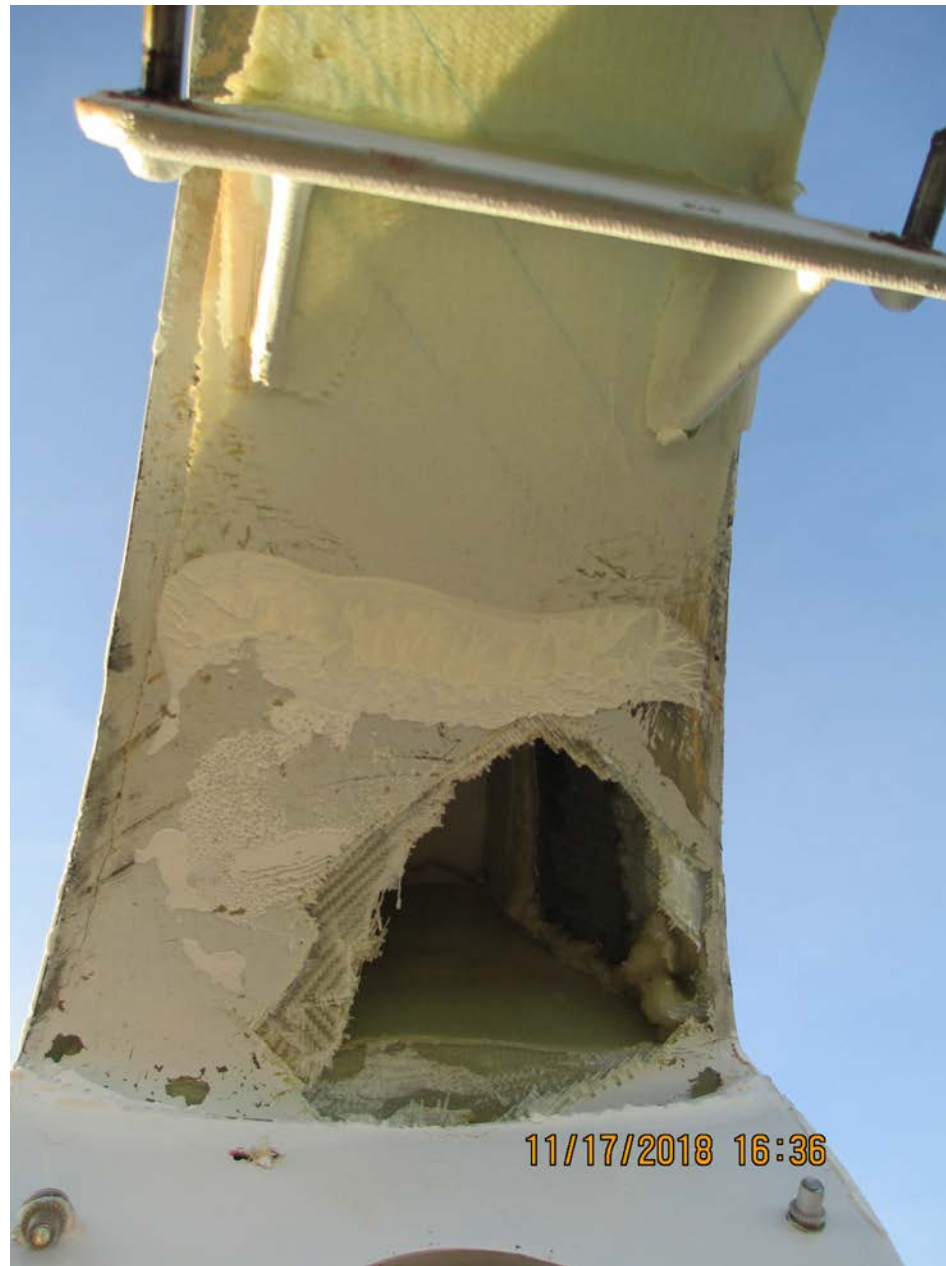
**Photo 5 – View of Fractured/Separated Tailcone Structure (FAA)**
