**NTSB File No. ERA19LA057**  
**Cirrus SR22T, N597CP, Kennesaw, GA 11/29/18**

**Hartzell Engine Technologies**  
**Turbocharger Examination Report**

**Turbocharger Examination**

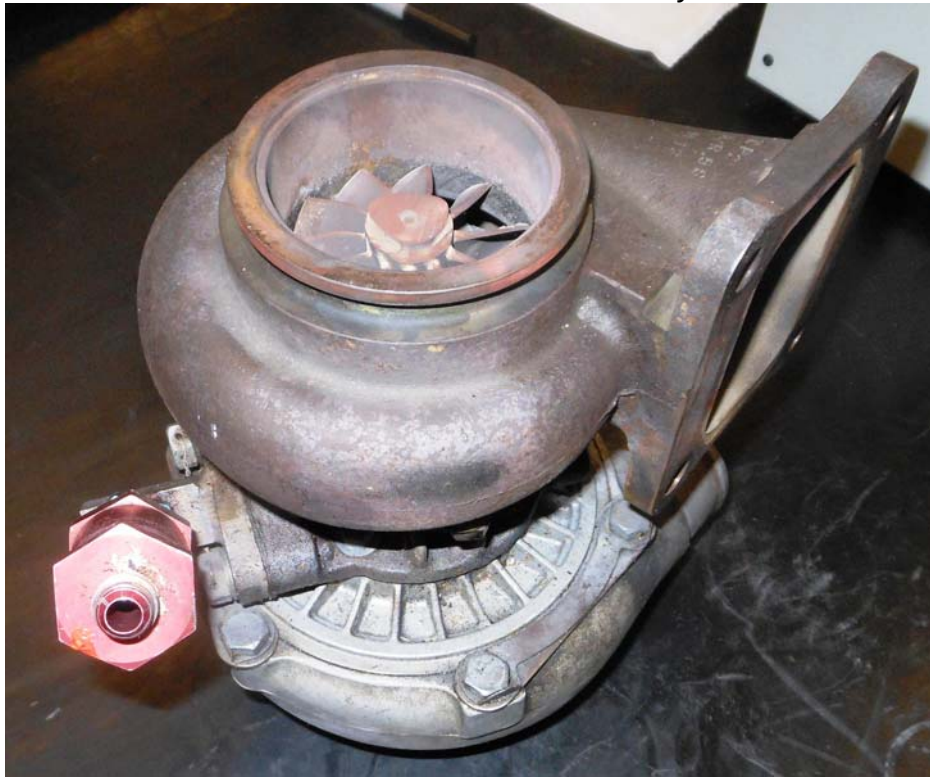
The left turbo assembly as-presented is shown Photo #1. The left turbocharger had no hoses, ducts, or oil lines attached to the turbocharger. There was an “L-shaped” tube fitting attached to the oil drain port with a check valve attached to the fitting as shown in Photo #1. The rotating group could not be turned by finger/hand force.

Photo #1 – Left turbo assembly

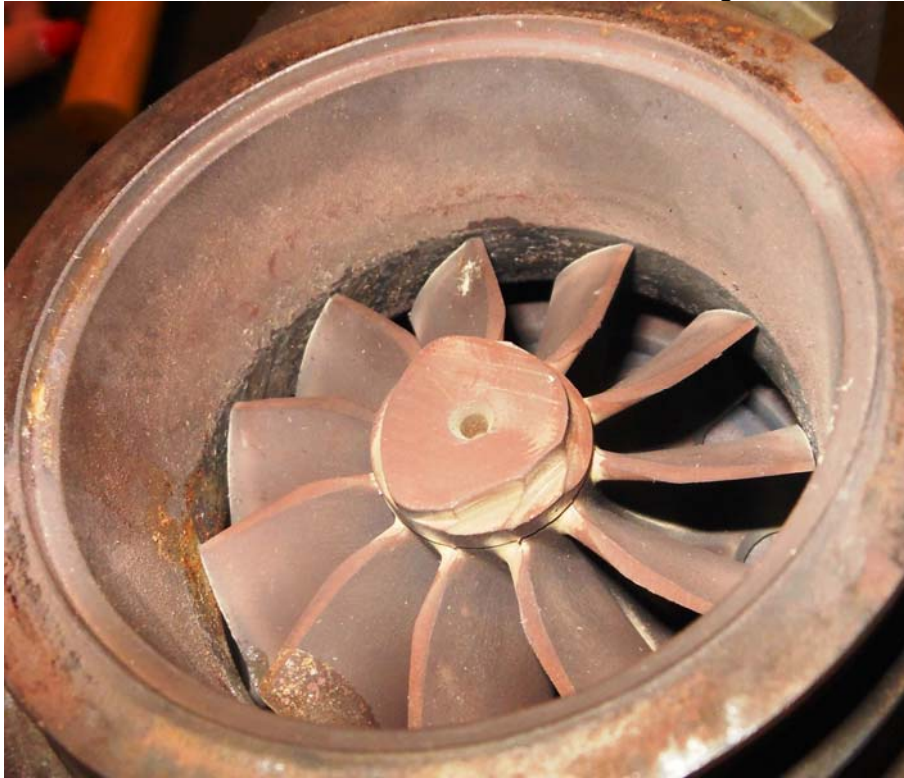
2. There appeared to be positive blade clearance between the turbine wheel blades and housing but evident rub marks in the turbine housing (Photo #2). There was no oil wetting in the turbine exhaust port and no other indications that oil escaped from the center housing into the turbine area. There was no excessive exhaust buildup in the turbine exhaust port.

Photo #2 –Left turbine exit/wheel damage

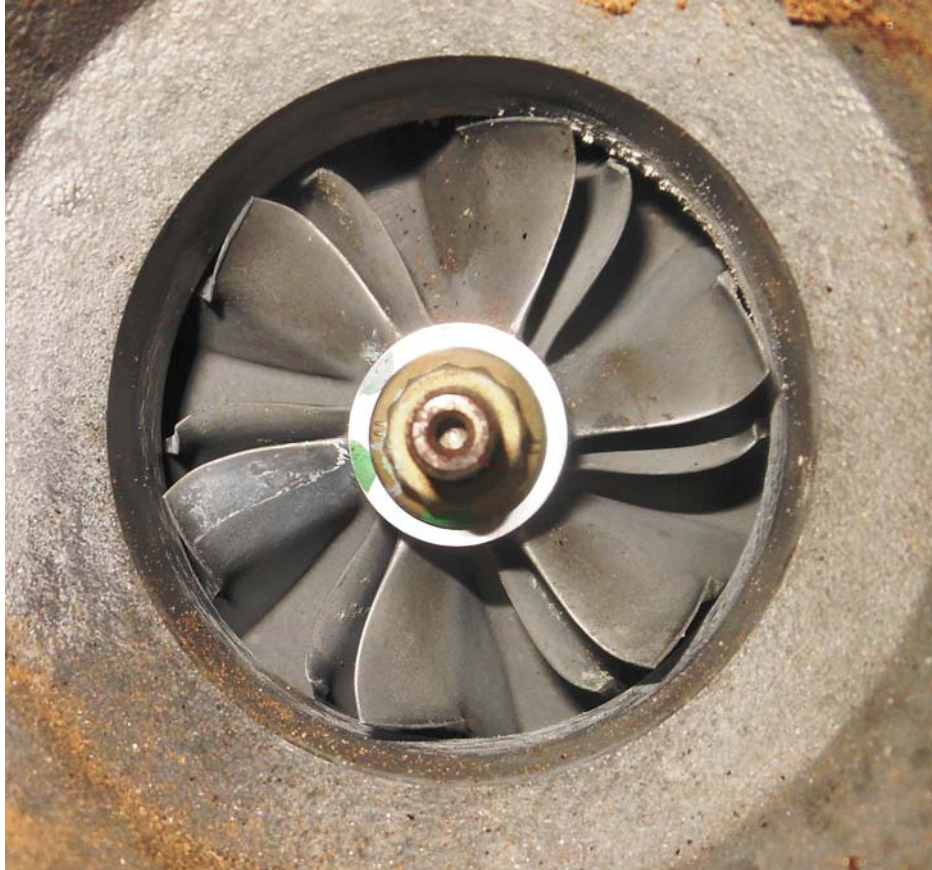
3. There was evident blade contact between the compressor wheel and compressor housing. The compressor wheel appeared displaced to one side with clearance on one side vs. contact on the other (Photo #3). There were evident rub marks on the compressor housing and evident compressor blade damage with deformation opposite rotation (Photo #8). There was no oil wetting in the compressor inlet or discharge ports and no other indications that oil escaped from the center housing into the compressor area.

Photo #3 – Left compressor inlet/wheel damage

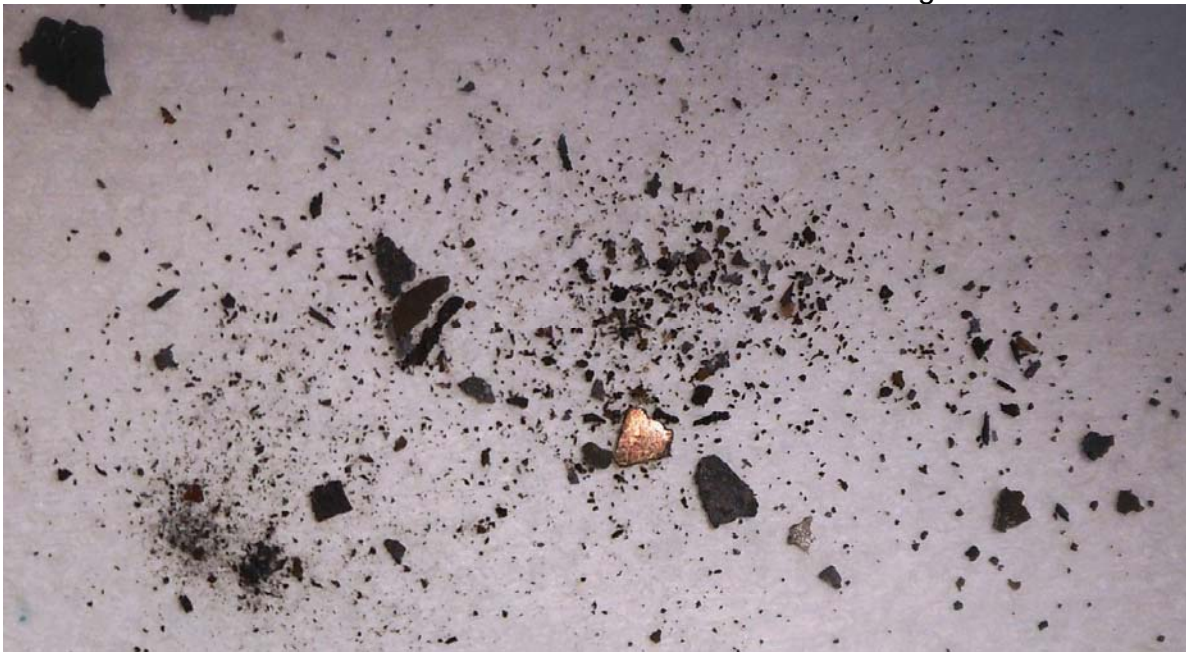
4. After removal of the turbine housing, Foreign Objects (FO) were observed in the volute area of the housing with other miscellaneous small debris. One piece FO appeared to be similar to engine bearing material (Photo #4). There did not appear to be any remarkable Foreign Object Damage (FOD) on the leading edges of either the compressor or turbine blades. Also after removal of the turbine housing, the rotating group (compressor wheel, turbine wheel and shaft) could be rotated together by hand/finger force but with some tactile roughness detectable in the bearings. The rotation by hand was video-recorded and is available in the collection of photos from the examination.

Photo #4 – FOD/debris from left turbine housing

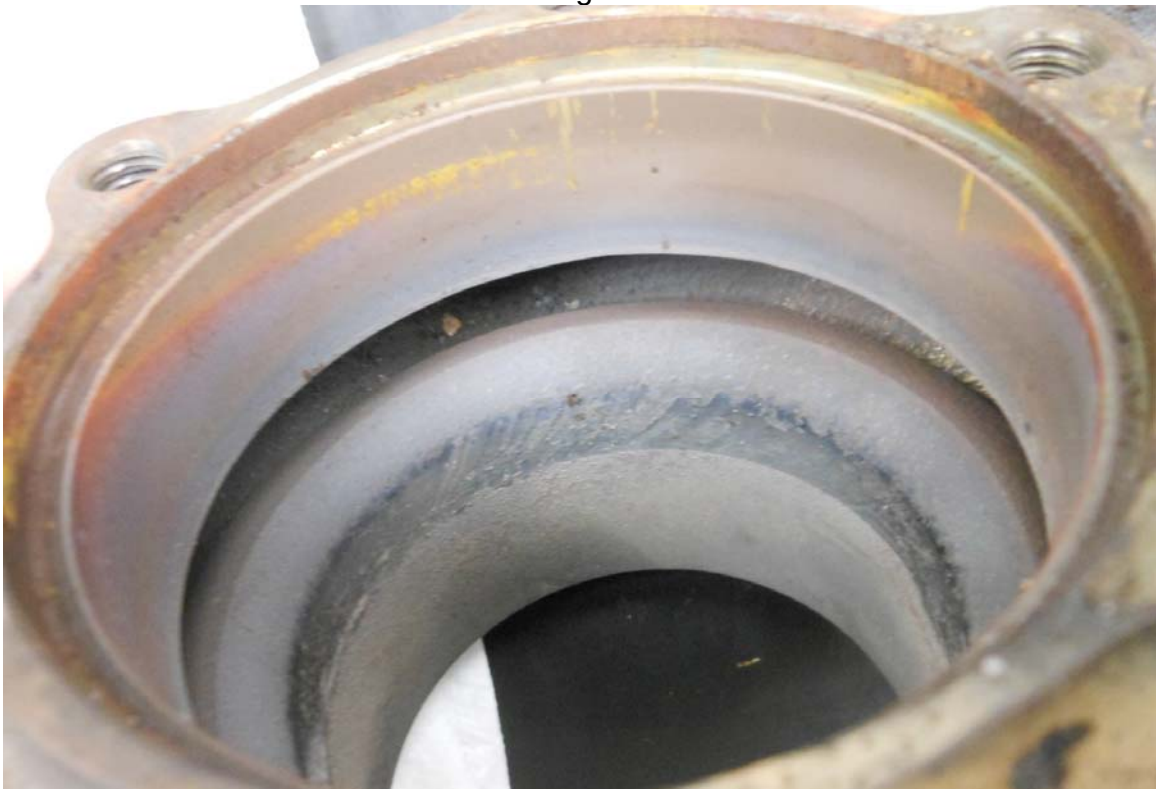
5. The turbine housing exhibited remarkable rub marks (Photo #5) with corresponding blade tip damage on the turbine wheel (Photo #6 and #13) indicating contact while rotating.

Photo #5 – Left turbine housing rub marks and FOD in volute

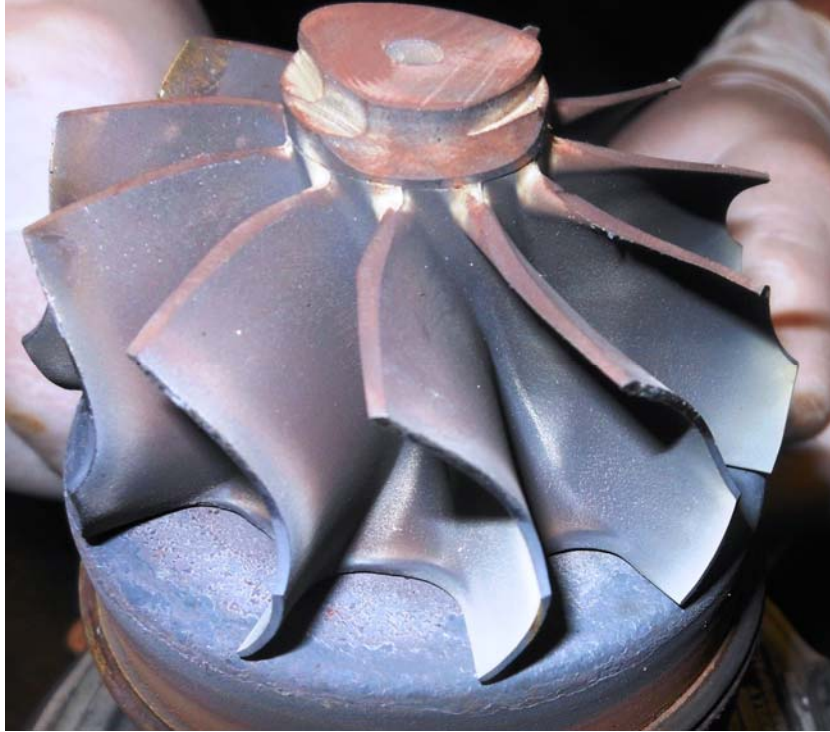
Photo #6 – Left turbine wheel and blade damage

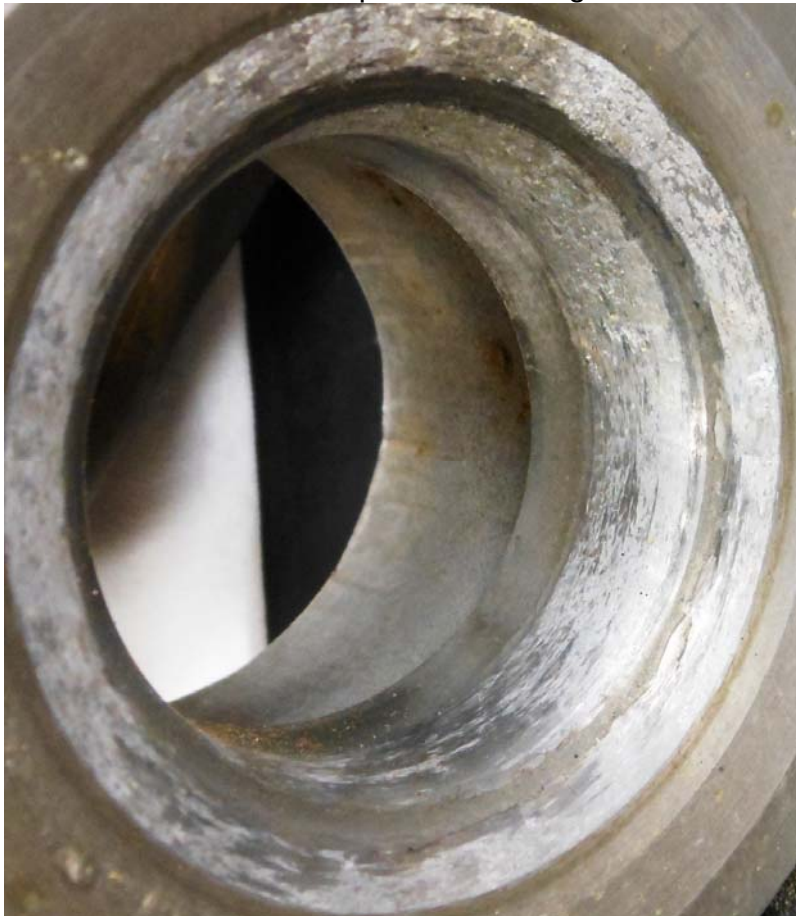
6. The compressor housing was removed and there were remarkable rub marks in two areas of the housing sidewalls (Photo #7). There were also rub/contact marks between the base of the compressor wheel and also the bottom hub area of the wheel and the compressor backplate (Photo #8).

Photo #7 – Left compressor housing rub marks

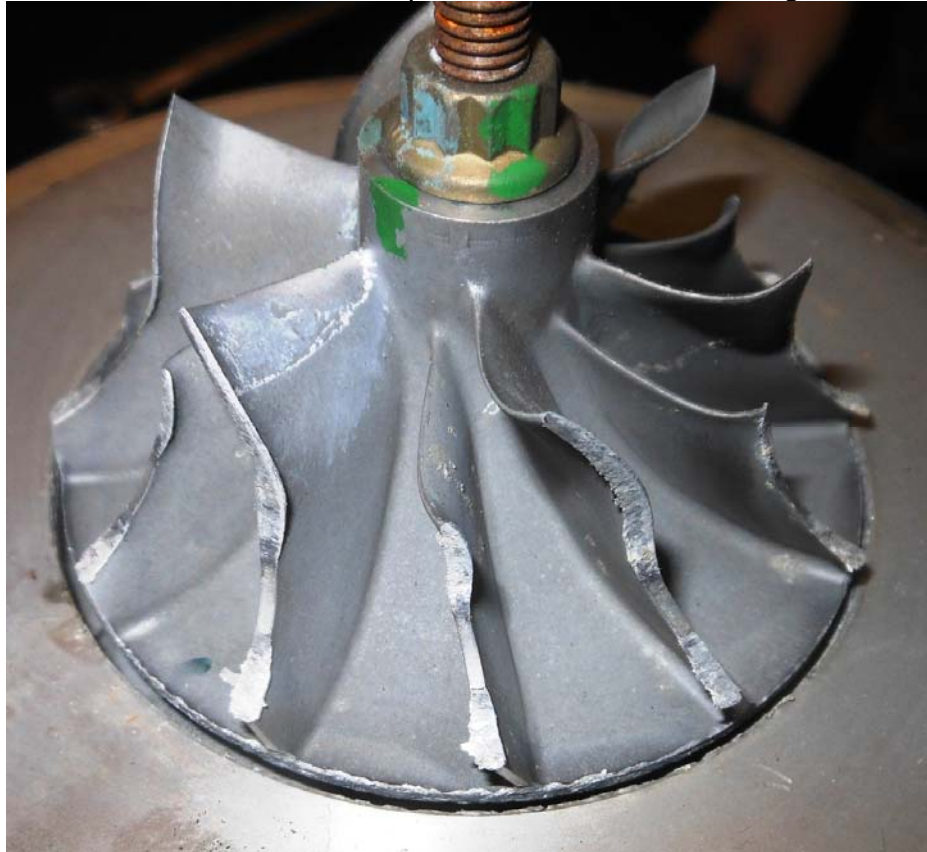
1. The rotor group was frozen/locked in position and could not be turned by finger/hand force. No attempt was made to turn the rotor group with any tools. The compressor wheel nut was present and securely holding the compressor wheel in place but the torque stripes were not aligned (Photo #8). Removal torque of the compressor nut was measured to be 15 in-lbs. Balance cuts were

Photo #8 – Left compressor wheel blade damage

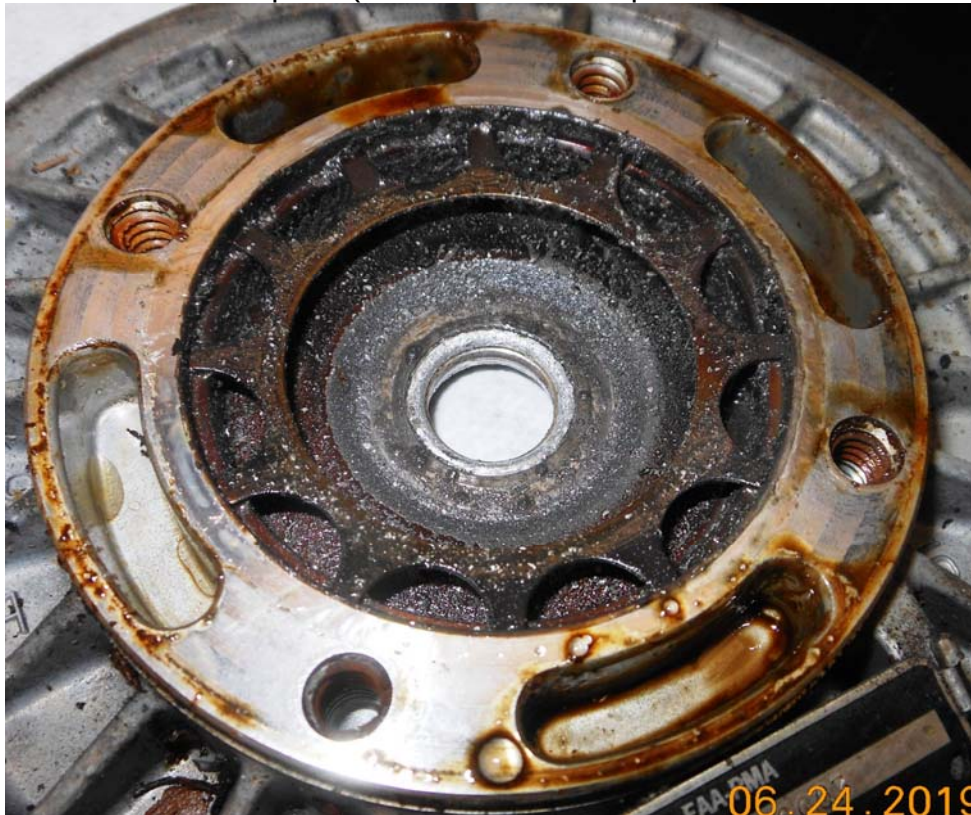
7. There were relatively clean, "fresh" small aluminum particles/dust in the space between compressor backplate and Center Housing (Photo #9). These particles did not appear to have been "flushed" into the drain area of the Center Housing suggesting they formed after oil interruption to the turbocharger.

Photo #9 – Left backplate (area between backplate and Center Housing)

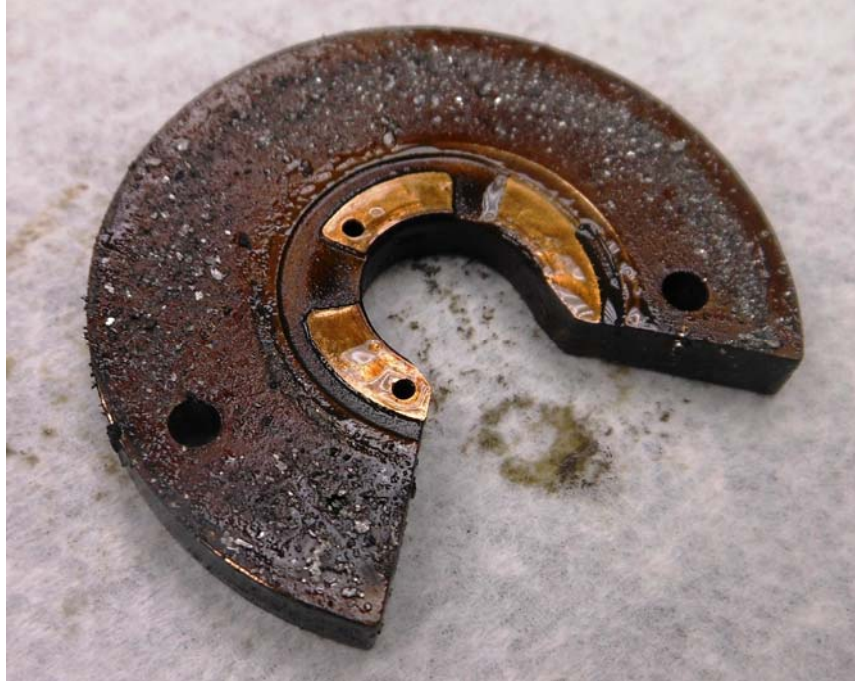
8. The thrust collar and thrust bearing separated from the Center Housing during the compressor backplate removal and were then removed from the backplate. The piston ring on the thrust collar was intact and free in the ring groove. The thrust bearing had similar small aluminum particles on the side of backplate and some residual oil on both sides (Photo #10). A small lip on the backplate that engages with the thrust collar was fractured, fretted and likely the source of these aluminum particles. Remnants of the fractured lip were lodged in the thrust collar.

Photo #10 – Left thrust bearing with residual oil and aluminum particles

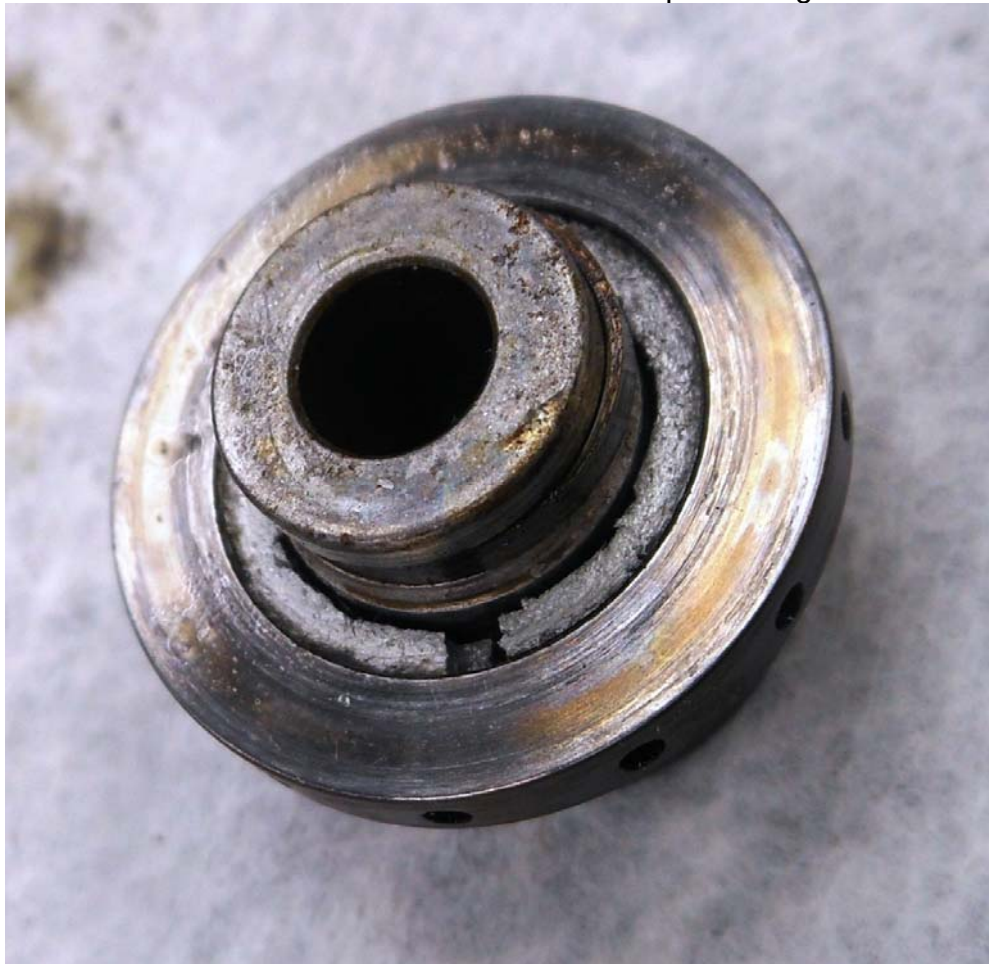
(Photo #11). There were small, but evident rotational score marks on both sides of the thrust bearing as well as the thrust collar.

Photo #11 – Left thrust collar and piston ring

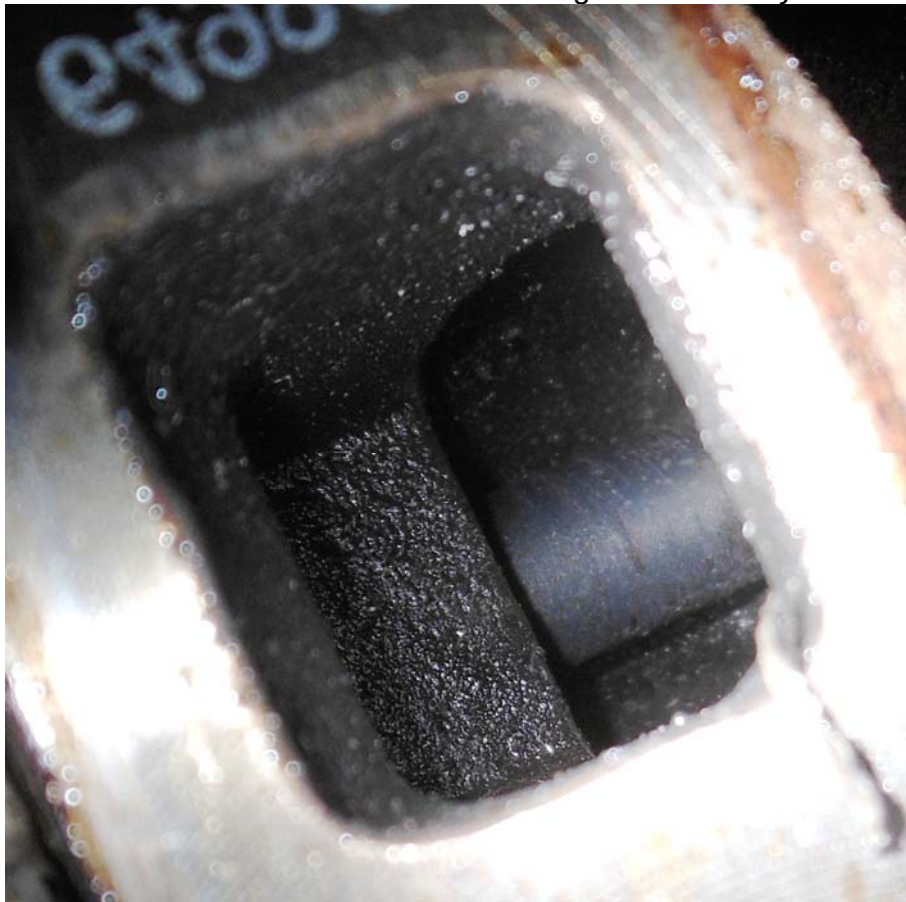
9. The "L fitting" was removed from the drain port of Center Housing. The Center Housing internal cavity was observed through this oil drain port. The internal Center Housing walls appeared wet with oil. The rotating group shaft appeared black in color and dry, not wet with oil. Despite the shaft appearing black in color, there was no indication of long-term, excessive coking or indication of excessive heat (Photo #12). The oil galleys in the Center Housing appeared open with no restrictions.

Photo #12 – Left Center Housing internal cavity

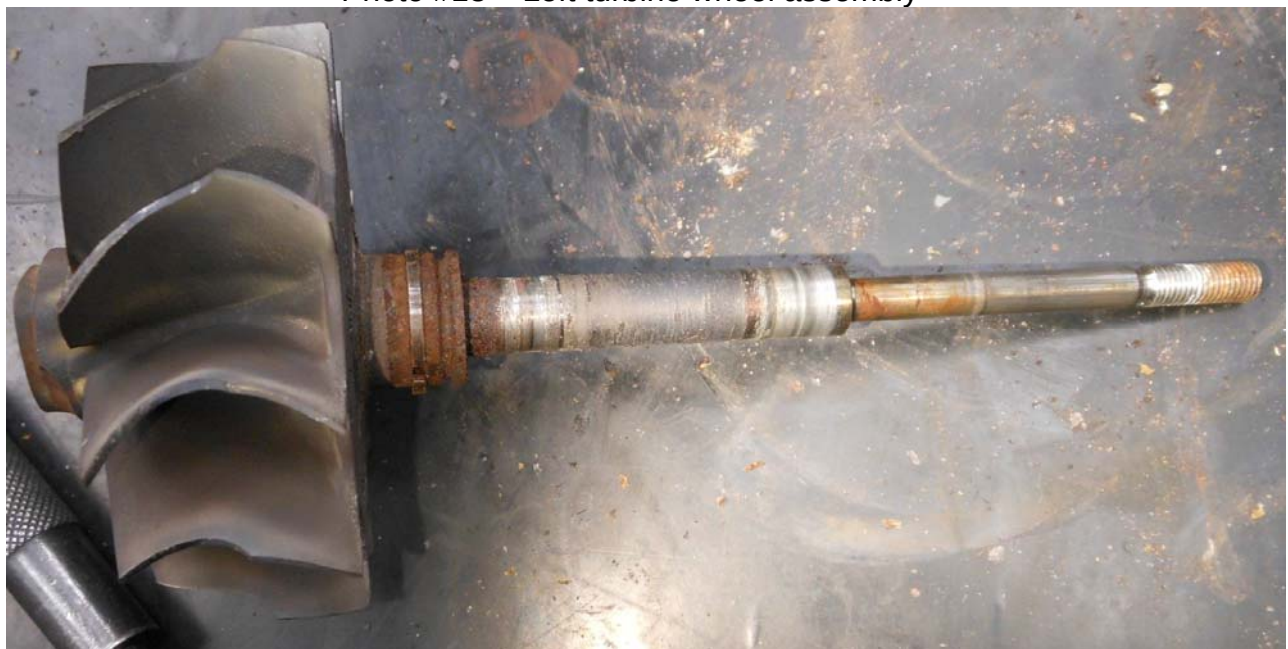
10. The shaft could not be removed from the assembly by hand force and had to be pressed through the compressor wheel and Center Housing for removal. The bearing journals on the shaft had rotational scoring marks and bearing material transfer signatures on both the turbine end and compressor ends (Photos #13 through #15). The piston ring on the turbine end was free to move in the groove.

Photo #13 – Left turbine wheel assembly

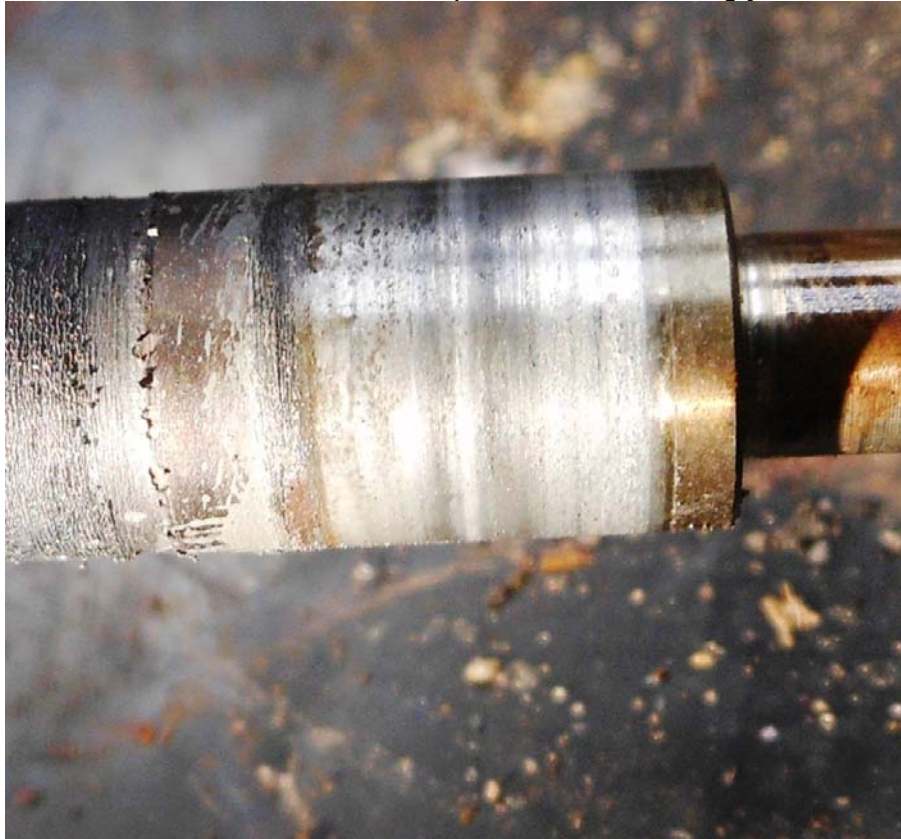
Photo #14 – Left shaft compressor-end bearing journal

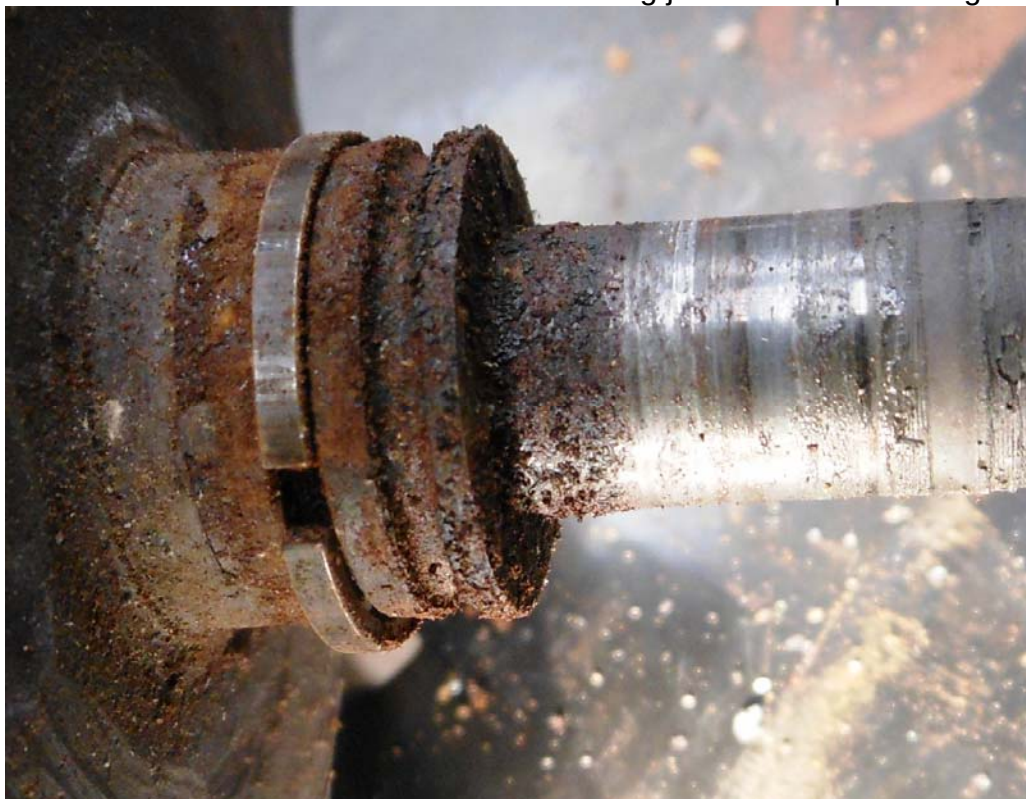
Photo #15 – Left shaft turbine-end bearing journal and piston ring

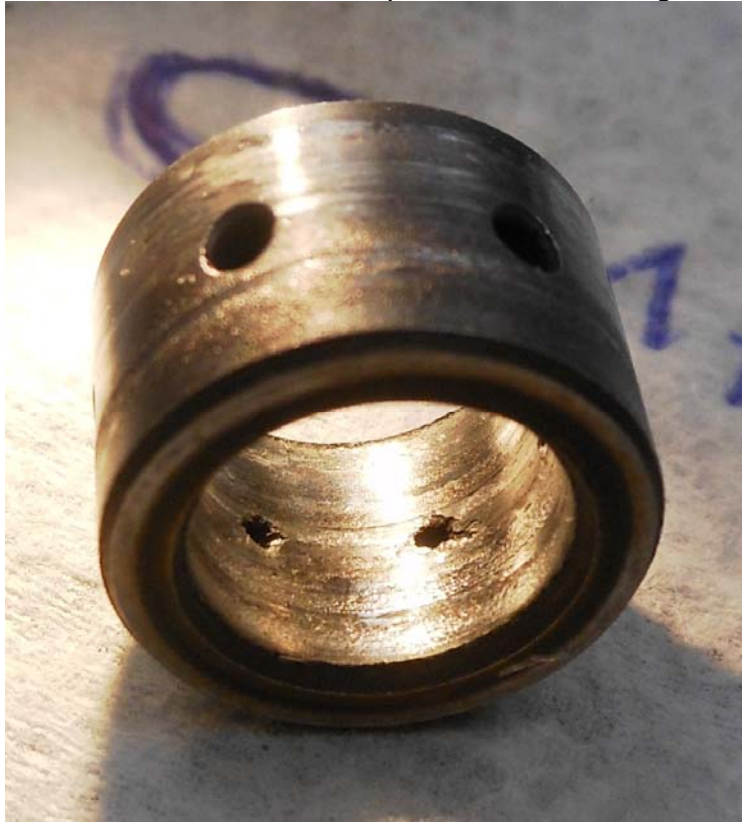
11. Both the turbine end and compressor end bearings had some residual oil coating when initially removed. Both bearings also rotational score marks on the OD and ID surfaces. The radial holes appeared mostly clear but there was evidence of rotational galling and bearing material wiping that partially closed some holes (Photos #16 and #17).

Photo #16 – Left compressor-end bearing

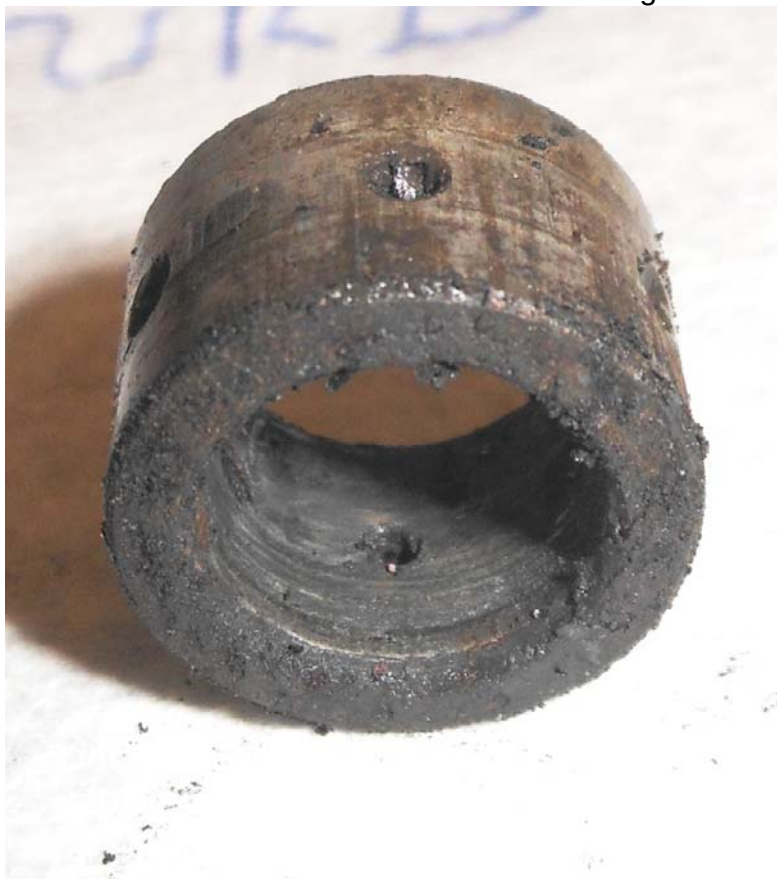
Photo #17 – Left turbine-end bearing
