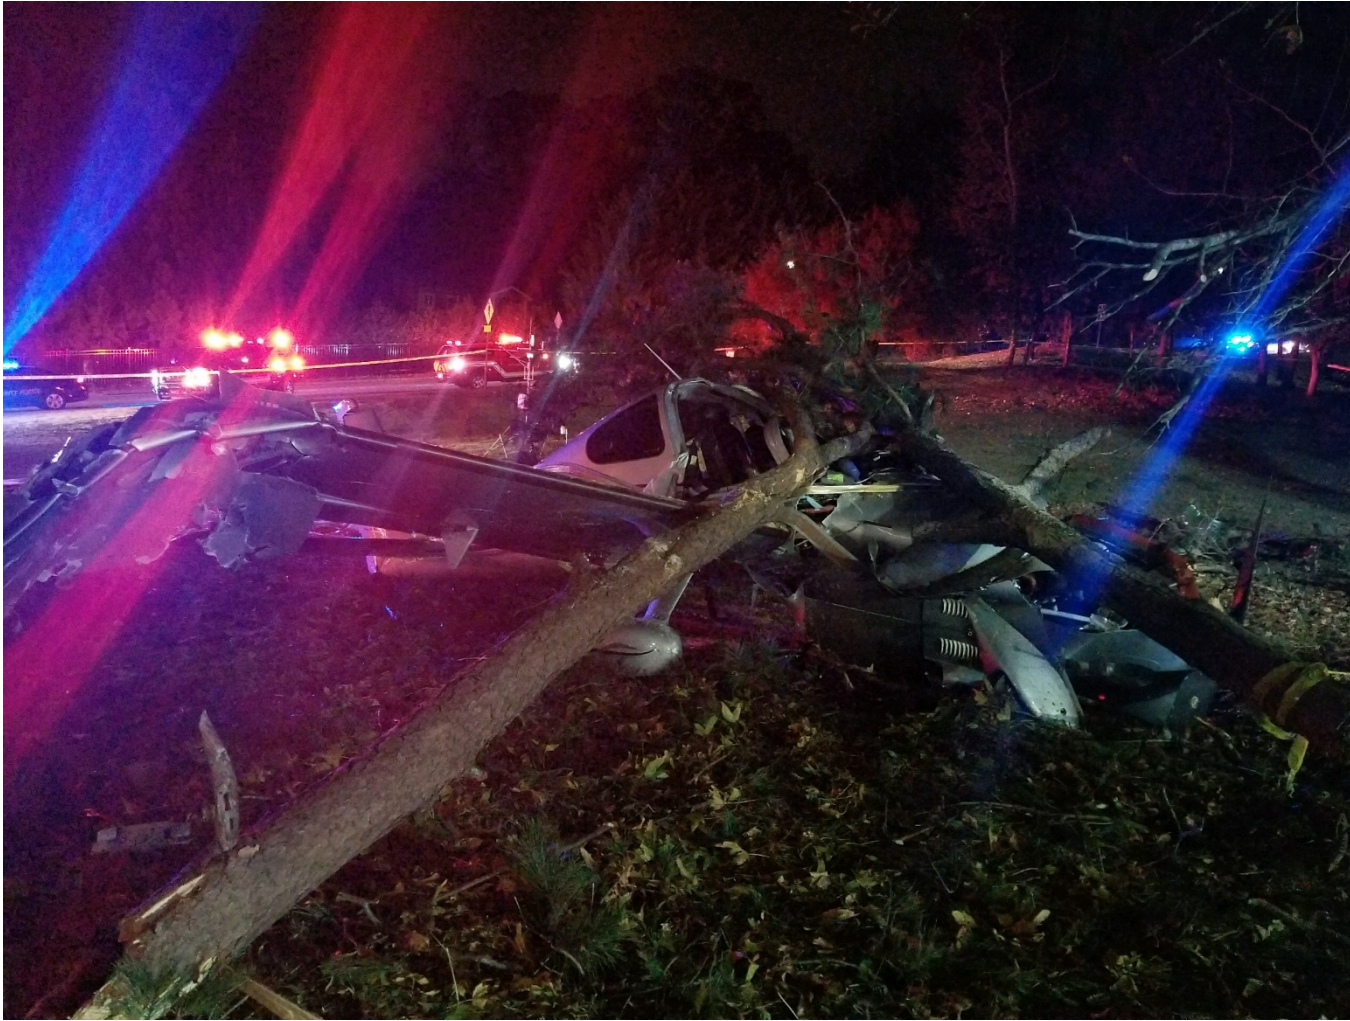
**Photo 1 – Right Side of Fuselage at the Accident Site (Photo Courtesy of FAA)**

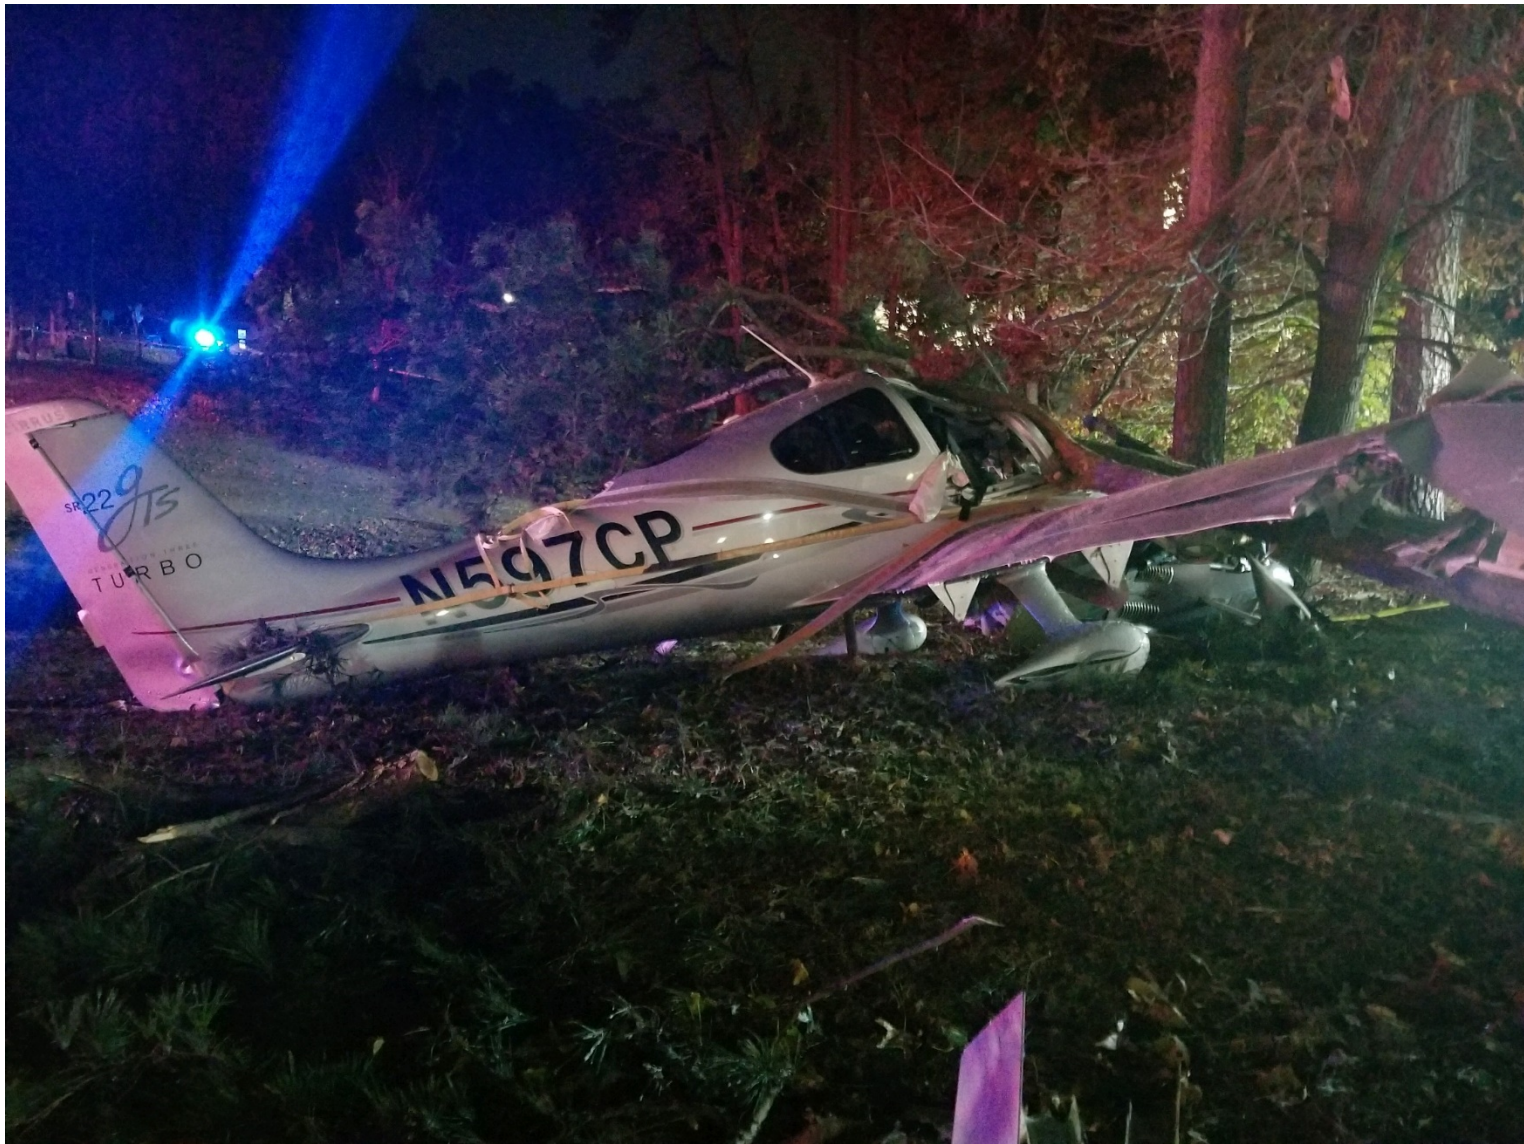
**Photo 2 - Right Side of Fuselage (Photo Courtesy of FAA)**

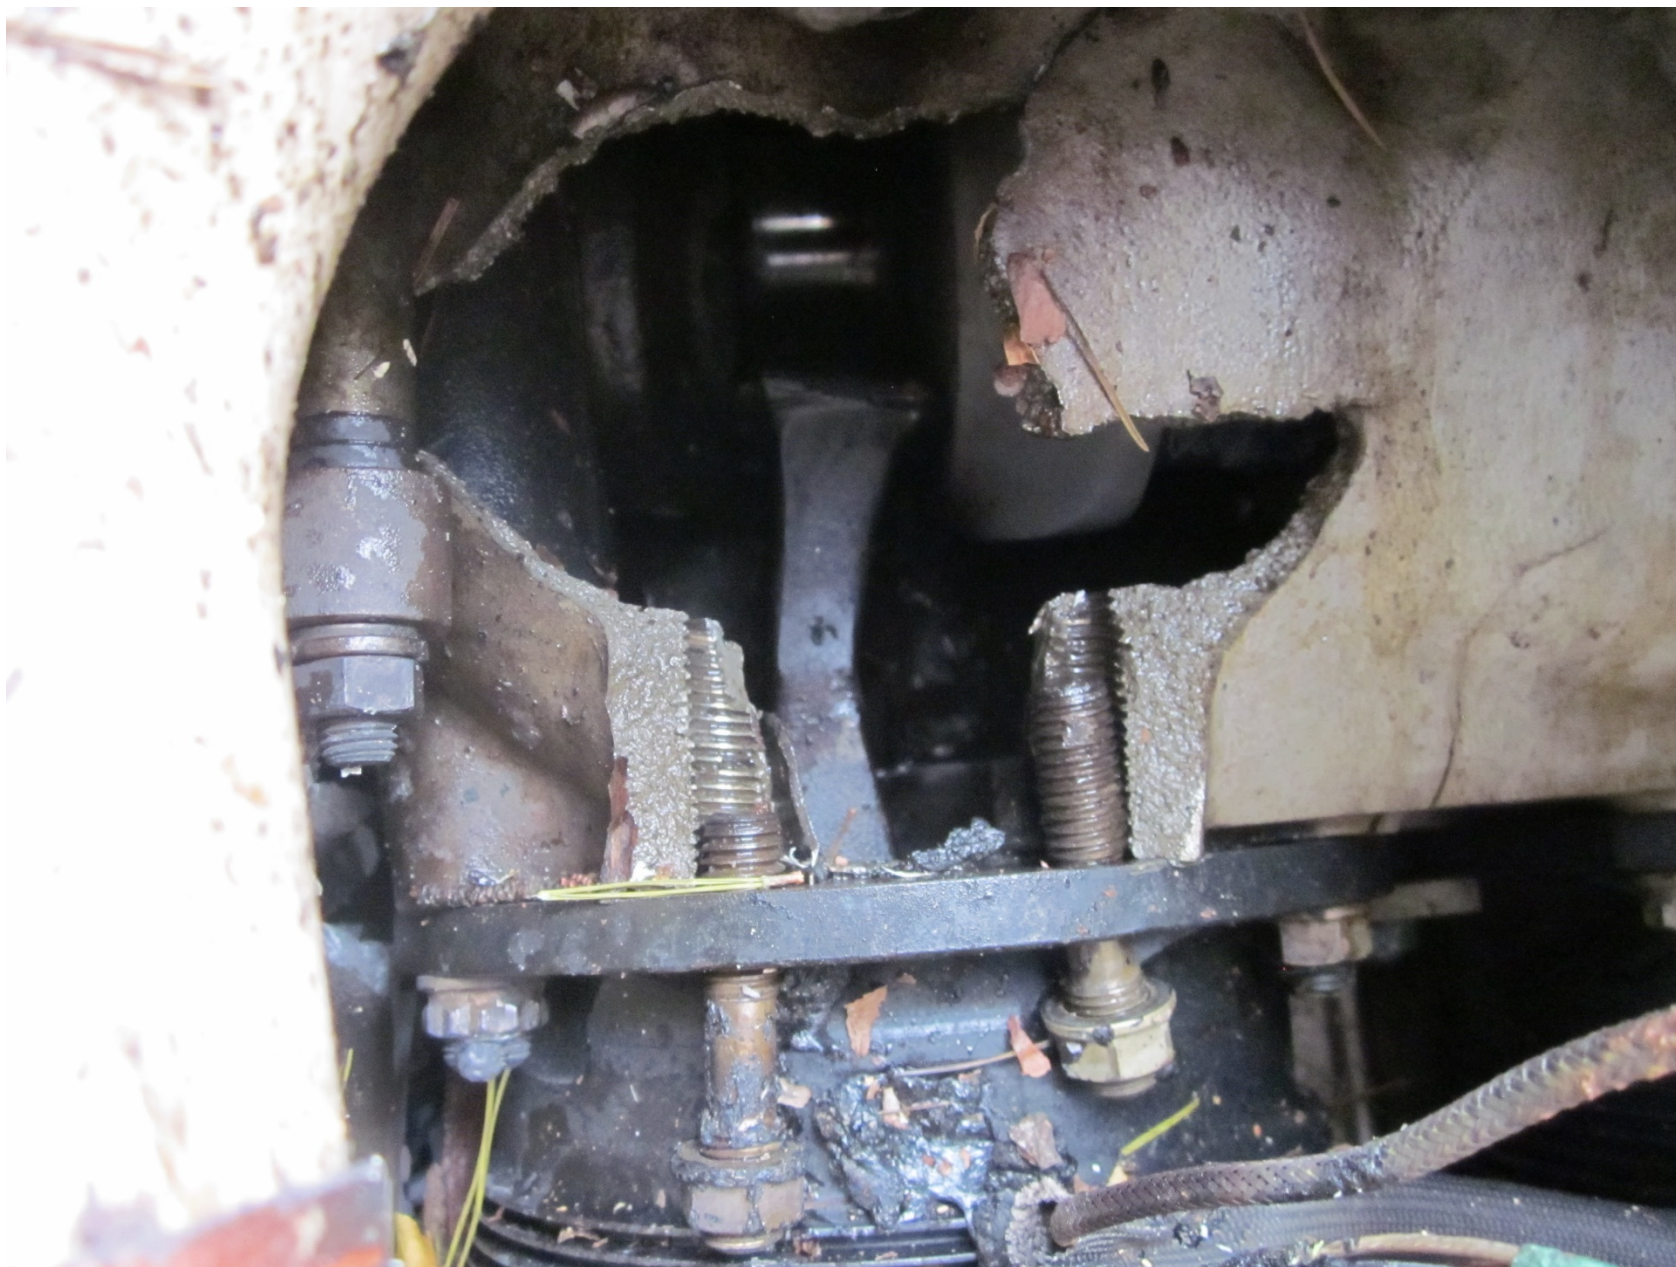
**Photo 3 – Puncture of Engine Crankcase at the No. 6 Cylinder, as Viewed at the Accident Site (Photo Courtesy of FAA)**
