**Number:** SB 2X-31-05 R2

**SNS SUBJECT:** 31-30 RECORDERS - Recoverable Data Module Replacement

Cirrus Design SR22 Serials 3026 thru 3368 w/ Perspective Avionics.

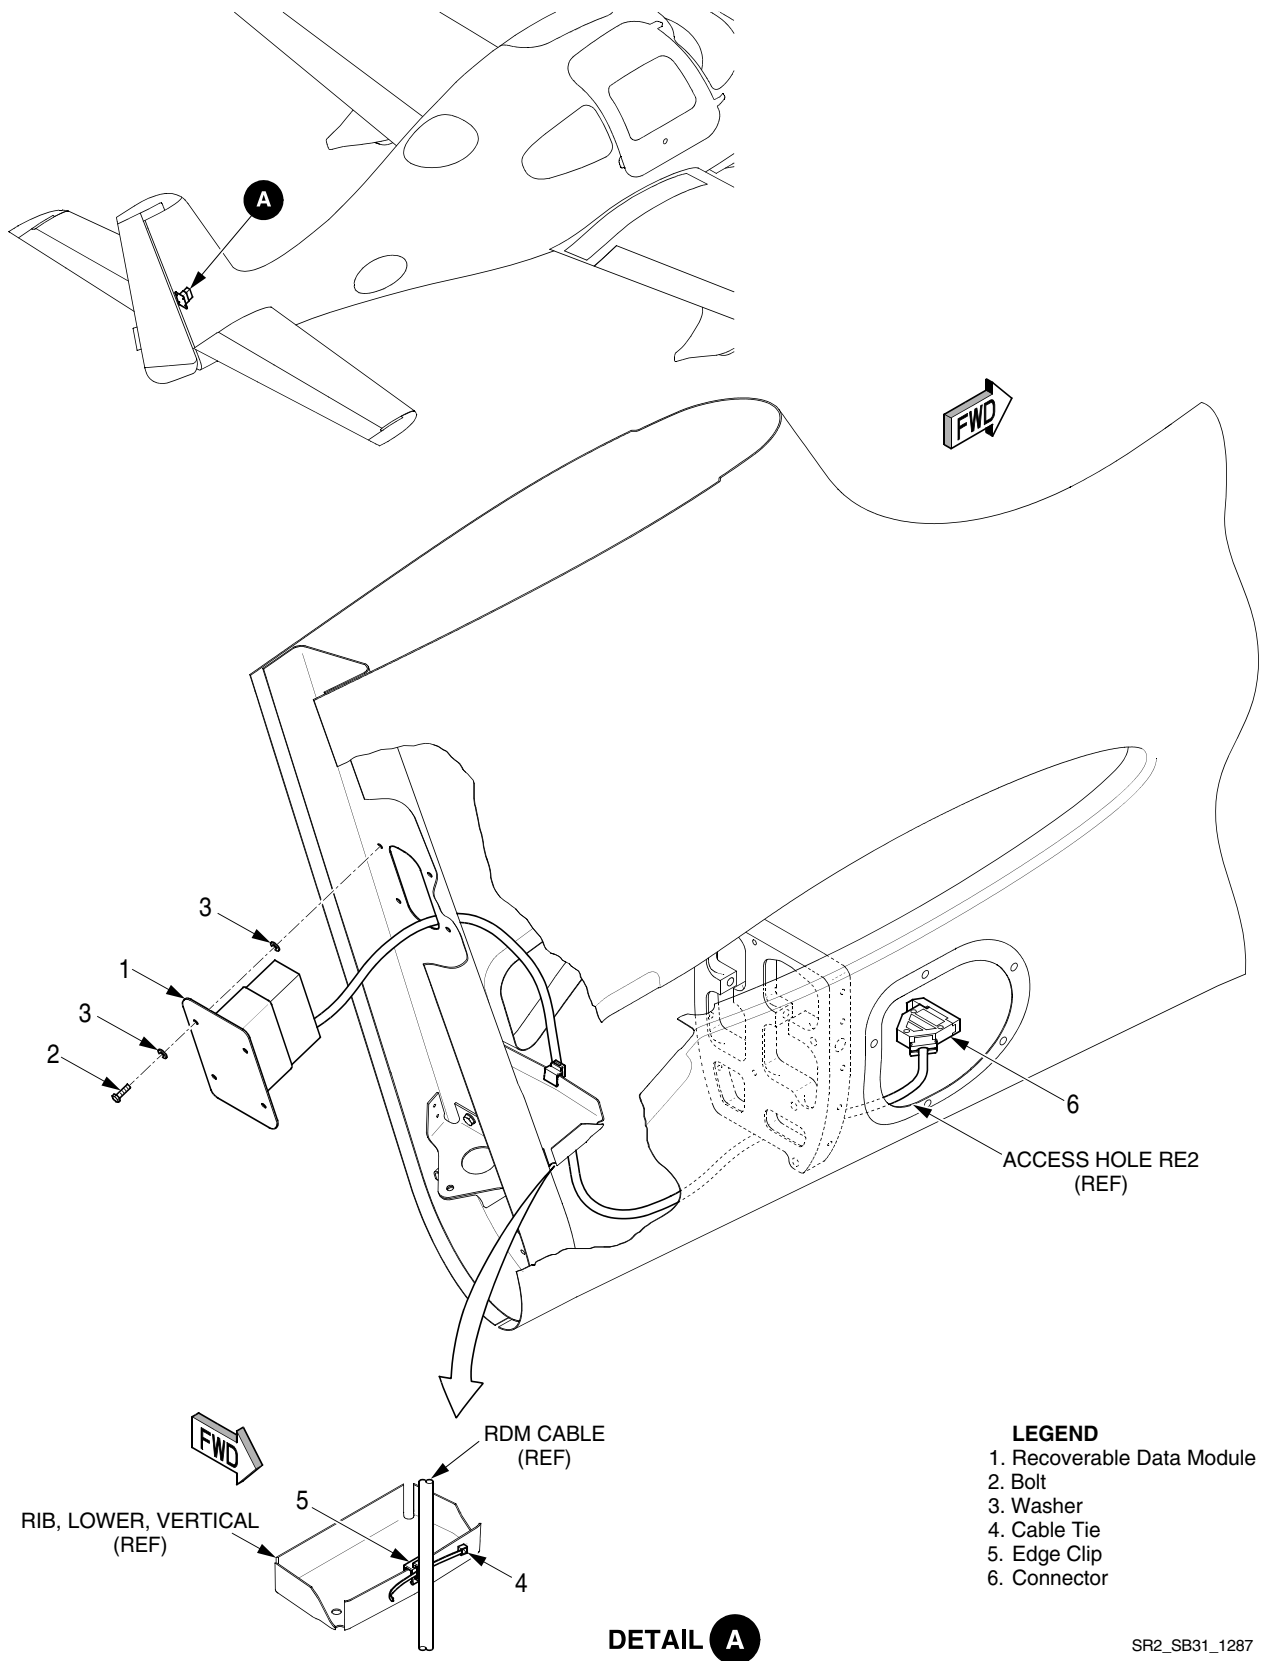
**Figure 1**  
**Recoverable Data Module Installation**

Cirrus Design recently discovered a condition on aircraft with Perspective Avionics where the Aircraft Data Logger (ADL) fails to store data correctly. Upon investigation, it was determined that the condition is caused by the Recoverable Data Module (RDM) internal software. To correct this condition, the affected RDM must be replaced with an RDM with improved software.

- (1) Remove cable ties securing RDM cable to empennage.
- (2) Disconnect RDM connector from wire harness.
- (3) Remove screws and washers securing RDM to empennage. Remove RDM from airplane.
- H. Package removed RDM and ship to Heads Up Technologies to receive a replacement RDM.
- I. Install replacement RDM.
  - (1) Position RDM to empennage and secure with screws and washers.
  - (2) Connect RDM connector to wire harness.

**WARNING:** Verify no interference exists between RDM cable and flight controls.

- (3) Install cable ties securing RDM cable to empennage.
- (4) If disconnected during removal, connect pitch trim cartridge to aft empennage bellcrank. (Refer to AMM 27-30)
- J. Reset FUEL QTY, GPS NAV GIA 1, and STALL WARNING circuit breakers.
- K. Perform Operational Test - Aircraft Data Logger System.
  - (1) Set BAT 1 switch to ON position.
  - (2) Open center armrest console and remove glove box trim to access diagnostic LED. (Refer to AMM 25-10)
