**NATIONAL TRANSPORTATION SAFETY BOARD**

**ENGINE EXAMINATION**

**ERA19LA063**

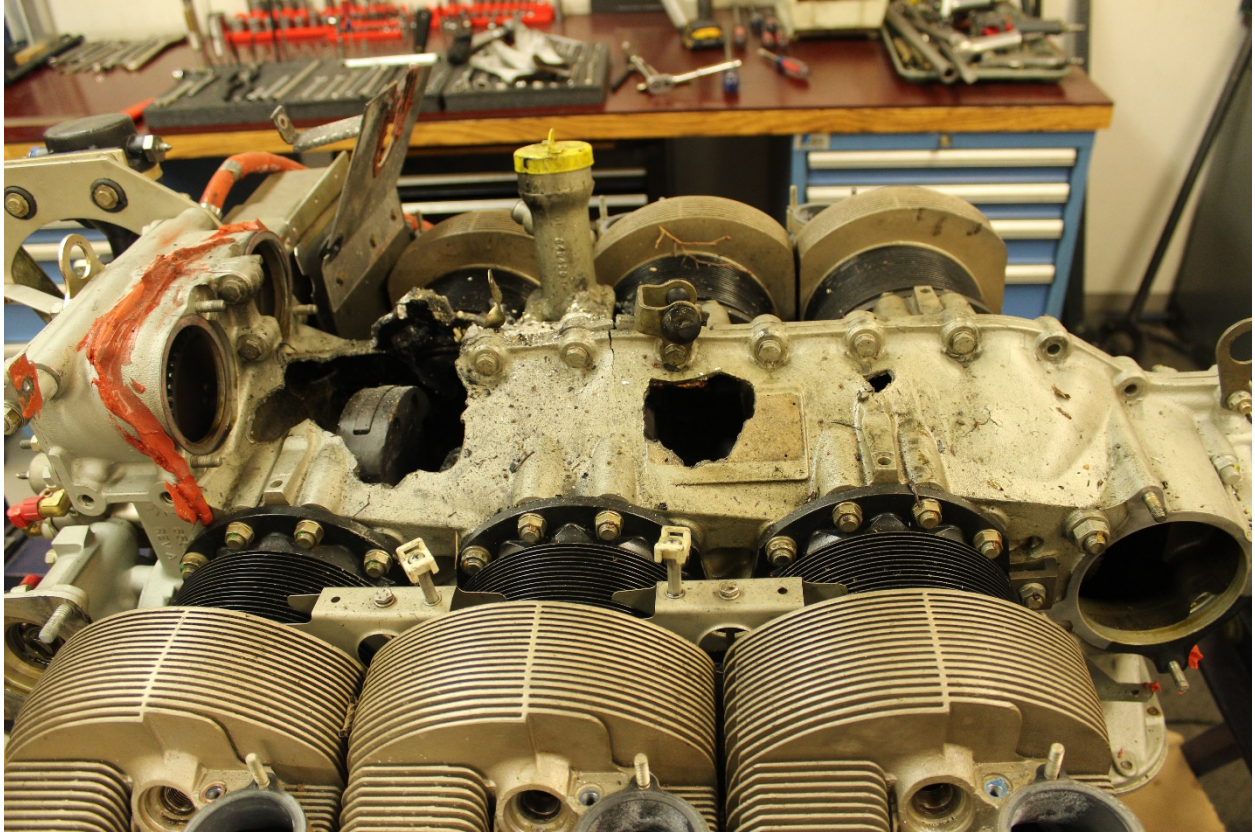
The oil cooler, turbos, and oil hoses were removed. The engine exhibited multiple holes in the top of the case.

Figure 2: Top of engine.

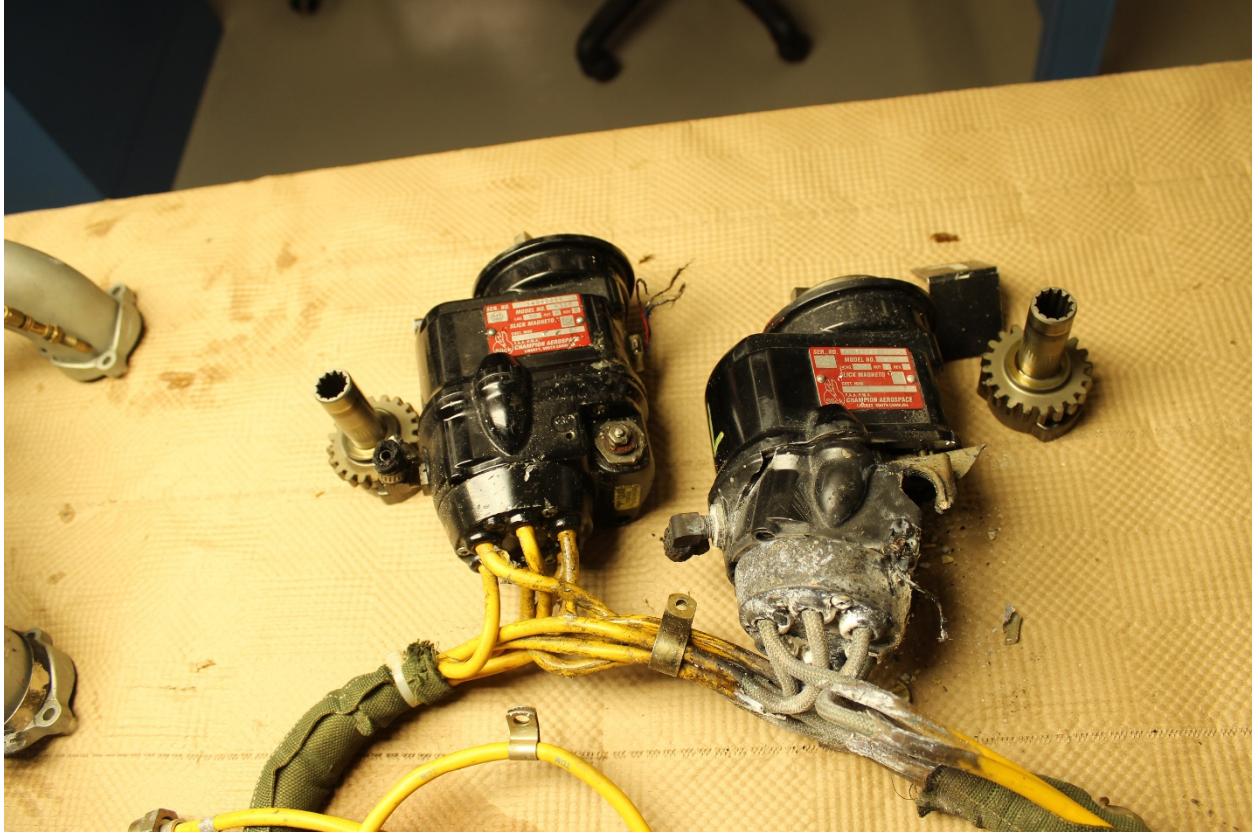
The left magneto had extensive internal thermal damage. Right magneto was undamaged.

Figure 3: Left and right magnetos.

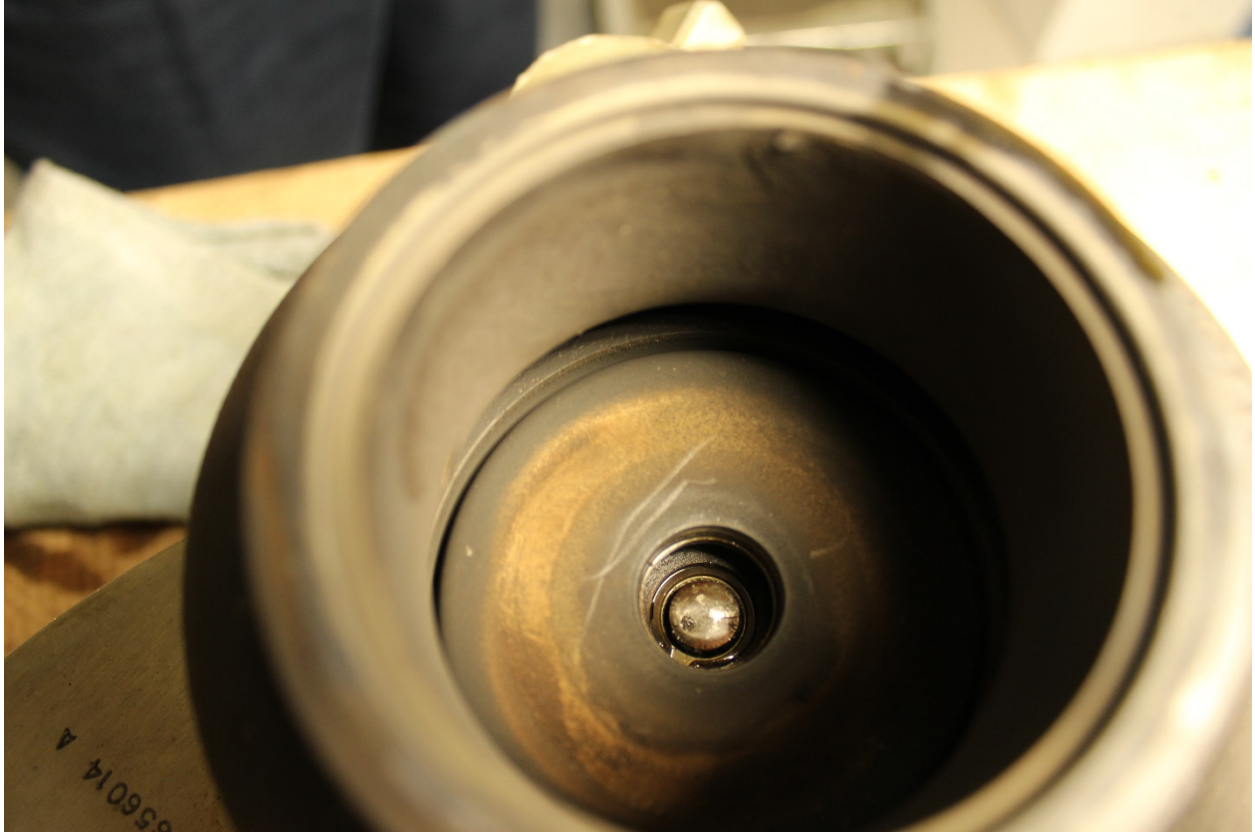
Examination of N618G was conducted on June 26, 2019 at CMI, Mobile, AL. Examination of the engine revealed the left turbo turbine wheel was missing.

The left turbo turbine side blades were not located. Field overhaul in May 2016 by ATC See WPR17LA137)

Figure 4: Missing turbine wheel from left turbo.

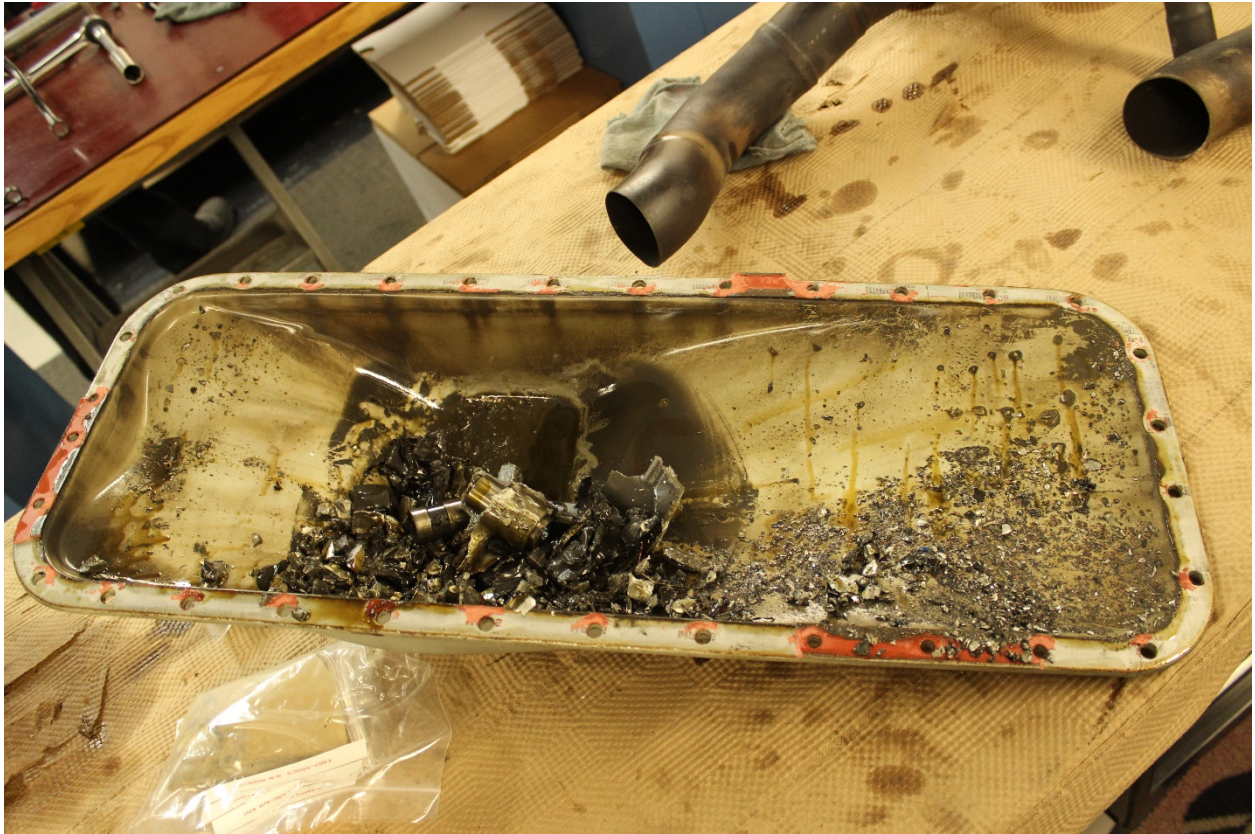
The oil sump was removed and exhibited numerous pieces of metal.

Figure 5: Oil sump contents.

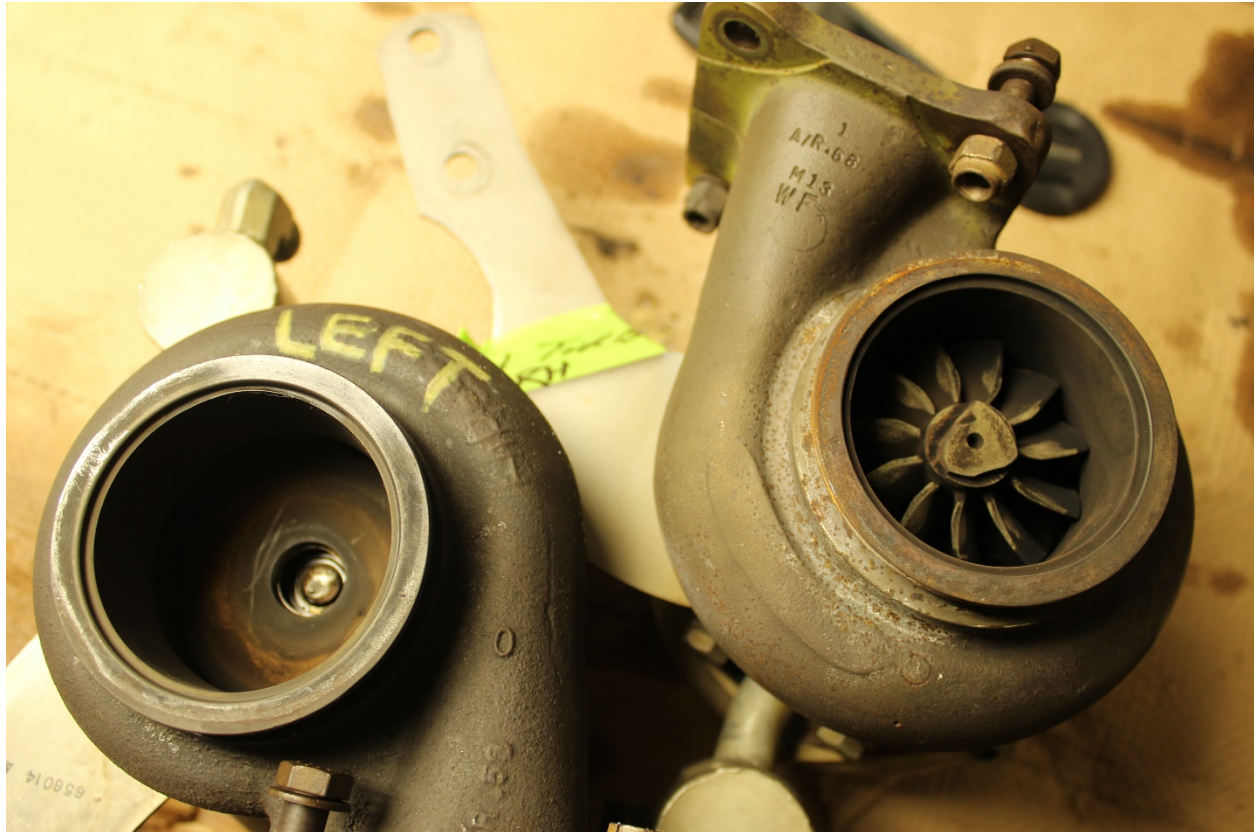
Figure 6: Left and right turbos.
