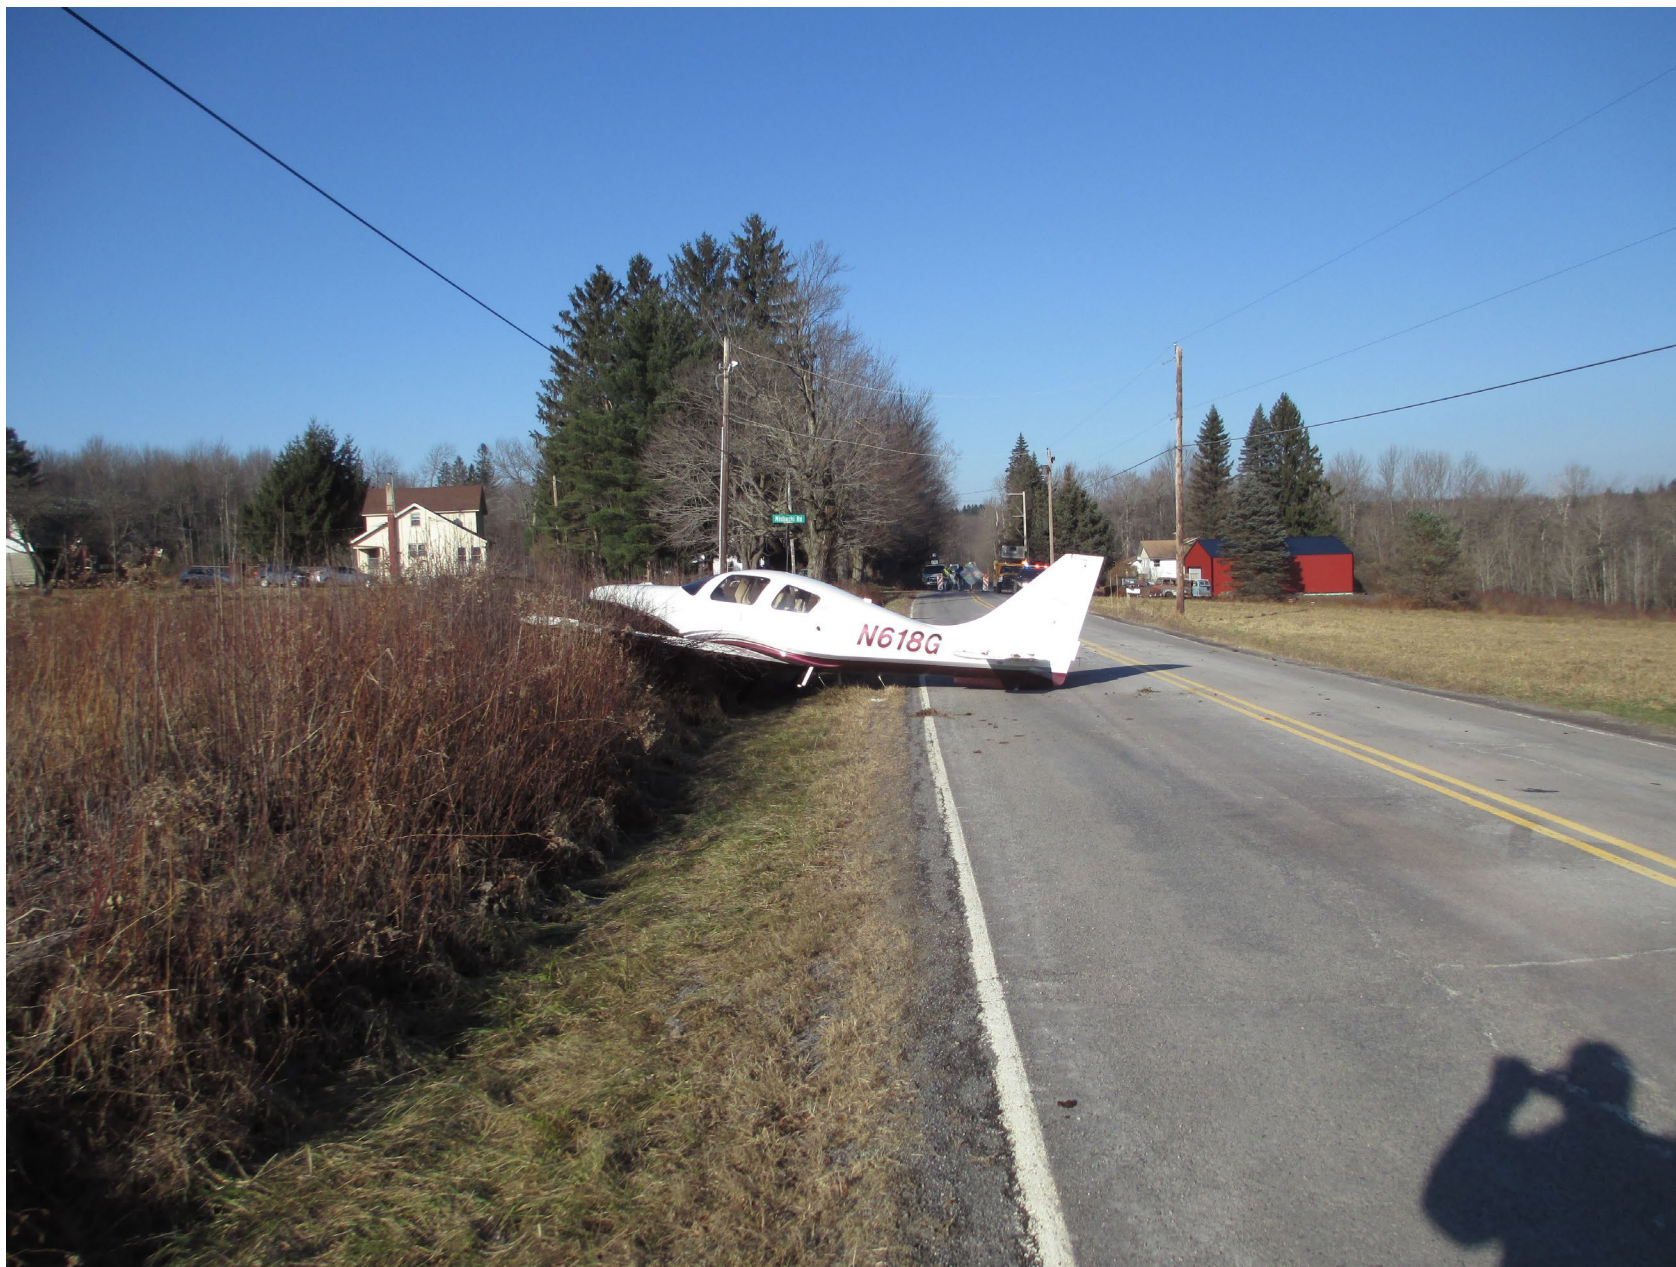
**Photo 1 – View of the airplane where it came to rest on a road. (Photo courtesy of the FAA)**

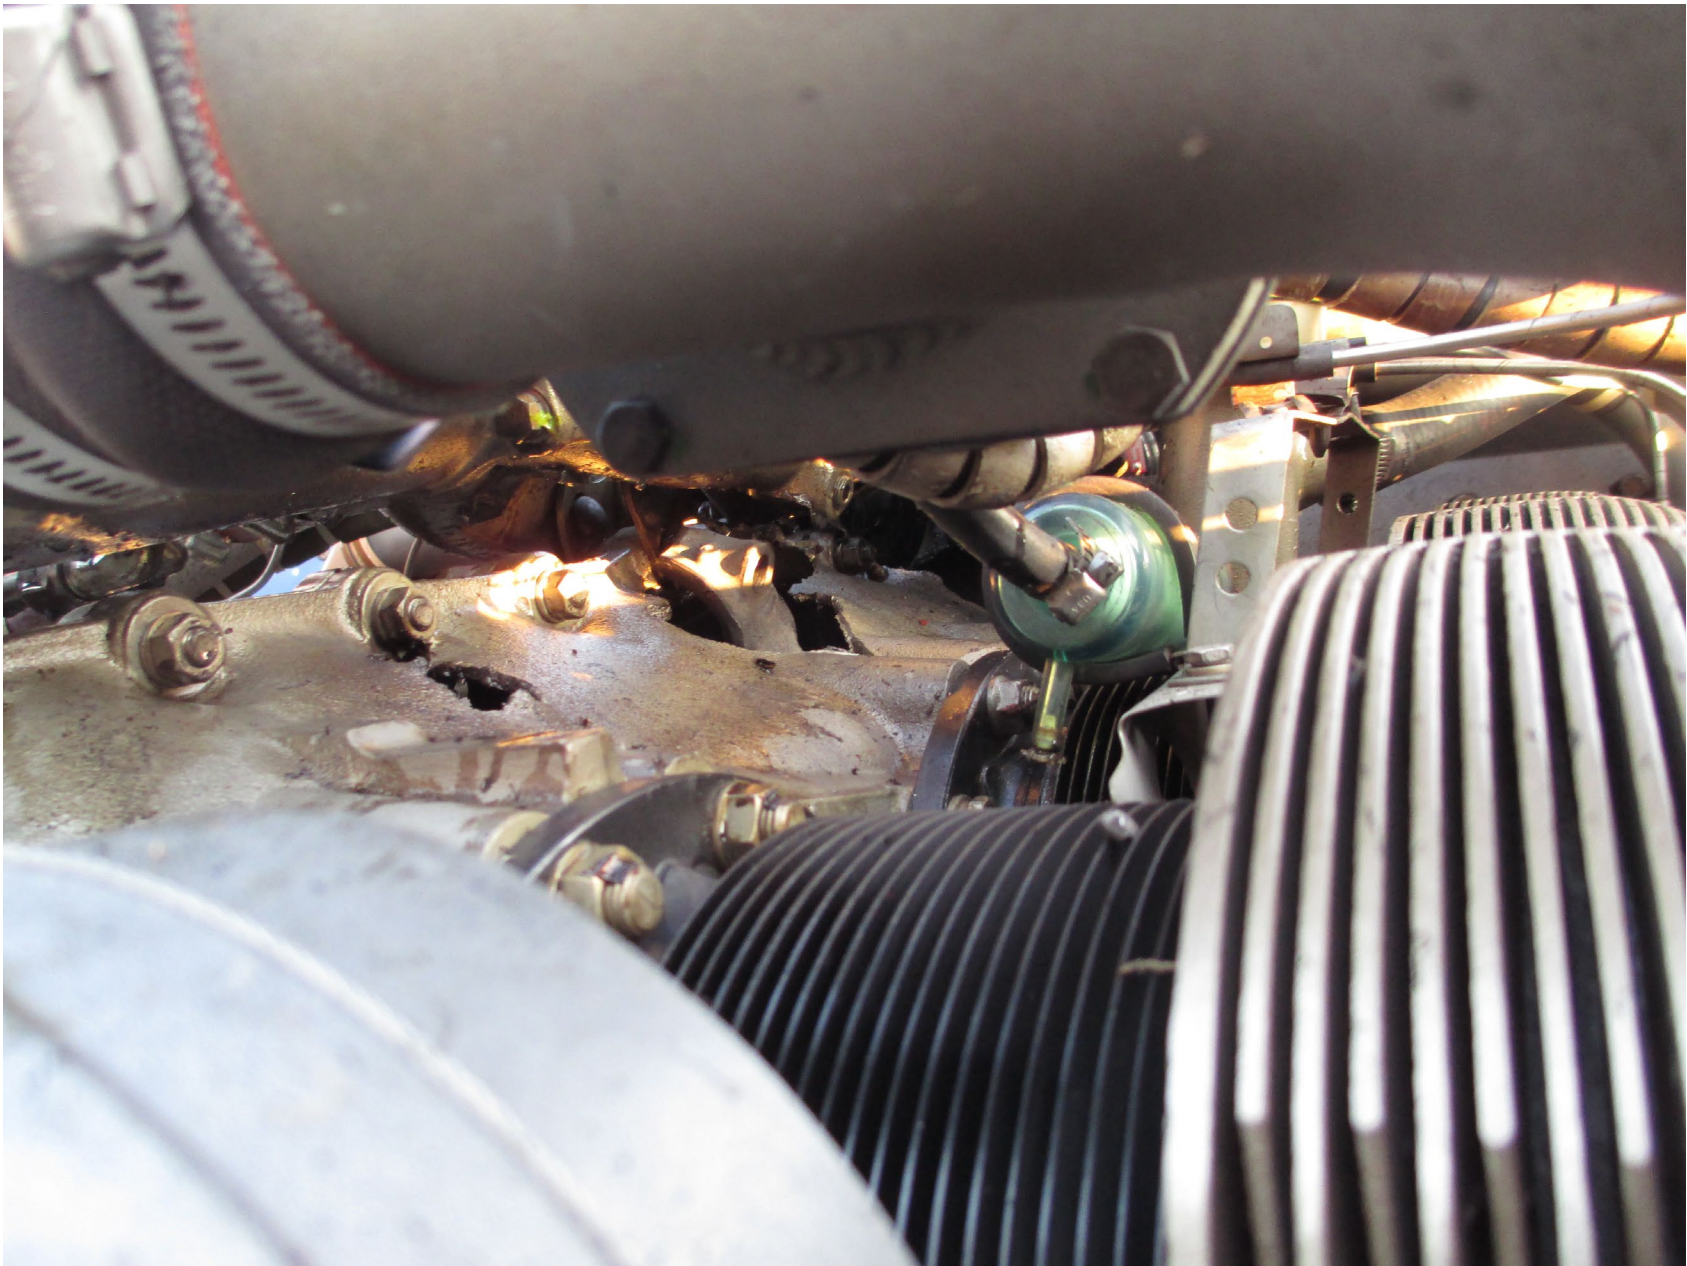
**Photo 2 – View of the holes in the top of the crankcase. (Photo courtesy of the FAA)**

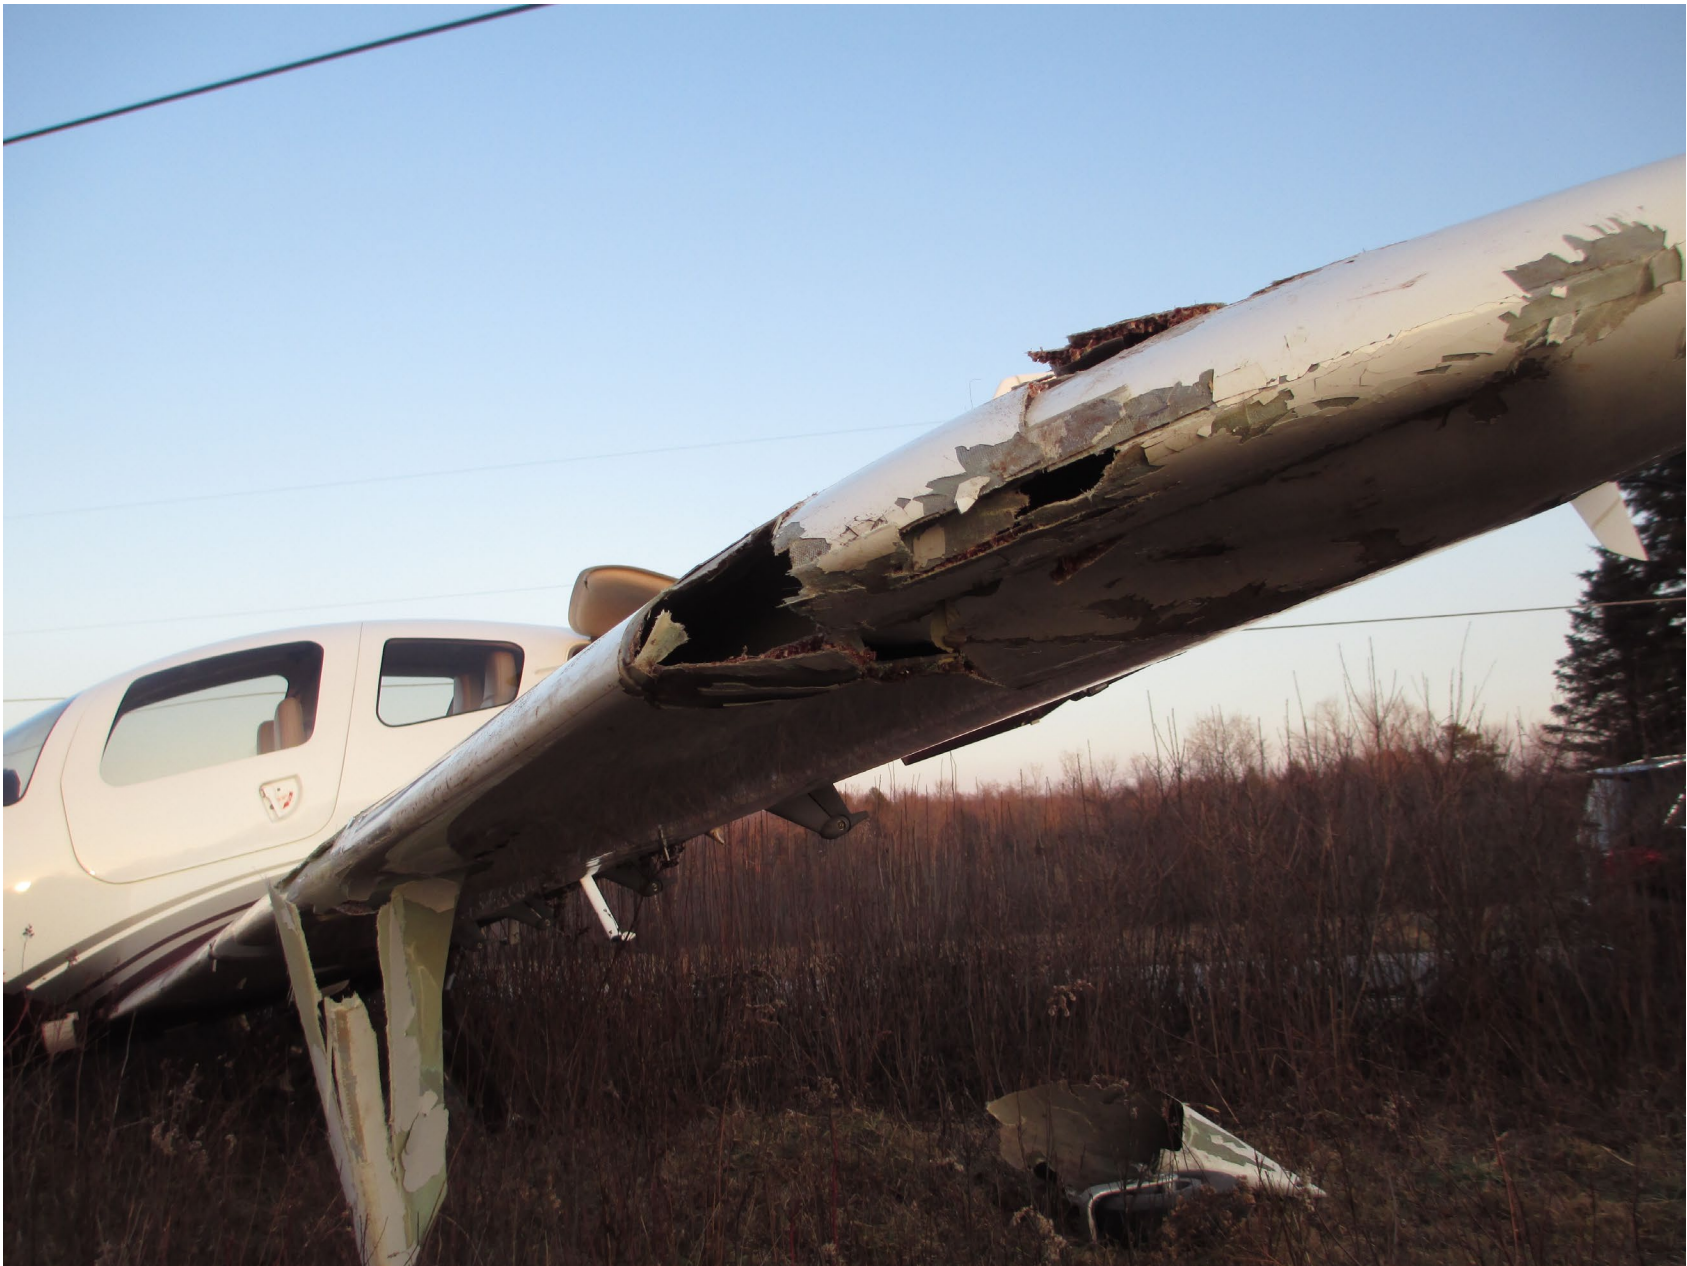
**Photo 3 – View of the damage to the left wing. (Photo courtesy of the FAA)**

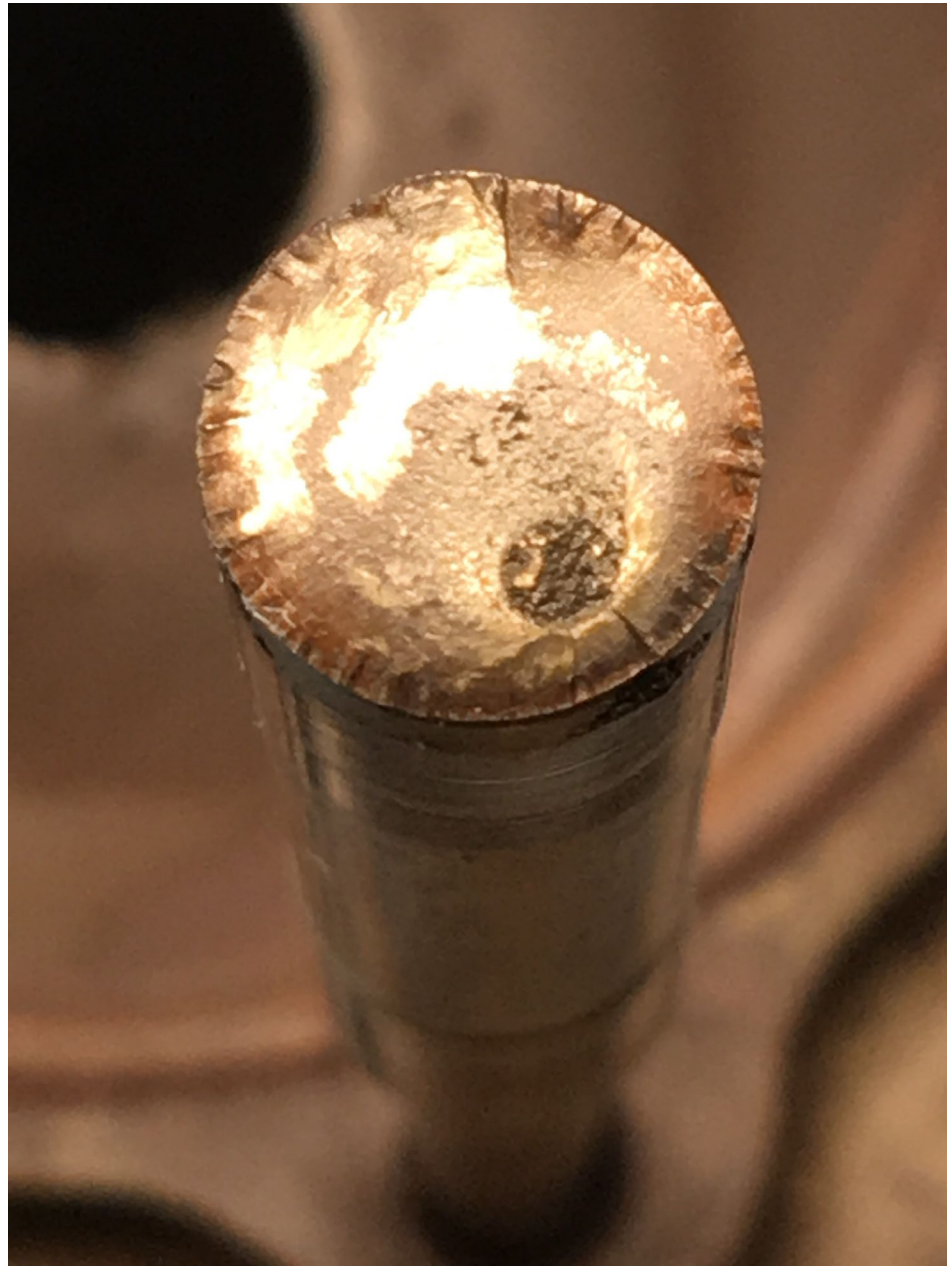
**Photo 4 – View of the fracture surface of the turbo turbine wheel assembly shaft.**

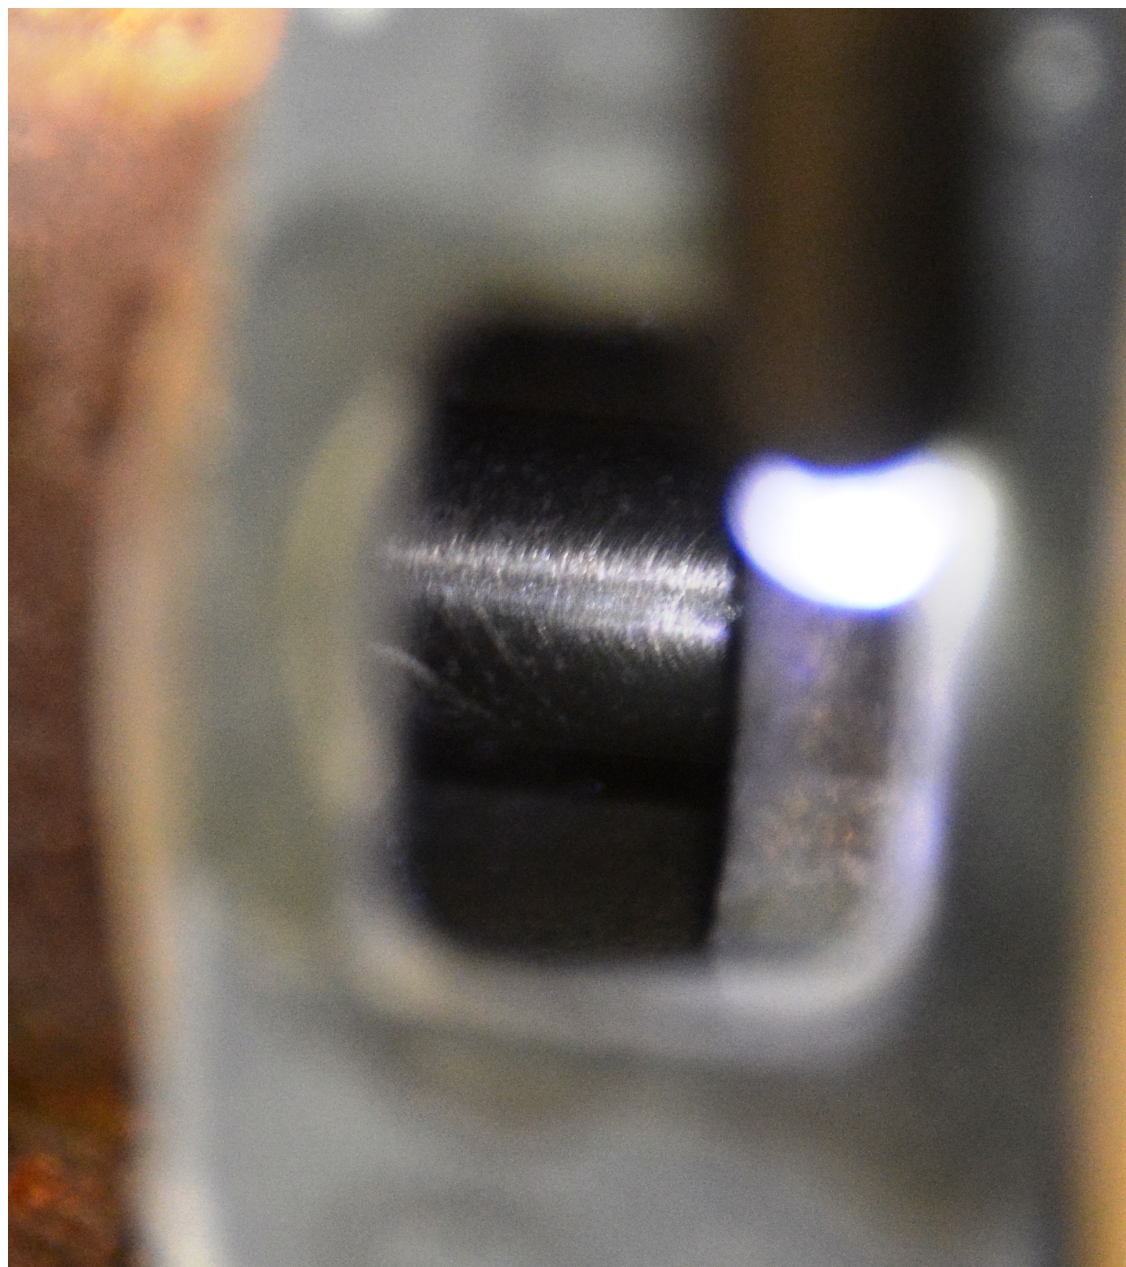
**Photo 5 – View of the scratches on the shaft before being removed from the center housing on the left turbocharger.**

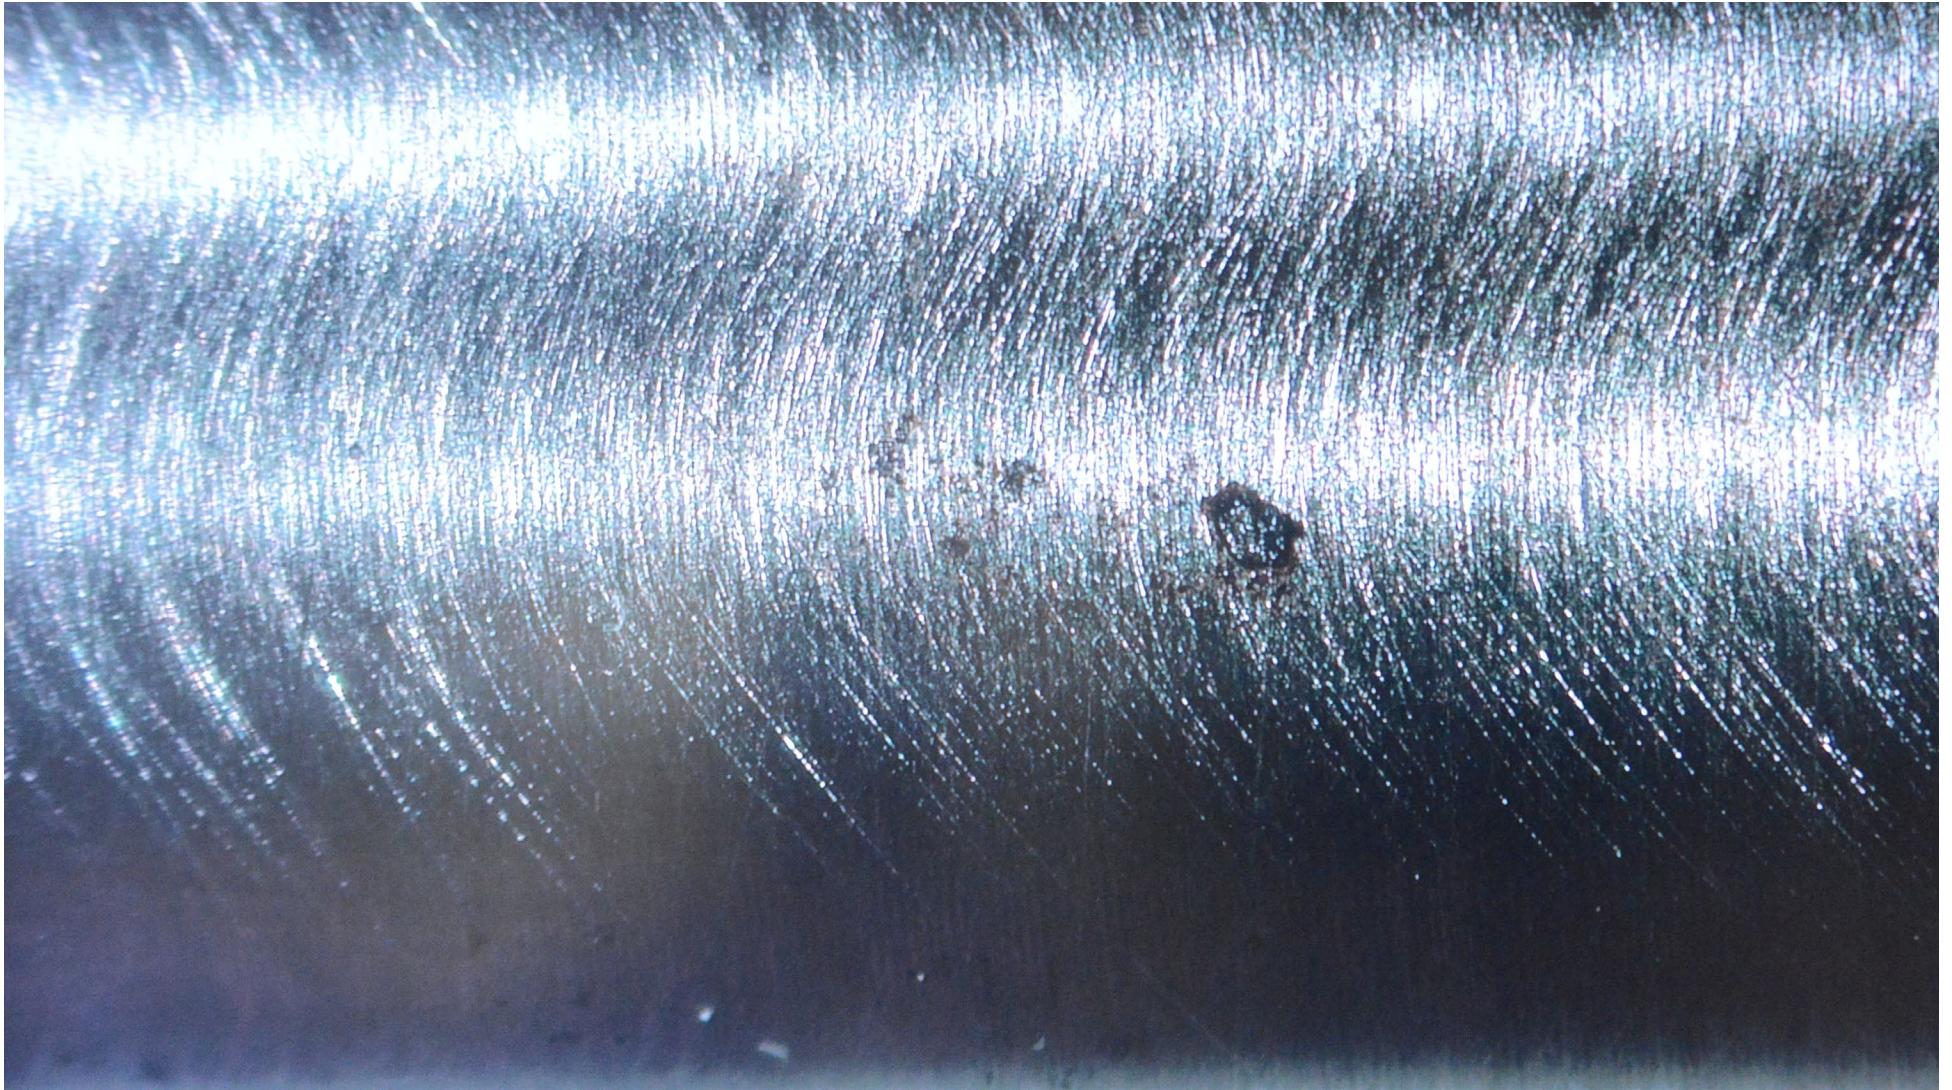
**Photo 6 – View of shaft corrosion pitting on left turbocharger.**
