# NATIONAL TRANSPORTATION SAFETY BOARD

## MATERIALS LABORATORY FACTUAL REPORT

Report No. 19-020

Place : Bell Glade, Florida  
Date : December 17, 2018  
Vehicle : Cessna 152, N4886B  
NTSB No. : ERA19LA069  
Investigator : Lynn Spencer, AS-ERA

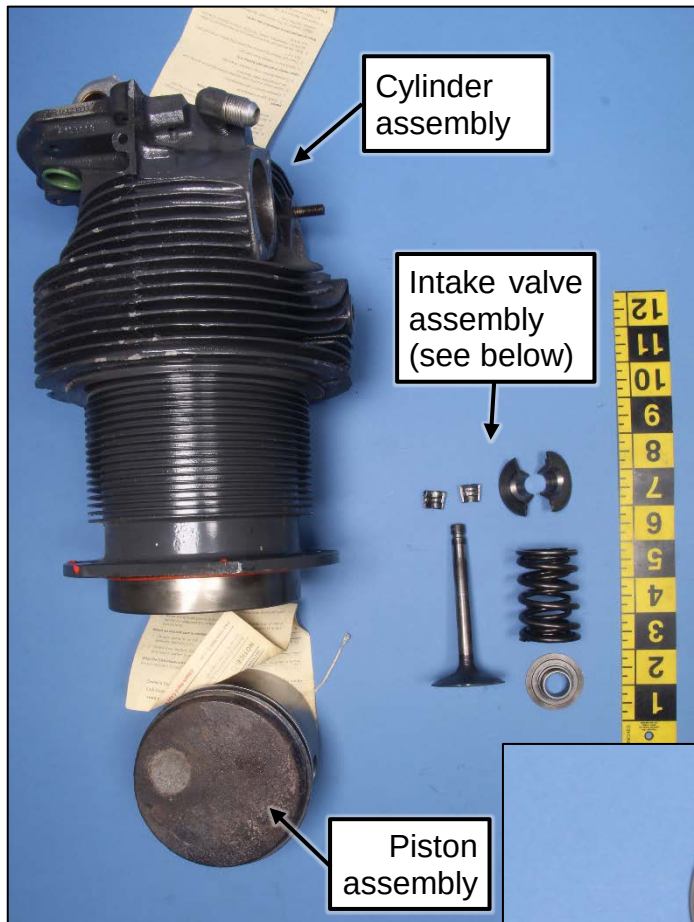
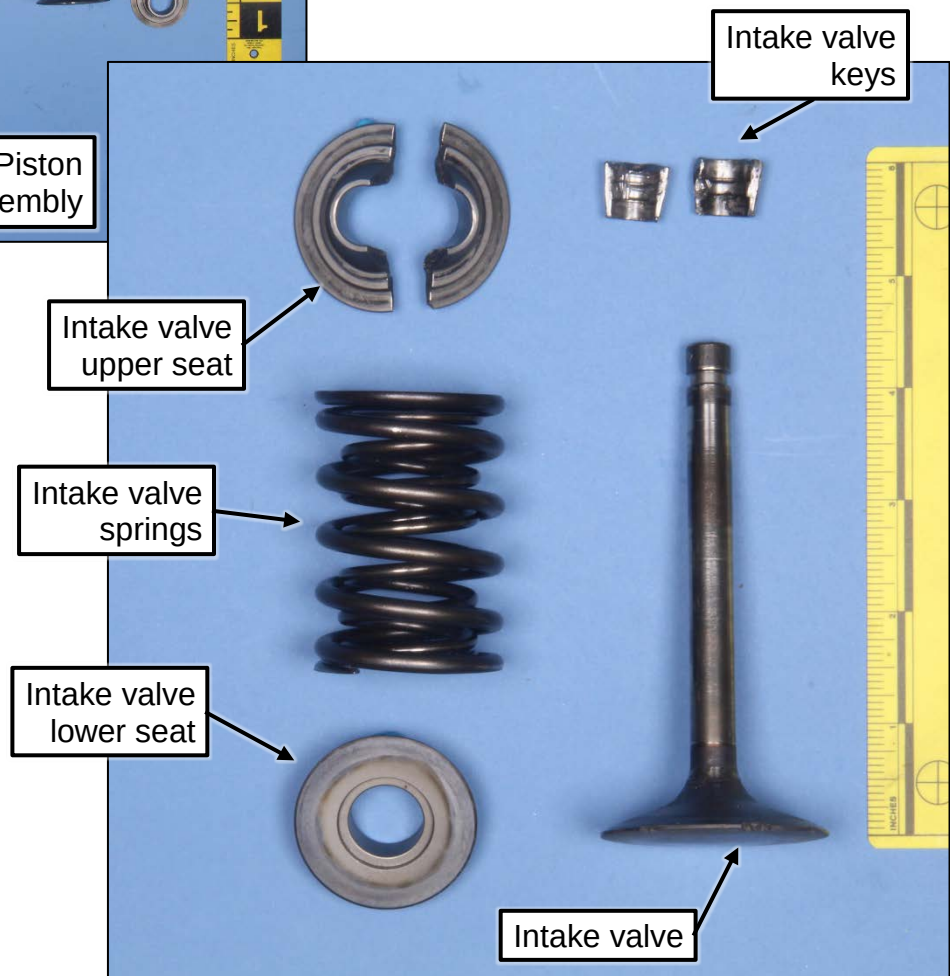
An overall view of the submitted components is shown in figure 1. As found during the engine teardown, the intake valve upper seat had fractured, and the intake valve was stuck within the intake valve guide. The exhaust valve remained assembled within the cylinder assembly as received. Markings on the side of the cylinder head near the rocker cover read "16A23033" and "A193088" on the intake side and "094176" and "6102" on the exhaust side, indicating the cylinder assembly was Lycoming Engines part number 16A23033. Markings on the tip of the intake valve read "SL-17236 T-T N7", indicating that it was a part number SL17236 intake valve made by Superior Air Parts.

A closer view of the intake valve components is shown in the lower image in figure 1. The intake valve upper seat was fractured into 2 pieces, and the fracture surfaces had rough matte gray features consistent with overstress fracture.

The intake valve head was dark in color, and pitting was observed in areas around the circumference of the head. Radial cracks were observed emanating inward from the pits at the outer edges.

Figure 1. Overall view of the submitted components (image to the left) and a closer view of the intake valve assembly components (image below).

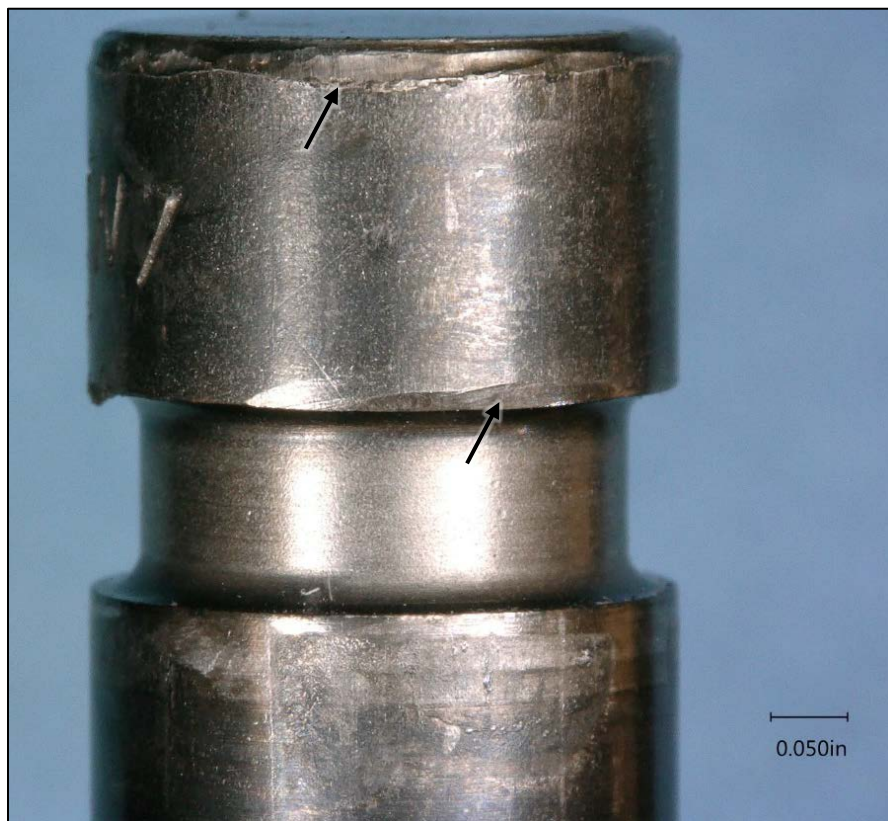
The tip of the intake valve stem is shown in figure 2. Contact damage was observed on the shoulder for the valve key groove and around the edge of the rocker contact face (see arrows in figure 2).

Figure 2. Intake valve tip. Unlabeled arrows indicate damage to the shoulder and the edge of the rocker contact face.

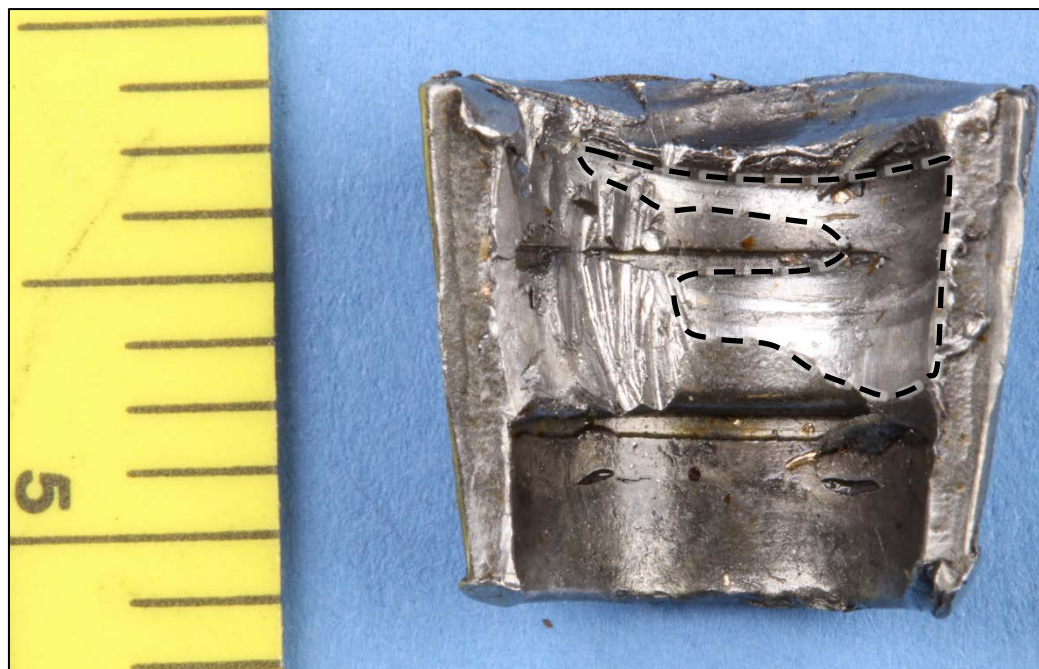
The interior face of one of the valve keys exhibited contact damage as shown in figure 3. A portion of the surface had smooth smeared features and the raised portion that normally fits into the groove in the valve tip was flattened. A dashed line in figure 3

outlines the deformed area with smooth features, and the overall shape of the region fit a cylinder with a circumference corresponding to the outer diameter of the intake valve tip oriented slightly off axis relative to the longitudinal axis of the key.

Figure 3. Interior face of one intake valve key. A dashed line indicates an area of smeared features with an off-axis cylindrical curvature matching the outer circumference of the intake valve tip.

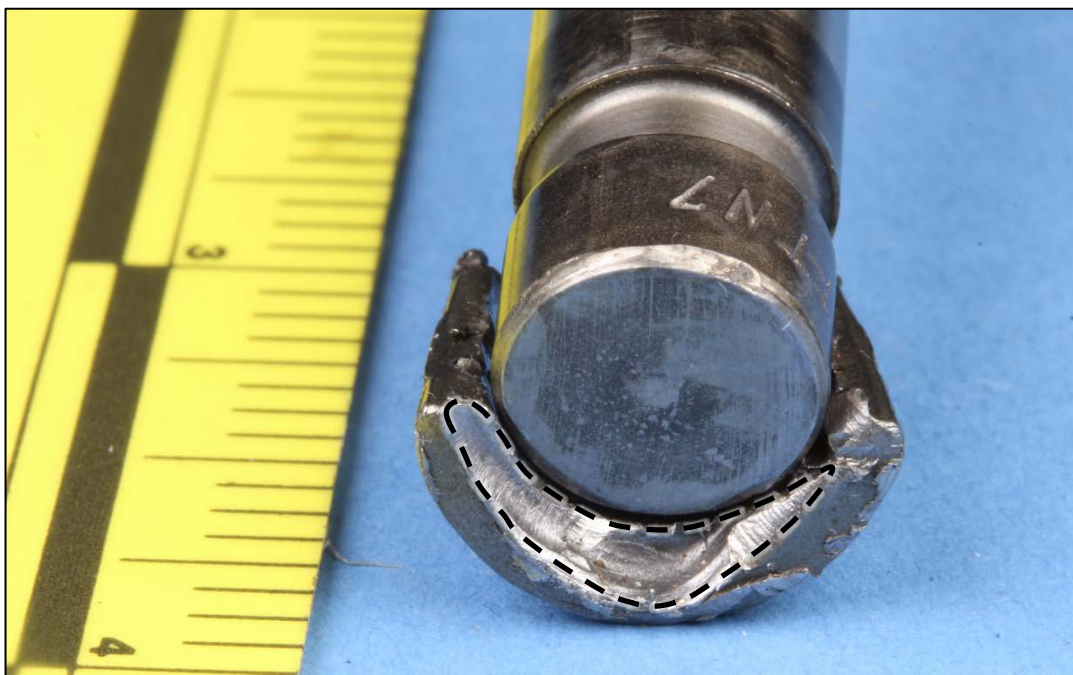
The tip of the intake valve is shown positioned on the valve key with the valve tip positioned on the smooth area outlined in figure 3. The rocker contact face on the valve tip had a machined surface that was mostly free of the normal rocker arm contact wear pattern characterized by a circular wear patch. A portion of the valve key extended past the rocker face, and sliding contact damage was observed on the valve key face adjacent to the valve tip as shown outlined in figure 4. The outer edge of the damaged area had an approximately 90-degree bend corresponding to contact with the edge of the square-shaped pad on the rocker arm for the Lycoming O-235 series engine.

Figure 4. View of the intake valve tip positioned on the valve key in the area of smooth features outlined in figure 3. An area of damage on the end of the key as outlined in this figure had a shape corresponding to contact with the square face of the rocker arm.

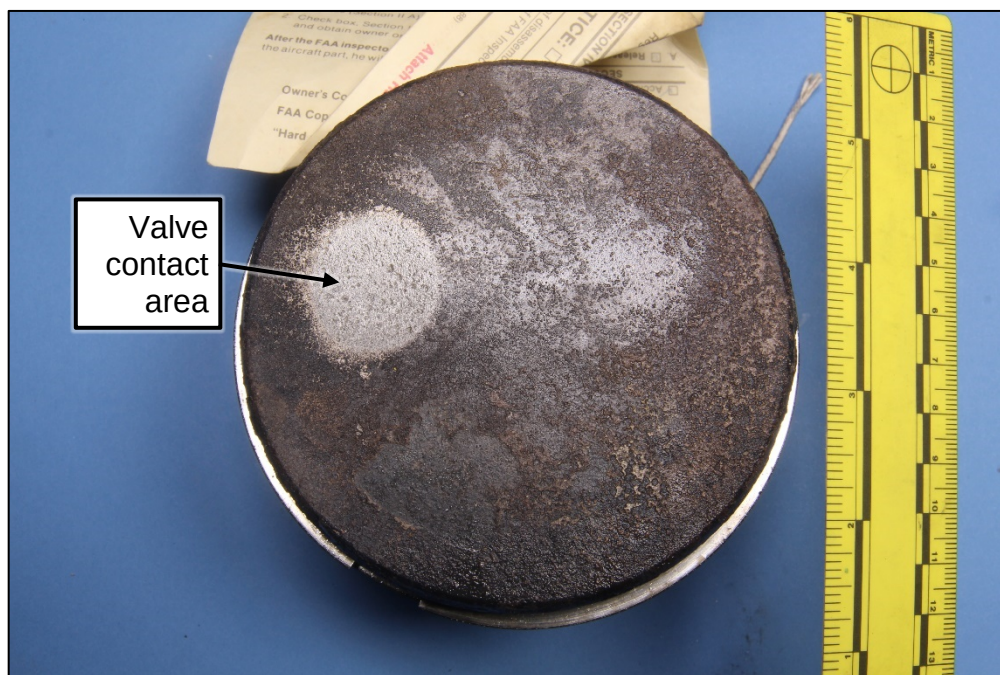
A view of the piston crown is shown in figure 5. Dark brown combustion deposits covered most of the piston crown except a nearly circular area located near the outer edge of the crown. The nearly circular area was slightly dished, corresponding to contact with the slightly convex face of the intake valve head.

Figure 5. Piston crown showing a contact area that was generally free from combustion deposits.
