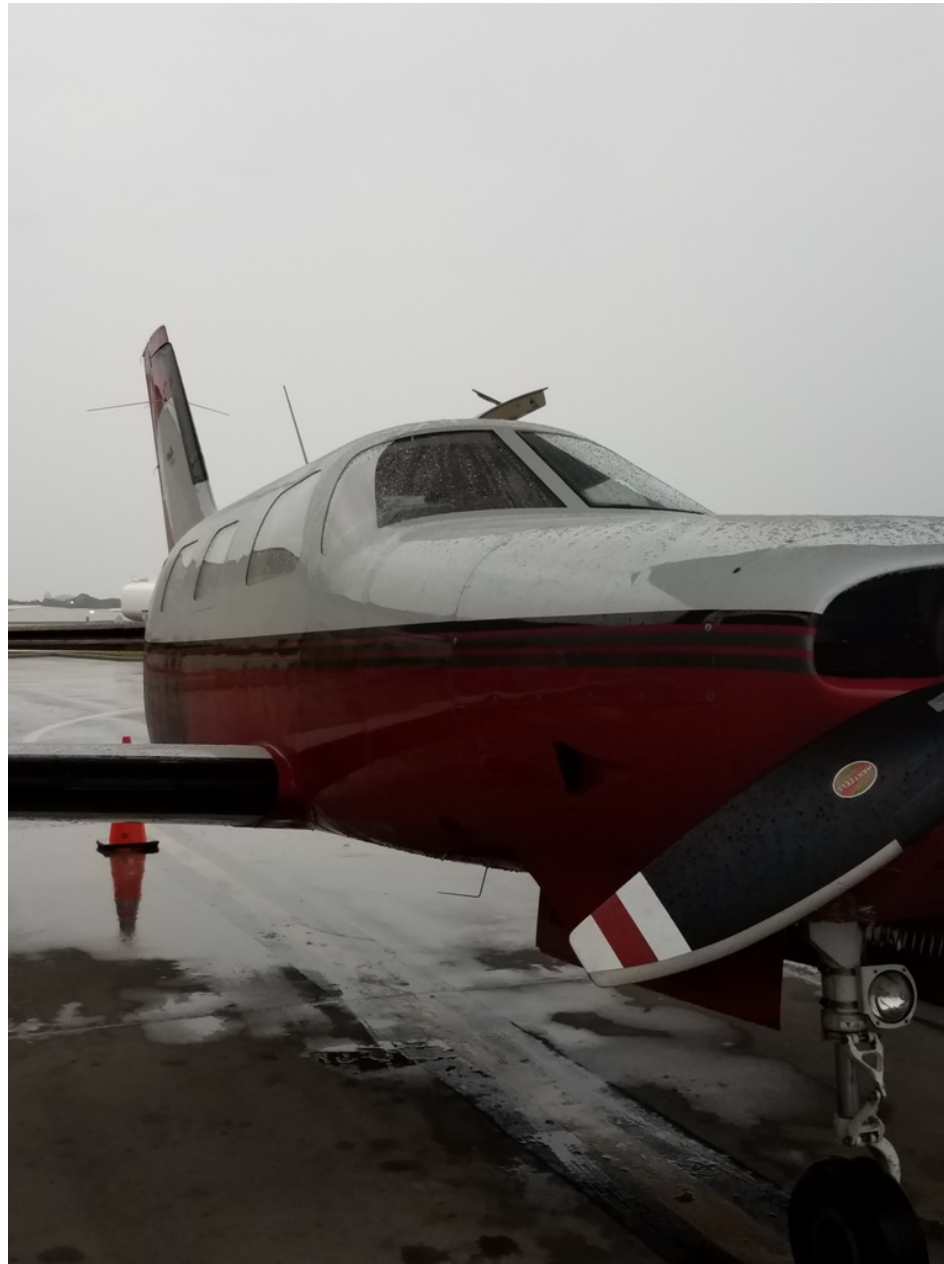
**Photo 1 – Digital Photograph Provided Through Attorney. Right Frontal View of the Airplane Taken Before Departure.  
Photo Metadata Indicated it Was taken at 0745:37 EST.**

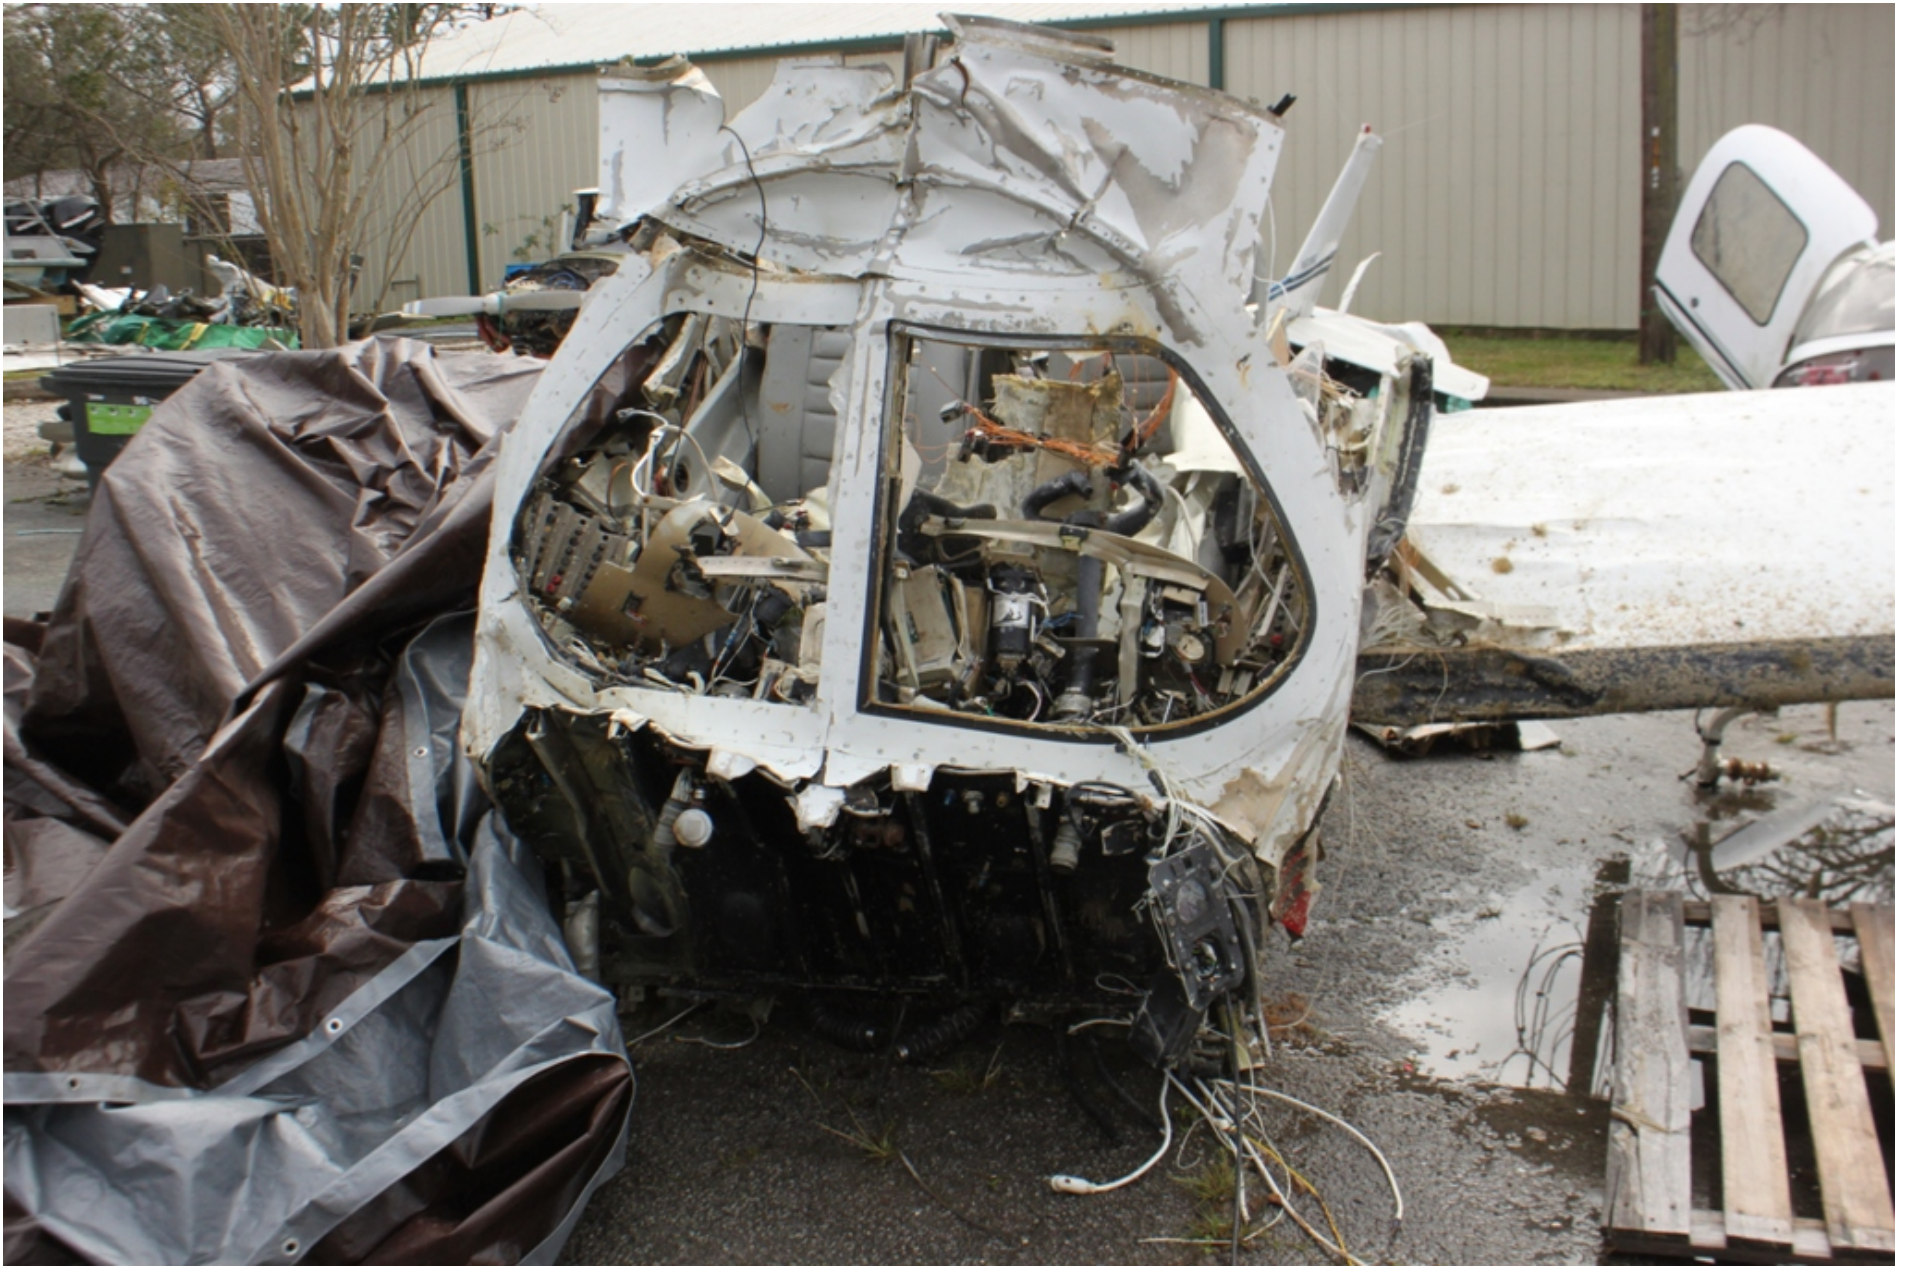
**Photo 2 – NTSB Digital Photograph. Frontal View of the Fuselage and Inboard Section of the Left Wing Following Recovery. Note the Damaged/Missing Windscreens.**

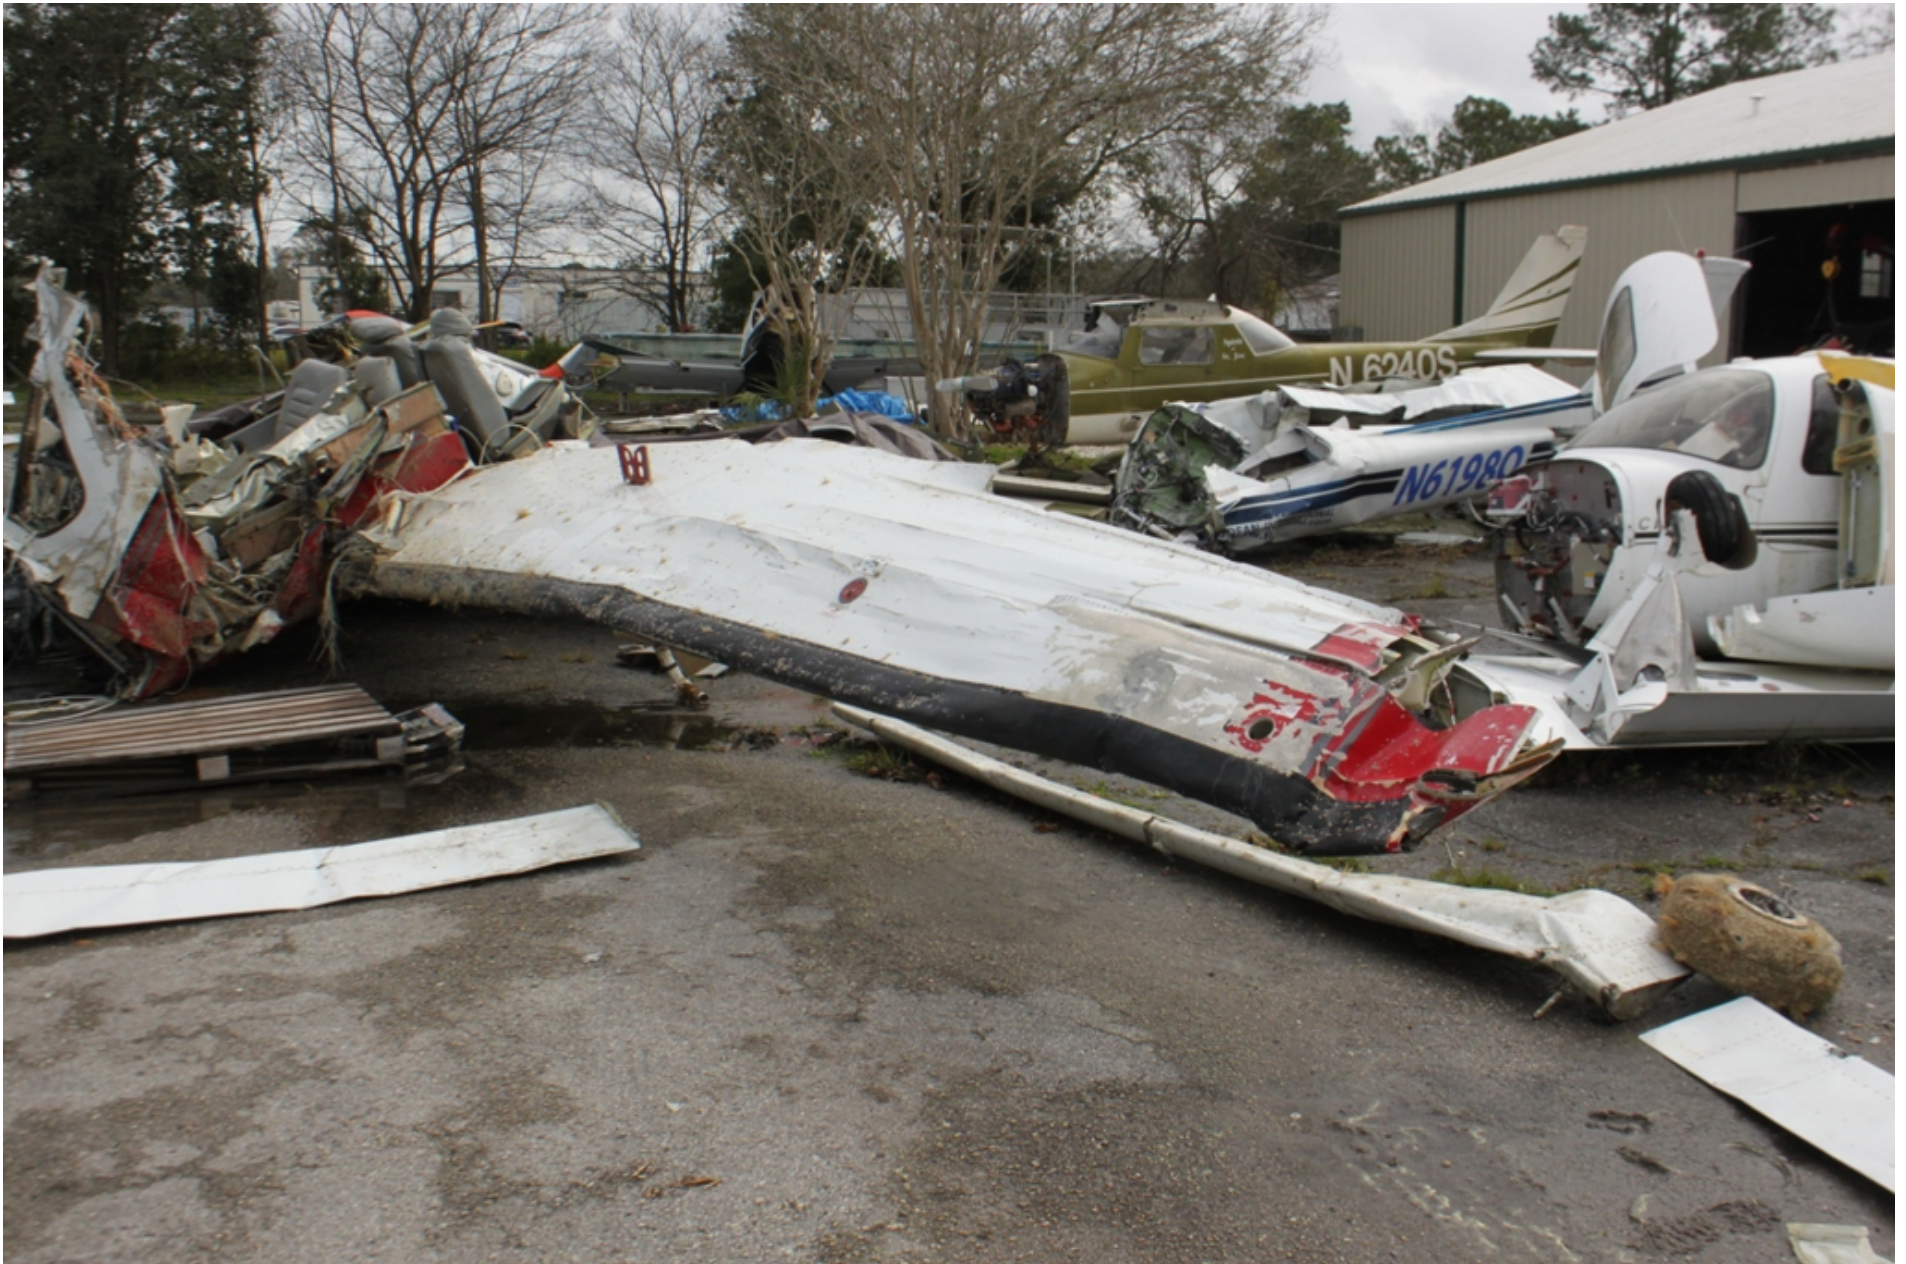
**Photo 3 - NTSB Digital Photograph. Left Forward Quartering View of the Left Wing and Left Side of the Fuselage Following Recovery.**

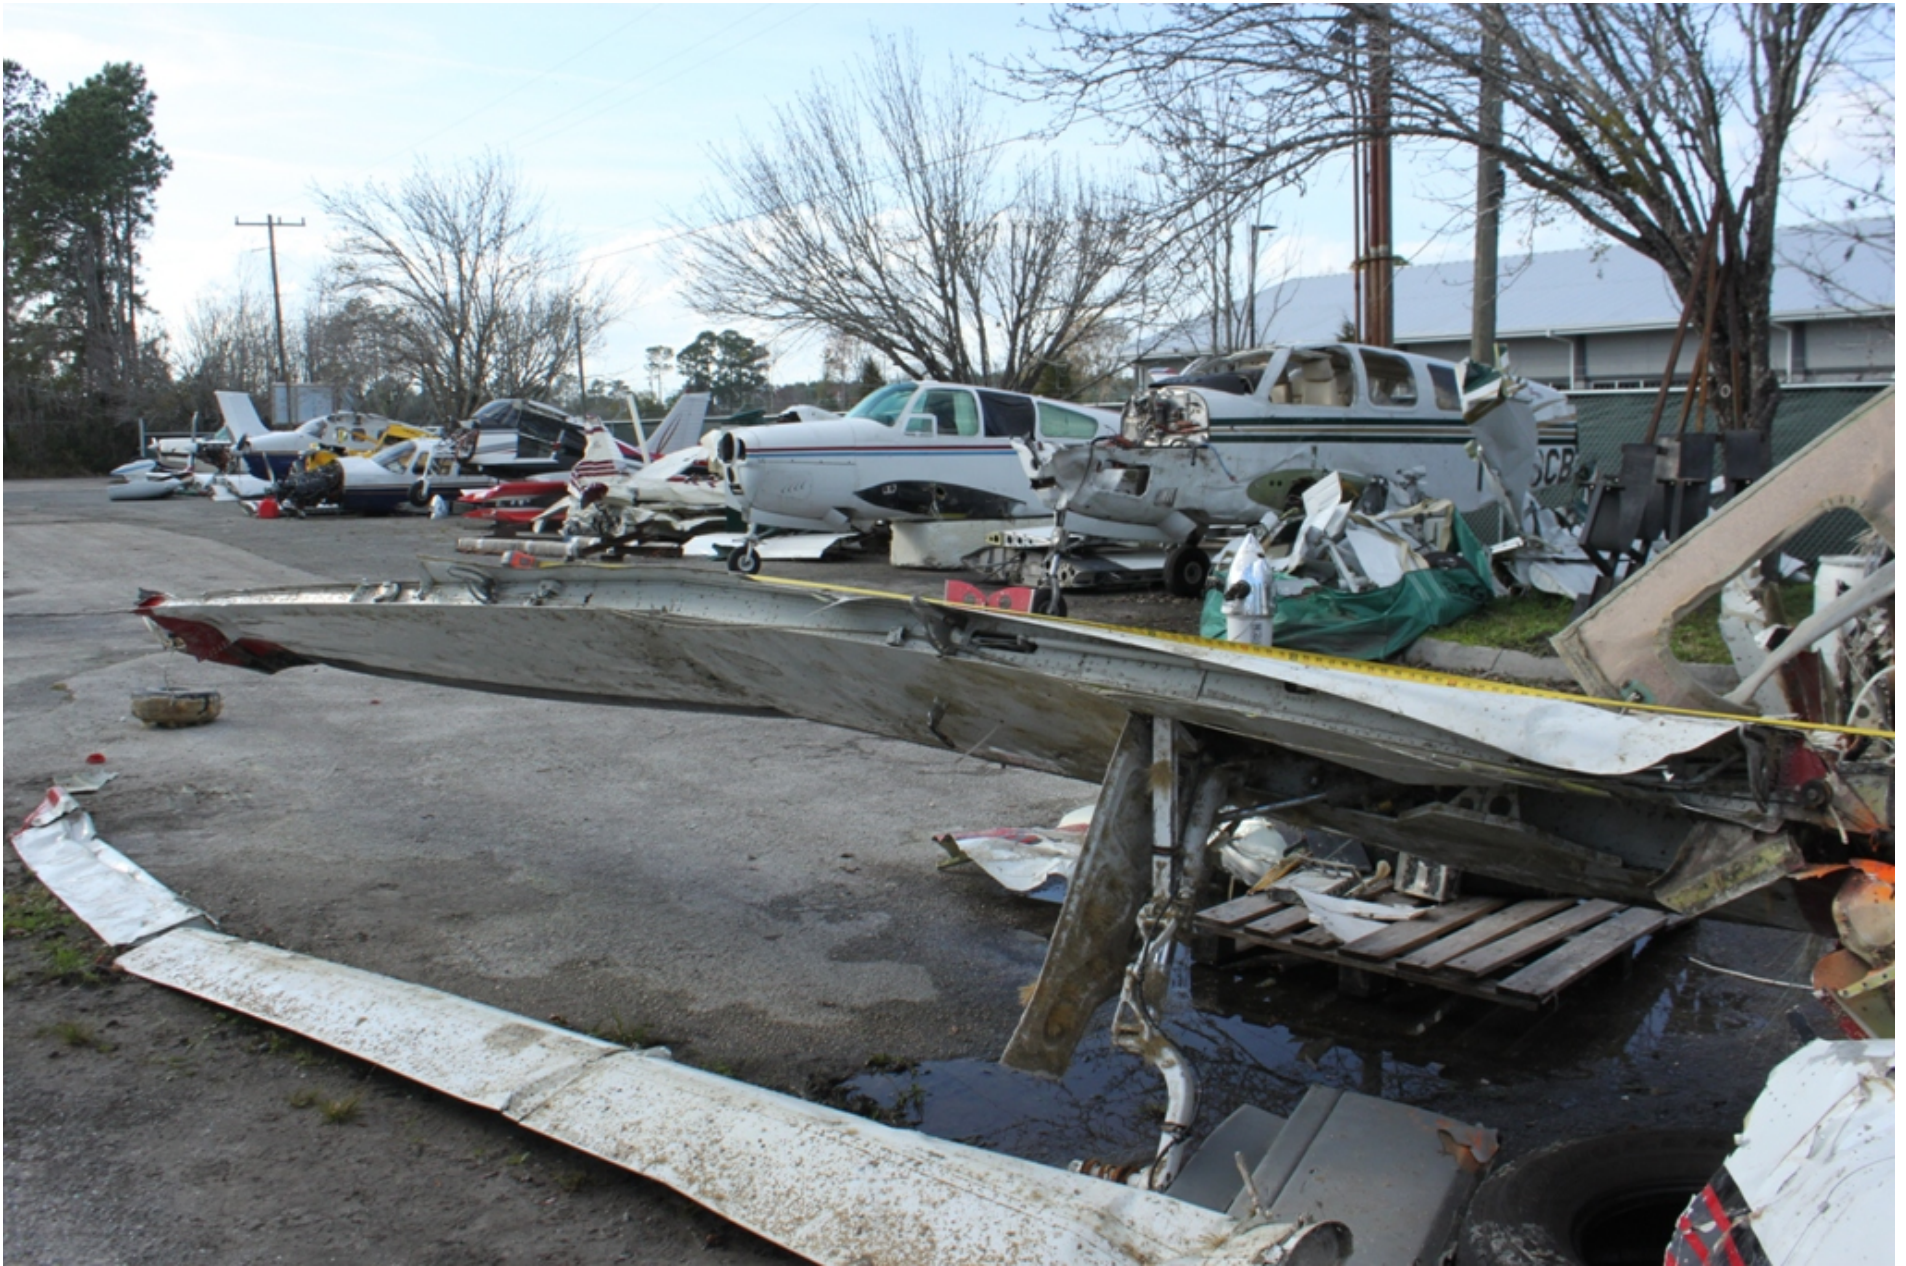
**Photo 4 - NTSB Digital Photograph. View Taken Behind Left Wing Looking Forward. Note the Permanent Bow/Displacement of the Wing.**

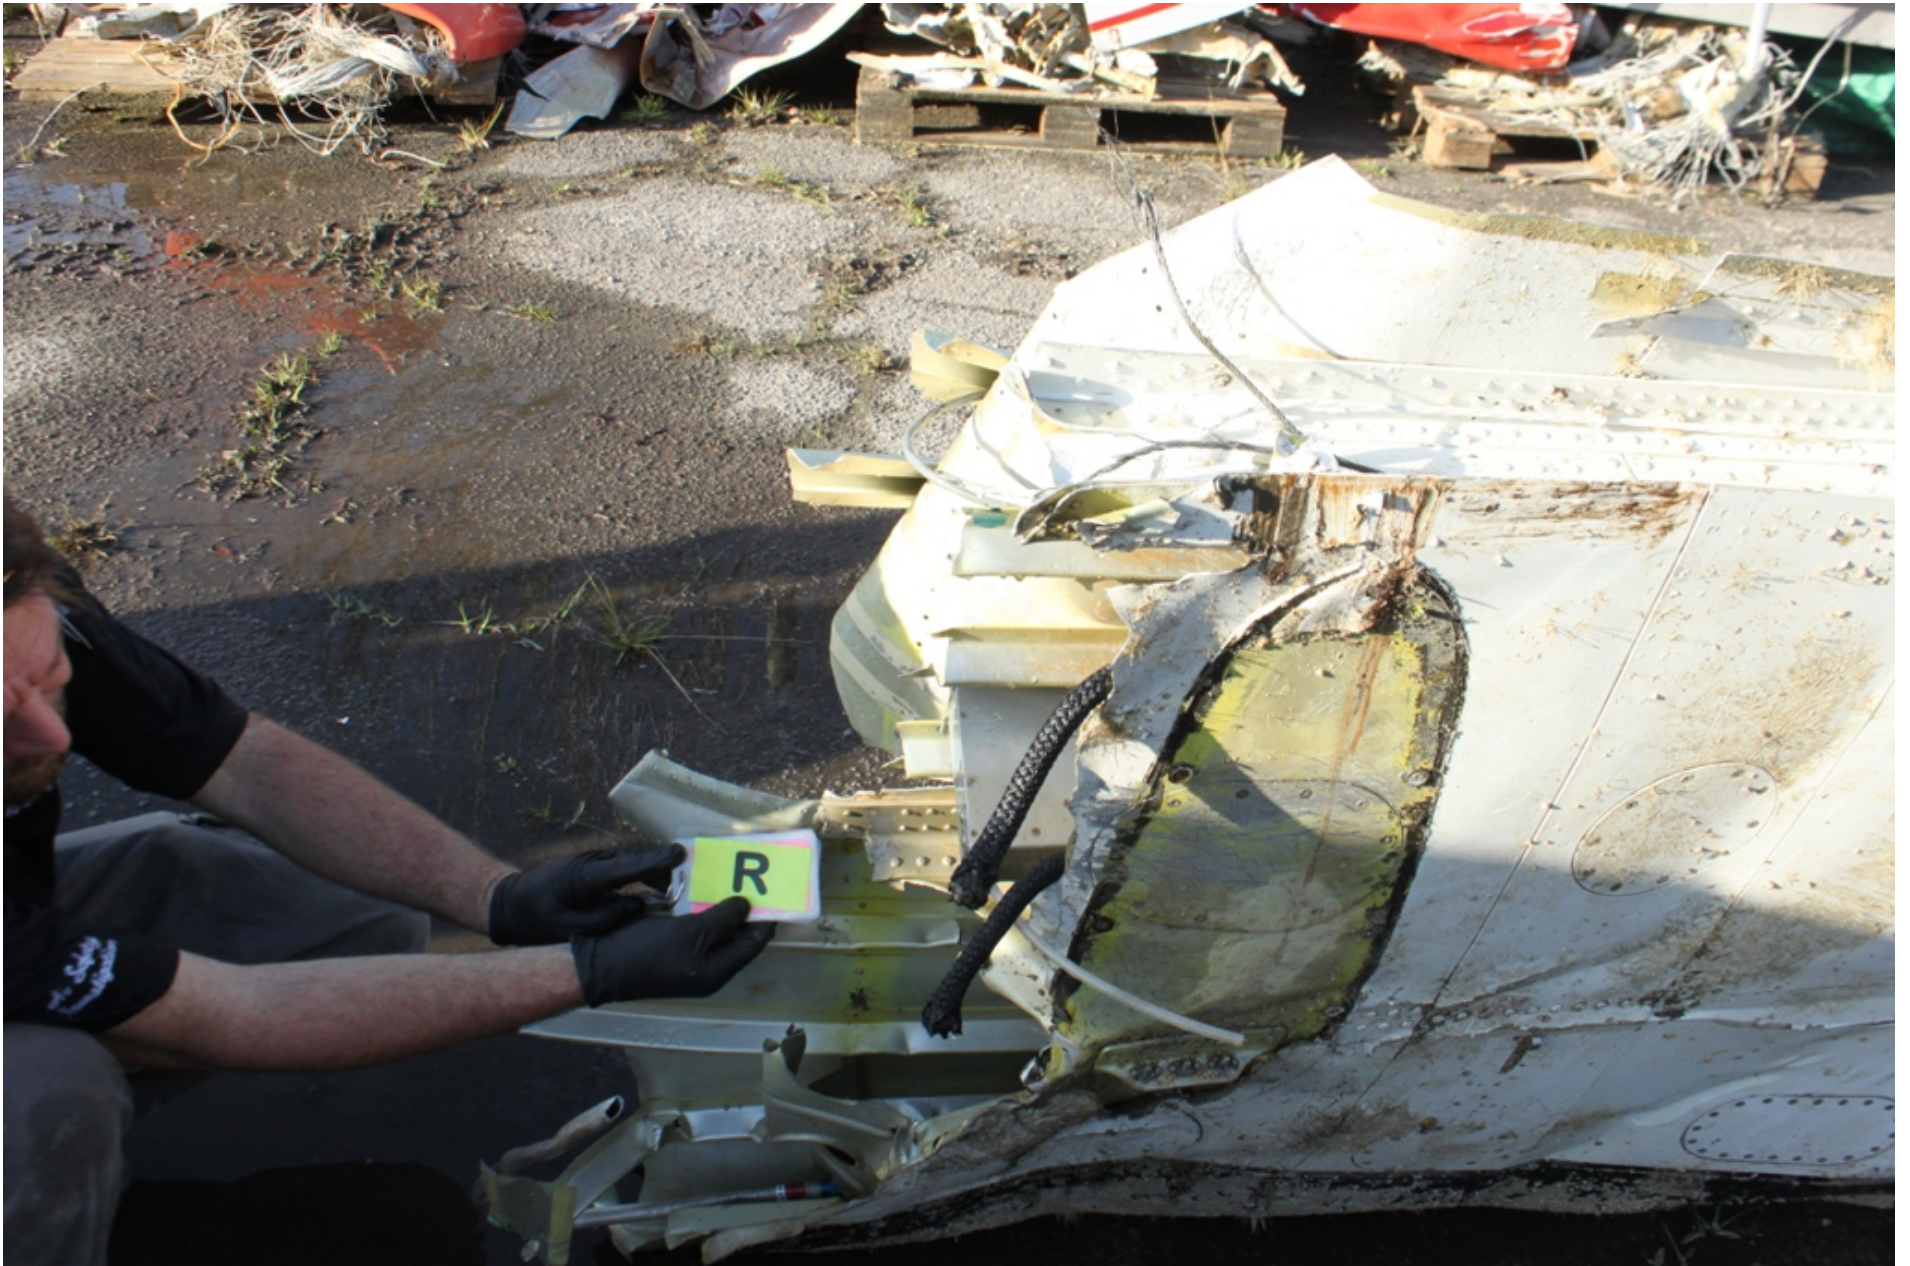
**Photo 5 - NTSB Digital Photograph. View Depicting the Lower Portion of the Right Wing and the Wing Fracture. Note the Separated Radar Pod Location.**

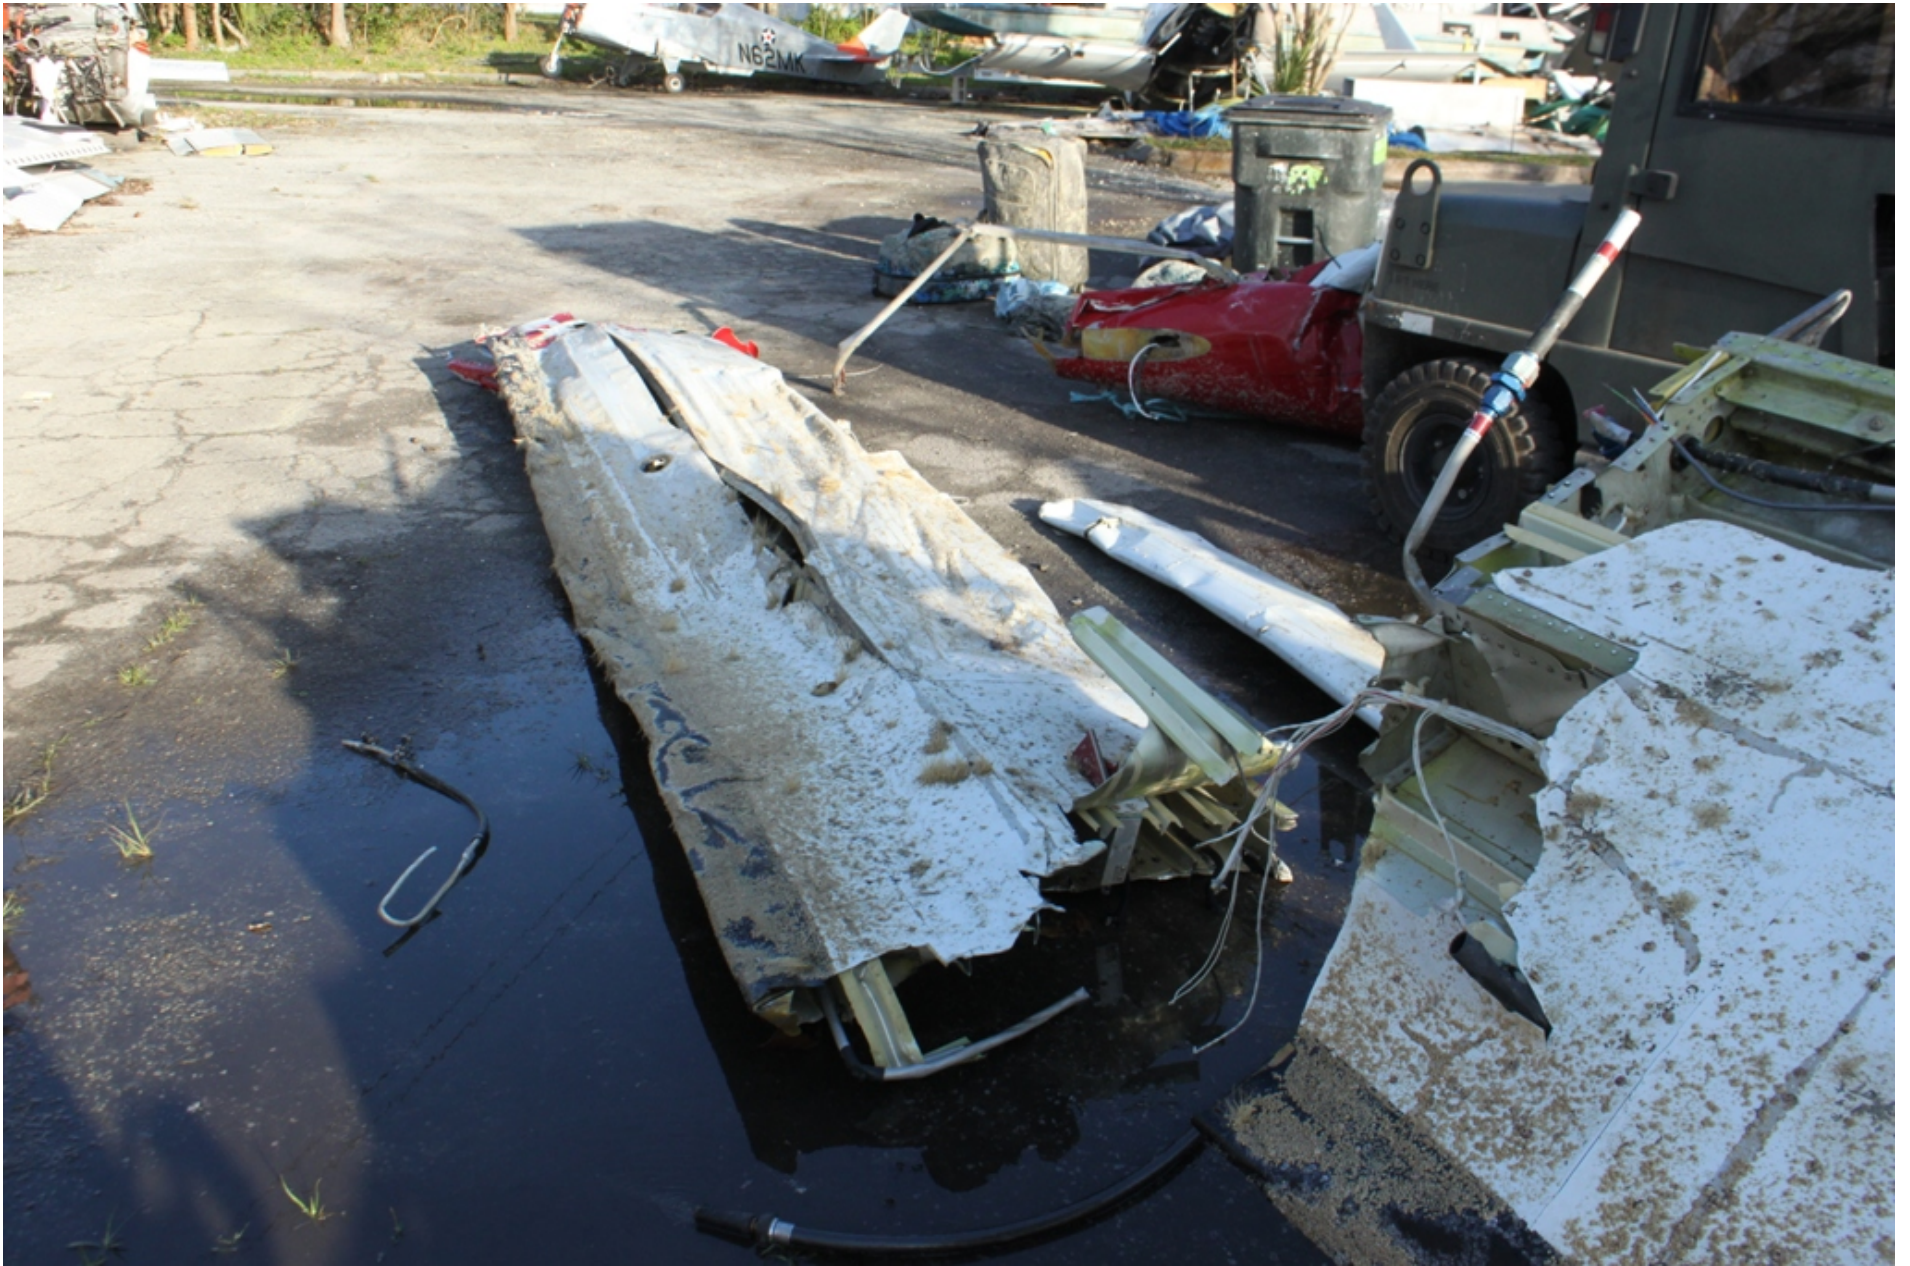
**Photo 6 - NTSB Digital Photograph. View Depicting the Separated Outboard Section of the Right Wing.**

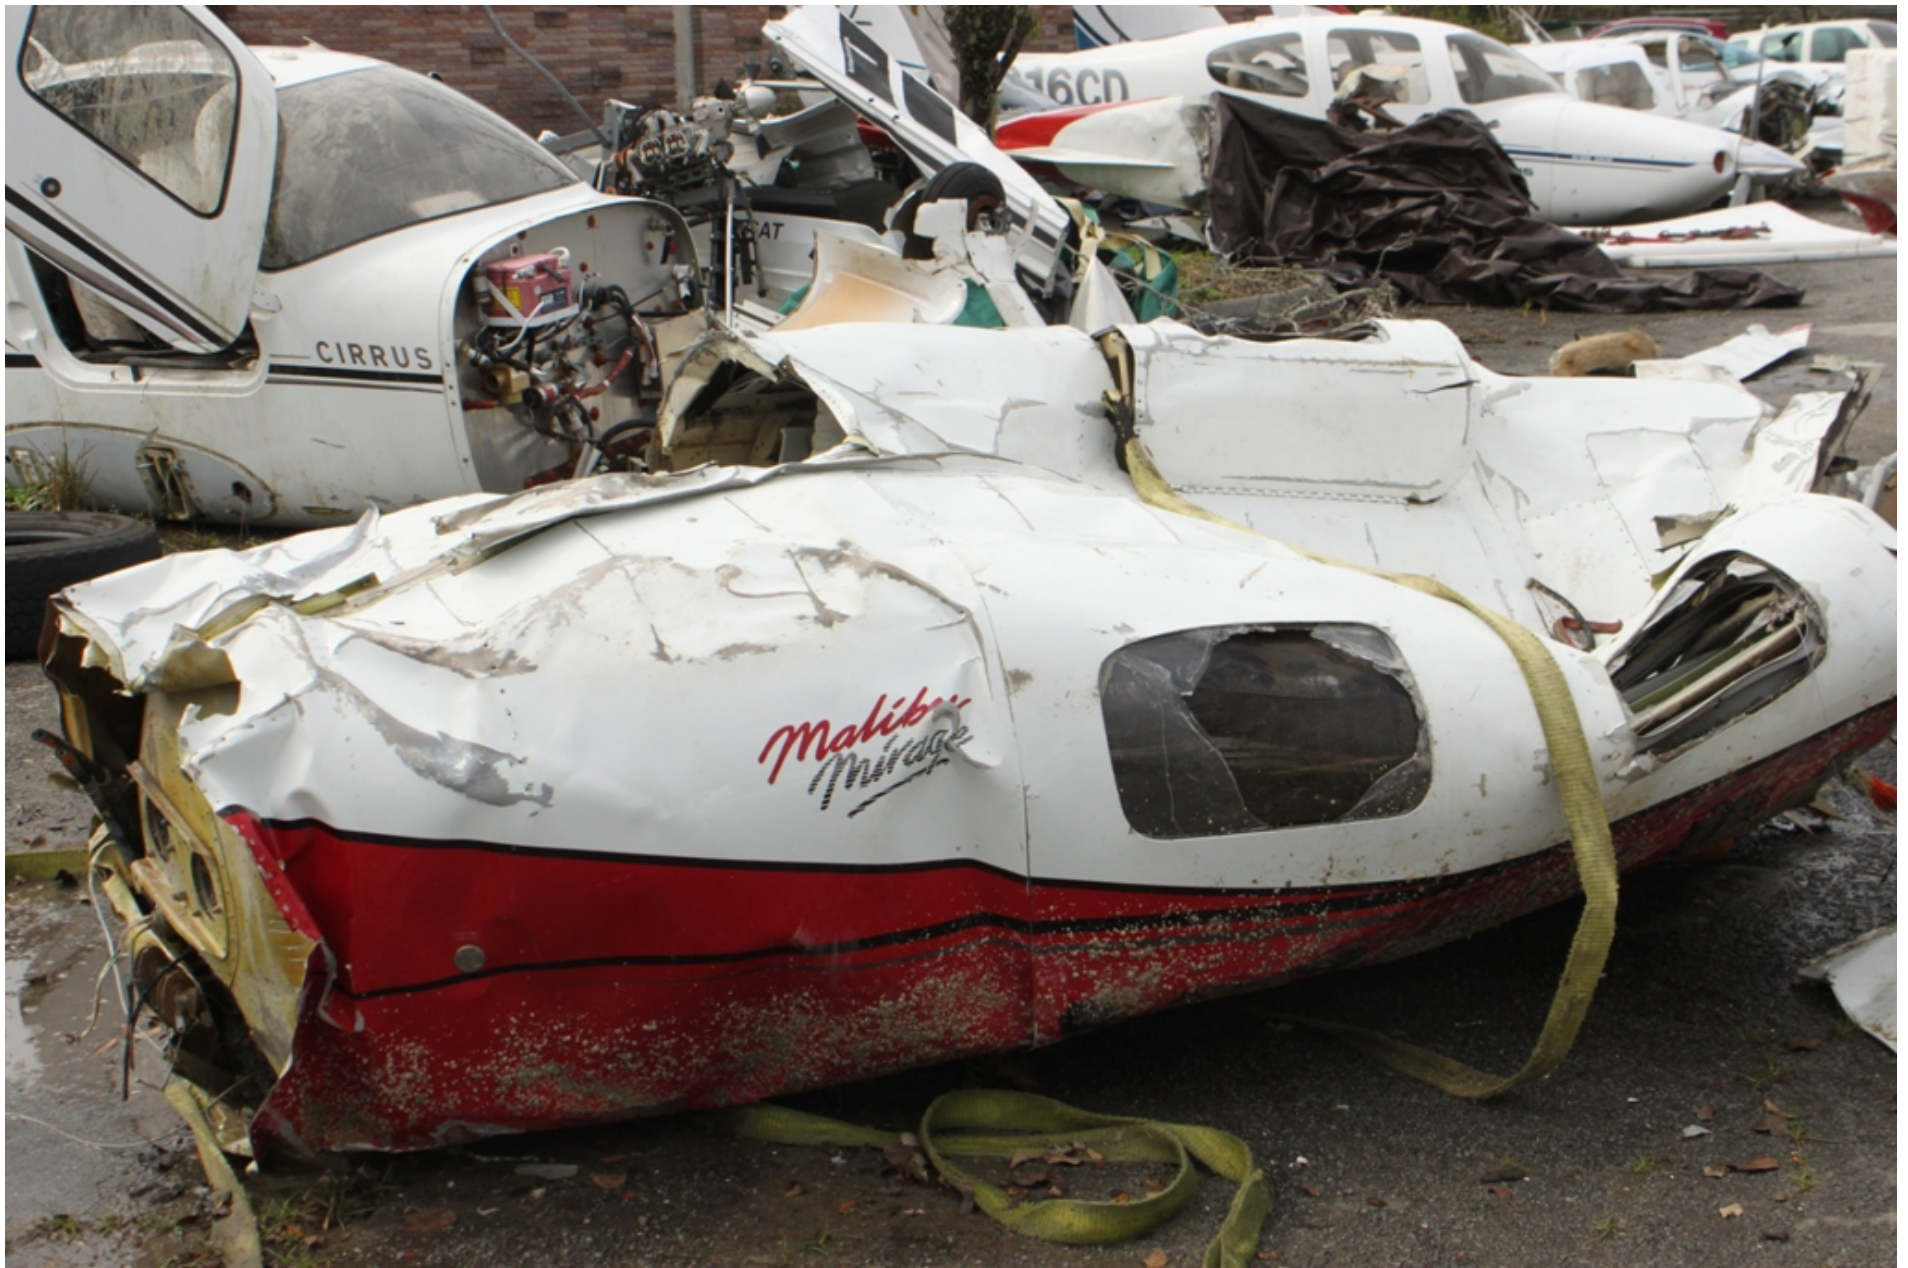
**Photo 7 - NTSB Digital Photograph. View Depicting the Right Side of the Fuselage From the Aft Pressure Bulkhead Forward. Note the Down Crushing on the Fuselage Crown.**

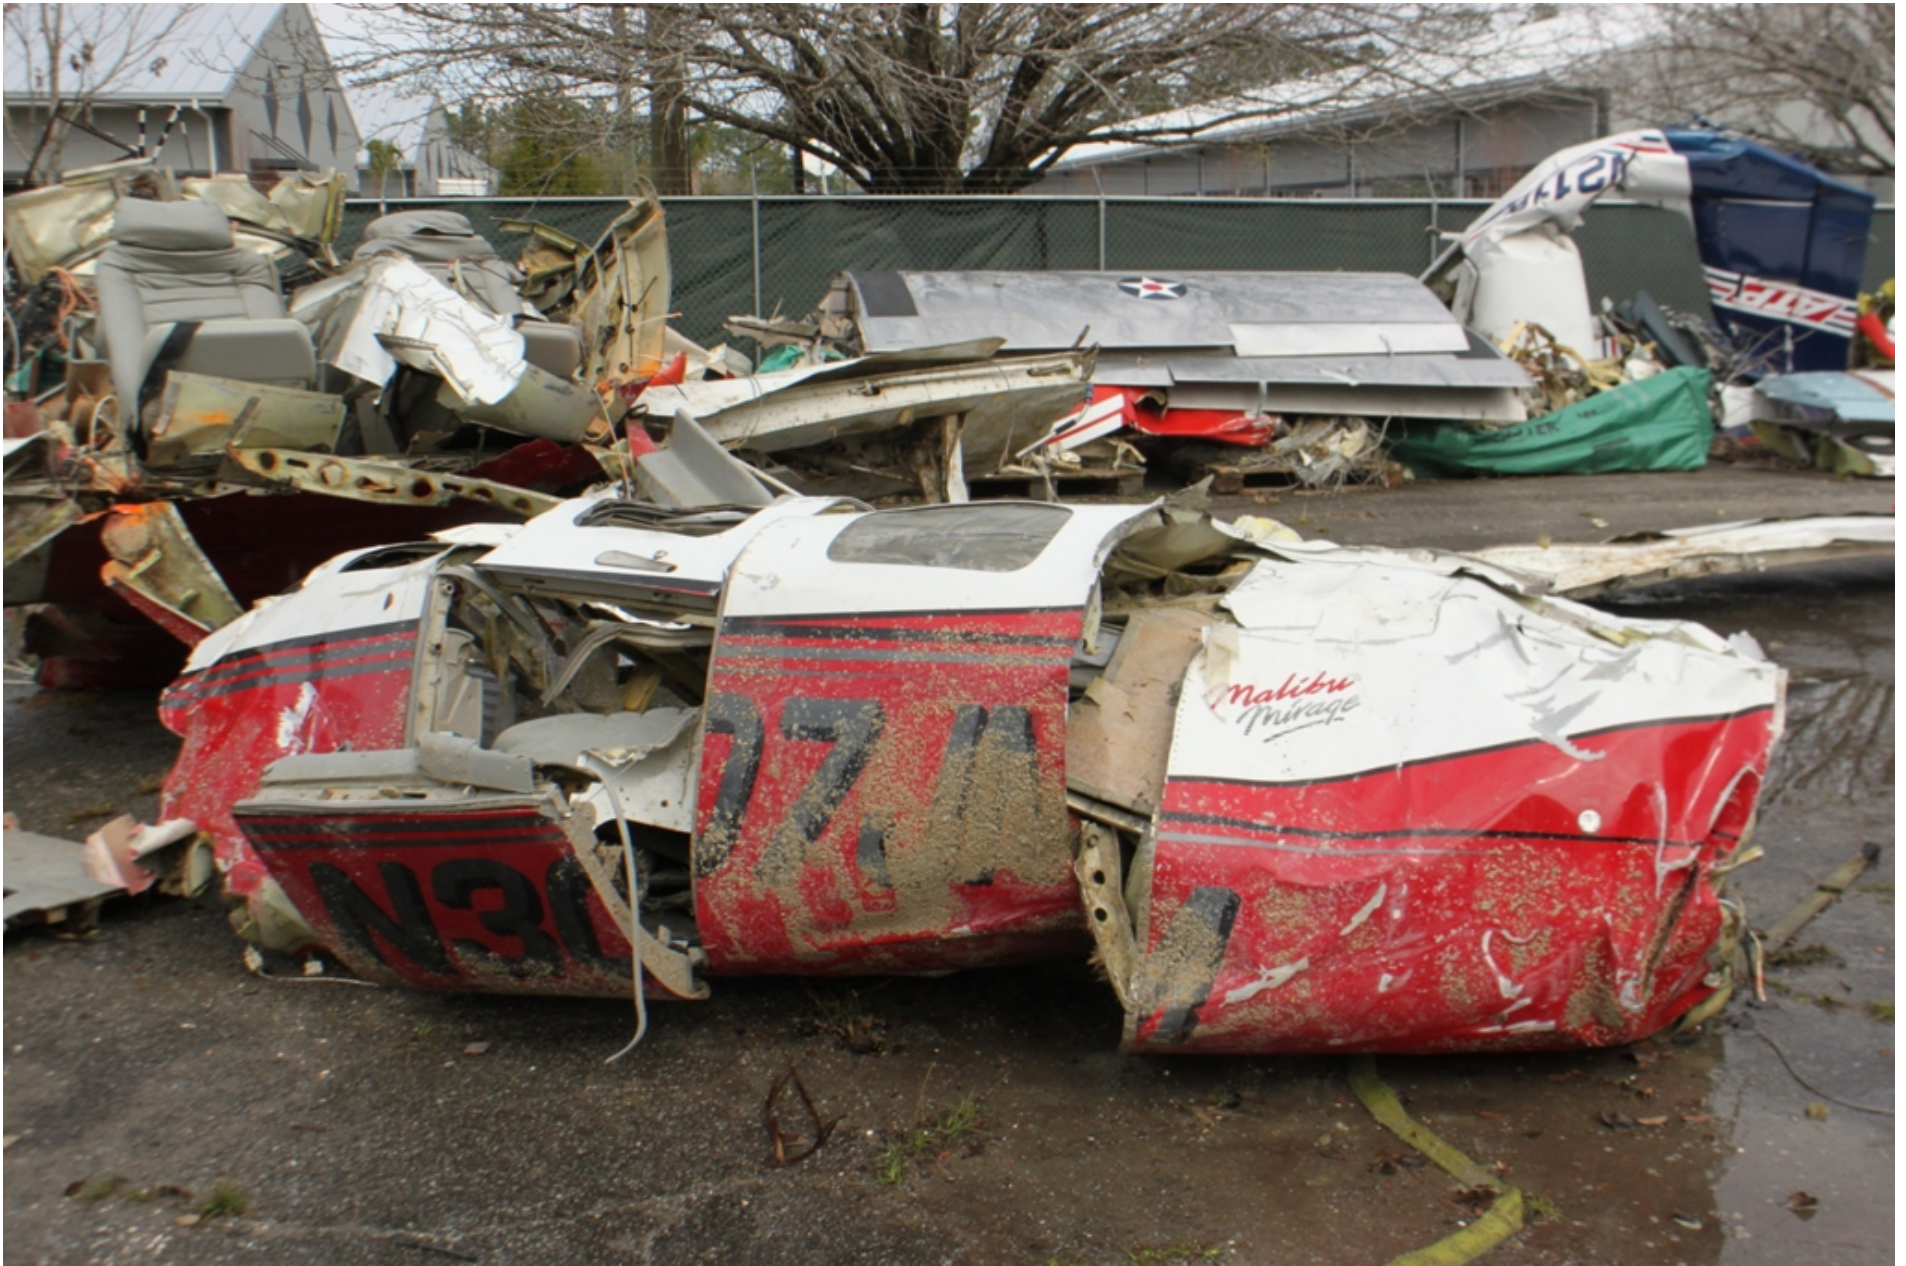
**Photo 8 - NTSB Digital Photograph. View Depicting the Left Side of the Fuselage From the Aft Pressure Bulkhead Forward to Just Forward of the Cabin Entry Door.**

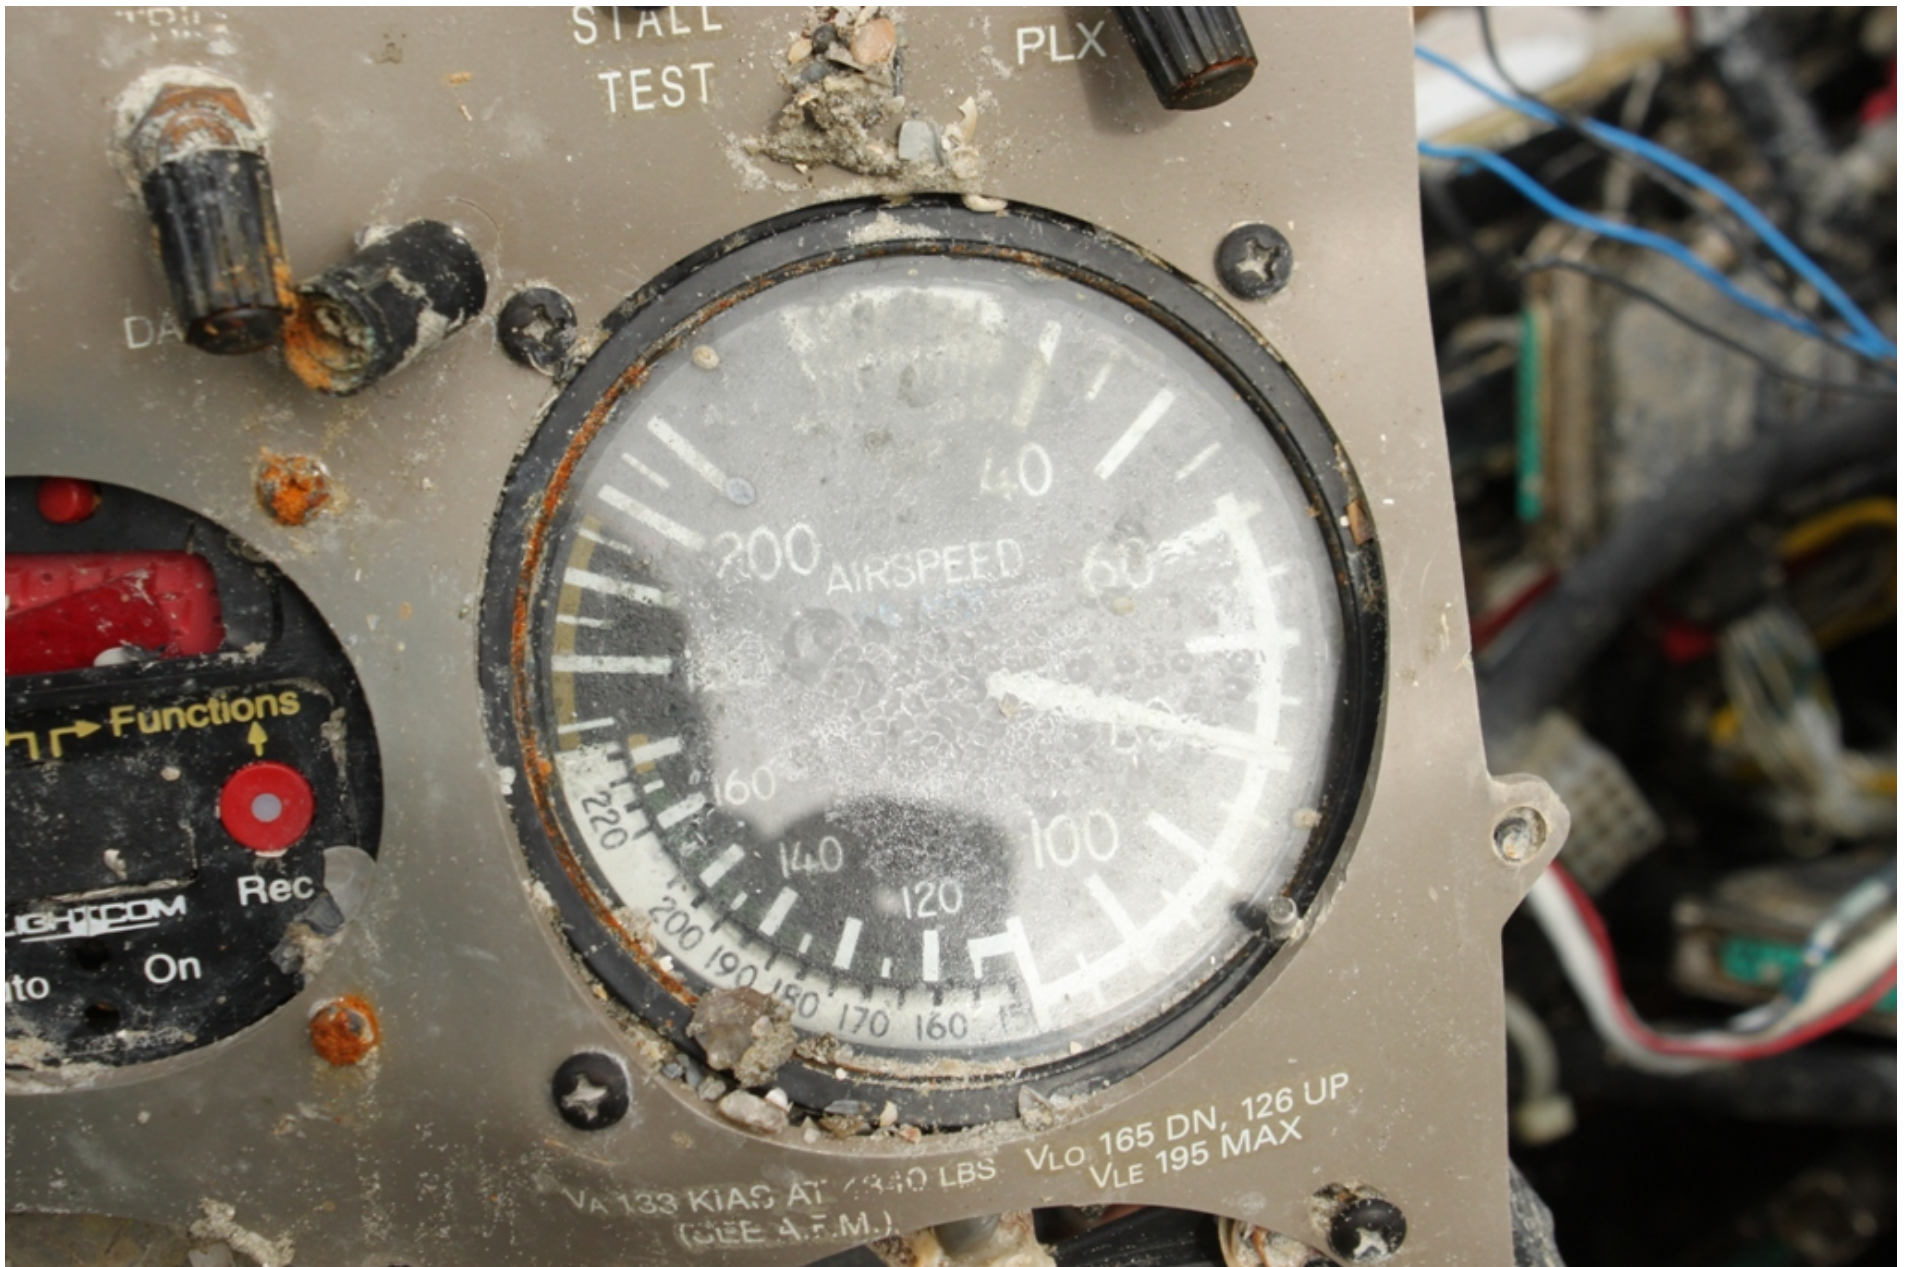
**Photo 9 - NTSB Digital Photograph. View of the Pilot's Side Airspeed Indicator. Needle at 79 Knots.**

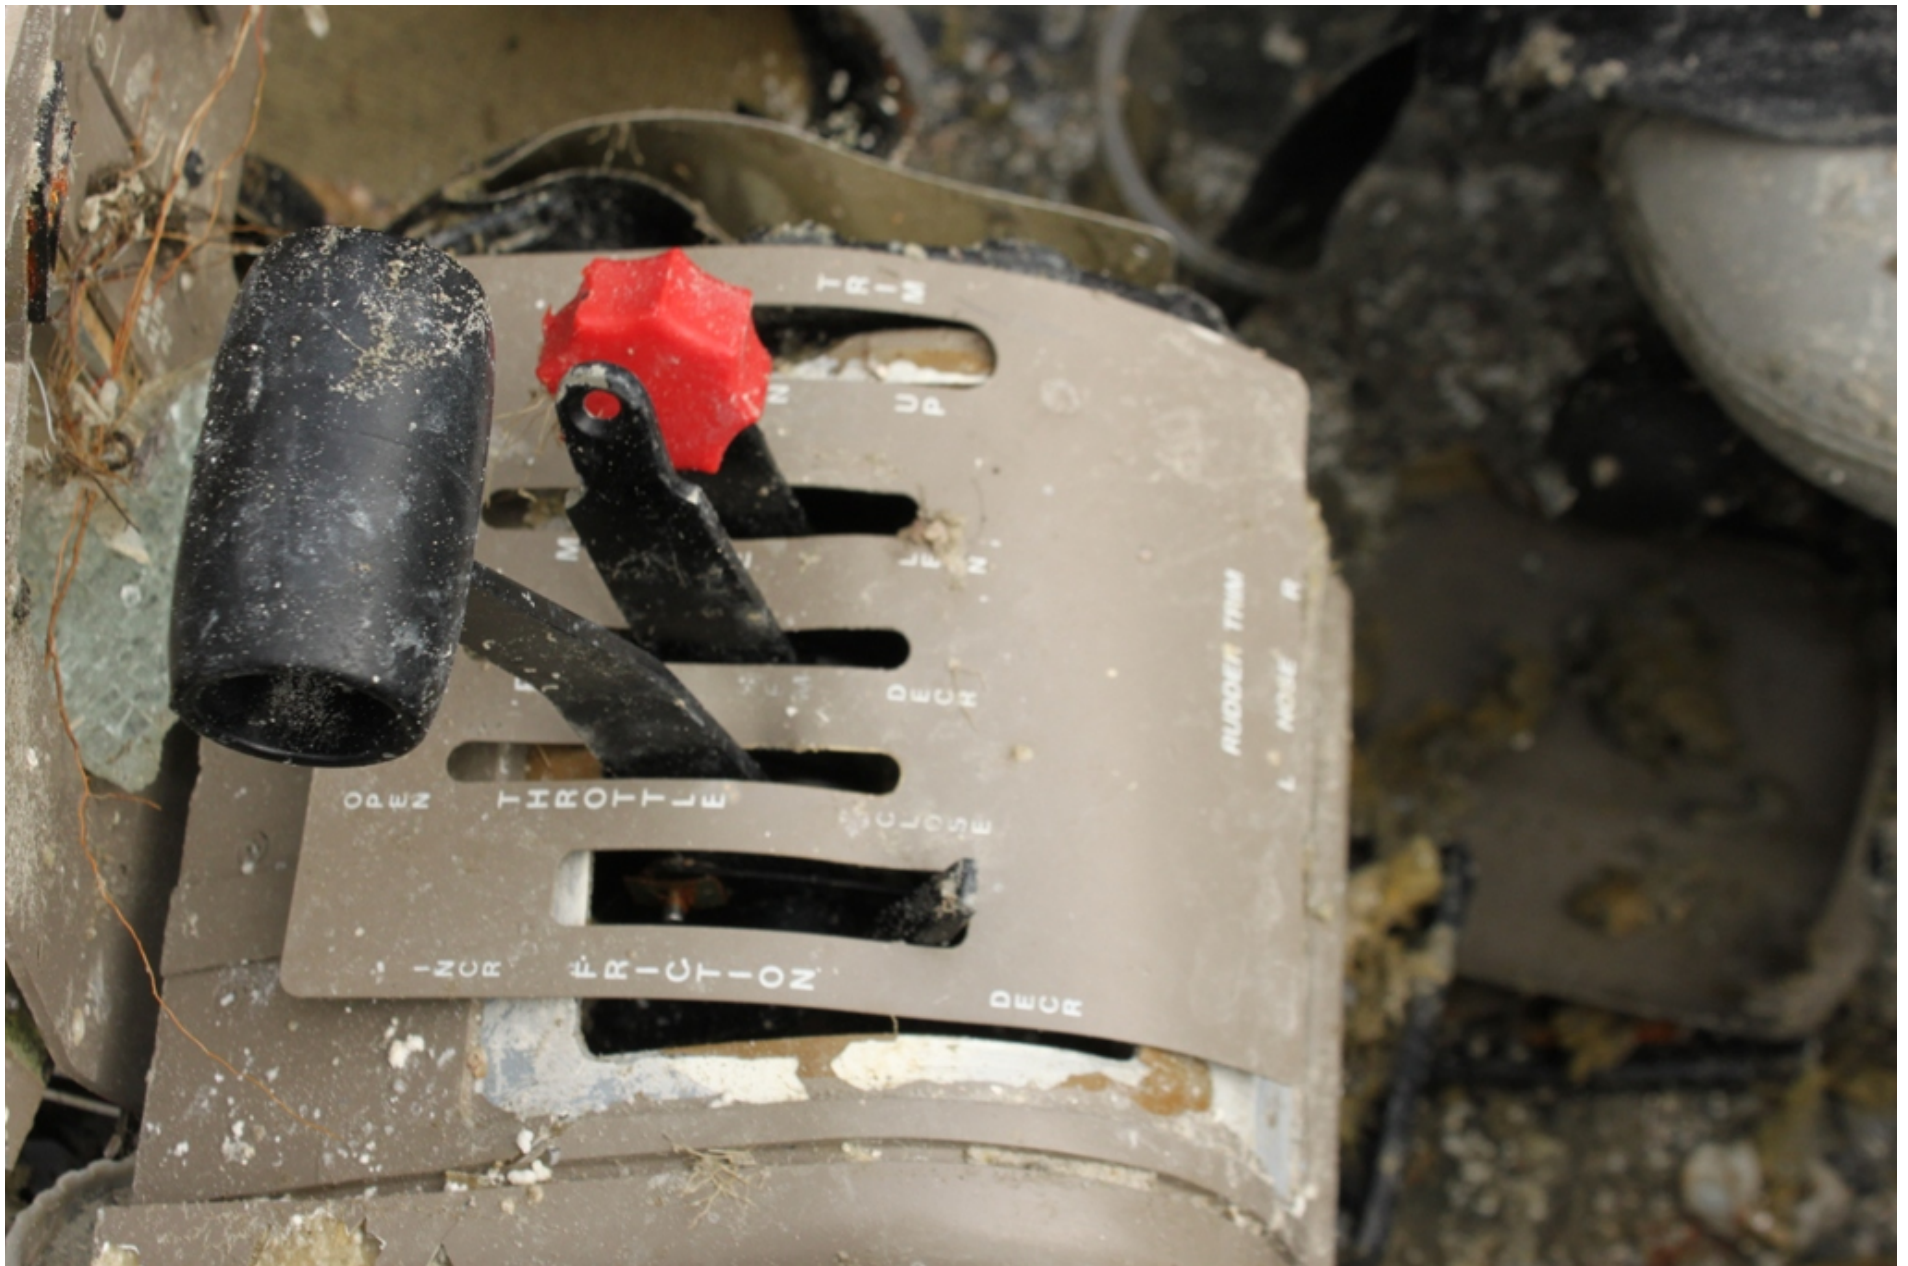
**Photo 10 - NTSB Digital Photograph. View of the Throttle Quadrant.**
