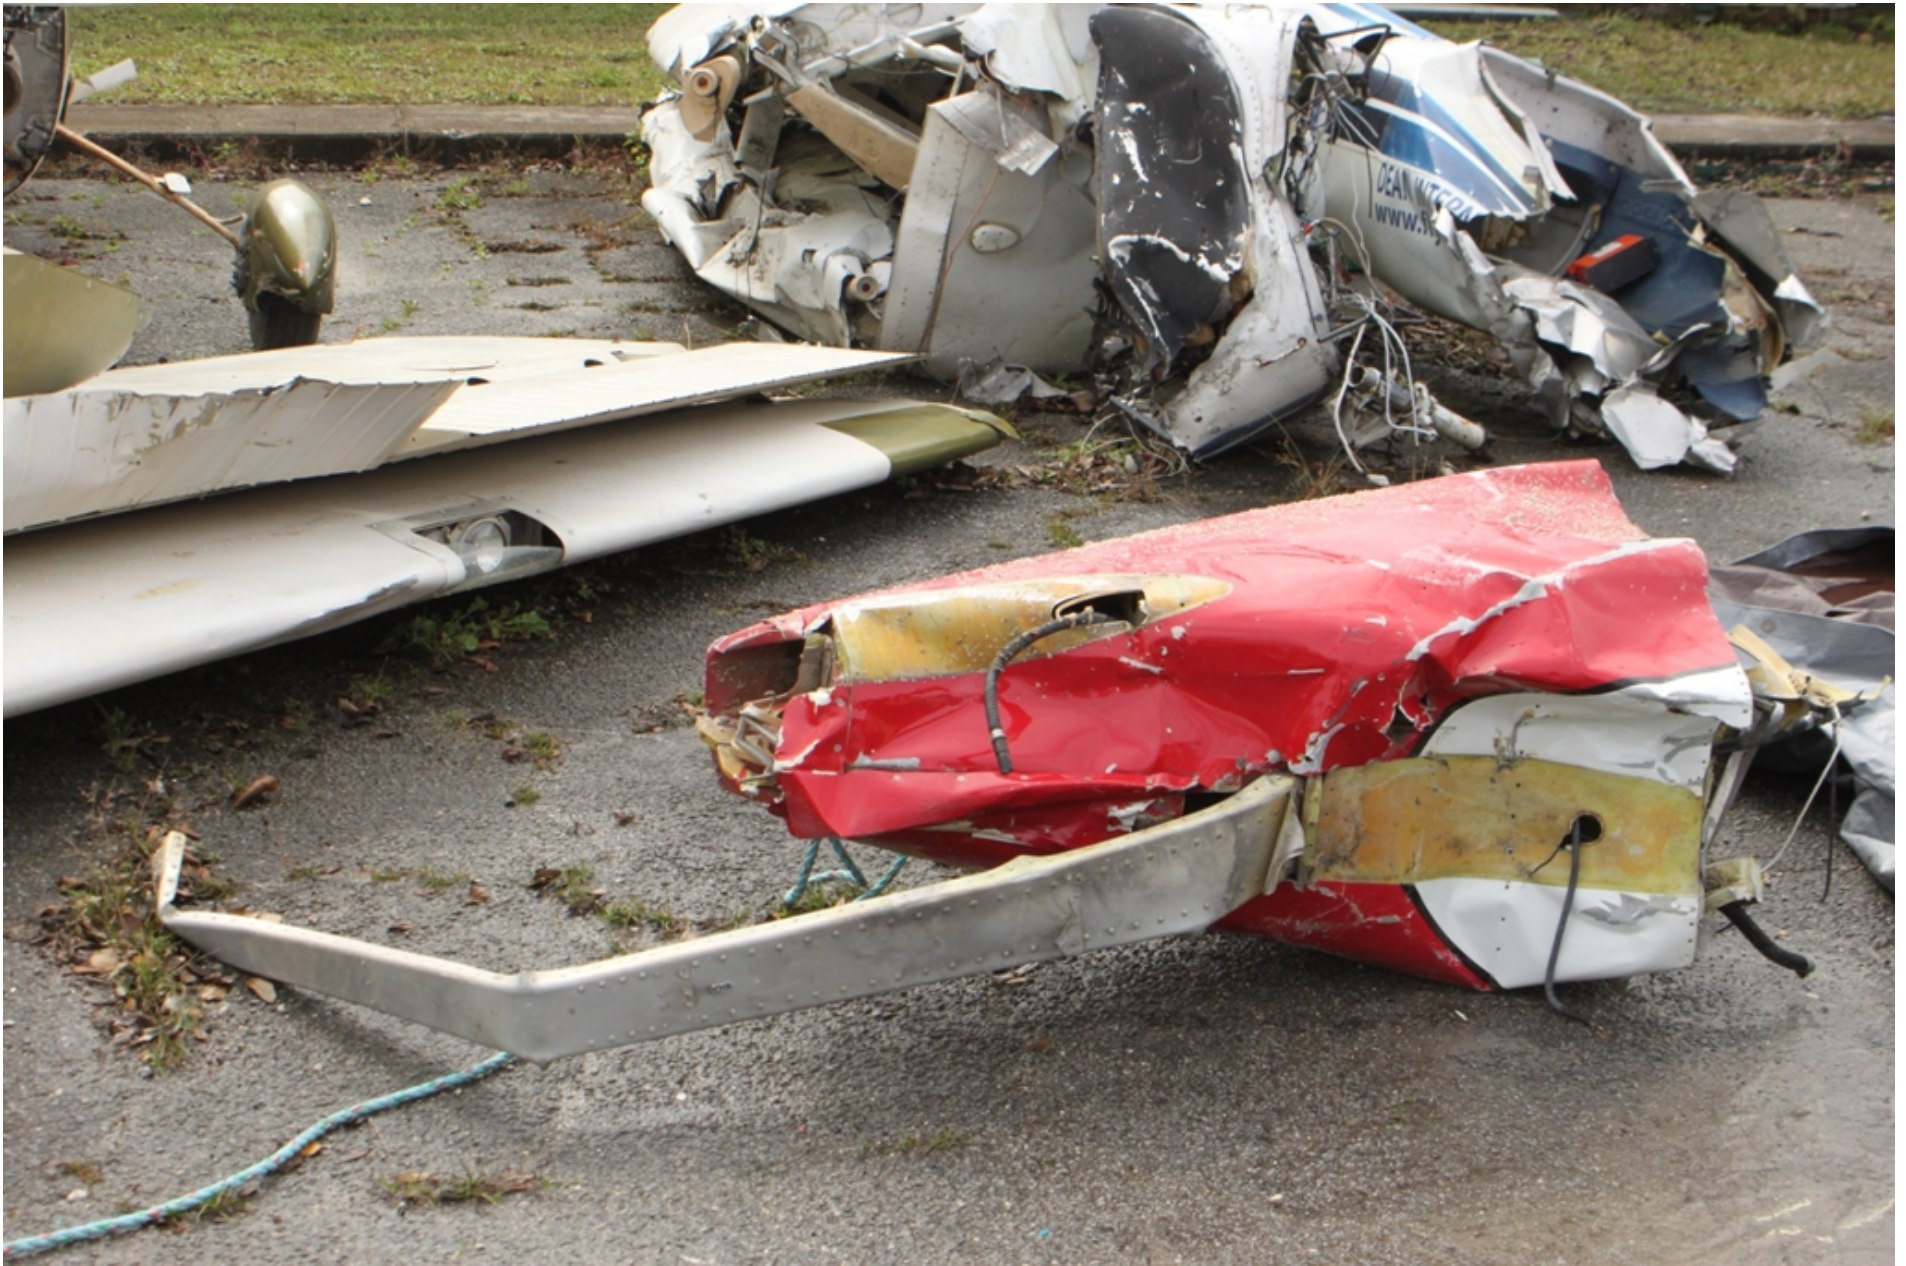
**Photo 11 - NTSB Digital Photograph. View of the Aft Empennage Depicting the Vertical Stabilizer Aft Spar. Note the Separated Horizontal Stabilizer and Elevators, and Majority of the Vertical Stabilizer and Rudder.**

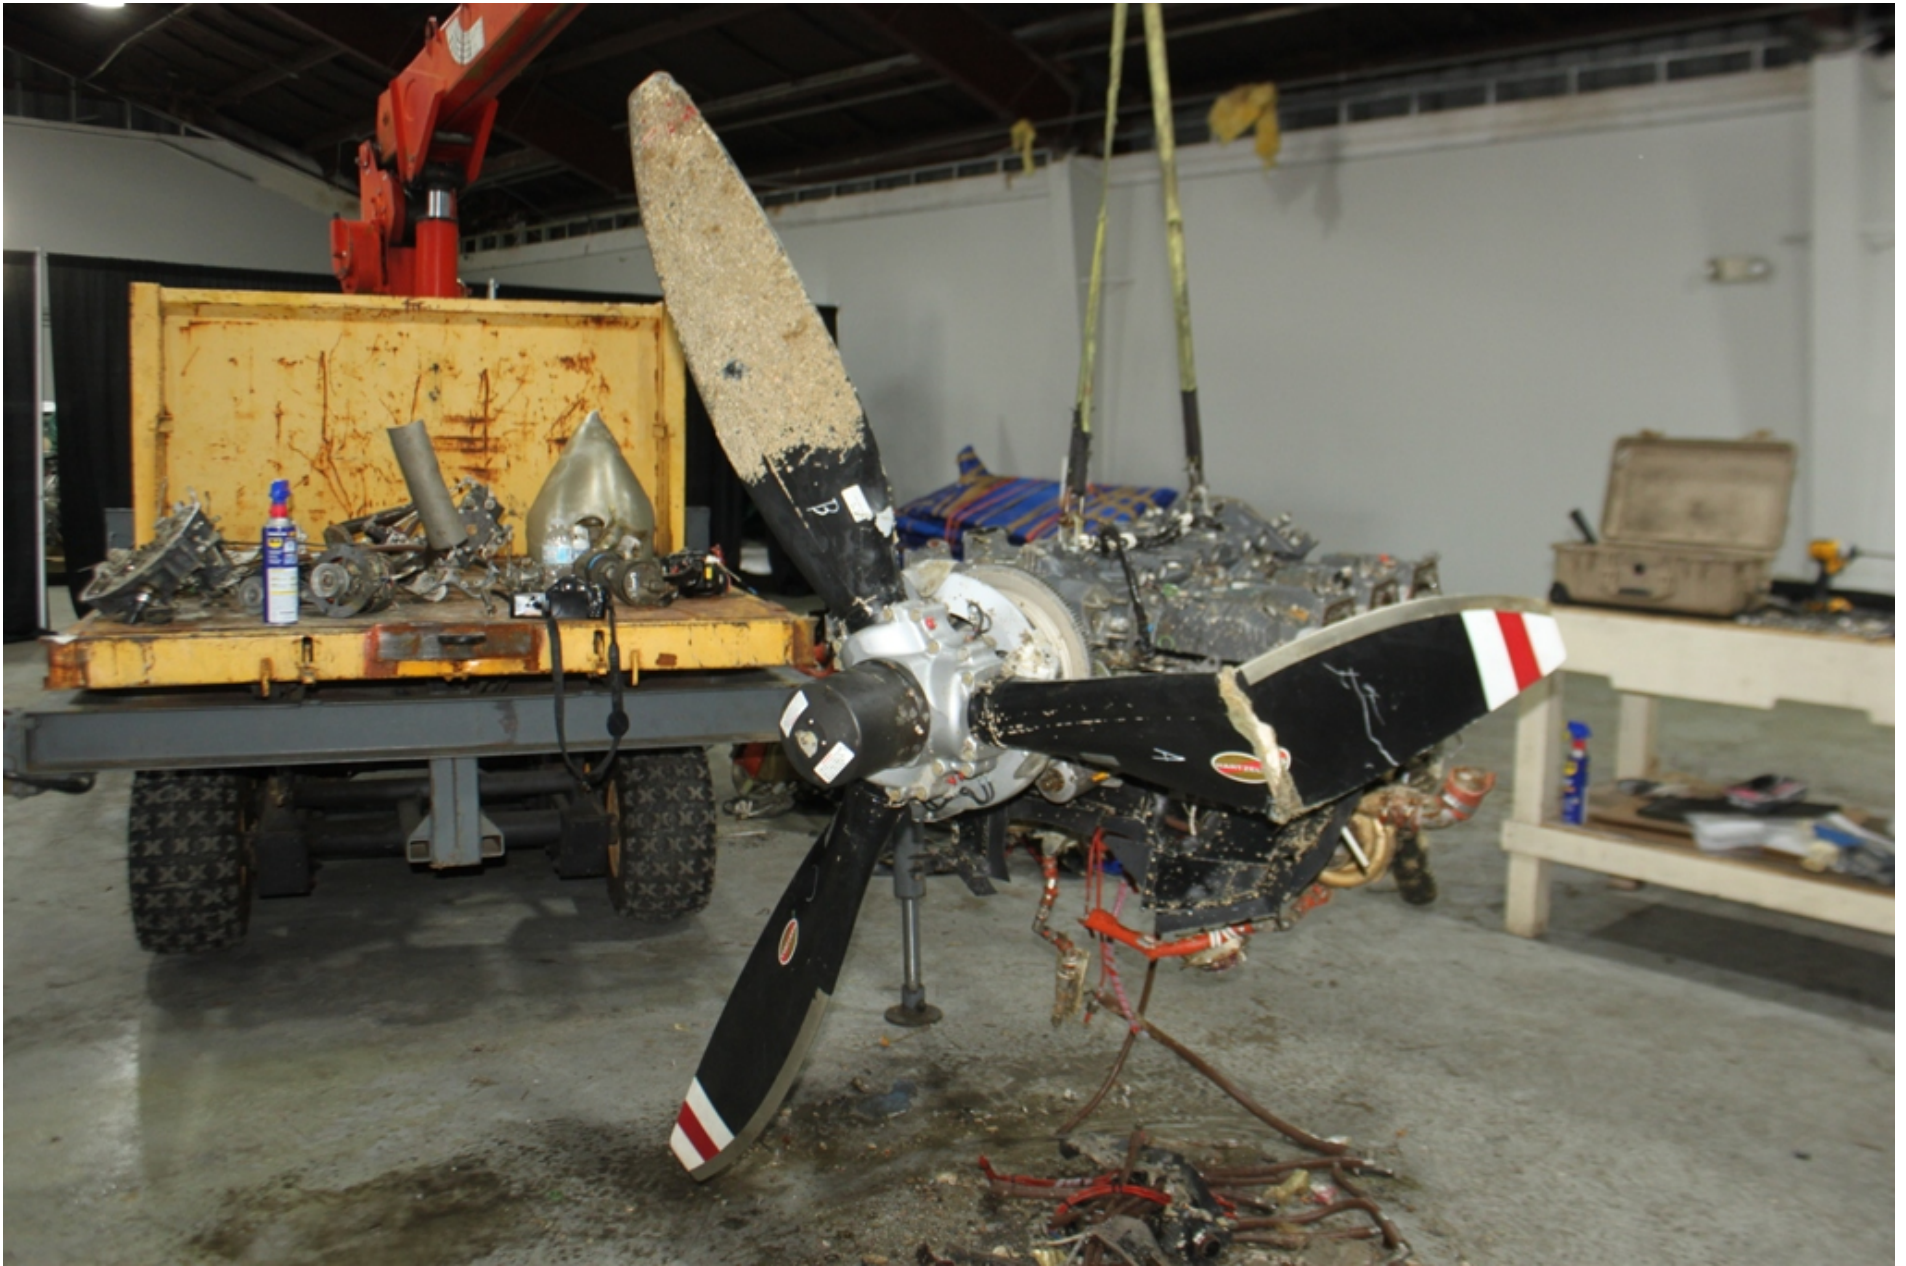
**Photo 12 - NTSB Digital Photograph. Frontal View of the Propeller and Engine Assembly.**

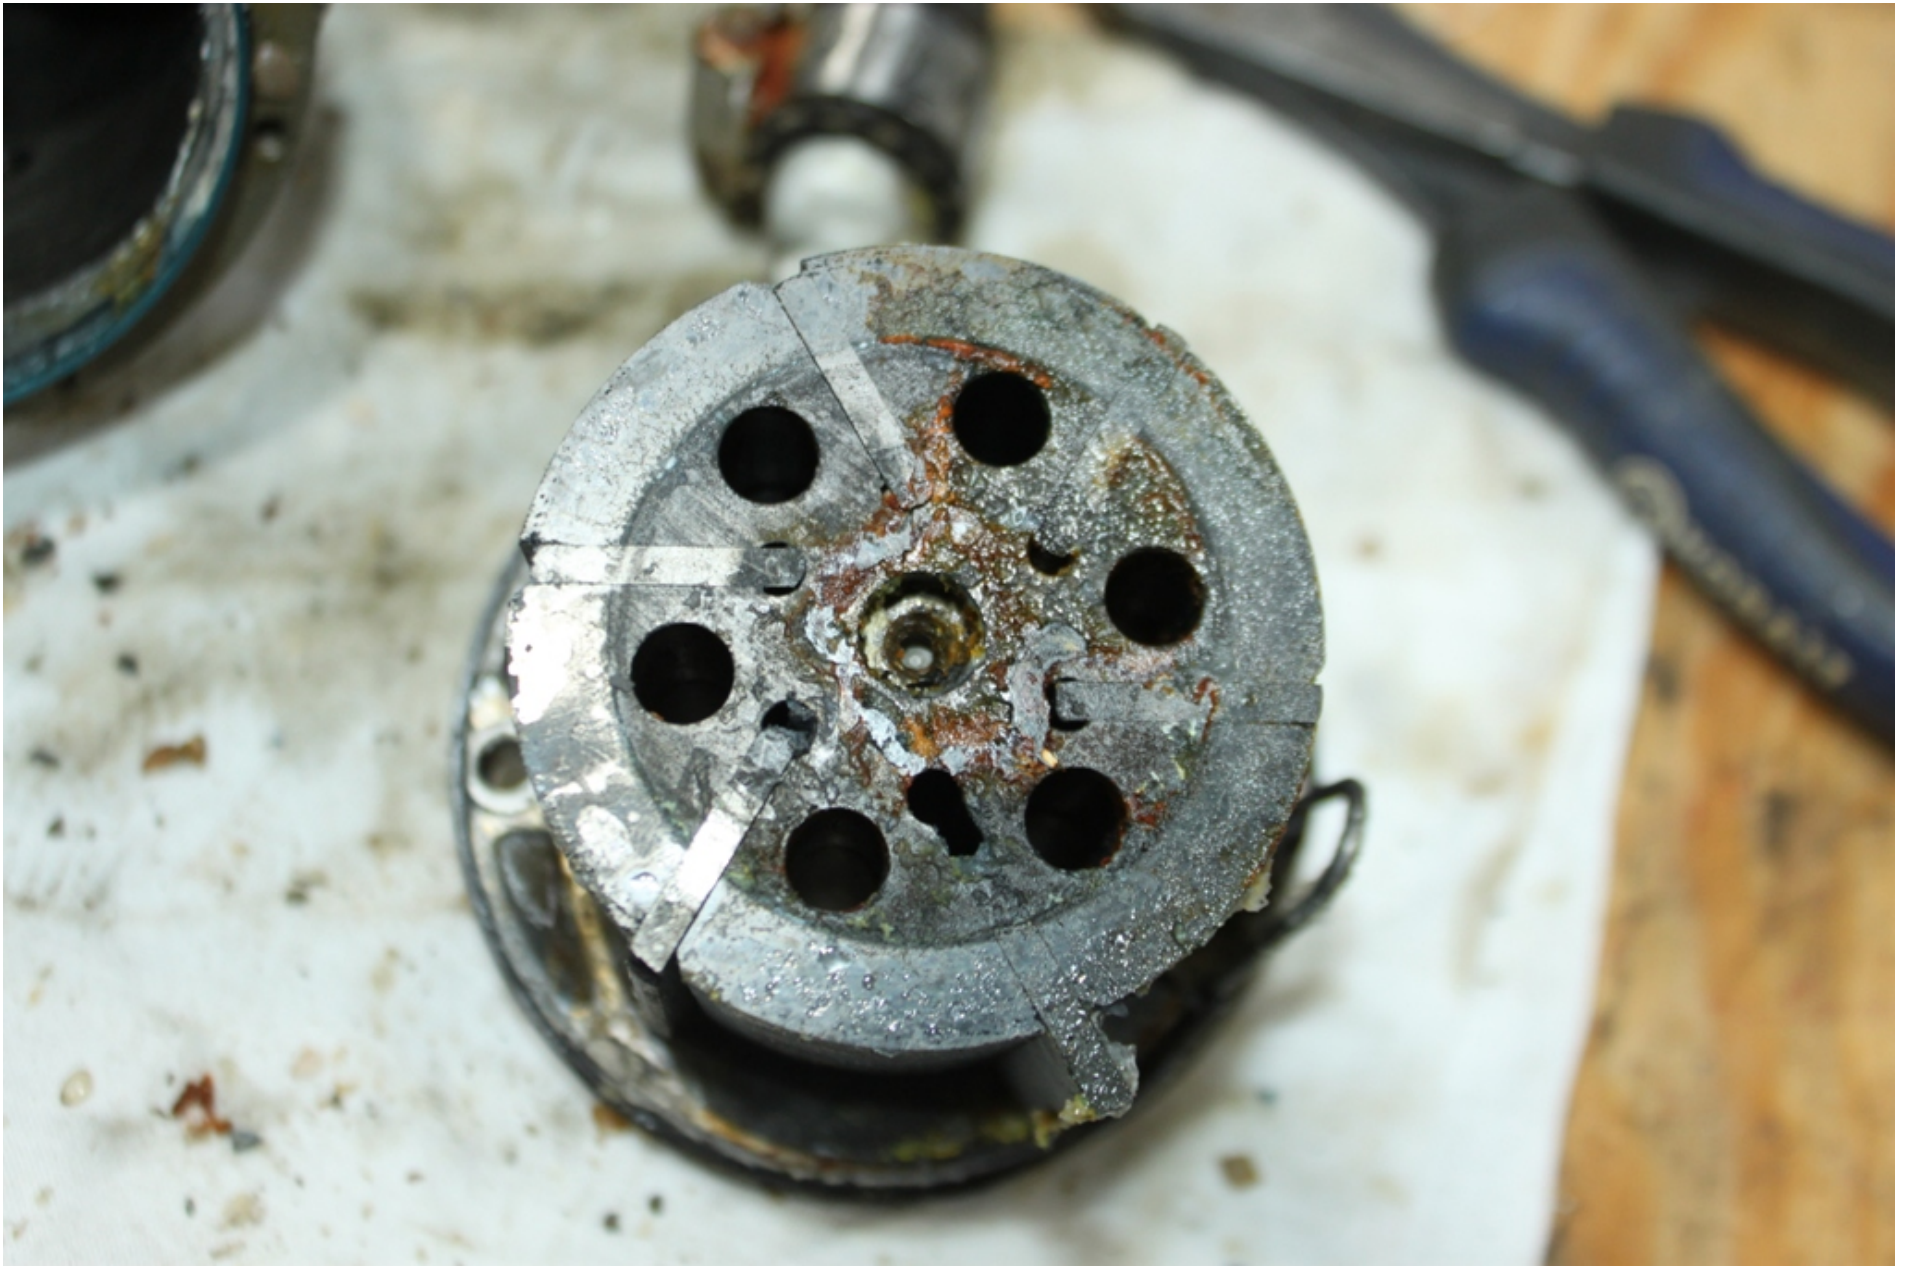
**Photo 13 - NTSB Digital Photograph. View of the Rotor and Vanes From One Engine-Driven Vacuum Pump.**
