# NATIONAL TRANSPORTATION SAFETY BOARD

## MATERIALS LABORATORY FACTUAL REPORT

Report No. 19-033

Place : Mayport, Florida  
Date : December 20, 2018  
Vehicle : Piper PA-46-350P  
NTSB No. : ERA19LA072  
Investigator : Timothy W. Monville, AS-ERA

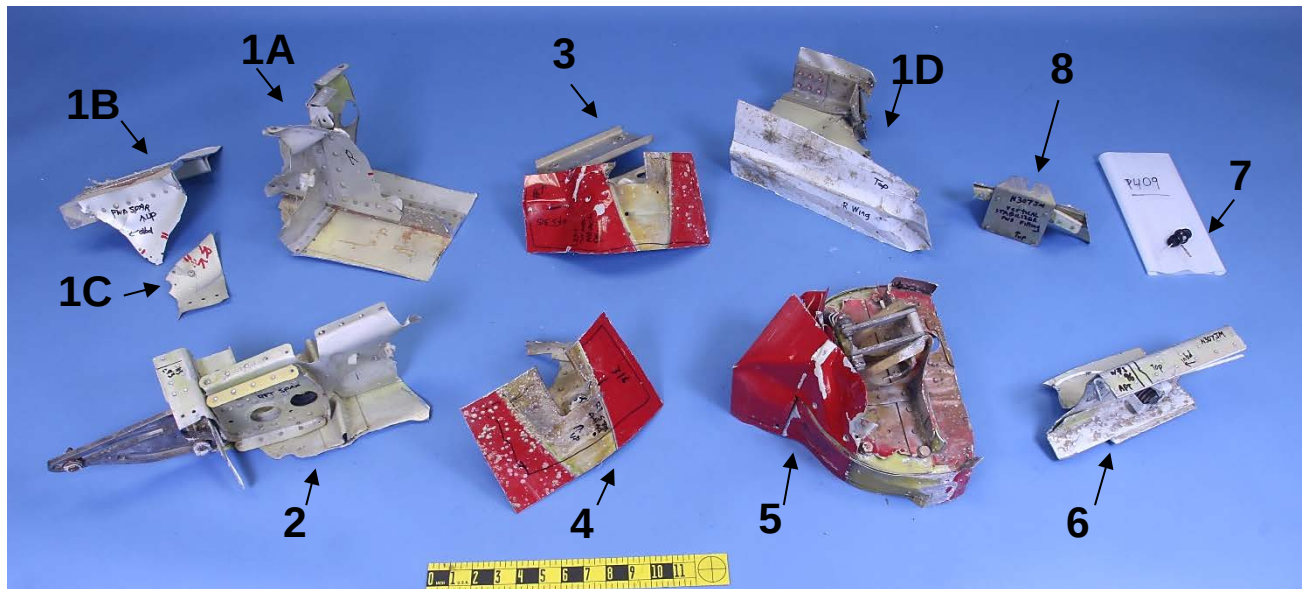
Figure 1 shows a photograph of the as-received pieces of the airplane. The pieces were saw cut on-site from the airplane to facilitate shipping and handling. Description of each item, as marked on each piece, is shown below the figure 1. The metallic pieces were covered with white barnacles and the fracture faces were covered with white oxide deposit consistent with parts that were submerged underwater. The forward spar for the right wing fractured into several pieces. A reconstruction of the forward spar pieces from the right wing is shown in figure 2.

Figure 1. As-received pieces from the airplane.

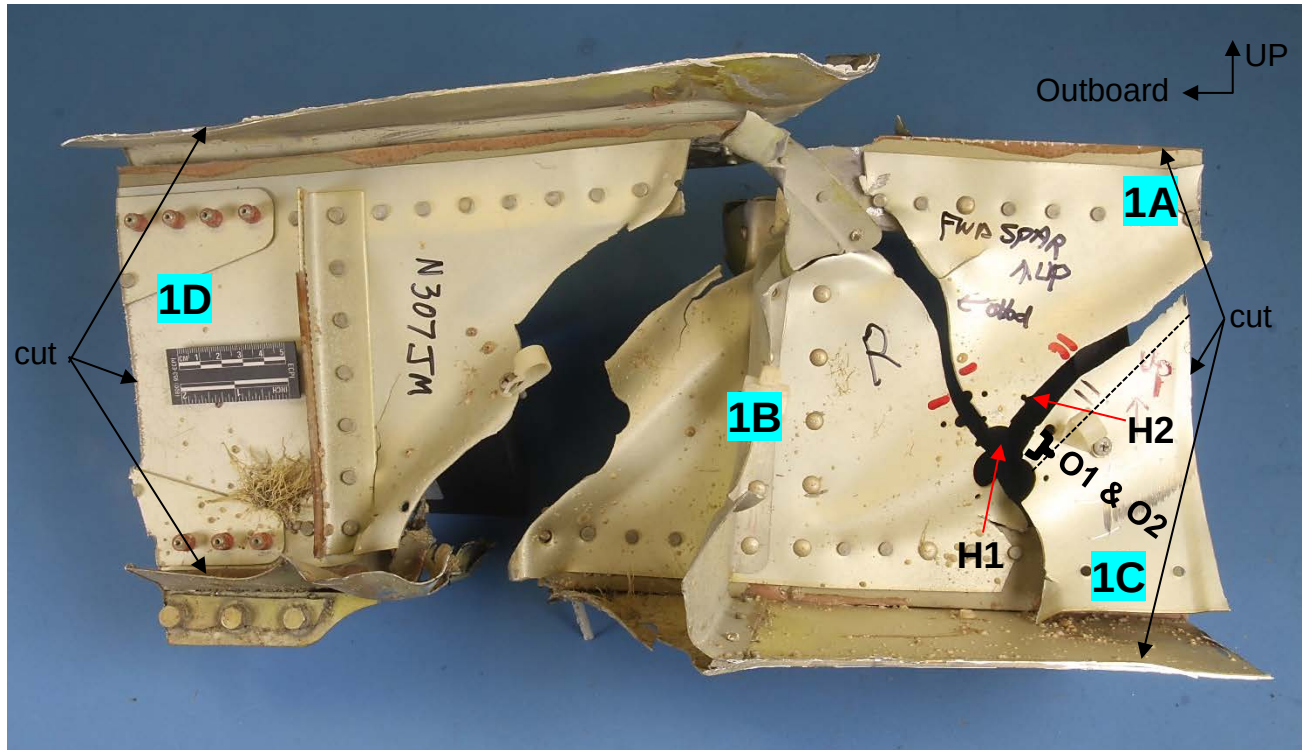
The fracture face from piece "1C" was saw cut from the larger piece, along the areas indicated by a dashed line in figure 2, to facilitate examination of the fatigue crack portions. The fracture face "1C" was immersed in a chromic-phosphoric acid solution at elevated temperature to remove oxide scale.<sup>1</sup> Scanning electron microscope examination of fracture face "1C" revealed each of the two flat fracture regions contained barely discernable crack

Figure 2. Close-up photograph of a portion of the forward spar for the right wing showing the forward face of pieces "1A" through "1D", as if they were intact.

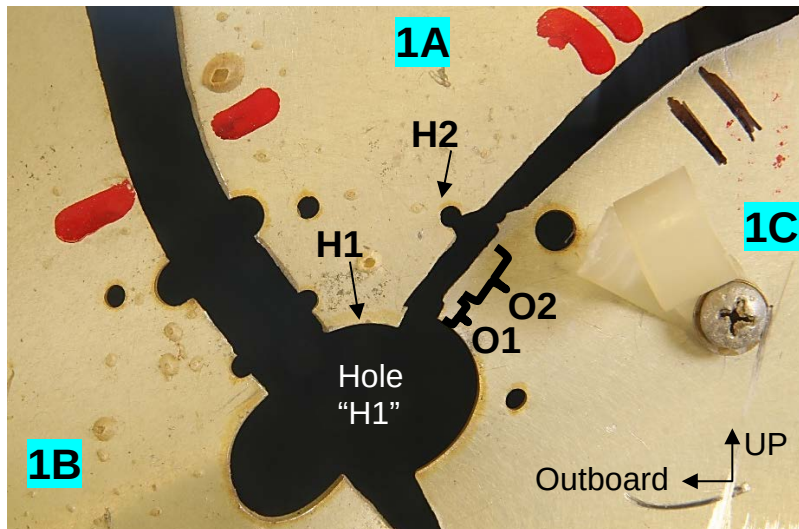
Bench binocular microscope examination of all the as-received pieces revealed they contained fractures on a slant plane with coarse fracture features consistent with overstress separation with the exception of the web on the spar for the right wing that contained two adjoining isolated areas on a flat plane consistent with fatigue cracking, in the areas indicated by brackets "O1" and "O2" in figures 2 and 3. The fatigue cracks emanated from the aft face of the web and intersected the two holes in the web, indicated by brackets "H1" and "H2" in figures 2 and 3. The fatigue cracks propagated in the general direction indicated by arrows in figure 4. The length of fatigue crack "O1" measured approximately 0.09 inch, and the length of fatigue crack "O2" measured approximately 0.4 inch.

Figure 3. Close-up photograph of the forward face of the web from the right wing that contained two adjoining fatigue cracks indicated by a brackets "O1" and "O2". The fatigue cracks emanated from the aft face of the web and intersected the two holes in the web, indicated by arrows "H1" and "H2". The larger hole "H1" had fractured into three arc segments.

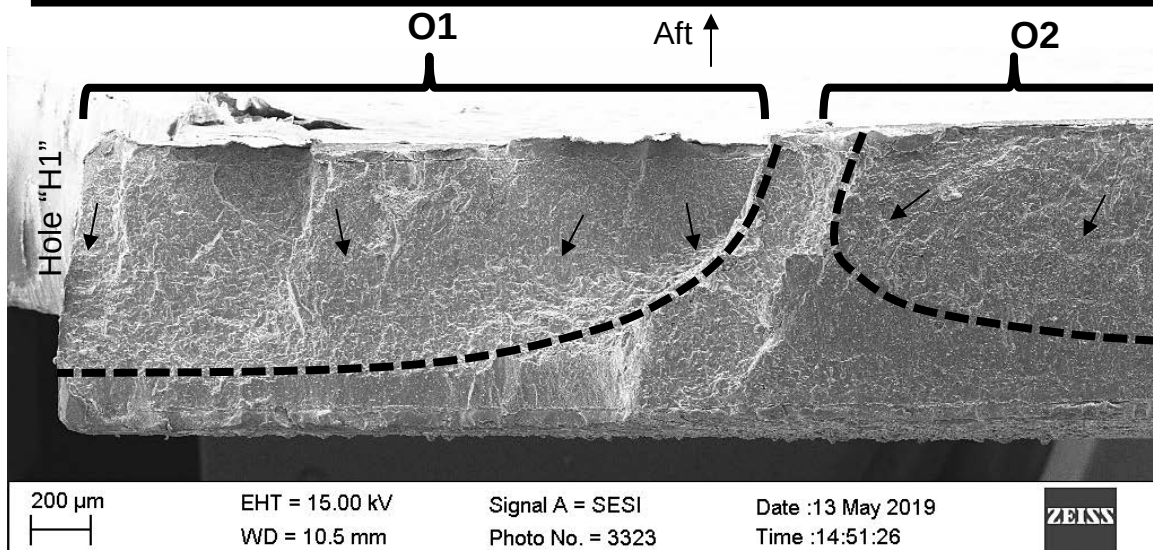
arrest marks (see figure 5) consistent with fatigue cracking that emanated from the aft face of the web. Fatigue crack "O1" extended through approximately 80% of the wall thickness, in the general direction indicated by arrows in figures 4 and 5, to the approximate areas indicated by dashed lines in figure 4. Fatigue crack "O2" extended through approximately 60% of the wall thickness to the areas indicated by dashed lines in figures 4 and 6. Figures 4 and 6 show partial views of fatigue crack "O2". The fracture areas located outside of the fatigue regions exhibited coarse texture fracture features on a slant plane consistent with overstress separation.

Figure 4. SEM photograph of fatigue crack “O1” and portion of fatigue crack “O2” that emanated from the aft face of the web, after cleaning with chromic acid cleaning solution. Arrows show general direction of fracture propagation. Fatigue cracks terminated approximately in the general area indicated by dashed lines.

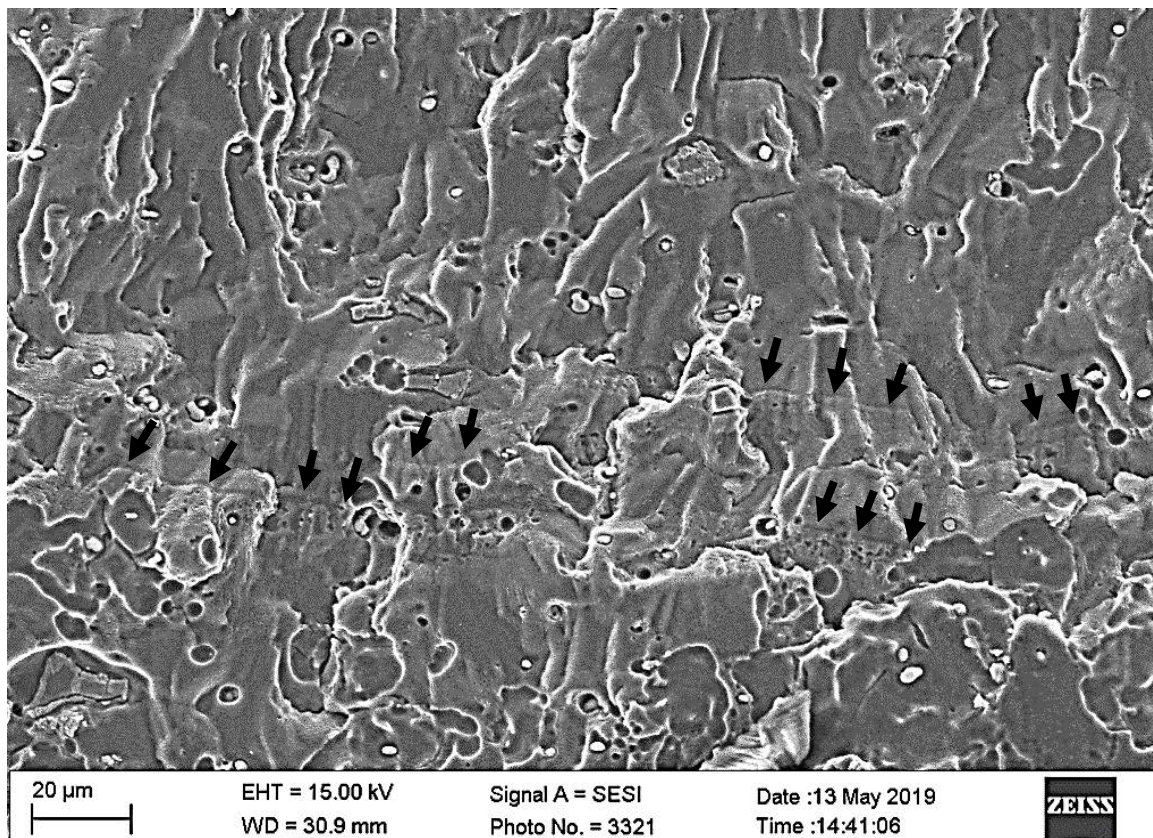
Figure 5. SEM photograph of fatigue origin “O1” showing barely discernable fatigue striations near the fatigue origin, after chromic acid cleaning. Arrows indicate location of several crack arrest marks and they also show the general direction of fracture propagation.

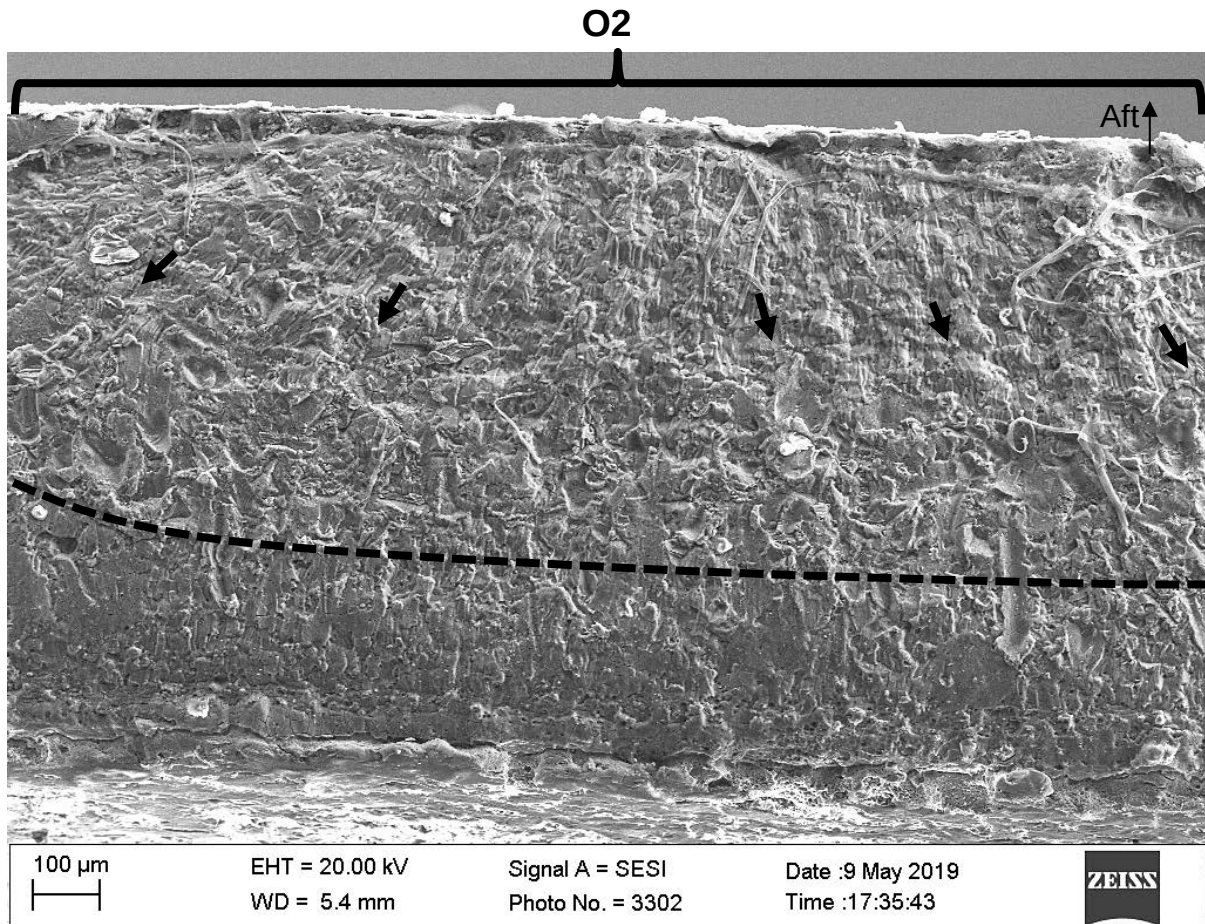
Figure 6. SEM photograph of portion of fatigue crack “O2” showing the fatigue origin, as-received condition prior to cleaning. Arrows show general direction of fracture propagation. Fatigue terminated approximately in the general area indicated by dashed lines.

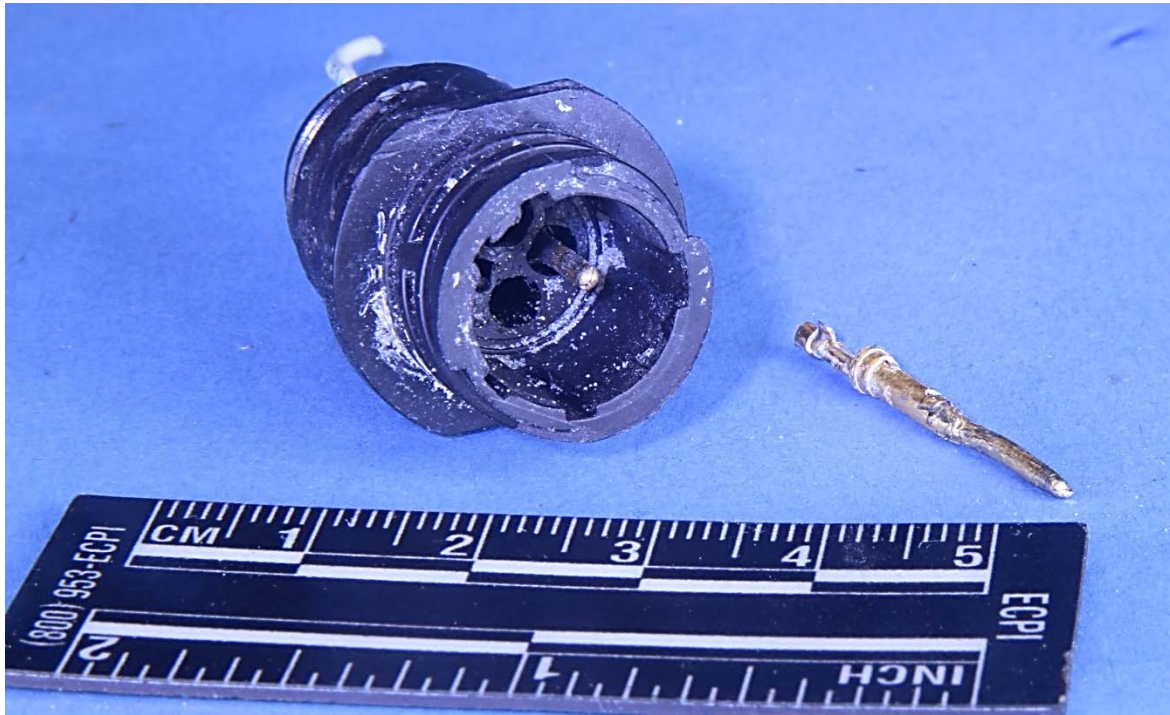
Examination of the electric socket assembly, indicated by arrow item 7 in figure 1, revealed an electrical pin separated from the socket assembly, see figure 7. Bench binocular microscope examination of the electric socket assembly revealed the holes for the pin contained deformation damage consistent with a pin that was forcefully pulled out from the socket.

Figure 7. Electric socket assembly (left side) and separated electrical pin (right side). These parts were received in a plastic bag labelled "P409".
