# NATIONAL TRANSPORTATION SAFETY BOARD

**MATERIALS LABORATORY FACTUAL REPORT – ADDENDUM**

Report No. 19-033

Place : Mayport, Florida  
Date : December 20, 2018  
Vehicle : Piper PA-46-350P  
NTSB No. : ERA19LA072  
Investigator : Timothy W. Monville, AS-ERA

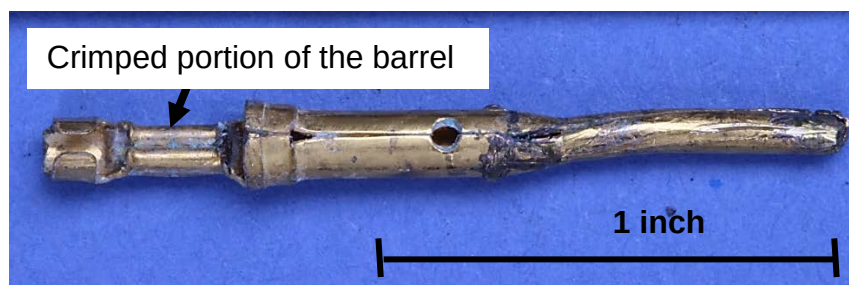
“Figures 8 shows a close-up photograph of the as-received #2 electrical pin. The pin was an open barrel type. Bench binocular microscope examination of the electrical #2 pin revealed the fractured end of a copper cable was attached (crimped) to the barrel portion of the pin. The copper cable contained multiple wire strands. The multiple wire strands were fully inserted into the barrel portion and they fractured outside of the crimped portion of the barrel. Scanning electron microscope examination of the electrical pin revealed the fractured ends of the wire strands were on a slant plane consistent with a cable that fractured from overstress separation. Figures 9 and 10 show photographs of the fractured wire strands that were retained within the crimped barrel portion.”

Figure 8. Close-up photograph of electrical #2 pin showing the crimped portion of the barrel.

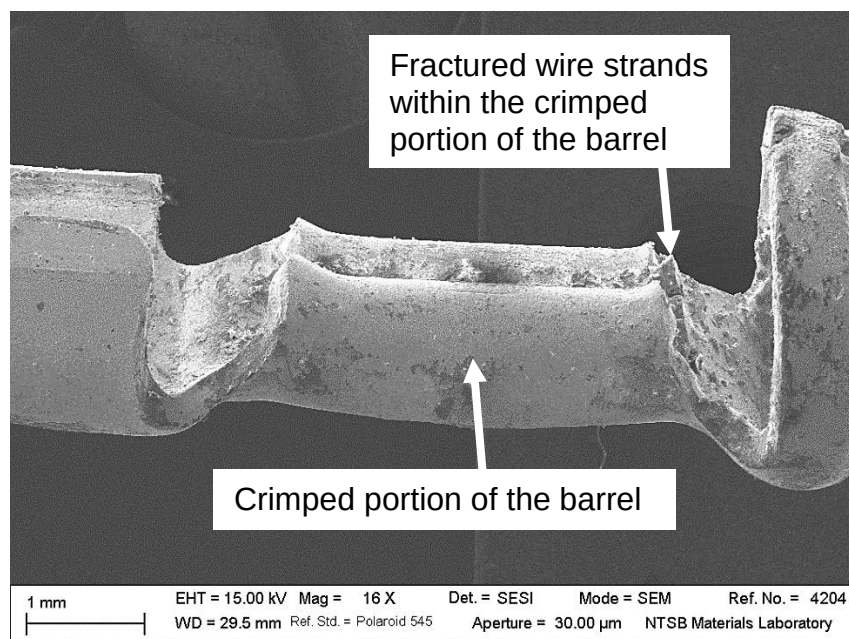
Figure 9. SEM photograph of the crimped portion of the barrel showing fragments of fractured wire strands that were retained within the crimped portion.

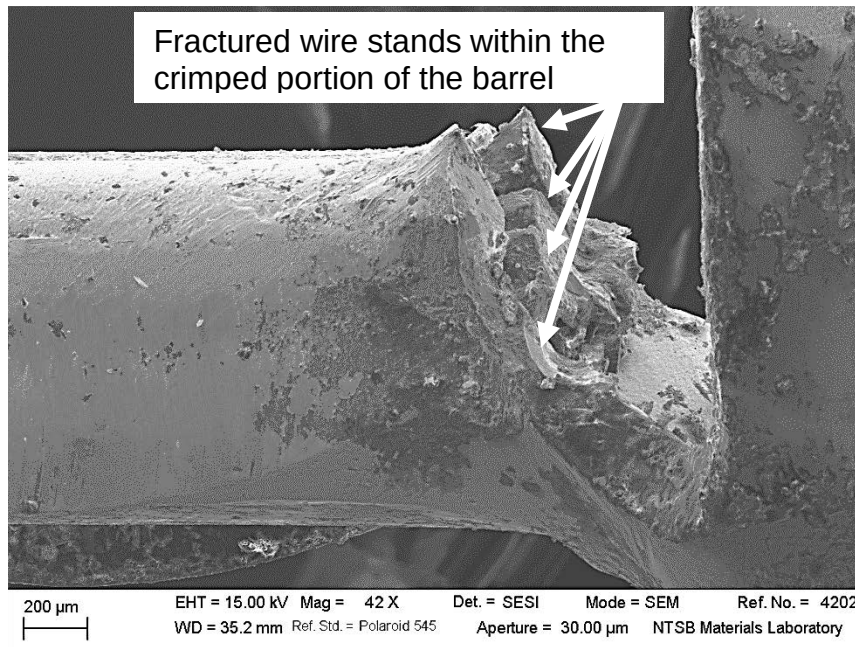
Figure 10. SEM photograph of the crimped portion of the barrel pin showing a higher magnification view of several fractured wire strands that were retained within the crimped portion.
